**MT. STEPHEN  
REMOTE AVALANCHE CONTROL SYSTEMS**

**PRELIMINARY GEOTECHNICAL AND  
GEOHAZARDS ASSESSMENT**

PROJECT NO.: 1572-002  
DOCUMENT NO.: N/A

DATE: January 25, 2019

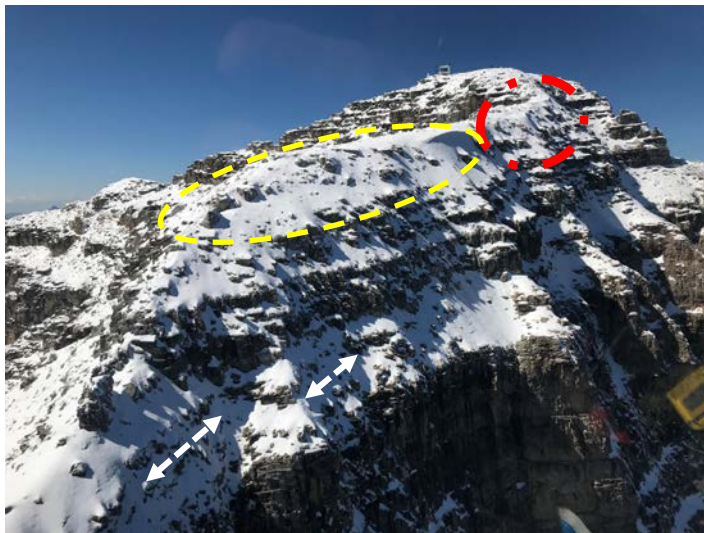
**Photograph B2.**  
**Summit East and West Locations**

Looking west at potential summit RACS locations along the eastern side of the ridgeline illustrated by the yellow dashed line (Summit East).

Potential Summit West locations illustrated by the red dot dash line.

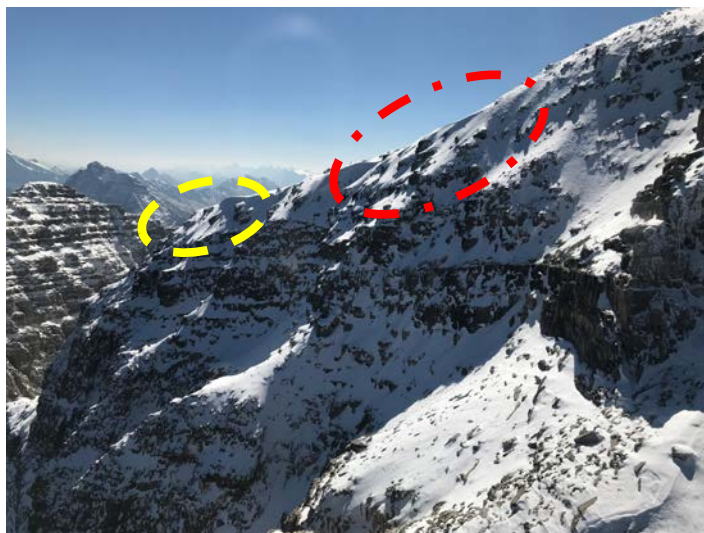
**Photograph B3.**  
**Summit East and West Locations**

Looking south at potential summit RACS locations along the eastern side of the ridgeline illustrated by the yellow dashed line (Summit East) and the red dot dash line (Summit West).

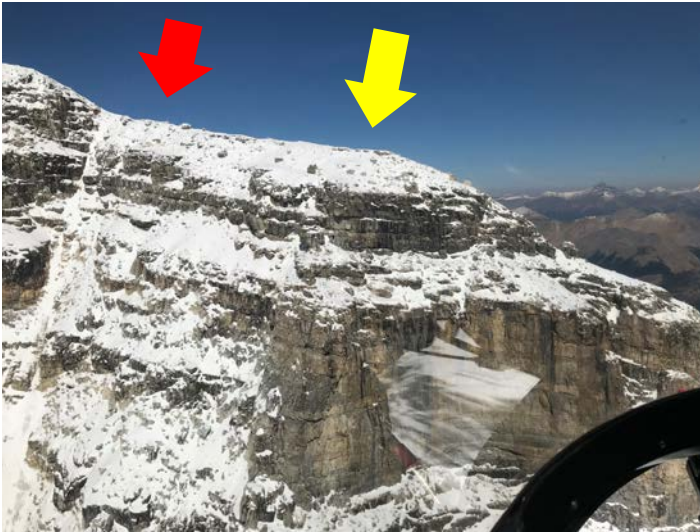
**Photograph B4.**  
**Summit East and West Locations**

Looking northeast at the southwest side of the potential summit RACS locations along the eastern side of the ridgeline (locations obscured by ridgeline). Summit East and West locations illustrated by yellow and red arrows, respectively.

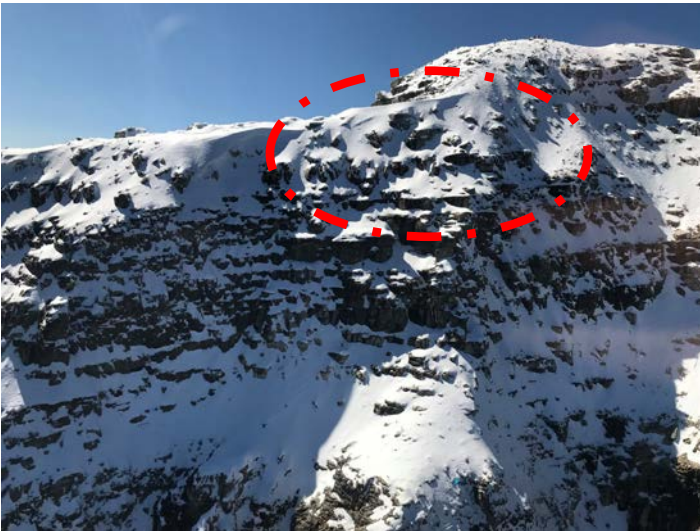
**Photograph B5.**  
**Summit West Location**

Looking southwest at potential Summit West RACS locations illustrated by the red dot dash line.

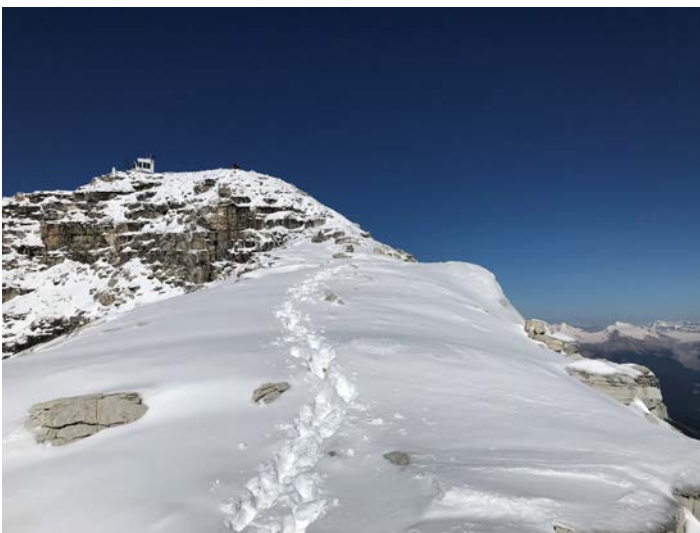
**Photograph B6.**  
**Summit East and West Locations**

Looking northwest along the ridgeline from Summit East towards Summit West and Mt. Stephen summit and alpine structure.

The proposed area for the Summit West RACS has limited slope length upslope, with an overall slope angle at approximately 35 to 45 degrees (Photograph B6 and B7). Rock fall releases upslope of the proposed RACS location, of sufficient volume to damage a RACS foundation, while possible, are not considered likely because the slope angle and short slope length above the proposed RACS location both act to limit rock fall velocity.

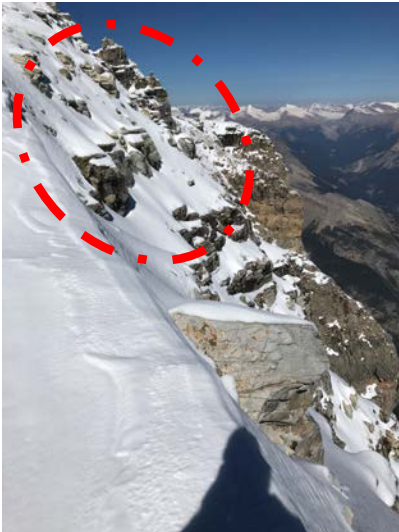
**Photograph B7.**  
**Summit West Location**

Looking northwest from the crest of the ridgeline towards Mt. Stephen's summit and alpine structure.

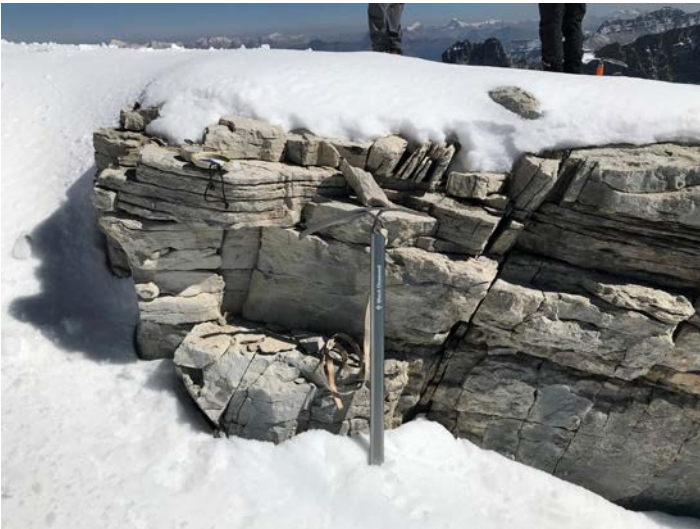
**Photograph B8.**  
**Summit East Ridgeline Rock Outcrop**

Frost shattered rock outcrop at the crest of the slope on the Summit East Ridgeline.

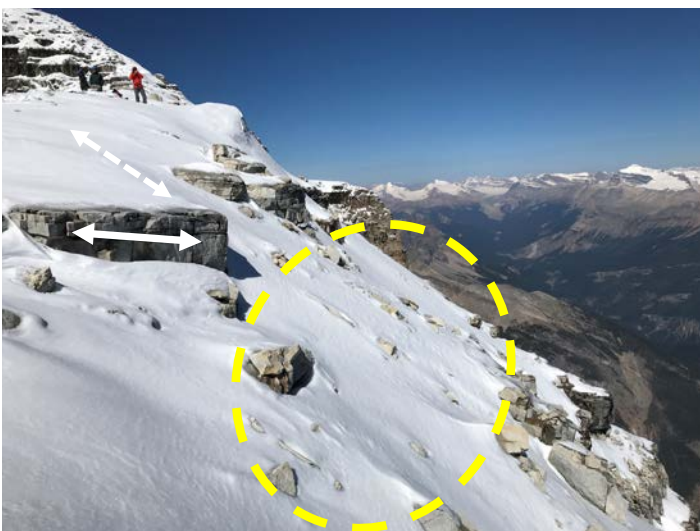
**Photograph B9.**  
**Summit East Location**

Looking northwest along potential Summit East RACS locations.

Joint Set 1 illustrated by white arrow.

Joint Set 2 orientation illustrated by dashed white arrow (joint set face not visible in photograph).

Rock slope observations for the proposed Summit East RACS area are similar to the Summit West RACS area (Photograph B9 and B10). The exact location of the Summit East RACS along the ridgeline is still to be determined, however, based on a review of site conditions, the foundations conditions and geohazard exposure is considered similar along the Summit East ridgeline. The area proposed a RACS is between the slope crest and approximately 15 m down slope distance. In the northwest section of that area a cornice appears to have formed that is not observed in the southeast section of the area along the ridgeline. The cornice development appears to coincide with a steeper rock slope section below the slope crest. Farther to the southeast within the proposed RACS area along the ridgeline the slope is less steep and there appears to be loose rock at the surface or small debris or talus piles. While obscured by snow cover, the slope profile and vertical rock faces visible through the snow cover suggests talus thickness is less than 1 m thickness. This could be confirmed in snow free slope conditions. As with the Summit West locations, depth of rock dilation is unknown.

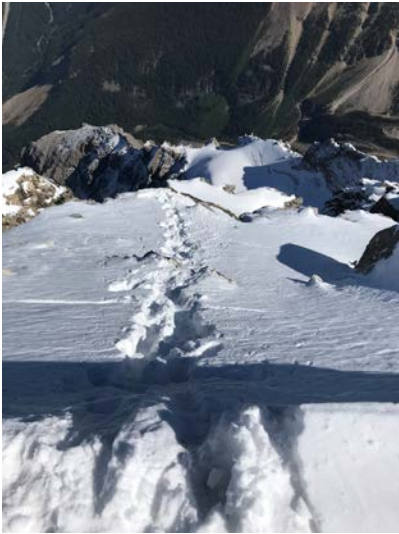
**Photograph B10.**  
**Summit East Location**

Looking northeast from the crest of the ridgeline towards Mt. Stephen glacier (obscured from view). Typical down slope view from the ridgeline crest shown in Photograph B9 (slope distance approximately 15 m).

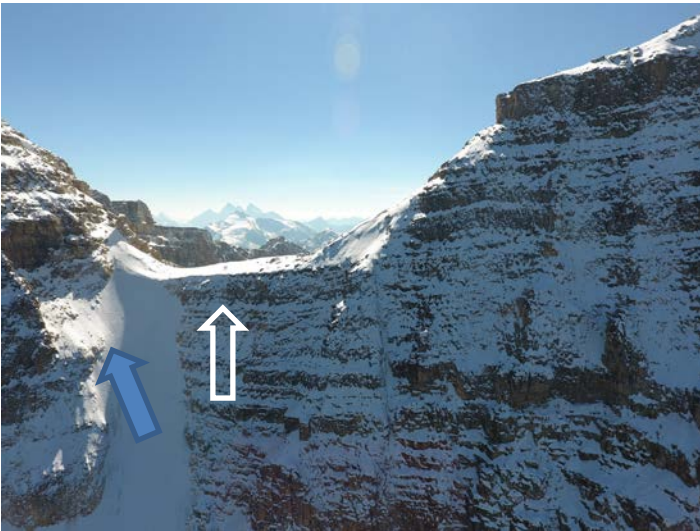
**Photograph B11.**  
**Col East and West Overview**

Looking south towards the potential Col RACS locations (white arrow illustrates approximate Col West location, blue arrow for Col East).

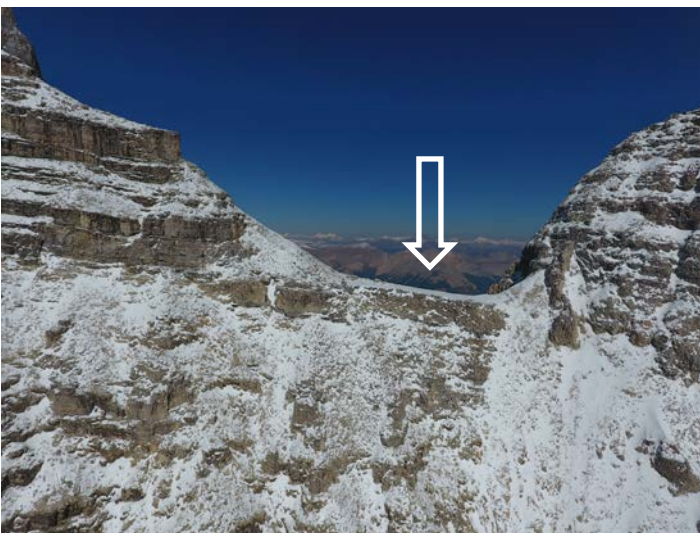
**Photograph B12.**  
**Col West**

Looking north towards the potential Col RACS locations (obscured by ridgeline).

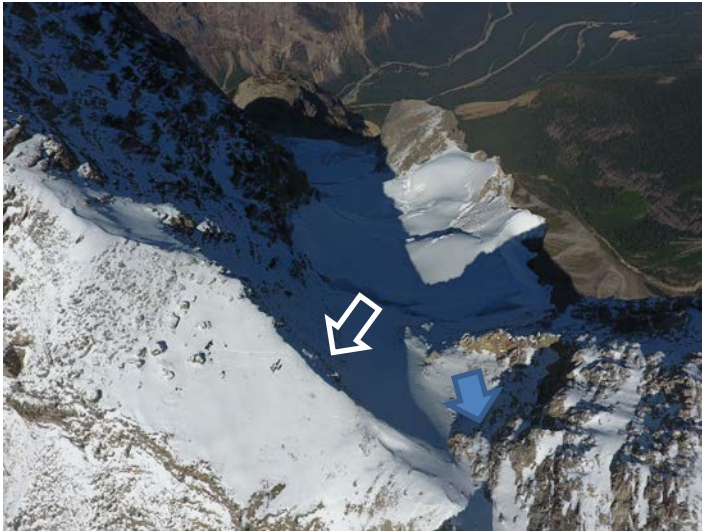
**Photograph B13.**  
**Col West**

Overview from above the Col area with white arrow locating proposed RACS position (approximate). North to the top of the photograph (white arrow illustrates approximate Col West location, blue arrow for Col East).

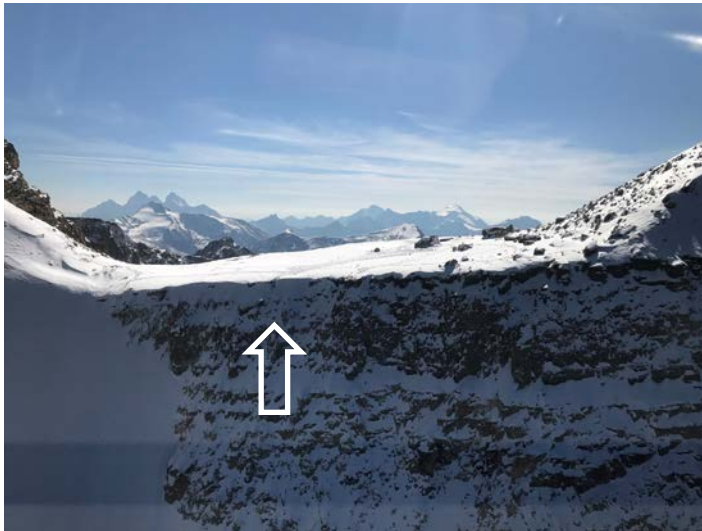
**Photograph B14.**  
**Col West**

Looking south towards the proposed Col West RACS location – proposed location above the arrow head.

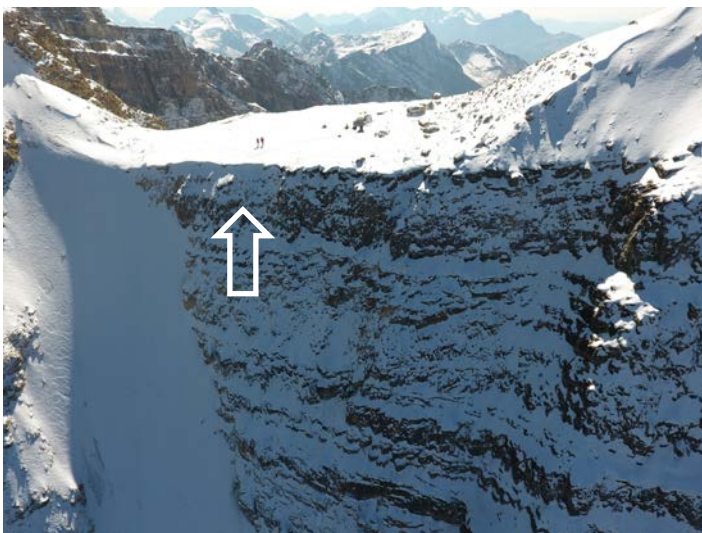
**Photograph B15.**  
**Col West**

Looking south towards the proposed Col West RACS location – proposed location above the arrow head.

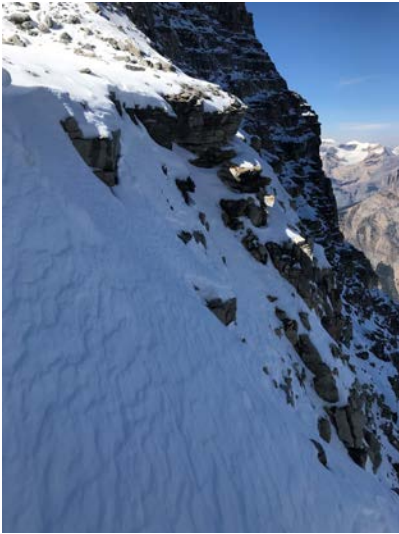
**Photograph B16.**  
**Col West**

Looking northwest along the crest of the Col from the approximate Col West location.

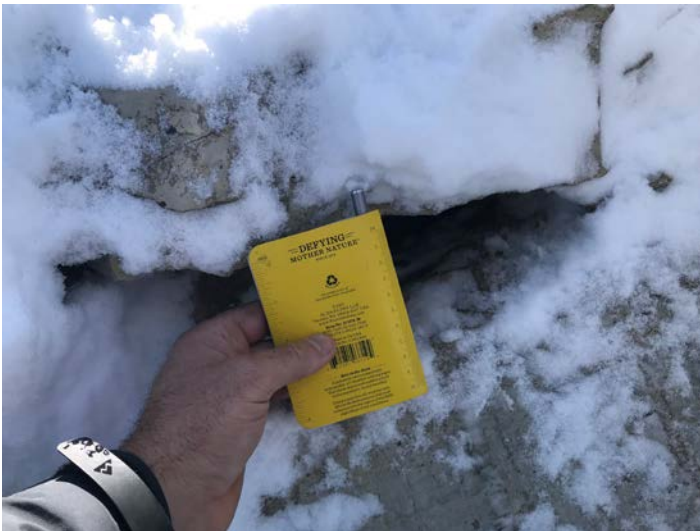
**Photograph B17.**  
**Col West**

Dilated bedding joint in the rock mass approximately 1 m below the slope crest near the proposed Col West location (dilation approximately 50 – 60 mm).

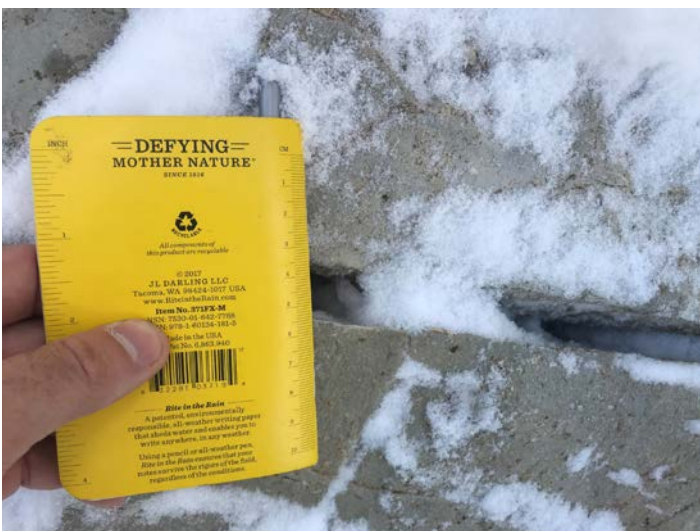
**Photograph B18.**  
**Col West**

Dilated bedding joint in the rock mass approximately 1.2 to 1.5 m below the slope crest near the proposed Col West location (dilation approximately 10 – 20 mm).

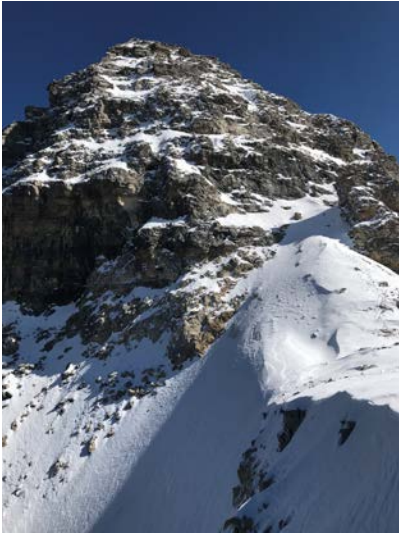
**Photograph B19.**  
**Col West**

Looking southeast along the crest of the Col from the approximate location of the proposed Col West RACS.

The rock mass on the southeast slope above of the col appeared fractured and deformed (visual observations from a distance) and may form part of the fault zone mapped by Cui et al. (2017) (Figure 2-1) (Photograph B19). If large rock fall events, or a rock slide, release from this slope to the southeast of the col, the col slope profile would likely divert rock fall and slide masses north or south of the col (i.e. they spill over laterally). The proposed Col West RAC position near the centre of the col appears favourable because of its maximum distance from each rock fall source zone. Also, the likelihood of rock fall events reaching the proposed RACS location from the slope southeast of the col are limited by the favourable topography. The central col section is approximately 4 m higher (vertical) than the southeast col margin.

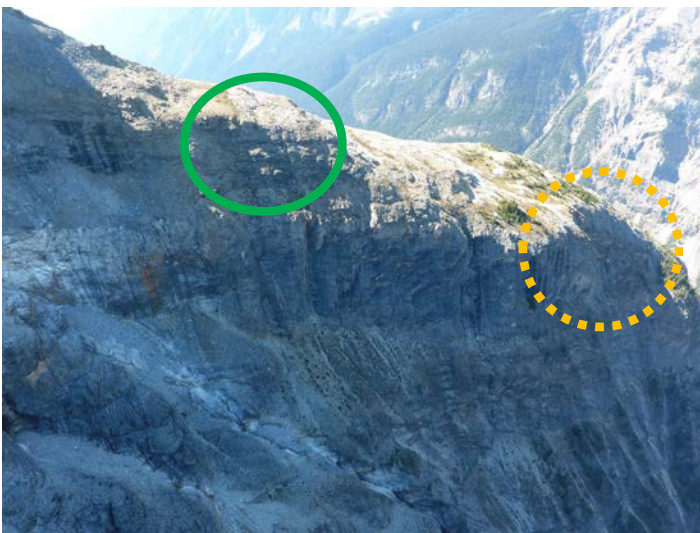
**Photograph B21.**  
**Low West – South and North**

Overview photograph looking west towards the two Low West locations. Green circle Low West – South location, yellow arrow Low West – North location.

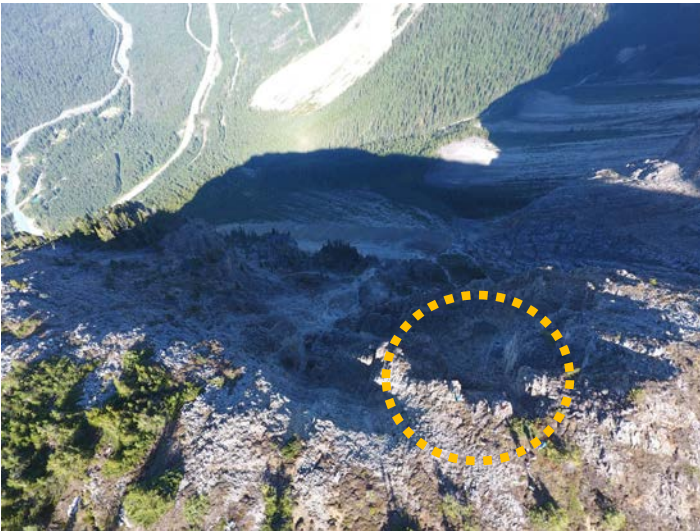
**Photograph B23.**  
**Low West – North**

Overview photograph looking down the slope at the Low West – North location (approximately inside orange dash).

Rock fall, rock topples and rock slides below the foundation elevation (considered 0 to 5 m below the ridge crest) that could undermine or intersect the proposed RACS foundation are considered very likely (Photograph B23, B26 and B27). This slope appears to be actively deforming, and shows evidence of recent rock fall, topple and slide activity.

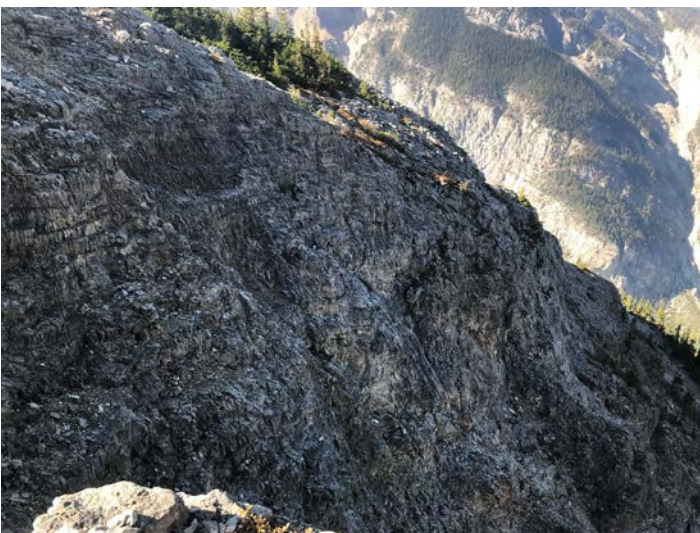
**Photograph B24.**  
**Low West – North**

Overview photograph looking north to northwest from the Low West – North location.

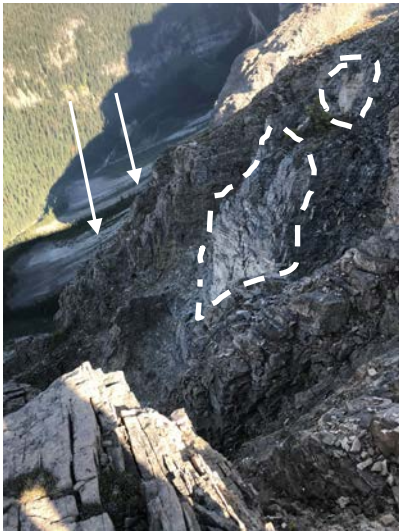
**Photograph B26.**

Closely spaced joints and toppling rock slope sections in small ridge spurs (white arrows). Light tan coloured area is a recent slope failure back scarp (inside white dash).

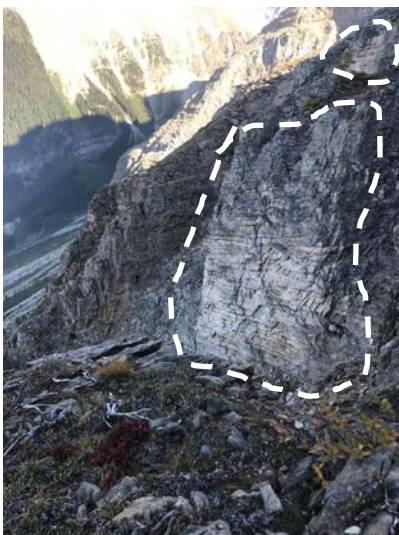
**Photograph B27.**

Closely spaced joints and toppling rock slope sections in small ridge spurs. Light tan coloured area is a recent slope failure back scarp (inside white dash) (same as Photograph B26).

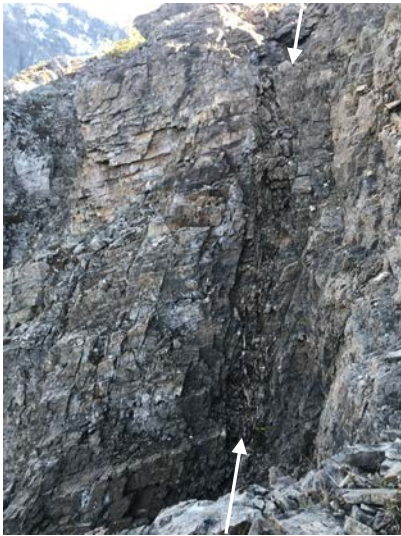
**Photograph B28.**  
**Low West – North**

Looking northwards towards closely spaced sub-vertical joints of Joint Set 1 (between arrows).

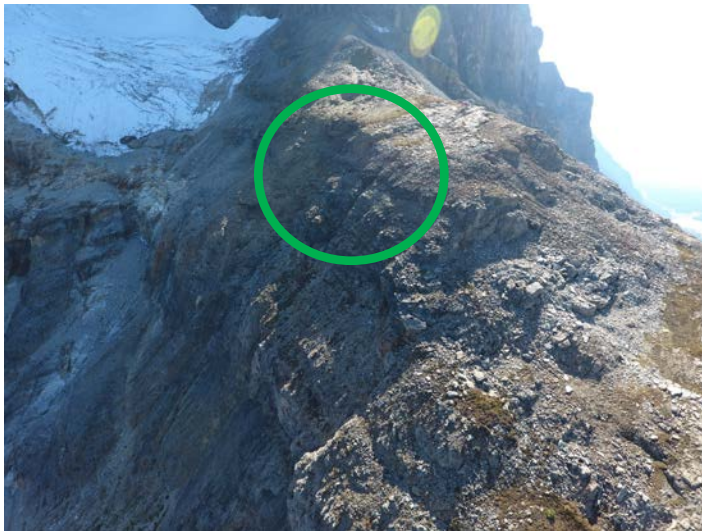
**Photograph B29.**  
**Low West – South**

Overview of the Low West – South location looking towards the southwest.

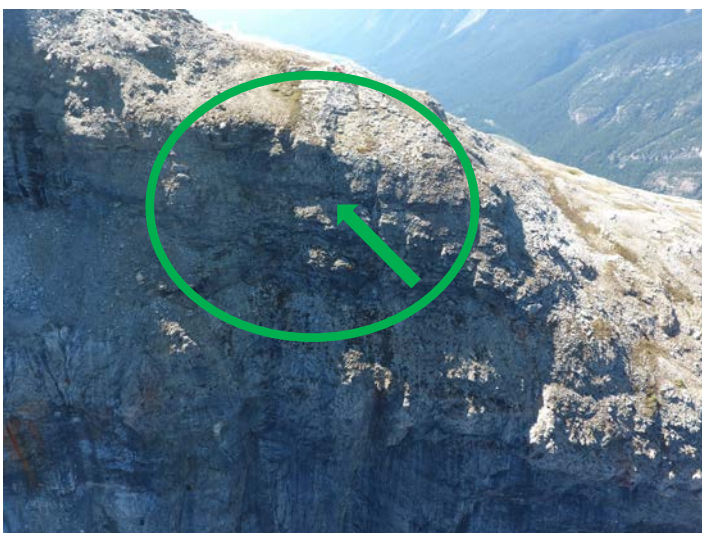
**Photograph B30.**  
**Low West – South**

Overview of the Low West – South location looking towards the west.

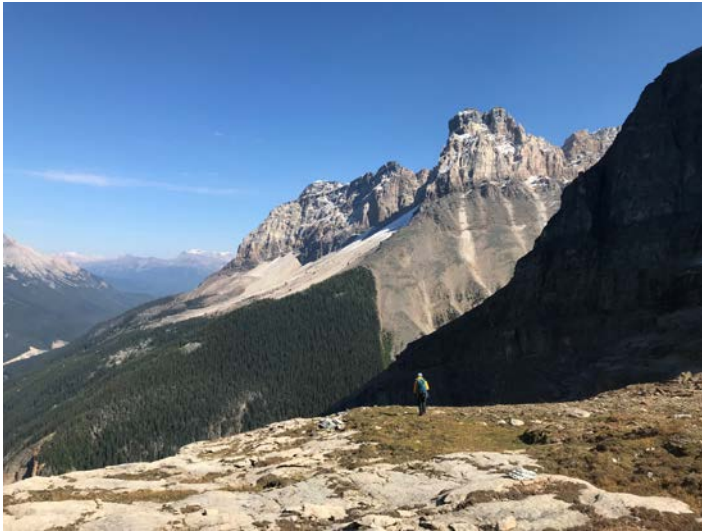
**Photograph B31.**  
**Low West – South**

Rigide above the proposed RACS location.

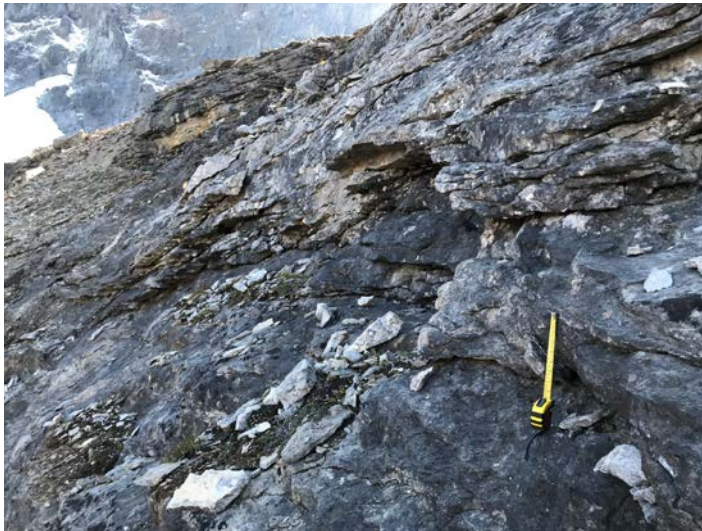
**Photograph B32.**  
**Low West – South**

Typical rock slope conditions.

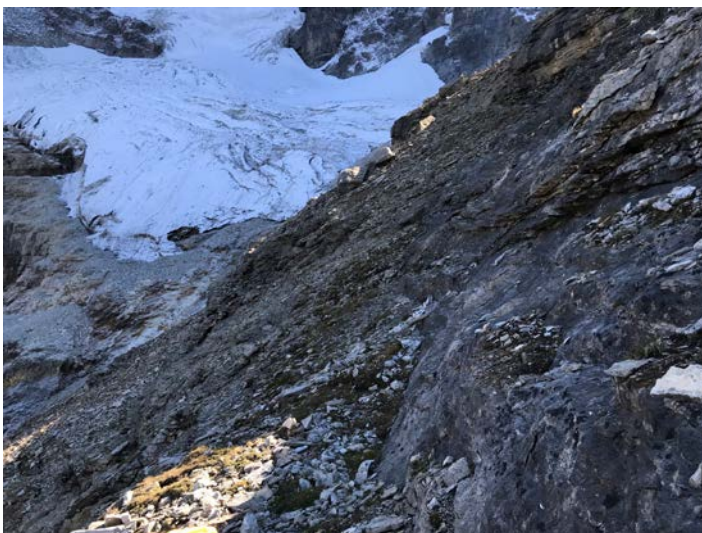
**Photograph B33.**  
**Low West – South**

Typical rock slope conditions of steeper rock outcrop slopes and shallower talus slope angles.

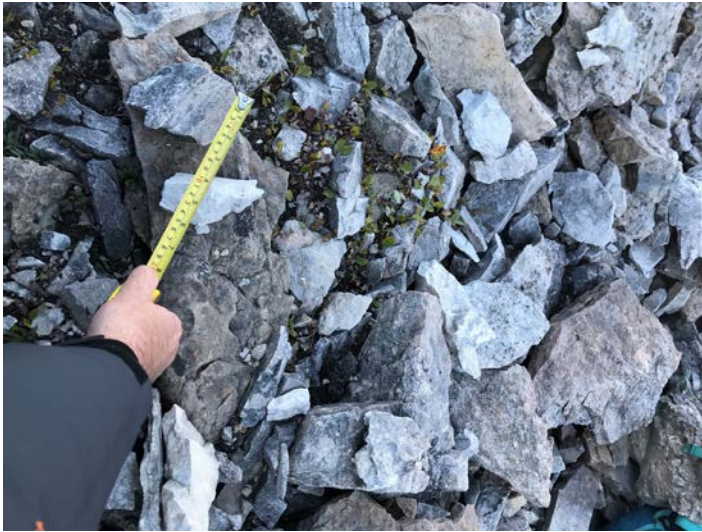
**Photograph B34.**  
**Low West – South**

Typical talus material at Low West – South (tape 20 cm length).

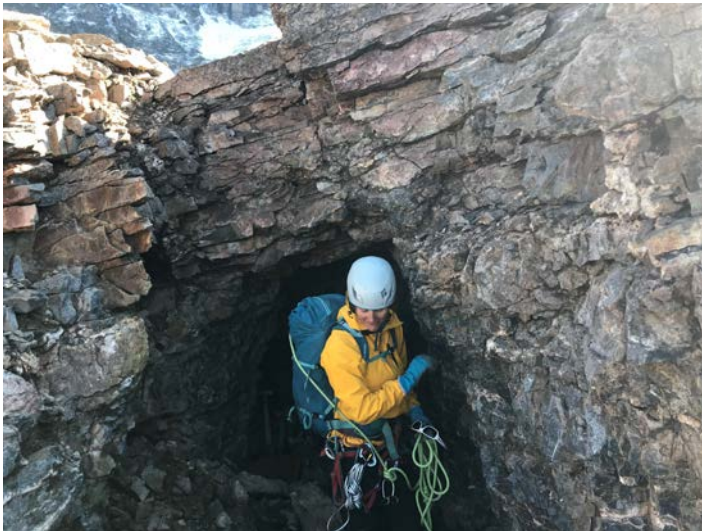
**Photograph B35.**  
**Low West – North**

Old mine workings between Low West – North and South locations on the ridge line.

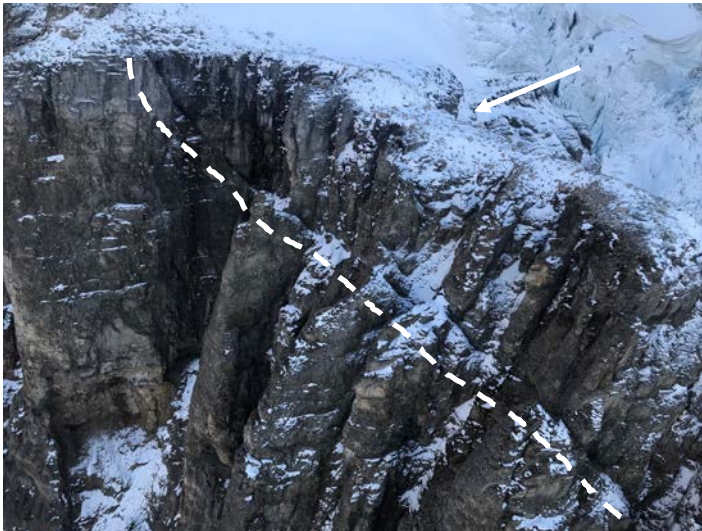
**Photograph B38.**  
**Low East – Option A**

Looking southwest towards the eastern side of the east glacier ridge. Low East – Option A RACS location illustrated by white arrow (location partially obscured by ridgeline). Fault plane location illustrated by white dash line – fault plane immediately above this line.

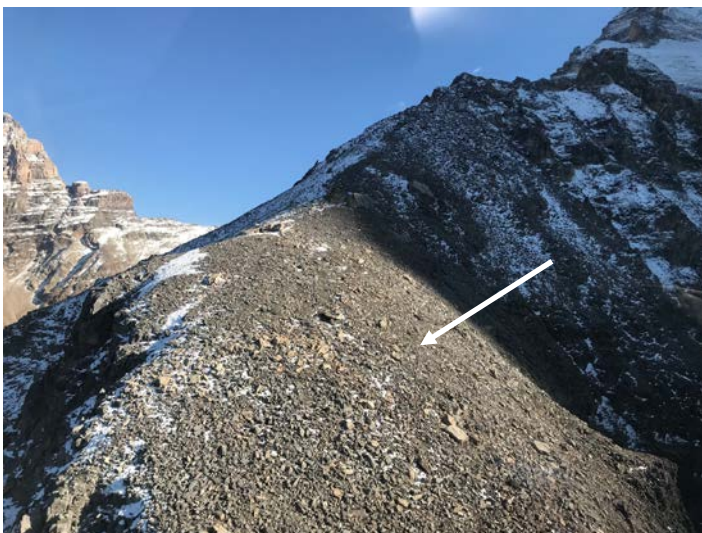
**Photograph B39.**  
**Low East – Option B**

Looking to the southeast at the Low East – Option B RACS location (illustrated by white arrow).

The proposed location for the Low East Option B RACS is approximately 2,480 m asl approximately 20 m (vertical distance) downslope of a broad ridgeline (Photograph D39). Option B is located upslope of the distal reaches of Mt. Stephen glacier. The proposed RACS location is in the middle of a talus deposit with intermittent fractured bedrock outcrops. The depth of talus is unknown. Construction of the RACS foundations may be challenging for anchor installation and foundation preparation at this location if the loose talus proves too deep to excavate to achieve a rock foundation for the RACS, and intermittent rock outcrops are not suitable for the RACS foundation.

Rock fall originating from the fractured bedrock outcrops of remobilization of the talus slope material is considered unlikely. There are no other rock fall source areas immediately upslope of this proposed location. From a geohazard risk perspective the site is favourable.
