**Designated Substances and  
Hazardous Building Materials  
Assessment – North Storage Shed  
and North Storage Bin**

North Storage Shed and North Storage Bin  
Port Weller Search and Rescue Station  
Port Weller ON

Project No.: 122150683

July 13, 2018

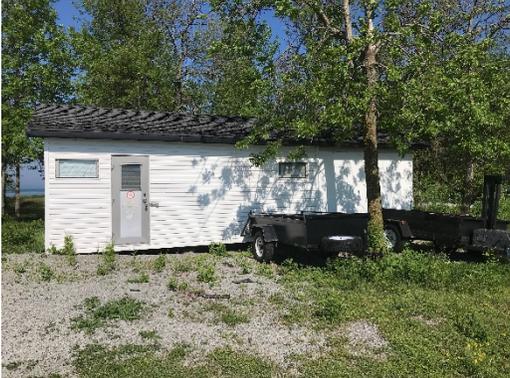
LOCATION	DESCRIPTION	PHOTOGRAPHS
North Storage Shed	<ul style="list-style-type: none"> <li>• General view of North Storage Shed</li> <li>• Non-asbestos containing roofing materials-shingles</li> <li>• Sample BS-03A</li> </ul>

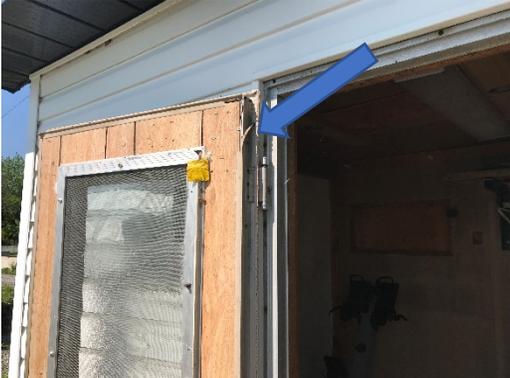
North Storage Shed	<ul style="list-style-type: none"> <li>• Non-asbestos-containing Interior door caulking – grey</li> <li>• Samples BS-01A-C</li> </ul>

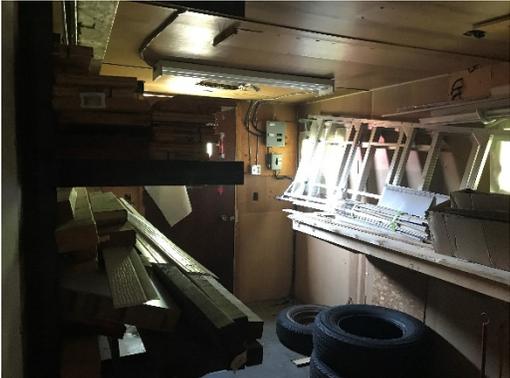
North Storage Shed	<ul style="list-style-type: none"> <li>• General view of North Storage Shed</li> <li>• Non-asbestos-containing vinyl sheet flooring -grey</li> <li>• Samples BS-02A-C</li> </ul>

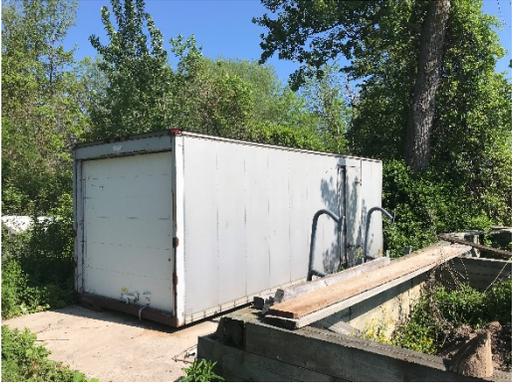
North Storage Bin	<ul style="list-style-type: none"> <li>• Non-asbestos-containing exterior caulking - grey</li> <li>• Samples BS-04A-C</li> </ul>
