| <b>Contact Information</b> | |
|--|---|
| <b>Office Address:</b> <u>760 Enterprise Crescent</u> | <b>Project Name:</b> <u>HMS PBS Tech Serv Bld</u> |

Project: P18-11001-63/HMS PBS Tech Serv Bld

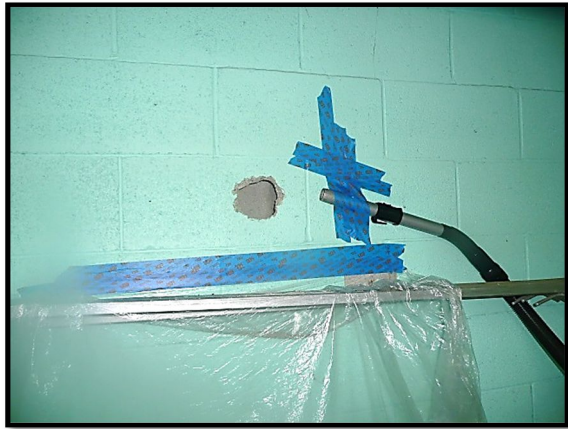
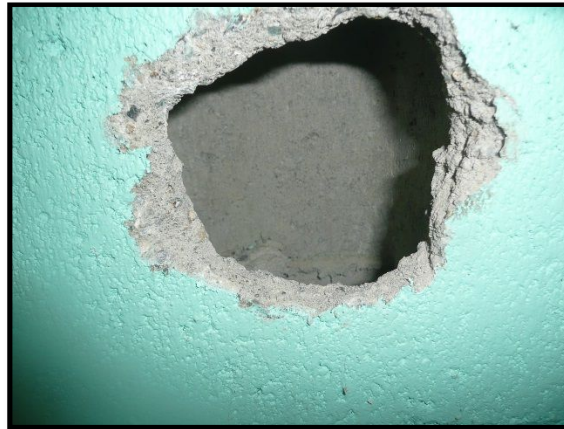
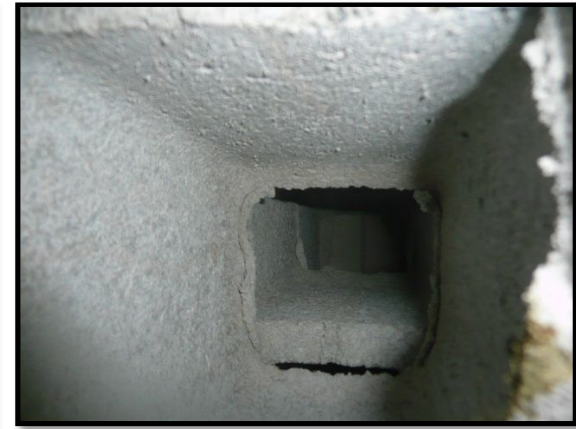
Exploration of the south concrete masonry unit wall of the Metal Storage Room #10. No indication of potential vermiculite insulation was found.

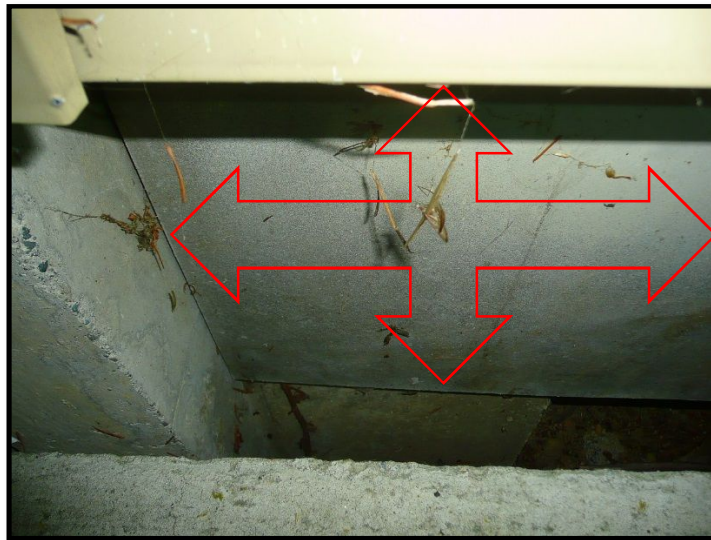
Southeast corner footing (left), tan metal siding (top), adjacent retaining wall (base) and concrete foundation slab cover of hard fireproof composite fibre cement board panelling (Transite Panel) (red arrows) which extends downward approximately 18" from the top side of the base sill plate (hidden).

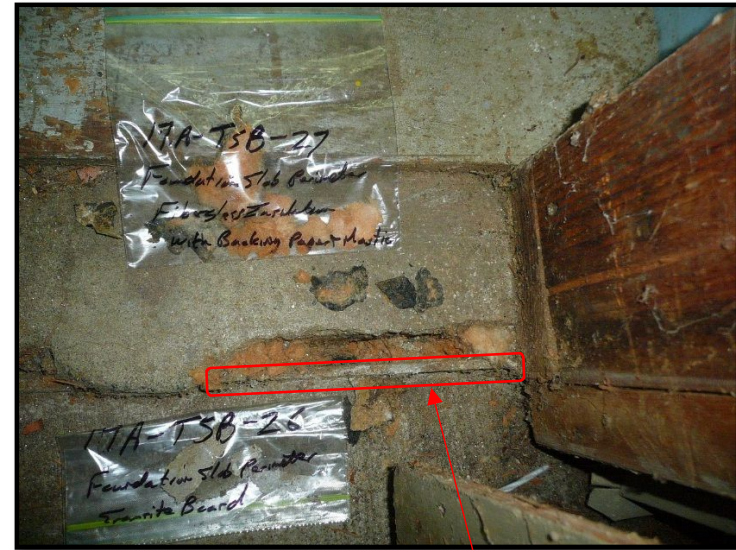
Sample 17A-TSB-26 of sub-grade hard fireproof composite fibre cement board panelling (Transite Panel) (10 % Chrysotile) and Sample 17A-TSB-27 of fibreglass insulation with backing paper and black mastic large (None Detected) as collected from the east elevation at the entrance to the Carpenter Shop Room #7.

| <b>Lab No.:</b> 6430720<br><b>Client No.:</b> 17A-TSB-26 | <b>Analyst Observation:</b> Grey Cement Product<br><b>Client Description:</b> Transite Panel | <b>Location:</b> Carpenter Shop Ext. Foundation<br><b>Facility:</b> |

| <b>Lab No.:</b> 6430721<br><b>Client No.:</b> 17A-TSB-27 | <b>Analyst Observation:</b> Tan Insulation<br><b>Client Description:</b> Fiberglass Insulation With Backing Paper<br>And Black Mastic | <b>Location:</b> Carpenter Shop Ext. Foundation<br><b>Facility:</b> |

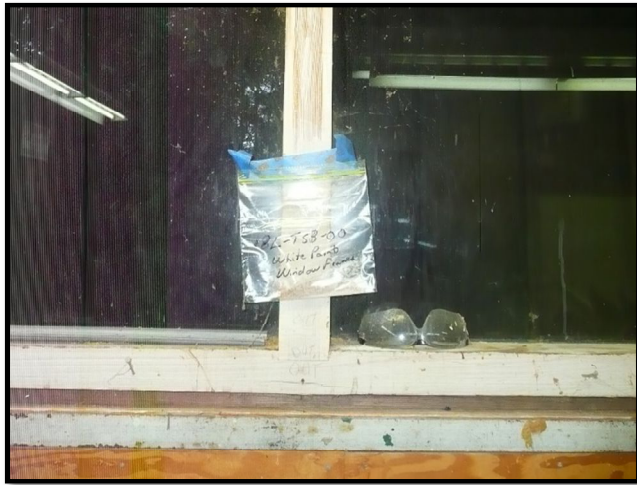
White Paint Sample 18L-TSB-00 from the interior side of wooden window frame in the Carpenters Shop Room # 7.

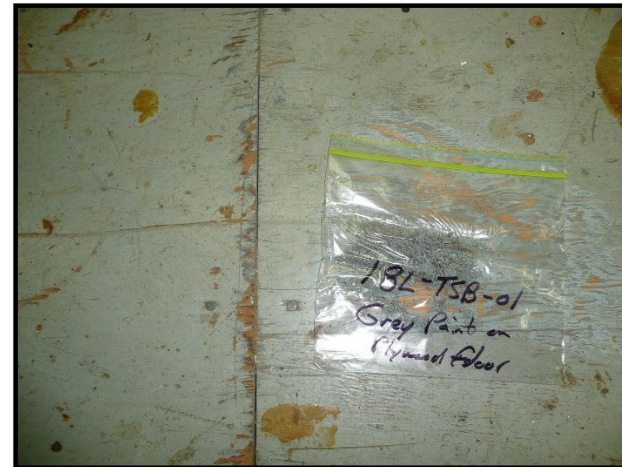
Grey Paint Sample 18L-TSB-01 and Painted Base Substrate TCLP Sample 18TCLP-TSB-01 from the plywood floor in the Carpenters Shop Room # 7.

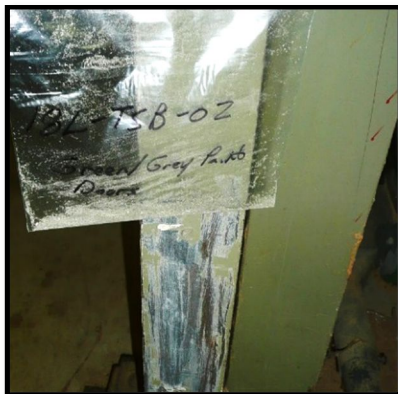
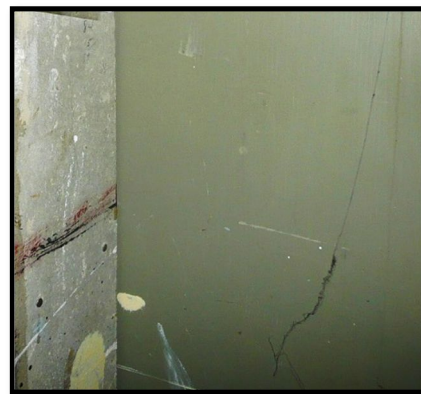
Green-Grey Paint Sample 18L-TSB-02 (left) from the interior door in the Carpenters Shop Room # 7 and same as Painted Base Substrate TCLP Sample 18TCLP-TSB-02 (right) from interior side of door to Paint Shop # 6.

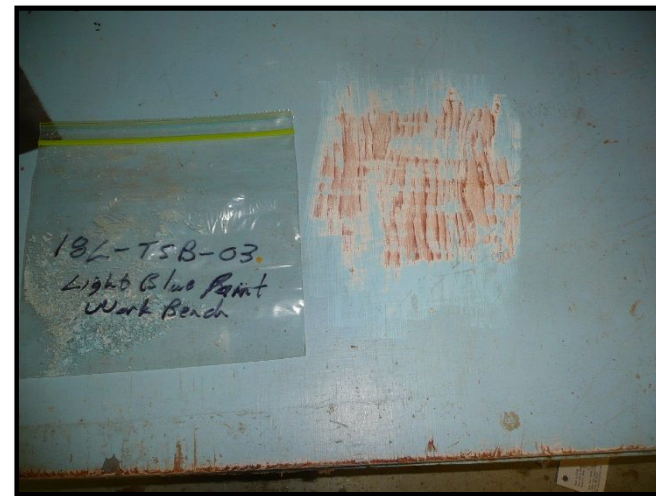
Light Blue Paint Sample 18L-TSB-03 and Painted Base Substrate TCLP Sample 18TCLP-TSB-03 from the wooden work bench in the Carpenters Shop Room # 7.

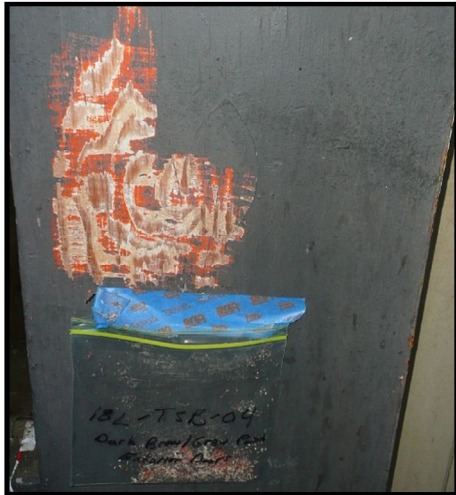
Brown-Grey Paint on Orange Paint and White Paint Sample 18L-TSB-04 and Painted Base Substrate TCLP Sample 18TCLP-TSB-04 from the exterior door of the Paint Shop # 6.

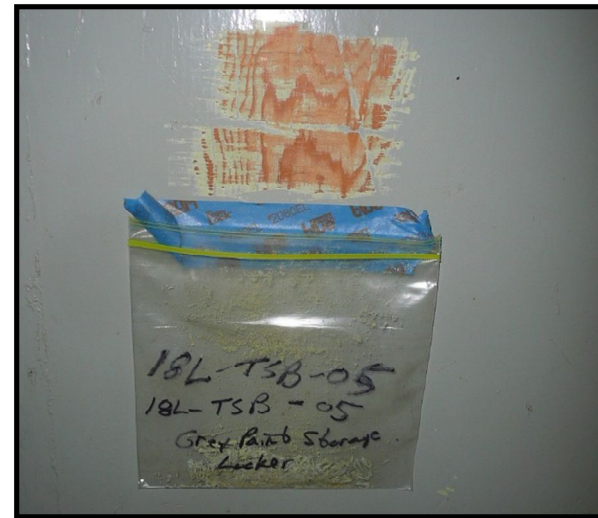
Light Grey-Green Paint Sample 18L-TSB-05 and Painted Base Substrate TCLP Sample 18TCLP-TSB-05 from the built-in wooden lockers in the Lumber Storage Room # 8.

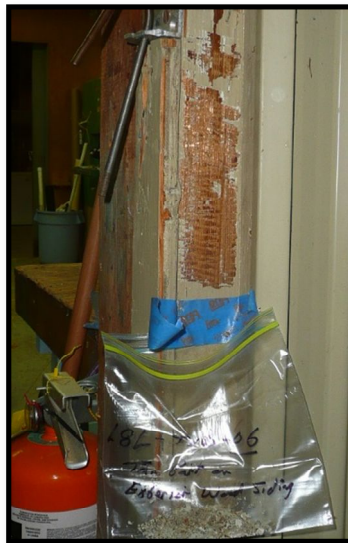
Tan Paint Sample 18L-TSB-06 from the exterior side of the wood siding (Original Cladding) at the east entrance

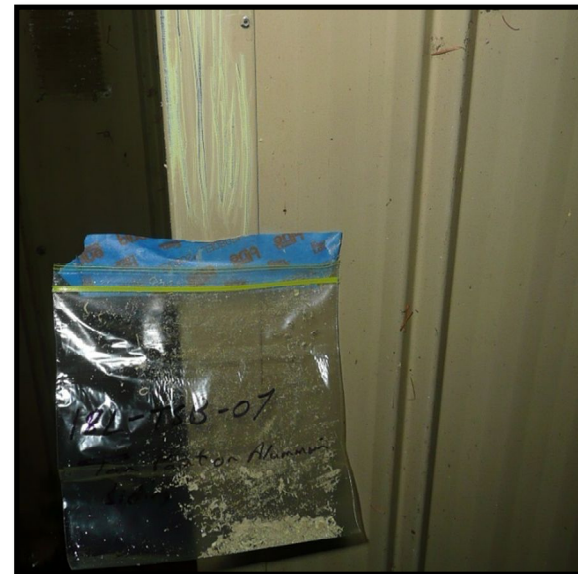
Tan Paint Sample 18L-TSB-07 from the exterior metal siding (Newer Cladding) of the buildings' northeast corner.

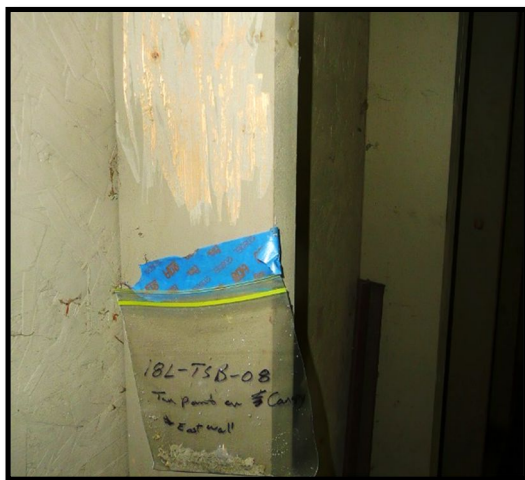
Tan Paint Sample 18L-TSB-08 from the interior side of the east wood wall of the attached east canopy.

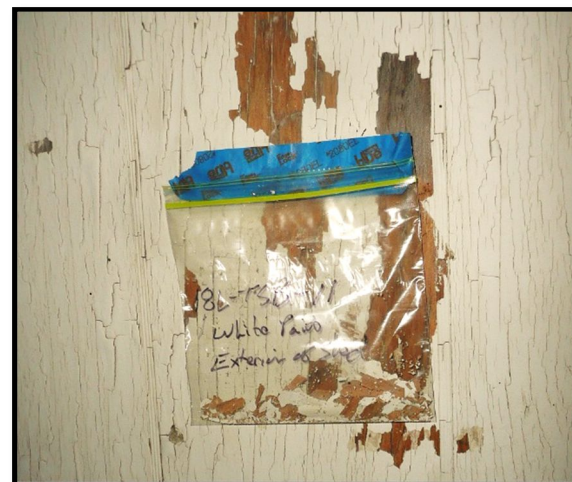
White Paint Sample 18L-TSB-11 and Painted Base Substrate TCLP Sample 18TCLP-TSB-11 from the wood exterior siding of the storage shed.

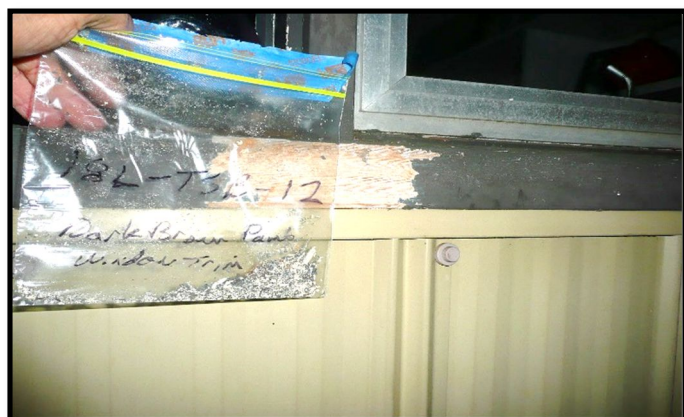
Dark Brown Paint Sample 18L-TSB-12 from the exterior side of wooden window frame at Paint Shop # 6 and Office #3.

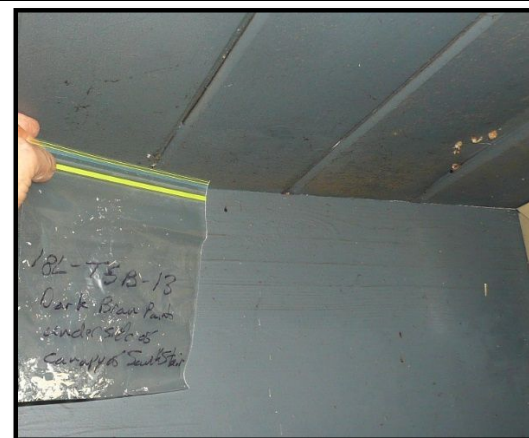
Dark Brown Paint Sample 18L-TSB-13 representative of the underside of the canopy over south staircase as collected from the east side of the Furnace Breaker Building.

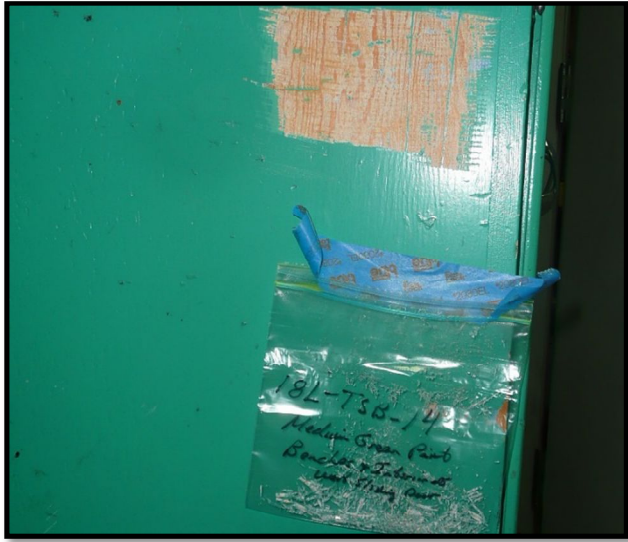
Medium Green Paint Sample 18L-TSB-14 and  
Painted Base Substrate TCLP Sample 18TCLP-TSB-14  
from the Machine Shop benches and interior side of exit door.

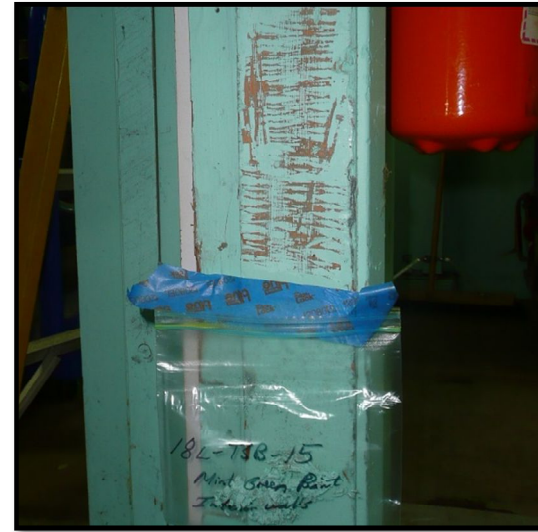
Mint Green Paint Sample 18L-TSB-15 from the  
Machine Shop interior walls.

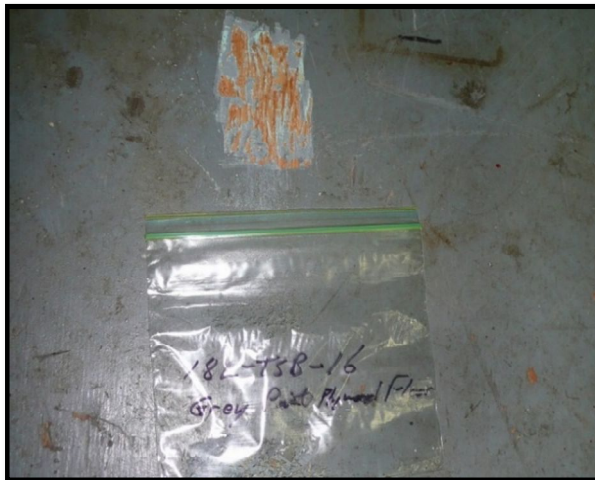
Grey Paint Sample 18L-TSB-16 from the  
machine shop interior plywood floor.

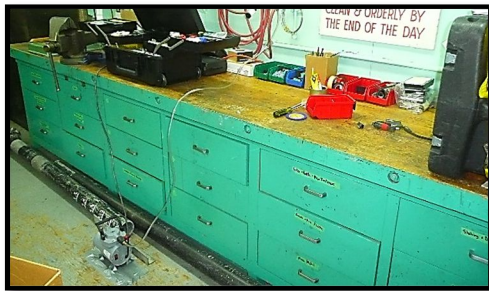
The preliminary TCLP analytical sample lead results for the medium green coloured paint on the Machine Shop: a.) east wood bench; b.) northwest cabinet; c.) southeast false double doors; d.) south-central door; and e.) interior side of sliding access exit door as represented by Sample ID 18TCLP-TSB-14 are in excess of the BC Ministry of Environment Special Waste criteria of 5mg/L. Therefore, if these wood items or the associated surface coating paint are to be disposed of they would be considered a lead-containing waste shown to be a “leachable toxic waste” and are to be characterized and disposed of as a regulated hazardous waste.
