Windermere Lake Groyne Installation of Navigation Markers: Environmental Regulations, Mitigations, and Monitoring Recommendations

Public Services and Procurement Canada
1230 Government Street
Victoria, BC V8W 3X9

Project No. 989593-11
TA No.: 700406254
R. No.: 074582.003

June 20, 2018

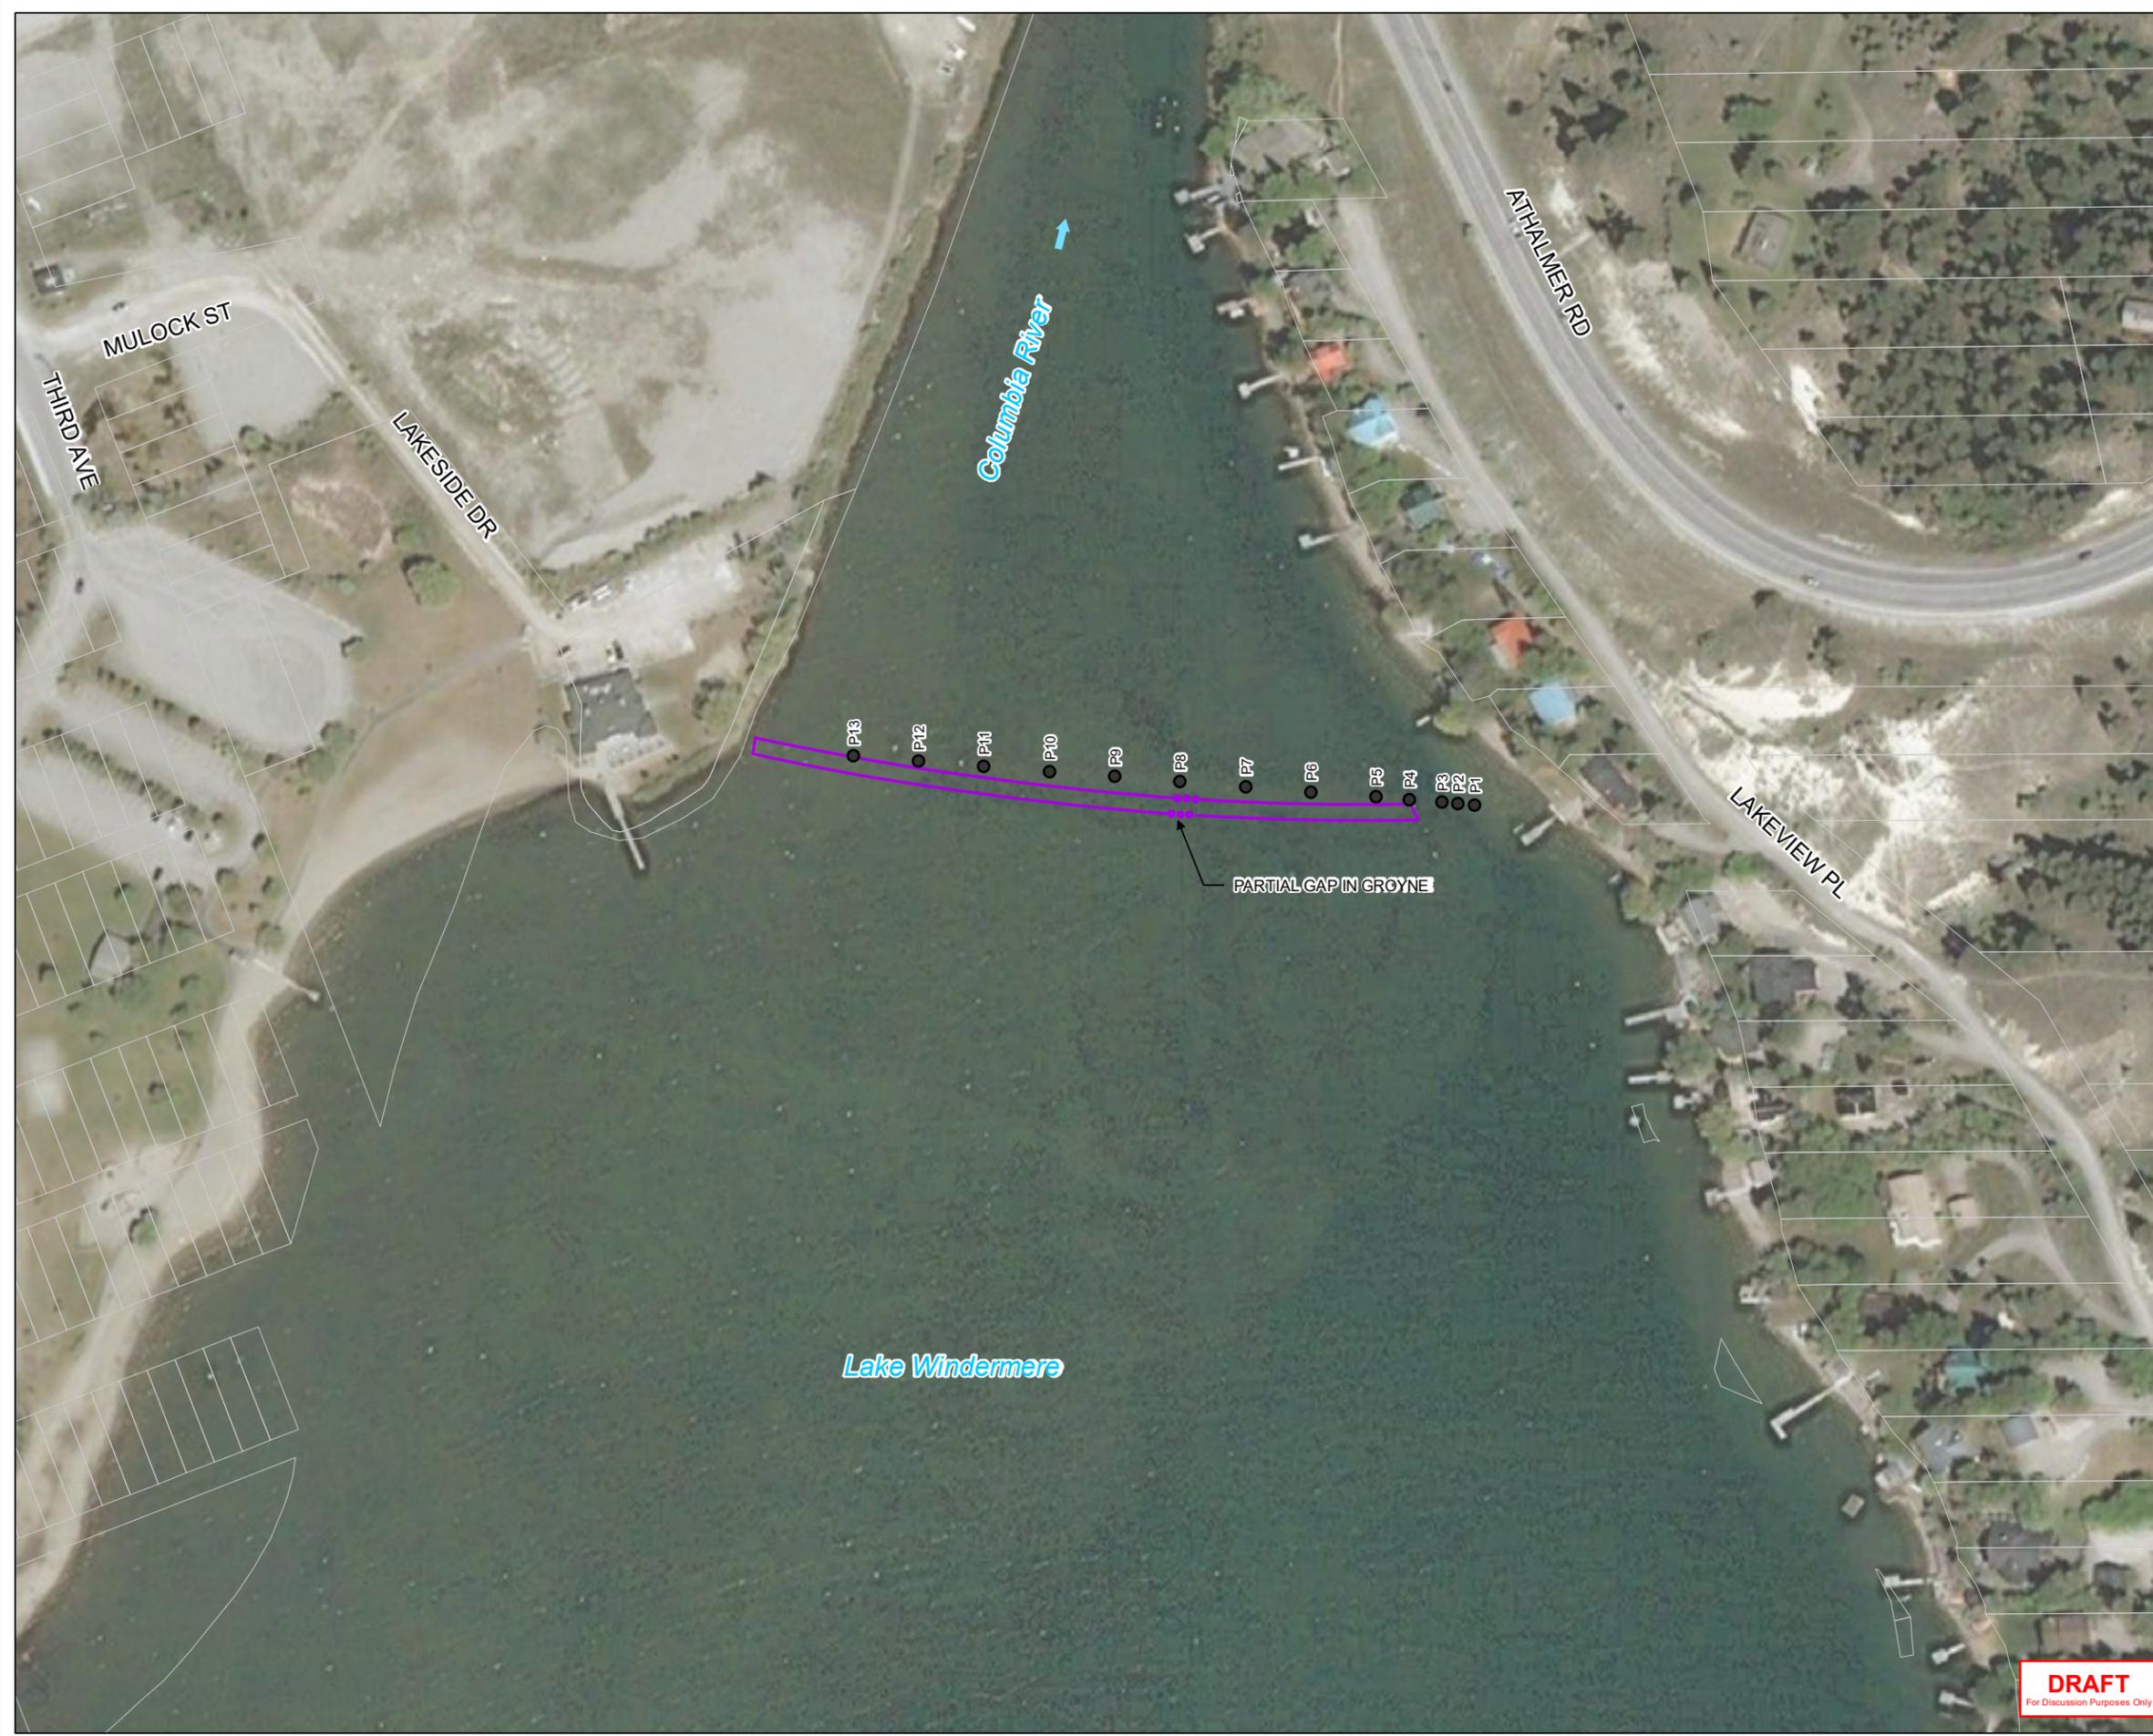
Figure 1-1 Location of the Existing Windermere Rock Groyne and the Proposed Navigation Markers (P1 through P13)..... 2

The groyne was originally installed in the 1890s to focus water and vessel traffic towards the navigation channel at the east end of the groyne, while reducing the need for ongoing dredging. However, minimal maintenance on the rock groyne has occurred since its construction and its functionality has declined substantially since that time. In addition, previously installed navigation markers on the groyne have deteriorated at a relatively rapid rate due to inclement weather conditions (e.g., winter ice formation) and vandalism. While the channel immediately east of the site is considered to be navigable, the groyne itself has become a navigation hazard to the public and boating community. For example, reports of boat propellers hitting the rock groyne have been documented when boats shortcut across shallow inundated sections of the groyne (e.g., a partial gap located close to the centre of the groyne, **Figure 1-1**) (Hemmera 2013).

The Project involves the installation of 13 navigation piles and signs as shown on **Figure 1-1**. The piles will consist of untreated 36 cm diameter (14 inch), approximately 10 m long, Douglas-fir round wood. Each pile will be topped with an aluminum cap. The piles will be driven into the substrate until refusal. Installation of the piles and signage is anticipated to take approximately two to three days to complete. No existing piles will be removed as part of the current scope of work. While the tender has not yet been awarded, it is anticipated that the equipment used for construction will include a boat, and barge and hammer (either a vibratory hammer or an impact hammer, to be determined upon selection of the successful Contractor).

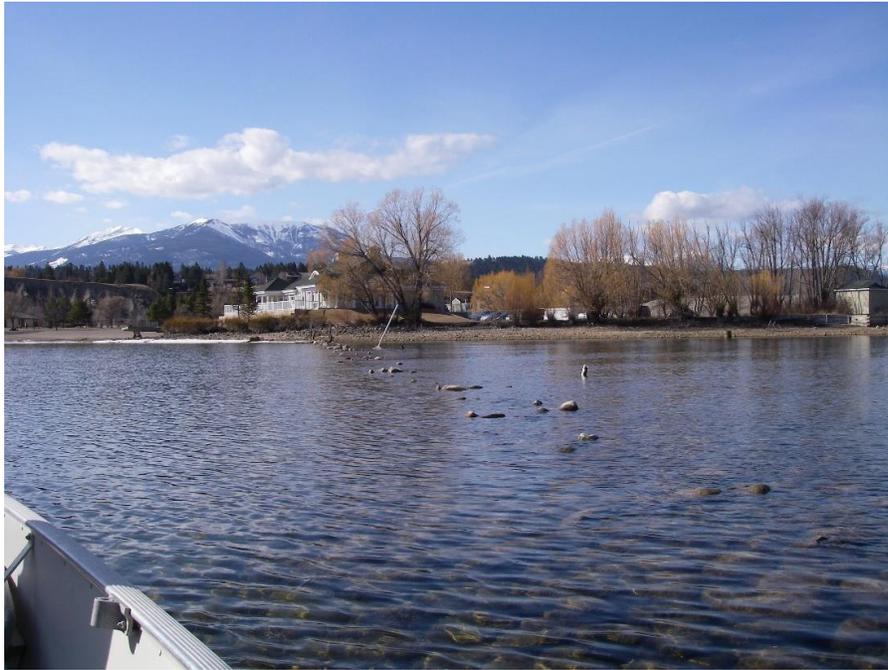
Photo 1 West-facing view of the rock groyne (March 2010).

The rock groyne (**Appendix A: Photos 1 and 2**) is located near the narrowing of the lake outlet at the north end of the lake (**Appendix A: Photo 3**). There are no documented streams that drain into Windermere Lake near the Project site (Hemmera 2013). The rock groyne is marginally elevated and was observed to extend, on average, 15 cm above the lake bottom during an assessment by Hemmera in November 2010 (Hemmera 2012*a*). A bathymetric survey conducted in 2010 indicated that bathymetry on both sides of the groyne were relatively uniform, with slightly higher elevations recorded on the downstream side of the groyne (Hemmera 2012*a*).

The Project site is surrounded by residences, many with recreational boat docks. James Chabot Provincial Park and the Lakeside Pub are both located on the west side of the Project site. The upland habitat adjacent to the site has been impacted by residential developments and road construction (e.g., Lakeview Place). This upland area can currently be described as a hilly, open shrub and grassland landscape with scattered coniferous and deciduous trees and shrubs (**Appendix A: Photos 1 and 2**).

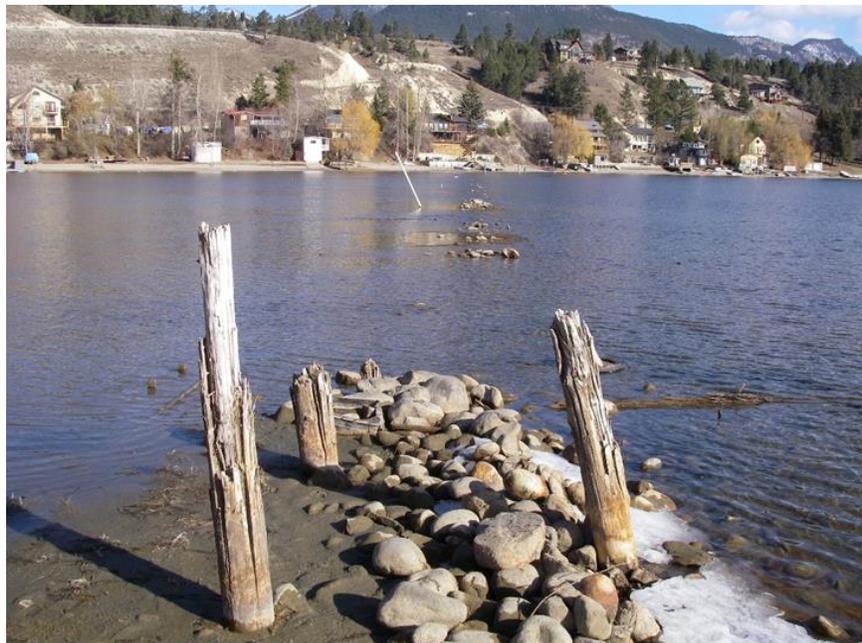
Photo 2 East-facing view of the rock groyne (March 2010).

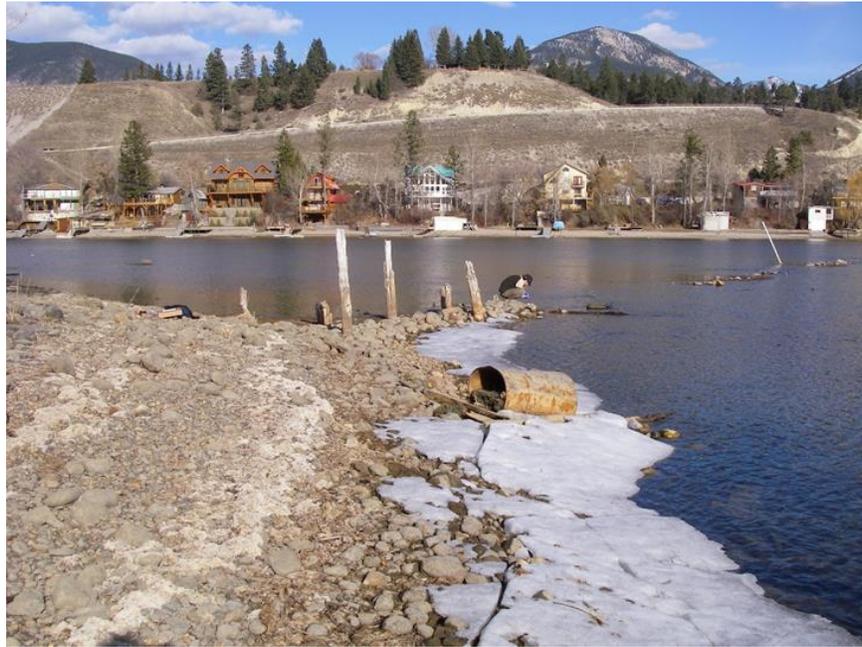
Photo 3 Northeast-facing view of the rock groyne depicting a narrowing of the lake north of the groyne (March 2010).

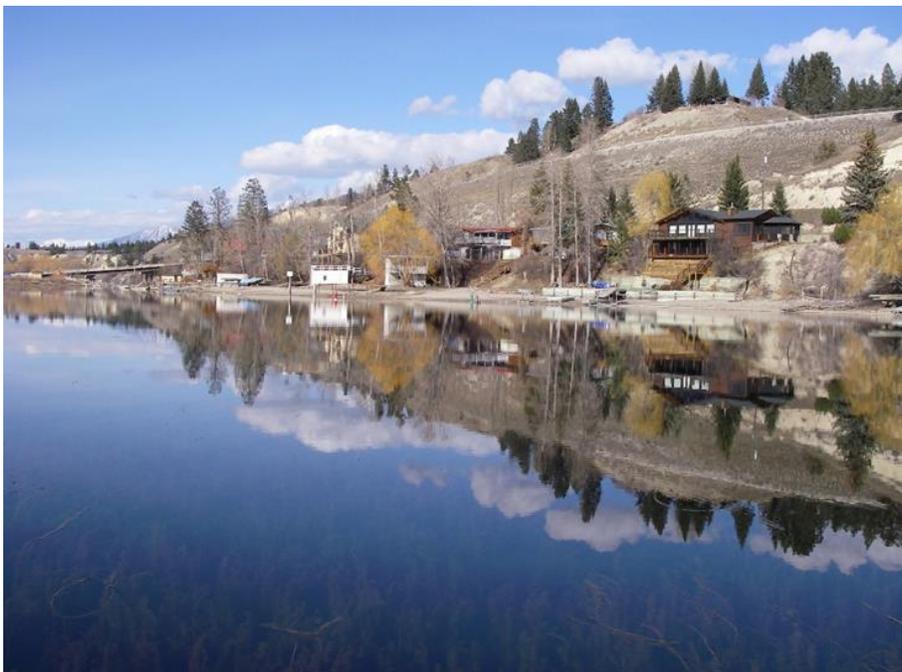
Photo 4 North-facing view of the navigation channel at the east end of the rock groyne depicting dense aquatic vegetation growth (March 2010).
