## **Churchill Airport Runway 15-33 and Taxiway A Repairs Geotechnical Information Package**

**RE: Churchill Airport Runway 15-33 and Taxiway A Repairs  
Geotechnical Information Package**

TREK Geotechnical Inc. is pleased to submit our Geotechnical Investigation Report for the above noted project located in Churchill, MB.

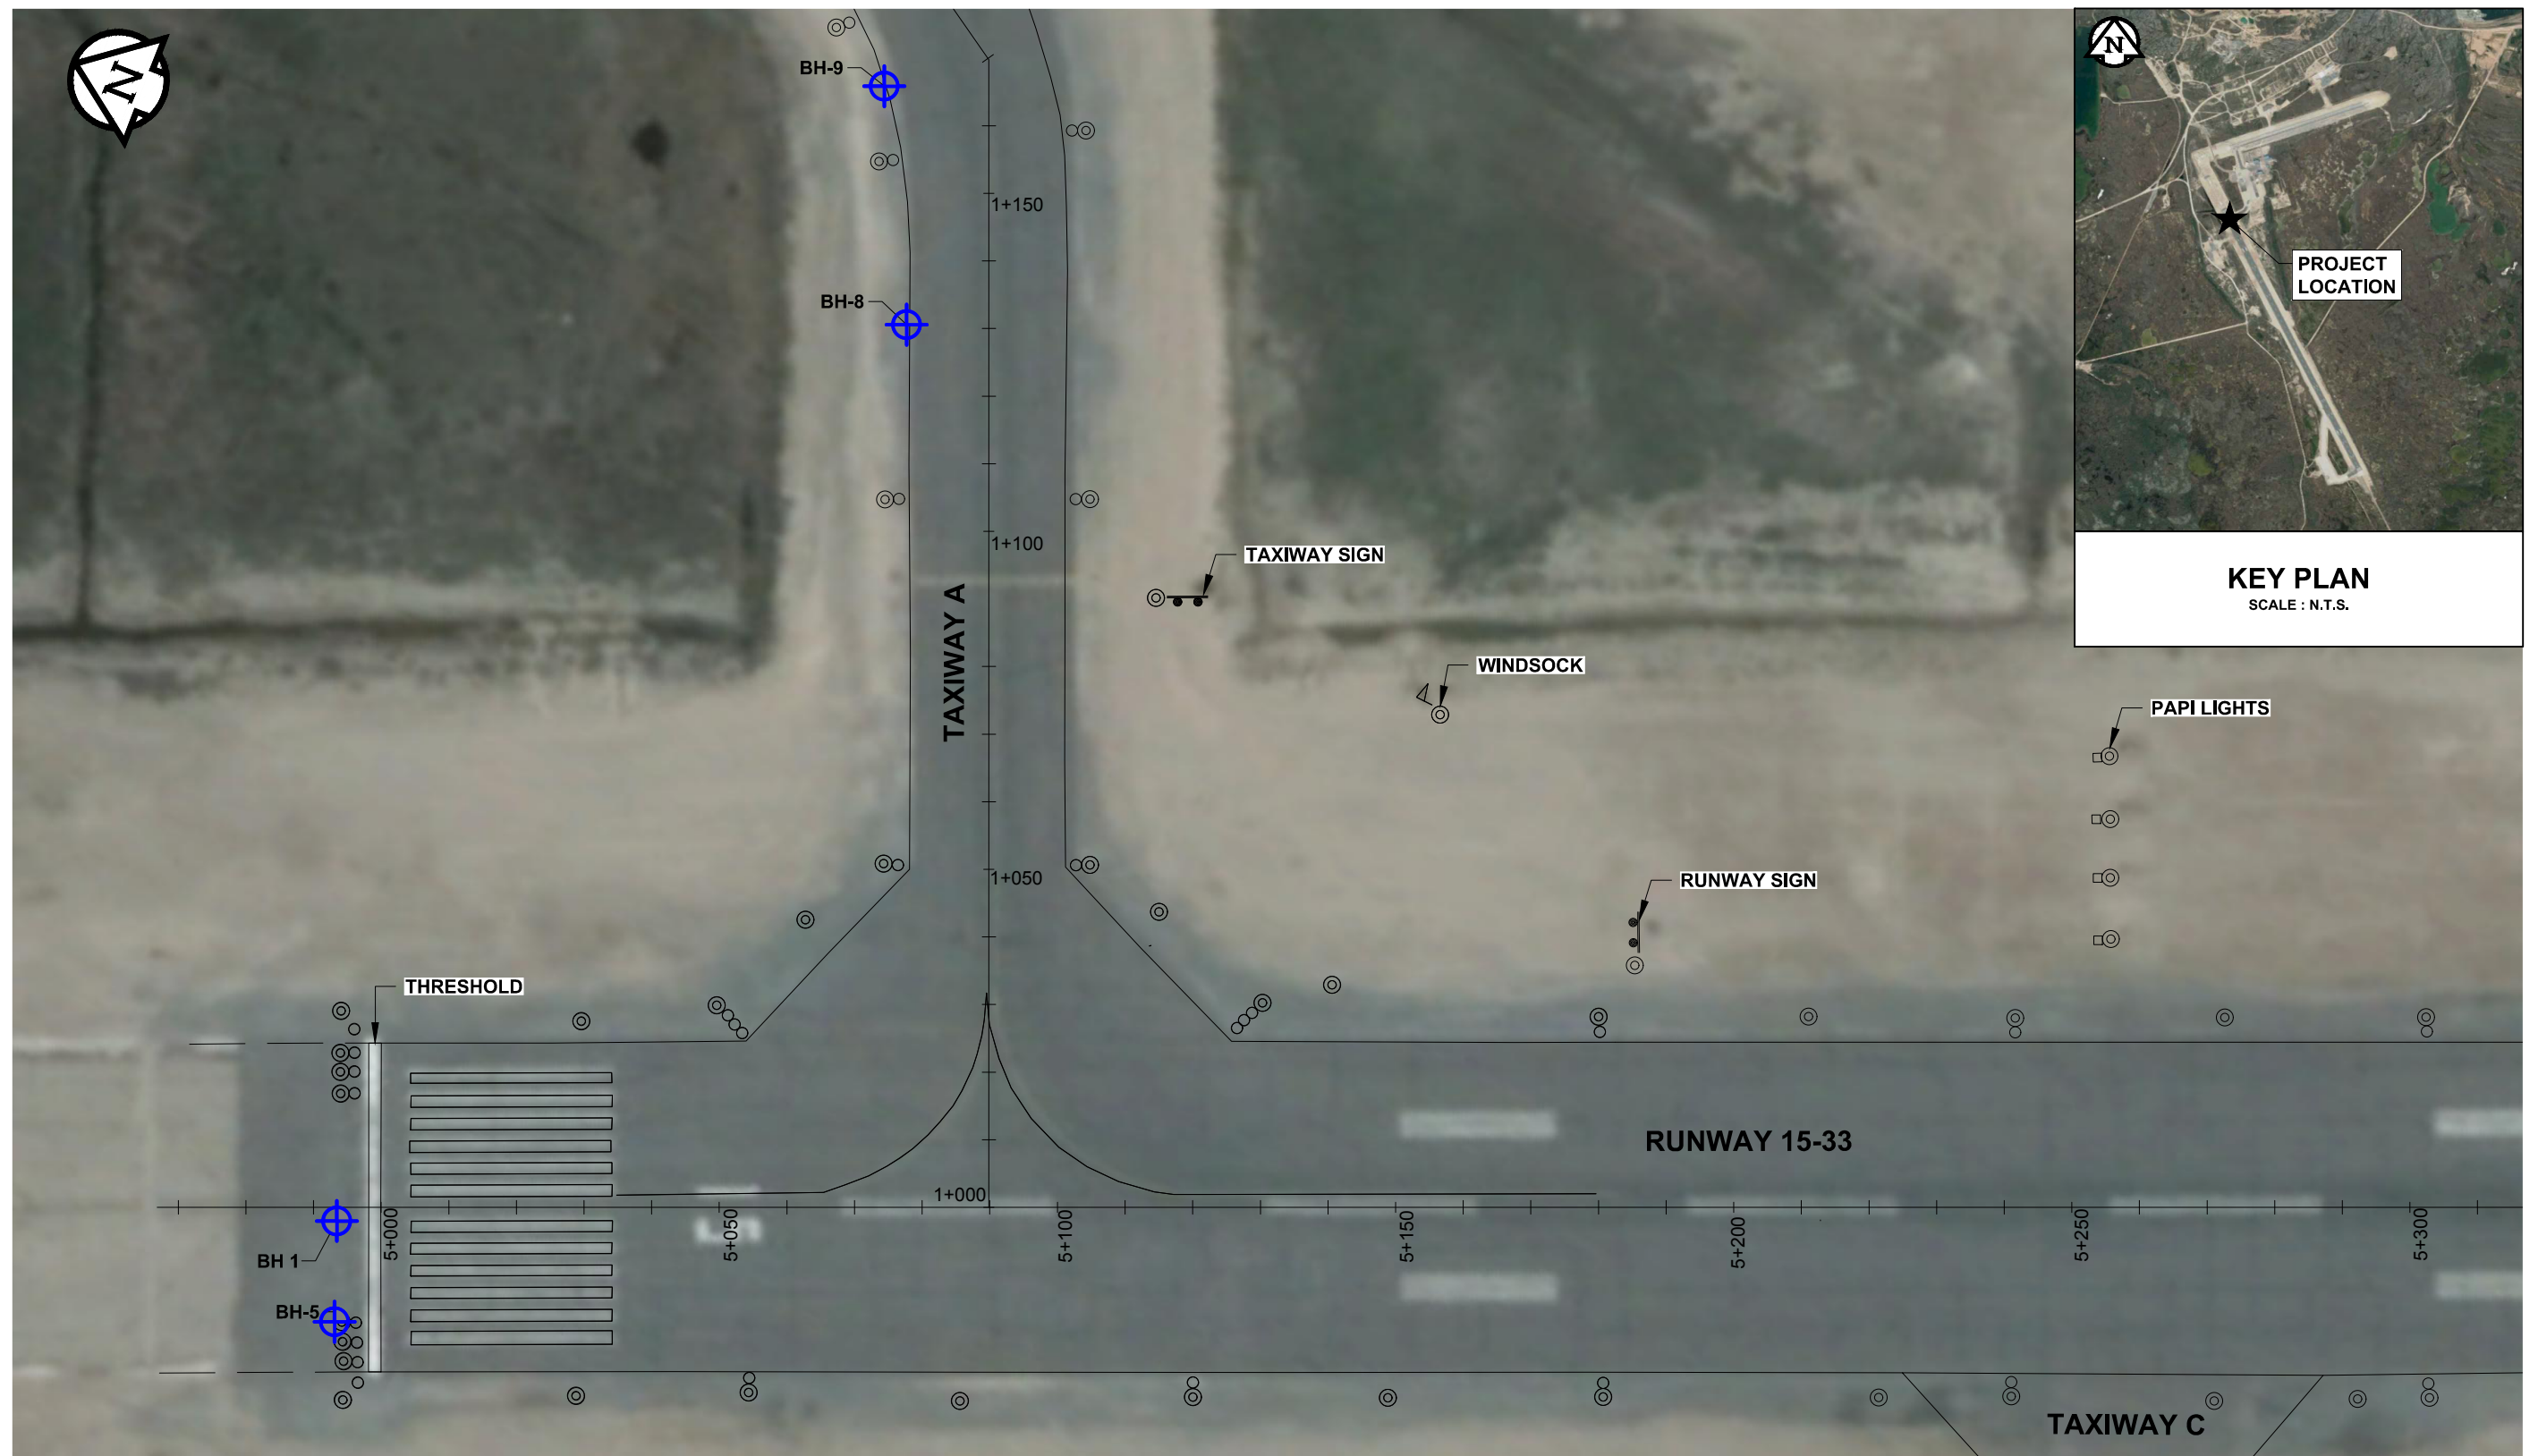
## **Test Hole Location Plan**

Test hole locations on Runway 15-33 (BH1 and BH5) were measured relative to the runway threshold and centerline, and the test hole locations on Taxiway A (BH8 and BH9) were measured relative to the airfield lights. All test hole locations were also recorded by handheld GPS. Test hole logs are provided in Appendix B and include a description of the soil units encountered during drilling and other pertinent information such as groundwater conditions, temperature recordings, and laboratory testing results.

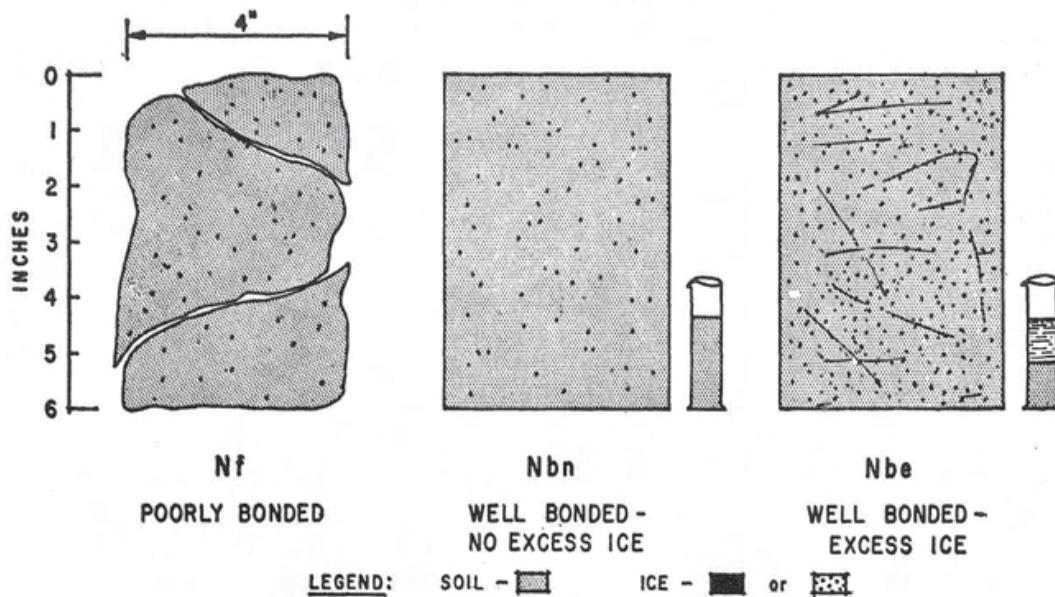
**FIG A. ICE NOT VISIBLE**

<sup>(a)</sup> Frozen soils in the N group may, on close examination, indicate presence of ice within the voids of the material by crystalline reflections or by a sheen on fractured or trimmed surfaces. The impression received by the unaided eye, however, is that none of the frozen water occupies space in excess of the original voids in the soil. The opposite is true of frozen soils in the V group (see p. 14).

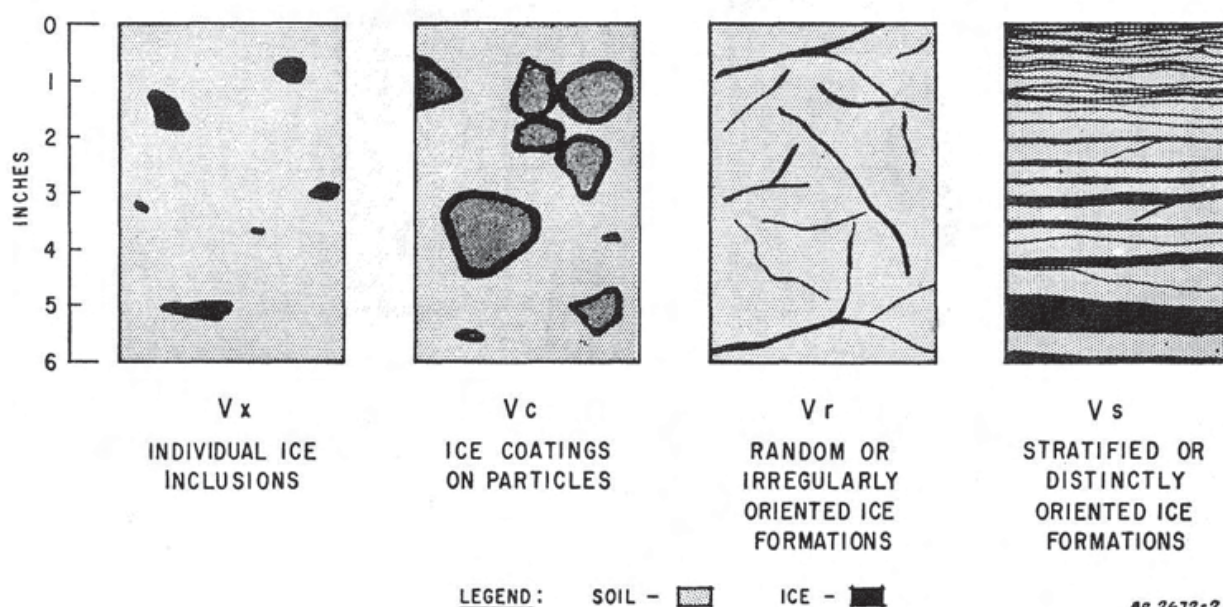
FIG B. VISIBLE ICE LESS THAN ONE INCH THICK

<sup>(a)</sup> Frozen soils in the N group may, on close examination, indicate presence of ice within the voids of the material by crystalline reflections or by a sheen on fractured or trimmed surfaces. The impression received by the unaided eye, however, is that none of the frozen water occupies space in excess of the original voids in the soil. The opposite is true of frozen soils in the V group.

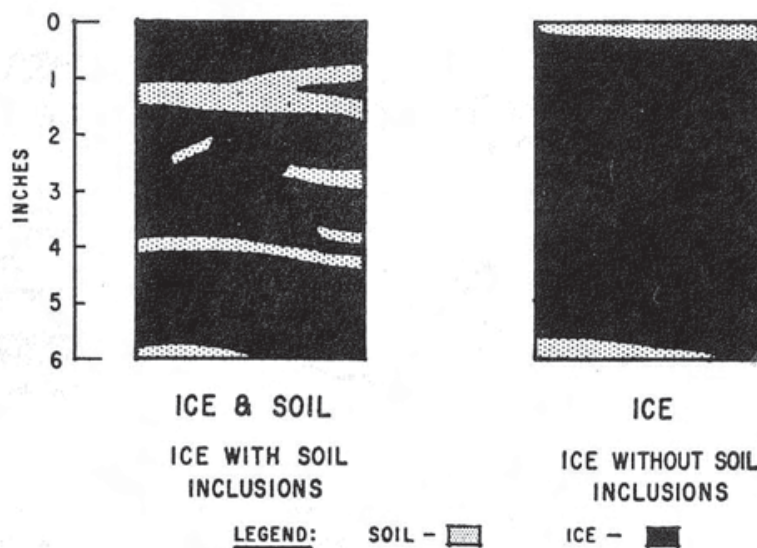
FIG C. VISIBLE ICE GREATER THAN ONE INCH THICK

(a) Where special forms of ice such as hoarfrost can be distinguished, more explicit description should be given.

(b) Observer should be careful to avoid being misled by surface scratches or frost coating on the ice.

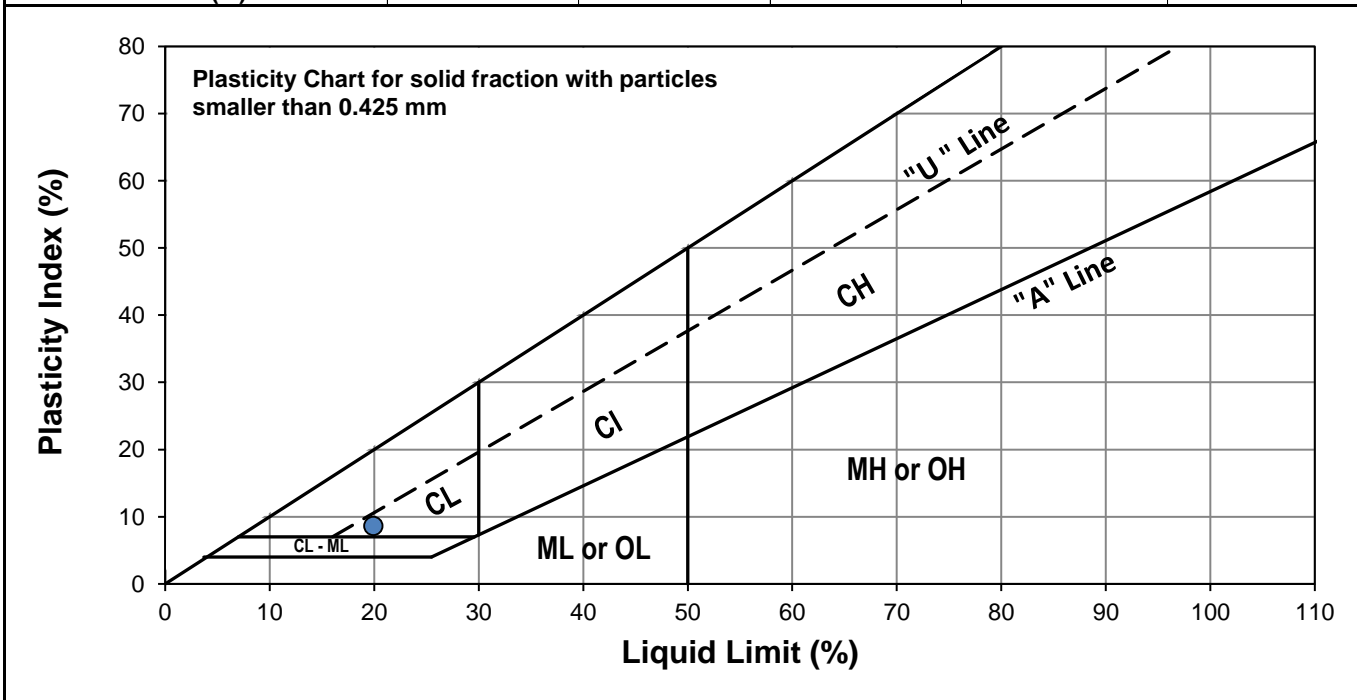
### Liquid Limit

Trial #	1	2	3		
Number of Blows (N)	15	26	34		
Mass Wet Soil + Tare (g)	26.480	25.523	25.552		
Mass Dry Soil + Tare (g)	24.294	23.682	23.730		
Mass Tare (g)	14.094	14.277	14.234		
Mass Water (g)	2.186	1.841	1.822		
Mass Dry Soil (g)	10.200	9.405	9.496		
Moisture Content (%)	21.431	19.575	19.187

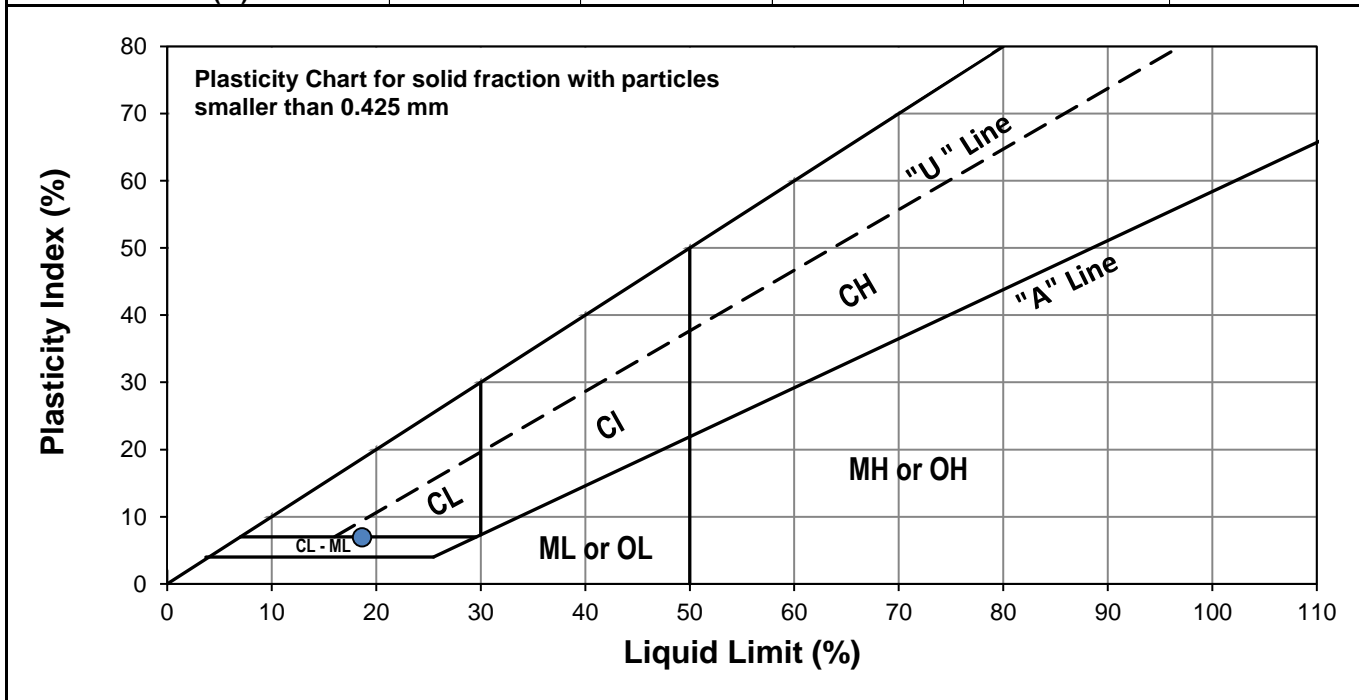
### Liquid Limit

Trial #	1	2	3		
Number of Blows (N)	17	20	32		
Mass Wet Soil + Tare (g)	26.132	25.173	26.630		
Mass Dry Soil + Tare (g)	24.203	23.432	24.683		
Mass Tare (g)	14.212	14.269	14.005		
Mass Water (g)	1.929	1.741	1.947		
Mass Dry Soil (g)	9.991	9.163	10.678		
Moisture Content (%)	19.307	19.000	18.234

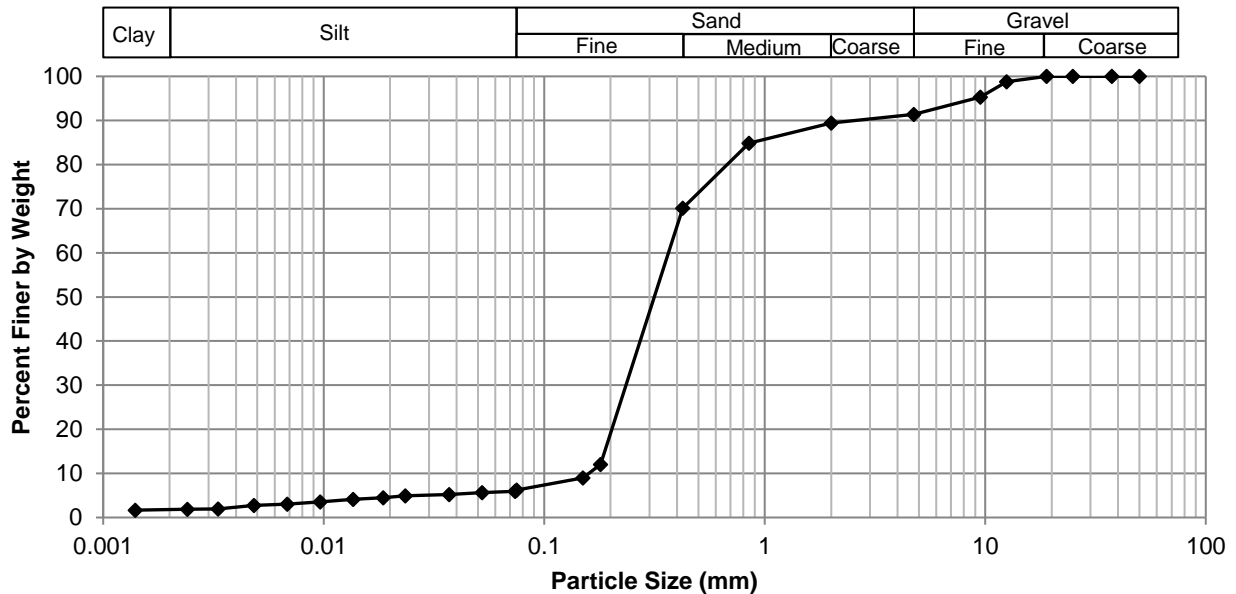
**Particle Size Distribution Curve**

<b>Gravel</b>	8.6%
<b>Sand</b>	85.2%
<b>Silt</b>	4.4%
<b>Clay</b>	1.8%

Gravel		Sand		Silt and Clay	
Particle Size (mm)	Percent Passing	Particle Size (mm)	Percent Passing	Particle Size (mm)	Percent Passing
50.0	100.00	4.75	91.39	0.0750	6.19
37.5	100.00	2.00	89.40	0.0738	5.91
25.0	100.00	0.850	84.87	0.0523	5.63
19.0	100.00	0.425	70.10	0.0371	5.21
12.5	98.80	0.180	12.00	0.0235	4.93
9.50	95.27	0.150	8.98	0.0186	4.51
4.75	91.39	0.075	6.19	0.0136	4.12
				0.0097	3.56
				0.0068	3.03
				0.0048	2.73
				0.0033	1.92
				0.0024	1.89
				0.0014	1.67

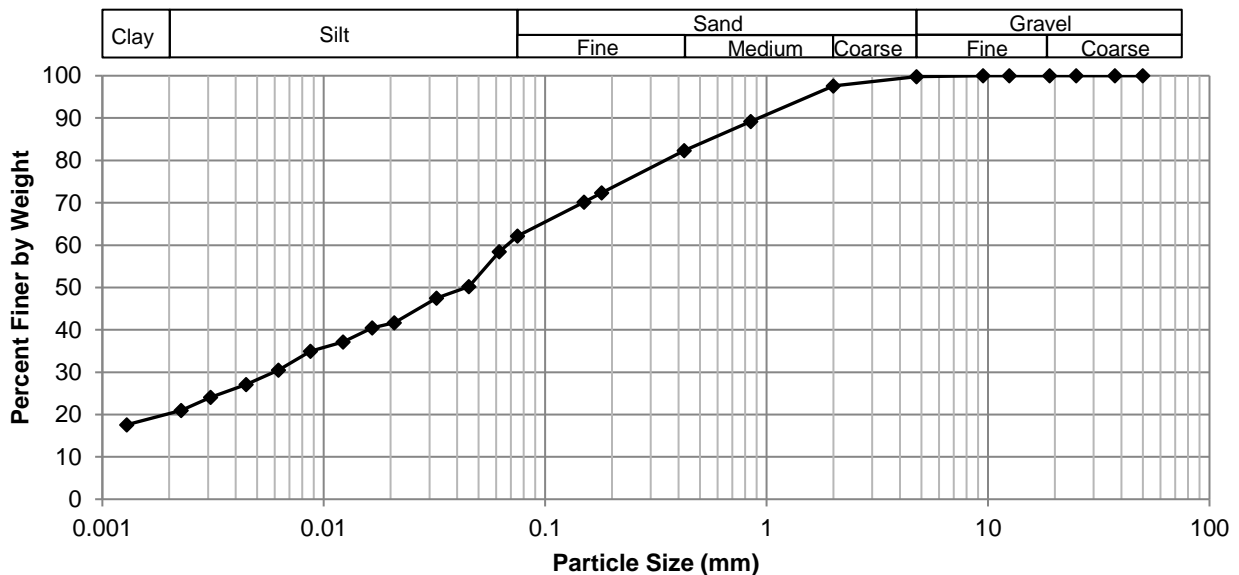
**Particle Size Distribution Curve**

<b>Gravel</b>	0.2%
<b>Sand</b>	37.6%
<b>Silt</b>	44.4%
<b>Clay</b>	17.8%

Gravel		Sand		Silt and Clay	
Particle Size (mm)	Percent Passing	Particle Size (mm)	Percent Passing	Particle Size (mm)	Percent Passing
50.0	100.00	4.75	99.79	0.0750	62.17
37.5	100.00	2.00	97.62	0.0621	58.49
25.0	100.00	0.850	89.18	0.0453	50.25
19.0	100.00	0.425	82.33	0.0323	47.50
12.5	100.00	0.180	72.32	0.0209	41.70
9.50	100.00	0.150	70.20	0.0166	40.48
4.75	99.79	0.075	62.17	0.0122	37.12
				0.0087	34.99
				0.0062	30.46
				0.0045	27.10
				0.0031	24.05
				0.0023	20.95
				0.0013	17.59

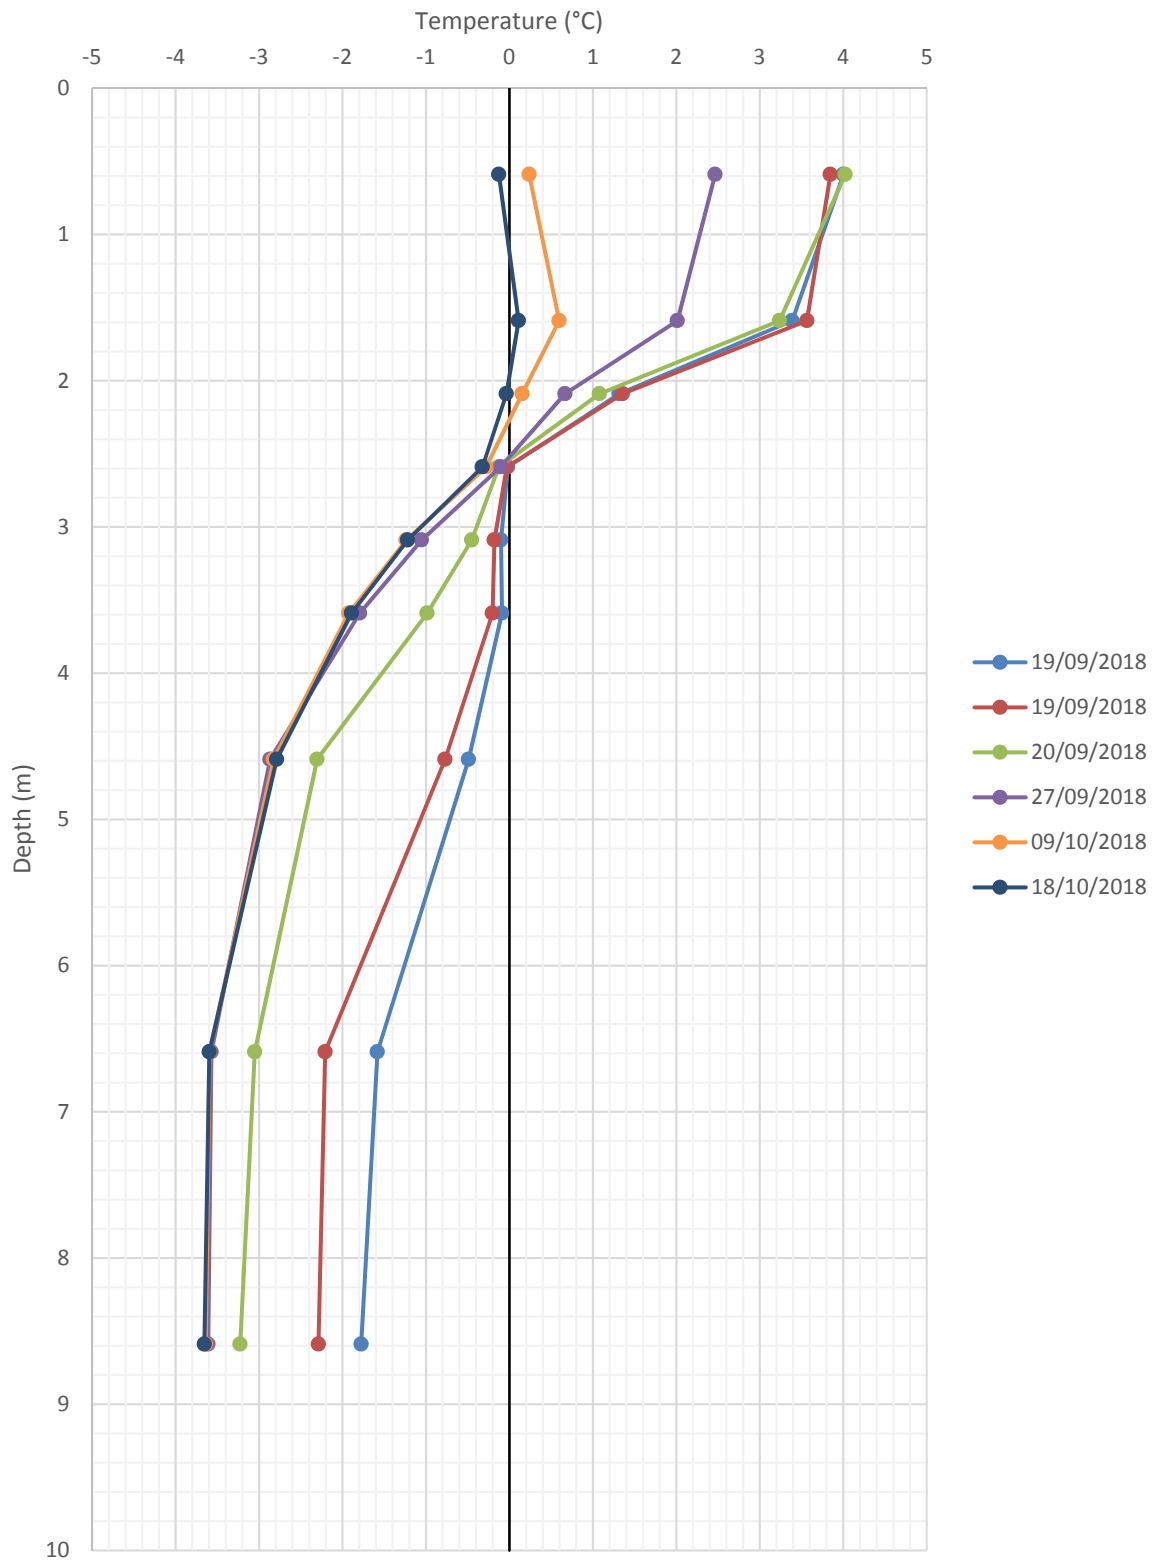
### BH5 - Ground Temperature vs. Depth

Based on measured ground temperatures and our visual observations during drilling, frozen soils were encountered at depths of 1.6 m below ground surface in BH5 and below 3 m in BH8 and BH9, extending to the depth of exploration in all test holes. The frozen soils consist of non-visible ice at 1.6 m to 2.7 m depth below grade in BH5 and 3.0 m to 4.6 m depth in BH8; frozen soils in BH9 contained entirely non-visible ice. The non-visible ice is poorly bonded in BH5 and well-bonded with excess ice in BH8 and BH9. The visible ice observed in BH5 and BH9 was comprised of varying amount of ice lenses (random and/or stratified), ice coating on soil particles, and ice inclusions.
