**ANNEX A Site  
Photographs**

R.087575.004 Reay Creek Remediation – Victoria Airport Lands  
1640 Electra Boulevard, Sidney, BC  
SLR Project No.: 205.03892.00004

Reay Creek Remediation Specifications  
Reay Creek, Victoria International Airport  
Sidney, BC

SITE PHOTOGRAPHS

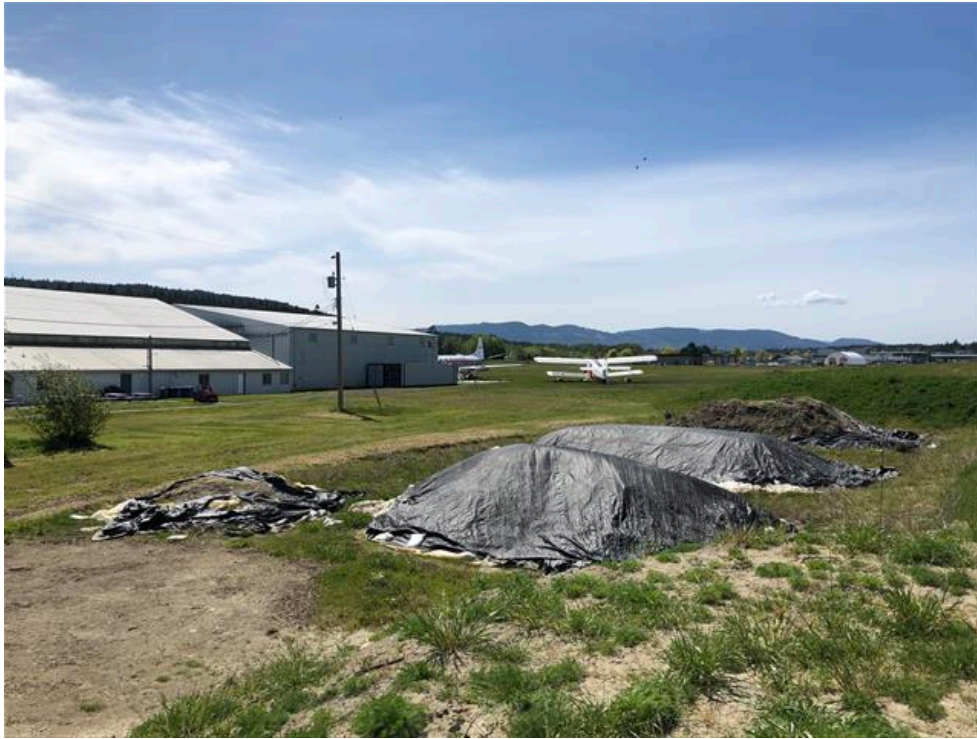
**Photo 1:** Existing soil stockpiles in contaminated soil stockpile area, looking west. BC Aviation Museum shown in background right. Stockpiles to be removed under contract.

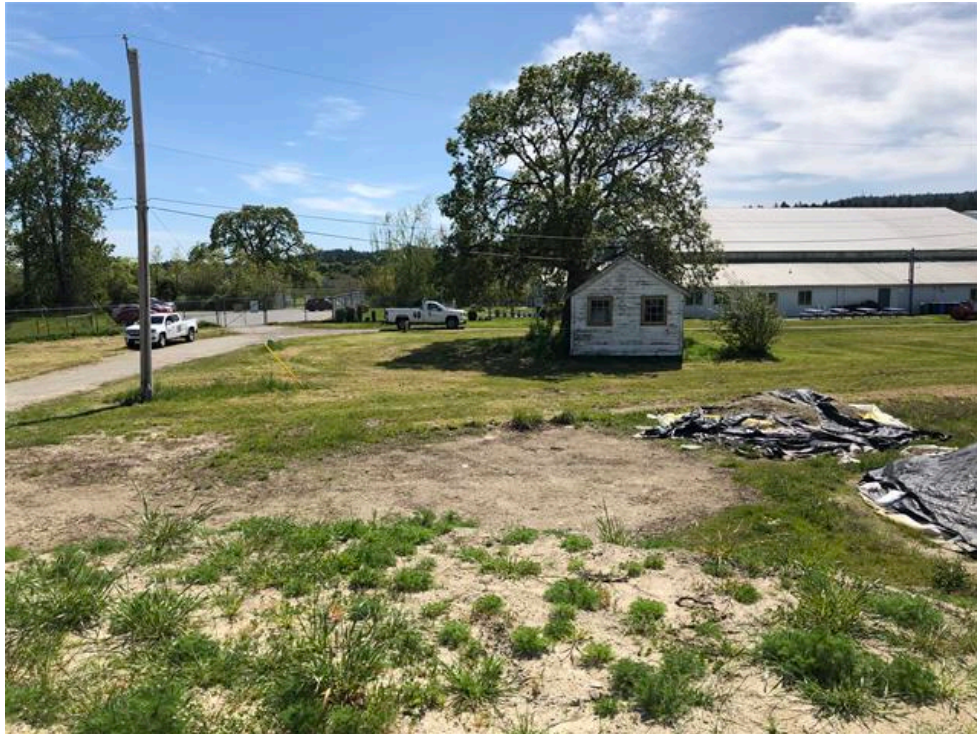
**Photo 2:** Shack and overhead power lines at south end of work area, looking south. Protect from disturbance.

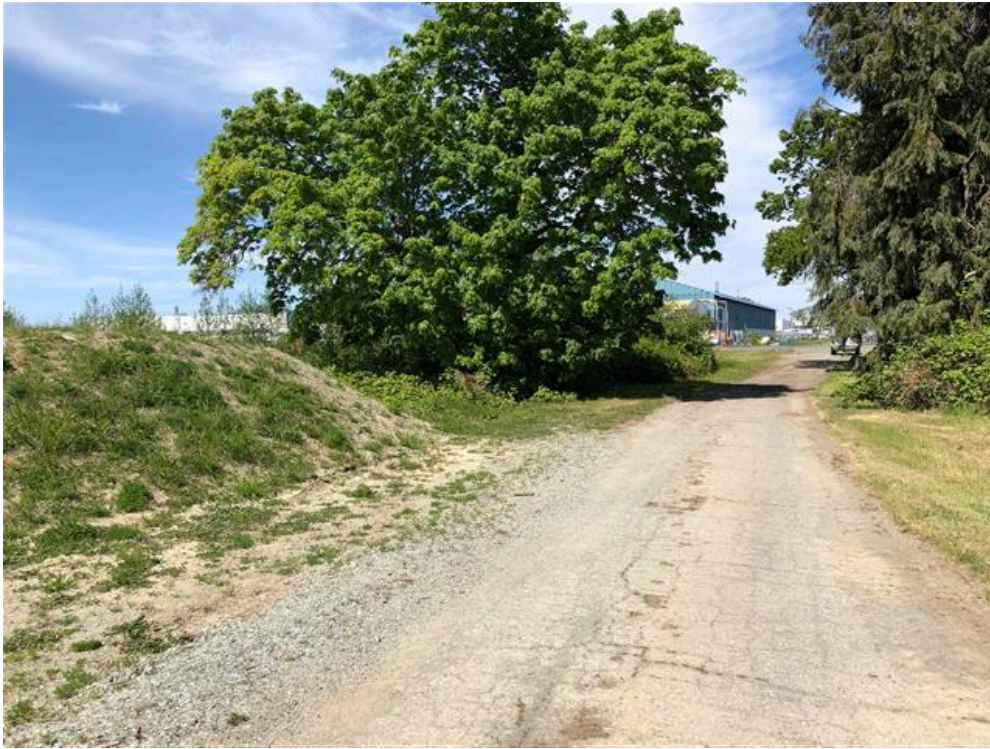
**Photo 3:** Paved road bisecting Reach 1C, looking north. Maintain roadway during and after construction.

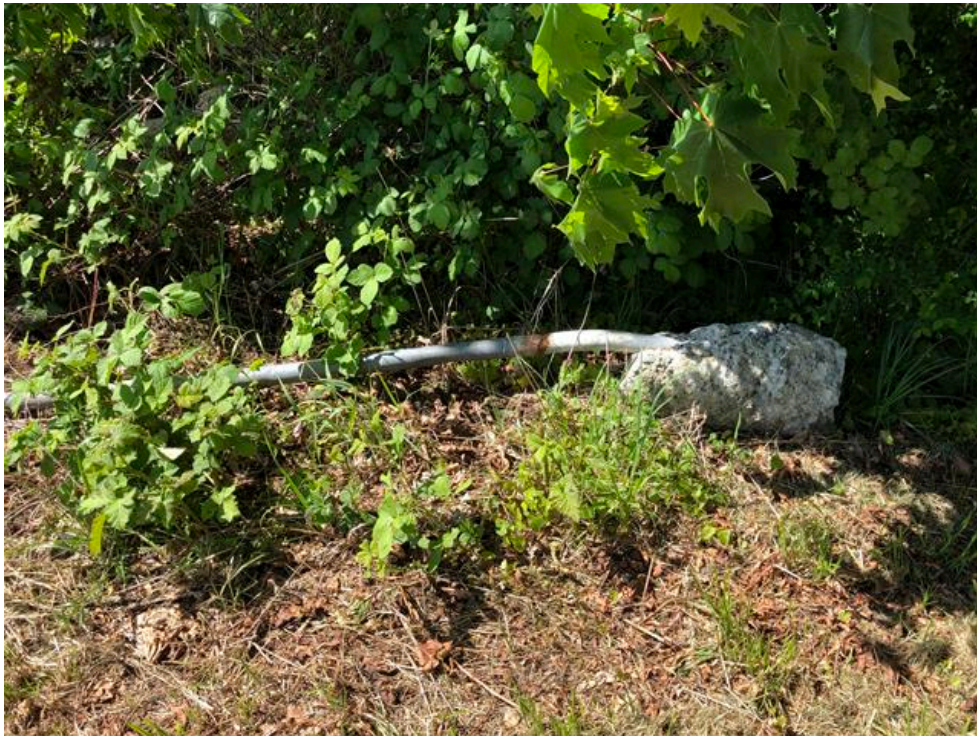
**Photo 4:** Remove and dispose debris if encountered.

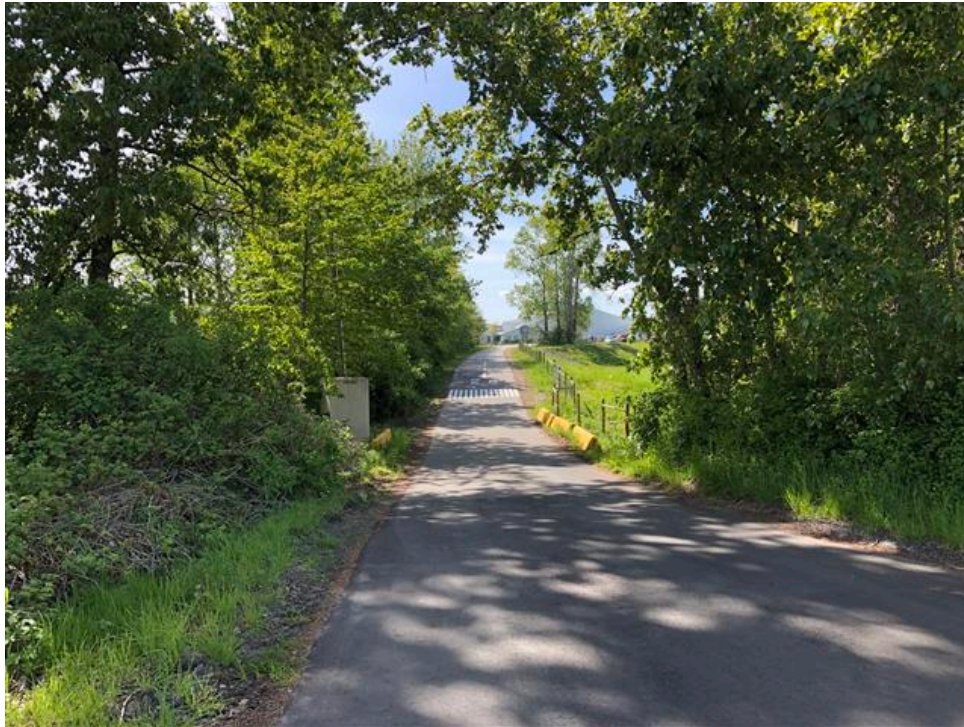
**Photo 5:** View of Norseman Road crossing Reay Creek, looking west. Reach 3 tributary channel with riparian vegetation visible along left of roadway.

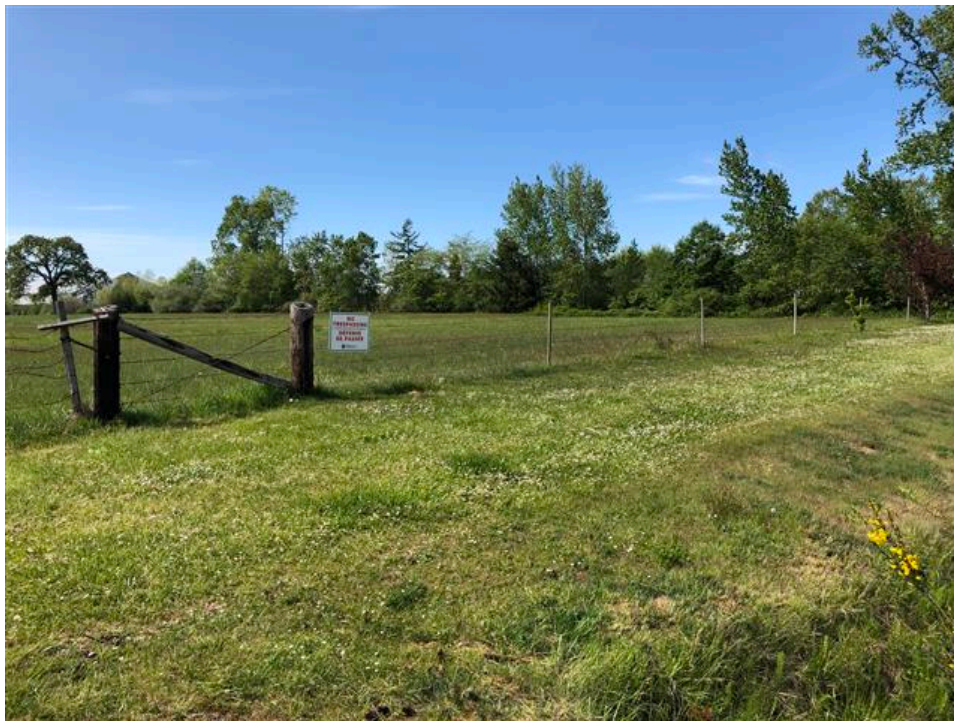
**Photo 6:** Potential alternate stockpile or laydown area south of Reach 3 area, looking northwest.

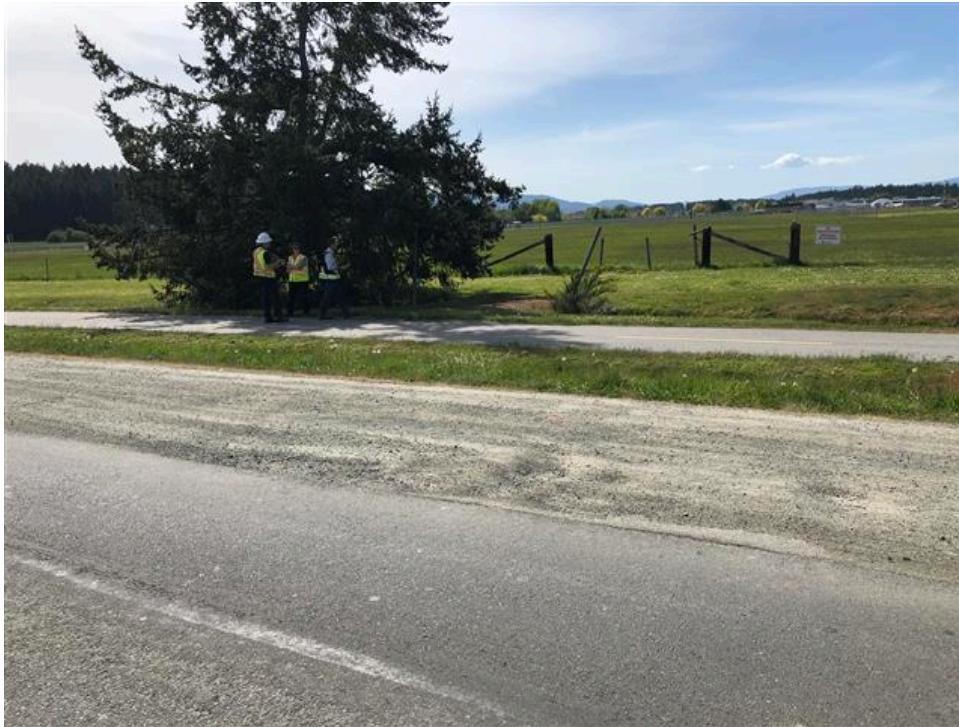
**Photo 7:** Access to potential alternate stockpile or laydown area, looking west. Cycling / Pedestrian path visible between Canora Road (foreground) and field. Access gate visible in background.

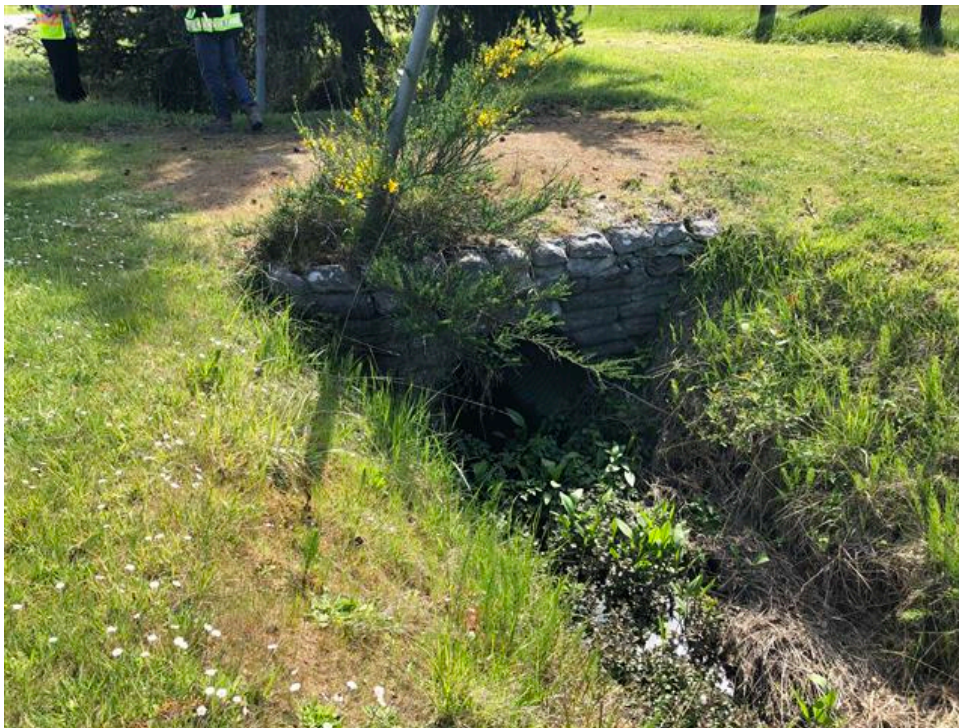
**Photo 8:** Access over road-side ditch to potential alternate stockpile or laydown area, looking southwest. Crossing to be maintained and protected.

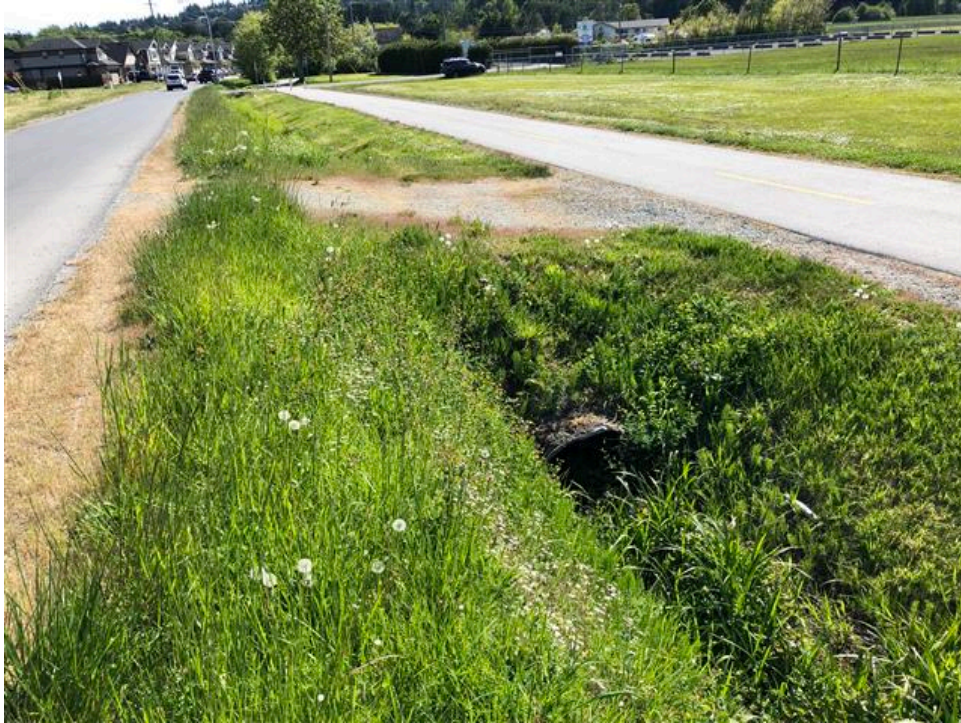
**Photo 9:** Alternate road-side ditch crossing to potential alternate stockpile or laydown area, looking south. Cycling / Pedestrian path visible in right of photograph. Crossing to be maintained and protected.

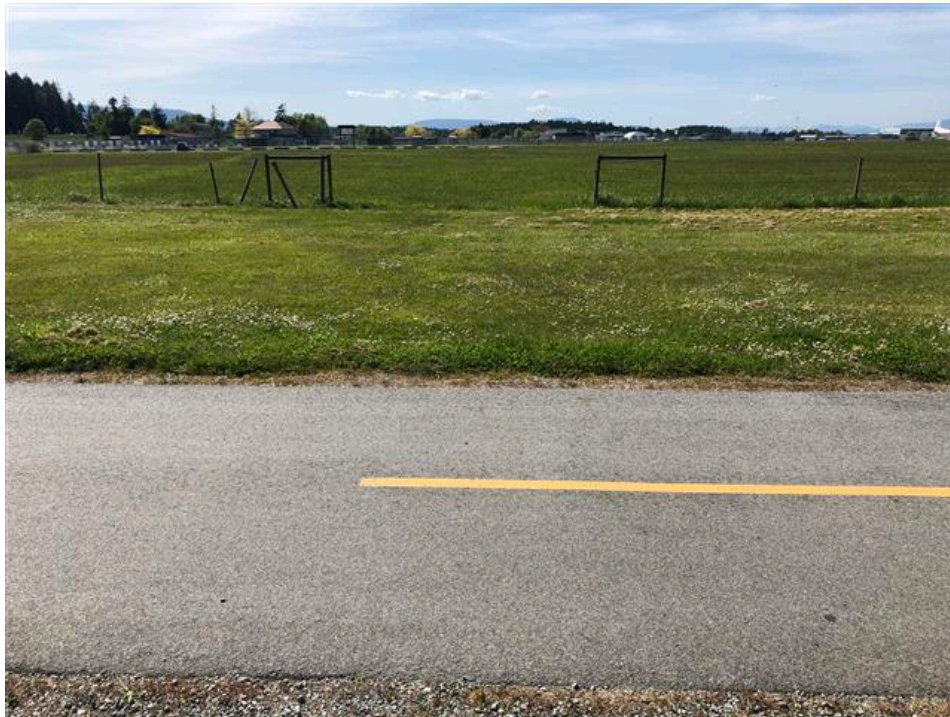
**Photo 10:** Access gate to potential alternate stockpile or laydown area, looking west. Cycling / Pedestrian path visible in foreground.

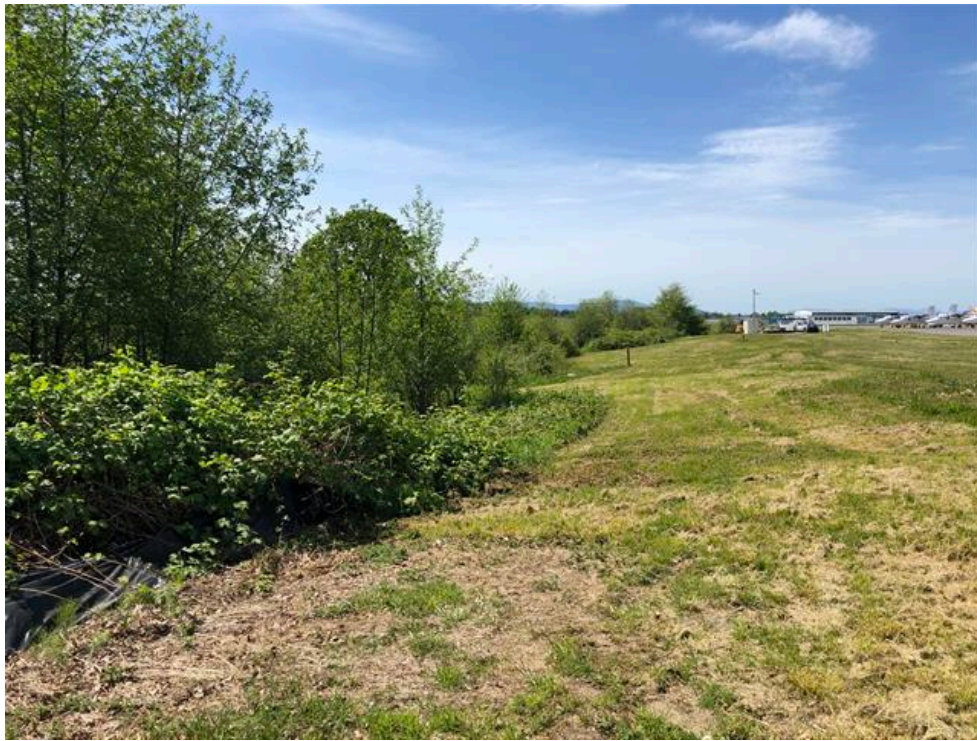
**Photo 11:** View of north side of Reach 1A and Reach 1C, looking west. Reay Creek channel with riparian vegetation visible on left of photograph

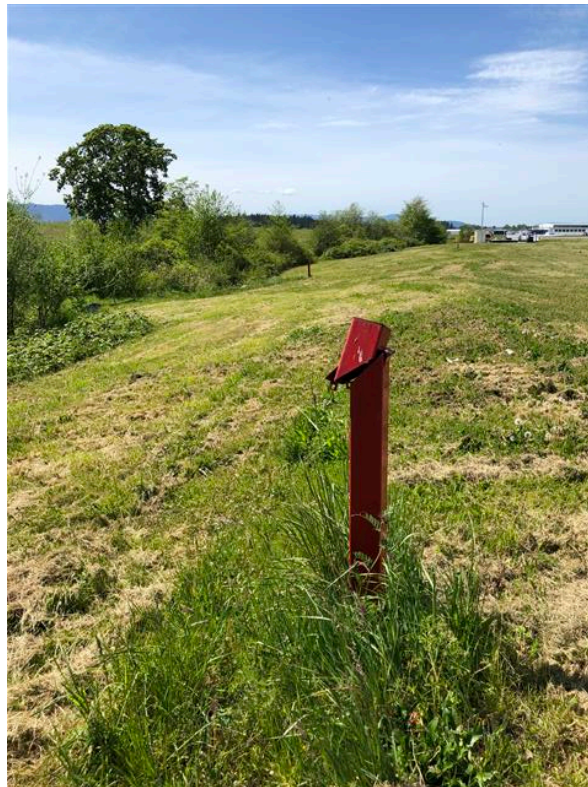
**Photo 12:** Monitoring wells adjacent to Reach 1A and Reach 1C to be protected.

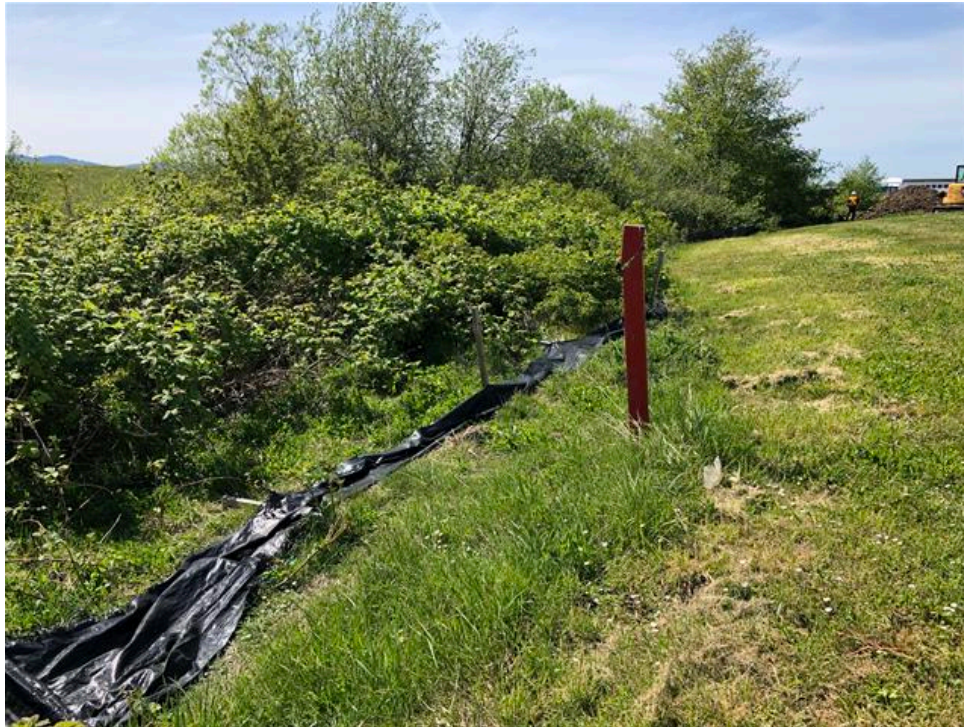
**Photo 13:** Invasive plant material along north bank of Reach 1A to be removed, looking west. Monitoring well to be protected.

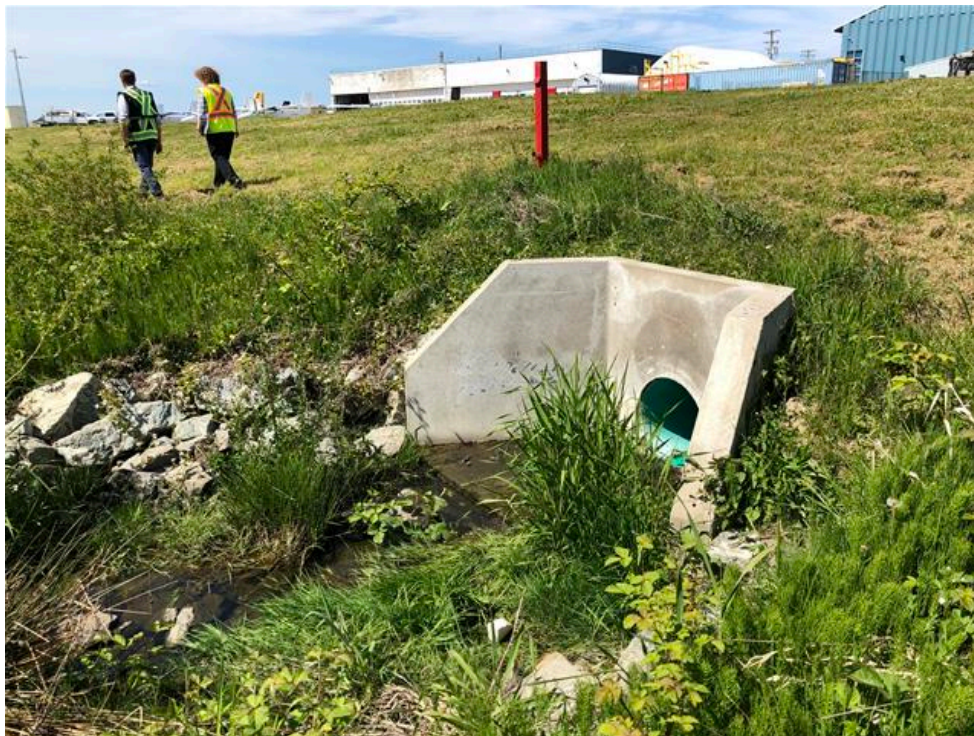
**Photo 14:** Stormwater outlet headwall adjacent to Reach 1A to be protected, looking northwest. Monitoring well in background to be protected.

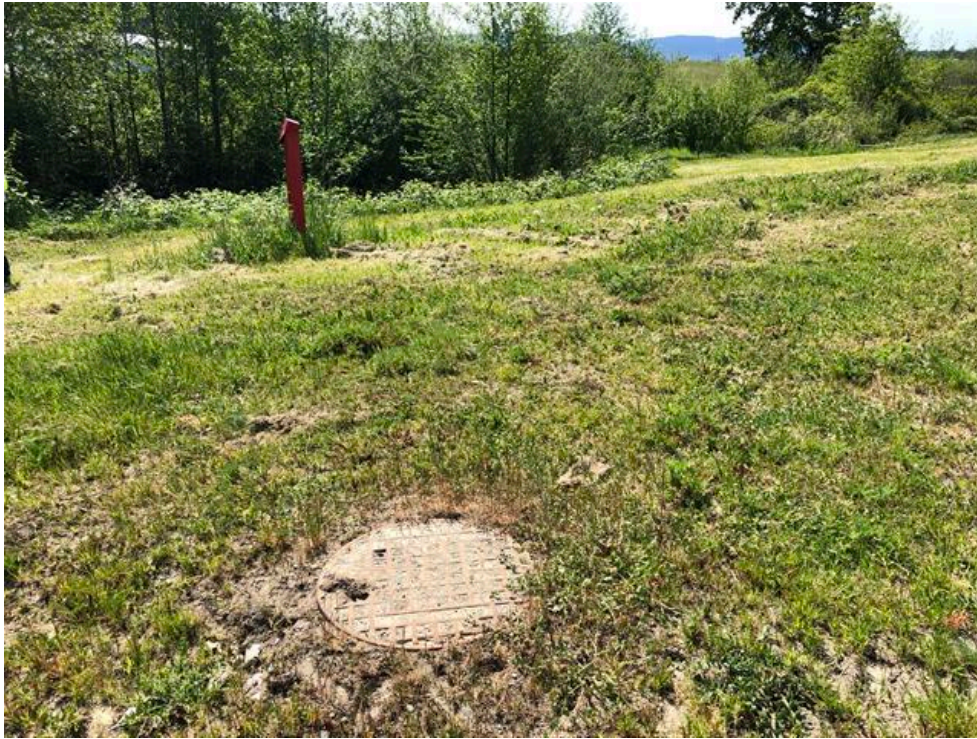
**Photo 15:** Storm lines adjacent to Reach 1C and Reach 1A to be protected, looking south.

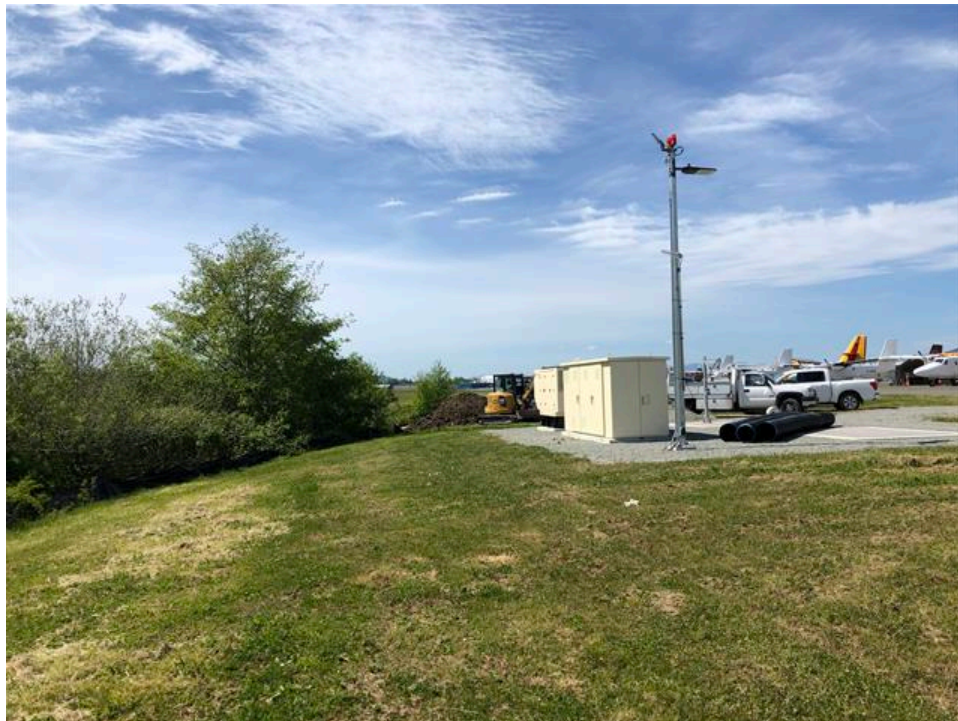
**Photo 16:** Utility infrastructure along north side of Reach 1A at upstream end, looking west.

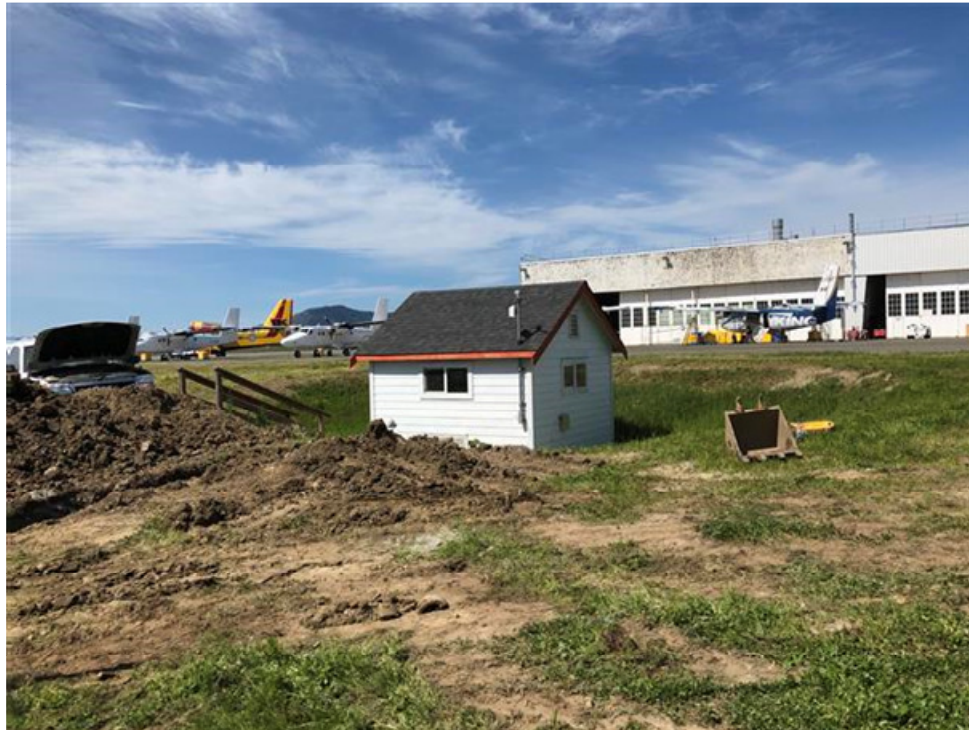
**Photo 17:** Pumphouse along north side of Reach 1A at upstream end, looking northwest.

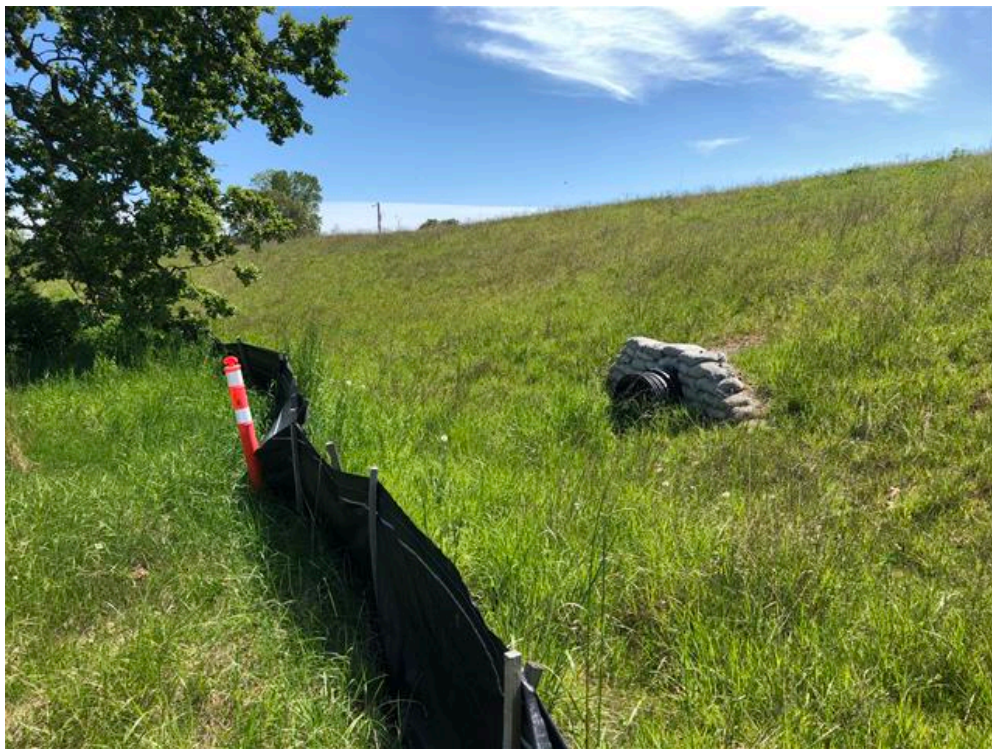
**Photo 20:** Culvert outlet on north side of berm near Reach 1B, looking east. Protect from disturbance.

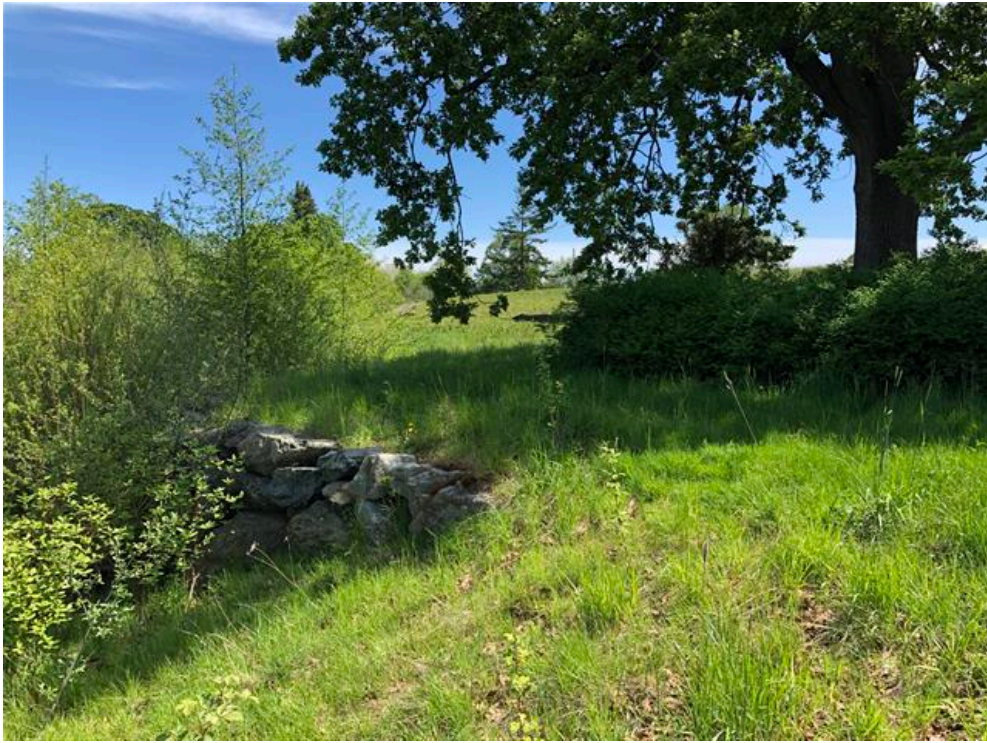
**Photo 21:** Stacked rock wall adjacent to Garry oak tree along Reach 1B, looking southeast. No machine access. Rock wall to be protected.

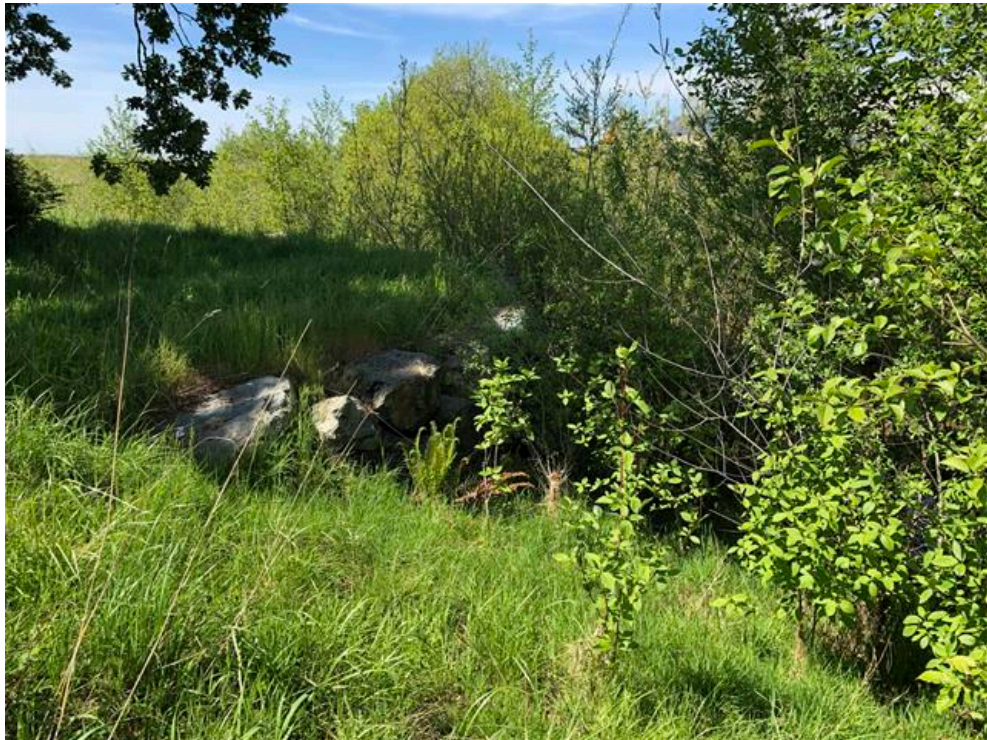
**Photo 22:** Stacked rock wall adjacent to Garry oak tree along Reach 1B, looking northwest. No machine access. Rock wall to be protected.

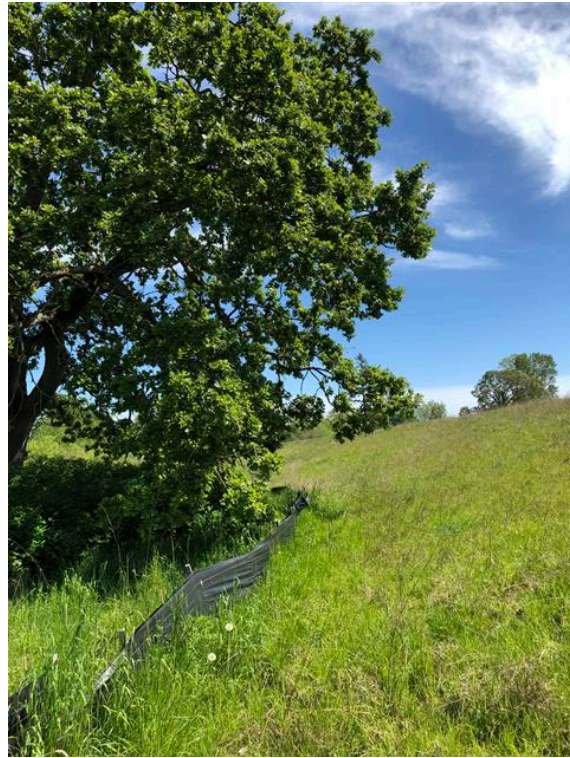
**Photo 23:** Potential access area around Garry oak tree along Reach 1B, looking east. Do not disturb existing berm to right.

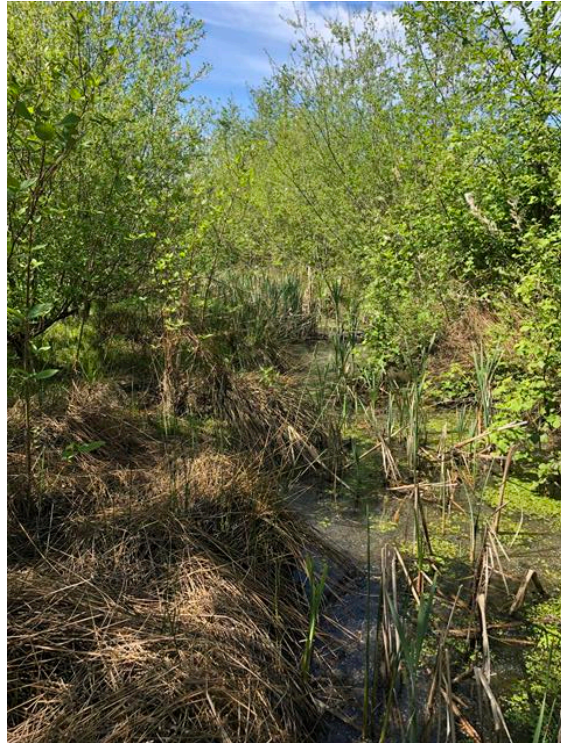
**Photo 25:** Reach 1B typical channel condition, looking west.

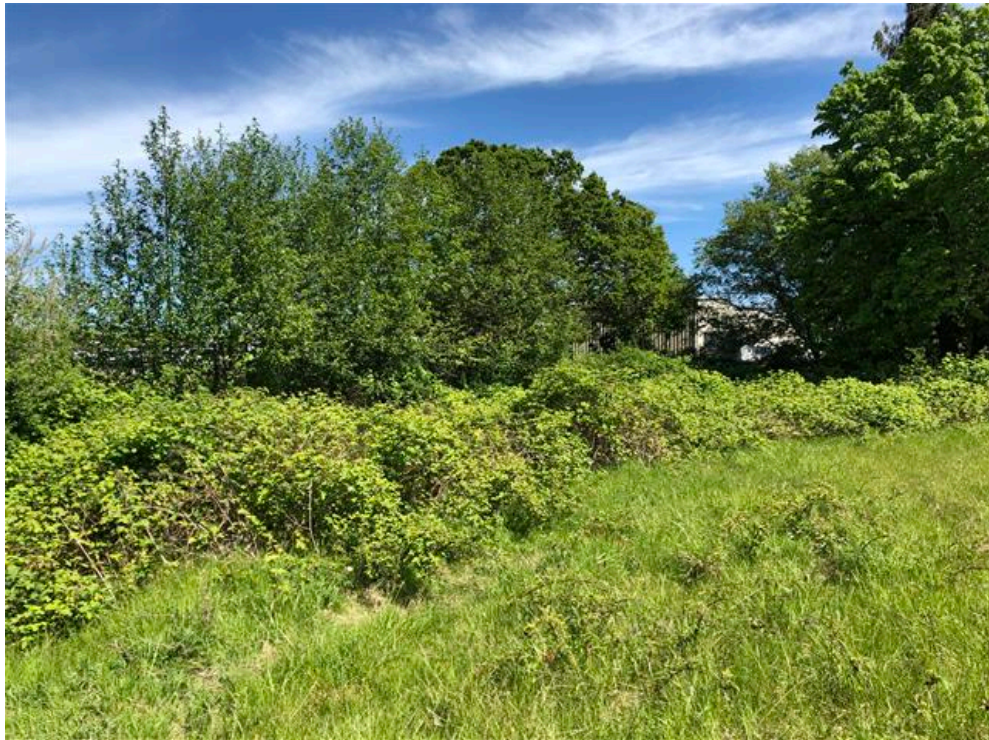
**Photo 26:** Invasive plant material along channel edge in Reach 1C, looking northwest.

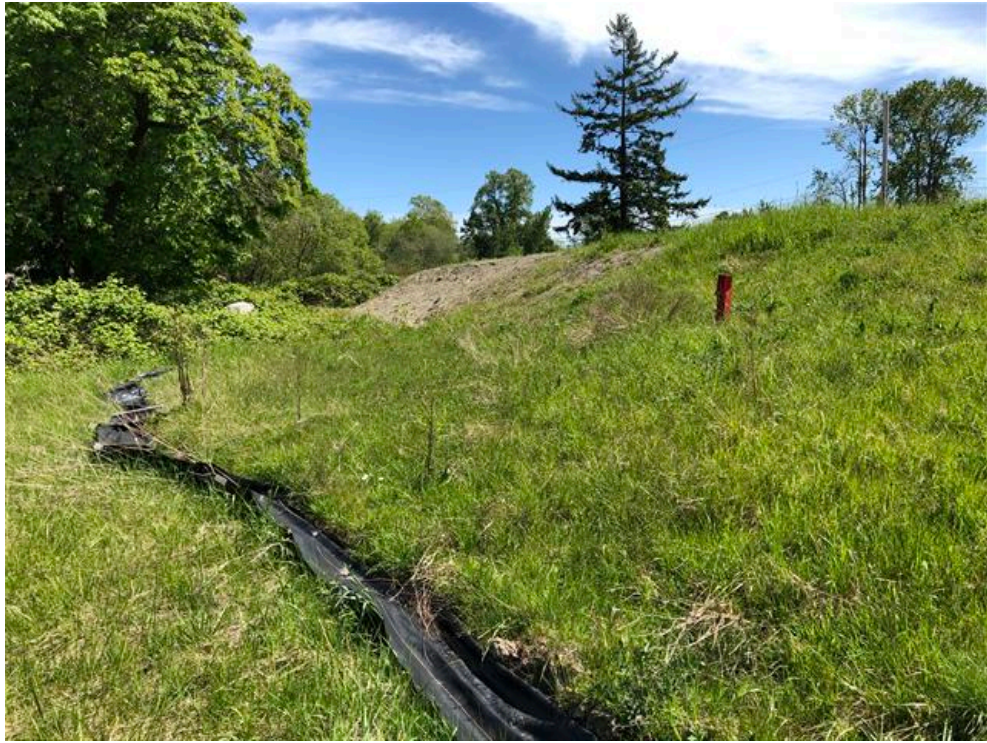
**Photo 27:** Monitoring well adjacent to berm near Reach 1C, looking east. Protect from disturbance.

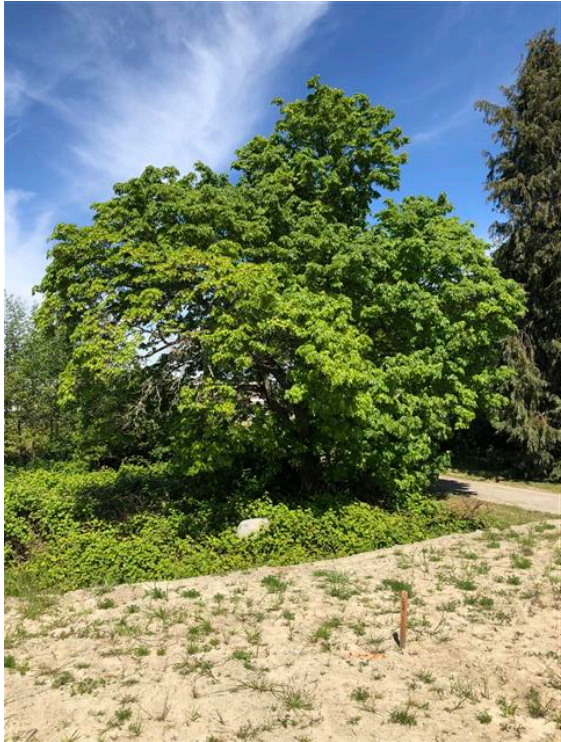
**Photo 28:** Oak tree adjacent to roadway bisecting Reach 1C, looking north. Retain significant trees on-site to fullest extent possible.

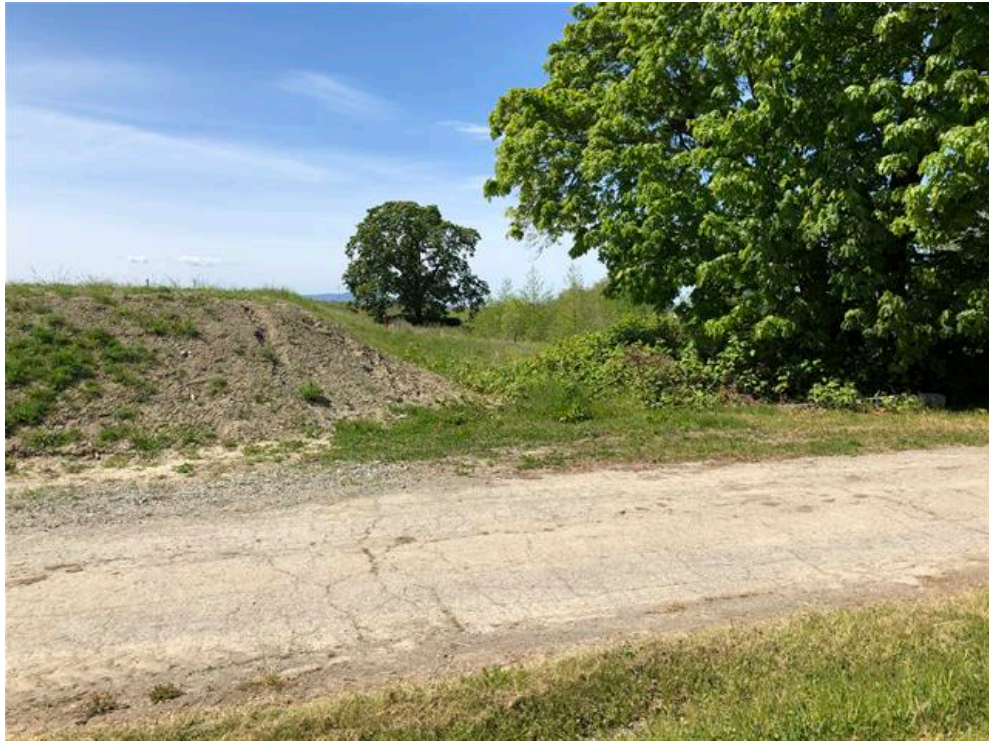
**Photo 29:** Potential access to Reach 1B, looking northwest. Relocation of end of berm on left may be required for significant tree protection.

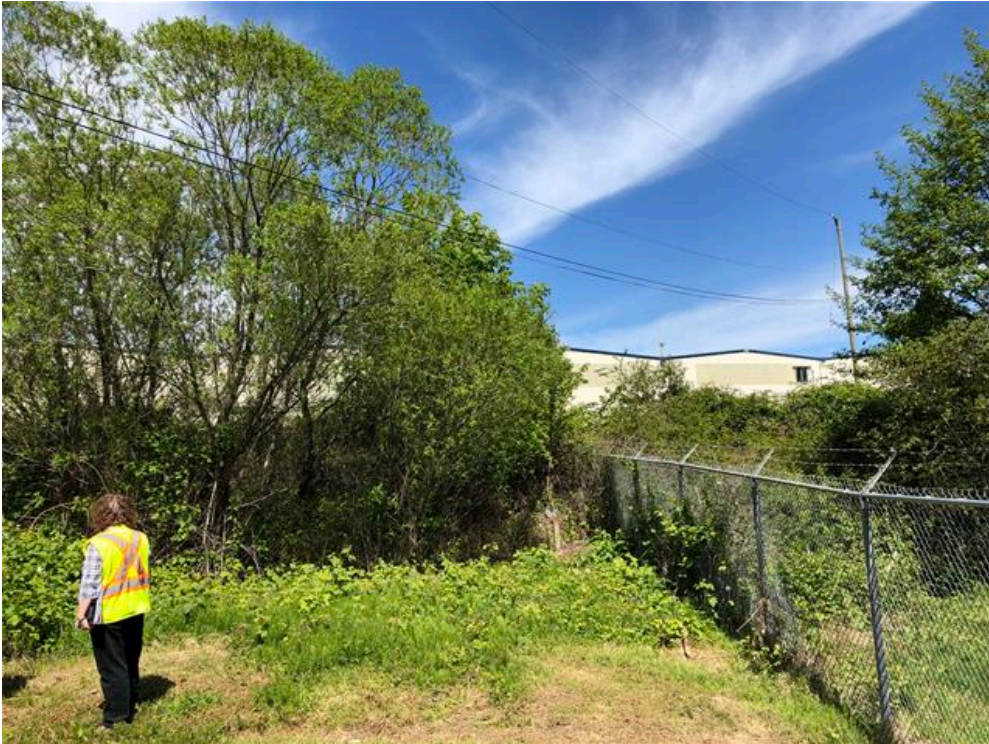
**Photo 30:** Downstream end of Reach 1C, looking northeast. Airside fence line and overhead power lines visible.

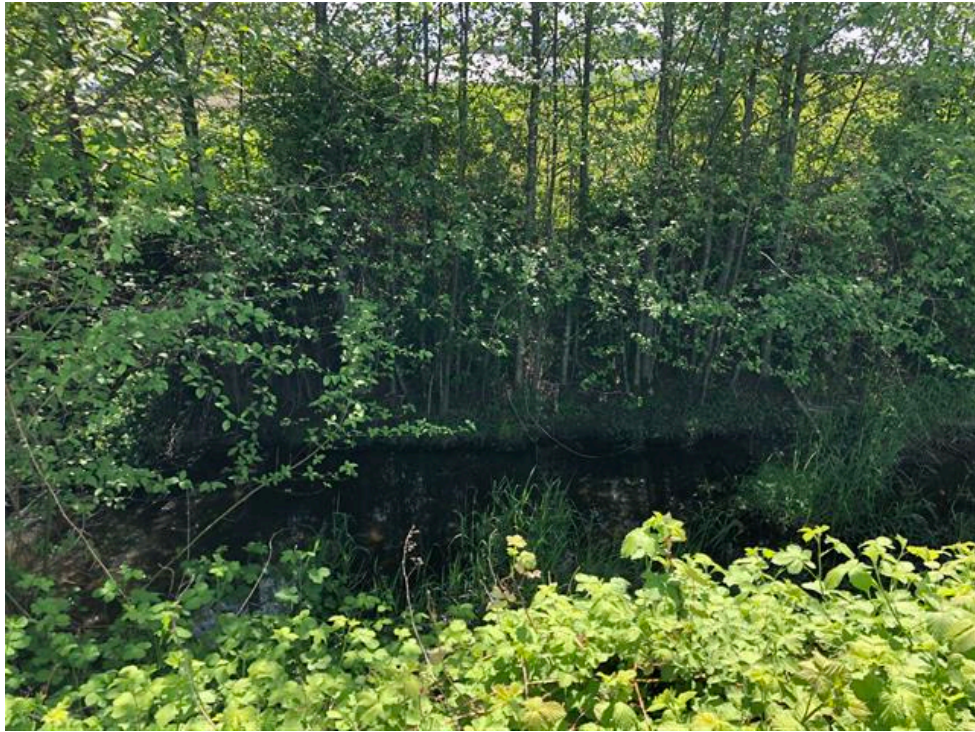
**Photo 31:** View of Reach 1C channel, looking south.

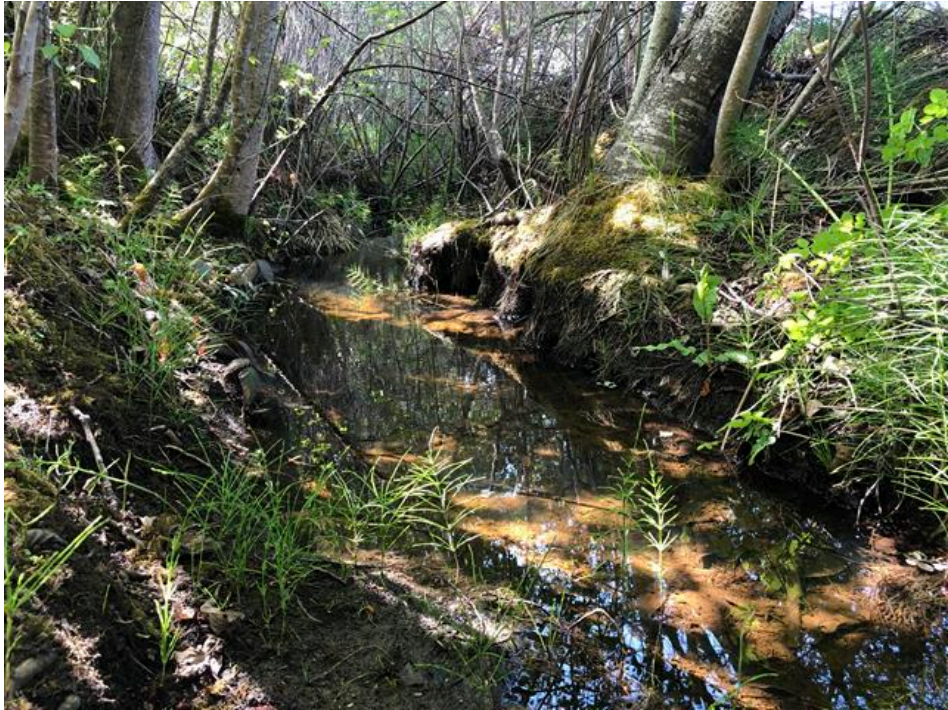
**Photo 32:** Reach 3 tributary channel typical condition, looking west.

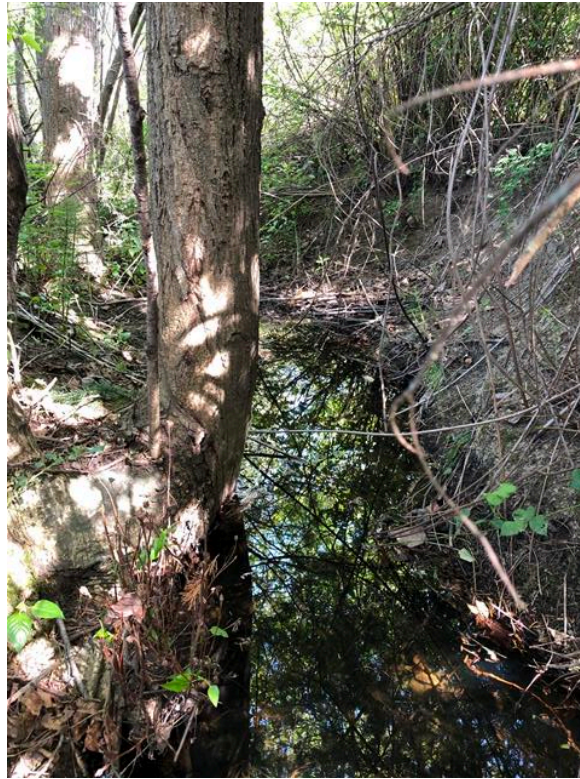
**Photo 33:** Tree adjacent to Reach 3 channel, looking east. Certified arborist to determine tree removal requirements for trees adjacent to creek.

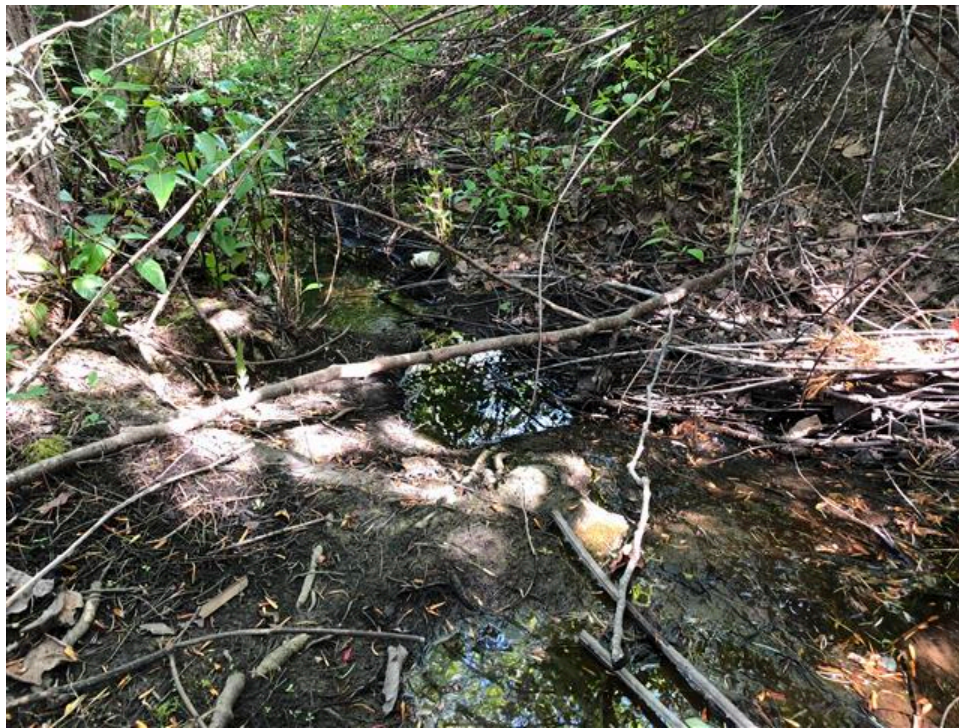
**Photo 34:** Root mass spanning bottom of Reach 3 channel, looking south. Maintain creek morphology to extent practicable. Use hand removal methods adjacent to tree roots.

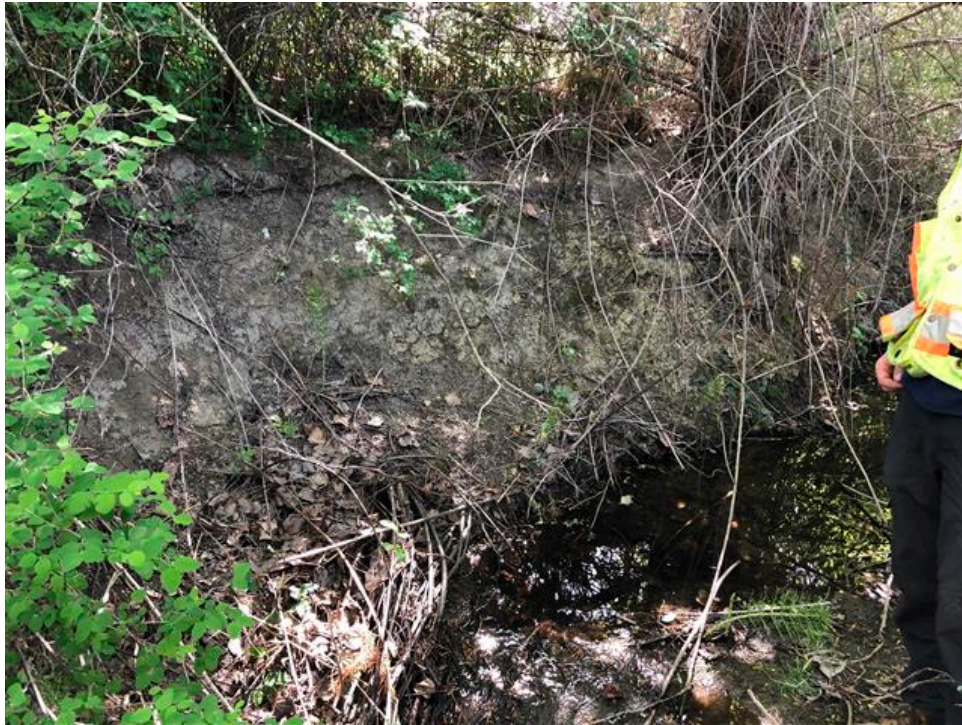
**Photo 35:** Eroded bank along south side of Reach 3 tributary channel, looking southwest.

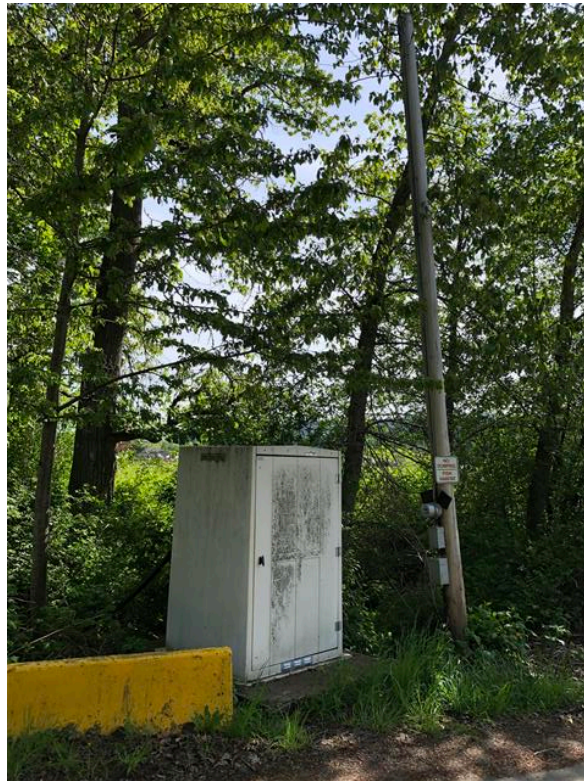
**Photo 36:** Water quality sampling infrastructure and power pole at upstream end of Reach 4, looking southwest. Sampling infrastructure within creek to be removed prior to project. Adjacent infrastructure to remain and be protected.
