**ANNEX A Site  
Photographs**

R.087575.004 Reay Creek Remediation – Victoria Airport Lands  
1640 Electra Boulevard, Sidney, BC  
SLR Project No.: 205.03892.00004

Reay Creek Remediation Specifications  
Reay Creek, Victoria International Airport  
Sidney, BC

SITE PHOTOGRAPHS

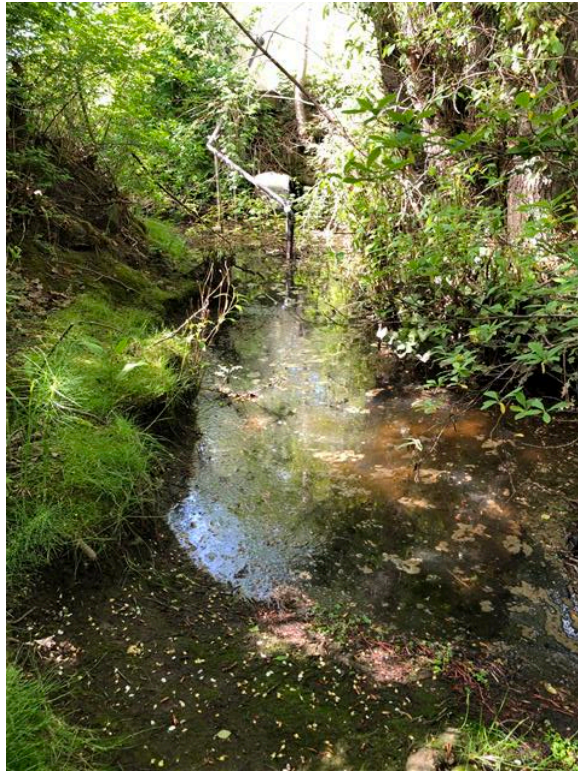
**Photo 37:** Upstream section of Reach 4, looking northwest. Water sampling infrastructure visible in background. To be removed prior to project.

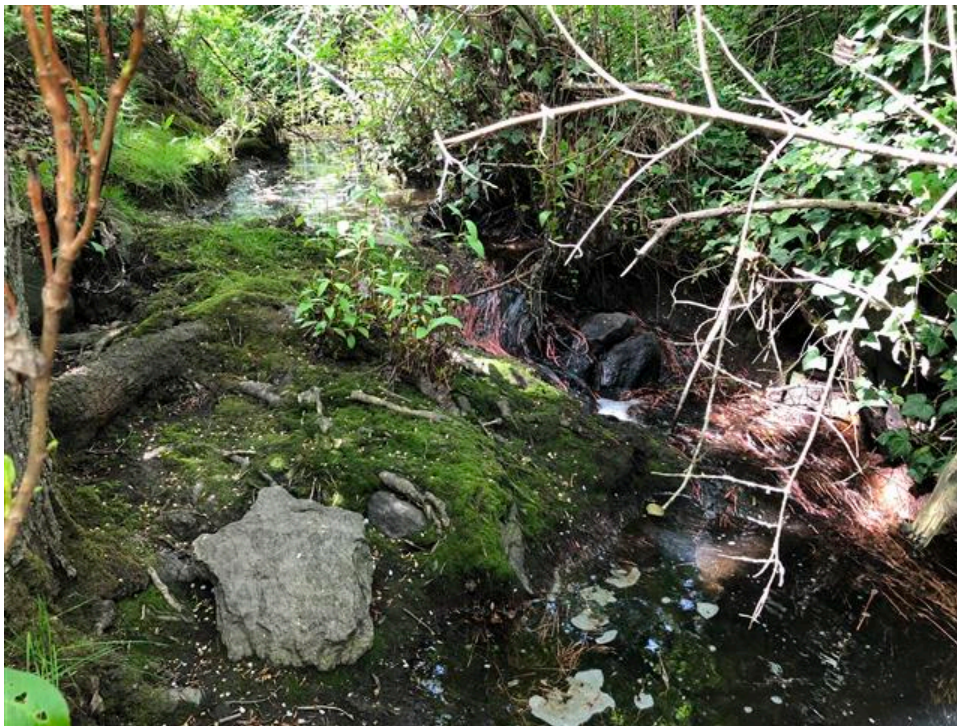
**Photo 38:** Natural drop structure within Reach 4 channel, looking northwest. Existing stream morphology to be retained to extent possible.

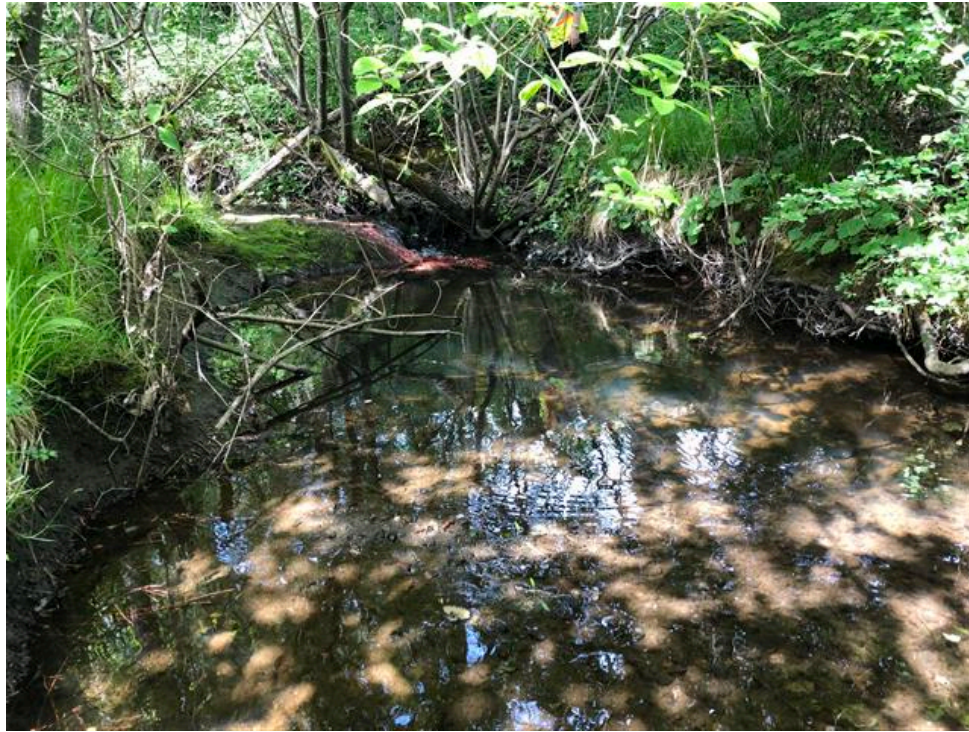
**Photo 39:** Reach 4 channel typical condition, looking northwest.

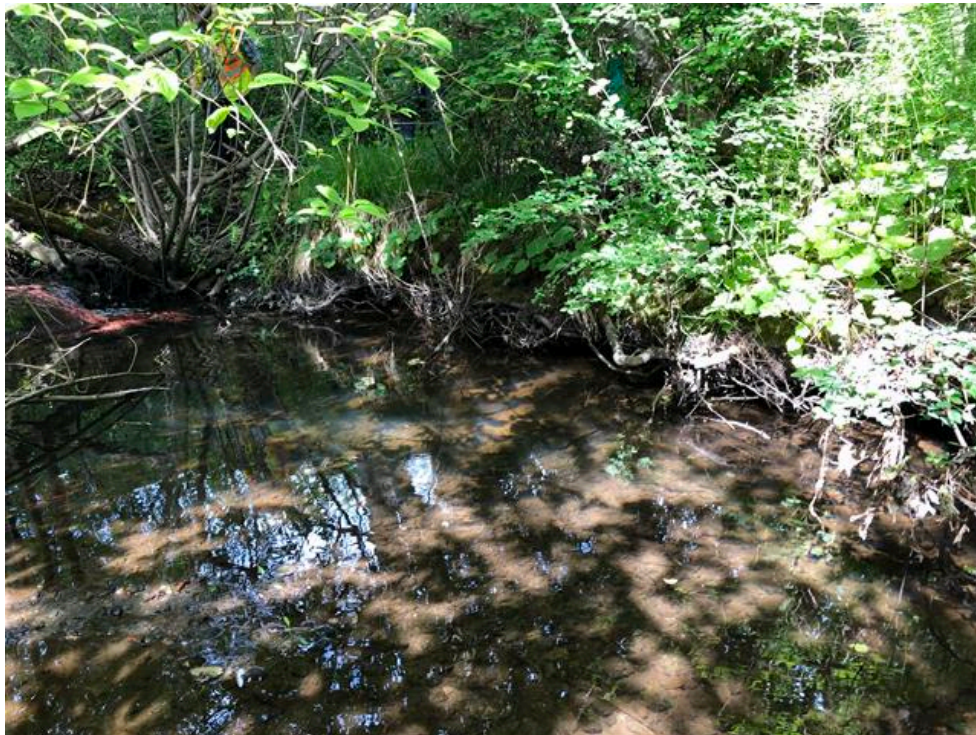
**Photo 40:** Undercut bank along east side of Reach 4 to be maintained for fish habitat, looking northeast.

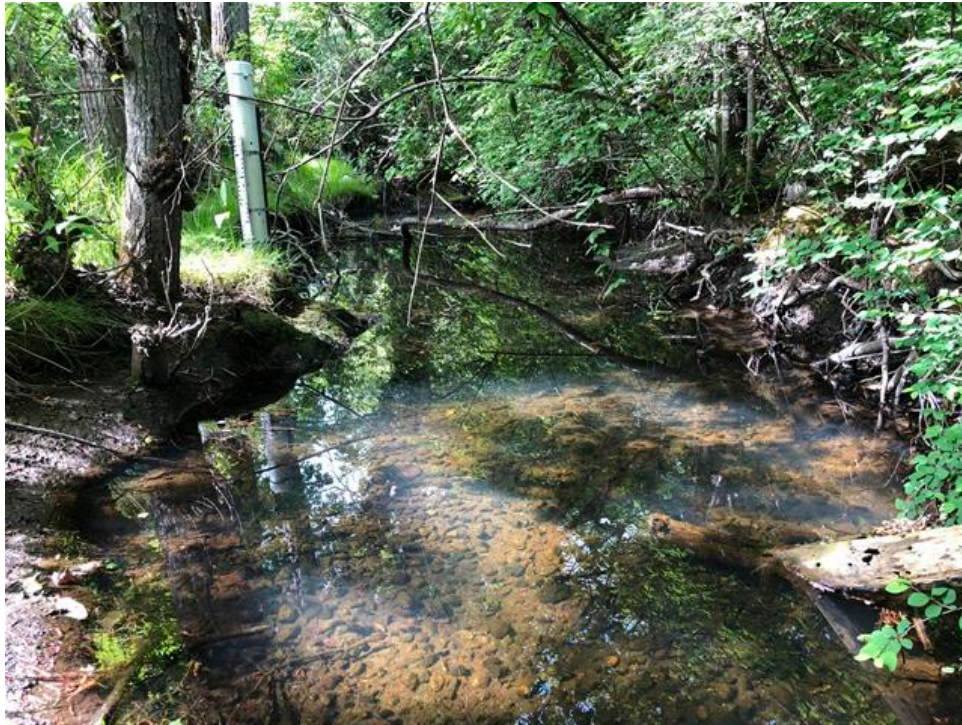
**Photo 41:** Pool area along Reach 4 typical condition, looking northwest.

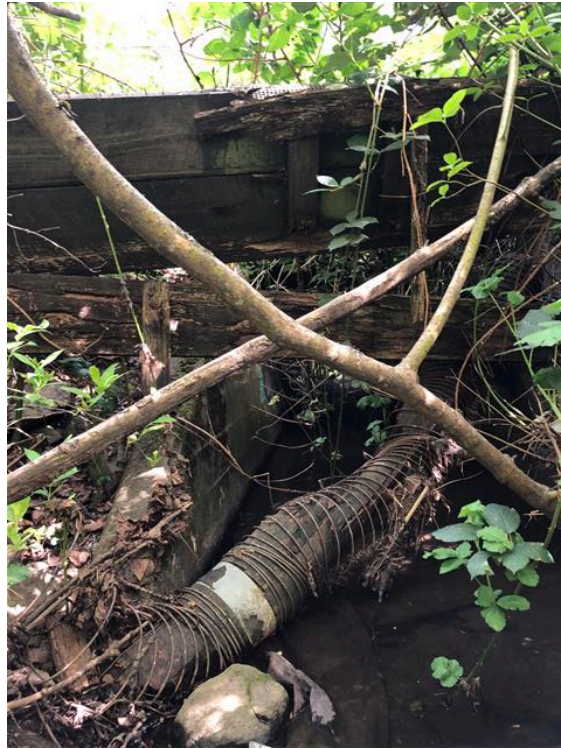
**Photo 43:** Old metal-coiled wood stave water pipe at downstream end of Reach 4 near Canora Road culvert, looking south. Pipe has collapsed into Reay Creek.
