**Public Services and Procurement Canada
Reay Creek Remediation Project
Sidney, BC**

Environmental Mitigation Strategy – Reay Creek Remediation

**March 2019
SLR Project No.: 205.03892.00003**

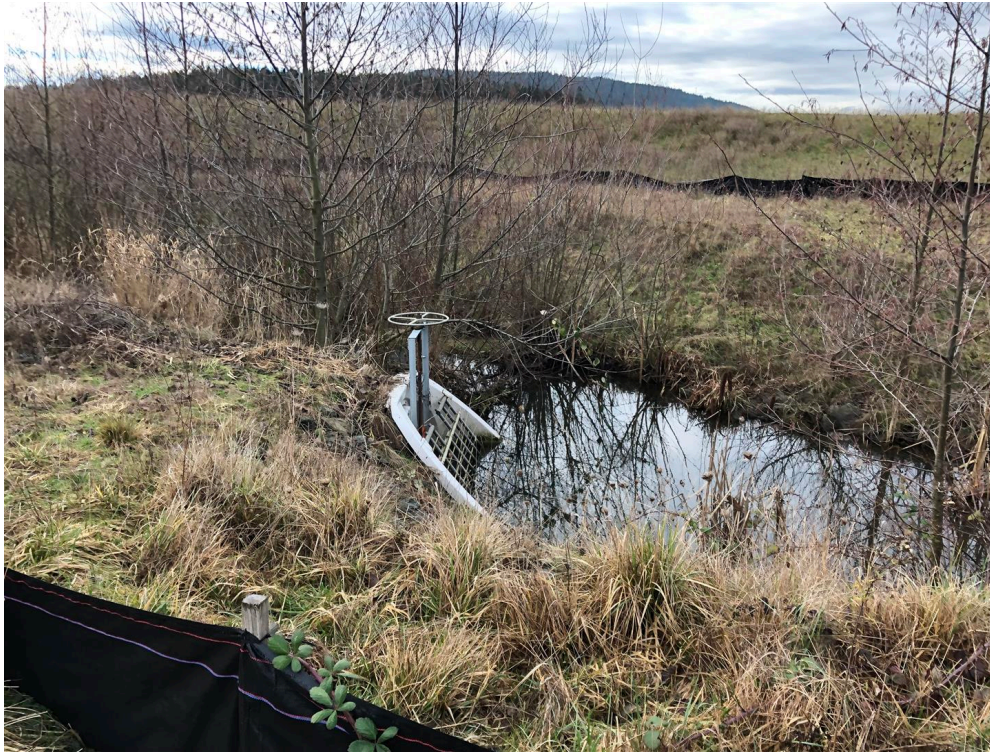
Photo 1: Flow controller at upstream end of Reach 1A, looking south.

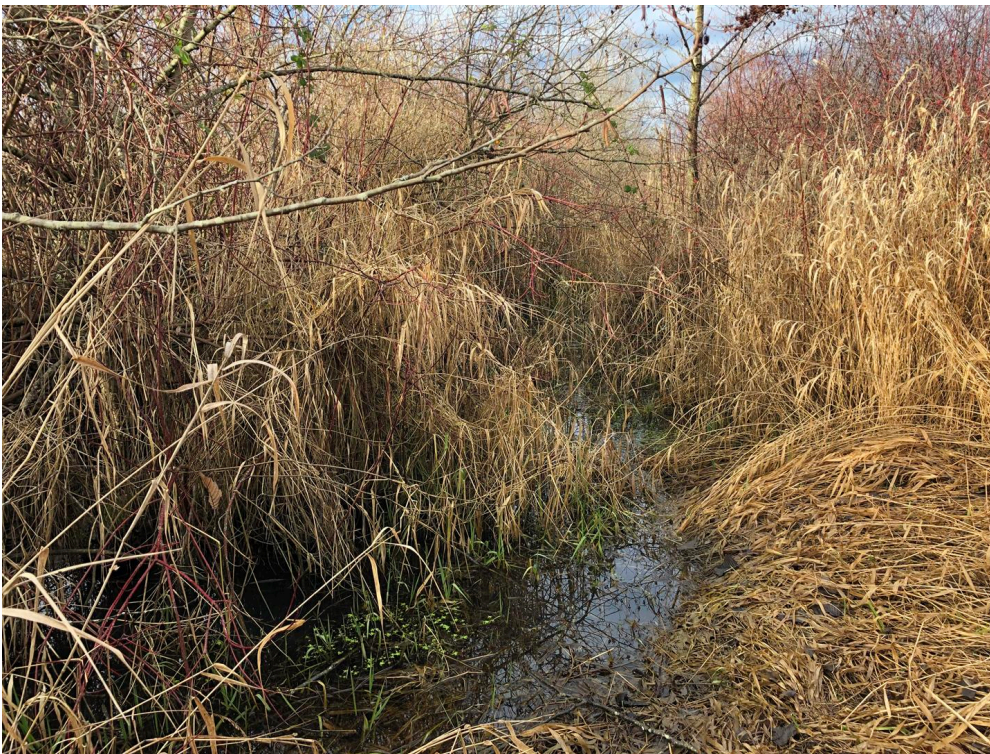
Photo 2: Instream vegetation consisting primarily of reed canarygrass in Reach 1A, looking west.

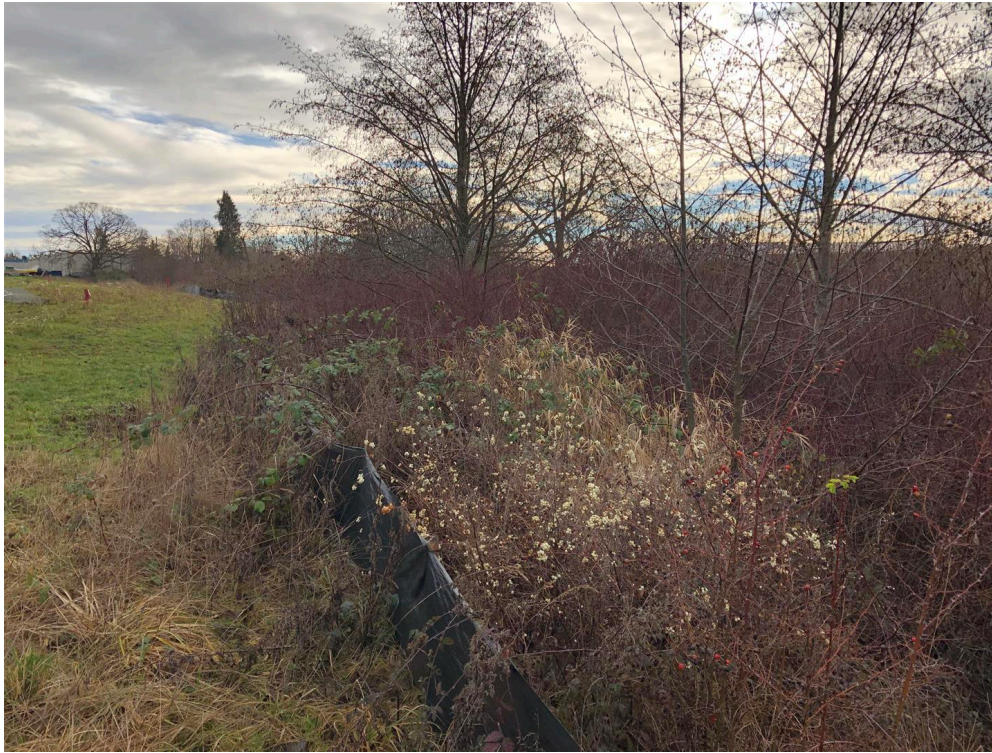
Photo 3: Typical riparian vegetation present along north bank of Reach 1A, looking east.

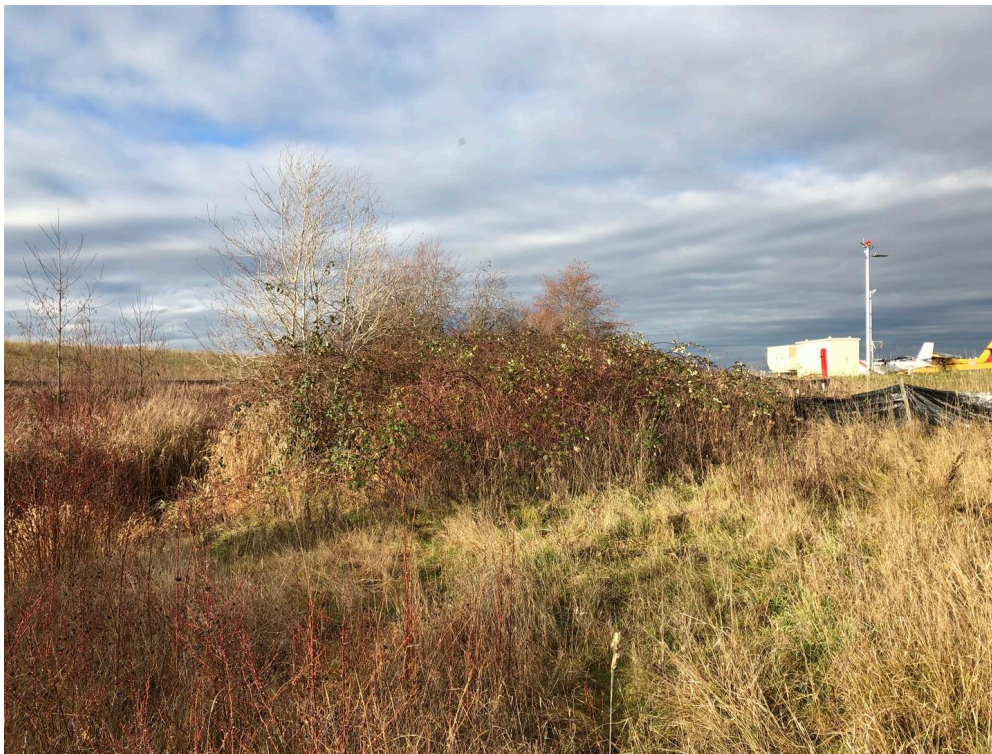
Photo 4: Large patch of Himalayan blackberry along north bank of Reach 1A, looking west.

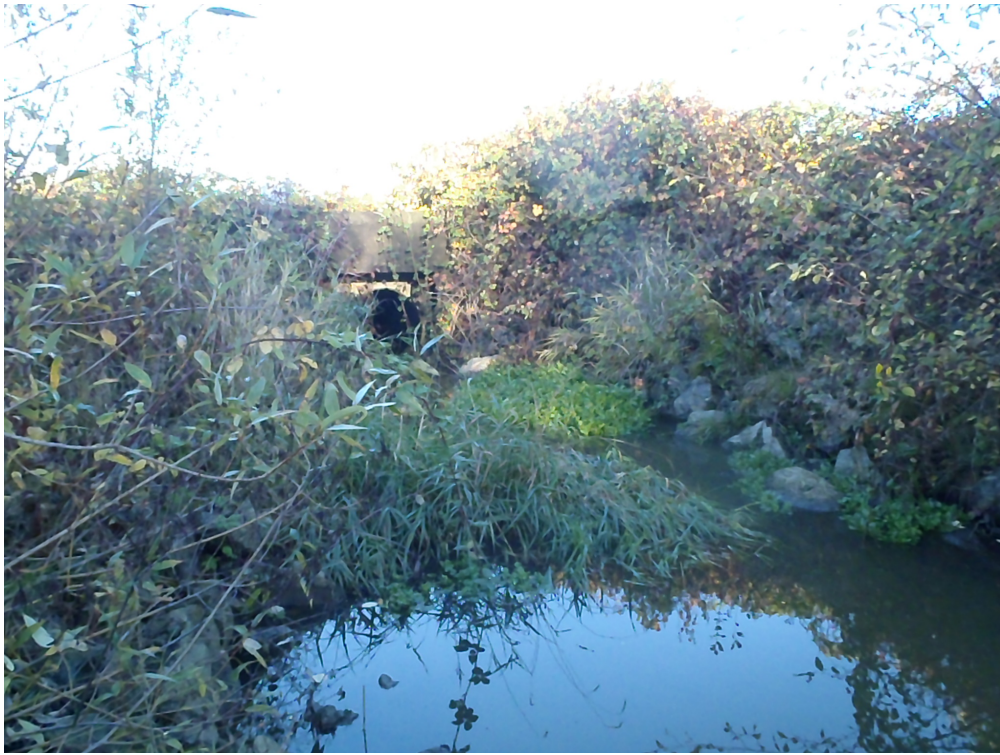
Photo 5: Headwaters of Reay Creek daylight from culvert at upstream end of Reach 1B, looking west.

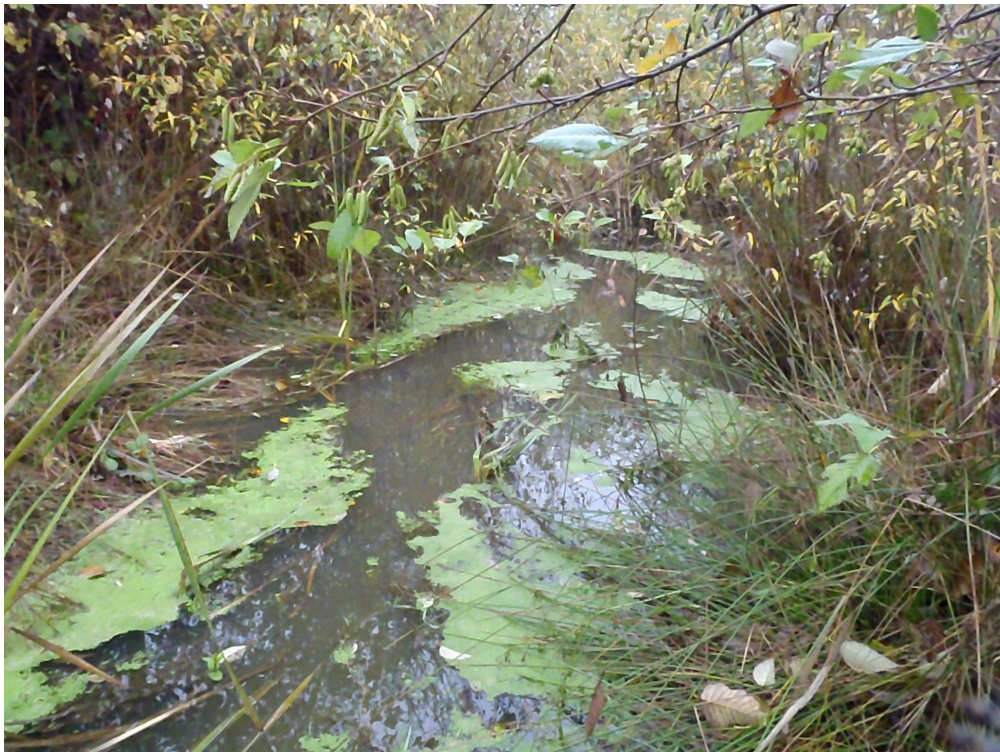
Photo 6: Instream aquatic vegetation (duckweed, sedges and rushes) in low flow areas of Reach 1B, looking east.

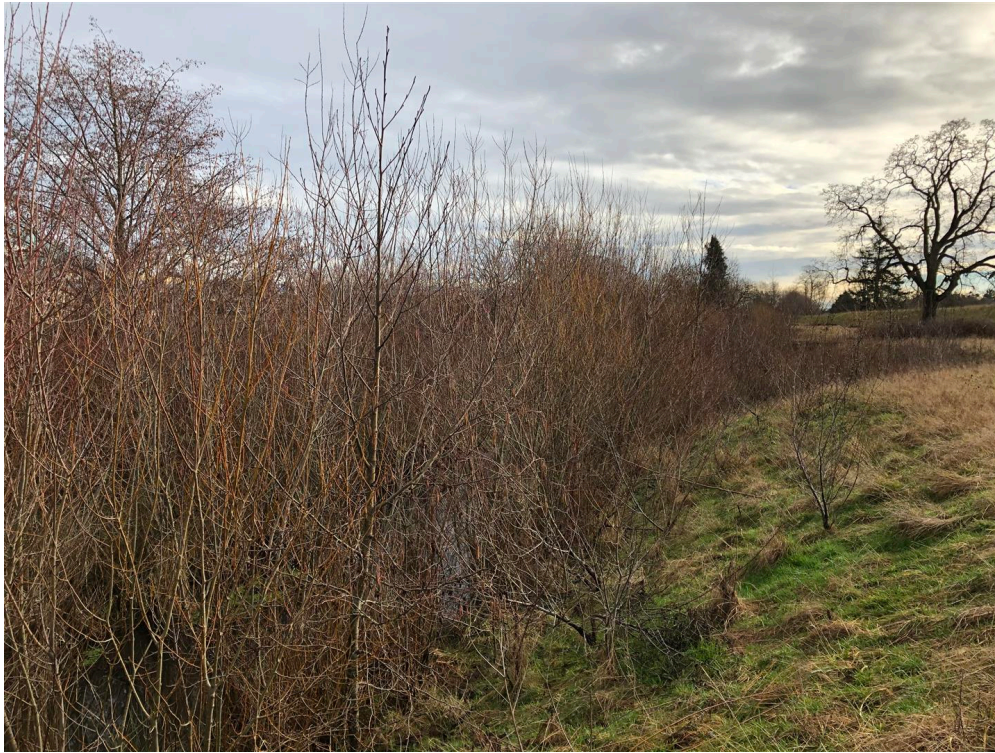
Photo 7: Typical riparian vegetation present along south bank of Reach 1B, looking east.

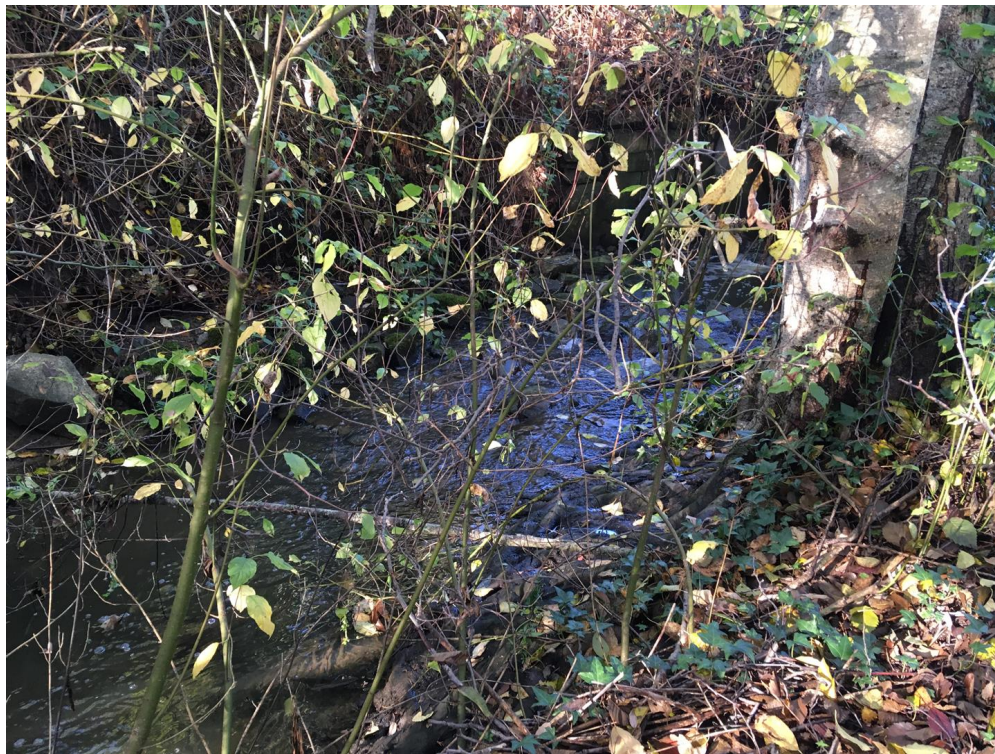
Photo 8: Typical riparian vegetation present along north and south banks of Reach 1C to the east of the access road, looking west.

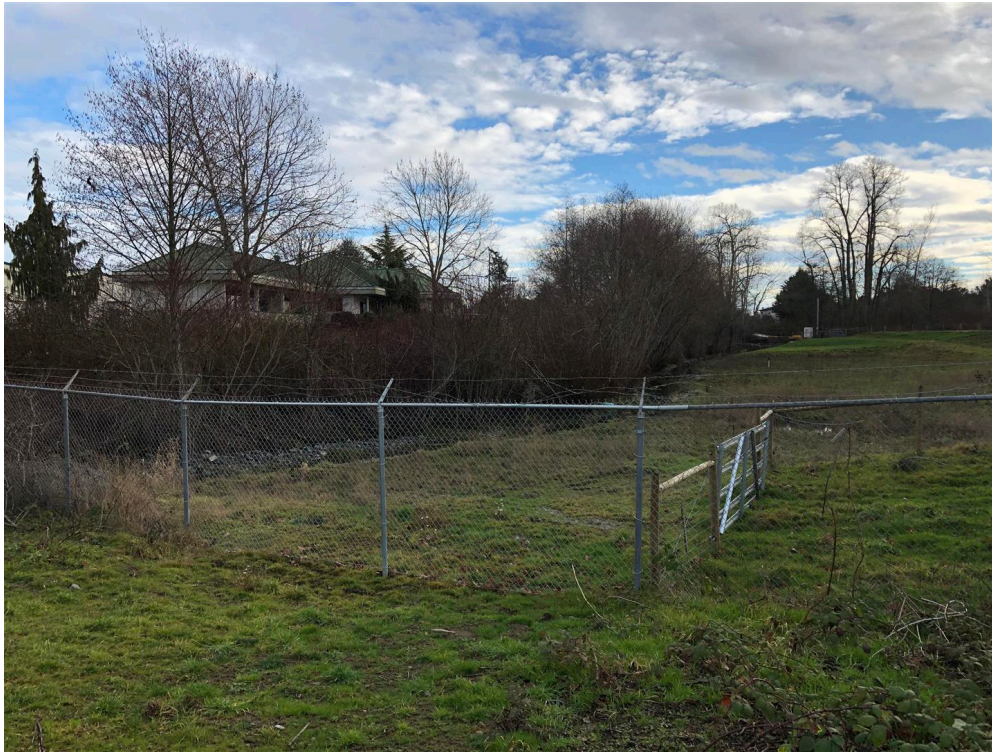
Photo 9: Typical riparian vegetation present along north bank of Reach 2, looking east.

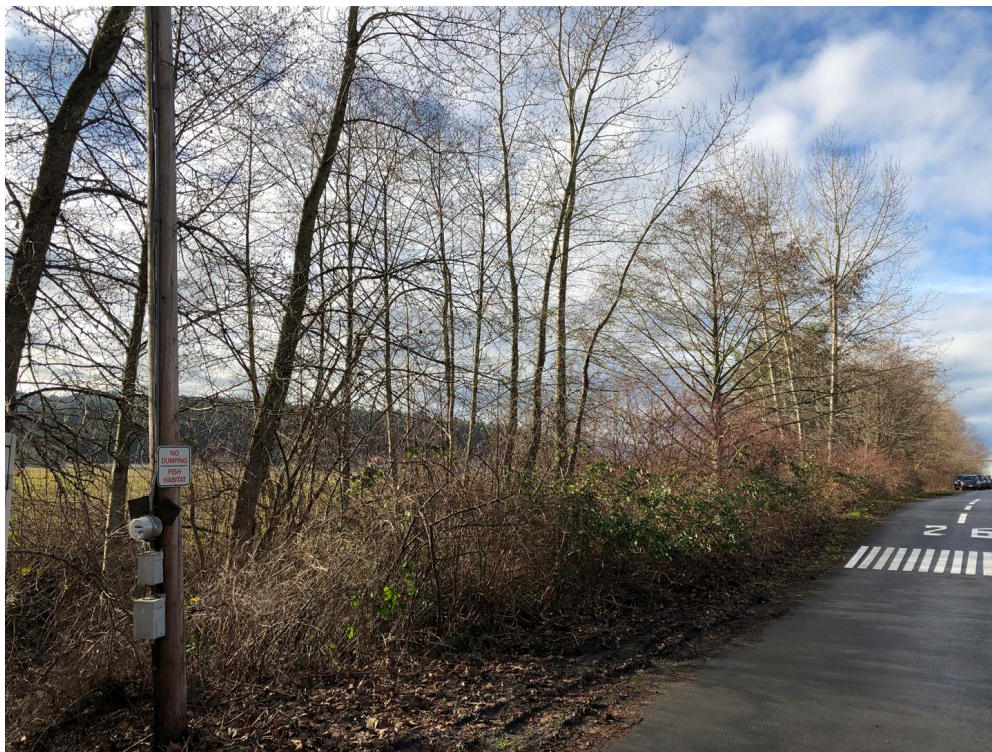
Photo 10: Typical riparian vegetation present along north and south banks of Reach 3, looking west.

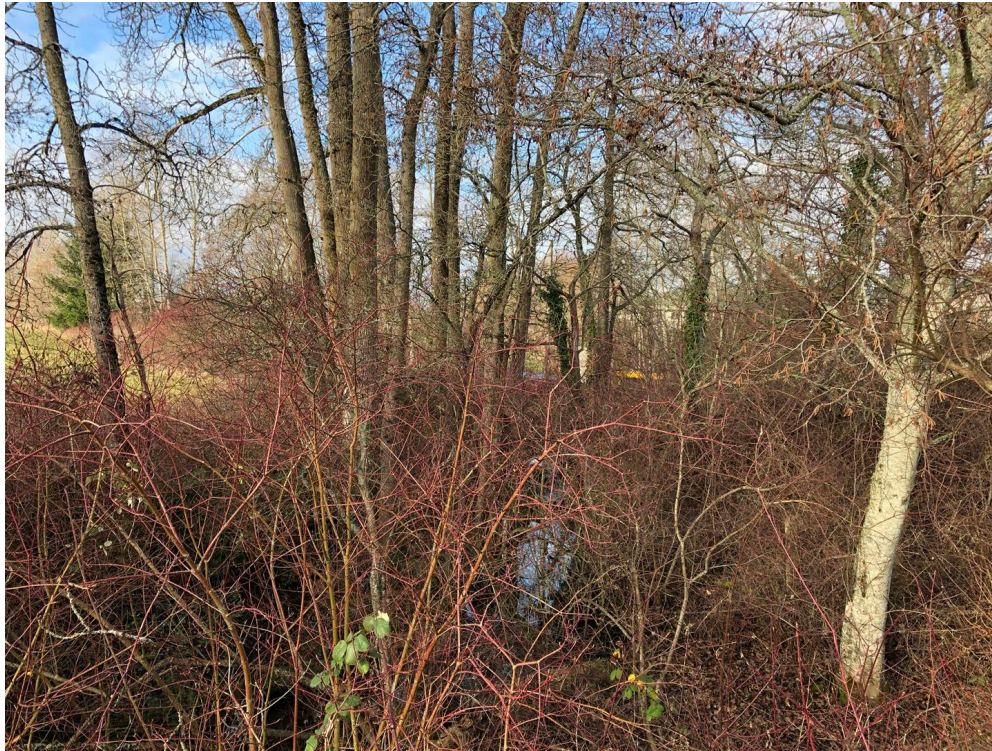
Photo 11: Typical riparian vegetation present along north and south banks of Reach 4, looking west.

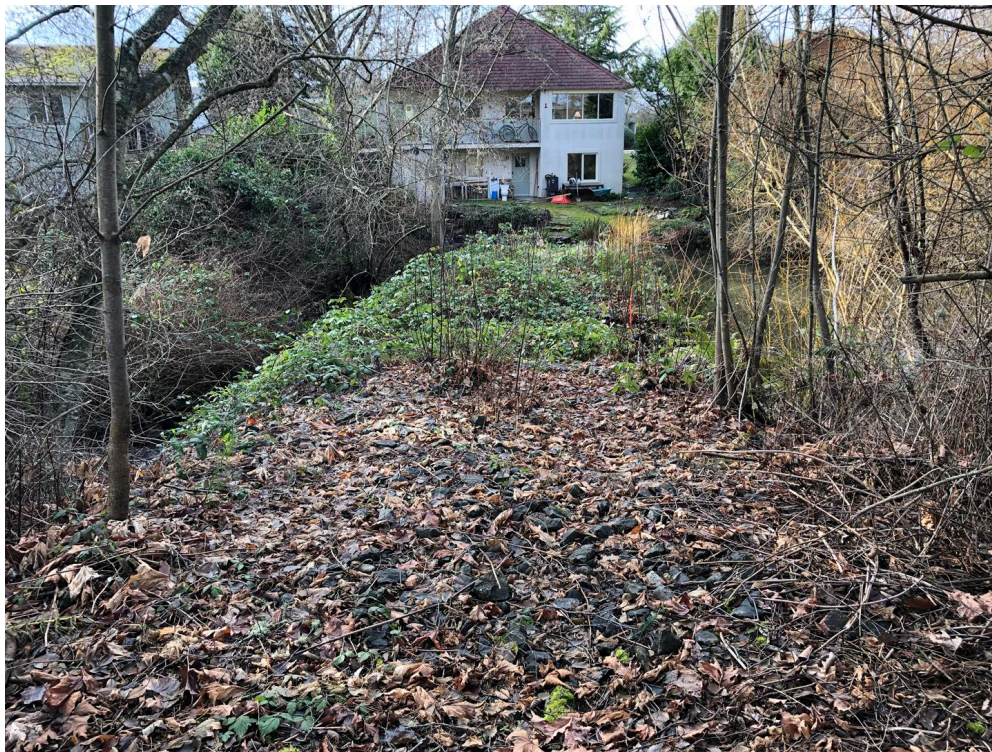
Photo 12: Reay Creek Pond Dam, looking west.

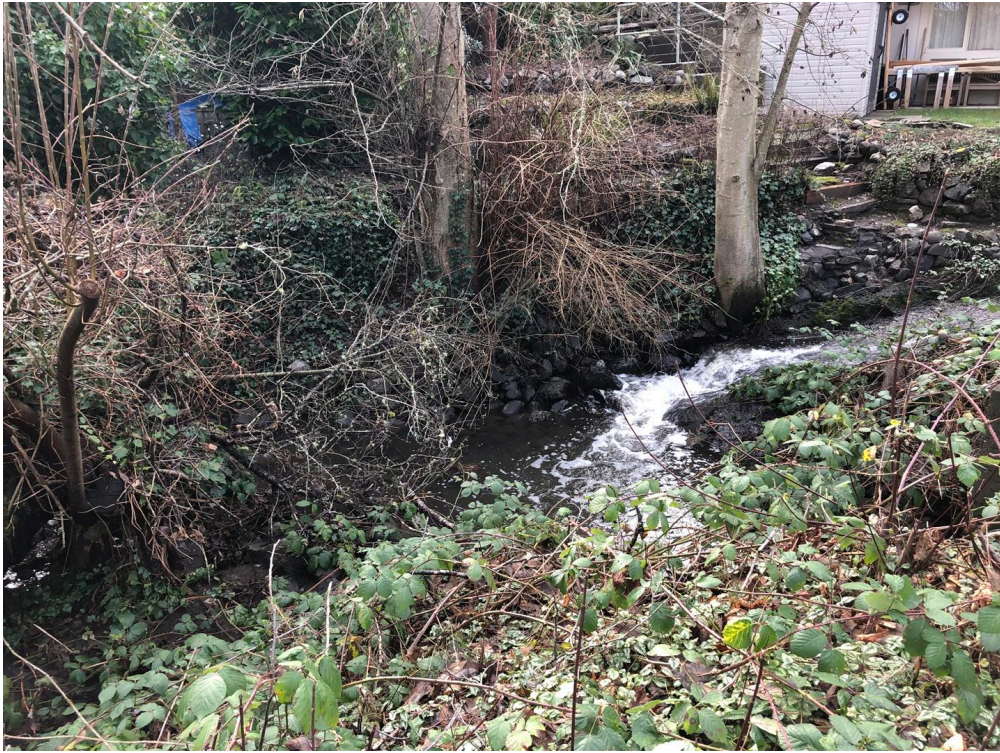
Photo 13: Spillway to the southwest of Reay Creek Pond Dam, looking west.

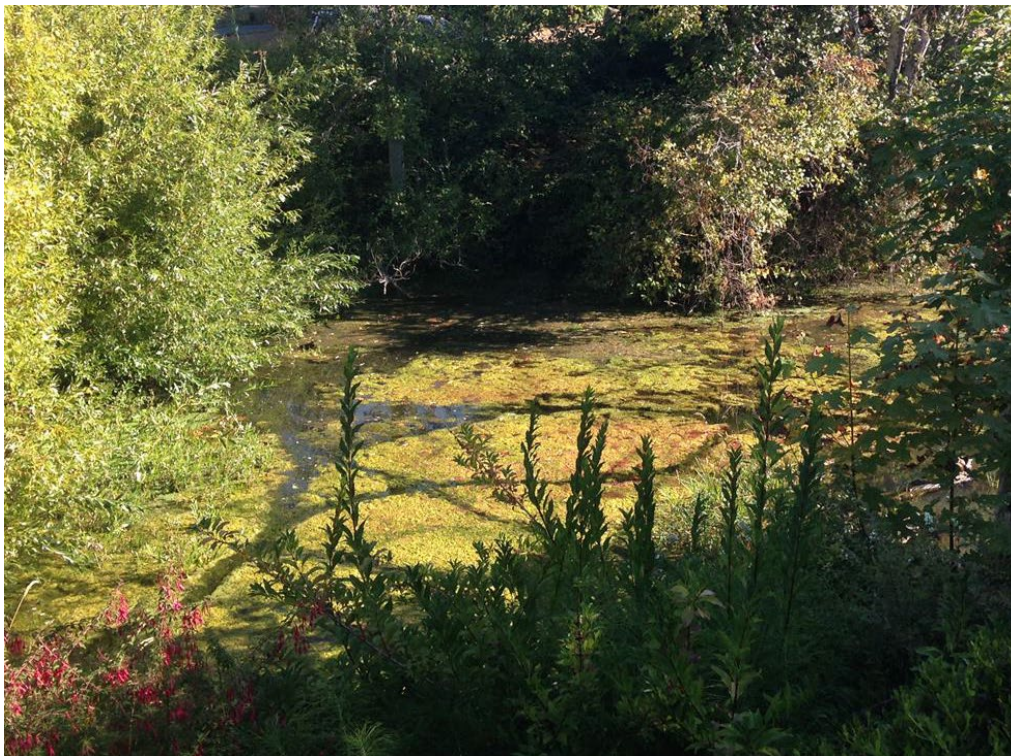
Photo 14: Instream aquatic vegetation in Reay Creek Pond during summer months, looking north.

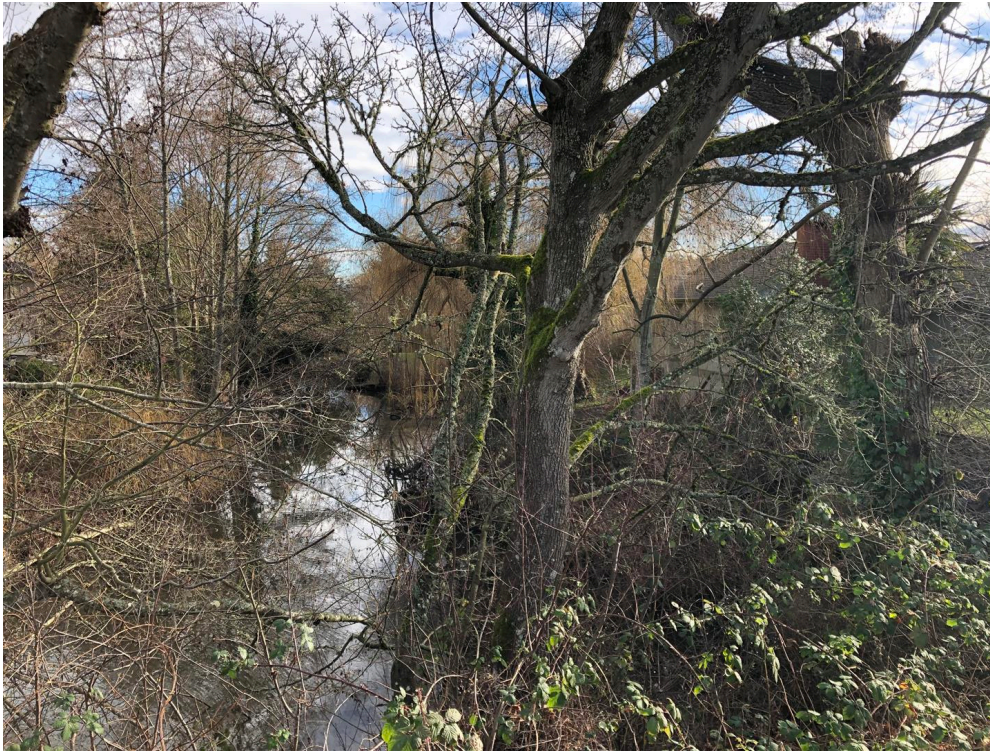
Photo 15: Typical riparian vegetation present along north bank of Reay Creek Pond, looking east.

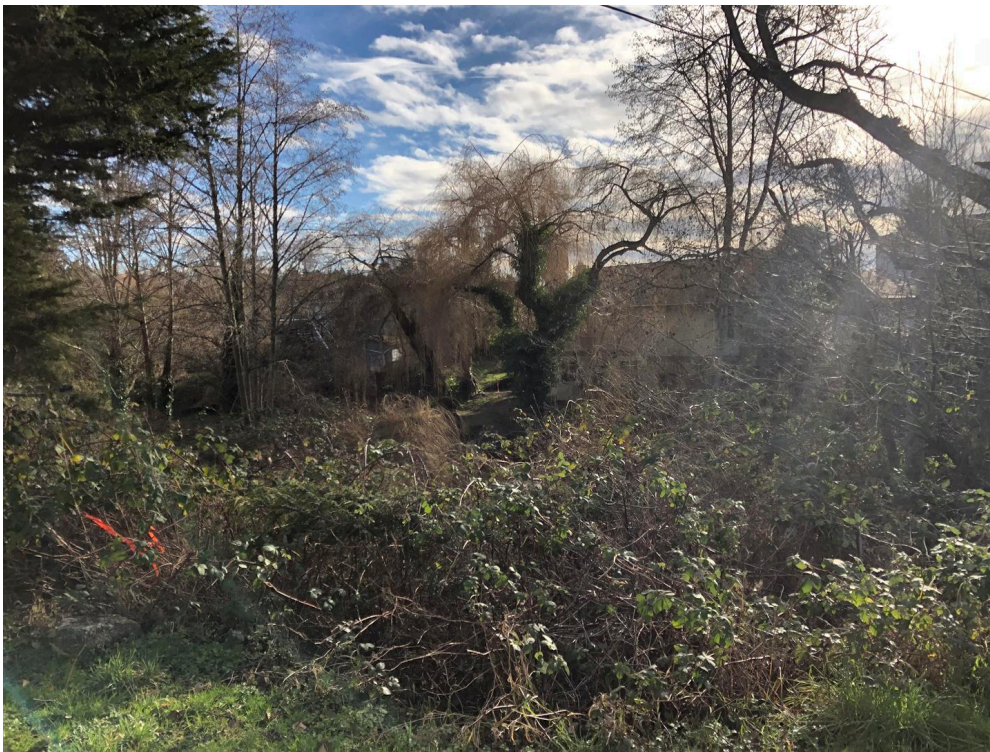
Photo 16: Patches of invasive species (Himalayan blackberry, English ivy) present along banks of Reay Creek Pond, looking south.
