DFO
West Vancouver
Laboratory
Archaeological Overview
Assessment

Submitted to:
Fisheries and Oceans Canada
4160 Marine Drive
West Vancouver, BC
V7V 1N6

May 16, 2018
Inlailawatash File: 17-5-22

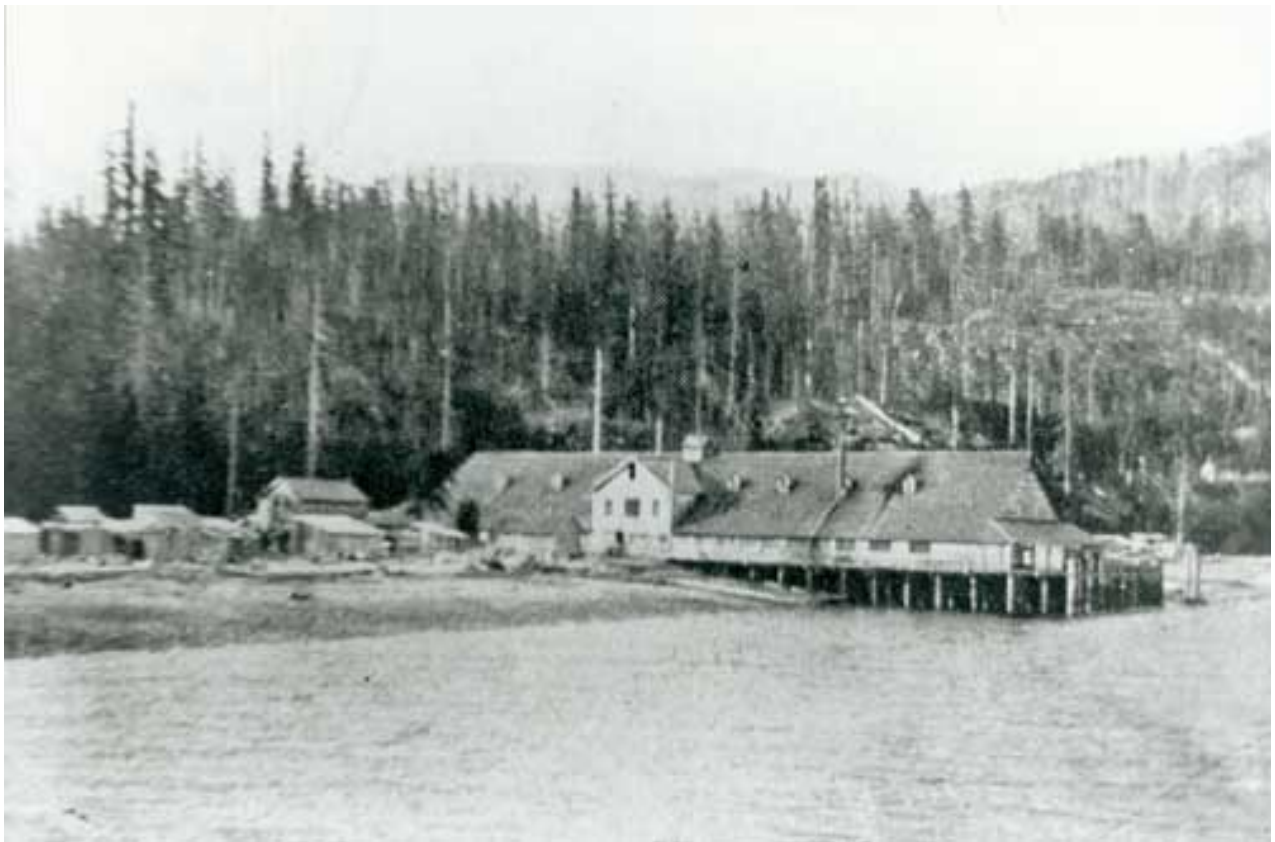
Figure 3. Photo of the Great Northern Cannery in 1908. Original photo loaned to the archives by L. Grafton [West Vancouver Archives reference code: 0268.WVA.RAH].

The landscape within and surrounding the project area has been significantly altered in the post-Contact historic period. For the northwest shore of Burrard Inlet Sandy Cove was one of the first locations to become industrialized. Beyond Sandy Cove to the east is West Bay, and to the west is Pilot Cove, Caulfeild Cove, and Starboat Cove leading to Point Atkinson. The first lighthouse was built on Point Atkinson in 1874 (the current lighthouse built in 1912 is a National Historic Site), and at this time the earliest land pre-emptions were also taking place (Hayes 2005:96). The Great Northern Cannery opened in 1891 at Sandy Cove (see Figures 3 and 4).

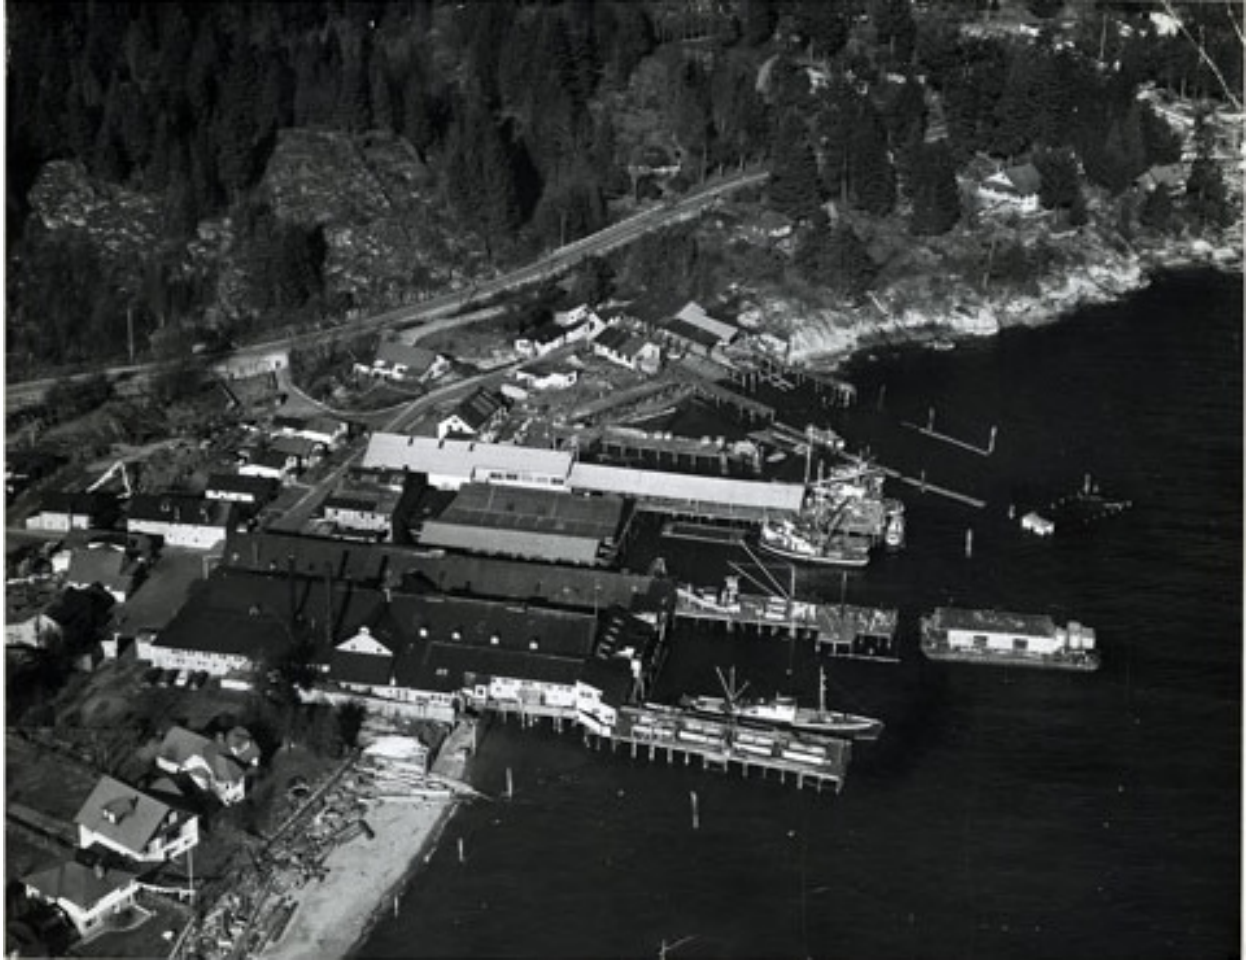
Figure 4. Aerial photo of the Great Northern Cannery circa 1950s. Photo by Aero Surveys Limited [West Vancouver Archives reference code: 1126.WVA.RAH].

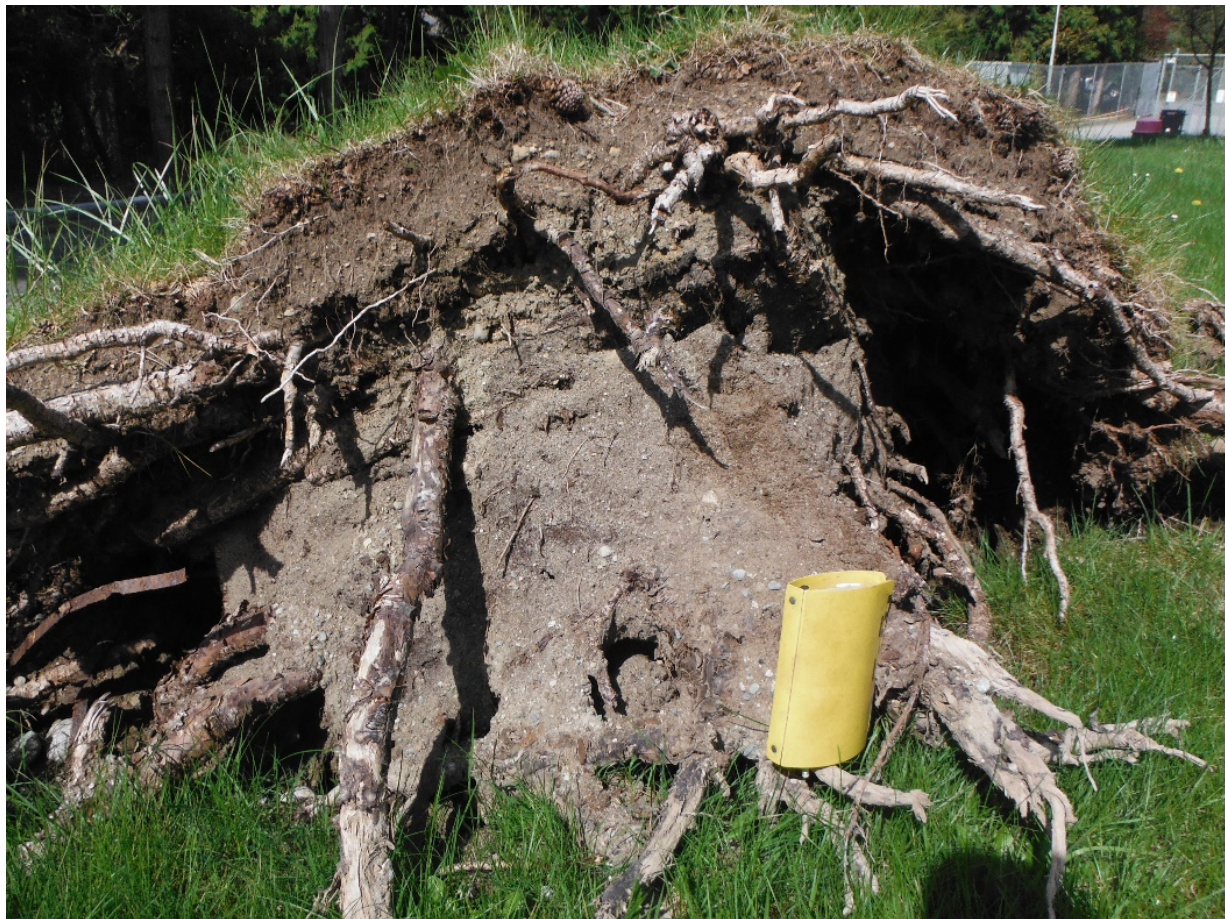
Figure 6. Exposed sediments at tree throw 1.

Exposure Label	Description
TT1	Located in the southwest section of northern portion of the project area – largely sandy deposits of yellow-grey medium to coarse sand with 10% sub-rounded to rounded pebbles.
TT2	Far eastern end of northern portion of project area – sediment is brown silty sand with sub-rounded pebbles.

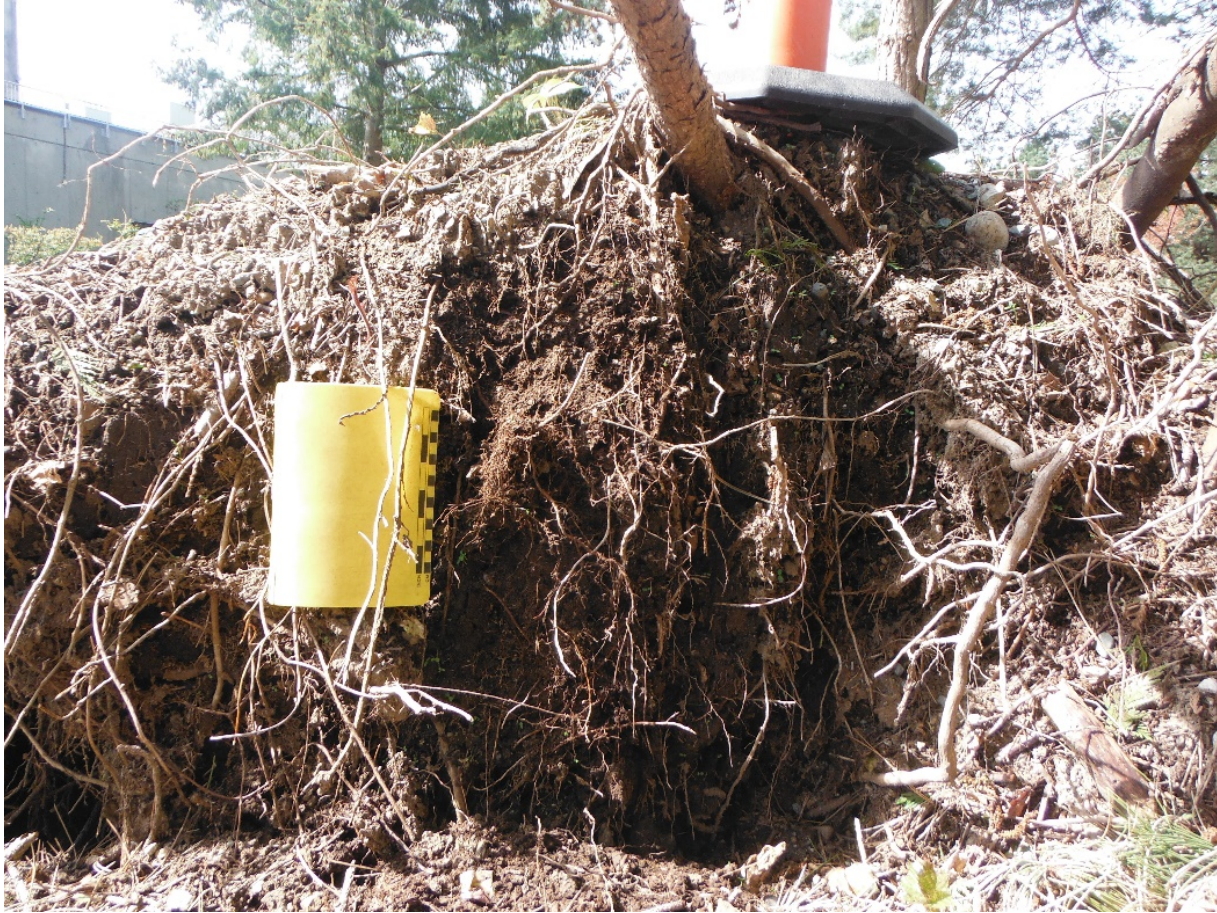
Figure 7. Exposed sediments at tree throw 2.

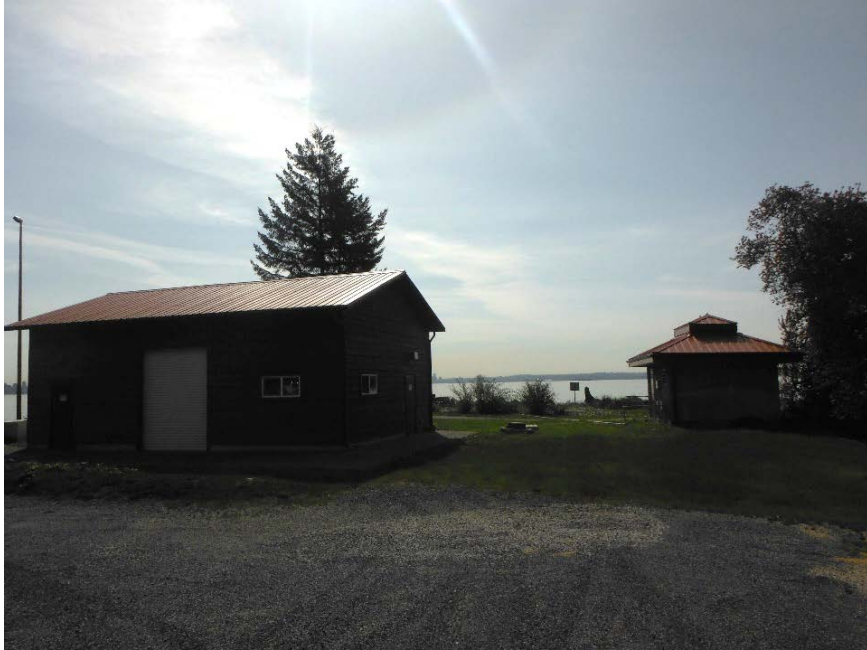
Figure 8. STA1, a grassy area adjacent to the shoreline. The area has been broken up by a gravel parking lot, a walking path, and two small buildings. Photo facing south.

2. An AIA include shovel-testing in the areas not capped by impenetrable surfaces (e.g., concrete, asphalt, existing buildings).
3. In areas capped by impenetrable surfaces it is recommended that any future construction excavations be monitored by a professional archaeologist to assess the sediments beneath the cap.
4. In the mound of fill located on the eastern side of the property near the shoreline no further archaeological assessment is required if future construction excavations occur above the original ground surface. If excavations reach original ground surface elevations, then monitoring by a professional archaeologist is recommended.
5. The inter-tidal and shoreline areas should be monitored for archaeological features if any development work such as shoreline stabilization or dock construction occur.

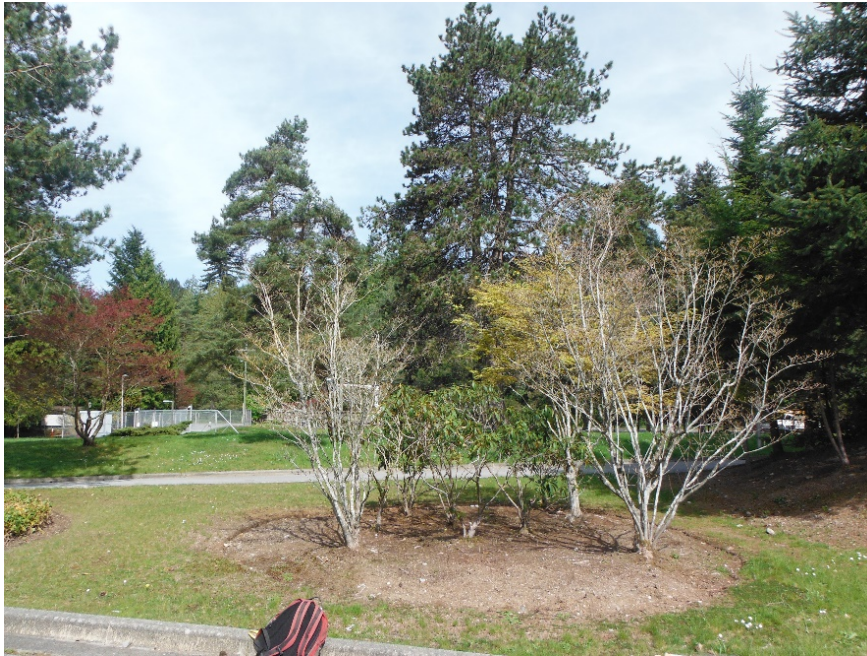
Figure 9. STA2, a small grassy area with planted shrubs and bushes. The area is bounded by an asphalt driveway and parking lot. Photo facing north.

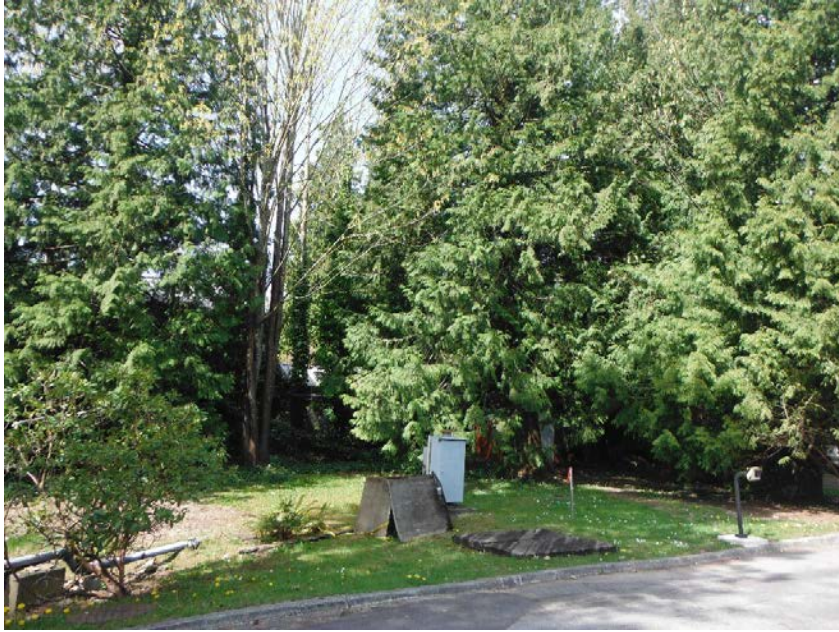
Figure 10. STA 3, a narrow grassy area with cedar trees along the western boundary of the DFO property. Photo facing northwest.

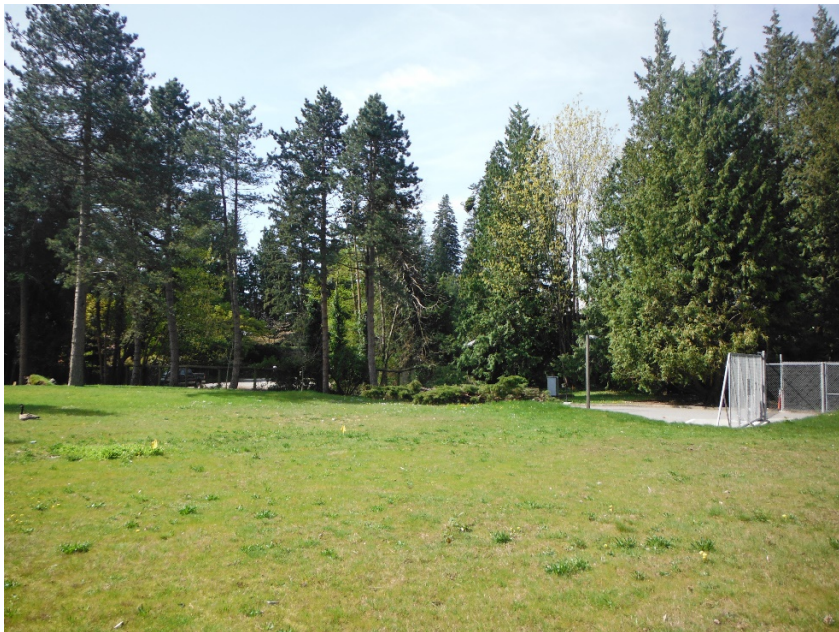
Figure 11. STA4, a large open grassy area at the north end of the DFO property. The area is bounded by a driveway to the south and a fence separating the property from Marine Drive to the north. Photo facing west.

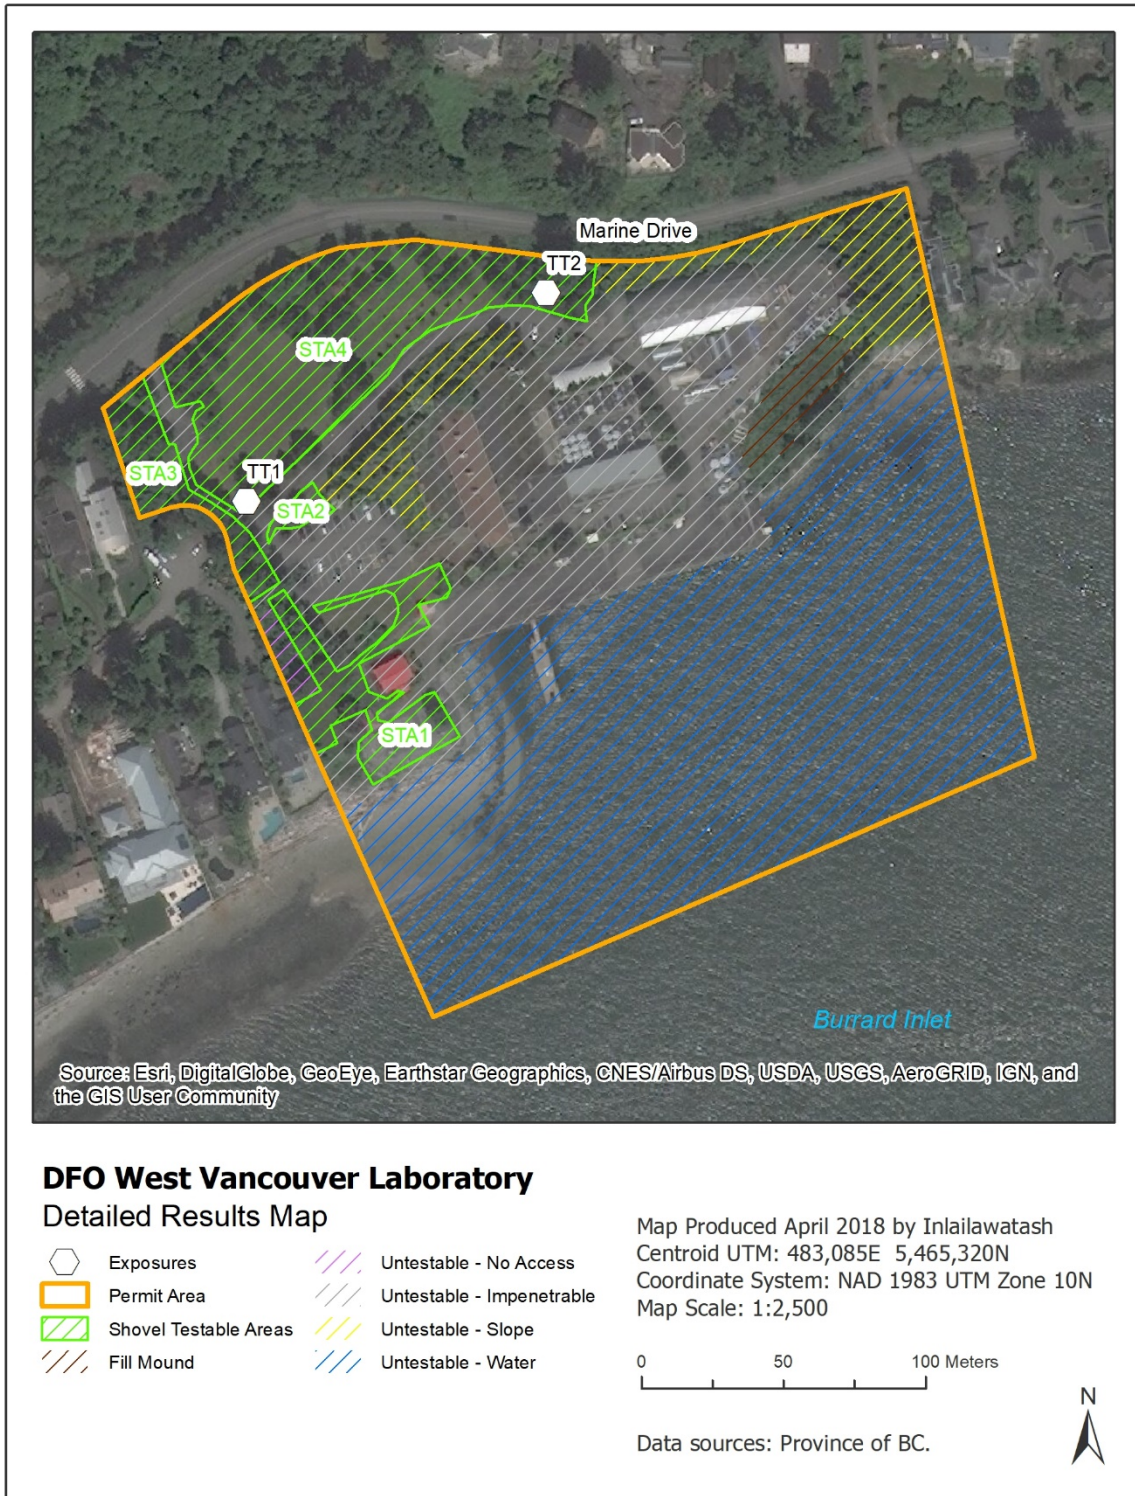
- *No Access* (this area is within the project area but is beyond the fence line and is inaccessible);
- *Impenetrable* (these areas are capped by surfaces such as asphalt and concrete and cannot be tested by hand shovels or probes);
- *Slope* (these areas had slopes that were too steep for shovel testing); and
- *Water* (this portion of the project area falls below the water line and cannot be tested by hand shovels or probes).

A two m high mound of fill composed of gravel mixed with asphalt and concrete was also identified in the eastern portion of the property. This oval-shaped mound is approximately 50 m long running northeast to southwest, and 15 m wide running northwest to southeast. The mound possibly covers original land surface however the depth of the fill is too great to allow for shovel testing to reach native soil.

Figure 12. Preliminary Field Reconnaissance results showing testable and untestable areas.

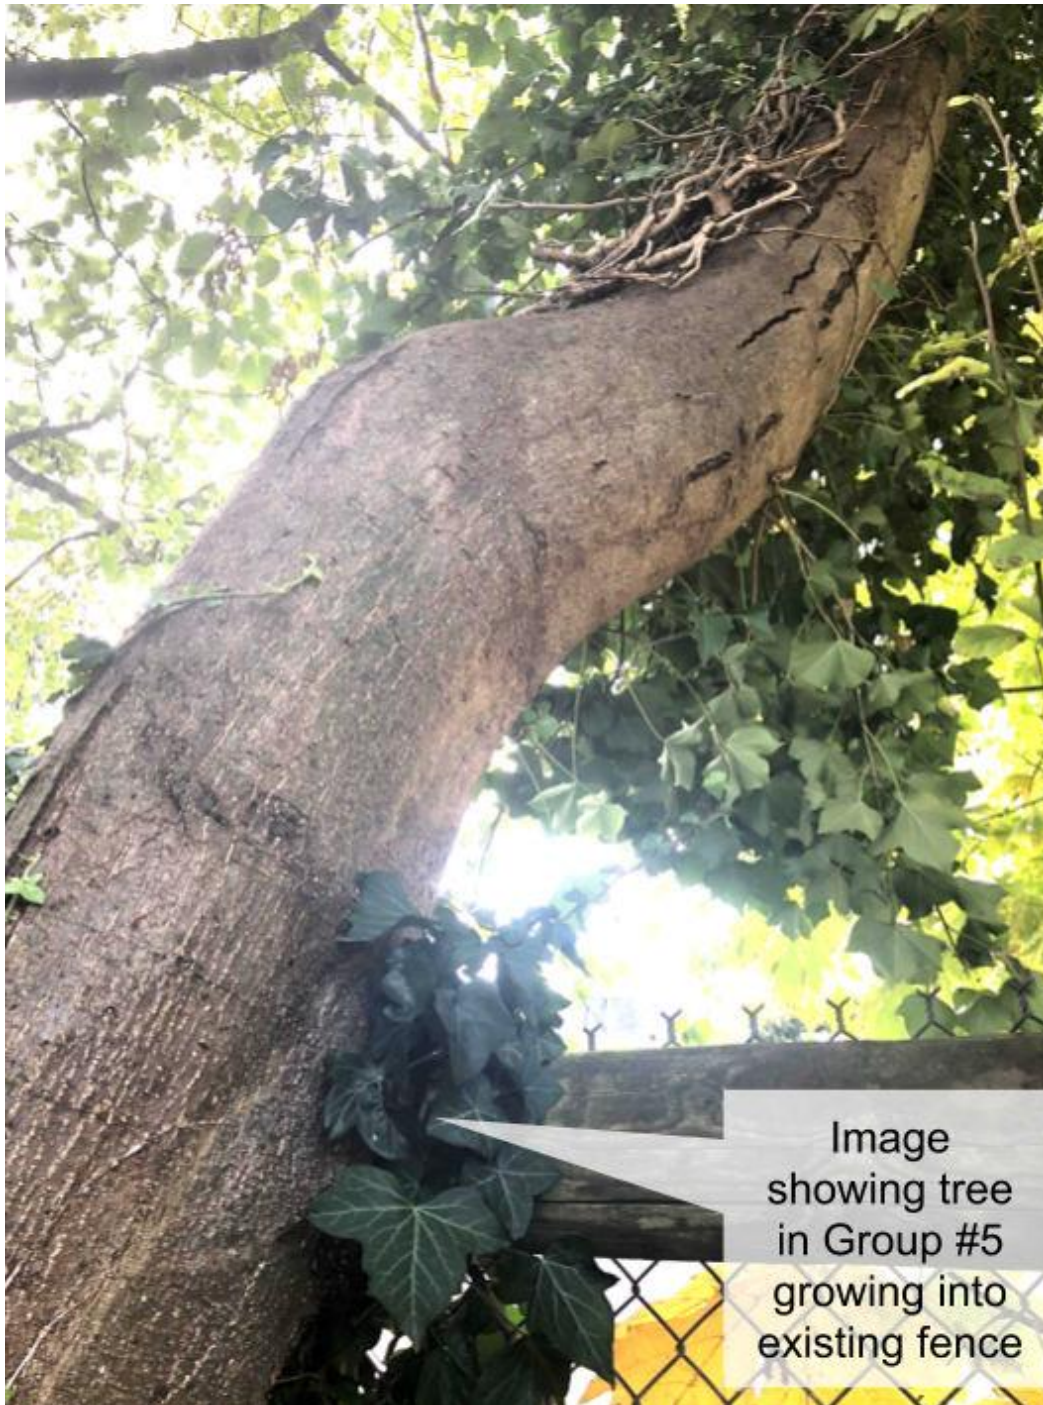
Tree Group #5

Tree #5 consists of a group of 1 maple and 3 alders growing at the fence line adjacent to Evergreen Ave. These 4 trees are in poor condition; they have heavy lean towards the street, stem defects and are growing into/pushing over the existing fence. They pose a high risk; targeting designated street parking on Evergreen. These trees are in direct conflict of and require removal to facilitate the construction of the new fence. 100% ownership of these trees is not clear, it is possible that they may be partially on DWV property, ownership should be confirmed prior to removing any of these trees.

Image
showing tree
in Group #5
growing into
existing fence

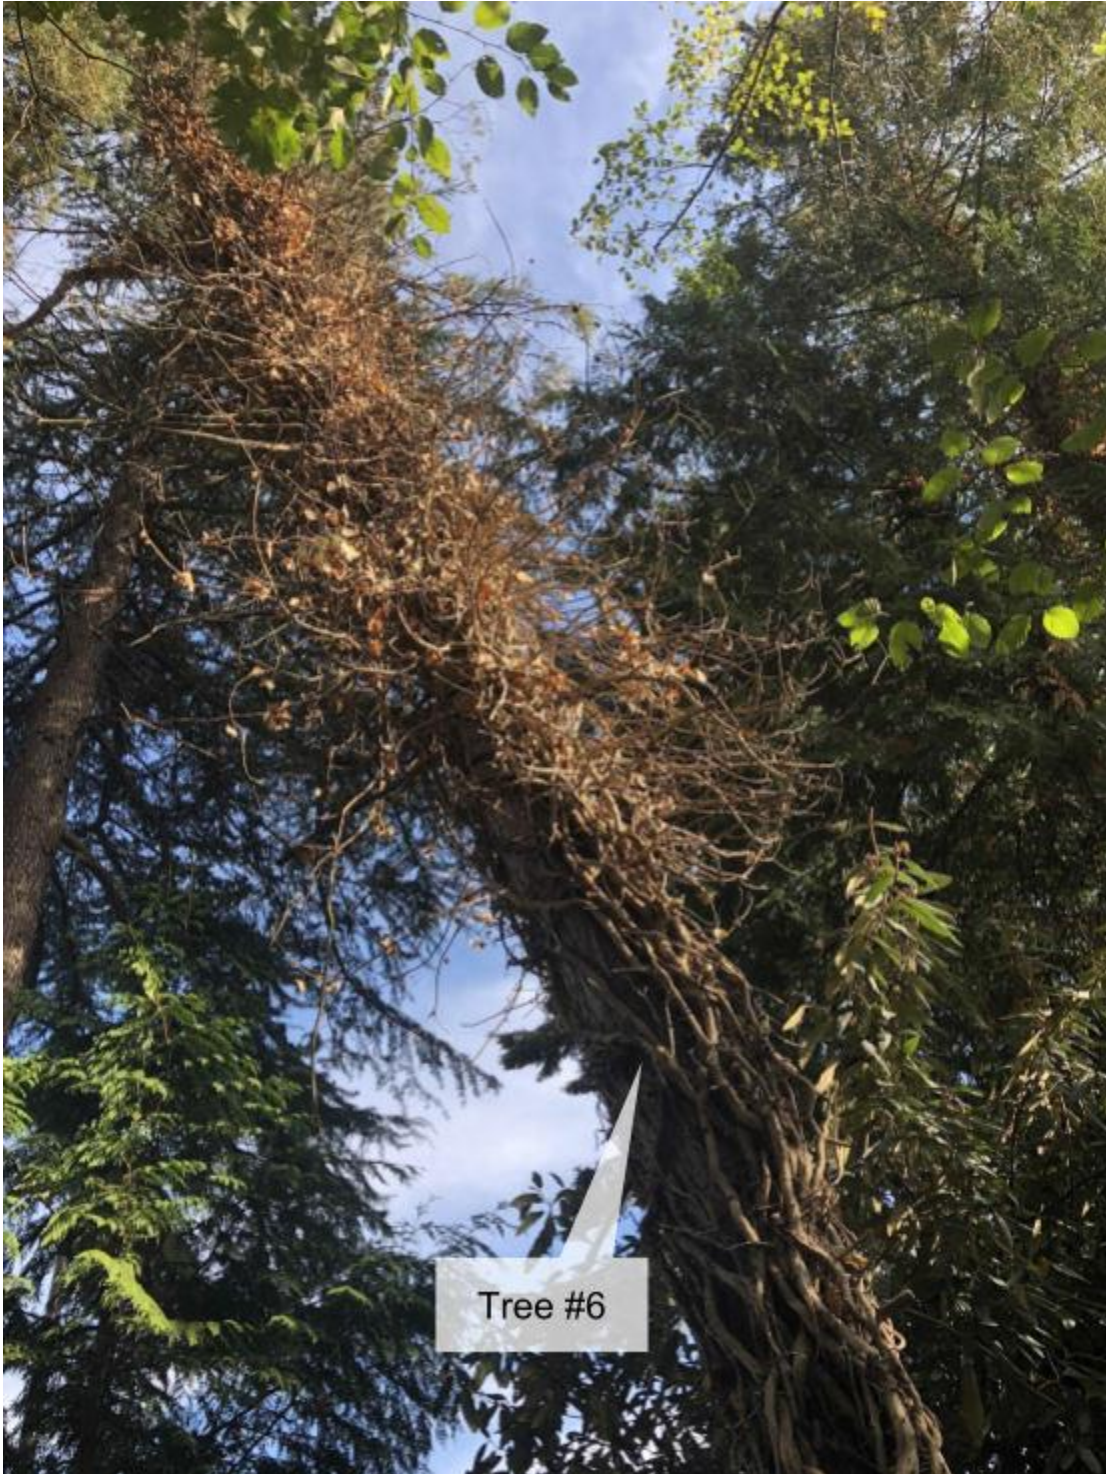
Tree #6 is a 35cms DBH pine. It is in poor condition, with an ivy covered stem and heavy lean towards the parking lot. While it is not in conflict with the new fence, it does pose a high risk and is recommended to be removed.

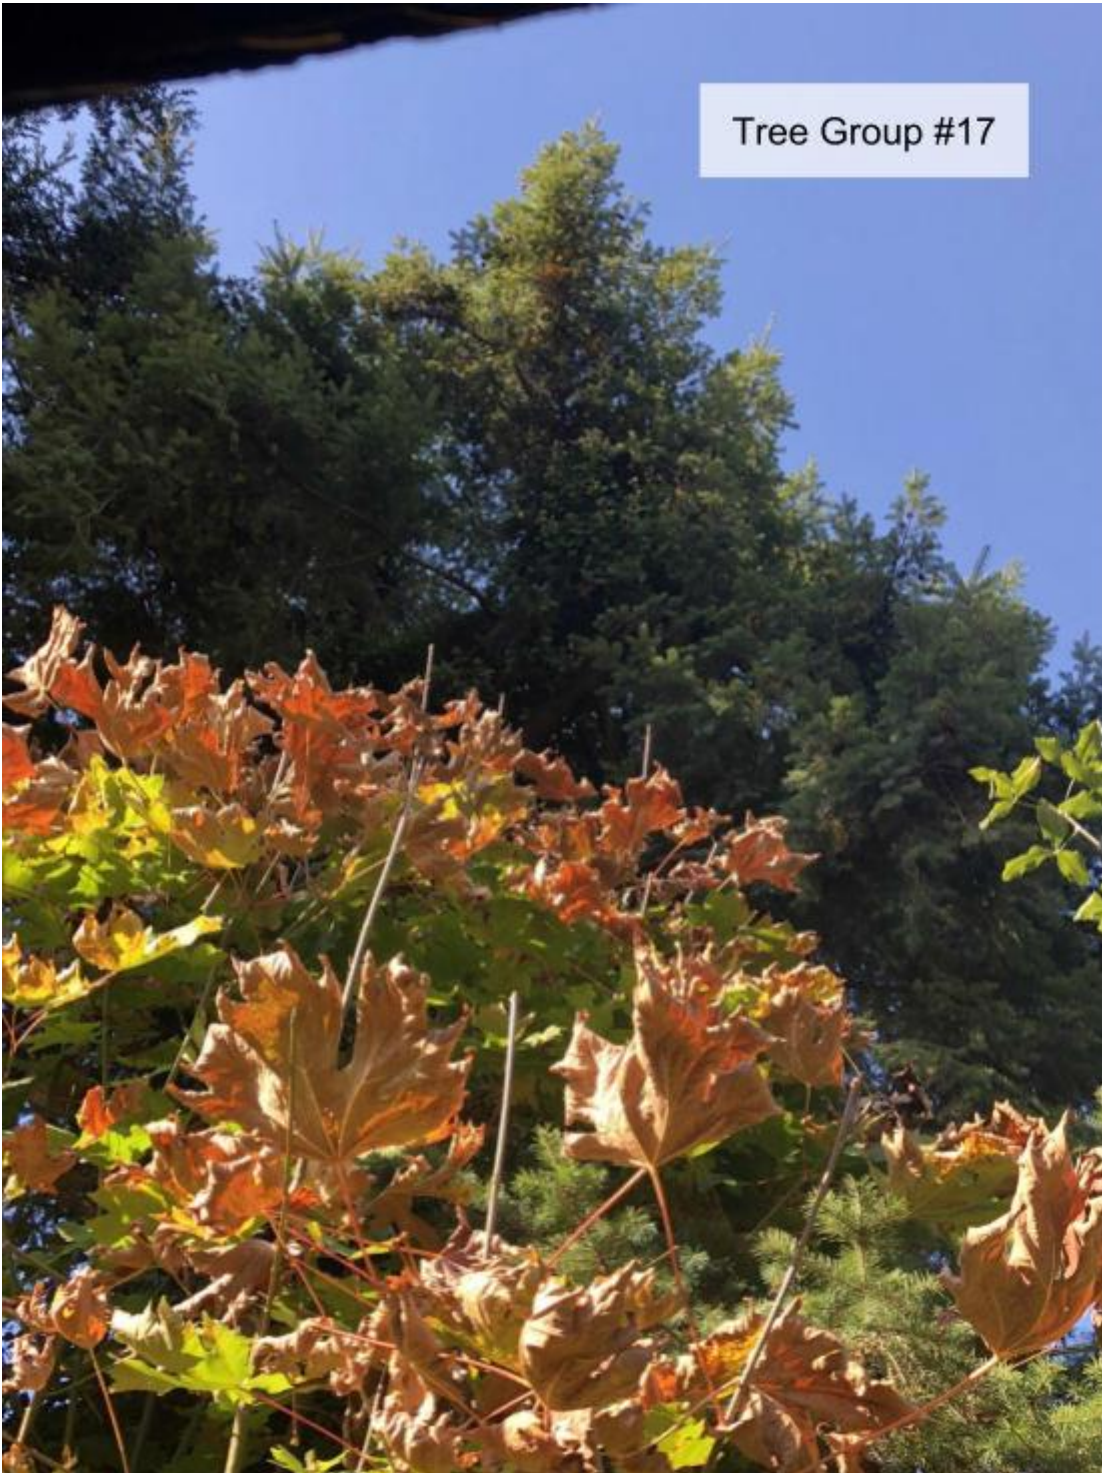
Tree #16 is a cedar growing at the NE corner of the building. It measures 88cms DBH and is in poor condition; previously topped. A large stem on this tree has previously failed and is hung up on the existing chain link fence. This tree presents a high risk and is recommended to be removed.

Tree #16 showing
large previously
failed stem

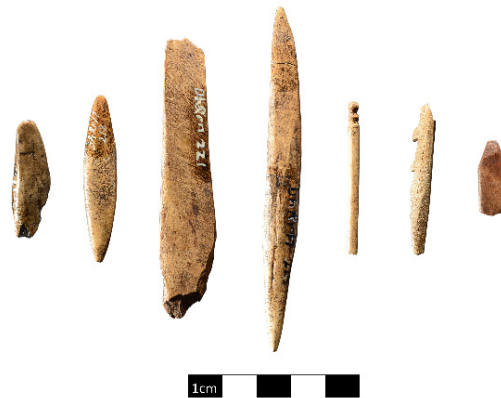
Figure 1. Bone Artifacts

The objects that commonly preserve in non-waterlogged (dry sediment) archaeological sites are made of bone, stone, shell, and antler. Distinguishing cultural from natural modification in many of these types of archaeological materials can be difficult. One means is by identifying toolmarks and intentional modification such as flake scars on chipped stone and grinding or sawing marks on bone, antler, and shell.

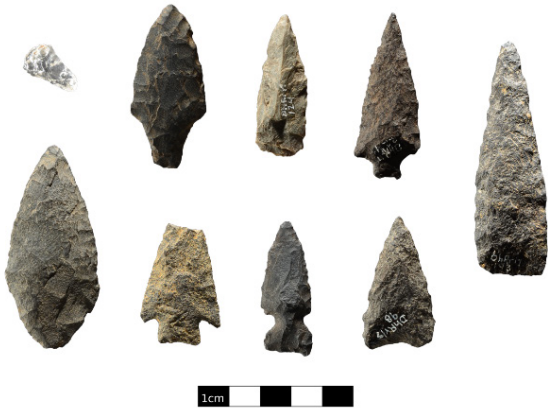
Figure 2. Chipped Stone Artifacts

Artifacts can be found as isolates or in association with other features. Isolated artifact scatters usually consist of stone artifacts (including formed tools and waste materials resulting from the production of such tools), and less-frequently, butchered animal bones.

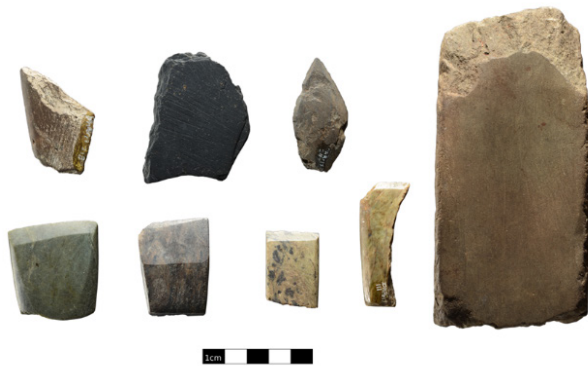
Figure 3. Ground Stone Artifacts

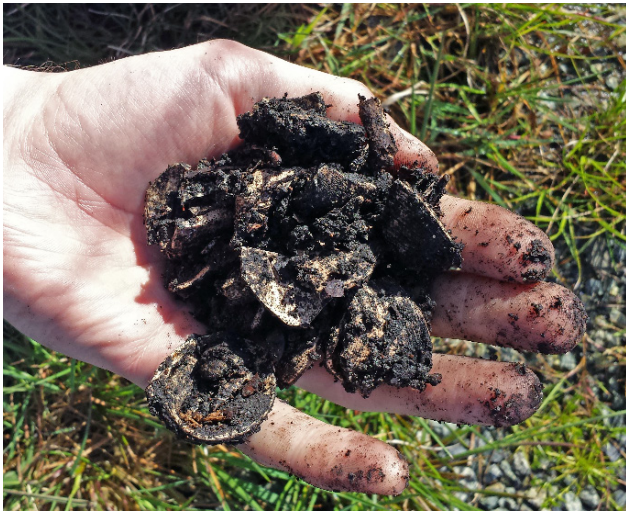
Figure 5. Midden with Whole Clam Shell and FCR

Figure 5 and Figure 6 show the variation in appearance of shell midden deposits. They can include varying densities of many shell types such as clam, mussel, cockle, barnacle, and urchin. In this area, middens are likely to be

characterized by dark black sediment with clam shell, charcoal, fire cracked rock, and sometimes preserved bone.

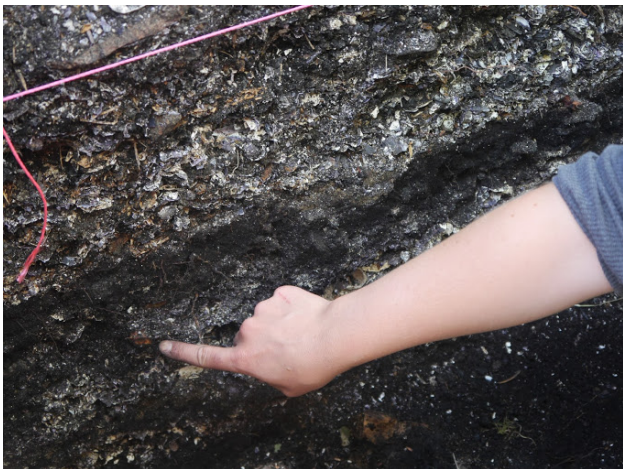
Figure 6. Midden with Fragmentary Mussel Shell, Clam Shell, Charcoal, FCR, and Bone

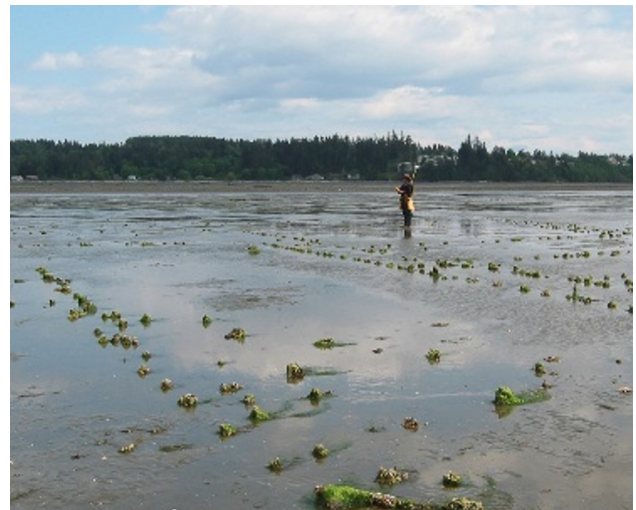
Intertidal marine resource features such as wooden fish traps or stone weirs are present near the shorelines and mouths of streams. These will be identifiable by small wooden stakes or boulder alignments.

Figure 7. Wooden Fish Weir Alignment

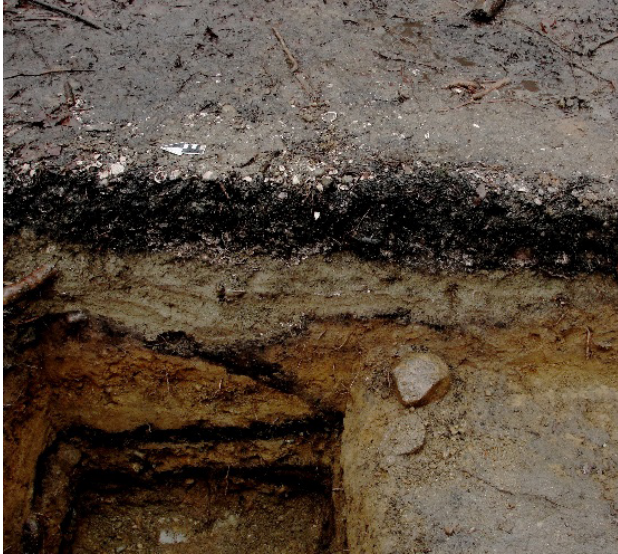
Hearth features are the remnants of fires, identifiable by dense black charcoal and light-coloured ash. Natural forest fires are very common on the coast and can leave similar traces, but hearths tend to be well-defined and associated with white-coloured burned bone, fire-cracked rock, and artifacts.

Figure 8. Stacked Hearth Features in a Deeply Stratified Site. Note Shell in Upper Layer.

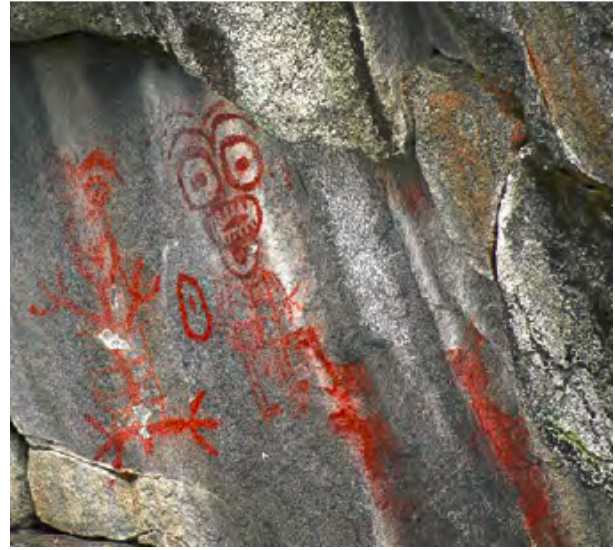
Petroglyphs are pecked art on boulders, rock faces, or other exposed rock surfaces. These are often faint, incised designs. Pictographs are applied designs to rock faces, using red ochre paint or other pigments.

Figure 9. Pictograph, red ochre designs applied onto a protected bedrock face

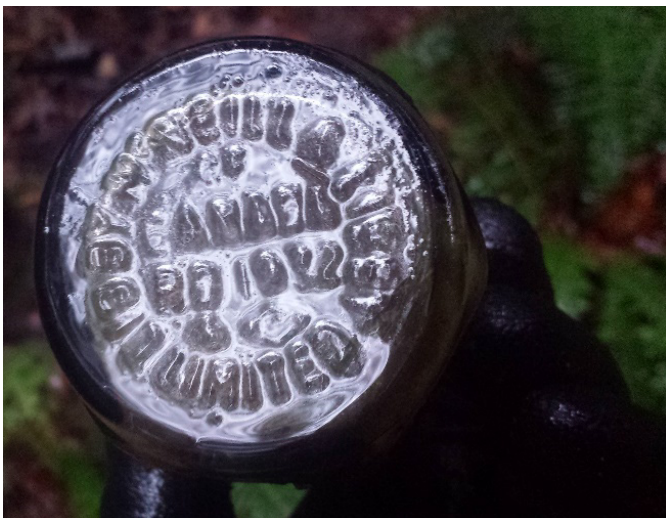
Figure 10. Historic Bottle Base

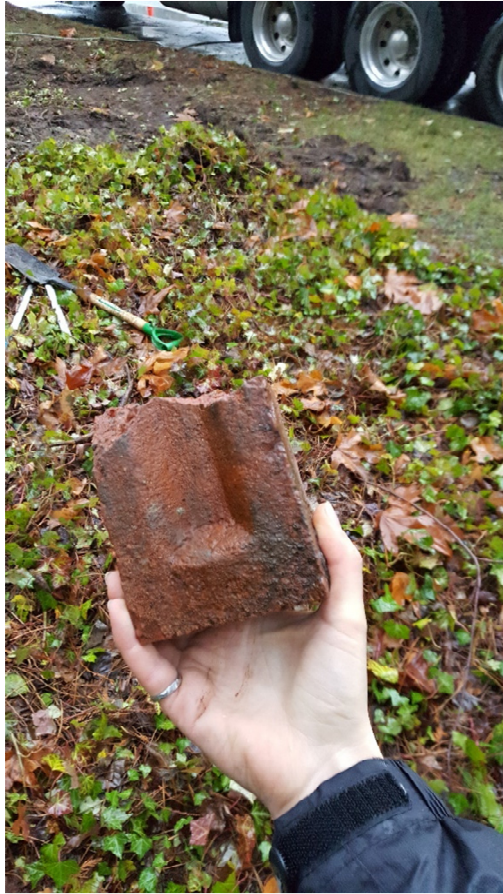
TP17-2, Brick from test pit
