FINAL GEOTECHNICAL REPORT

**Percy Lake Dam Access Road
5P201-17-5130 (45396098)**

Parks Canada Agency

**A/G Project 17555-1
February 13, 2019**

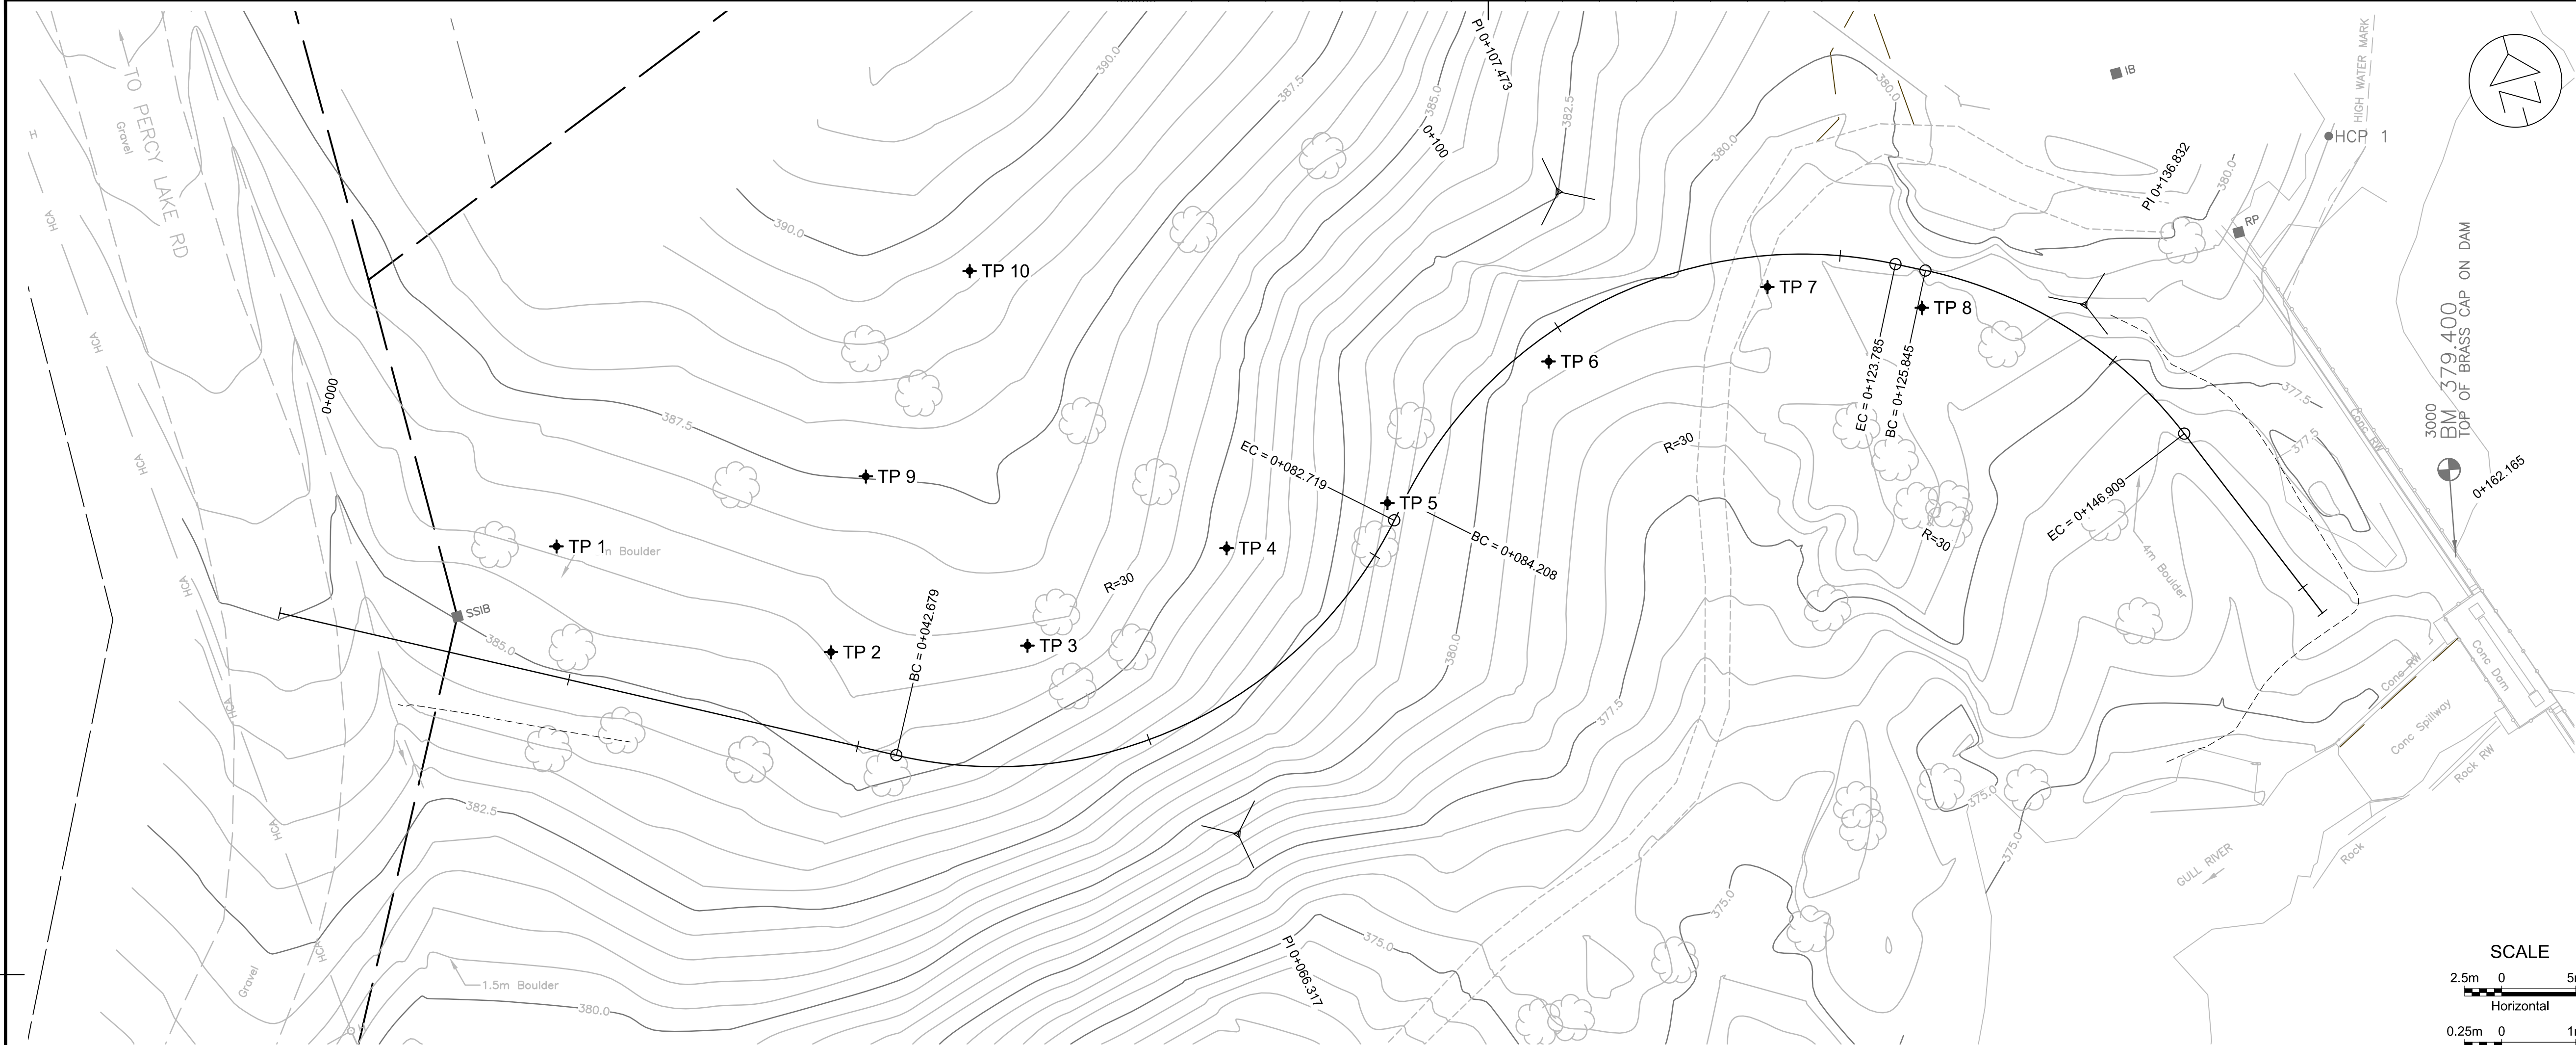
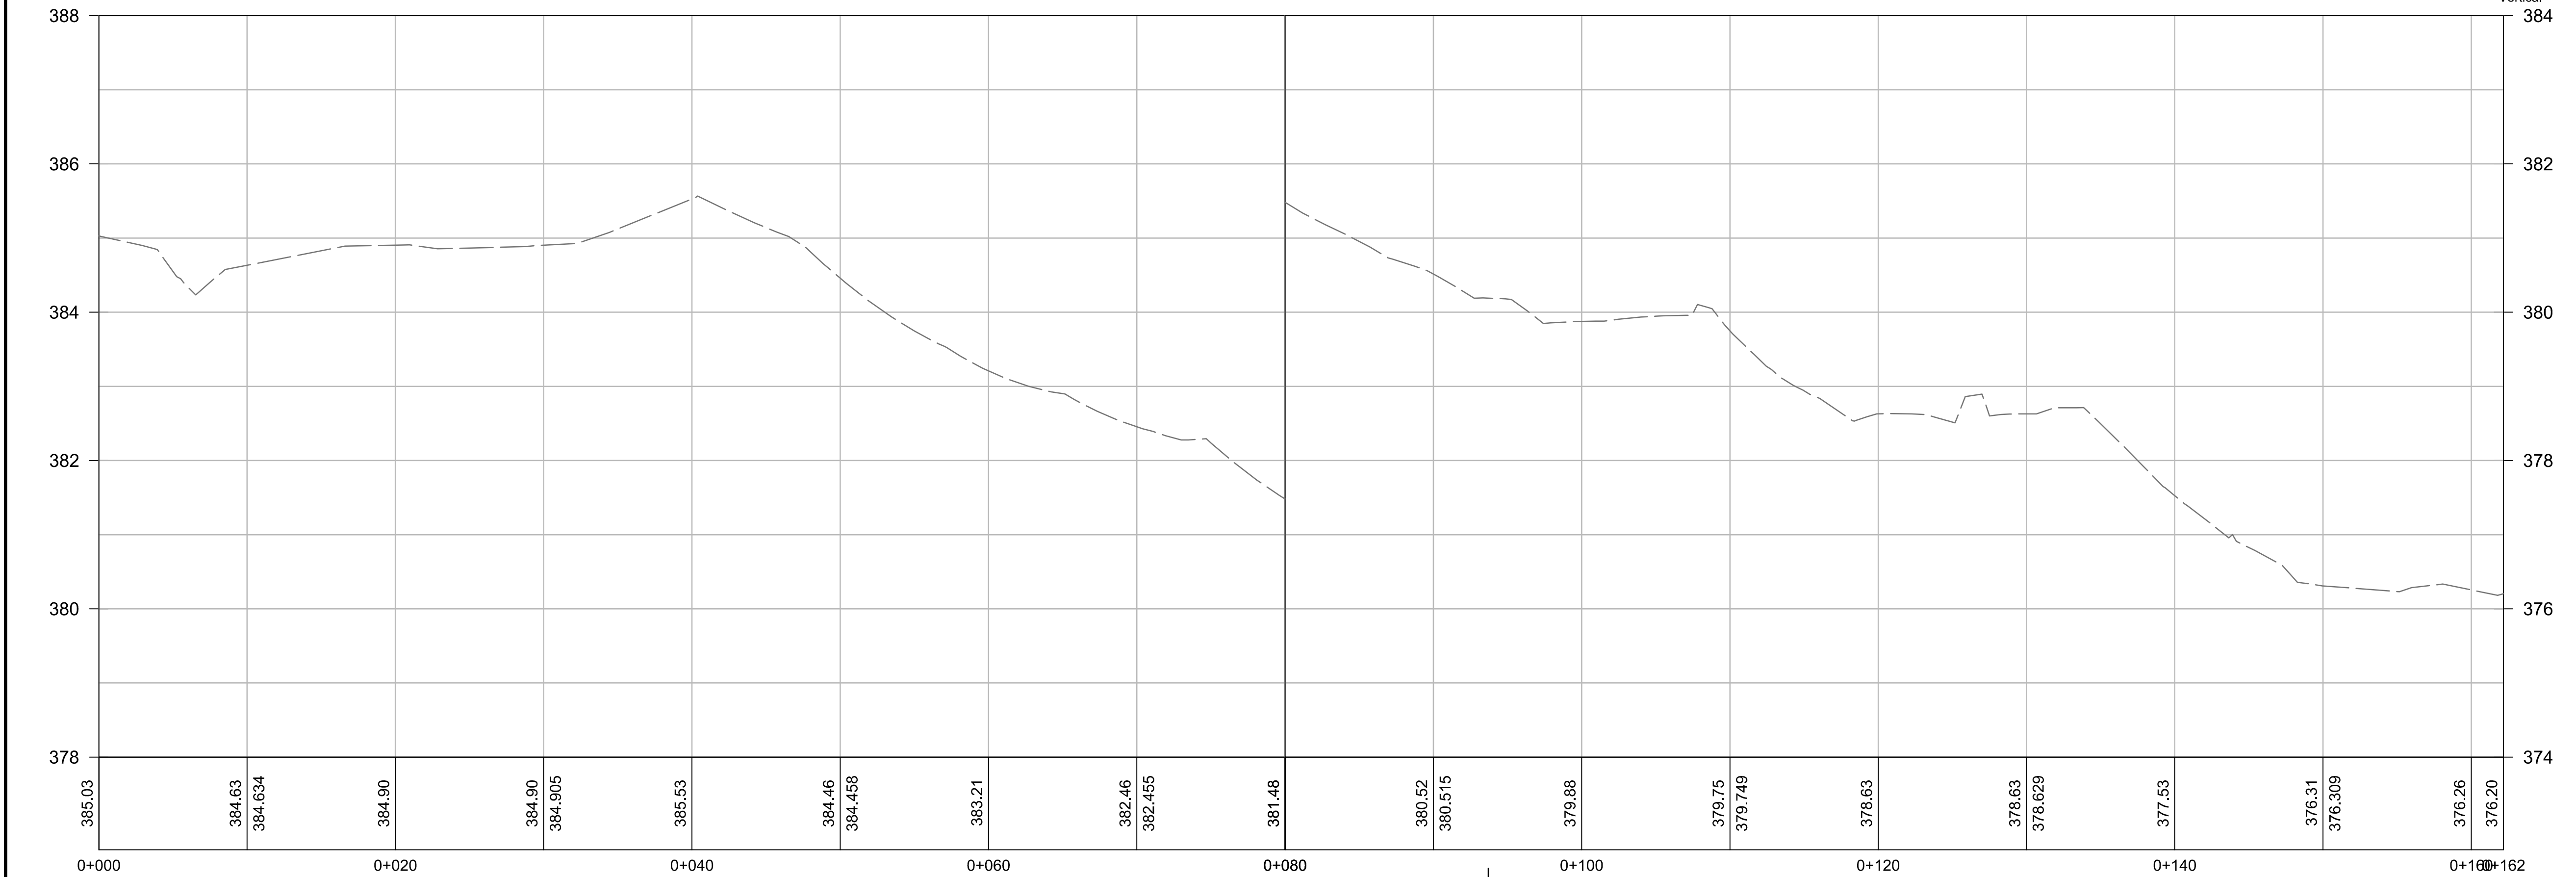
Figure No. 1
Site and Test Pit Location Plan

drawing title titre du dessin TEST PIT LOCATIONS STA. 0+000 TO 0+162

The test pit program was completed on February 1, 2018. All test pitting was completed under the constant supervision of a qualified member of Ainley's geotechnical team. A Site and Test Pit Location Plan showing test pit locations is attached to this report as **Figure No. 1**.

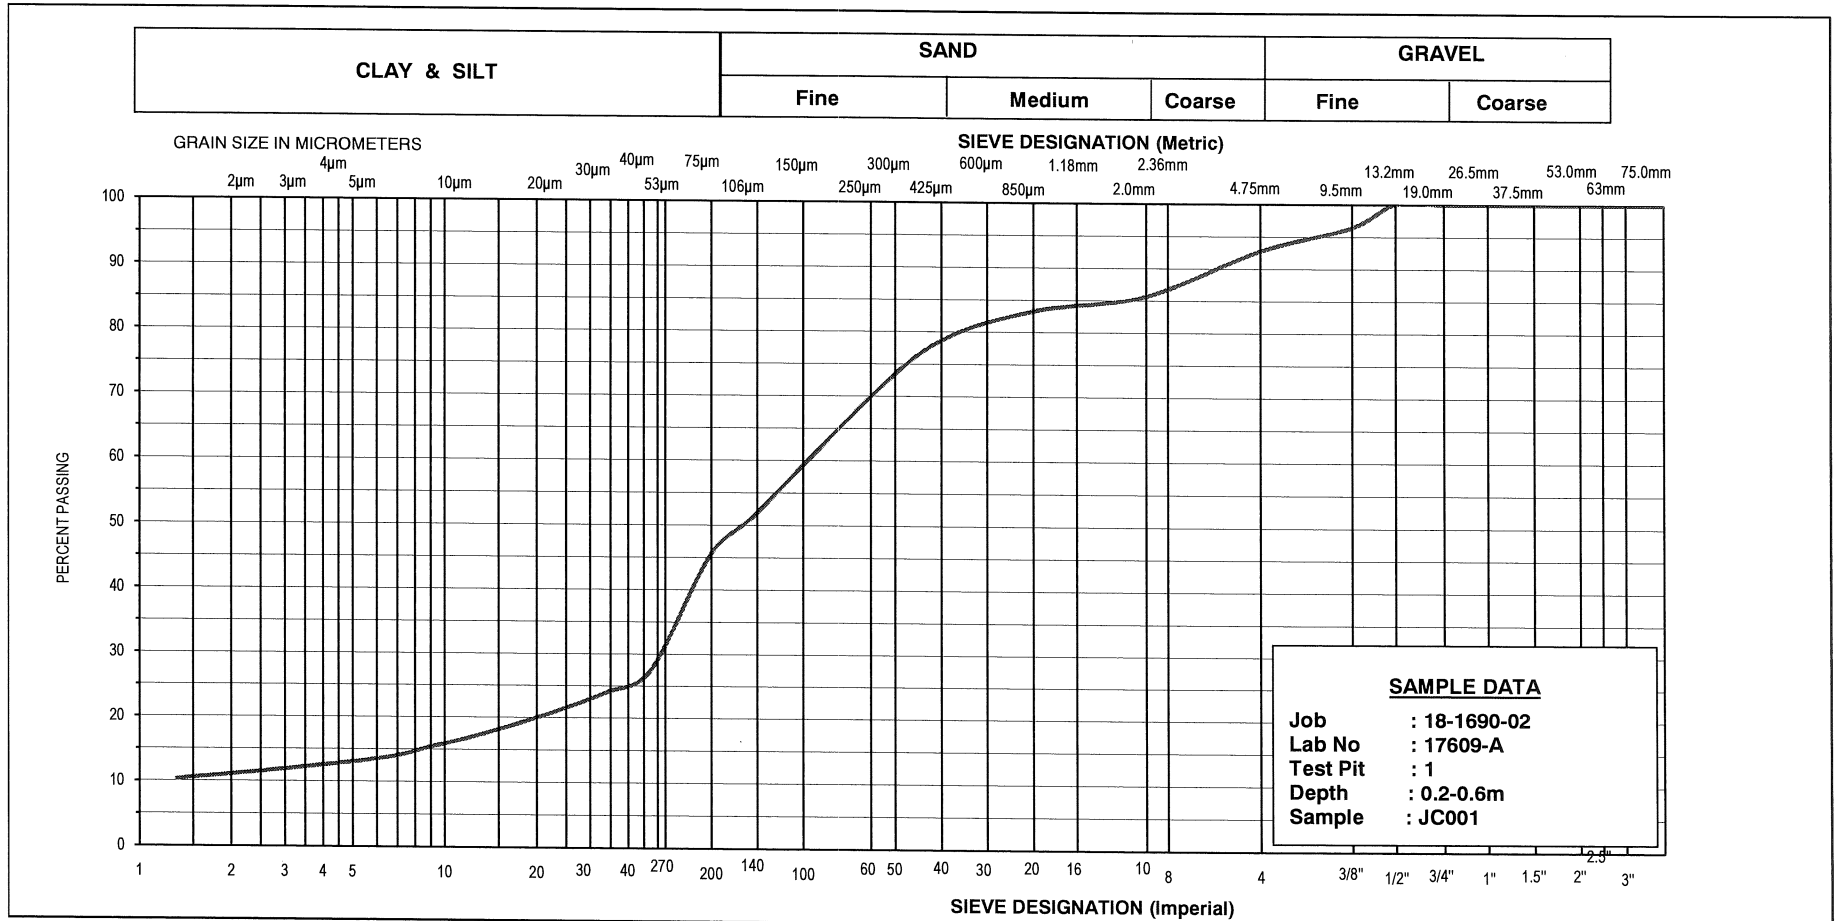
% +3"	% Gravel		% Sand			% Fines	
	Course	Fine	Course	Medium	Fine	Silt	Clay
	0	7	7	7	33	35	11

SNC-LAVALIN 1164 Clyde Court Kingston, Ontario K7P 2E4	GRAIN SIZE DISTRIBUTION		Client: Ainley
	SILTY SAND		Project: 17555-1
	Some Clay, Trace Gravel		Location: Percy Lake Dam Access Road
			Date: February 13, 2018

One (1) representative sample of the sand with varying amounts of silt, gravel, clay, cobbles, boulders and rootlets was submitted for gradation and moisture content determination. The

percentage of material passing the 4.75 mm and 75 µm sieves was found to be 81.2 and 40.5 respectively. The moisture content was found to be 17.6% at the time of the site investigation. The material does not meet the requirements for Select Subgrade specification in accordance with OPSS 1010.

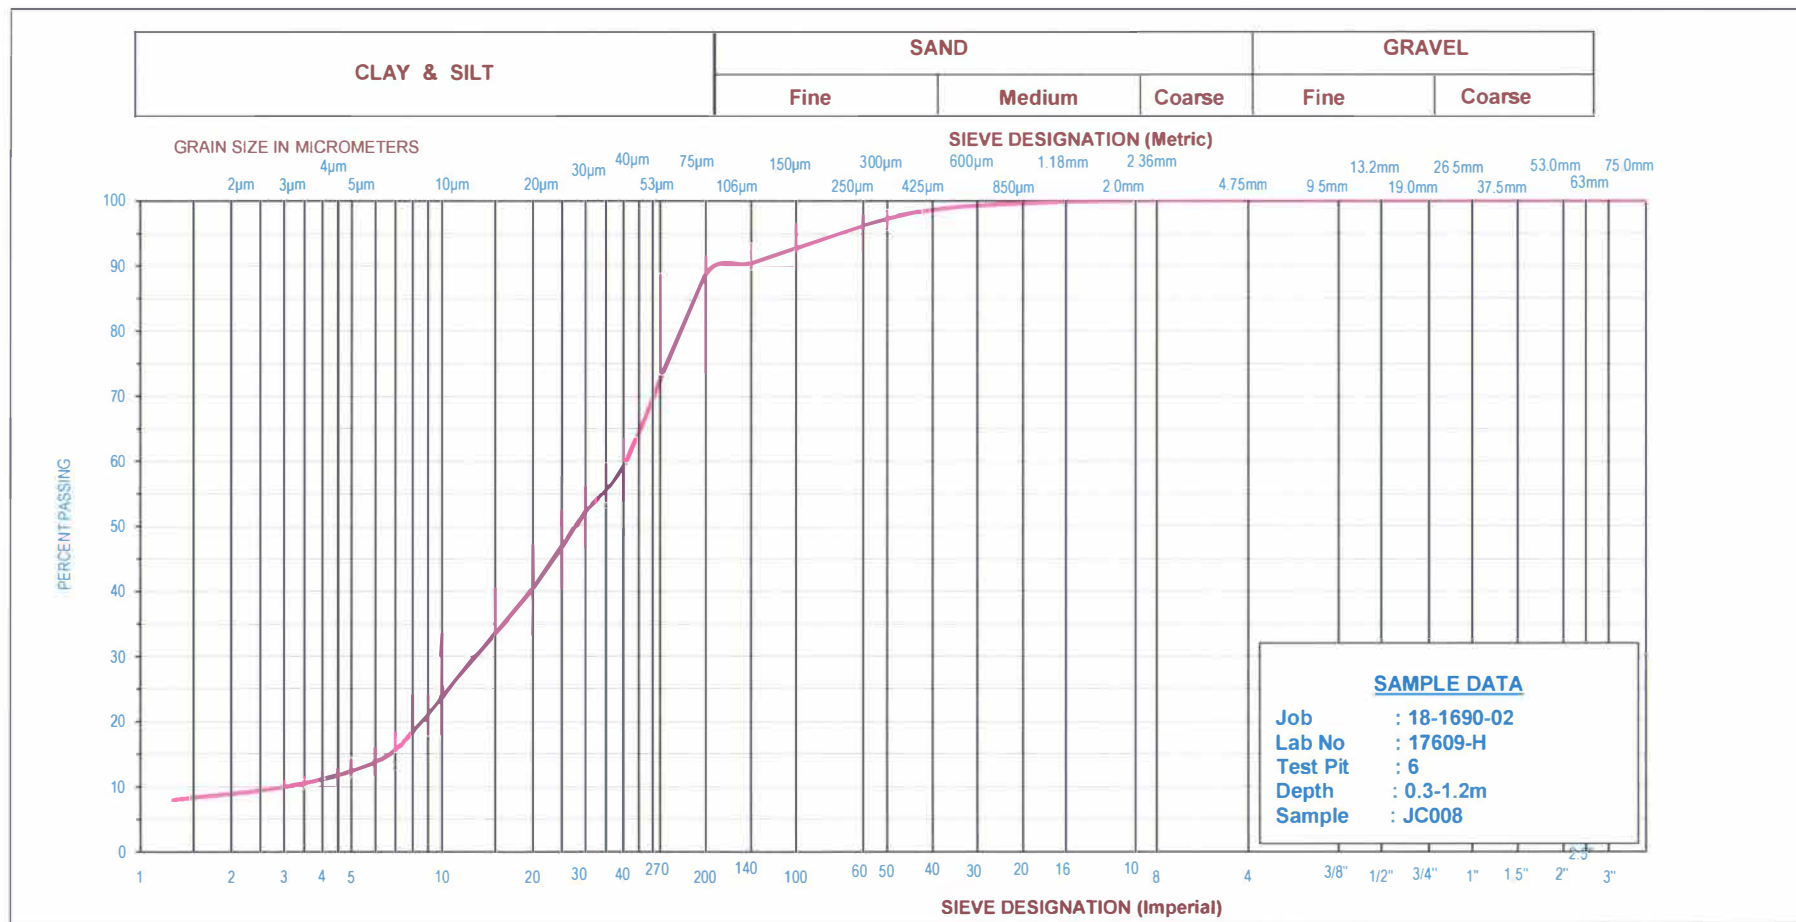
% +3"	% Gravel		% Sand		% Fines	
	Course	Fine	Course	Medium	Silt	Clay
	0	0	0	1	80	9

SNC-LAVALIN 1164 Clyde Court Kingston, Ontario K7P 2E4	GRAIN SIZE DISTRIBUTION		Client: Ainley	
	SILT		Project: 17555-1	
	some Sand trace Clay		Location: Percy Lake Dam Access Road	
			Date: February 13, 2018	Moisture Content 34.1%

Two (2) representative samples of the silt with varying amounts of sand, clay, cobbles and boulders were submitted for gradation and moisture content determination. The material was found to have a High Susceptibility to Frost Heaving (HSFH). The moisture contents were found to be 34.1% at the time of the site investigation.

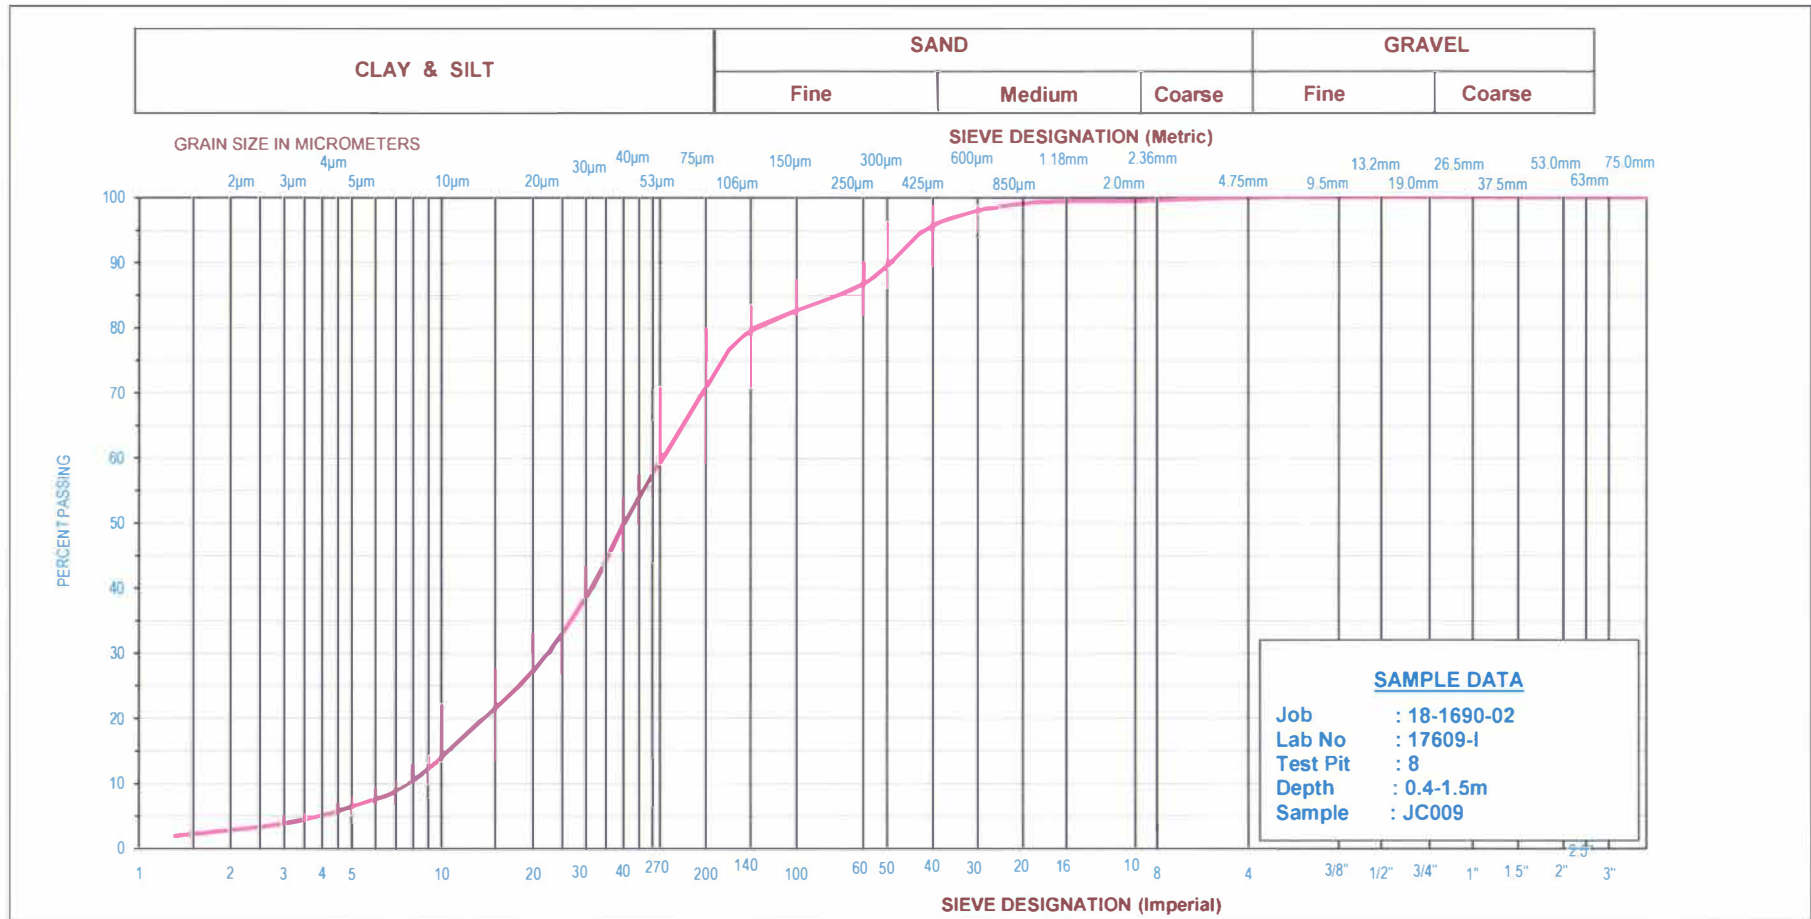
% +3"	% Gravel		% Sand			% Fines	
	Course	Fine	Course	Medium	Fine	Silt	Clay
	0	0	1	4	25	67	4

SNC-LAVALIN 1164 Clyde Court Kingston, Ontario K7P 2E4	GRAIN SIZE DISTRIBUTION	Client: Ainley
	5ILT With Sand trace Clay	Project: 17555-1 Location: Percy Lake Dam Access Road Date: February 13, 2018
		Moisture Content 34.1%
