**GEOTECHNICAL INVESTIGATION REPORT  
CORNWALL ISLAND REAR RANGE TOWER  
CORNWALL ISLAND, ONTARIO**

**Report Reference No. 17-143  
November 15, 2017**

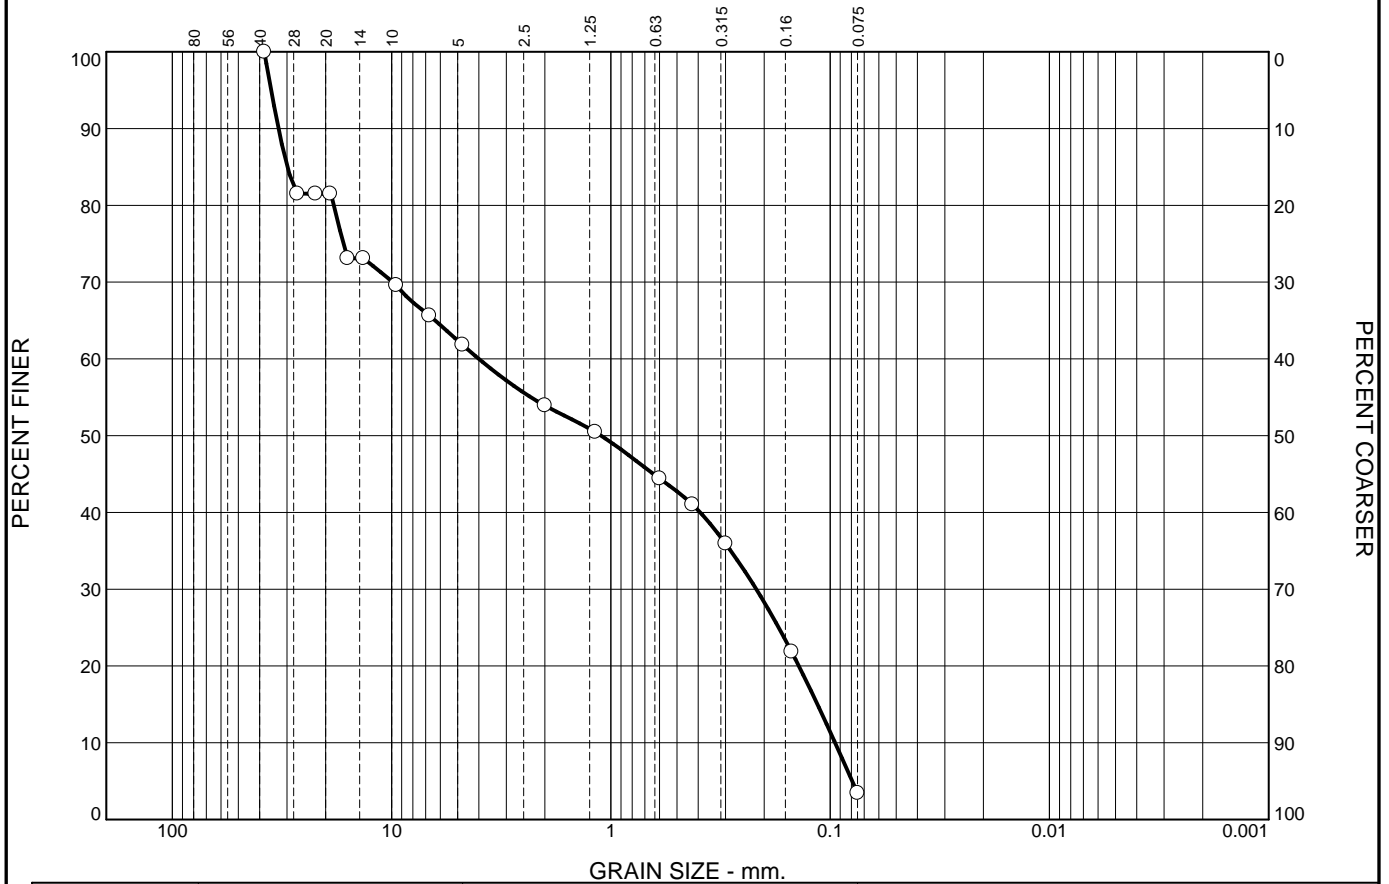
% +3"	% Gravel		% Sand			% Fines	
	Coarse	Fine	Coarse	Medium	Fine	Silt	Clay
0	18	20	8	13	38	3

LL	PL	D <sub>85</sub>	D <sub>60</sub>	D <sub>50</sub>	D <sub>30</sub>	D <sub>15</sub>	D <sub>10</sub>	C <sub>c</sub>	C <sub>u</sub>
		29.8781	4.0021	1.1087	0.2173	0.1143	0.0950	0.12	42.14

Material Description	USCS	AASHTO
○ SAND and GRAVEL, trace silt	SP

<p><b>Project No.</b> 17-143      <b>Client:</b> Department of Fisheries and Oceans</p> <p><b>Project:</b> Cornwall Island Rear Range Tower</p> <p>○ <b>Sample Number:</b> BH1 sample 3</p>	<p><b>Remarks:</b></p> <p>○ Tested on October 18, 2017</p>
<p><b>Alston Associates</b></p> <p><b>Geotechnical Division of Terrapex</b></p>	
<p><b>Figure</b>    FIG</p>

Grain size analyses carried out on a sample of the gravel and sand retained from depths between 0.2 to 2.1 mbgs revealed that the soil consists of 59% sand, 38% gravel, and 3% silt and clay. The test results are enclosed in Appendix D.

Based on the result of the gradation analysis, the Coefficient of Permeability (k) of the sand and gravel is estimated to be  $10^{-1}$  cm/s; high permeability.

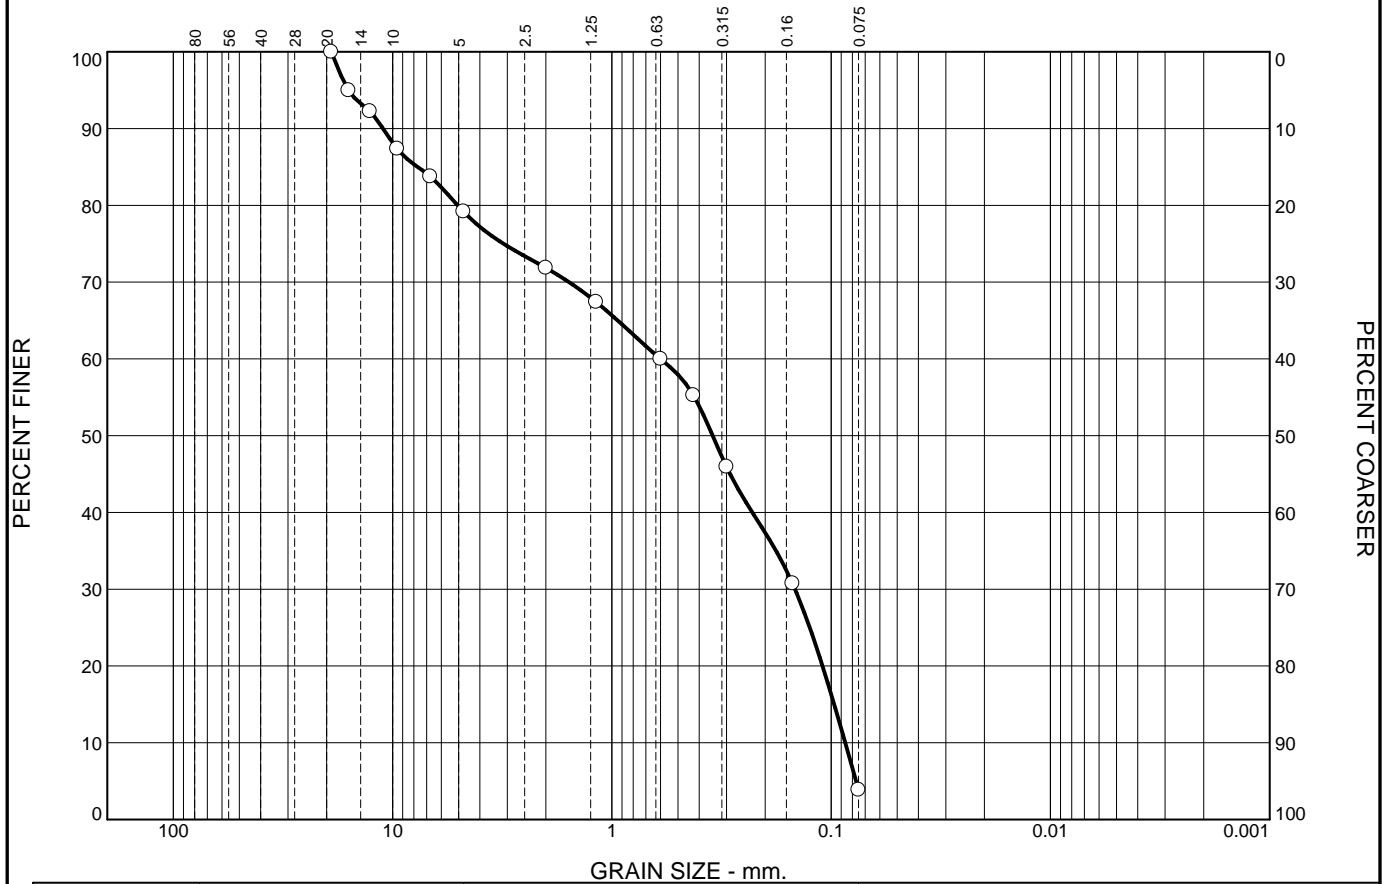
%	% Gravel		% Sand			% Fines	
	Coarse	Fine	Coarse	Medium	Fine	Silt	Clay
○	0	21	7	17	51	4

LL	PL	D <sub>85</sub>	D <sub>60</sub>	D <sub>50</sub>	D <sub>30</sub>	D <sub>15</sub>	D <sub>10</sub>	C <sub>c</sub>	C <sub>u</sub>
○		7.6930	0.6005	0.3471	0.1461	0.0969	0.0862	0.41	6.96

Material Description	USCS	AASHTO
○ GRAVELLY SAND, trace silt	SP

<p><b>Project No.</b> 17-143      <b>Client:</b> Department of Fisheries and Oceans</p> <p><b>Project:</b> Cornwall Island Rear Range Tower</p> <p>○ <b>Sample Number:</b> BH 1 sample 4</p>	<p><b>Remarks:</b></p> <p>○ Tested on October</p>
<p><b>Alston Associates</b></p> <p><b>Geotechnical Division of Terrapex</b></p>	
<p><b>Figure</b>    F2G</p>

Sieve analysis carried out on a sample of the gravelly sand retained from an approximate depth of 2.5 mbgs, revealed that the soil consists of 75 % sand, 21 % fine gravel, and 4 % silt. The test results are enclosed in Appendix D.

Based on the result of the gradation analysis, the Coefficient of Permeability (k) of the gravelly sand is estimated to be  $0.7 \times 10^{-2}$  cm/s; high permeability.

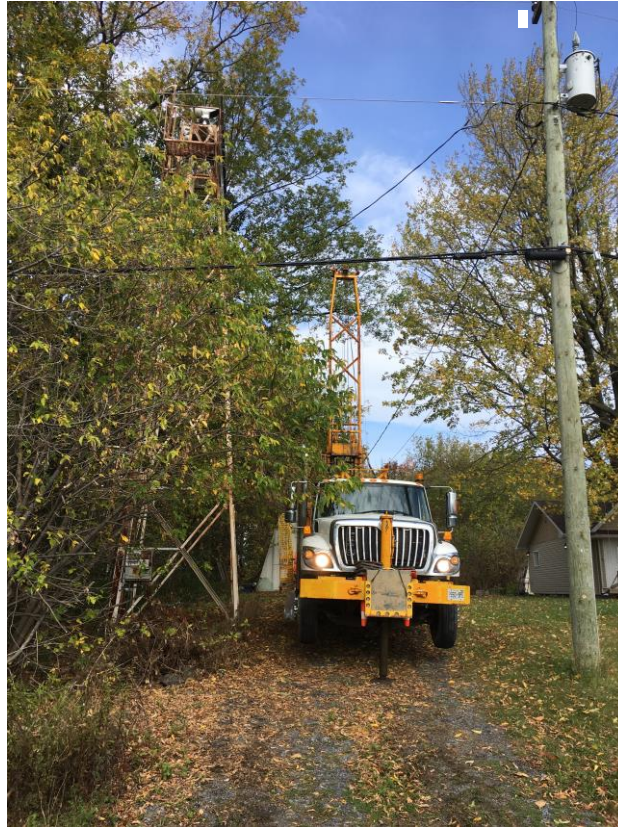
**Client:** DFO**Date:** October 17, 2017**Project No:** 17-143**Photo No:** 1**Description:**

- Standing on Island Road in front of range tower, looking north.

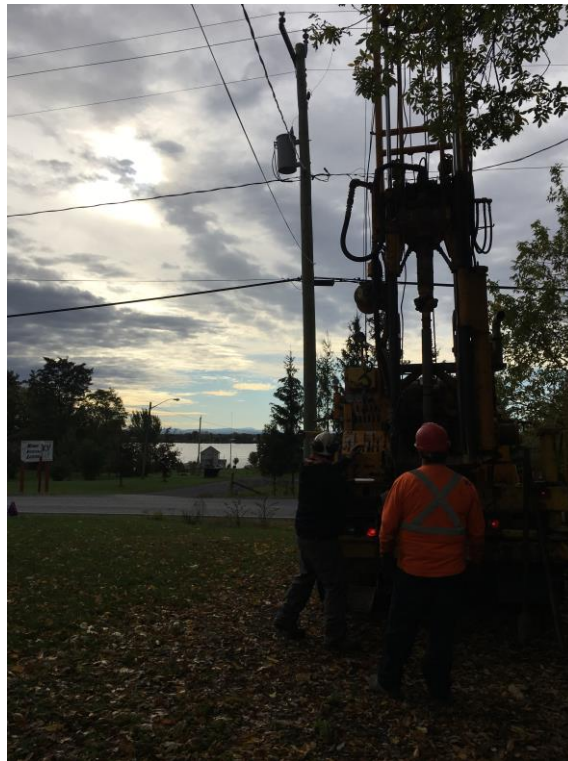
**Client:** DFO**Date:** October 17, 2017**Project No:** 17-143**Photo No:** 2**Description:**

- Standing in gravel access road, behind Borehole 1, looking South.

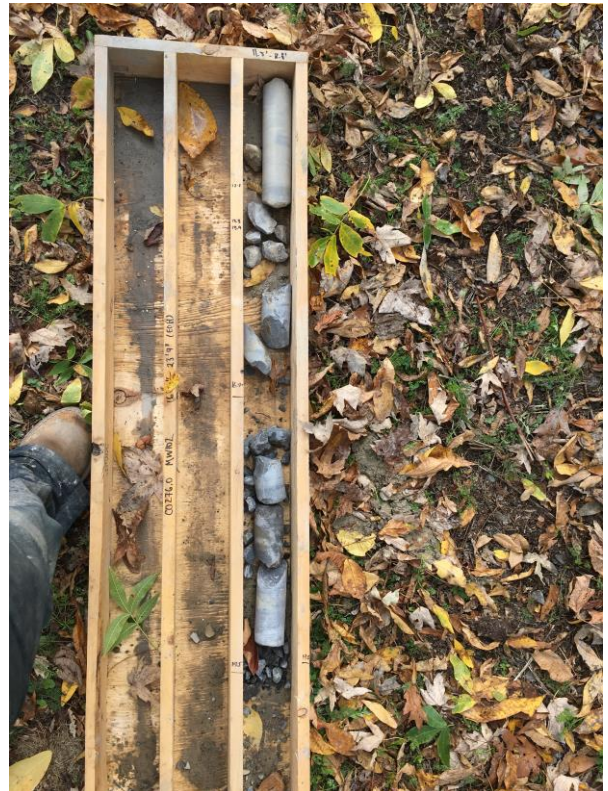
**Client:** DFO**Date:** October 17, 2017**Project No:** 17-143**Photo No:** 3**Description:**

- Core box of cobbles/boulders retrieved from rock coring

Below an approximate depth of 4.1 mbgs, the gravelly sand deposit is underlain by a stratum which contains larger boulders. Due to the frequency and diameter of the boulders it was not possible to advance the borehole by auguring, and a diamond drill was used to core through the boulders from depths of 4.1 to 7.5 mbgs. The collected rock cores indicate the boulders consist of limestone and a coarse water bearing layer may be present within this zone. Photographs of the rock cores collected are enclosed in Appendix D.
