DESIGN BRIEF

BOILER ROOM - SANITARY SUMP PIT REFURBISHMENT

Canadian Centre for Inland Waters

ARC Project: 17-167-020

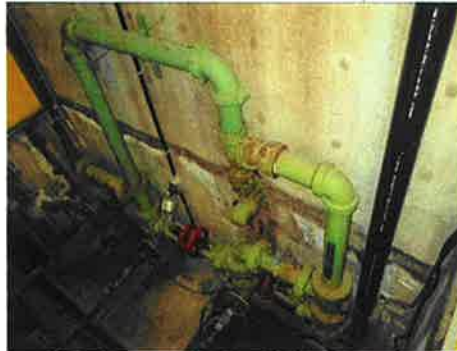
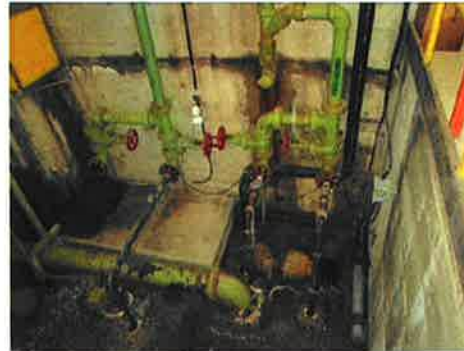
Given evidence of infiltration at the wall penetration for the 4" ductile iron drain pipe, which is 6' above the floor of the service tunnel, we can assume that the groundwater is closer to the higher values in this range.

- 6) Given the extent of the current groundwater infiltration in the service tunnel and sump pit area we would recommend limiting the refurbishment to the pit surfaces alone and defer additional floor / wall treatment until exterior civil works can be undertaken to rectify the observed infiltration.

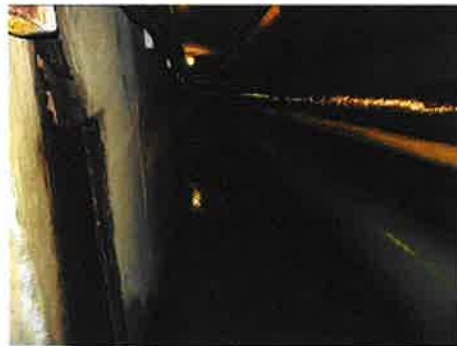
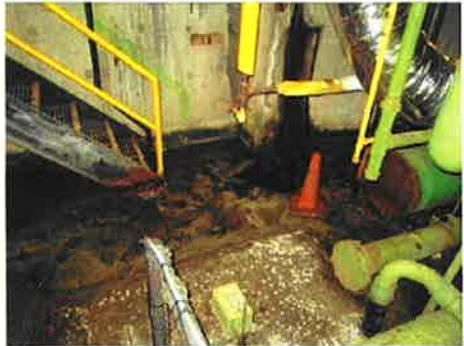
Additionally, groundwater is running steadily between the service tunnel wall and the service tunnel floor. Assuming 1 psi per 2.31' of water head, groundwater pressure could be in the order of 3.7 psi at this wall / floor joint.

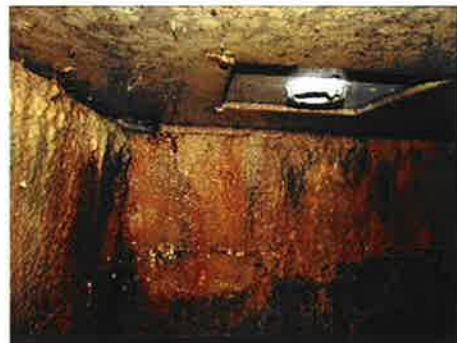
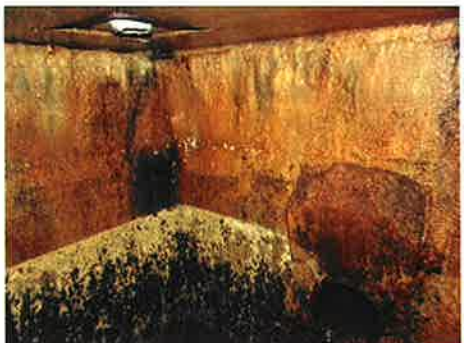
The existing sump pits are heavily corroded as evidenced in the photos below.

- 5) The existing sump pits are heavily corroded. This is understood to be due to boiler blowdown temperatures, chemical treatment carryover and almost 50 years of operation. We recommend that the refurbishment of the existing sump pits be limited to the following surface preparation and treatment:

- a. The sumps will be removed from service, including both inflow and discharge, for a minimum of 3 days each to allow for cleaning, surface preparation, application of restoration compounds, and adequate curing before being placed back into service.

- b. Temporary discharge by way of pumped suction lines through watertight plugs in the inlets will probably be required.
 - c. The existing steel cover plates and frames will be removed and replaced with new galvanized steel.

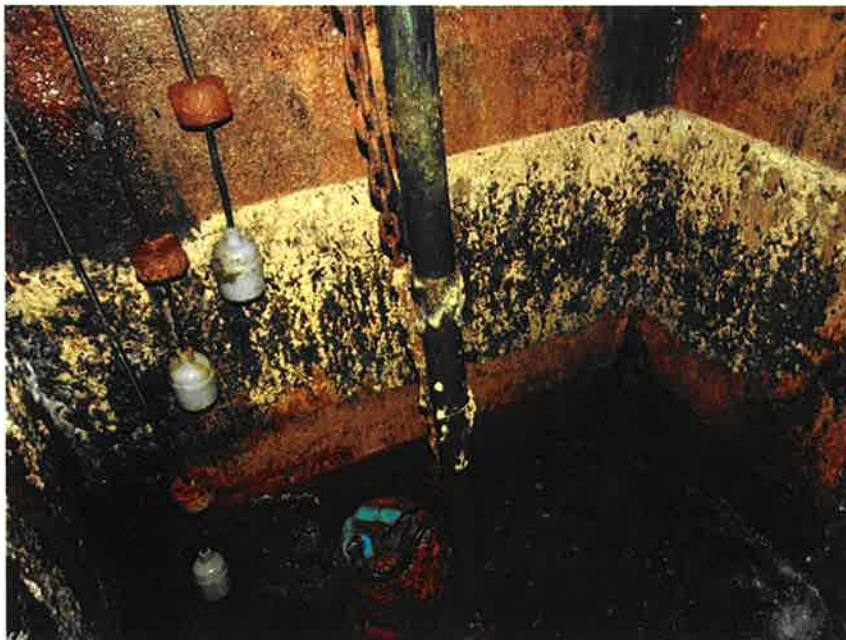
As noted above, pump #1 was not functioning during our field survey. Additionally, issues have been conveyed with respect to float reliability and pumps not alternating service correctly.

Corrosion, as evidenced in the photo below, is believed to be a major contributor to these issues.

We recommend replacing the existing sump pumps, like for like, since they have generally performed well and have not overloaded the receiving system. In addition, we recommend replacing the existing float system to improve system operational reliability. (Note: Once both pumps are operational, a test should also be conducted to determine the parallel pump flow rate in order to determine any potential overload risk.)

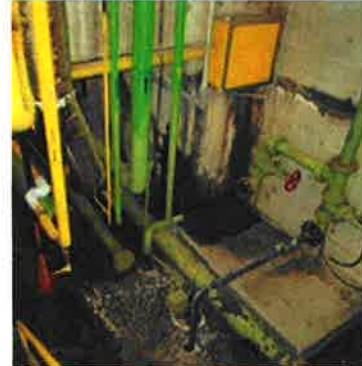
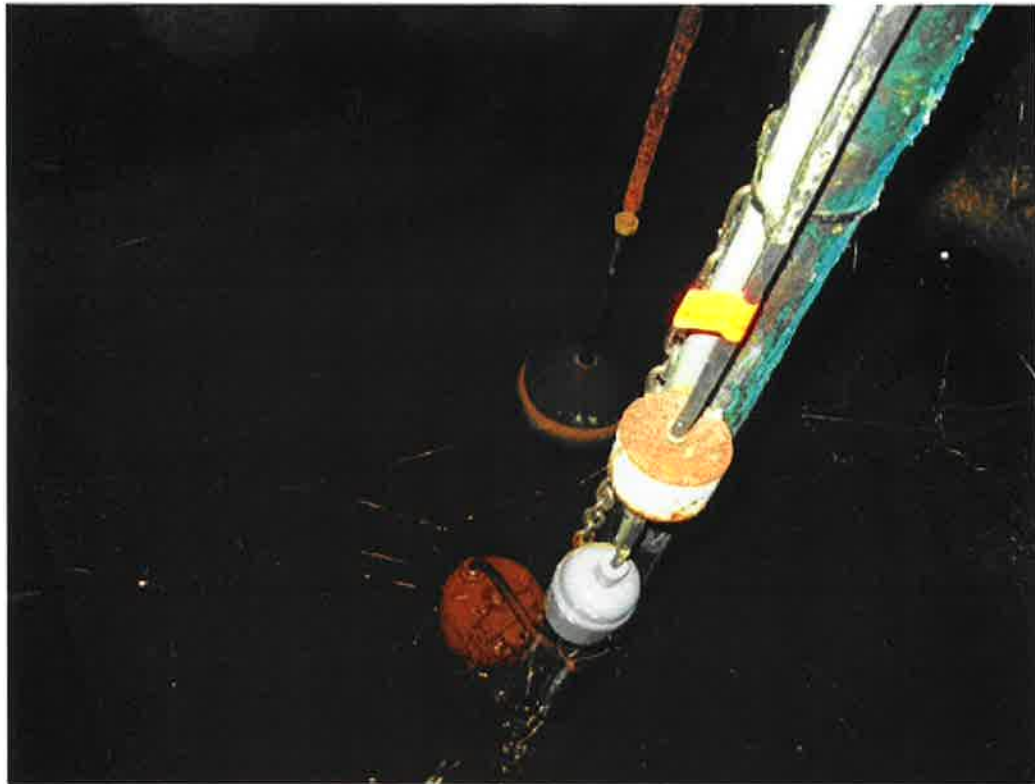
It should also be noted that the overflow pump that services the original bilge sump is stand alone and operates off a directly connected float switch.
