Subject: Project-Specific Designated Substances Survey
Window and Bronze Door Repair Project
Supreme Court of Canada
301 Wellington Street, Ottawa, Ontario

DST File No.: GV-OT-026933

Bulk Asbestos Sample Photo Log

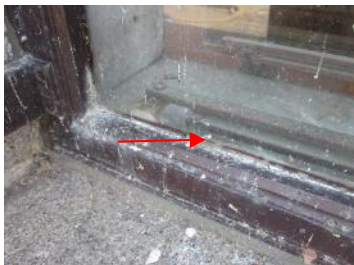
Sample ID:	26933-01A-C	26933-02A-C	26933-03A-C
Photo:

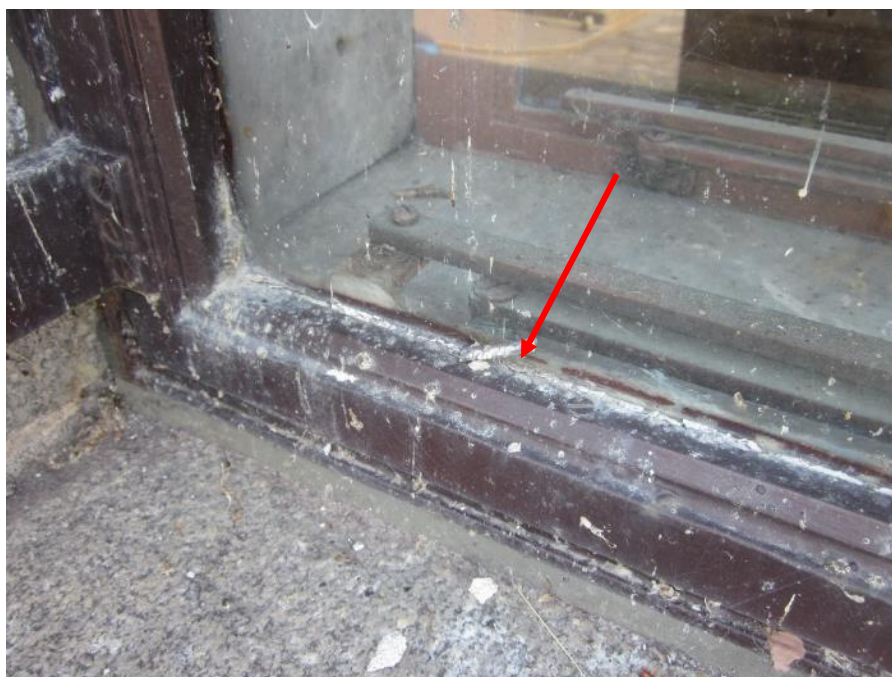
- Non-friable black and white window putty, generally observed between and beneath the metal frame components and the window glass. Black and white window putty was confirmed by laboratory to contain 2.81% and 0.91% Chrysotile asbestos, respectively (Samples 26933-05A and 26933-07A). Based on visual observations of all the different types of windows, all building window types should be assumed to be comprised of asbestos-containing window putty between and beneath the metal frame components and glass of each respective window throughout the building, unless proven otherwise by bulk sampling and laboratory analysis.

Photo 1: Typical example of asbestos-containing window putty, installed between the metal frame components and the glass (F Window, South Elevation pictured).

Type 1 work procedures can be used for the removal of non-friable ACMs (e.g. window putty), provided that the material can be wetted and removed using only non-powered hand tools. If these conditions cannot be met, then more stringent (e.g., Type 2 or Type 3) procedures are necessary.

- Appropriate work procedures and precautionary measures must be used, as outlined in *O.Reg. 278/05*, as amended, when performing work that may disturb ACMs or suspected ACMs, including prior to building demolition.

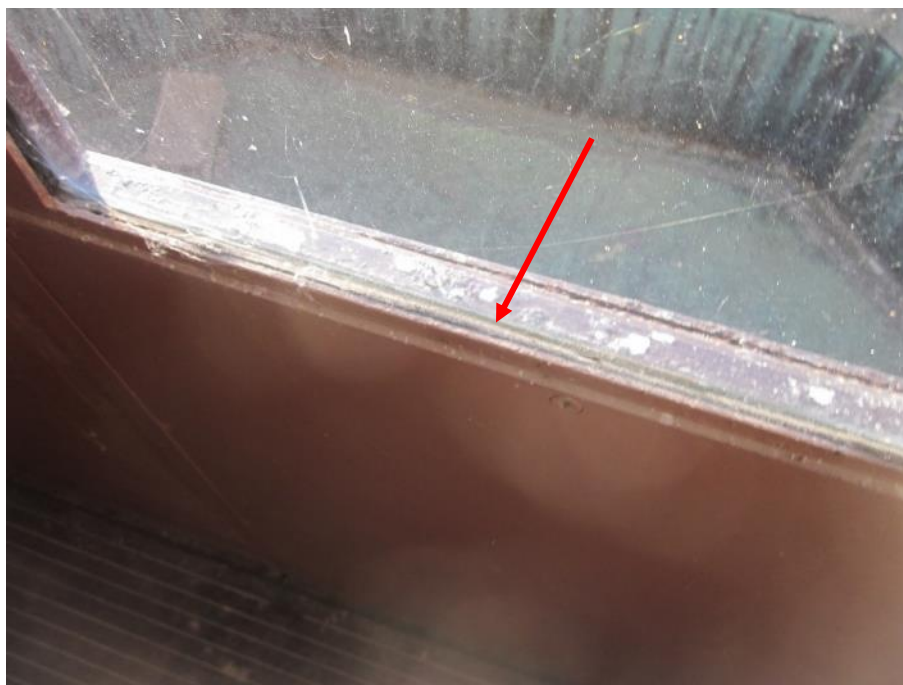
Photo 2: Typical example of asbestos-containing window putty installed between metal frame components and the glass (Window D-D, South Elevation pictured)

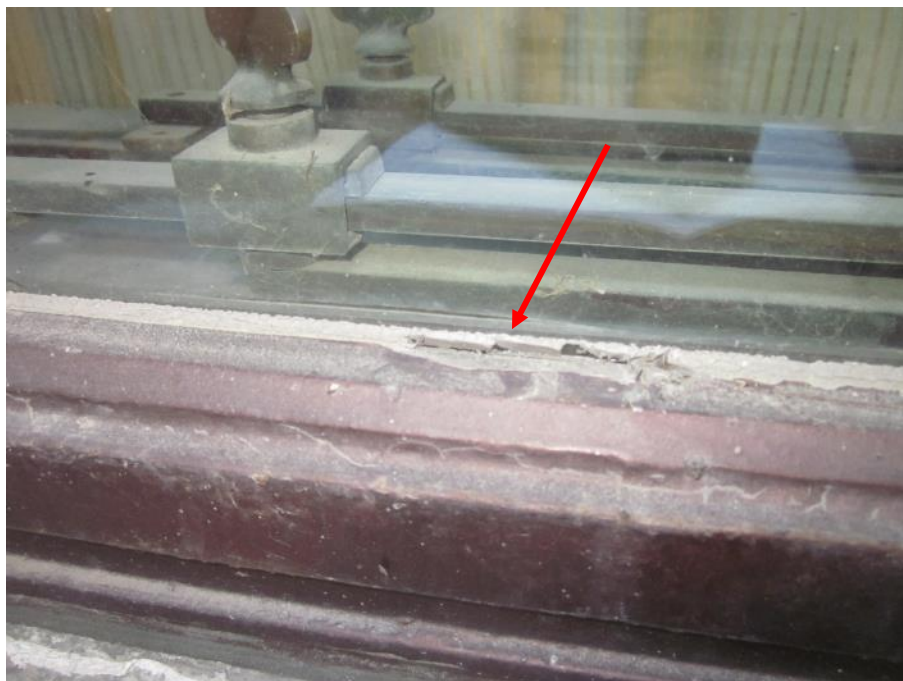
Photo 3: Typical example of asbestos-containing window putty installed between metal frame components and the glass (Window O, West Courtyard pictured).

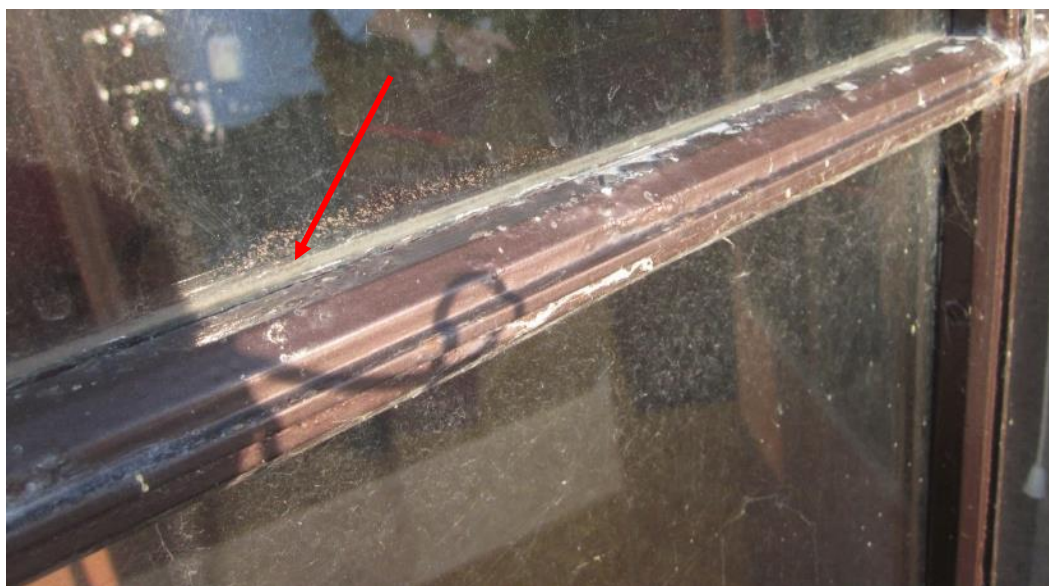
- Brown paint collected from Window D-D, North Elevation, contains 921 ppm lead (Sample 26933-Pb01);
- Brown paint collected from Window JJ, East Elevation, contains 707 ppm lead (Sample 26933-Pb02).

Photo 4: Typical brown painted window components contain 707 to 921 ppm lead

For the purposes of this project, all paints/surface coatings in the project area are considered to be lead-containing. The time weighted average exposure limit (TWael) for airborne lead is prescribed by *Ontario Regulation 490/09 Designated Substances*, as amended. Work procedures and personal protective equipment must be used to ensure that workers are not exposed to airborne lead levels that exceed this TWael.
