FINAL **Facilities Assessment and Demolition Cost Estimate**

**MS4 & MS5 – Waste Material
Storage & Garbage
Incinerator Building,
Sable Island, Nova Scotia**

March 2015

Pinchin File: 01-02-00968

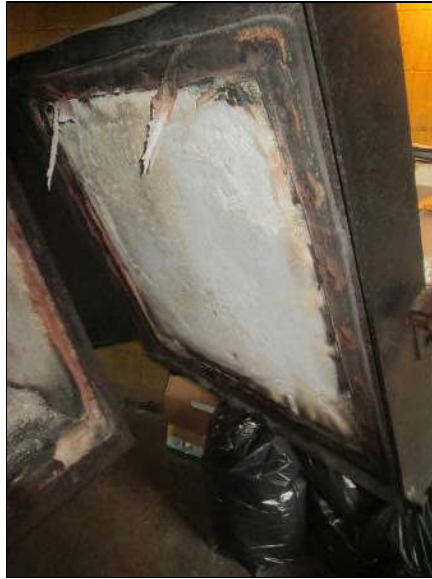
Sample	Location/Description	Asbestos Content
MS5-S001A	Location 02, Incinerator Room, incinerator door gasket	50-75% Chrysotile
MS5-S001B	Location 02, Incinerator Room, incinerator door gasket	Not Analyzed

Photograph 1 – Asbestos-containing incinerator door gasket.

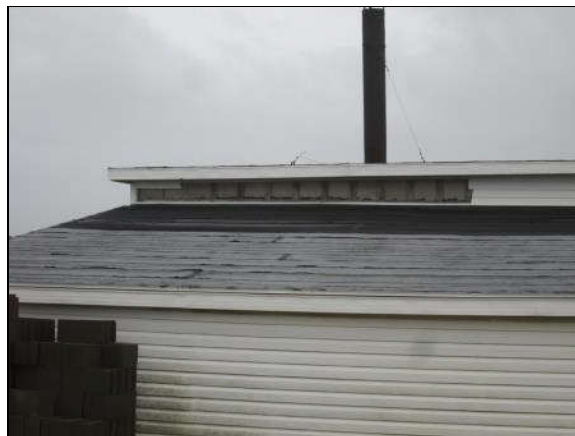
Sample	Location/Description	Asbestos Content
MS5-S001C	Location 02, Incinerator Room, incinerator door gasket	Not Analyzed
MS5-S002A	Location 02, Incinerator Room, incinerator fire brick	None Detected
MS5-S002B	Location 02, Incinerator Room, incinerator fire brick	None Detected
MS5-S002C	Location 02, Incinerator Room, incinerator fire brick	None Detected
MS5-S003A	Location 04, Building Exterior, tar and roof material	a) 10-25% Chrysotile b) None Detected
MS5-S003B	Location 04, Building Exterior, tar and roof material	Not Analyzed
MS5-S003C	Location 04, Building Exterior, tar and roof material	Not Analyzed

Photograph 2 – Asbestos-containing roofing materials.
