## Parks Canada Basic Impact Analysis

Saltwater Pool Bathhouse Rehabilitation – Fundy National Park

Parks Canada – Fundy National Park, New Brunswick

NBSouth-2019-EIA-9

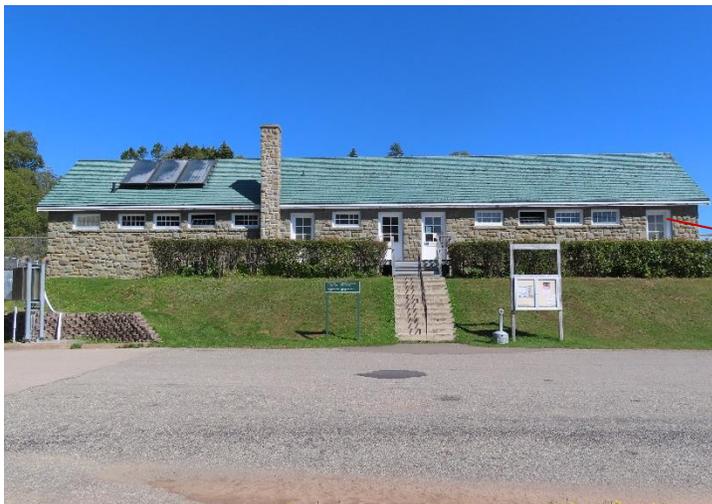
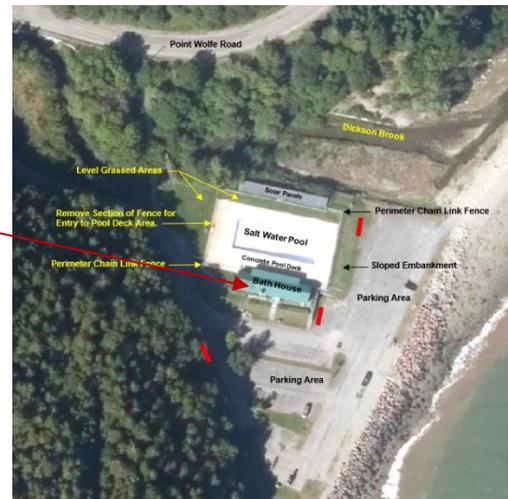
Figure 1: Saltwater Pool Bathhouse, Fundy National Park

The existing Saltwater Pool Bathhouse in Fundy National Park is showing signs of disrepair and requires rehabilitation. The Bathhouse is located adjacent to a saltwater swimming pool located in the Headquarters area of the park just off the Point Wolfe Road near the Bay of Fundy shoreline at Cannon Town Beach (Appendix II & Figure 1). The pool and bathhouse is a major asset and feature for Fundy National Park. The pool was rehabilitated in 2017-2018 and the new design reflects the need for parents with young children to be able to play in a shallow water environment using water and water features in a creative and fun way. The surrounding pool deck allows for both sun and shade lounging. The pool is designed to accommodate lane swimming and meets the Federation Internationale de Natation Amateur (FINA) standards for Provincial short course events. The present project's primary purpose is to renovate and alter the interior layout of the bathhouse as well as to improve the main entrance and adjacent site to provide an improved level of compliance with contemporary barrier-free design standards. In addition, deferred maintenance to structure will be addressed.

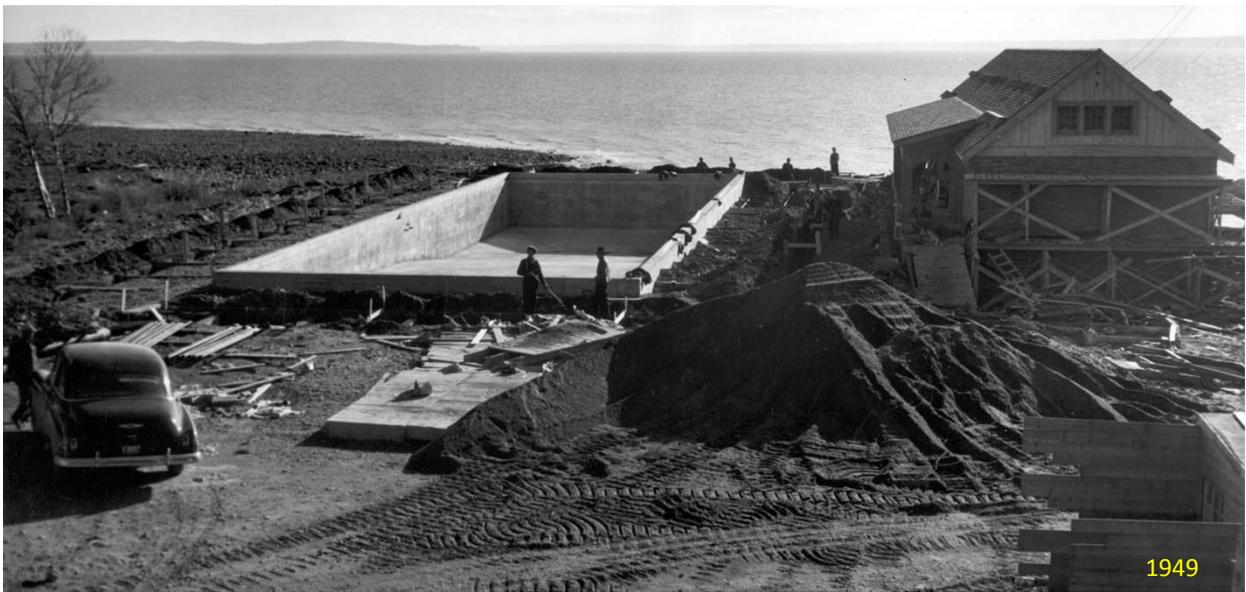
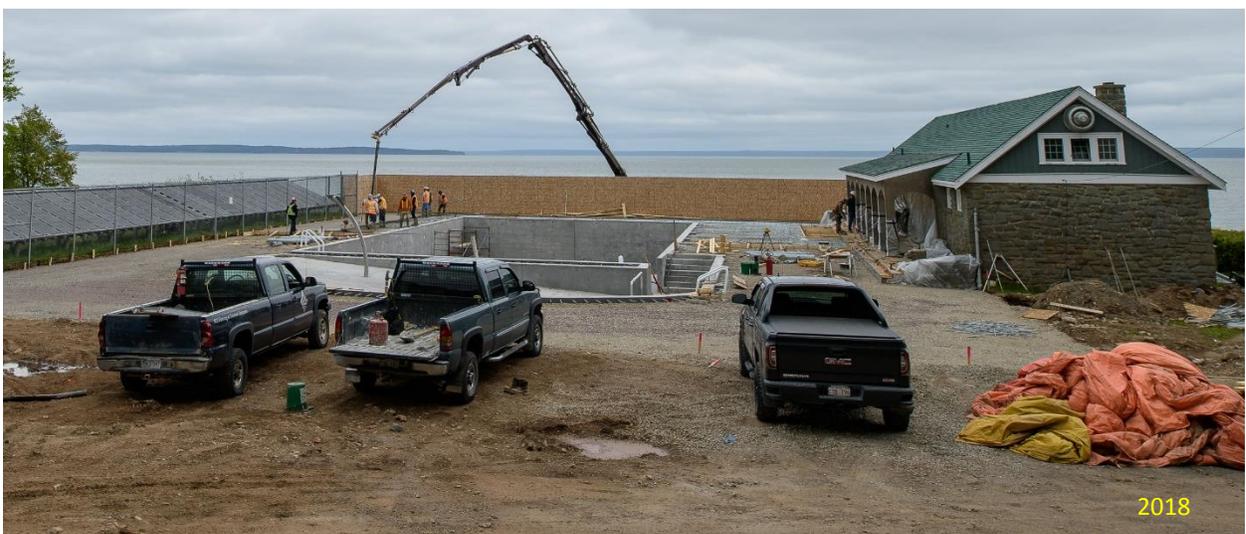
Figure 2: Pool and Bathhouse under Construction in 1949 & Pool in 2018

The existing pool and bathhouse was built in 1949-1950 when Fundy National Park was first created (Figure 2). The concrete rectangular pool is filled with saltwater from the Bay of Fundy and is known to be the only saltwater pool in the Parks Canada system. The Bathhouse, a Herbert Stanley Brown design, is a single storey, rectangular building faced on all four sides with rough-cut, irregularly coursed stone and topped by a medium-pitch gable roof clad in cedar shingles. An arched portico with a shed roof is attached to the poolside elevation. In 2005 the Saltwater Pool Bathhouse was designated “Recognized” by the Federal Heritage Buildings Registration Office (FHBRO) because of its historical associations and its architectural and environmental values. The building has not seen significant interior improvements since the 1980’s. It has a simple existing layout and the current project will further simplify the interior and reduce circulation bottlenecks. A study of barrier-free design opportunities for the building was undertaken by Public Works and Government Services of Canada (PWGSC) in 2008 and it is expected that the current project may adopt some of the features that were proposed at that time including door-less entrances to the male and female change rooms within the building.

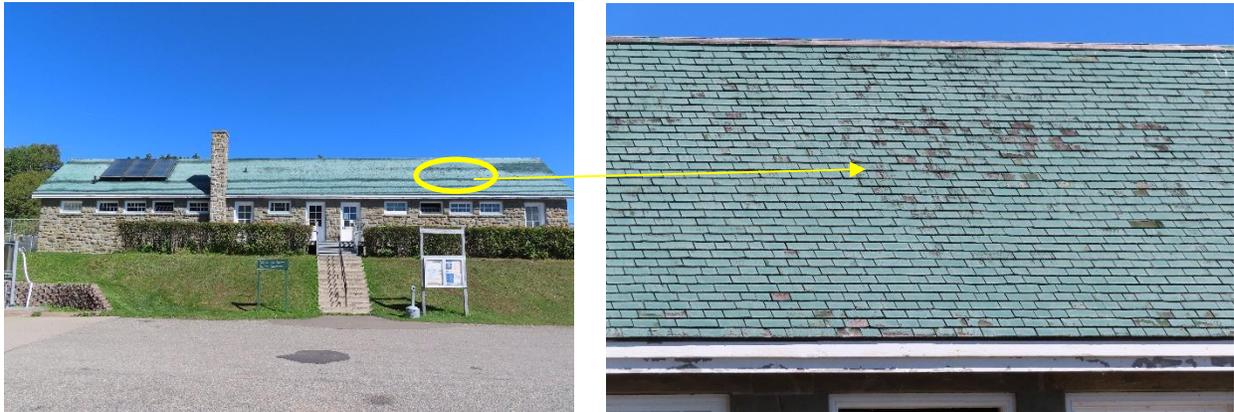
Figure 3: Bathhouse Roof Requiring Replacement

- Replacement of the cedar shingle roofing (Figure 3)

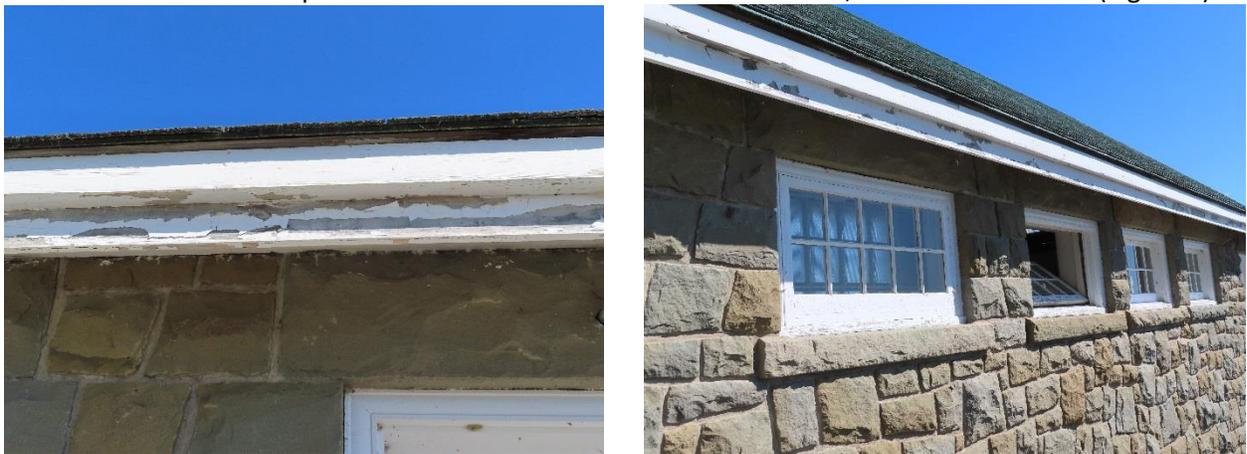
Figure 4: Exterior Wood Trim and Windows Requiring Replacement

- Restoration or replacement of deteriorated exterior wood trim, doors and windows (Figure 4)

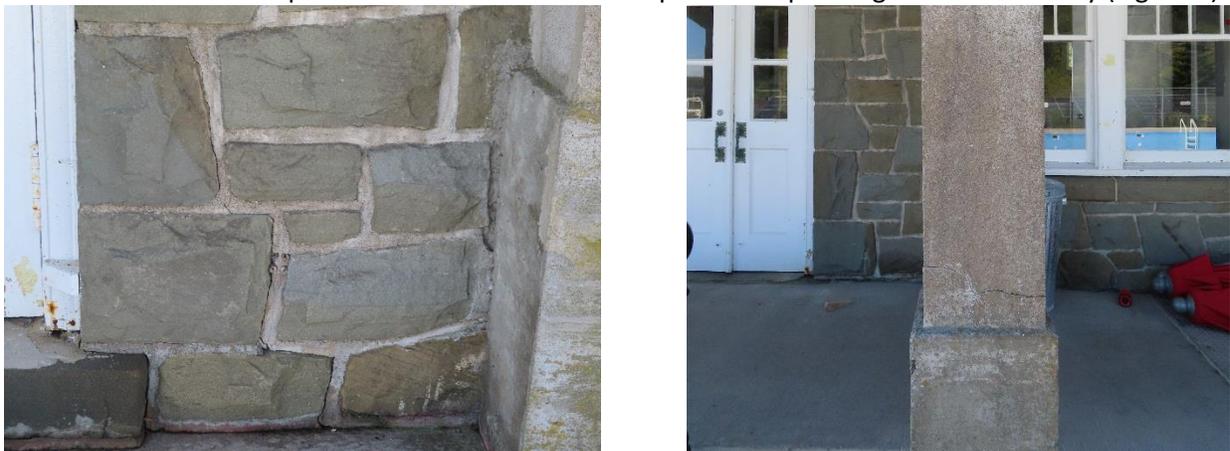
Figure 5: Areas of Stone Masonry and Concrete Deficiencies

- Conservation repair of exterior concrete and repair and repointing of stone masonry (Figure 5)

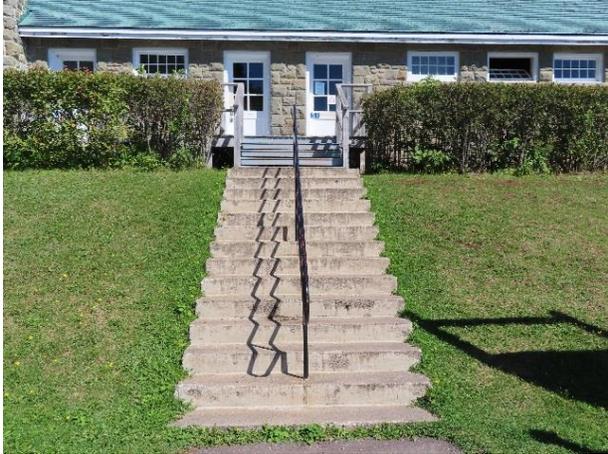
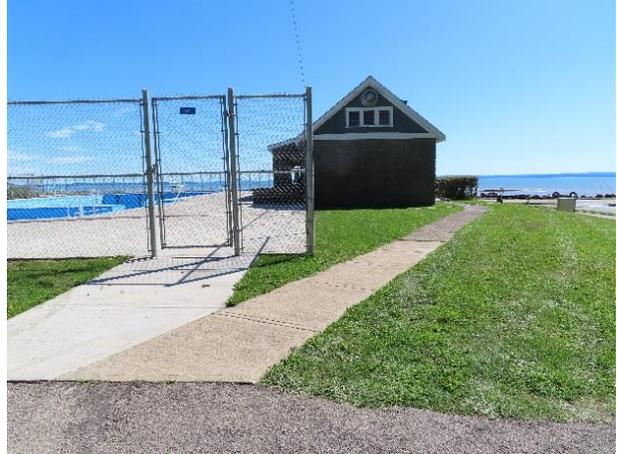
Figure 6: Existing Access Entrances

- Universal Accessibility improvements will include:
  - Power-assisted entrance door operators
  - Improved ramps and stairs to the main entrance (Figure 6)
  - Interior renovations to create sightline entrances to change rooms, and assistive care washroom/shower/family change facilities

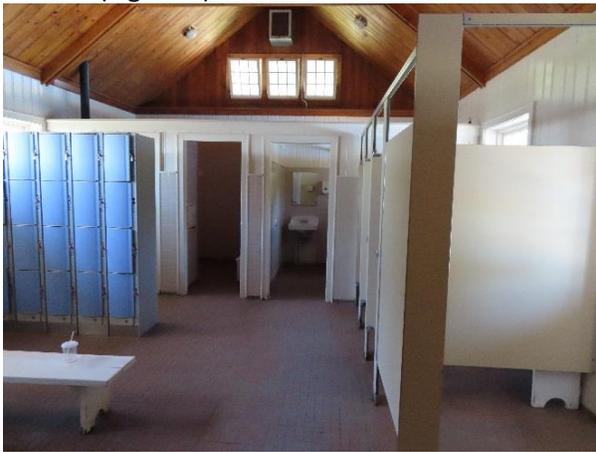
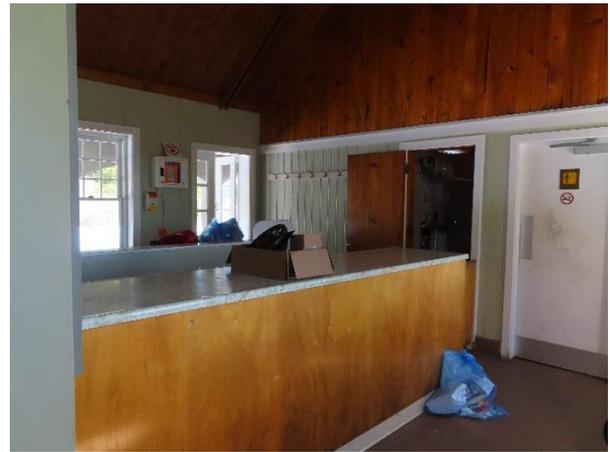
Figure 7: Interior Views of the Bathhouse

- A general refurbishing of the facility is required to bring it to a higher standard of accommodation (Figure 7)

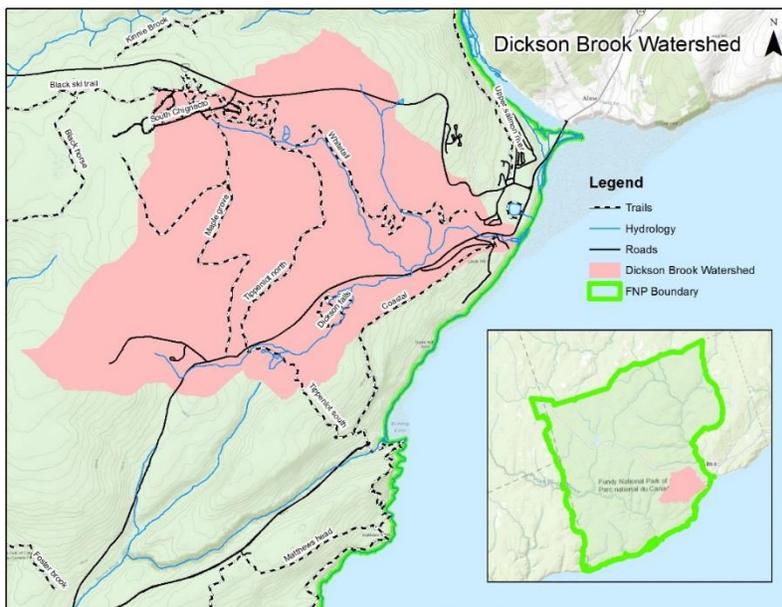
Figure 10: Dickson Brook Watershed

The Saltwater Pool and Bathhouse is located adjacent to the mouth of Dickson Brook, a watercourse located in the Dickson Brook watershed, one of the few watersheds located entirely within park boundaries (Figure 10). The Dickson Brook watershed has a total drainage area of approximately 8 square kilometers.

While this is not considered large, it is characterized by very steeply sloping topography with tributary streams that are up to 14 times steeper than the lower main stem (Newbury, 2004). Due to the steep terrain, streams and brooks are subject to fast flowing water especially during snow melt or heavy rain fall events when the area is prone to flash flooding. In such cases, evidence of scouring, erosion and movement of soil and vegetation have been apparent and such occurrences have the capability to change the formation and character of waterways.
