Designated Substance Report Washrooms 034, 044, 134, 212, 312, and 234 Renovations East Block, Parliament Hill Ottawa, Ontario

2019-12-16

**Environment, Health and Safety
Real Property Services
Public Services and Procurement Canada**

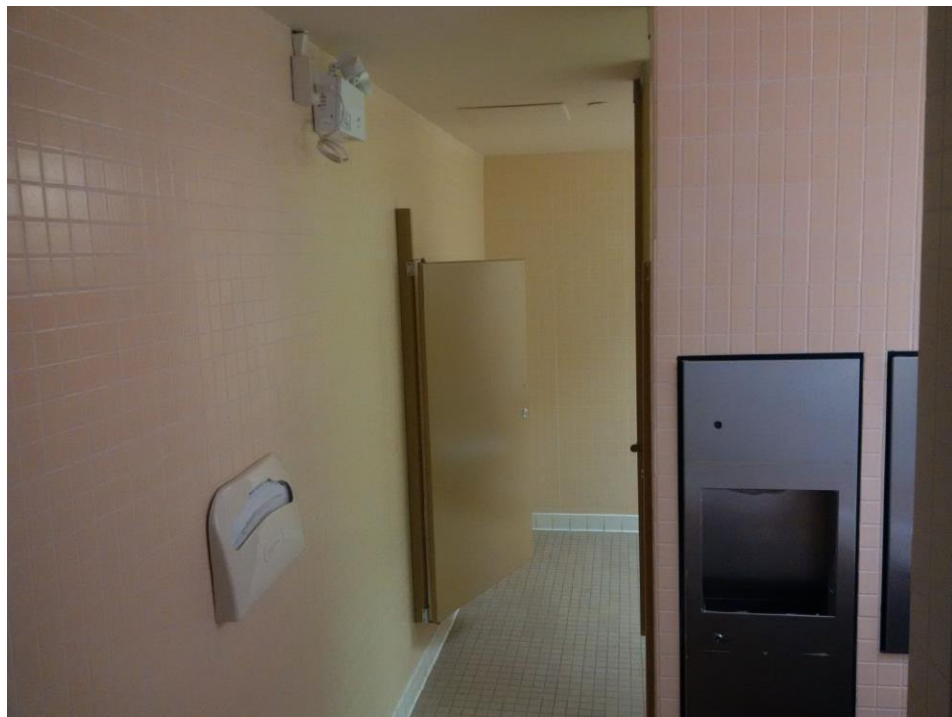
Photo 2: Women's washroom 044.

Old peeling paint was observed on the masonry walls behind drywall in room 044. This paint was inaccessible for sampling, and is assumed to be lead-containing.

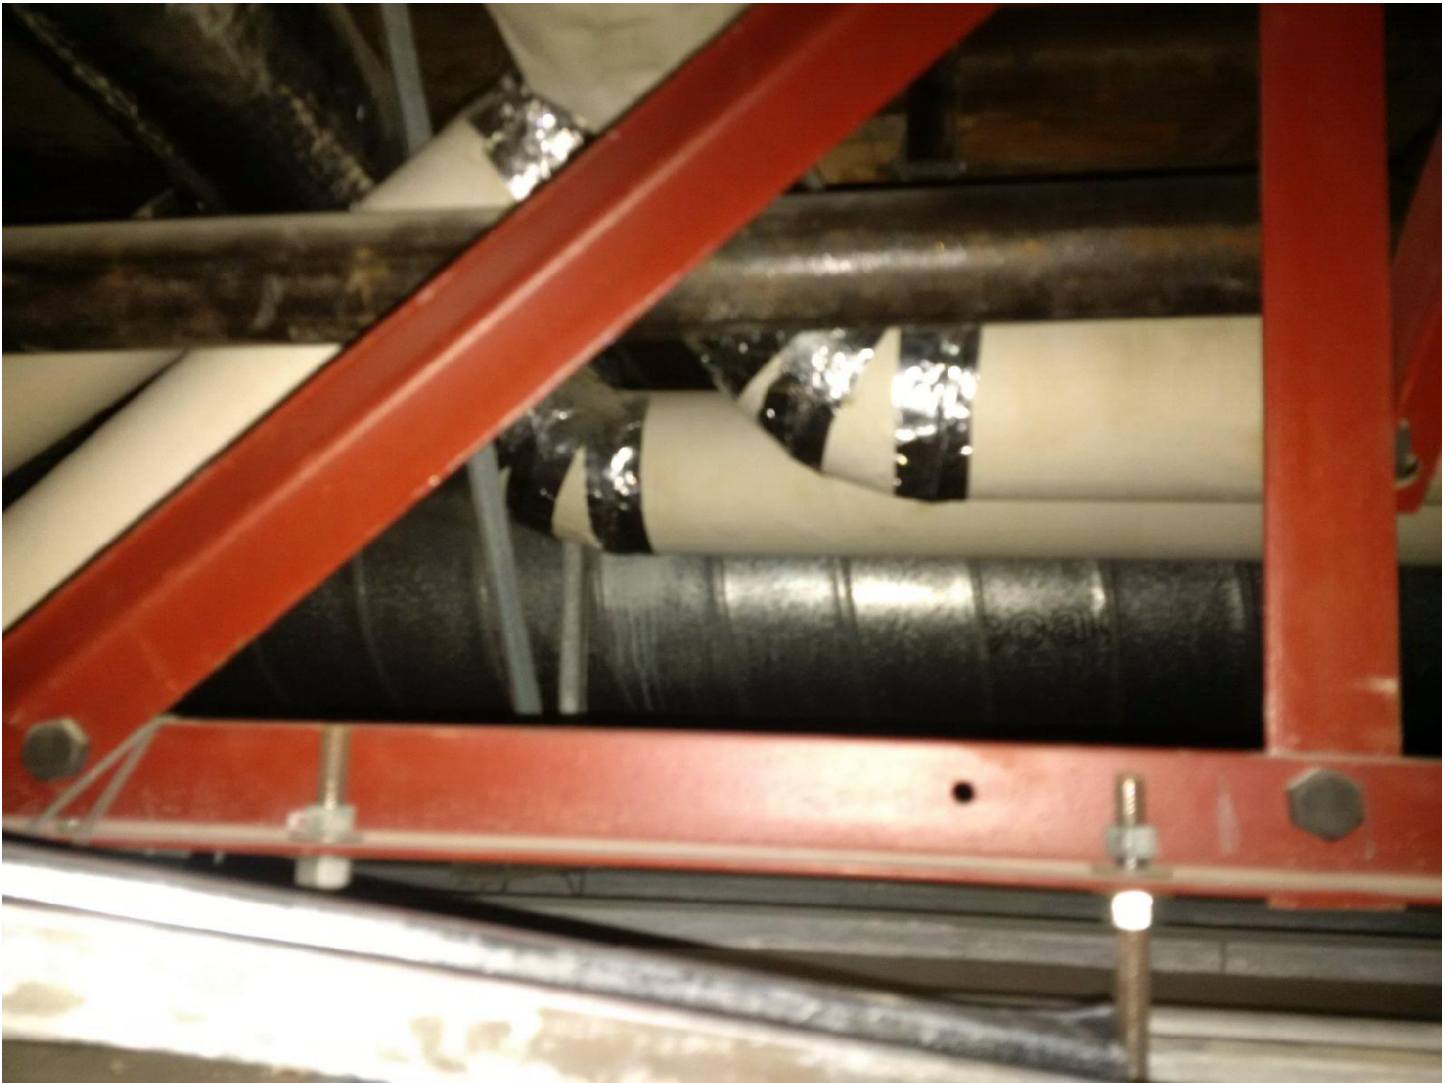
Access hatches were opened and inspected to determine if there were any concealed asbestos-containing materials present in the washrooms. All pipes observed were either bare or insulated with fibreglass (Photo 3).

Photo 3: Typical ceiling space above washroom 044, with pipes insulated with fibreglass and bare pipes and ducts.
