## ADDENDUM #3

PACIFIC REGION  
PORT HARDY LOGISTICS DEPOT  
PORT HARDY, B.C.  
Project No: 8H500

drawing **Canadian Coast Guard Proposed Jensen Cove Site Topographic Survey Over Lots 22 & 23, Plan VIP45348 Port Hardy, BC**

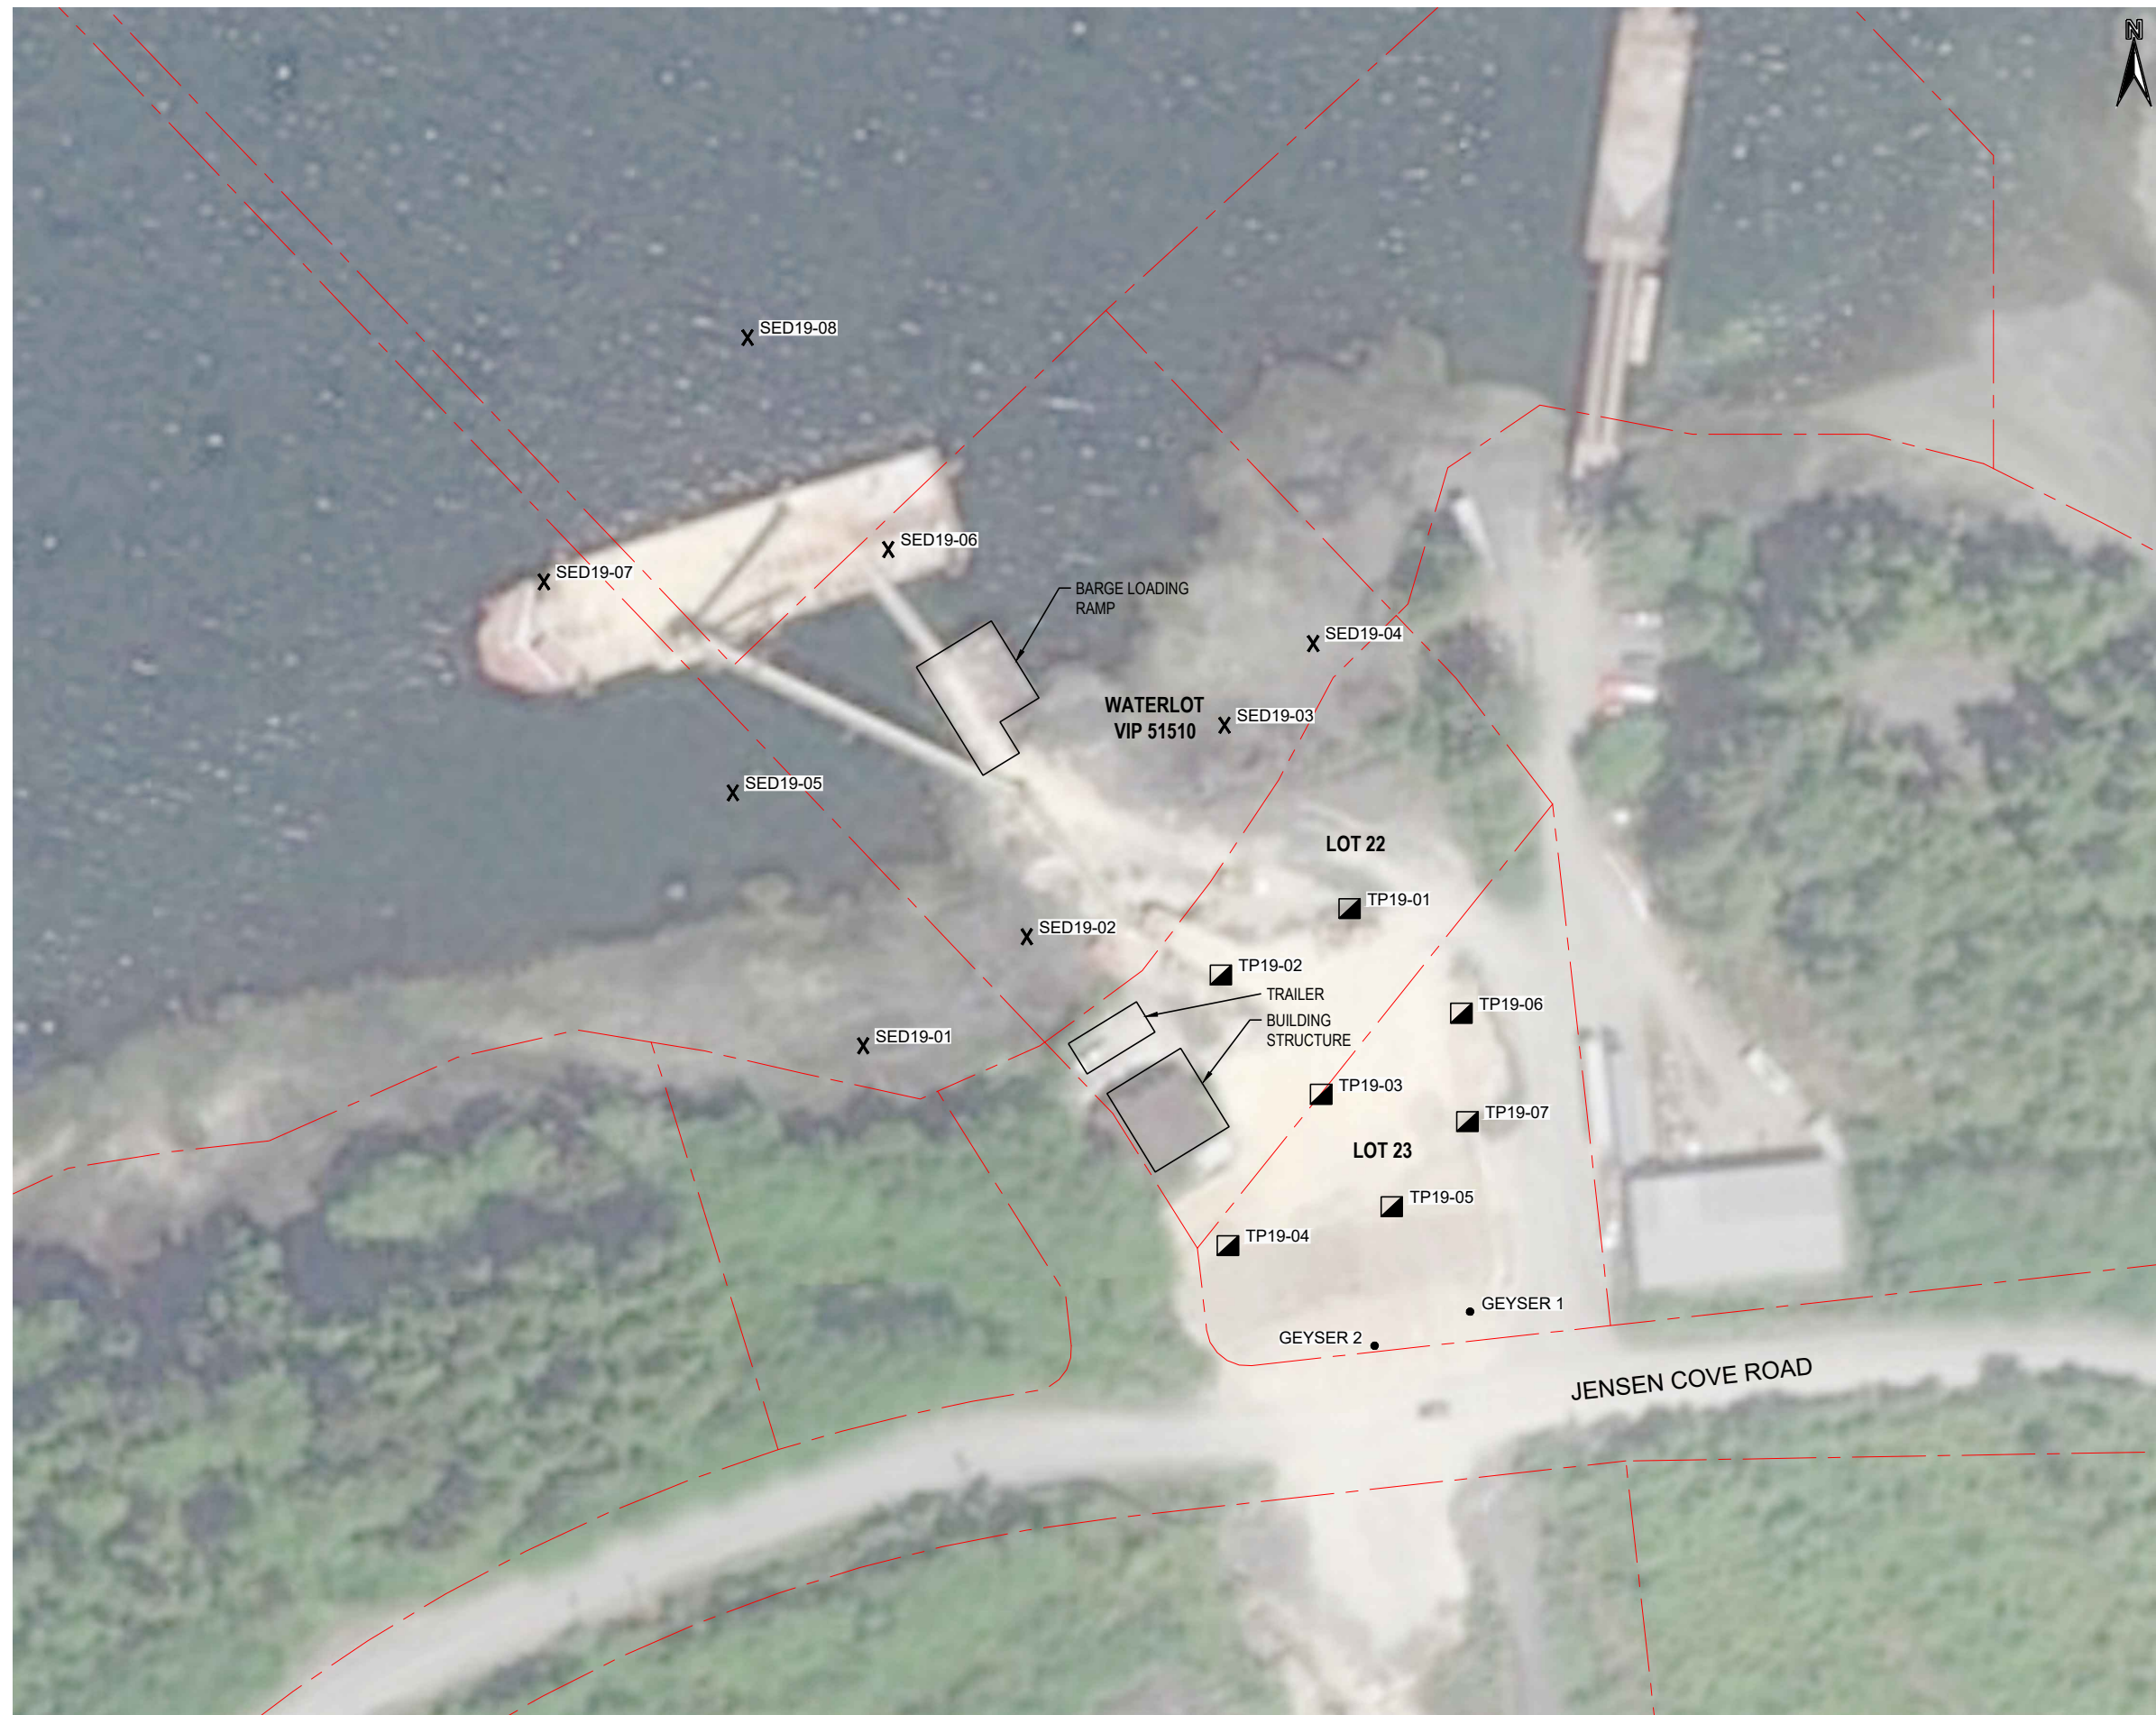
**FIGURE 3**

- PROPERTY BOUNDARY
- X** SEDIMENT SAMPLE
- TEST PIT
- STOCKPILE SAMPLE

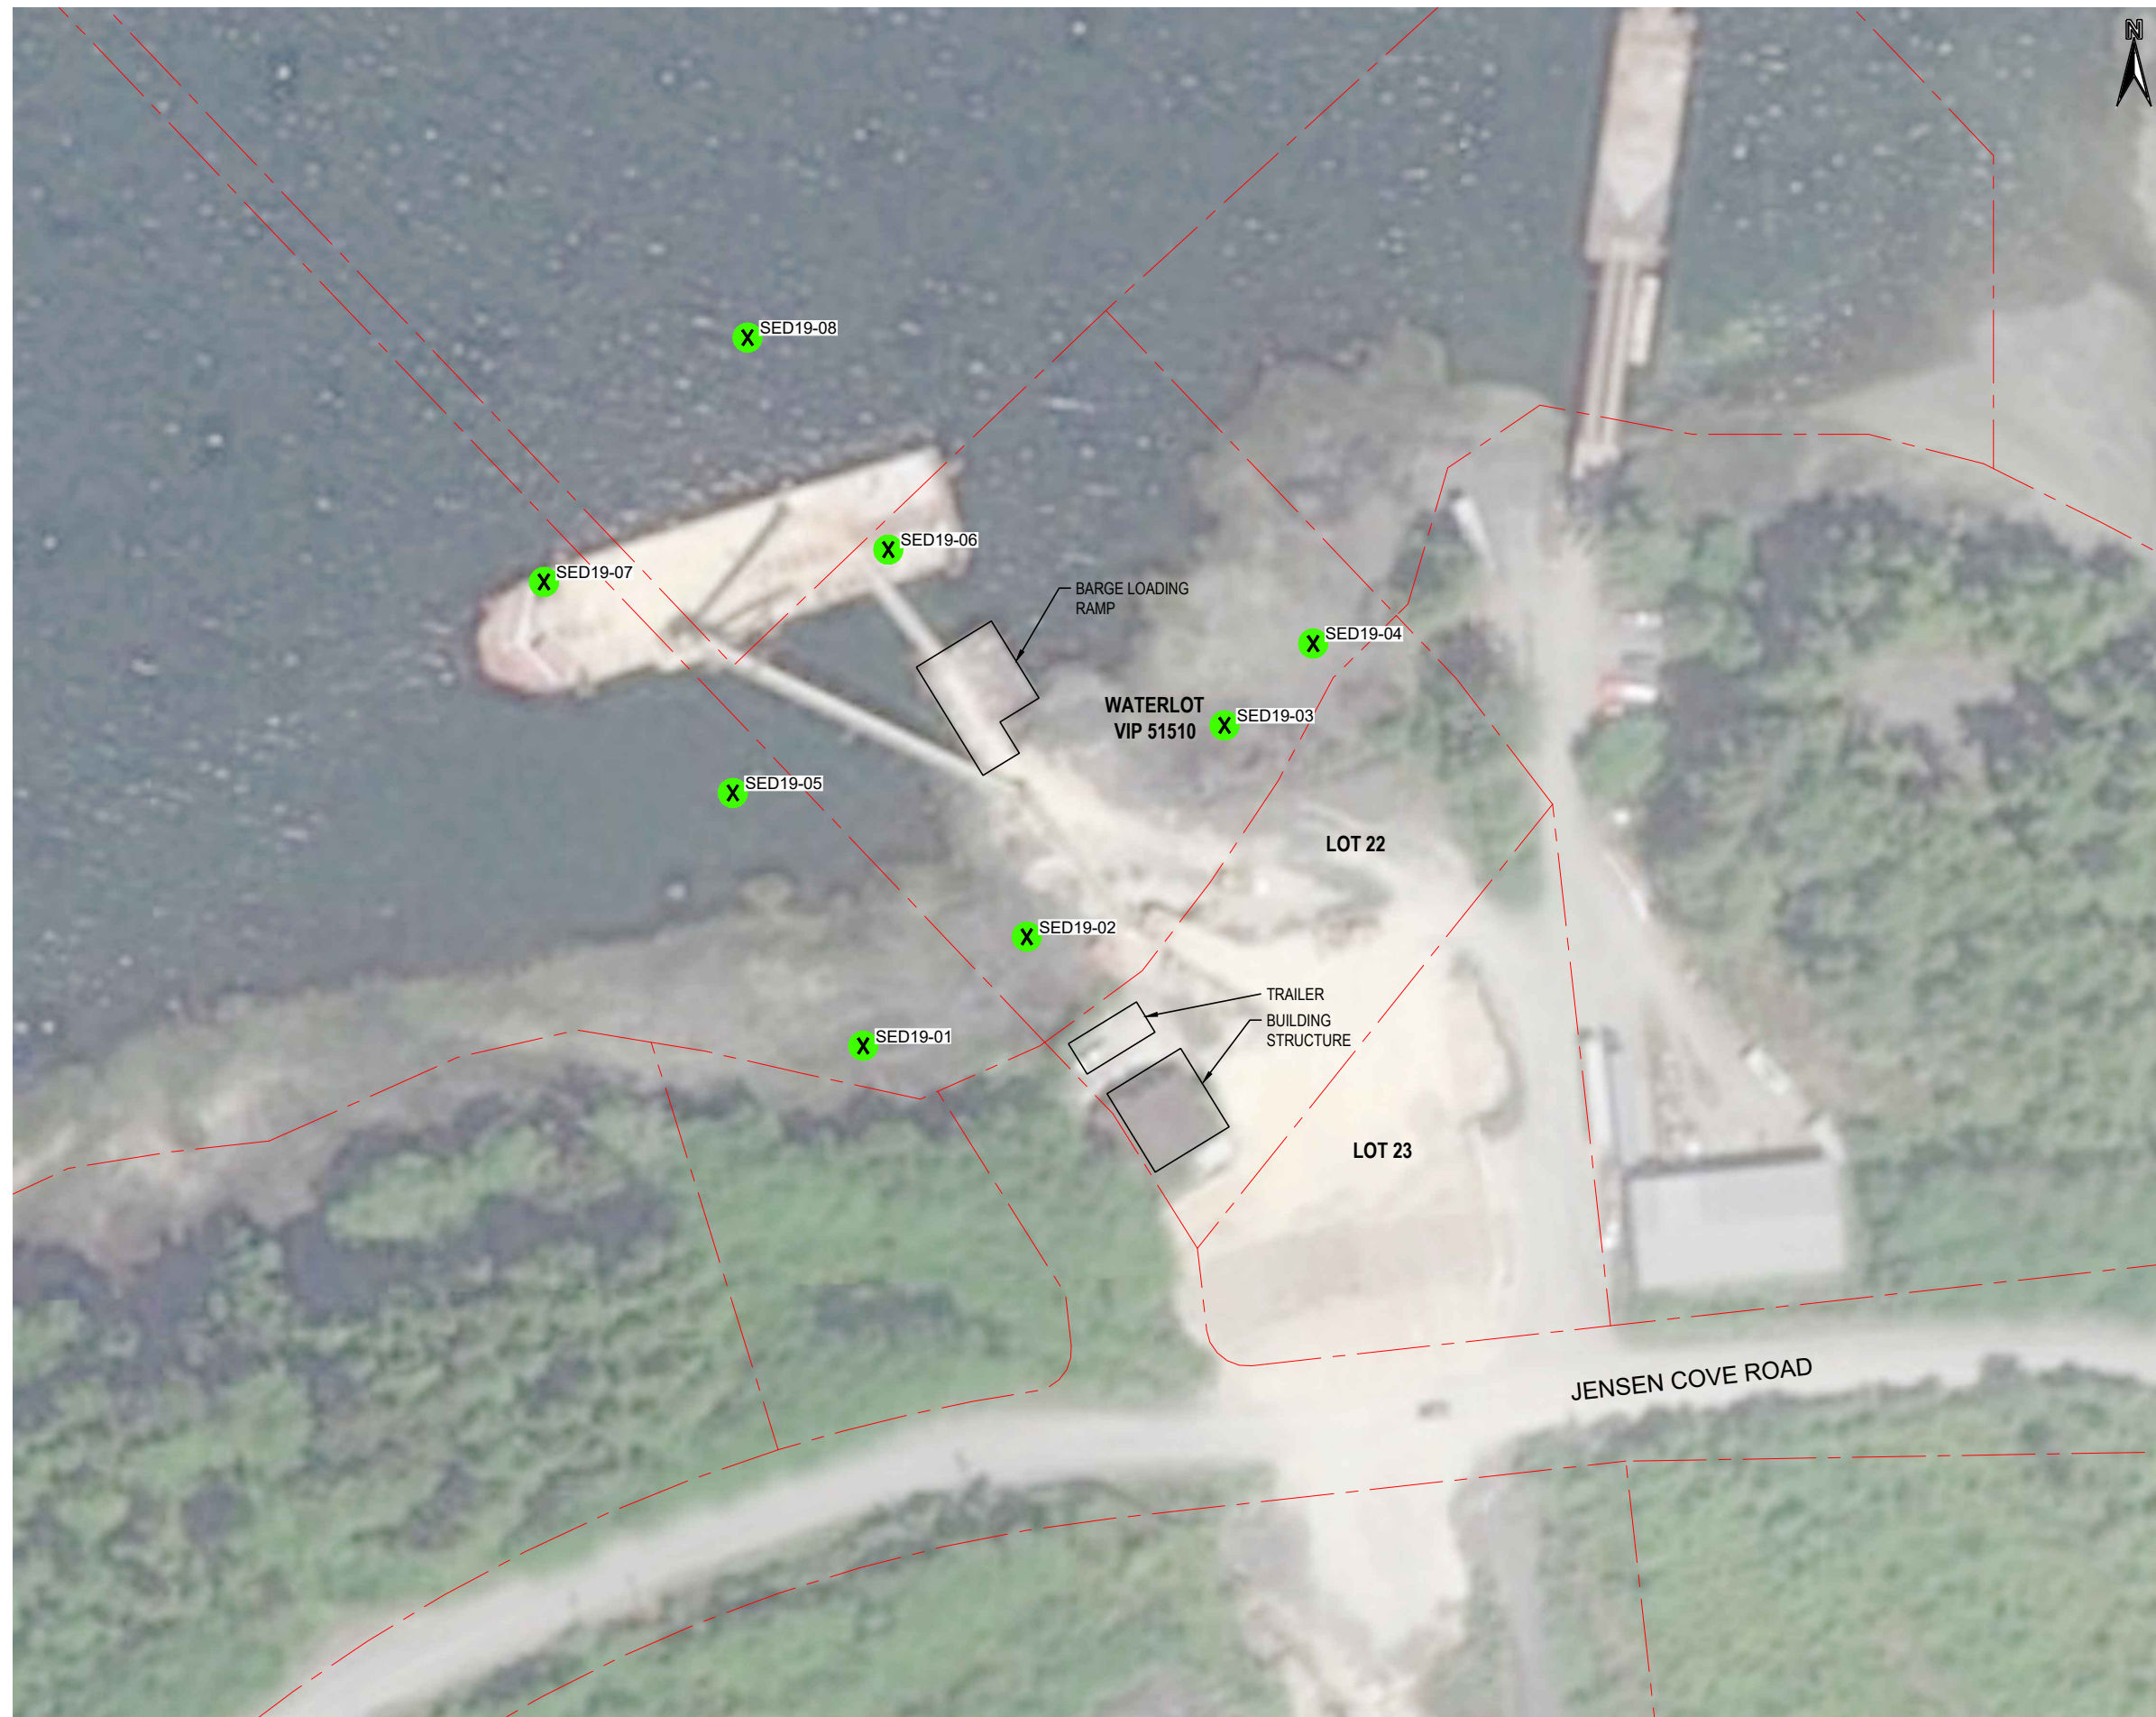
- PROPERTY BOUNDARY
- X** SEDIMENT SAMPLE
- LABORATORY ANALYSIS RESULTS**
- CONCENTRATIONS LESS THAN OR EQUAL TO APPLICABLE CSR SedMT
- CONCENTRATION(S) GREATER THAN APPLICABLE CSR SedMT

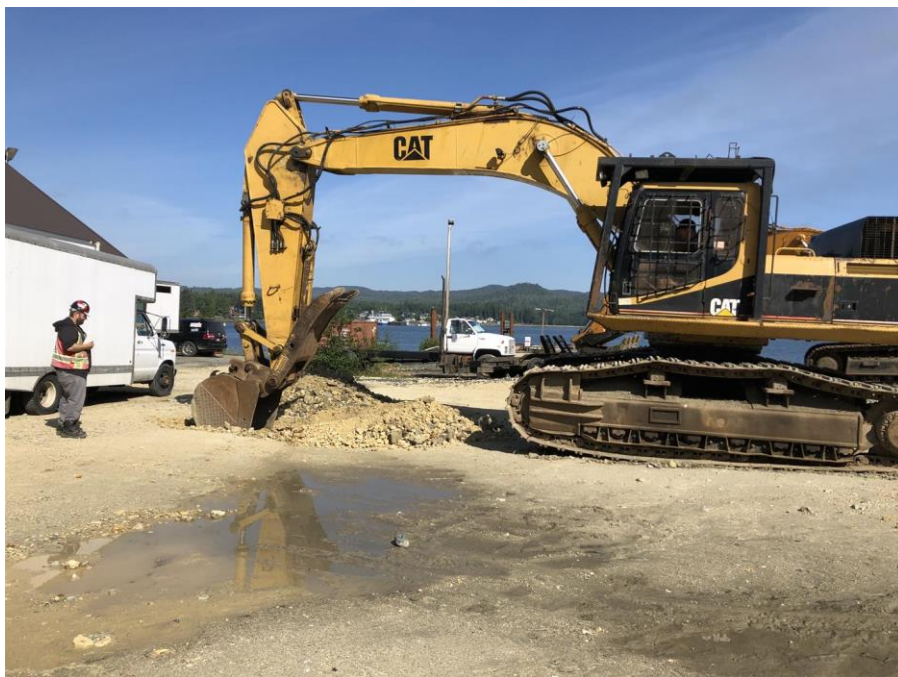
**Photo 6:** View of the advancement of test pit TP19-03.

Soil samples were classified according to soil unit, structure, colour, odour and staining, if present. A test pit log that includes sample depths and soil descriptions is presented in Appendix C.

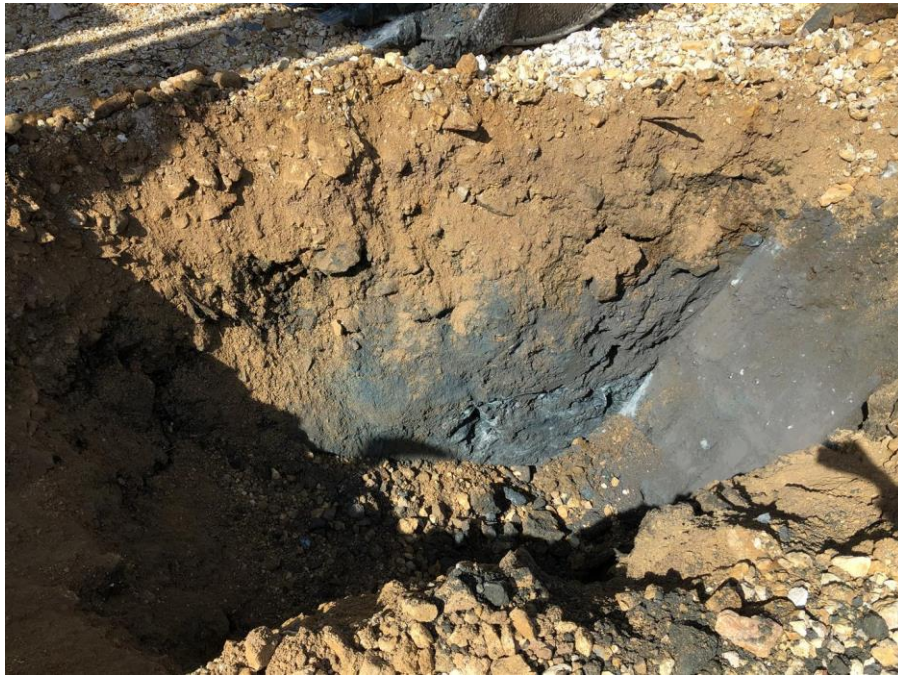
**Photo 7:** View of the weathered bedrock encountered at 1.7 mbg at test pit TP19-04.

The site is in an area with shallow bedrock and bedrock outcrops. Groundwater at the site is inferred to be found in a bedrock aquifer. Regional groundwater is inferred to follow the local topography and flow from the south of the site toward the south and into the Pacific Ocean at Hardy Bay.

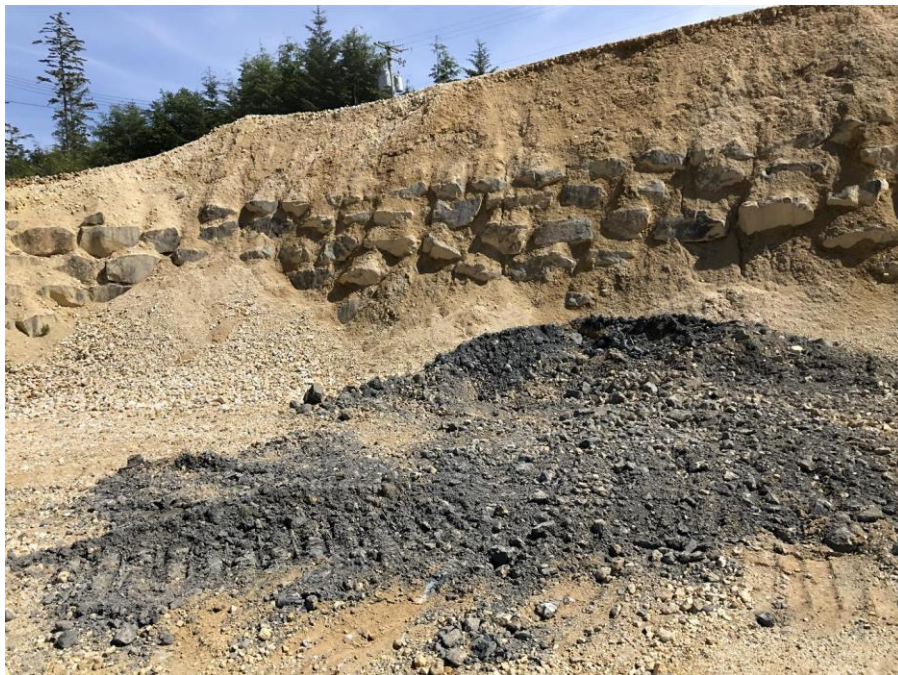
**Photo 8:** View of the geyserite stockpile that was sampled during the field program.

The stockpile samples were classified according to soil unit, structure, colour, odour and staining, if present. The stockpile sample descriptions are presented in Appendix C. Lewkowich collected GPS coordinates of each stockpile sample.

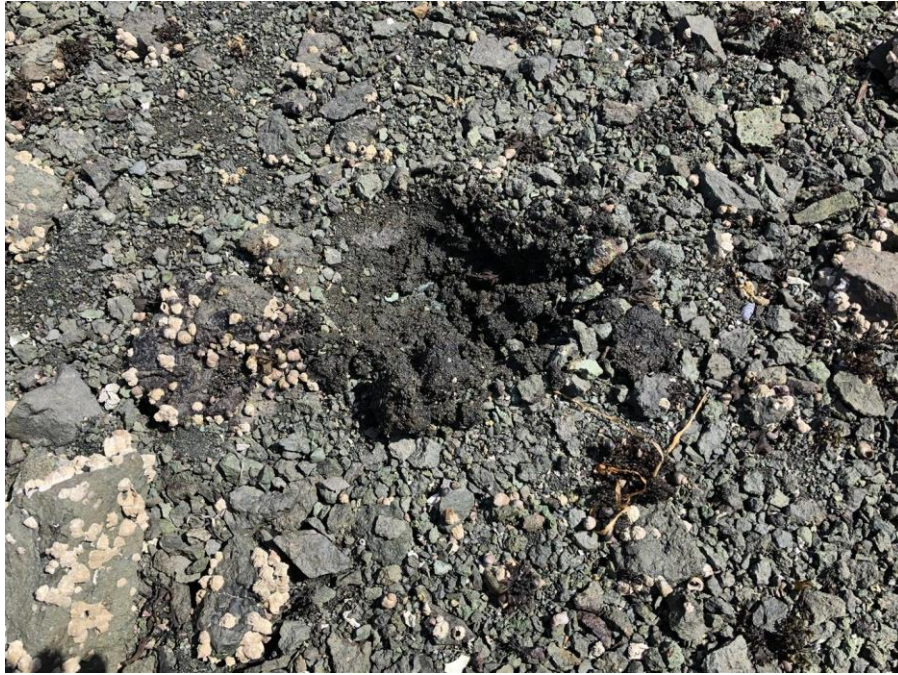
**Photo 9:** View of the intertidal sediment grab sample SED19-01.

SLR staff accompanied by DFO collected four hand-dug intertidal sediment grab samples at four location in the intertidal zone at the site. The subtidal locations were selected based on a grid and using visual reference points. At each location, SLR and DFO identified a location with suitable substrate for the collection of a sediment sample (i.e., an area of softer sediment and not bedrock or boulders). The sediment was collected using a decontaminated stainless-steel trowel and placed in a Ziploc® bag for transport back to the upland portion of the site. The sediment samples were placed in laboratory supplied jars. The HSVL for each sample was recorded from the Ziploc® bag prior to filling the sample jars.
