**Talbot River Dam, Lock 39 and Talbot Canal
2013 Geotechnical Site Investigation
Report**
FINAL

KGS Group 12-0006-028
August 2014

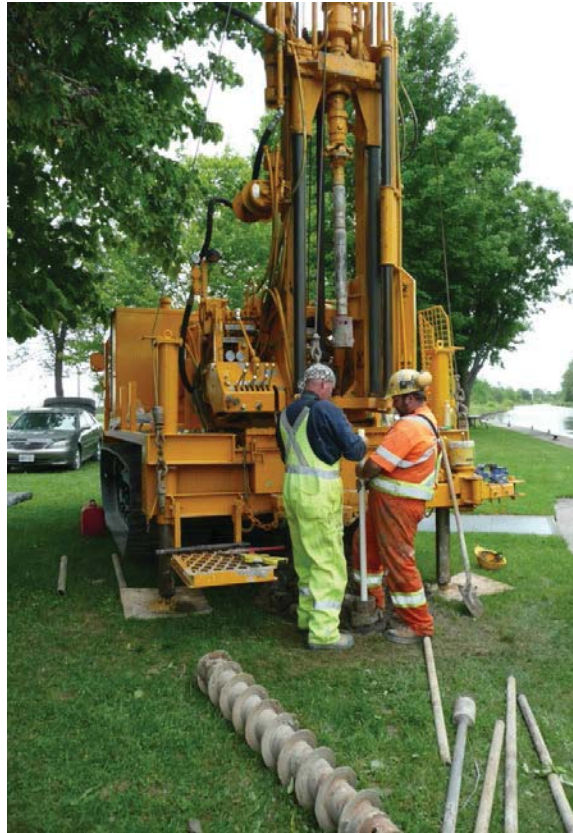
PHOTO 1
CME 75 DRILL RIG AT TH13-202

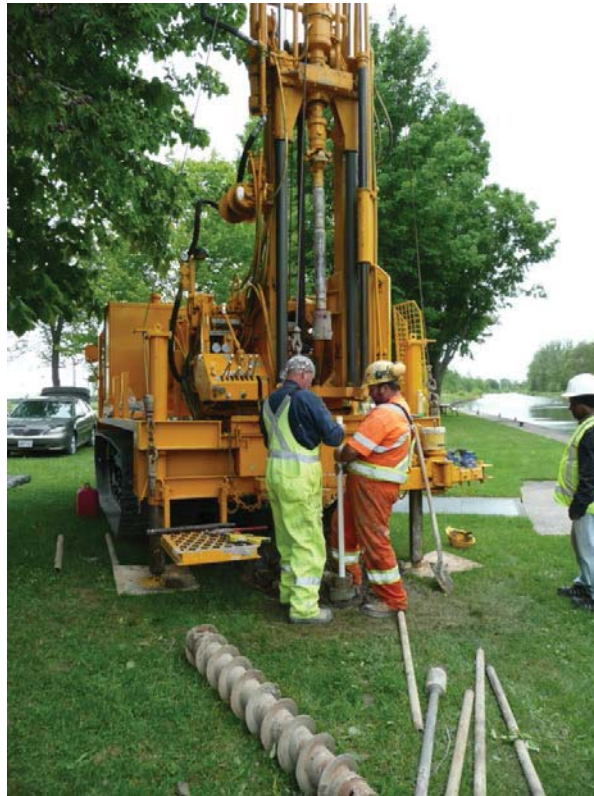
PHOTO 3
INSTALLATION OF STANDPIPE PIEZOMETER AT TH13-202

As described in Section 2.0, three (3) standpipes (in TH13-101, -202 and -304) and two (2) VW piezometers (in TH13-101 and -202) were installed to monitor the groundwater conditions within the embankments and their foundations. Installation details, including the tip elevations of the piezometers, are shown on the summary test hole logs in Appendix A.

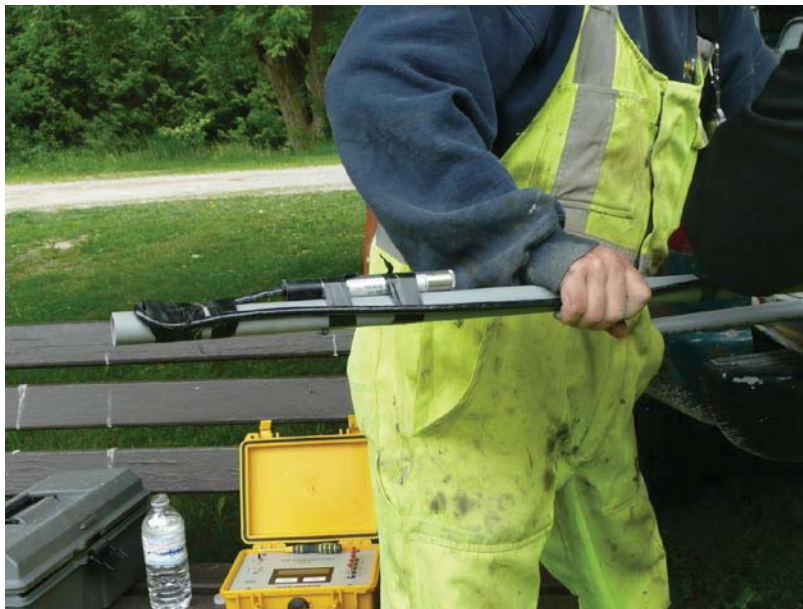
PHOTO 4
DT 2011 VIBRATING WIRE PIEZOMETER INSTALLED AT TH13-202

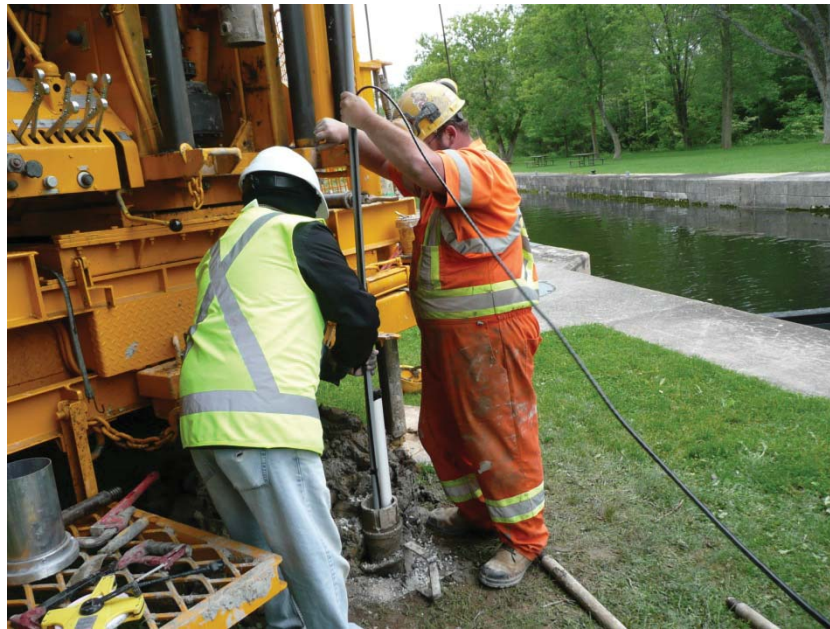
PHOTO 5

INSTALLATION OF VIBRATING WIRE PIEZOMETER AT TH13-202

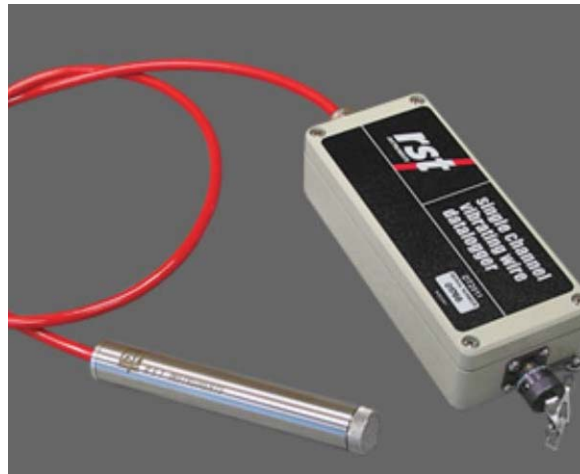
A Single Channel Data Logger Model DT2011 (Figure 2.3-1), manufactured by RST instruments, was installed on each of the piezometers in TH13-202 and TH13-105 in the earthfill embankments. The vibrating wire piezometer and battery powered data logger are economic and designed for reliable, unattended and continuous monitoring of a single vibrating wire sensor. The logger is encased in a water resistant IP 66 enclosure and connects directly to the vibrating wire piezometer via an IP68 rated sealed entry. The DT2011 loggers run on two (2) “AA” alkaline batteries and have an internal memory of 128KB that can store over 30,000 data sets of frequency and temperature. The operating temperature of the recorder is between -40°C to 60°C . Periodic battery changing and downloading of the data is typically performed two times per year.

FIGURE 2.3-1
DT2011 DATA LOGGER WITH VIBRATING WIRE PIEZOMETER

The DT2011 loggers are controlled and programmed with the Windows-based LogViewer® Software. Prior to installation, the DT2011 logger was programmed and verified in the field to ensure it was functioning properly. The vibrating wire piezometer was read with a standard readout box and readings were compared to DT2011 values for verification.

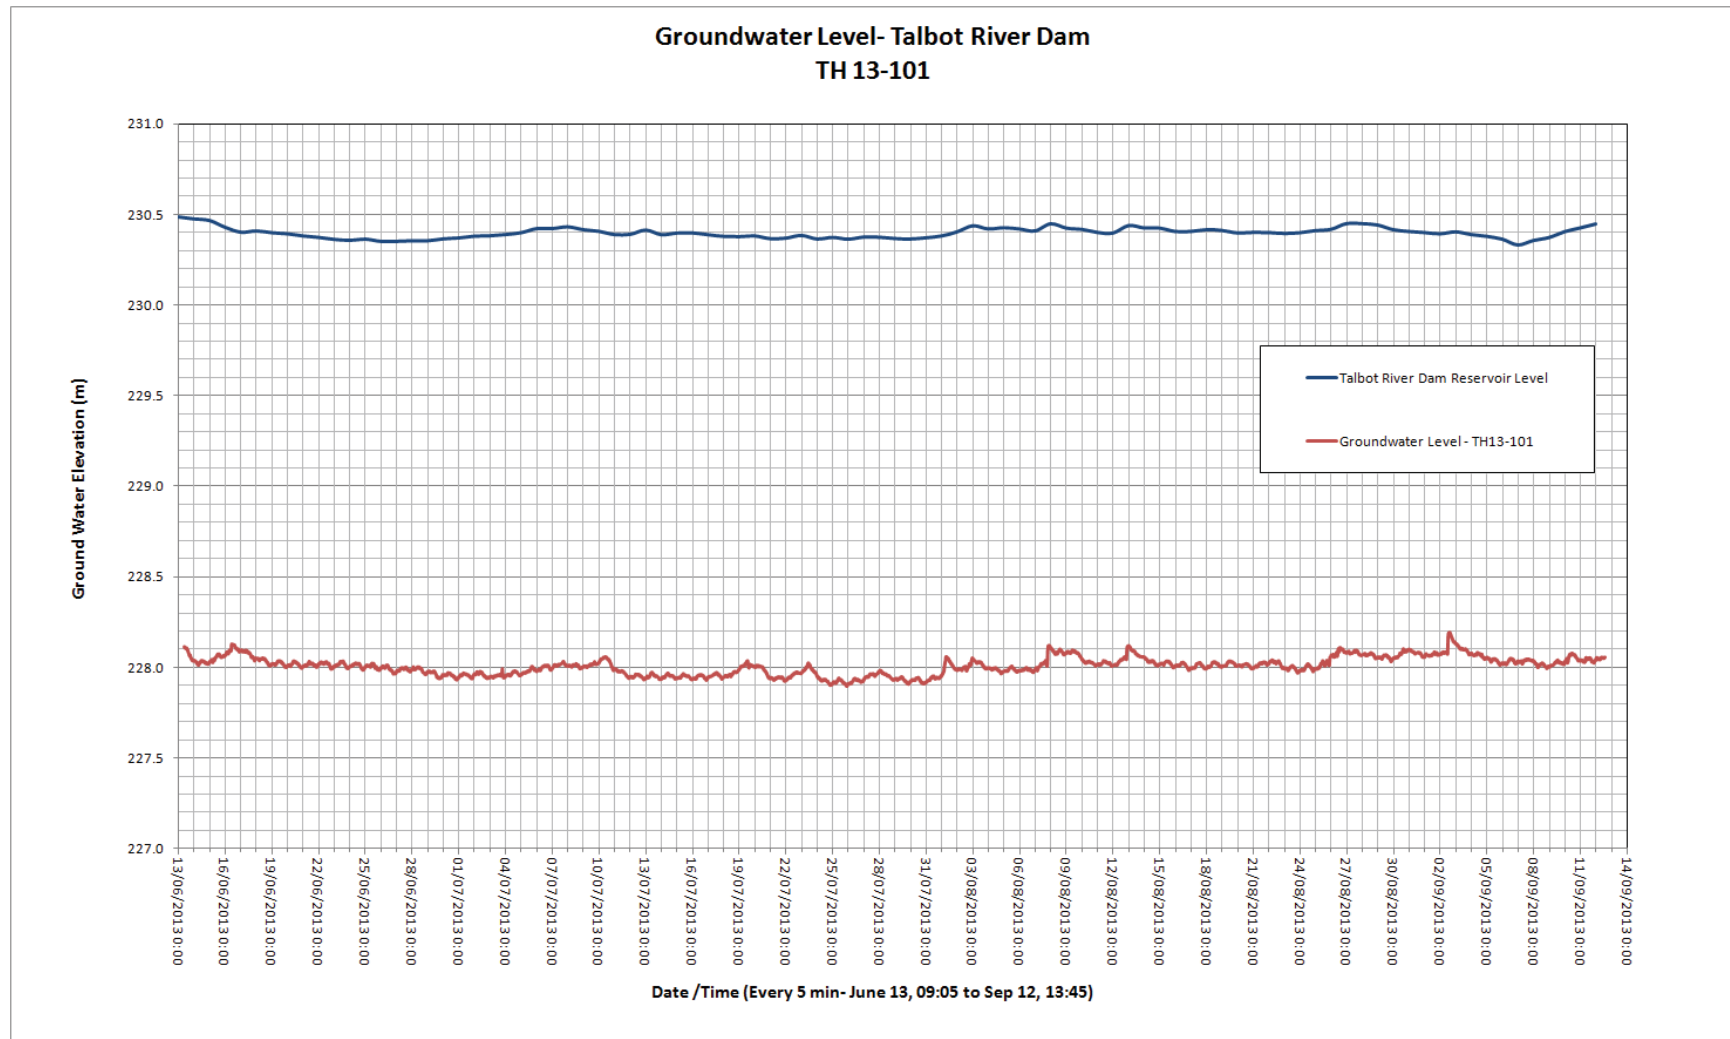
FIGURE 3.4A
 GROUNDWATER LEVEL MEASUREMENTS - NORTH EMBANKMENT OF TALBOT RIVER DAM

From June 6, 2013 to September 12, 2013 the vibrating wire piezometers were set up to collect data every 5 minutes in order to monitor groundwater levels within the embankment fills or foundation soils and to observe groundwater fluctuations during operation of the lock. The monitoring data from the installed VW piezometers are summarized in Figures 3.4a and 3.4b together with the upstream reservoir levels and Talbot Canal levels from PCA. The typical lock operation consists of lowering and refilling of approximately 6.0 m over an approximate 20 to 30 minute period. The review of piezometer data revealed that the groundwater levels during the lock operations have shown only approximately 25 to 50 mm groundwater fluctuation, indicating that there is a very slight to no impact on the piezometric levels within the embankment during the lock operation. As shown in Figures 3.4a and 3.4b, the piezometric levels measured in the Right Earthfill Embankment of Talbot River Dam varied between El. 227.9 m to El. 228.2 m during the monitoring period and between El. 227.8 m to El. 228.4 m at the north embankment of Lock 39.

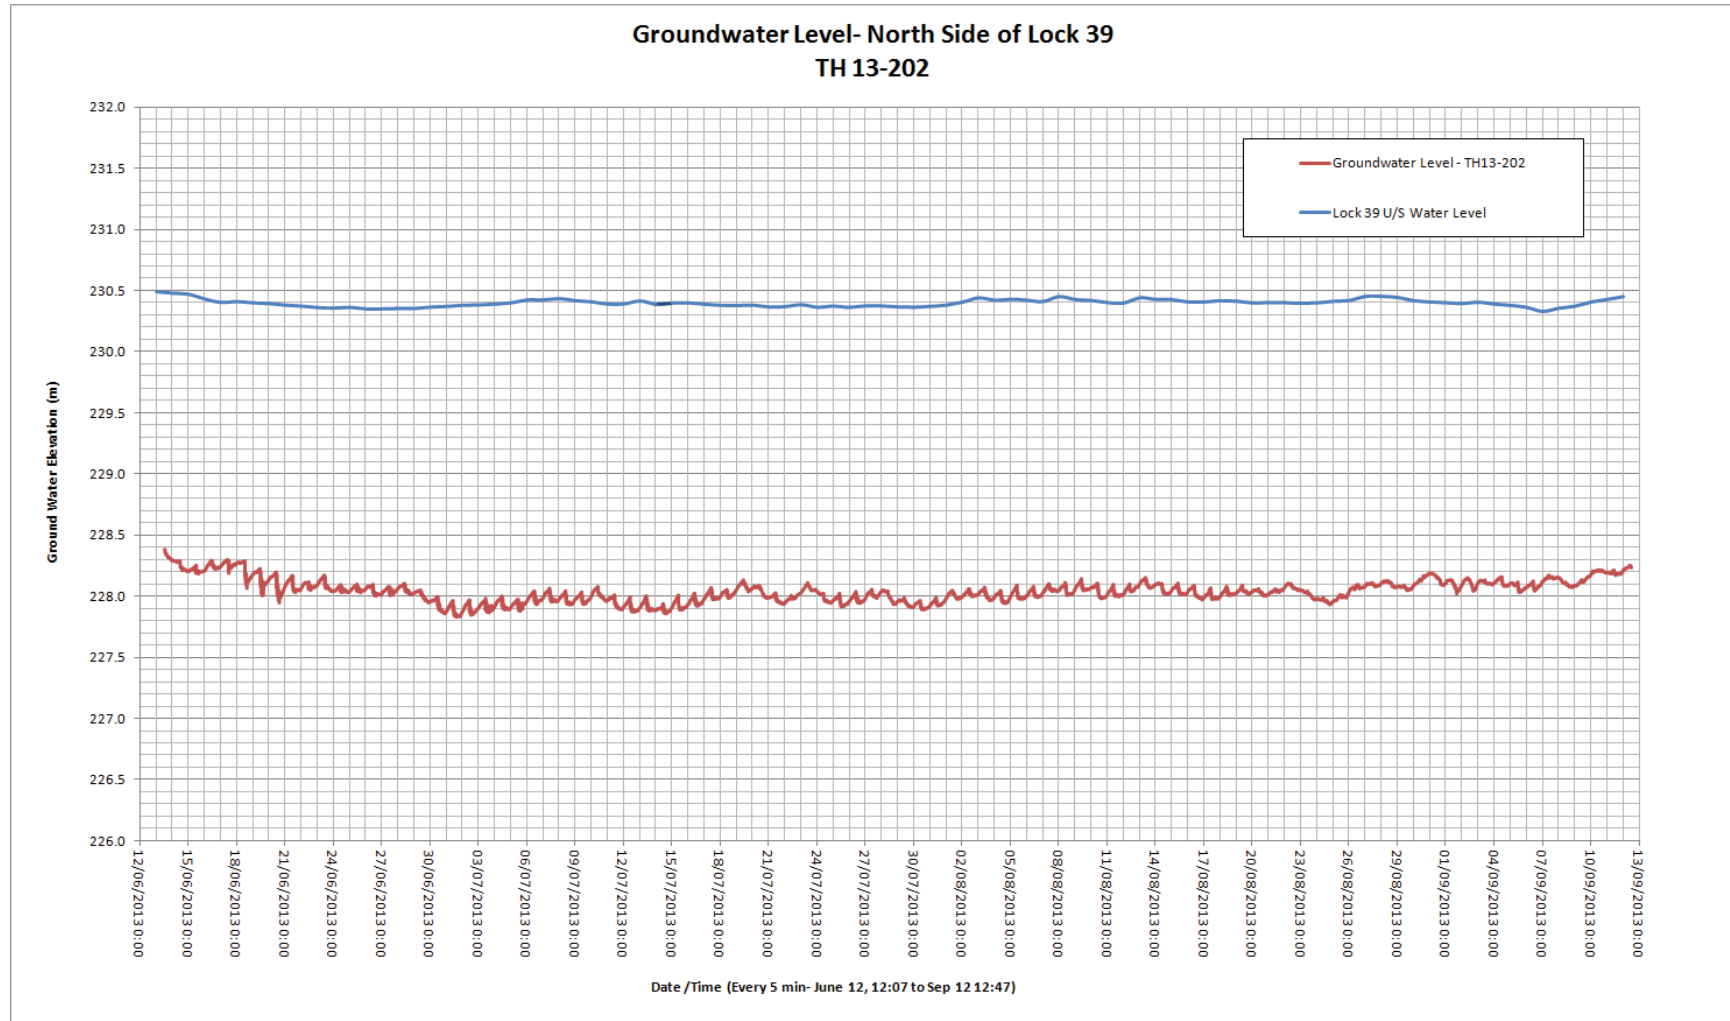
FIGURE 3.4B
GROUNDWATER LEVEL MEASUREMENTS - NORTH EMBANKMENT OF LOCK 39

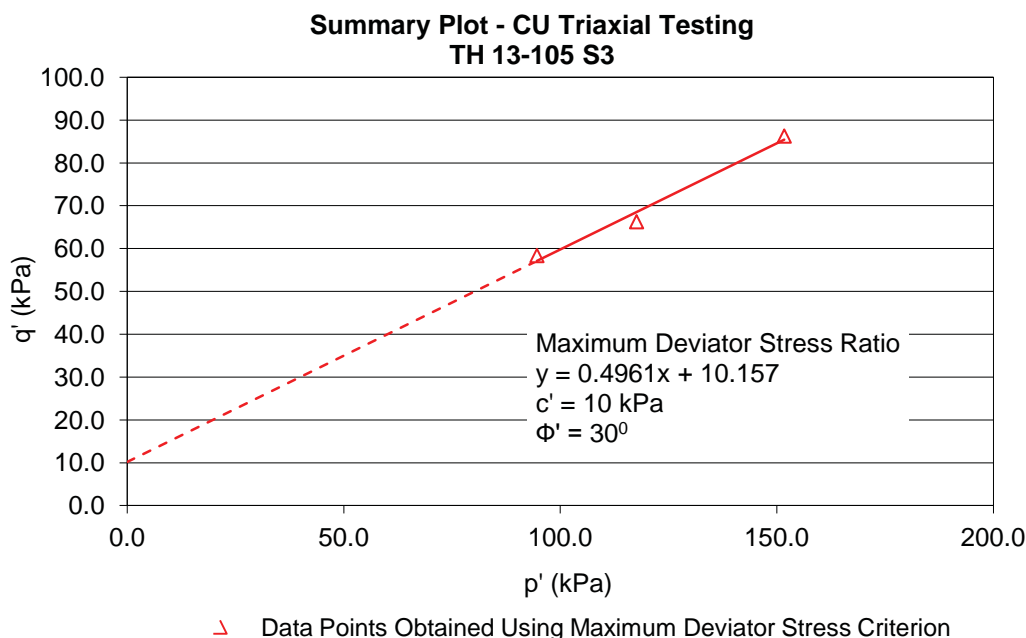
Effective Cohesion of clayey silt to silty clay fill $c' = 10$ kPa.

FIGURE 3.5-1
PLOT OF P-Q USING MAXIMUM DEVIATOR STRESS CRITERION

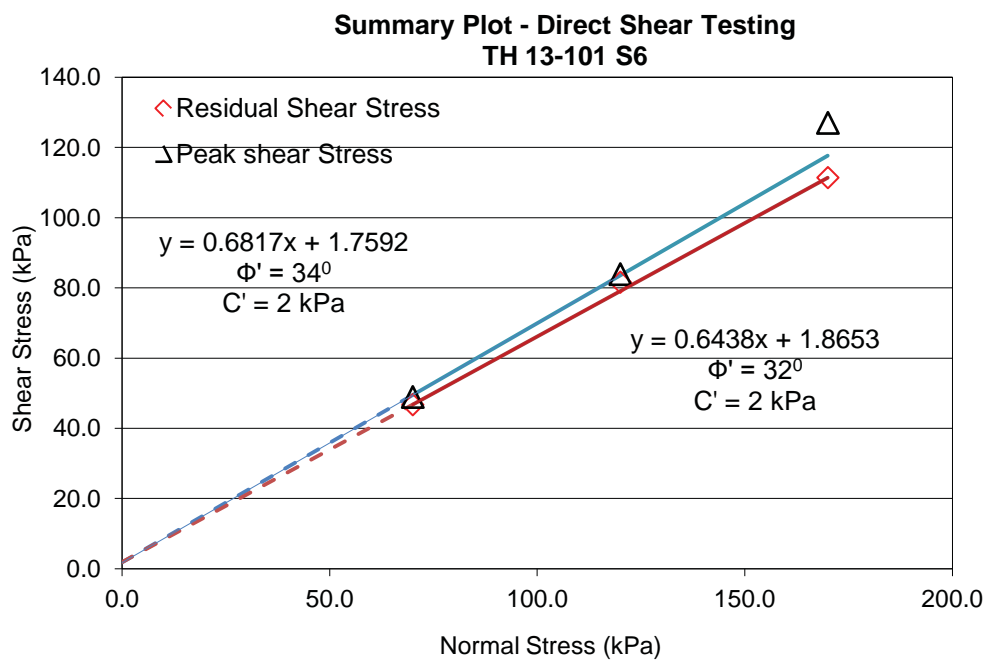
Effective Peak cohesion of sandy silt to silty sand $c' = 2 \text{ kPa}$.

FIGURE 3.5-2
PLOT OF SHEAR STRESS VS NORMAL STRESS

Direct shear tests were undertaken to estimate the effective shear strength parameters of relatively cohesionless soil. Three (3) Consolidated Drained Direct Shear Tests were performed (DST) on the disturbed split spoon sample of sandy silt to silty sand fill at the normal stresses of 70 kPa, 120 kPa and 170 kPa, representative of the in-situ normal stress state at the embankments. The sample was obtained from TH13-101 S6 at depths from 3.05 m to 3.66 m below grade. The direct shear test sample was prepared at the wet density of 19.5 kN/m^3 with 15% moisture content. Note that the sample was reconstituted to a density considered reasonably representative of the existing state to provide an approximation of the in-situ conditions. However, some variability can be expected and should be considered within the DSR analysis.

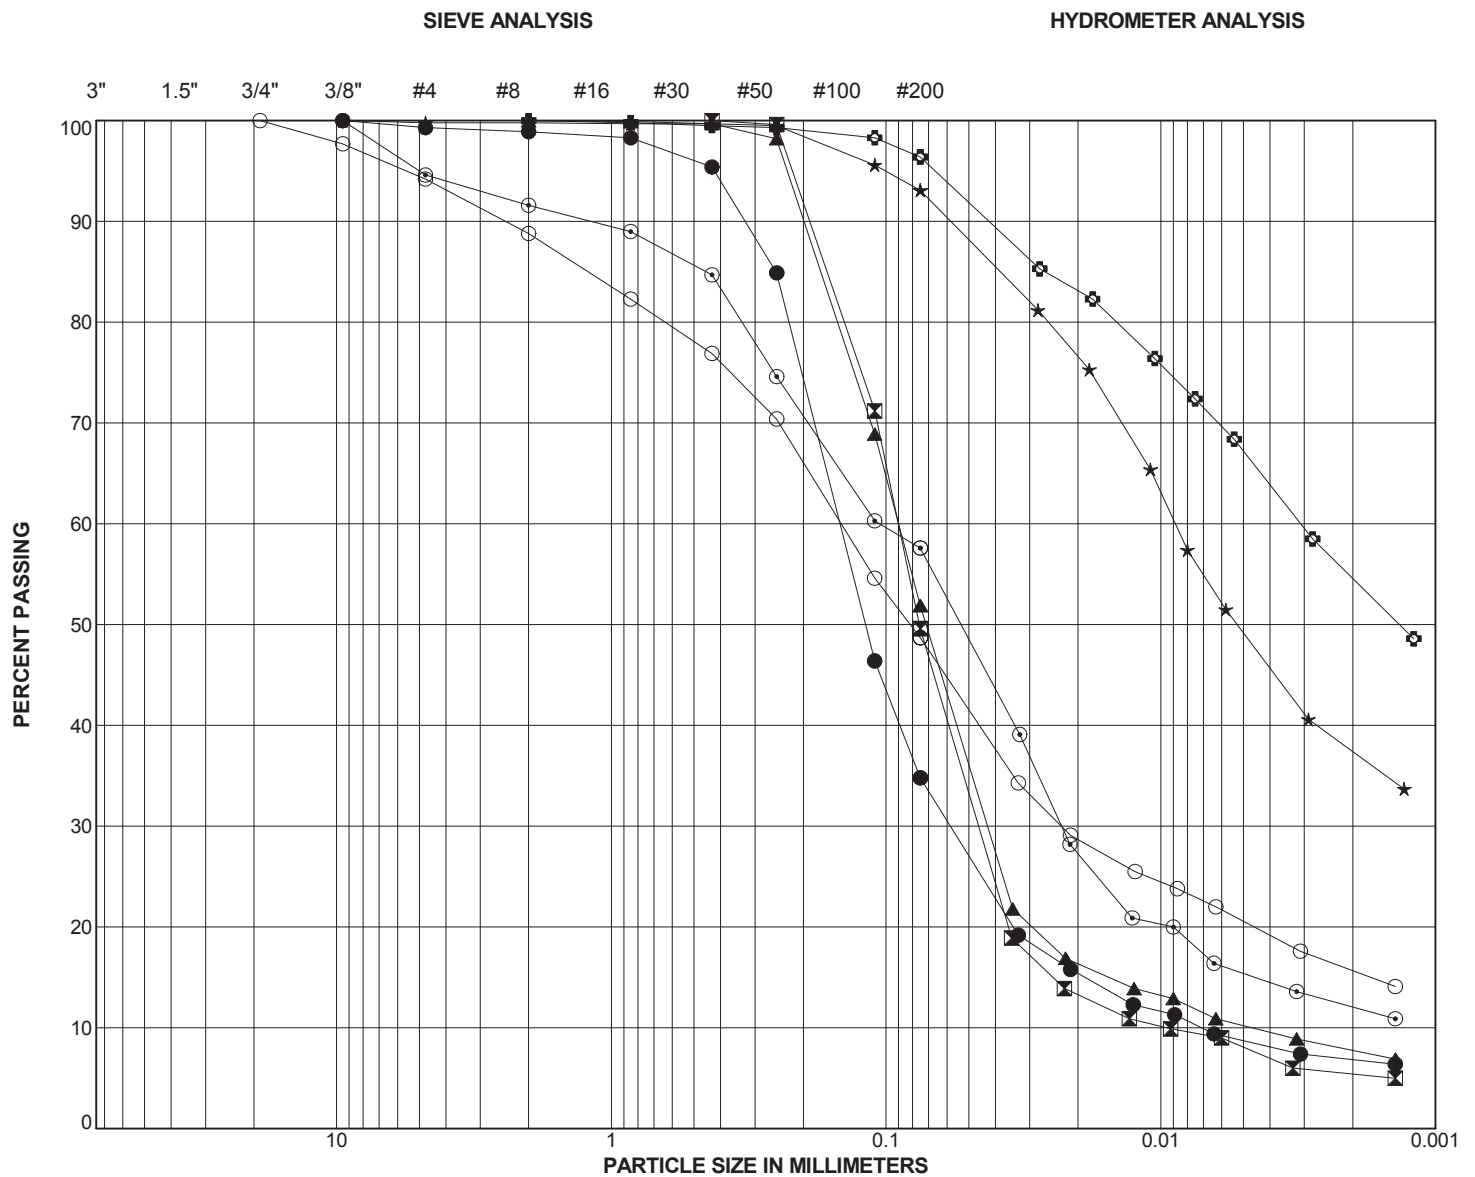
SYMBOL	HOLE	DEPTH (m)	SAMPLE #	% GRAVEL	% SAND	% SILT	% CLAY	% SILT & CLAY	Cu	Cc	CLASSIFICATION
●	TH 13-101	2.4	S5	0.7	64.5	28.0	6.8	34.8	20.7	3.3	
▲	TH 13-101	4.3	S8	0.0	50.4	44.2	5.4	49.6	9.5	2.5	
▲	TH 13-102	0.6	S2	0.0	48.1	44.1	7.8	51.9	19.4	4.4	
★	TH 13-102	3.7	S7	0.2	6.7	55.7	37.4	93.1			CI
⊗	TH 13-103	5.5	S10	5.4	37.0	45.5	12.1	57.6			
⊗	TH13-105	3.8	S4	0.0	3.6	41.8	54.6	96.4			CI
○	TH13-105	6.1	S7	5.8	45.5	33.0	15.7	48.7

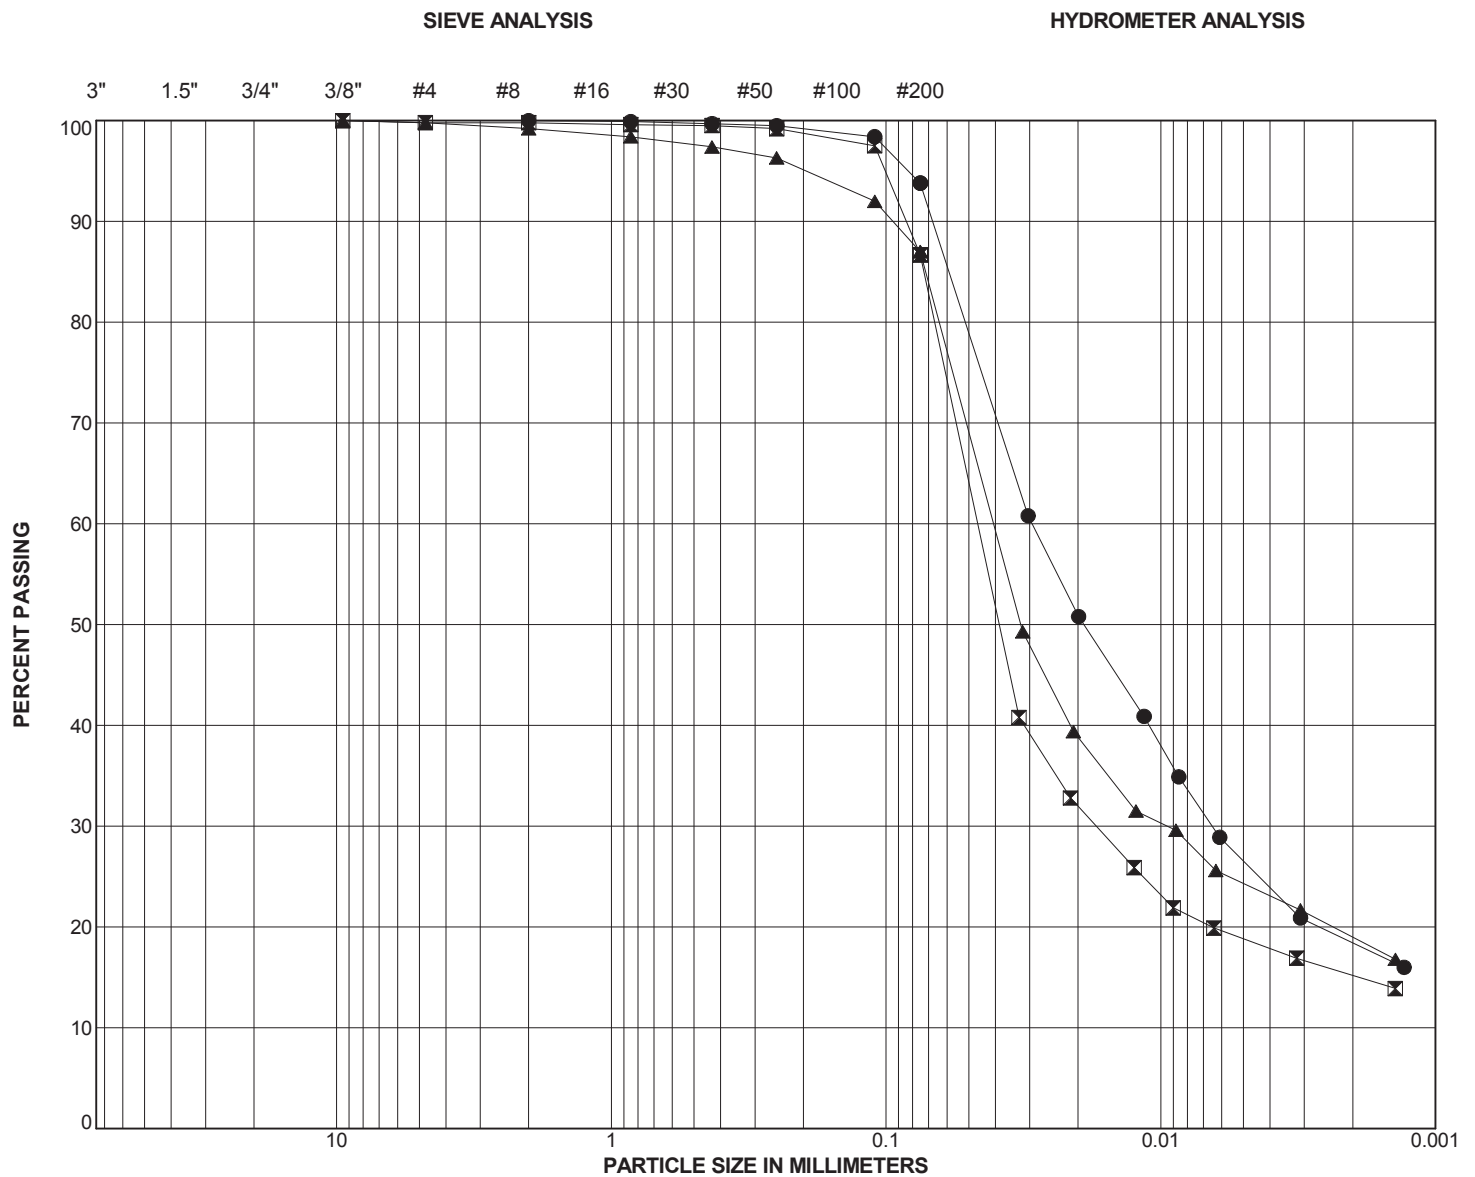
Figure 02

SYMBOL	HOLE	DEPTH (m)	SAMPLE #	% GRAVEL	% SAND	% SILT	% CLAY	% SILT & CLAY	Cu	Cc	CLASSIFICATION
●	TH13-201	6.1	S5	0.0	6.2	75.4	18.4	93.8			CL
⊠	TH13-202	4.6	S4	0.2	13.1	71.5	15.2	86.7			
▲	TH13-202	10.7	S8	0.2	12.8	68.0	19.0	87.0

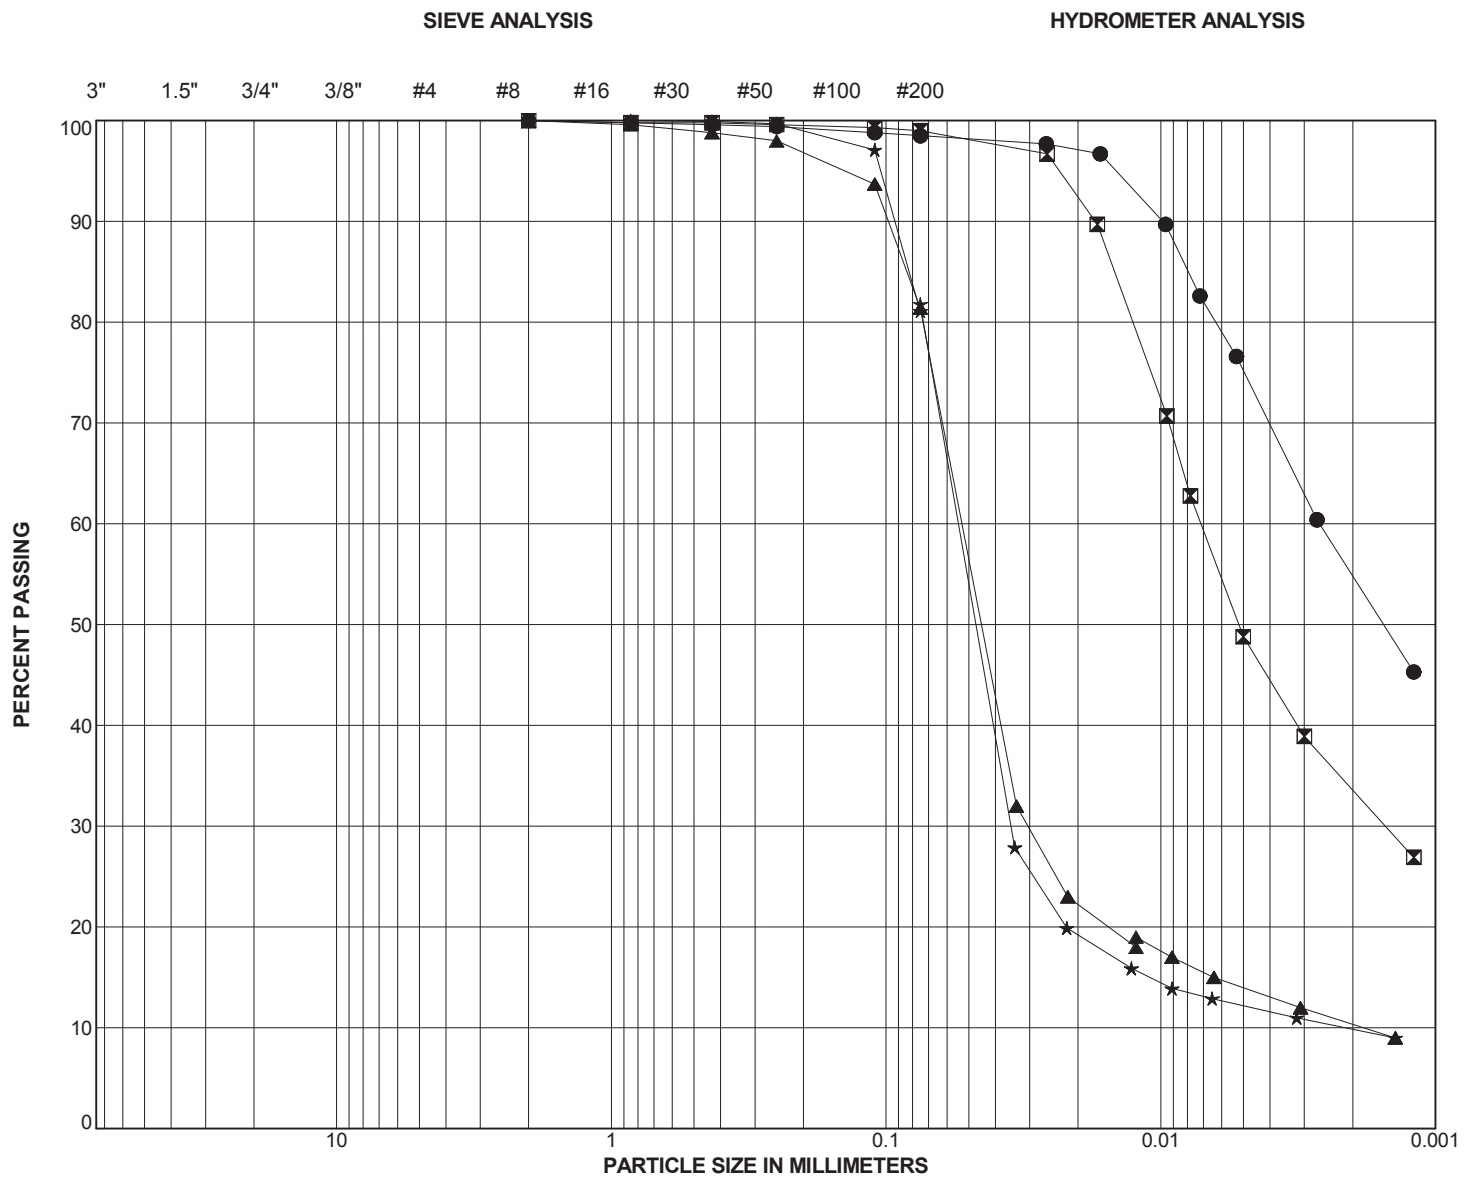
Figure 03

SYMBOL	HOLE	DEPTH (m)	SAMPLE #	% GRAVEL	% SAND	% SILT	% CLAY	% SILT & CLAY	Cu	Cc	CLASSIFICATION
●	TH13-301	4.9	S4	0.0	1.5	43.7	54.8	98.5			
■	TH13-304	3.4	S3	0.0	1.0	65.4	33.6	99.0			
▲	TH13-306	2.1	S4	0.0	18.6	71.1	10.3	81.4	29.0	9.6	
★	TH13-307	3.4	S6	0.0	18.2	71.9	9.9	81.8	25.9	10.6

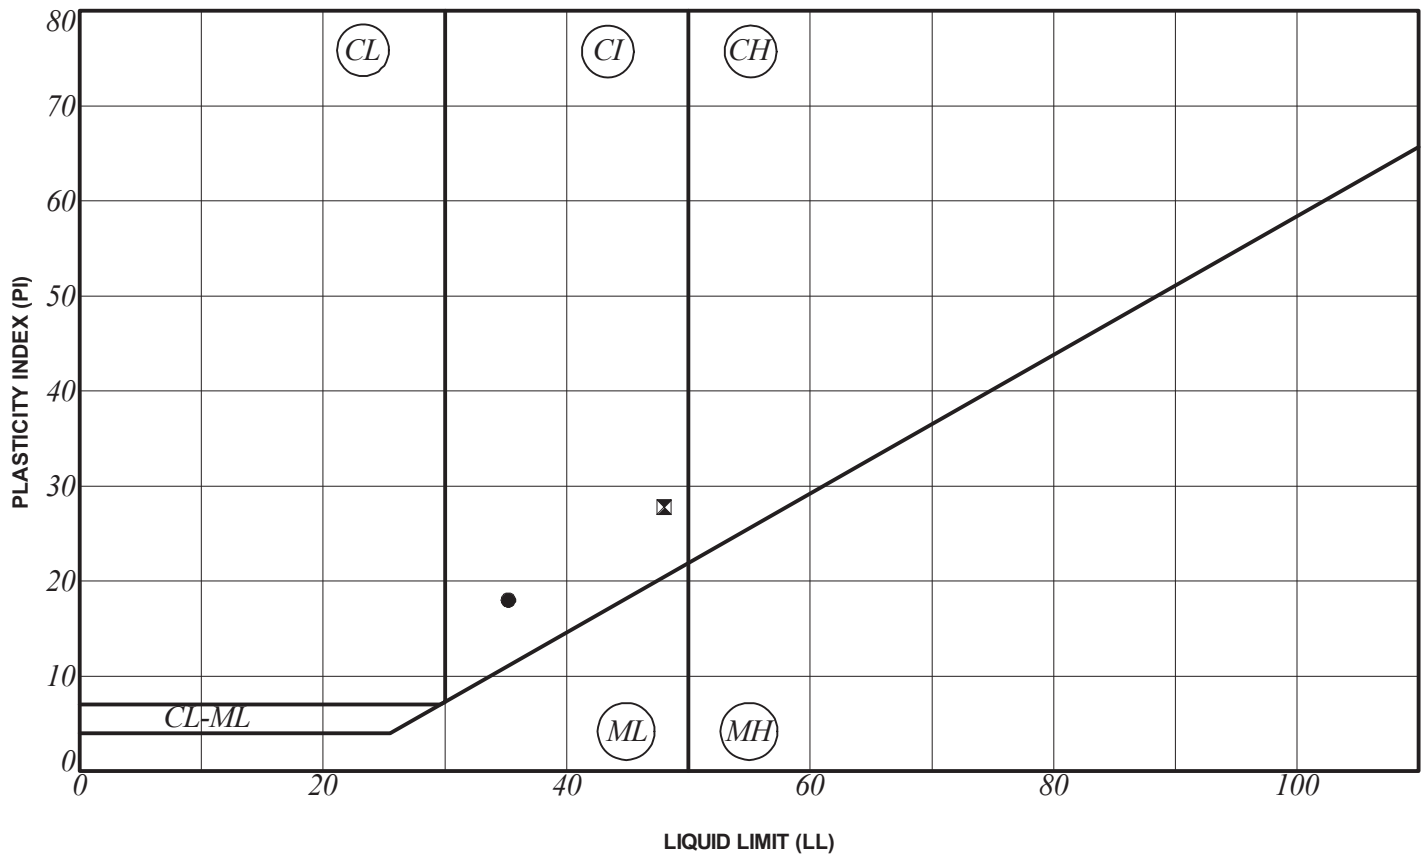
SYMBOL	HOLE	DEPTH (m)	SAMPLE #	LL	PL	PI	% SAND	% SILT	% CLAY	% MC	CLASSIFICATION
●	TH 13-102	3.7	S7	35	17	18	6.7	55.7	37.4	35.7	CI
⊠	TH13-105	3.8	S4	48	20	28	3.6	41.8	54.6	42.8	CI

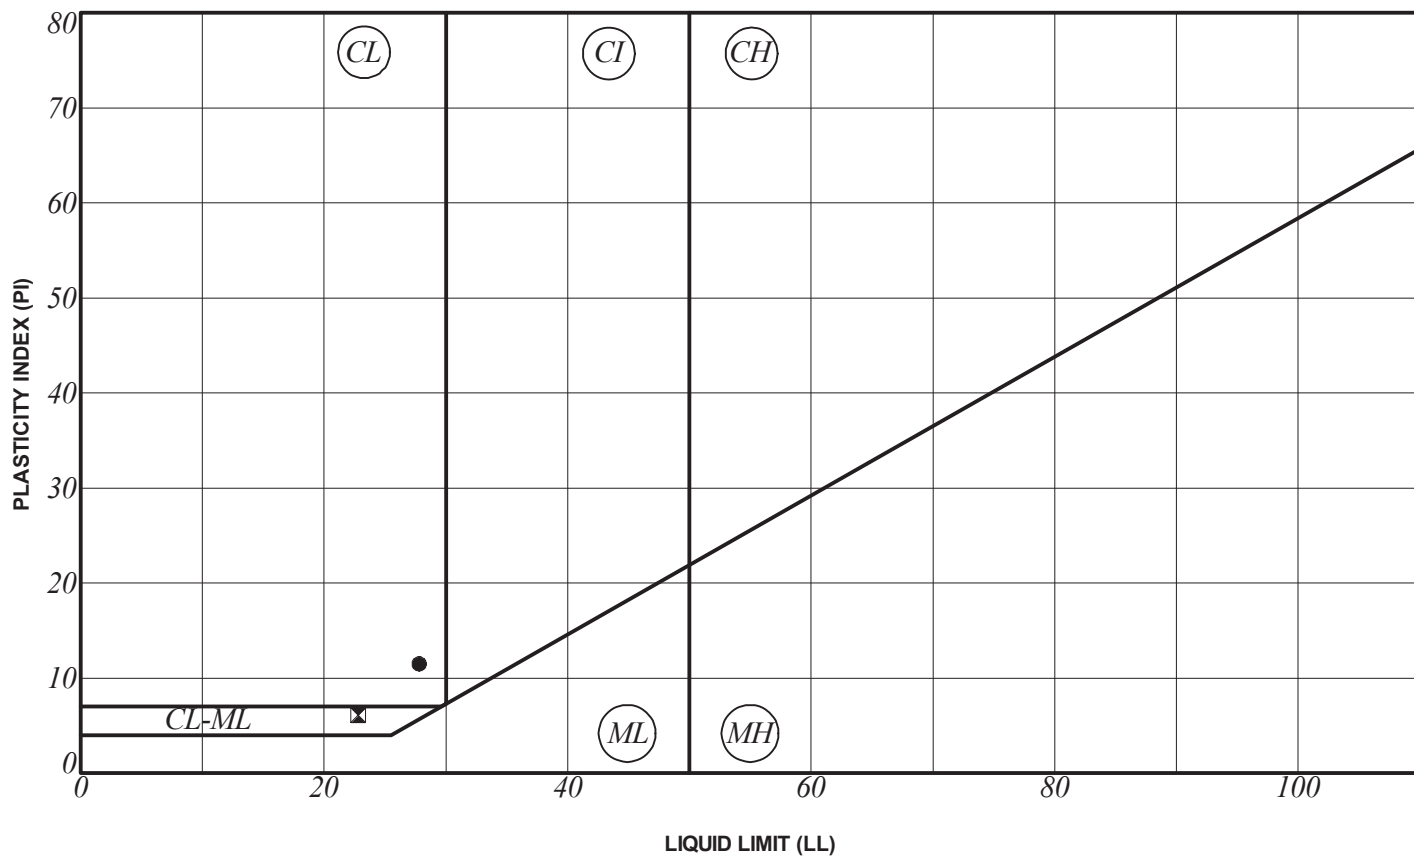
SYMBOL	HOLE	DEPTH (m)	SAMPLE #	LL	PL	PI	% SAND	% SILT	% CLAY	% MC	CLASSIFICATION
●	TH13-201	6.1	S5	28	16	12	6.2	75.4	18.4	24.7	CL
⊠	TH13-202	3.0	S3	23	17	6				18.7	CL-ML

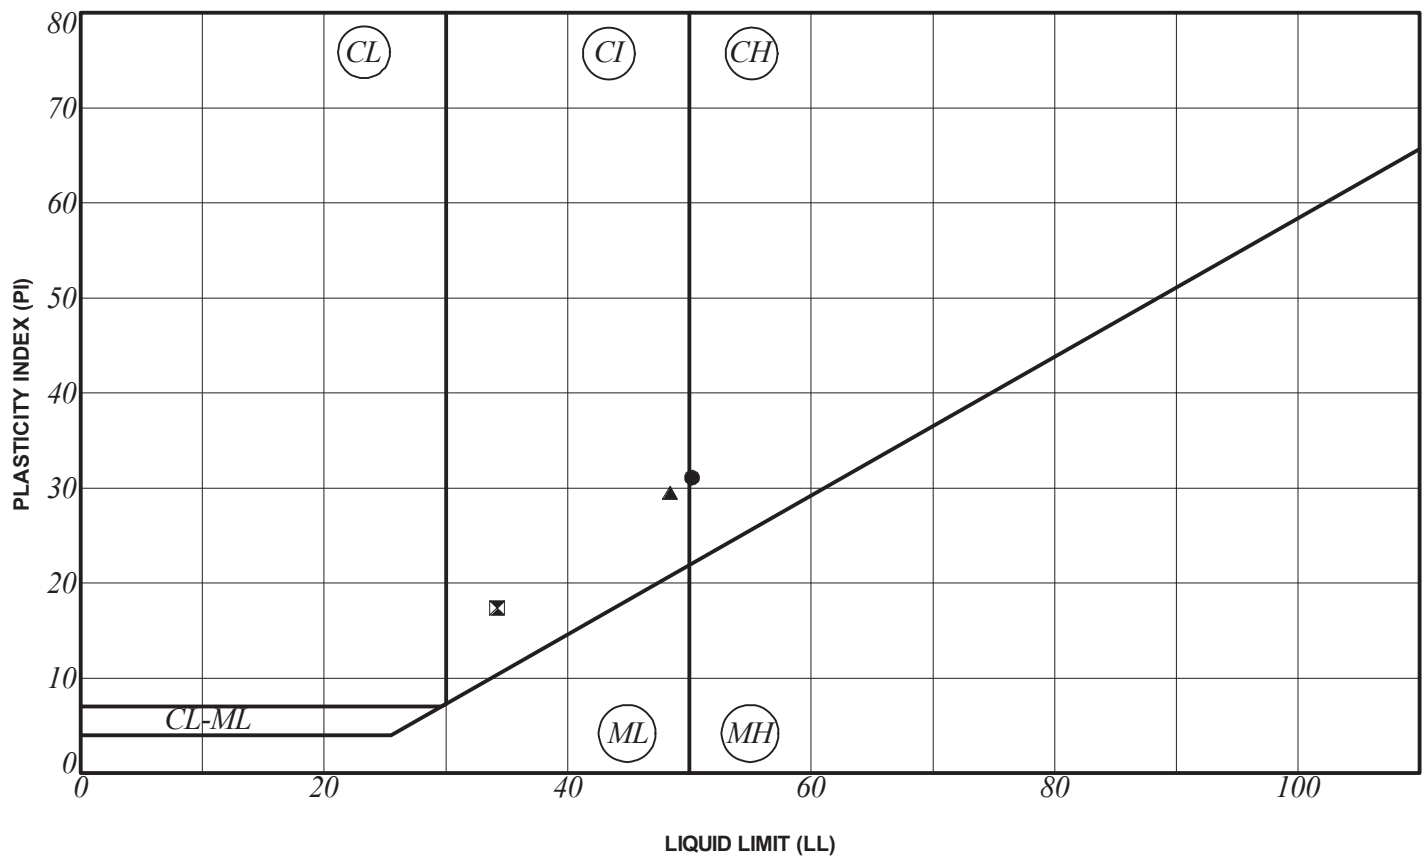
Figure 04

SYMBOL	HOLE	DEPTH (m)	SAMPLE #	LL	PL	PI	% SAND	% SILT	% CLAY	% MC	CLASSIFICATION
●	TH13-301	4.9	S4	50	19	31	1.5	43.7	54.8	43.9	
⊠	TH13-304	3.4	S3	34	17	17	1.0	65.4	33.6	31.0	
▲	TH13-305	3.4	S3	48	19	30				43.1

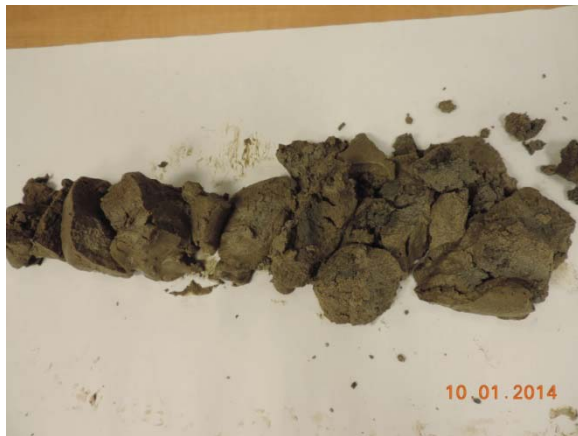
Photo 1: Right Earthfill Embankment
(TH13-103, S8, and depth 14'-16')
Note: sandy silt to silty sand

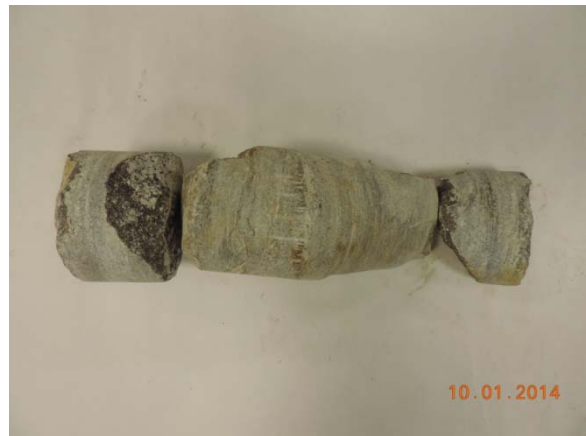
Photo 2: Right Earthfill Embankment
(TH13-101, Bedrock Core and depth 21.0')
Note: limestone bedrock

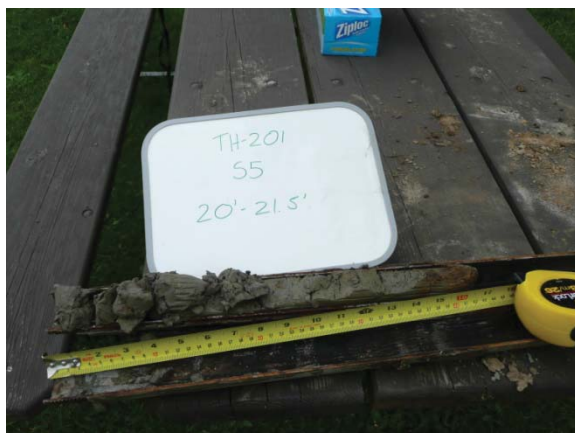
Photo 3: Lock 39 Earthfill Embankment
(TH13-201, S5, and depth 20'-21.5')
Note: clayey silt to silty clay

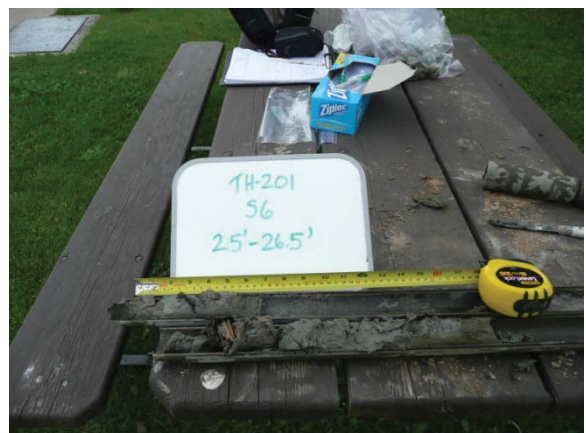
Photo 4: Lock 39 Earthfill Embankment
(TH13-201, S6, and depth 25'-26.5')
Note: clayey silt to silty clay

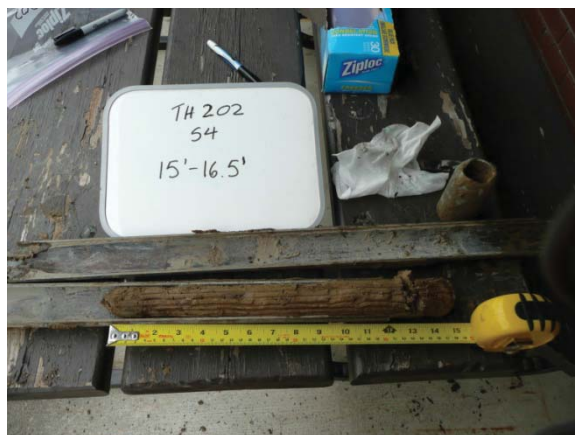
Photo 5: Lock 39 Earthfill Embankment
(TH13-202, S4 and depth 15'-16.5')
Note: clayey silt to silty clay

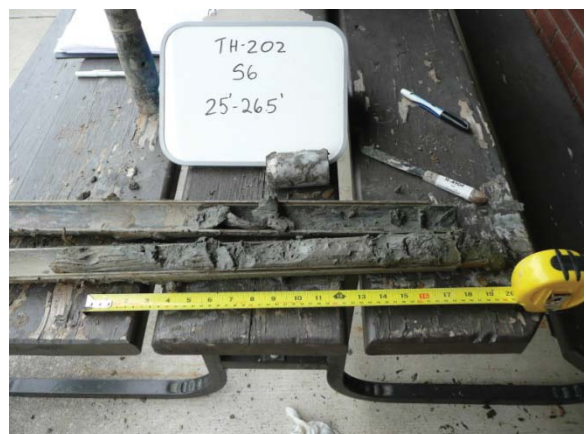
Photo 6: Lock 39:Earthfill Embankment
(TH13-202, S6, and depth 25'-26.5')
Note: clayey silt to silty clay

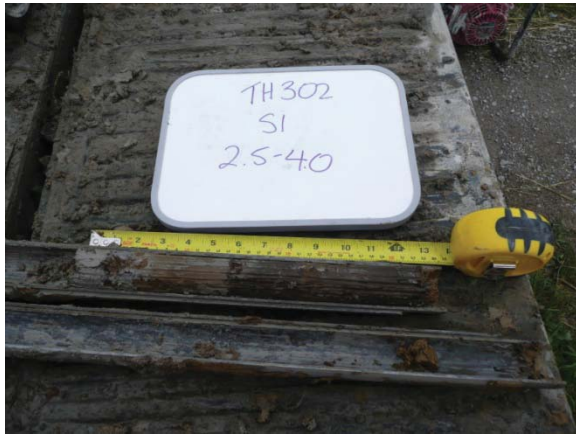
Photo 7: Northwest Canal Embankment
(TH13-302, S1, and depth 2.5'-4.0')
Note: clayey silt to silty clay

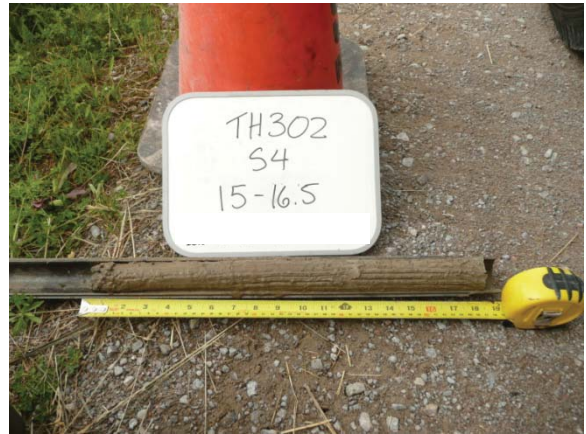
Photo 9: Northwest Canal Embankment
(TH13-302, S4, and depth 15'-16.5')
Note: clayey silt to silty clay

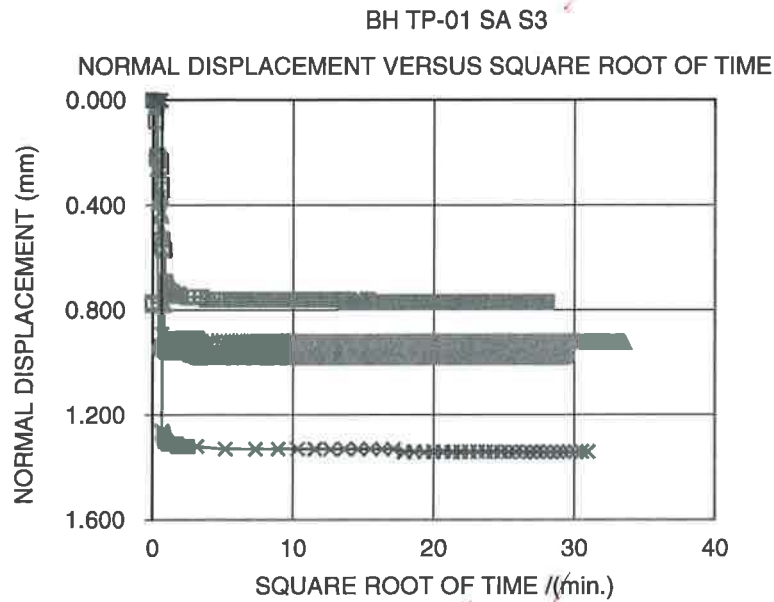
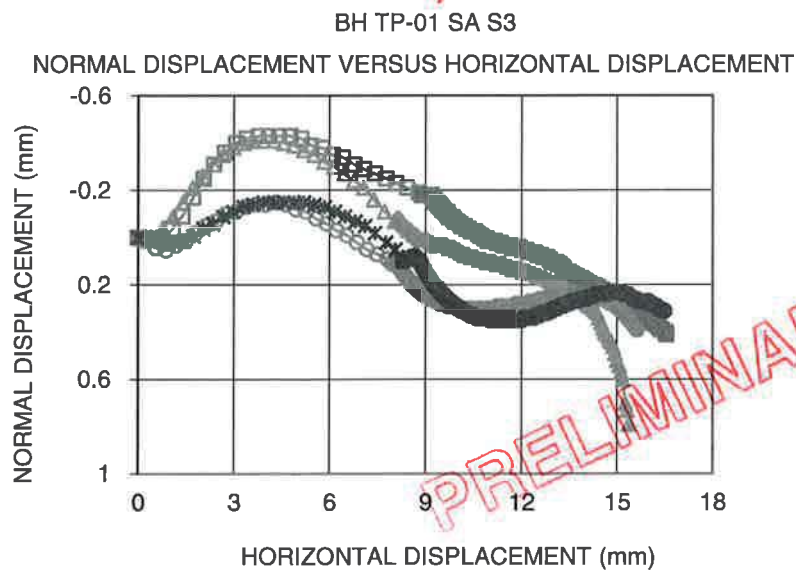
CONSOLIDATED DRAINED DIRECT SHEAR TEST
SHEET 3 OF 3

—●— SPECIMEN A, NORMAL STRESS =100 kPa	—●— SPECIMEN B, NORMAL STRESS =300 kPa
—●— SPECIMEN C, NORMAL STRESS =500 kPa	—●— A Residual
—●— B Residual	—●— C Residual
—●— SPECIMEN D, NORMAL STRESS=700 kPa	—●— D Residual
