Detailed Impact Analysis

Dam Rehabilitation
Port Severn Main Dam & Blind Dam D

Trent-Severn Waterway
District Municipality of Muskoka
Port Severn Road (Muskoka Road 5)
Port Severn, Ontario, Ontario

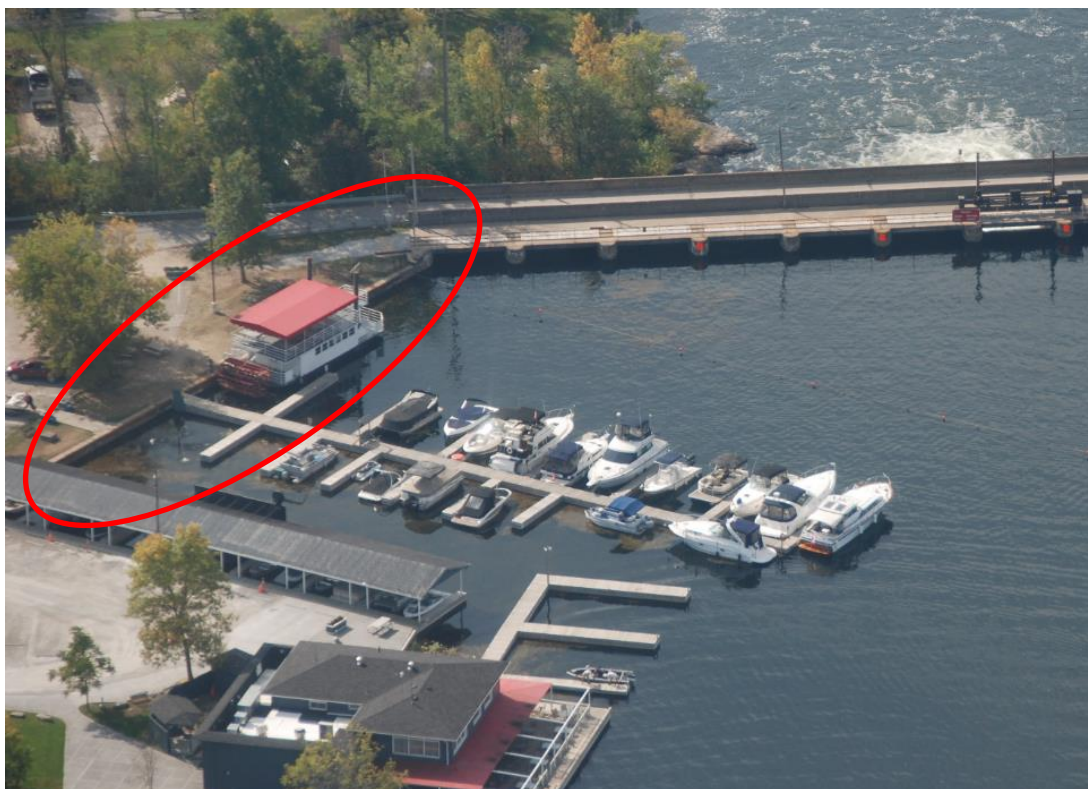
Blind Dam D (Dam D), located about 195m northeast of the Main Port Severn Dam (Figure 3), is a concrete structure built around the same time as the other Port Severn dams. It is a 119m long retaining wall of concrete founded on bedrock with an earth embankment. The height of the structure is around 2.4m. Dam C (along with Dam A and C) functions as a retaining wall to manage the water elevations and prevent flooding of adjacent lands, which are a mixture of residential properties, restaurants, parking lots and marinas. Since its construction, the area behind this dam (as the case with the other blind dams A, B, C, and F, Figure 5), has been developed and landscaped, which serves to obscure the original function.

Blind Dam D (Parks Canada photo taken September 2017)

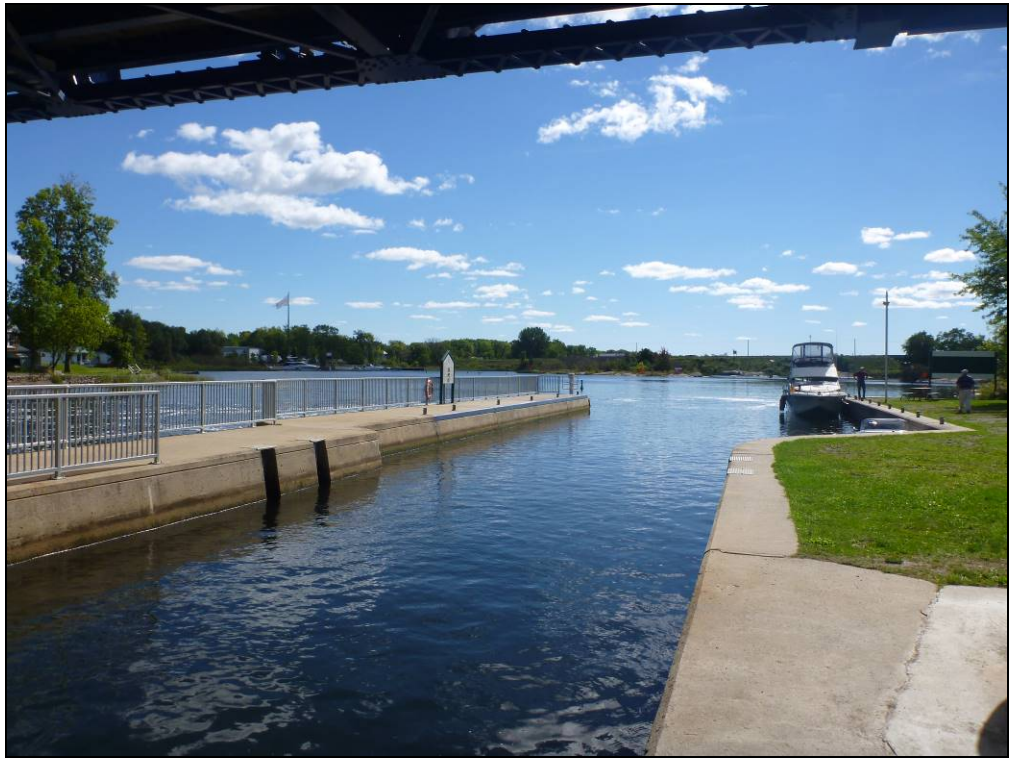
Concrete riparian walls limit access to shore for nesting by turtles (September 24, 2016).

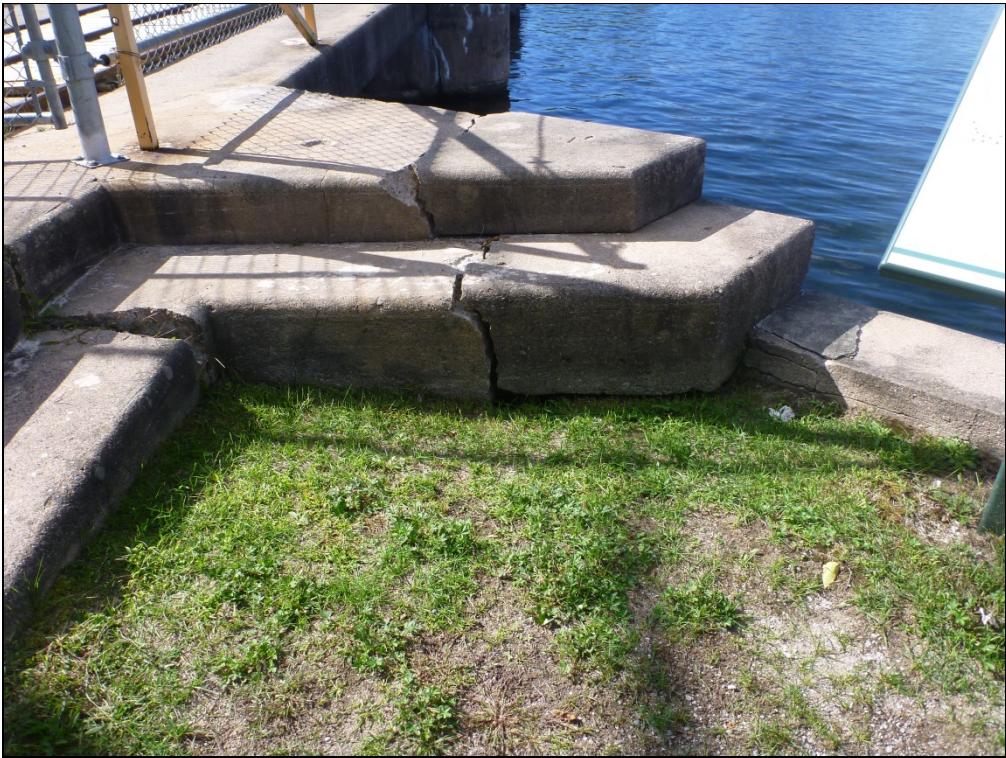
No significant crevices in the foundations were observed for use as Critical Habitat for snakes (September 24, 2016).
