DESIGNATED SUBSTANCE AND HAZARDOUS MATERIALS SURVEY REPORT

PORT SEVERN MAIN DAM AND LOCK 45 PORT SEVERN, ONTARIO

OCTOBER 11, 2018

PSPC PROJECT NO.: R.076951.033

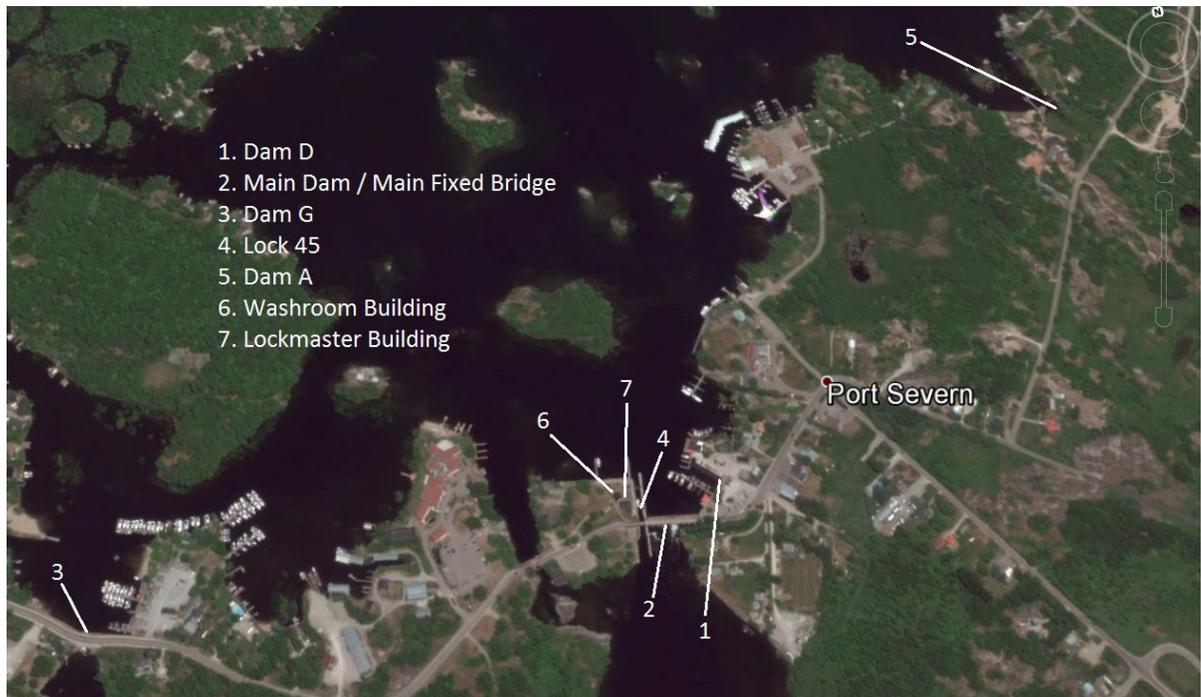
Figure 1 – Project-Specific Areas Surveyed

Washroom Building	The Washroom Building, constructed in 1988, is a one-storey structure located adjacent to (West) of Lock 45. The building consists of ceramic tile flooring, concrete block walls and drywall ceilings. The attic space in the building is made of a wooden beams and columns and filled with pink man-made mineral fibre (MMMF) insulation. The exterior of the building is comprised of brick walls and a metal sheet roofing.
Lockmaster Building	The Lockmaster Building, constructed in 1988, is a one-storey structure located adjacent to the Washroom Building. The building consists of ceramic tile flooring throughout. The Kitchen is finished with vinyl floor tiles and the Electrical/Mechanical Room has a concrete floor. The interior walls and ceilings are finished with drywall. The attic space in the building is made of wooden beams and columns and filled with pink man-made mineral fibre (MMMF) insulation. The exterior of the building is comprised of brick walls and a metal sheet roofing.

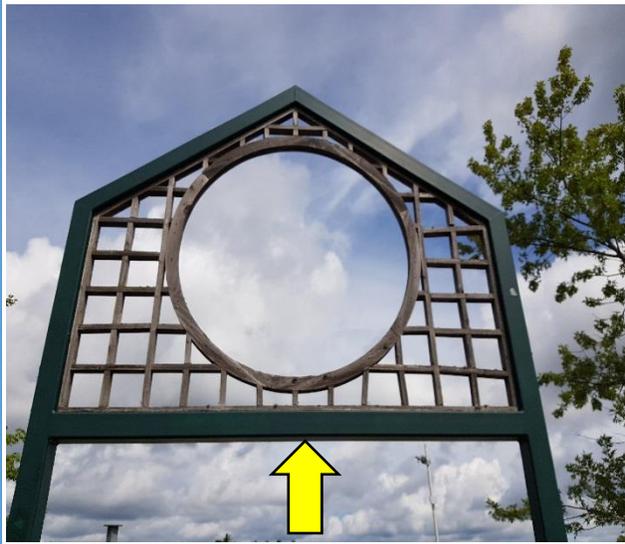
Sample ID: Pb-07

MATERIAL DESCRIPTION	ASSESSMENT	ACTION ¹
<p>Dark Green Paint (Photo #1)</p> <p>Lead-containing paint observed on the metal beams attached to the Lockmaster Building and throughout the Main Dam Site.</p>	<p>Sample ID: Pb-07</p> <p>Concentration: 1,400 ppm</p> <p>Paint Condition: Good</p>	<p>In general, the following procedures are recommended if/when removing lead-containing materials, coatings and paint applications:</p> <ul style="list-style-type: none"> – Follow Type 1 – if the coating is to be removed with a chemical gel or paste; – Follow Type 1 – if operating construction or demolition equipment (e.g. excavator, bulldozer) during building renovation or demolition where lead-based paints or surface coatings are present on building materials and are being disturbed; – Follow Type 2a – if the coating is to be removed by scraping or sanding using non-powered hand tools, or manual demolition of lead-painted building components by striking with sledgehammer or similar tool; – Follow Type 3a – if the coating is to be removed using power tools; or, – Follow Type 3b – if the coating is to be removed by abrasive blasting. <p>If lead-containing paint applications and surface coatings are not removed prior to demolition, ensure that demolition waste complies with the requirements of <i>General - Waste Management Regulation, R.R.O. 1990, Regulation 347</i>.</p>

Photo #1: View of lead-containing dark green paint on metal beams throughout the subject areas.

Work that will disrupt and/or pulverize (including drilling, cutting, grinding or abrading) confirmed or suspected lead-containing materials must follow the recommendations provided in the EACO *Lead Abatement Guidelines* (dated 2014) or Ministry of Labour *Guideline for Lead on Construction Projects*, dated September 2004 (revised April 2011). In addition, the aforementioned painted surfaces (containing lead) should be handled with appropriate health and safety precautions so as to comply with requirements of the Designated Substances regulation, *O. Reg. 490/09*, and disposal of these materials must also comply with the requirements of *O. Reg. 347 – General – Waste Management*.

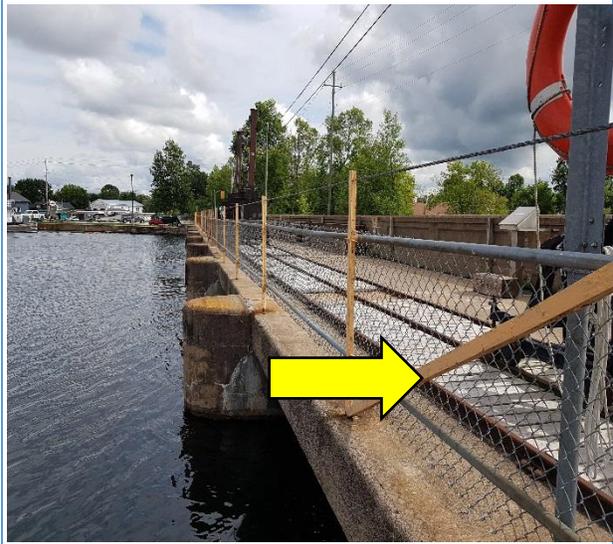
Sample ID: Pb-08

<p>Light Yellow Paint (Photo #2 & 3)</p> <p>Lead-containing paint observed on the metal railings on the Main Dam and Dam G</p>	<p>Sample ID: Pb-08</p> <p>Concentration: 32,000 ppm</p> <p>Paint Condition: Good</p>	
<p>Grey Paint (Photo #4)</p> <p>Lead-containing paint observed on the metal hatches around Lock 45</p>	<p>Sample ID: Pb-10</p> <p>Concentration: 3,800 ppm</p> <p>Paint Condition: Good</p>

Photo #2: View of lead-containing light yellow paint on the metal railings on the Main Dam.

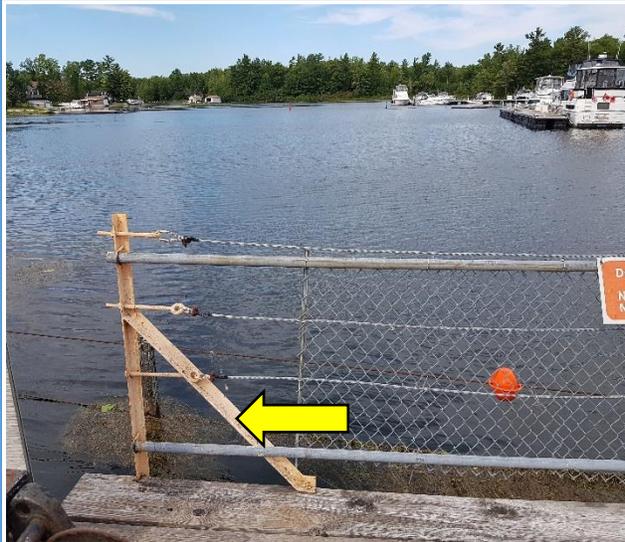
Sample ID: Pb-08

Photo #3: View of lead-containing light yellow paint on the metal railings on the Dam G.

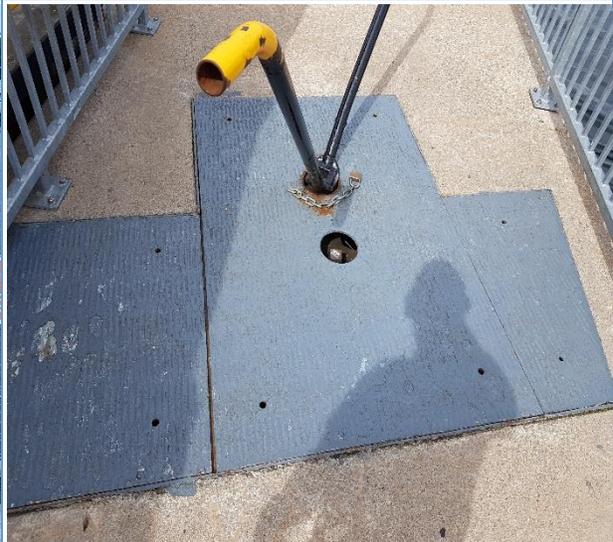
Sample ID: Pb-10

Photo #4: View of lead-containing grey paint on the metal hatches on Lock 45.

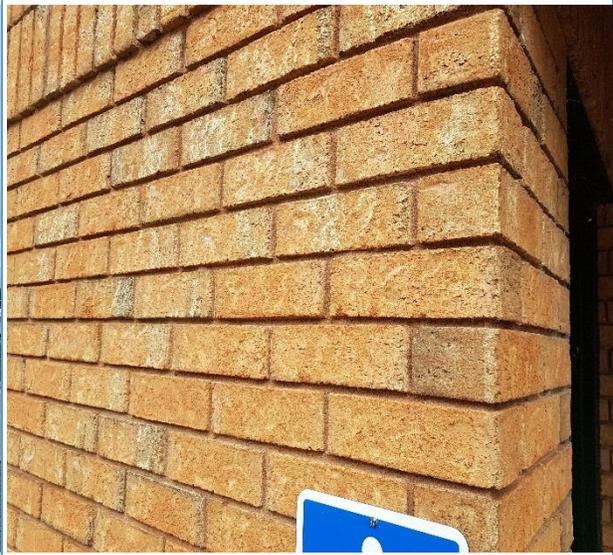
Sample ID: M-1A-C

Photo #6: View of the non-asbestos exterior brick mortar on the Washroom Building.

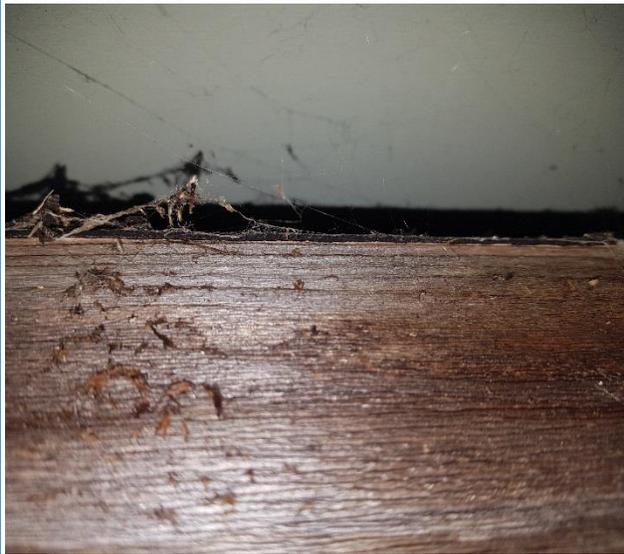
Sample ID: TP-3A-C

Photo #7: View of the non-asbestos tar paper insulation under the metal sheet roofing of the Washroom Building.

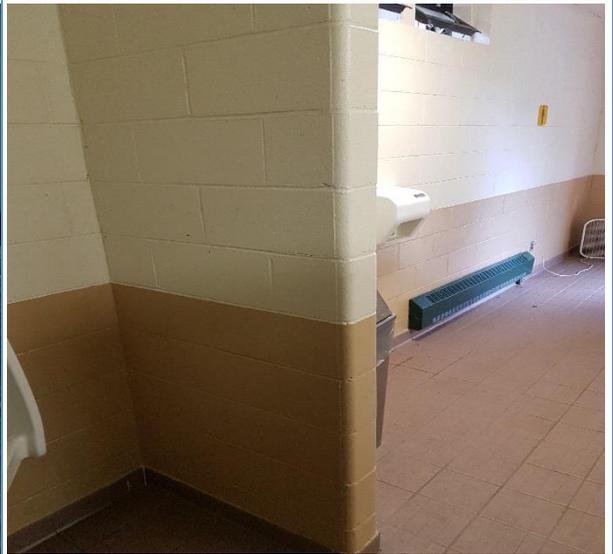
Sample ID: CBM-4A-C

Photo #8: View of the non-asbestos concrete block mortar from the interior walls of the Washroom Building.

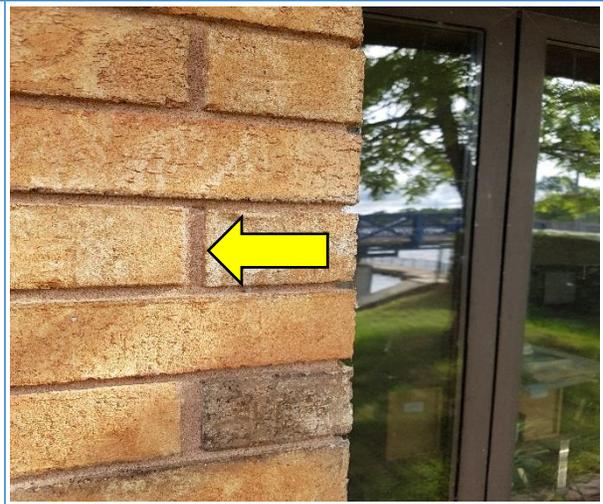
Sample ID: M-5A-C

Photo #10: View of the non-asbestos exterior brick mortar on the Lockmaster Building.

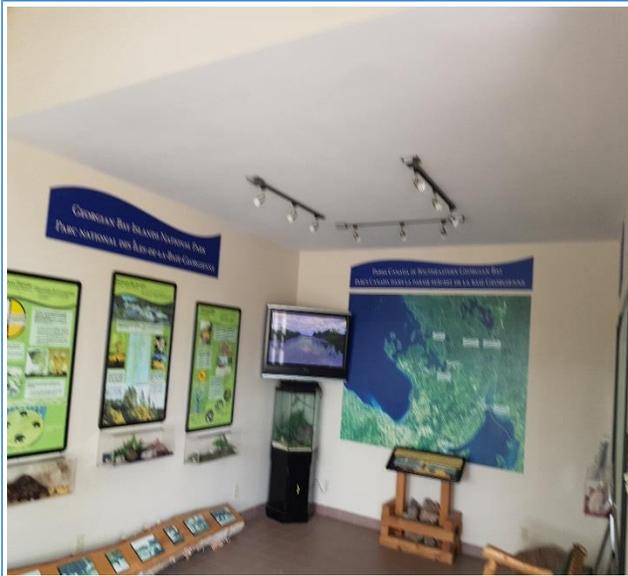
Sample ID: DJC-9A-C

Photo #11: View of the drywall finishes with non-asbestos drywall joint compound in the Lockmaster Building.

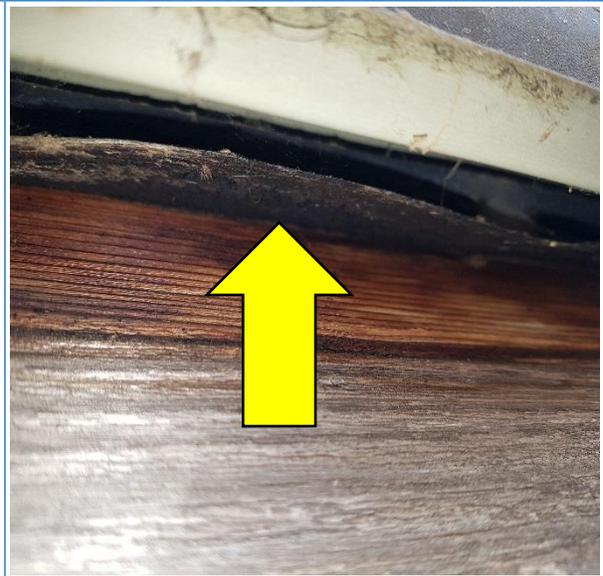
Sample ID: MEM-10A-C

Photo #12: View of the non-asbestos black membrane between the exterior and interior walls of the Lockmaster Building.

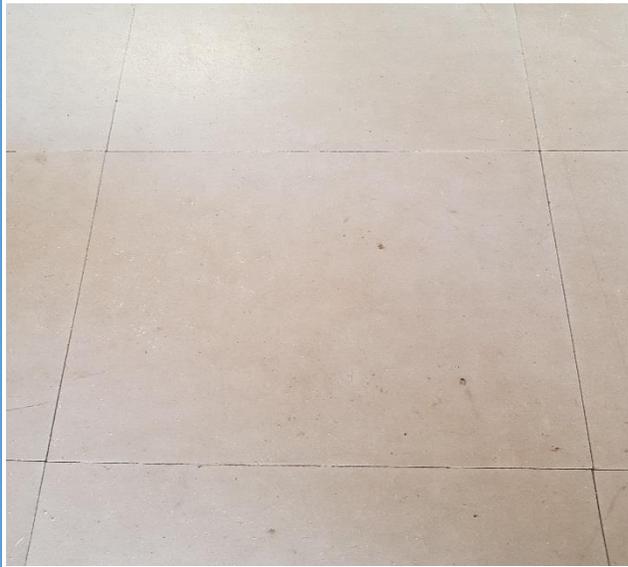
Sample ID: VFT-11A-C

Photo #13: View of the non-asbestos 12"x12" beige vinyl floor tile in the Kitchen of the Lockmaster Building.

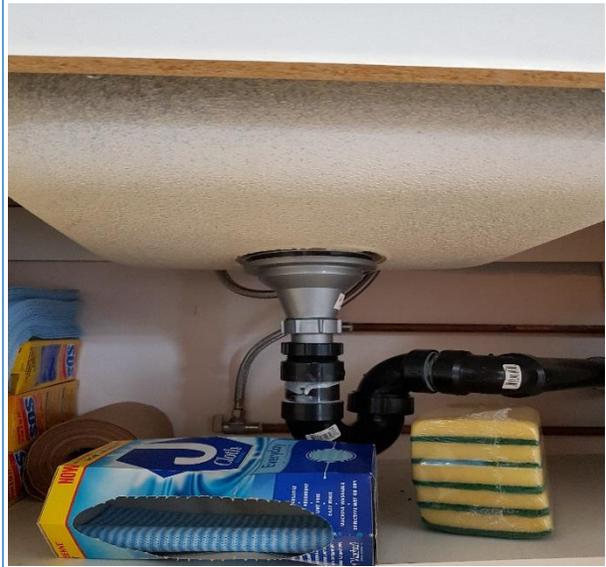
Sample ID: AC-12A-C

Photo #14: View of the non-asbestos acoustic undercoating on the sink in the Kitchen of the Lockmaster Building.

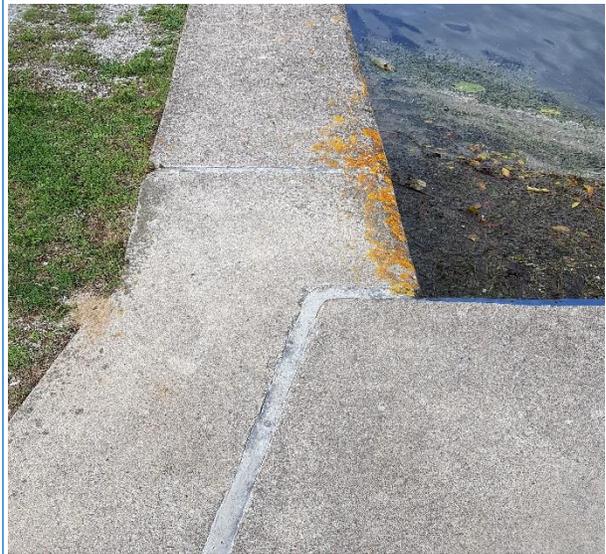
Sample ID: CLK-13A-C

Photo #16: View of the non-asbestos grey caulking used in the expansion joints on the Upper Approach Wall.

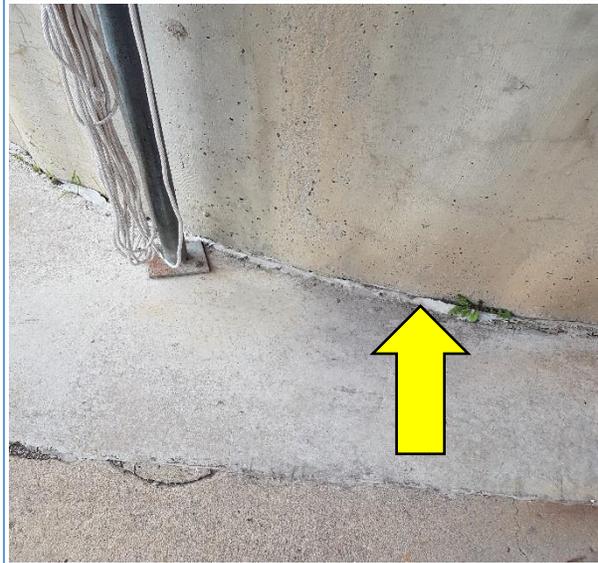
Sample ID: CLK-14A-C

Photo #18: View of the non-asbestos white caulking on the Lower Approach Walls.

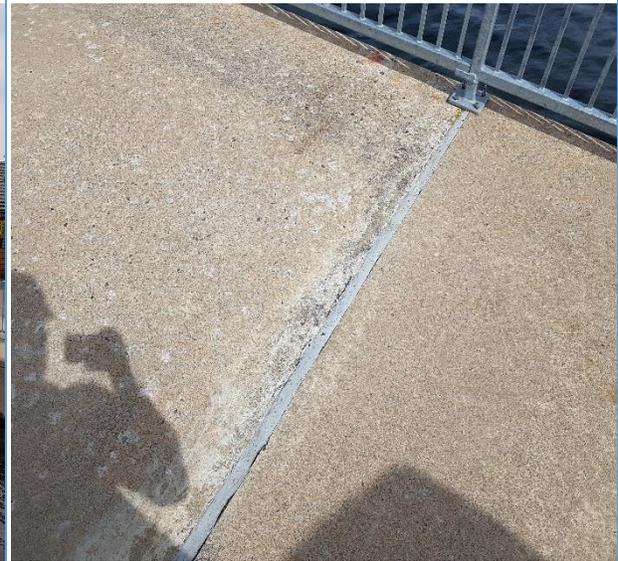
Sample ID: CLK-16A-C

Photo #22: View of the non-asbestos grey caulking on Lock 45.

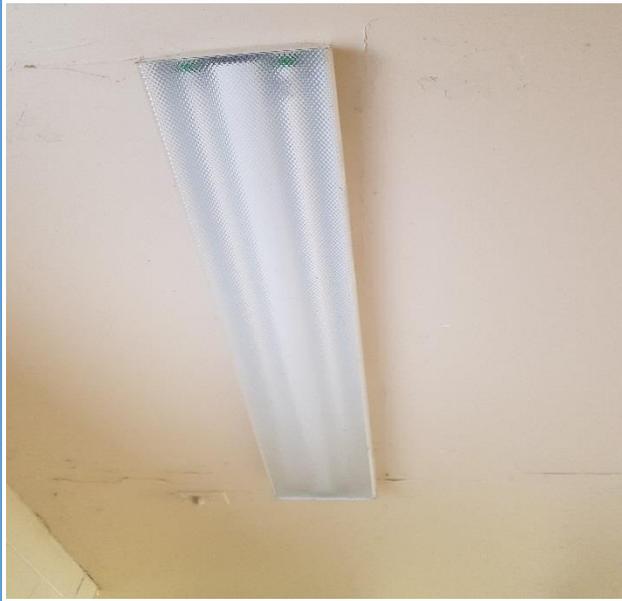
Sample ID: N/A

Photo #25: View of T-8 fluorescent light tubes containing mercury in the Washroom Building.

The presence of mercury within assembled units (e.g. fluorescent light bulbs) should not be considered a hazard provided that the assembled units remain sealed and intact. Avoid direct skin contact with mercury and avoid inhalation of mercury vapour. Dispose of mercury following applicable legislative requirements.

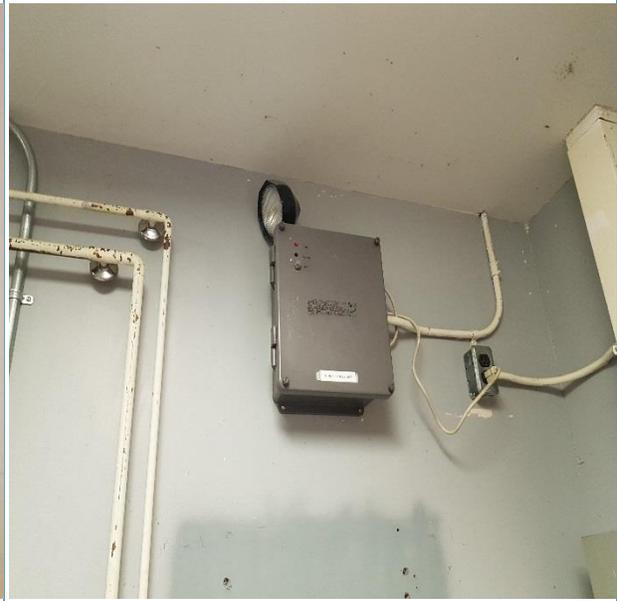
Sample ID: N/A

Photo #26: View of the emergency lighting in the Lockmaster Building. Emergency lights are presumed to contain lead-acid batteries.

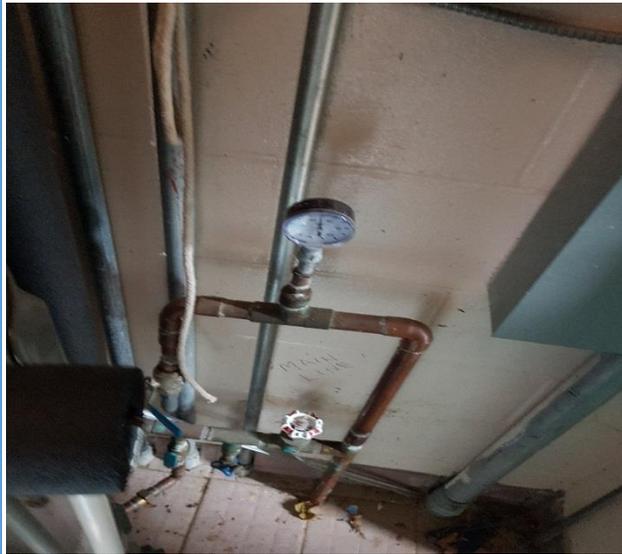
Sample ID: N/A

Photo #27: View of copper piping in the Janitor's Closet in the Washroom Building. Lead-containing solder is presumed to be present.

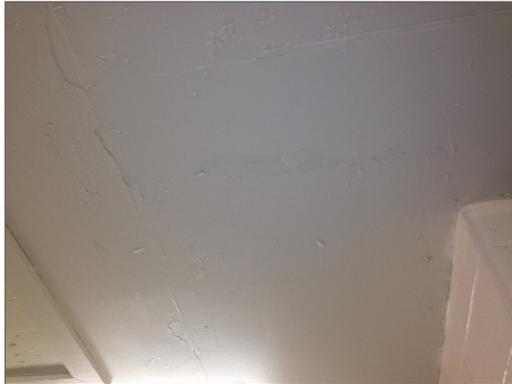
Drywall (gypsum board) and drywall joint compound is present as a ceiling finish throughout the building. Three building samples of drywall joint compound were collected (samples b122703.0001A-C) and found to be non-asbestos.

Photo 1 – Non-asbestos drywall located throughout the building.

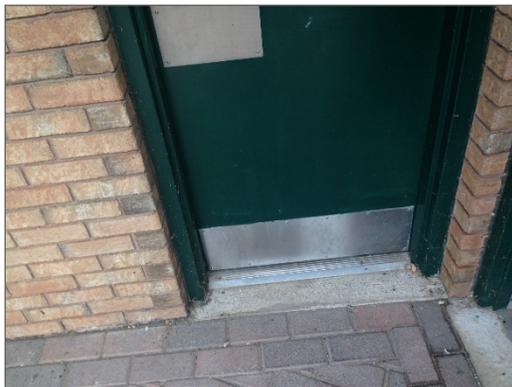
Brown caulking is present around exterior doors. Three samples of caulking were collected and all were determined to be non-asbestos (samples b122703.0002A-C).

Photo 2 – Non-asbestos caulking located on exterior door.

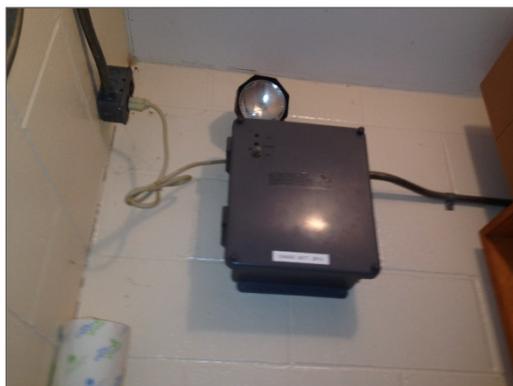
Lead-containing batteries are present in emergency lighting present in the storage room.

Photo 3 – Backup emergency lighting with lead-acid batteries present in the storage room.

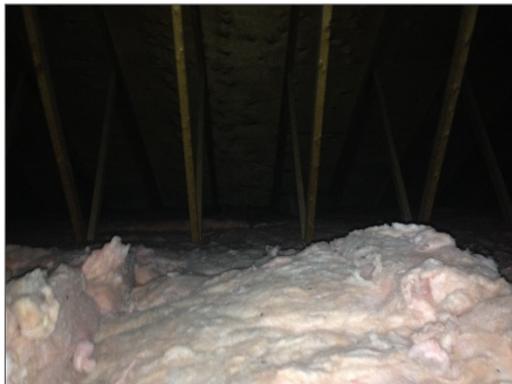
Glass and/or Mineral Wool insulation is present in the building as insulation in the attic and around the domestic hot water tank.

Photo 4 – Batt insulation present in attic.
