GEOTECHICAL REPORT

November 19, 2019 File: SGL19-028

Re: Proposed Telegraph Cove (Mt. Collinson) Communications Site Report of Geotechnical Assessment

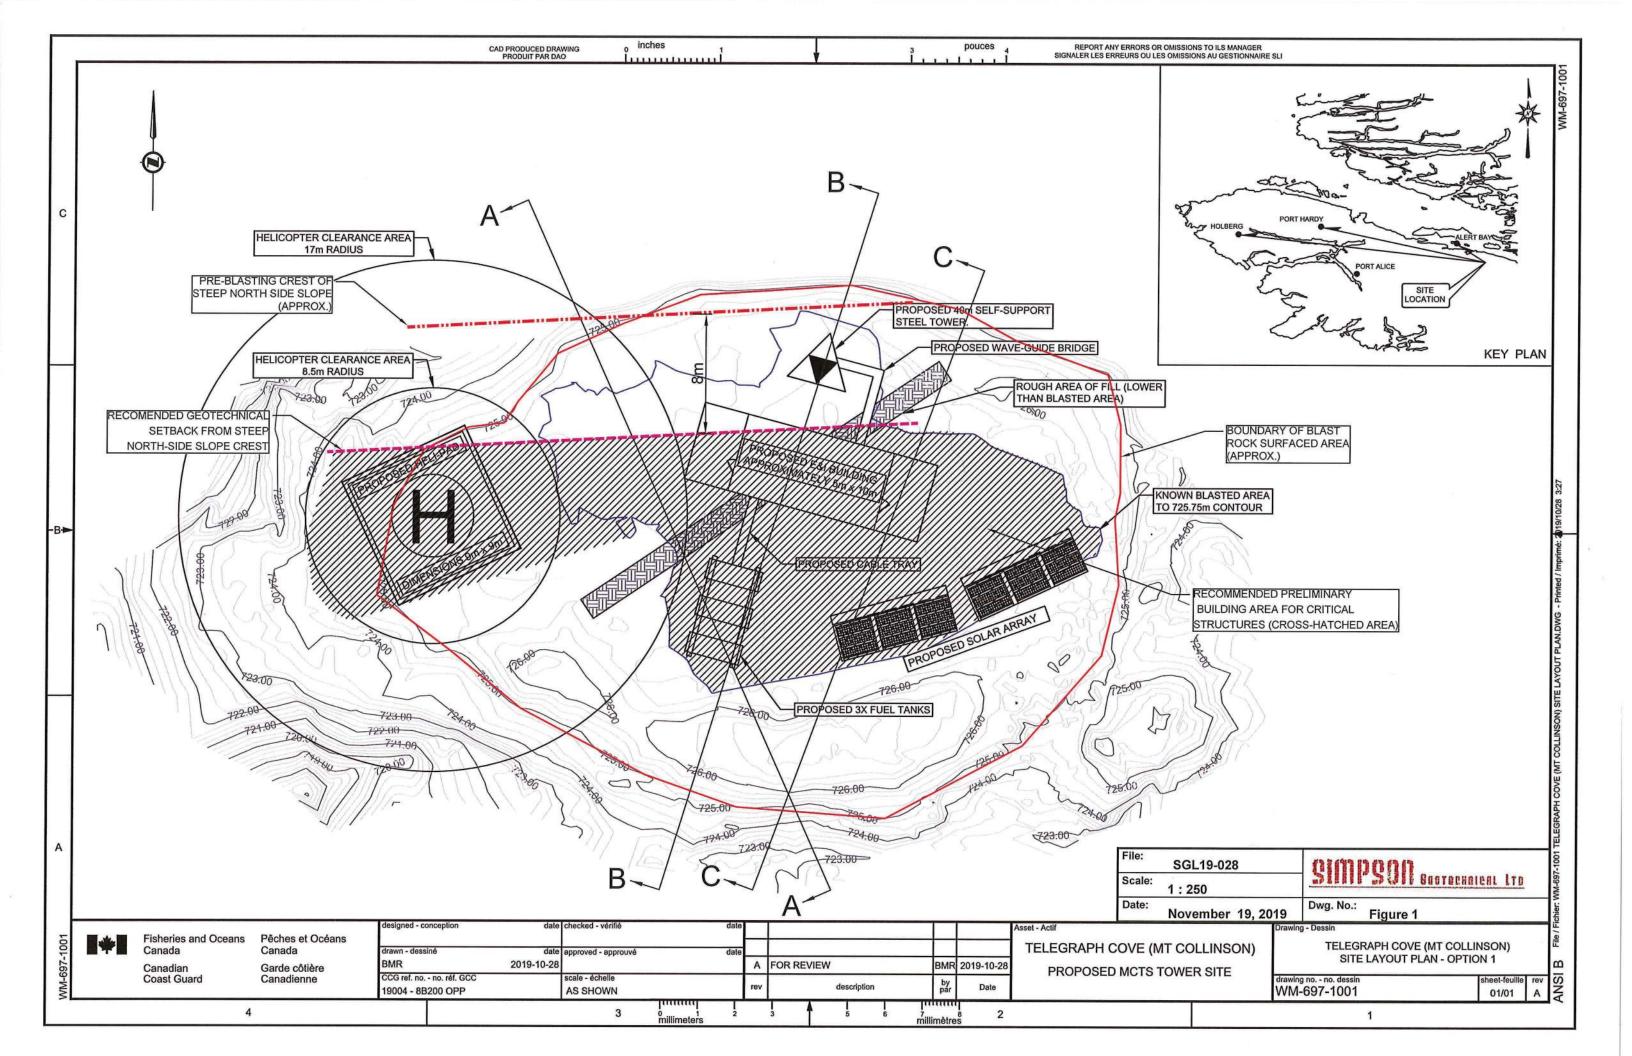
Attachments: Figure 1 – Site Location

The finished site topography was provided to us by the Canadian Coast Guard and is shown on Figure 1. We were also provided with pre-blasting topography, which is shown on the cross sections on Figure 2. The pre and post blasting topography indicate that substantial quantities of fill material has been located to the northern and southern sides of the site, as illustrated in the cross sections shown on Figure 2. Photographs of the stripped rock surface were also provided to us, included as Photos 1 and 3.

Immediately northwards of the site the slope continued down at approximately 70 to 80 degrees for at least 30m. The approximate crest of that slope is shown on Figure 1, and Photo 1. The undisturbed portion of that slope was vegetated in primarily low brush, while the tops of trees growing at the bottom of that slope reached to nearly the site elevation.

Due to the potential for toppling block failure from the north-side of the site and the postdisaster designation of the proposed facility, a minimum 8m geotechnical setback upland from the crest of the north-side slope is recommended for critical structures that are intended to remain functional following the major 2% in 50 year probability of occurrence design seismic event. That recommended setback and building is illustrated on Figure 1.

For preliminary site layout and planning purposes, critical structures should also be located within the blasted surface area of the site, or on the intact, undisturbed, essentially flat basaltic bedrock area westwards of the prepared blast rock site surface. That results in in the approximate preliminary recommended building area for critical structures shown cross-hatched on Figure 1.

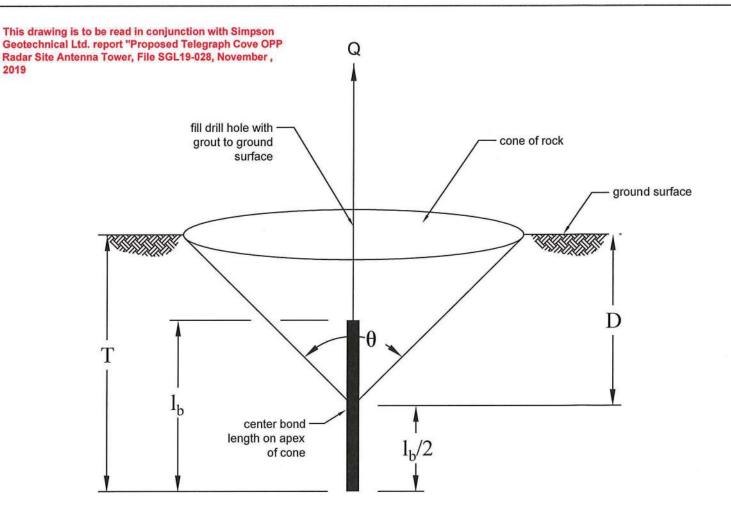
Project:	Proposed Telegraph Cove OPP Radar Site Antenna Tower				ower		almbaaa		
Title:	Rock Anchor Uplift Capacity				SIMPS JA BEOTECHNICAL LTD				
Client:	Canadian Coast Guard					(i)			
File:	SGL19-028	Drawn by:	RRS	Scale:	NTS	Date:	November 19, 2019	Dwg. No.: Figure 3

Rock anchors for uplift resistance should be designed by a Professional Engineer experienced in rock anchor design. The uplift resistance may be determined as shown on Figure 3, based on a maximum cone apex angle of 90 degrees (45 degrees each side of the long axis of the anchor). The apex of the inverted cone should be located no deeper than the midpoint of the anchor bond length. Anchors located laterally closer than 1.2 x T (where T is the anchor depth) should be considered to as act as a group.

Where:

$$Q = \frac{f_{(r)} + w_0}{FS}$$

$$f_{(r)} = \frac{\sigma_t \pi D^2}{\cos \frac{\theta}{2}}$$

$$W_c = \frac{\pi}{3} D^3 \gamma$$

reduce cone volume accordingly when uplift cone is truncated by local topography

$$T = D + \frac{l_b}{2}$$

$$l_b = \frac{Q}{\pi \, \mathrm{d} \, \tau_a}$$

Q = vertical uplift capacity of rock anchor (kN)

T = total depth of rock anchor (m)

$f_{(r)}$ = resisting tensile force on surface of cone (kN)

W_c = weight force of rock cone (kN)

D = depth to apex of cone (m)

θ = apex angle of cone (degrees)

σ_t = working tensile strength on surface of cone (kPa)

γ_r = unit weight of rock (kN/m³)

l_b = bond length of anchor (m)

τ_a = grout to rock working bond stress (kPa)

d = drillhole diameter (m)

FS = factor of safety applied to the load (minimum FS = 1.5 recomended)

Local topography may truncate the uplift cone when uplift rock anchors are located laterally closer to a slope than that anchor depth into the bedrock. The reduction in uplift cone volume by truncation of the uplift cone by local topography should be considered in the tower location, anchor design and installation.

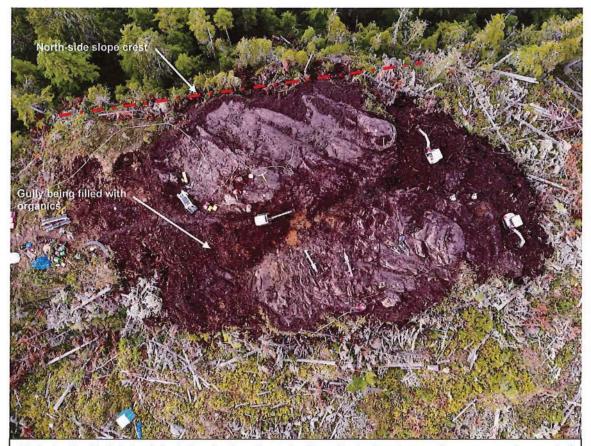
Photo 1 – Provided photo of site during clearing. General outline of bedrock surface can be seen, as well as crest of steep north-side slope. Stripped organics are being pushed into gully to southwest of cleared bedrock.

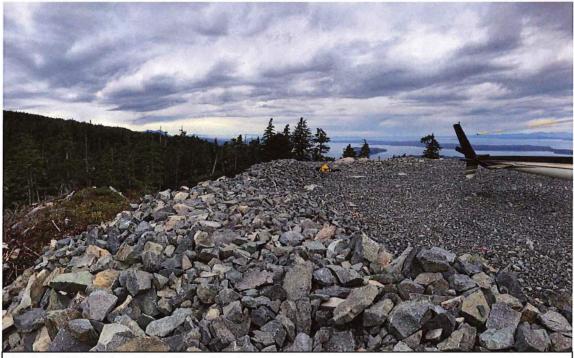
The site was essentially flat and level and located at a local topographic high point on the flank of Mt. Collinson. The site surface comprised angular grey basaltic rock pieces that ranged from gravel to boulder size. The central area of the site was surfaced with primarily smaller gravel and cobble sized particles, while larger cobble and boulder sizes were on the surface around the perimeter of the site (see Photo 2).

Photo 2 - Finished site surface looking westwards.

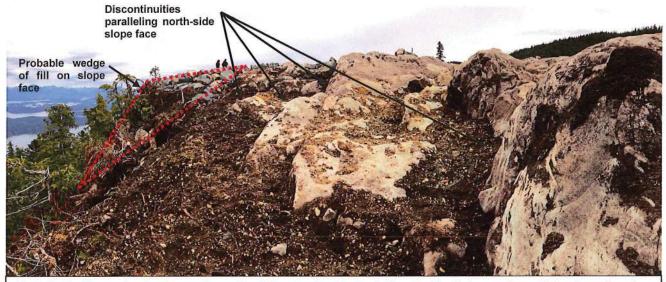
The slopes westward and eastward of the site sloped relatively gently down from the prepared site surface. An area of bare, undisturbed, gently sloped basaltic bedrock was present to the west of the prepared site surface (Photo 5), while to the east was essentially undisturbed and vegetated with brush and small trees.

The bedrock exposed on the western side of the site showed persistent steeply inclined discontinuities that generally paralleled the north-side slope (Photo 5) at a spacing of 1 to 2m. Less persistent discontinuities formed an orthogonal and blocky structure in the rock. The bedrock discontinuities and structure suggest possible toppling block failure mechanism may occur from the steep slope immediately northwards of the prepared site area.

Photo 5 – Looking eastwards along northern side of site. Persistent bedrock discontinuities that generally parallel northern slope face are visible, as well as probable wedge of fill on north side slope crest.
