CANADIAN COAST GUARD
520 Exmouth Road
Sarnia, ON
N7T 8B1

Subject: Lead and Mercury Sampling Report – CCGS Limnos, CCIW, Burlington, Ontario

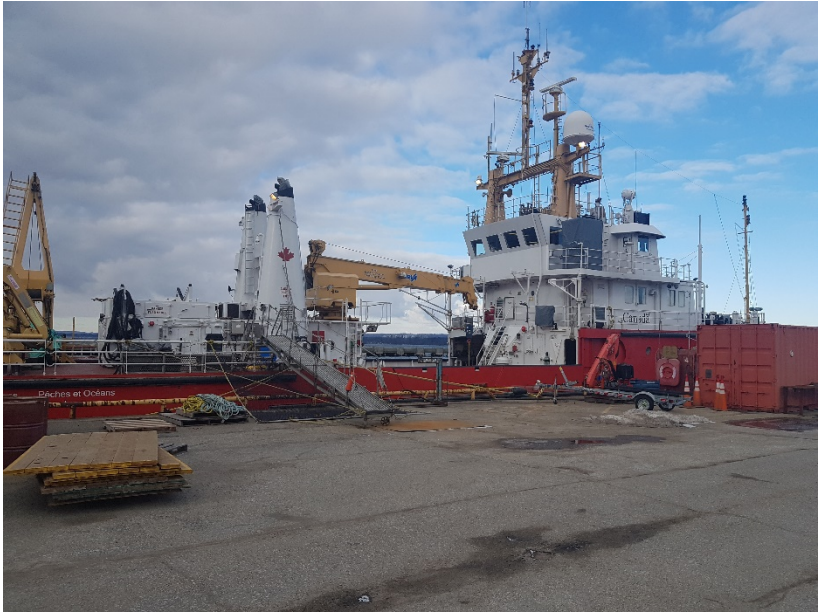
MATERIAL DESCRIPTION	ASSESSMENT	PHOTO ²	ACTION ¹
Red paint – Monkey’s Island deck	Sample ID: 0001 Concentration: 223 µg/g Condition: Good	2	In general, the following procedures are recommended if/when removing lead-containing materials, coatings and paint applications:
Yellow paint – Monkey’s Island main mast	Sample ID: 0002 Concentration: 28400 µg/g Condition: Good	3	<ul style="list-style-type: none">– Follow Type 1 – if the coating is to be removed with a chemical gel or paste;– Follow Type 2a – if the coating is to be removed by scraping or sanding using non-powered hand tools, or

2	Representative photo of red paint observed on the Monkey's Island deck.

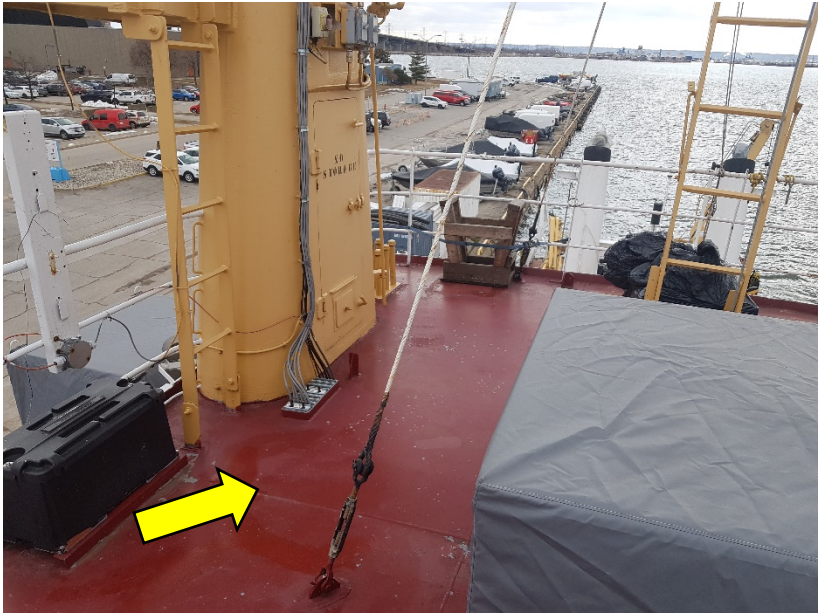
PHOTO NO.	MATERIAL DESCRIPTION & LOCATION	PHOTO
<u>3</u>	Representative photo of yellow paint observed on the Monkey's Island main mast.

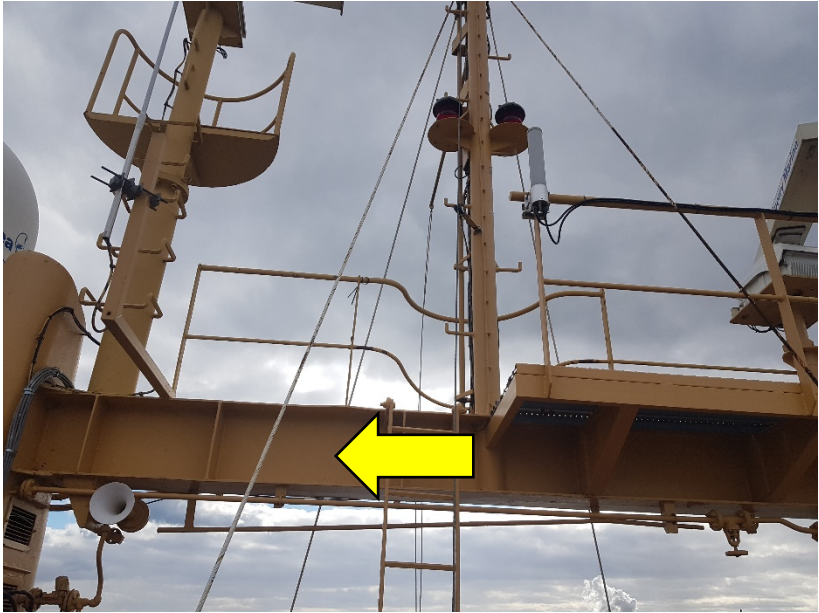
White paint – Bridge deck – Aft stair tower	Sample ID: 0006 Concentration: 0.21 µg/g Condition: Good	4	Mercury is present, but below the 10µg/g regulatory limit. As such, no further action is recommended.
White paint – Focsl deck (bulkhead)	Sample ID: 0007 Concentration: 0.07 µg/g Condition: Good	5	Mercury is present, but below the 10µg/g regulatory limit. As such, no further action is recommended.

<u>4</u>	Representative photo of white paint observed on the bridge deck, AFT stair tower.

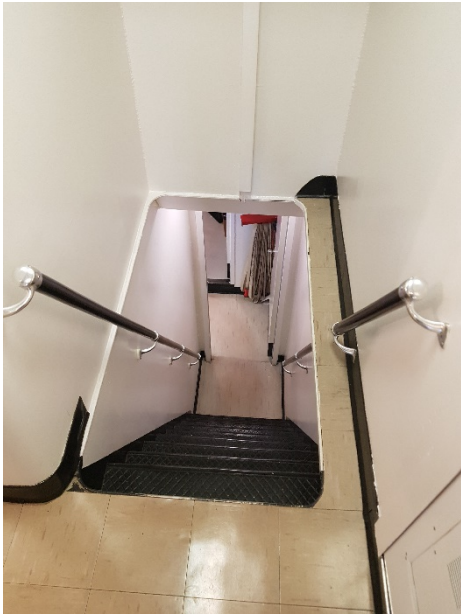
White paint – Focsle deck (bulkhead)	Sample ID: 0007 Concentration: 30 µg/g Condition: Good	5	
White paint – Focsle deck linen locker	Sample ID: 0008 Concentration: 893 µg/g Condition: Good	-	In general, the following procedures are recommended if/when removing lead-containing materials, coatings and paint applications: — Follow Type 1 – if the coating is to be removed with a chemical gel or paste; — Follow Type 2a – if the coating is to be removed by scraping or sanding using non-powered hand tools, or manual demolition of lead-painted building components by striking with sledgehammer or similar tool; — Follow Type 3a – if the coating is to be removed using power tools; or, — Follow Type 3b – if the coating is to be removed by abrasive blasting. If lead-containing paint applications and surface coatings are not removed prior to demolition, ensure that demolition waste complies with the requirements of General – Waste Management Regulation, R.R.O. 1990, Regulation 347.

PHOTO NO.	MATERIAL DESCRIPTION & LOCATION	PHOTO
<u>5</u>	Representative photo of white paint observed on the Focsle deck bulkhead.

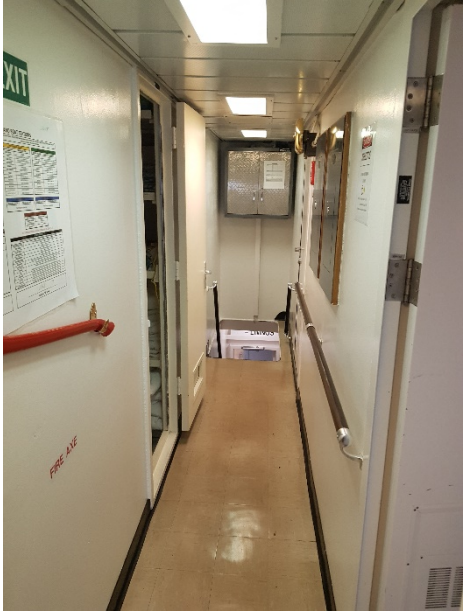
MATERIAL DESCRIPTION	ASSESSMENT	PHOTO ²	ACTION ¹
White paint – Focsle deck stair tower	Sample ID: 0010 Concentration: 19 µg/g Condition: Good	6	The concentration of lead was below 90 µg/g. Therefore, no further action is required.
White paint – Focsle deck Egen Compartment (Inboard)	Sample ID: 0011 Concentration: 6780 µg/g Condition: Good	-	<p>In general, the following procedures are recommended if/when removing lead-containing materials, coatings and paint applications:</p> <ul style="list-style-type: none"> — Follow Type 1 – if the coating is to be removed with a chemical gel or paste; — Follow Type 2a – if the coating is to be removed by scraping or sanding using non-powered hand tools, or manual demolition of lead-painted building components by striking with sledgehammer or similar tool; — Follow Type 3a – if the coating is to be removed using power tools; or, — Follow Type 3b – if the coating is to be removed by abrasive blasting. <p>If lead-containing paint applications and surface coatings are not removed prior to demolition, ensure that demolition waste complies with the requirements of General – Waste Management Regulation, R.R.O. 1990, Regulation 347.</p>

<u>6</u>	Representative photo of white paint observed on the Focsle deck stair tower.

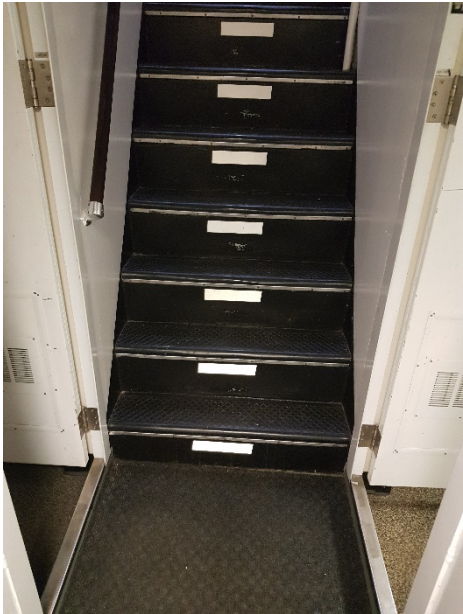
PHOTO NO.	MATERIAL DESCRIPTION & LOCATION	PHOTO
<u>7</u>	Representative photo of yellow paint on the Focsle deck FWD mast.

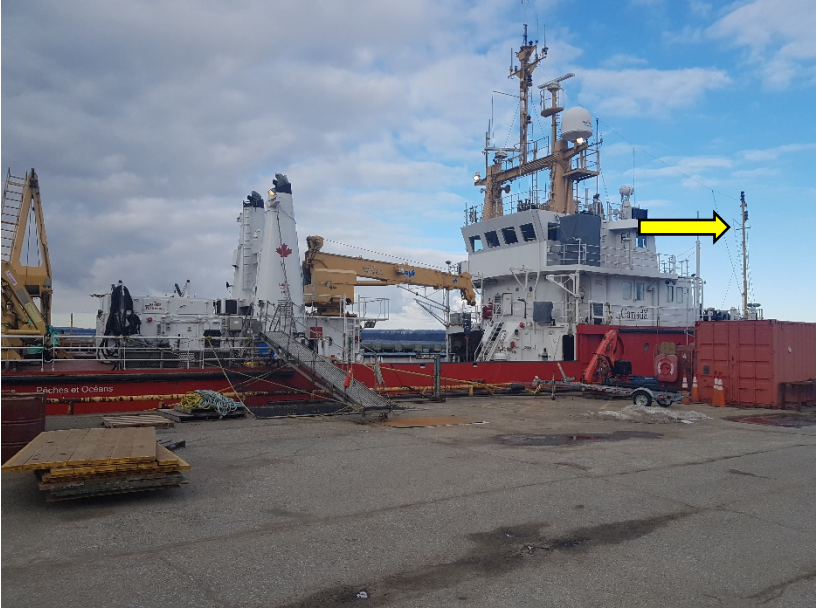
<p>A photograph of the Focsle deck FWD mast. A yellow arrow points to a section of the mast, indicating yellow paint. The ship is red and white, with various equipment and cranes visible on the deck. The name 'Béchies et Océans' is visible on the side of the ship.</p>
<u>8</u>	Representative photo of white paint observed on the main deck exterior funnel.

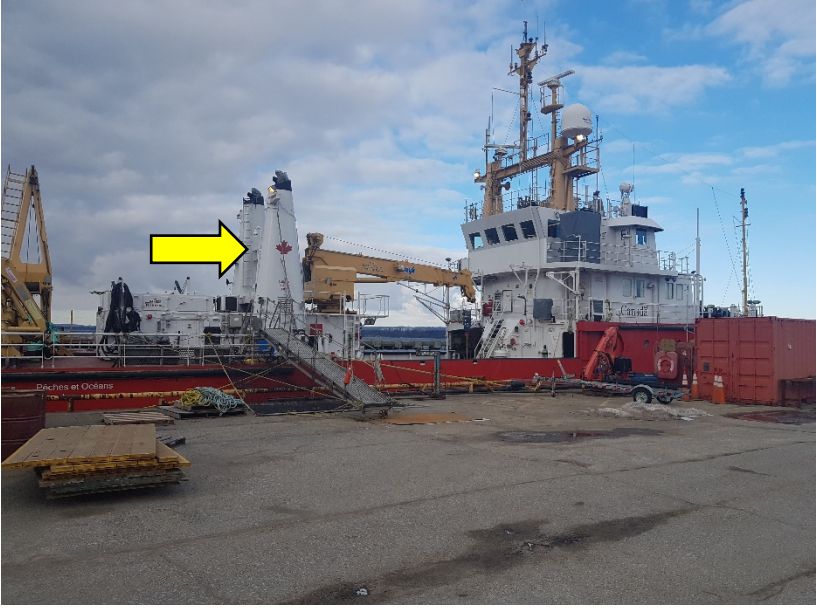
White paint – Main deck, Exterior funnel	Sample ID: 0023 Concentration: 0.09 µg/g Condition: Good	8	Mercury is present, but below the 10µg/g regulatory limit. As such, no further action is recommended.
White paint – Main deck bulworks (port)	Sample ID: 0024 Concentration: 0.04 µg/g Condition: Good	-	Mercury is present, but below the 10µg/g regulatory limit. As such, no further action is recommended.
White paint – Main deck bulworks (starboard)	Sample ID: 0025 Concentration: 0.02 µg/g Condition: Good	-	Mercury is present, but below the 10µg/g regulatory limit. As such, no further action is recommended.
White paint – Main deck, deck lockers	Sample ID: 0026 Concentration: 0.83 µg/g Condition: Good	-	Mercury is present, but below the 10µg/g regulatory limit. As such, no further action is recommended.
Yellow paint – Arva crane	Sample ID: 0027 Concentration: 0.07 µg/g Condition: Good	9	Mercury is present, but below the 10µg/g regulatory limit. As such, no further action is recommended.

<p>A photograph of the main deck exterior funnel. A yellow arrow points to a section of the funnel, indicating white paint. The ship is red and white, with various equipment and cranes visible on the deck. The name 'Béchies et Océans' is visible on the side of the ship.</p>

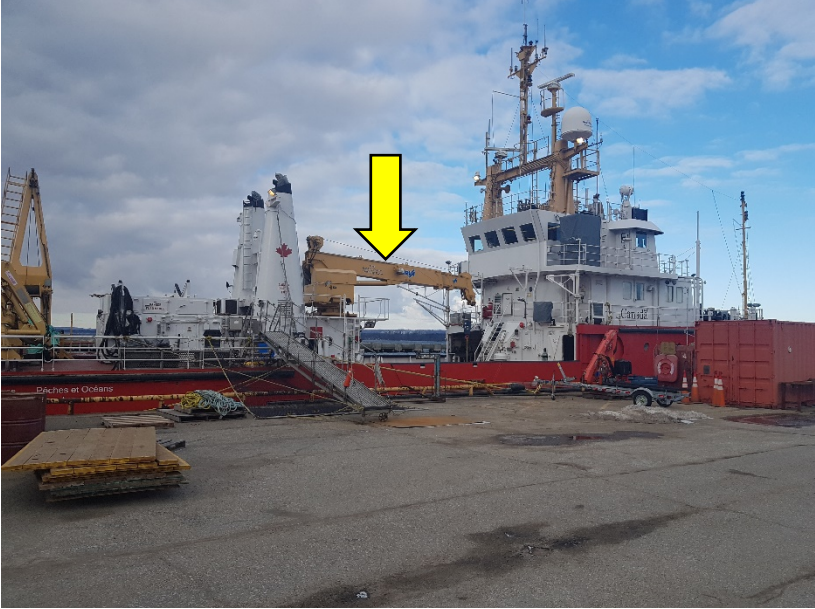
Yellow paint – Arva crane	Sample ID: 0027 Concentration: 27 µg/g Condition: Good	9	The analyte was below 90 µg/g. Therefore, no further action is required.
White paint – Main deck bulkhead	Sample ID: 0028 Concentration: 60 µg/g Condition: Good	-	
White paint – AFT deck houseworks	Sample ID: 0029 Concentration: 9320 µg/g Condition: Good	-	<p>In general, the following procedures are recommended if/when removing lead-containing materials, coatings and paint applications:</p> <ul style="list-style-type: none"> – Follow Type 1 – if the coating is to be removed with a chemical gel or paste;
White paint – Sewage compartment (bulkhead)	Sample ID: 0030 Concentration: 825 µg/g Condition: Good	10	<ul style="list-style-type: none"> – Follow Type 2a – if the coating is to be removed by scraping or sanding using non-powered hand tools, or manual demolition of lead-painted building components by striking with sledgehammer or similar tool;

PHOTO NO.	MATERIAL DESCRIPTION & LOCATION	PHOTO
<u>9</u>	Representative photo of the yellow paint observed on the Arva crane.

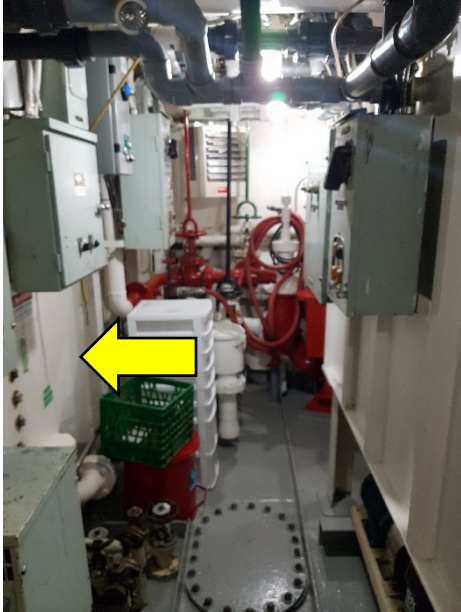
<u>10</u>	Representative photo of white paint observed on the sewage compartment bulkhead.

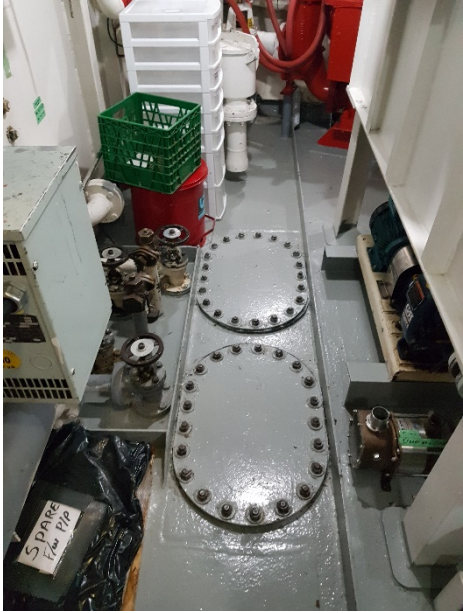
MATERIAL DESCRIPTION	ASSESSMENT	PHOTO ²	ACTION ¹
Grey paint – Sewage compartment (deck)	Sample ID: 0032 Concentration: 332 µg/g Condition: Good	11	If lead-containing paint applications and surface coatings are not removed prior to demolition, ensure that demolition waste complies with the requirements of General – Waste Management Regulation, R.R.O. 1990, Regulation 347.
White paint – Sewage compartment (grey water tank)	Sample ID: 0033 Concentration: 67 µg/g Condition: Good	12	The concentration of lead was below 90 µg/g. Therefore, no further action is required.
White paint – Tank top stair tower	Sample ID: 0034 Concentration: 82 µg/g Condition: Good	-	
White paint – Tank top (cleaning locker)	Sample ID: 0035 Concentration: 33 µg/g Condition: Good	13	
White paint – Tank top (incinerator room)	Sample ID: 0036 Concentration: 20 µg/g Condition: Good	14	
White paint – Tank top (heads)	Sample ID: 0037 Concentration: 113 µg/g Condition: Good	15	In general, the following procedures are recommended if/when removing lead-containing materials, coatings and paint applications: <ul style="list-style-type: none"> – Follow Type 1 – if the coating is to be removed with a chemical gel or paste; – Follow Type 2a – if the coating is to be removed by scraping or sanding using non-powered hand tools, or manual demolition of lead-painted building components by striking with sledgehammer or similar tool; – Follow Type 3a – if the coating is to be removed using power tools; or, – Follow Type 3b – if the coating is to be removed by abrasive blasting. If lead-containing paint applications and surface coatings are not removed prior to demolition,

PHOTO NO.	MATERIAL DESCRIPTION & LOCATION	PHOTO
<u>11</u>	Representative photo of the grey paint observed on the sewage compartment deck.

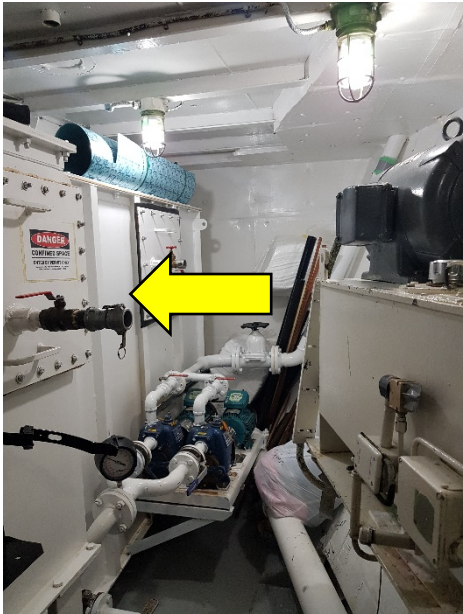
White paint – Sewage compartment (grey water tank)	Sample ID: 0033 Concentration: 0.15 µg/g Condition: Good	12	Mercury is present, but below the 10µg/g regulatory limit. As such, no further action is recommended.
White paint – Tank top stair tower	Sample ID: 0034 Concentration: 0.09 µg/g Condition: Good	-	Mercury is present, but below the 10µg/g regulatory limit. As such, no further action is recommended.
White paint – Tank top (cleaning locker)	Sample ID: 0035 Concentration: 0.08 µg/g Condition: Good	13	Mercury is present, but below the 10µg/g regulatory limit. As such, no further action is recommended.
White paint – Tank top (incinerator room)	Sample ID: 0036 Concentration: 0.03 µg/g Condition: Good	14	Mercury is present, but below the 10µg/g regulatory limit. As such, no further action is recommended.
White paint – Tank top (heads)	Sample ID: 0037 Concentration: 0.10 µg/g Condition: Good	15	Mercury is present, but below the 10µg/g regulatory limit. As such, no further action is recommended.

<u>12</u>	Representative photo of the white paint observed on the grey water tank in the sewage compartment.

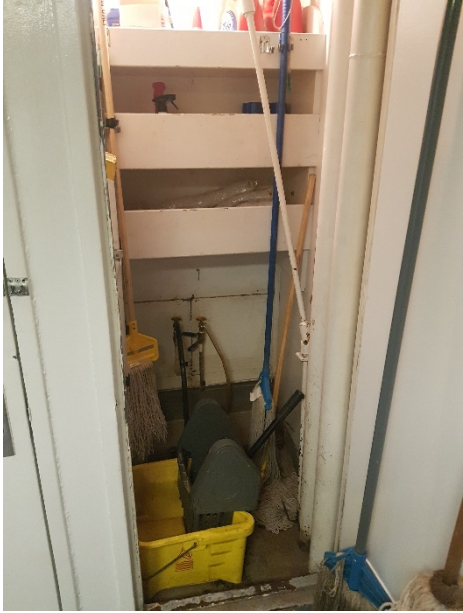
PHOTO NO.	MATERIAL DESCRIPTION & LOCATION	PHOTO
<u>13</u>	Representative photo of the white paint observed in the tank top cleaning locker.

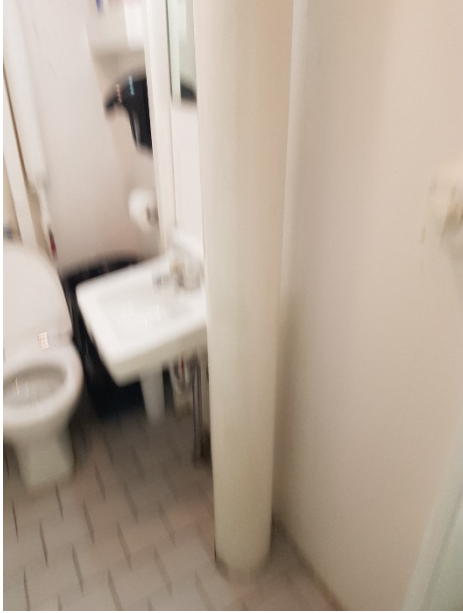
PHOTO NO.	MATERIAL DESCRIPTION & LOCATION	PHOTO
<u>15</u>	Representative photo of the white paint observed in the tank top heads (washrooms).

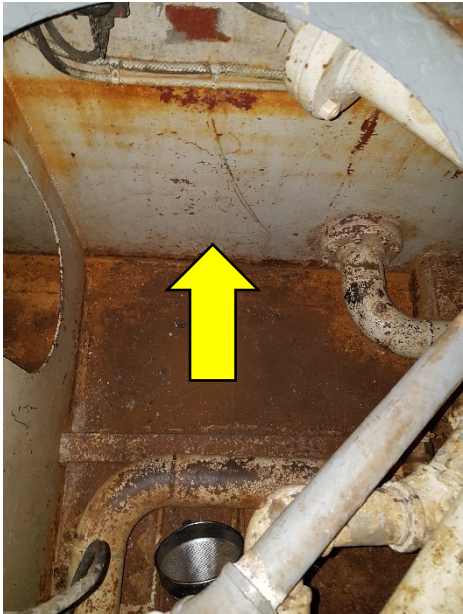
Grey paint – FWD void space	Sample ID: 0038 Concentration: 1420 µg/g Condition: Good	16	
Red paint – AFT void space	Sample ID: 0039 Concentration: 5040 µg/g Condition: Good	17	
Red paint – AFT cofferdam	Sample ID: 0040 Concentration: 27600 µg/g Condition: Good	18

<u>16</u>	Representative photo of the grey paint in the FWD void space.

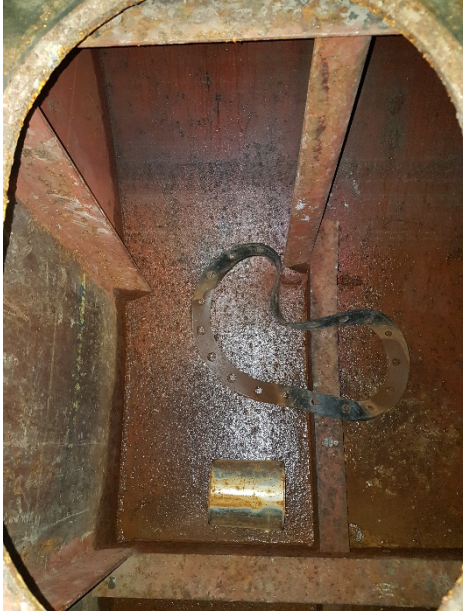
PHOTO NO.	MATERIAL DESCRIPTION & LOCATION	PHOTO
<u>17</u>	Representative photo of the red paint in the AFT void space.

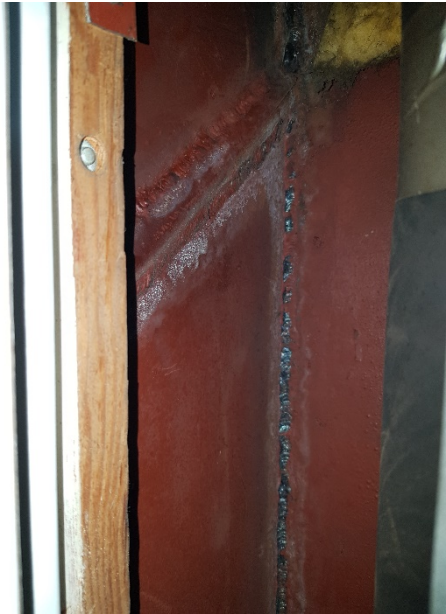
<u>18</u>	Representative photo of the red paint in the AFT cofferdam.

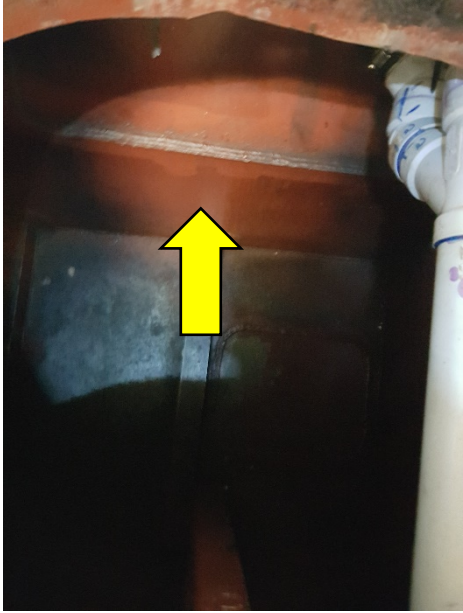
MATERIAL DESCRIPTION	ASSESSMENT	PHOTO ²	ACTION ¹
Red paint – Echo sunder compartment	Sample ID: 0041 Concentration: 62500 µg/g Condition: Good	19	ensure that demolition waste complies with the requirements of General – Waste Management Regulation, R.R.O. 1990, Regulation 347.
White paint – Engine room (port deckhead)	Sample ID: 0042 Concentration: 955 µg/g Condition: Good	-	
White paint – Engine room (starboard deckhead)	Sample ID: 0043 Concentration: 454 µg/g Condition: Good	-	
White paint – Engine room (bulkhead port)	Sample ID: 0044 Concentration: 3260 µg/g Condition: Good	-	
White paint – Engine room (bulkhead starboard)	Sample ID: 0045 Concentration: 7460 µg/g Condition: Good	-	
Old exhaust lagging	Sample ID: 0046 Concentration: <10 µg/g Condition: Good	20	The concentration of lead was below 90 µg/g. Therefore, no further action is required.
Green paint – MCR bulkhead	Sample ID: 0047 Concentration: 10700 µg/g Condition: Good	-	In general, the following procedures are recommended if/when removing lead-containing materials, coatings and paint applications: — Follow Type 1 – if the coating is to be removed with a chemical gel or paste;

PHOTO NO.	MATERIAL DESCRIPTION & LOCATION	PHOTO
<u>19</u>	Representative photo of the red paint observed in the Echo Sounder Compartment.

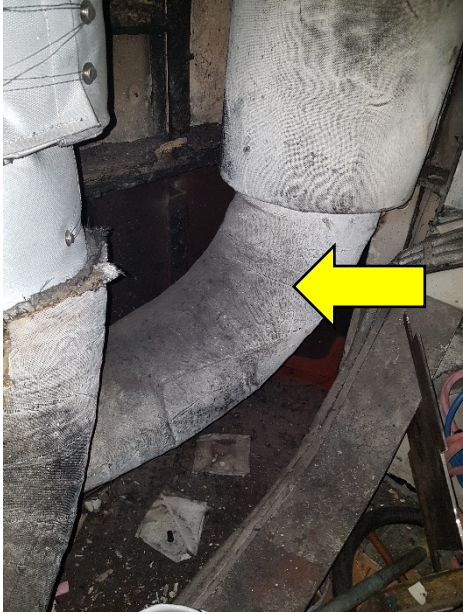
<u>20</u>	Representative photo of the old exhaust lagging.
