**Department of Fisheries and
Oceans**

**Cape Race Building Demolitions
Project No. F5211-200346**

Issued for Tender

October 16, 2020
CBCL Project No. 203055.00

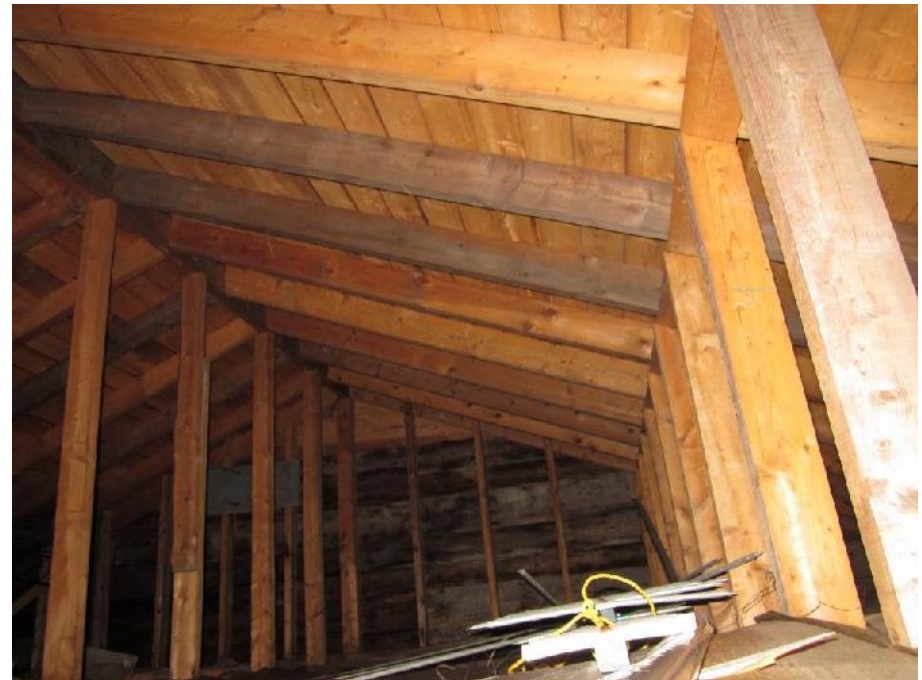
Photo 4: View of the attic in the Former Dwelling. Note dark-stained wood on exterior wall.

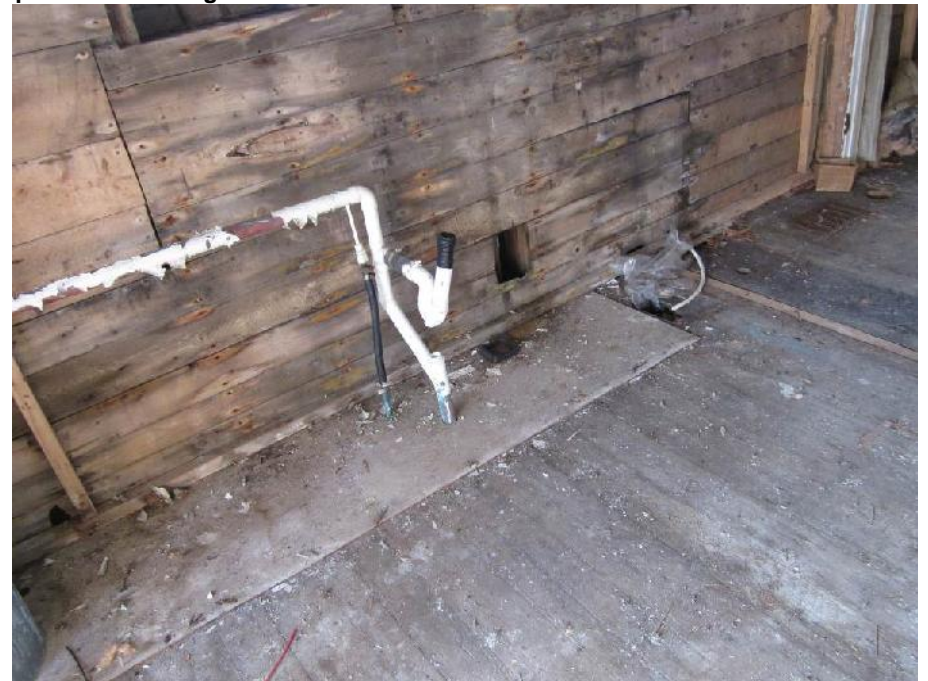
Photo 8: View of exposed piping in the kitchen (Room 2) of the Former Dwelling. Note dark-stained wood on exterior wall.

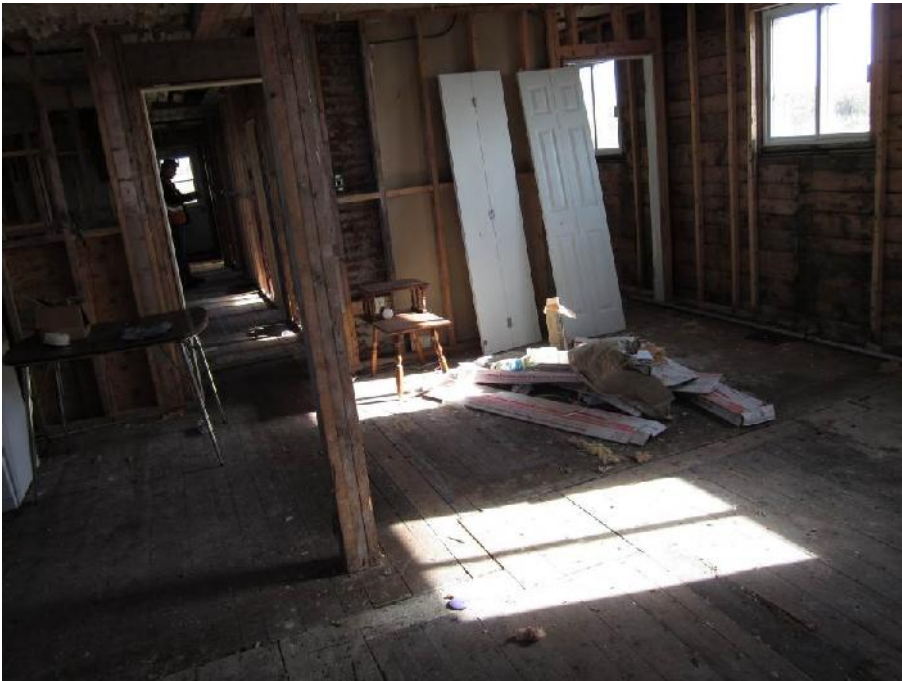
Photo 9: View of the dining room (Room 3) in the Former Dwelling. Note drywall near brick chimney in the adjacent control room (Room 5).

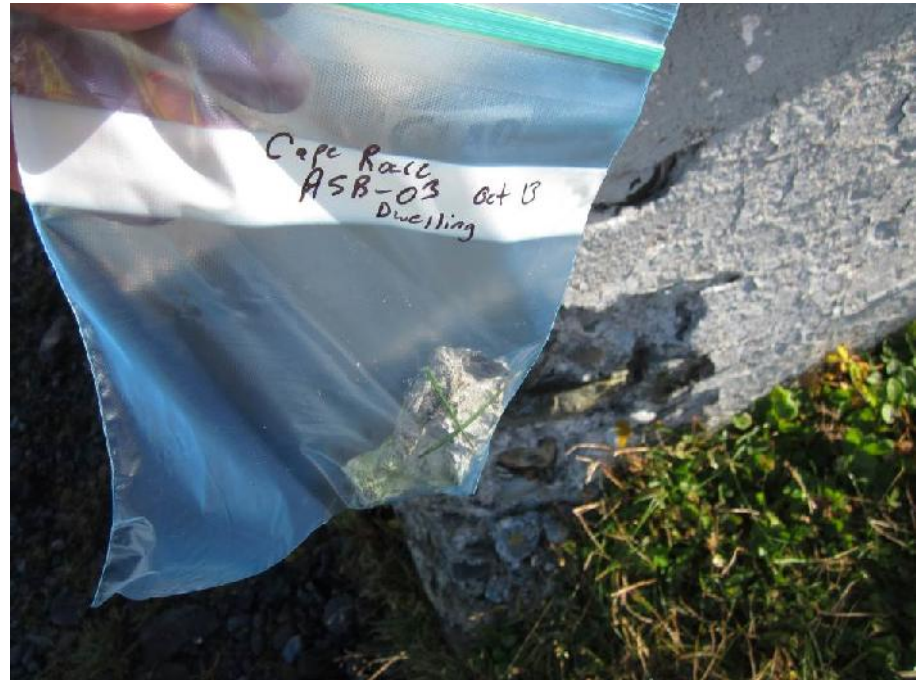
Photo 22: View of location of concrete sample ASB-03 (exterior foundation wall).

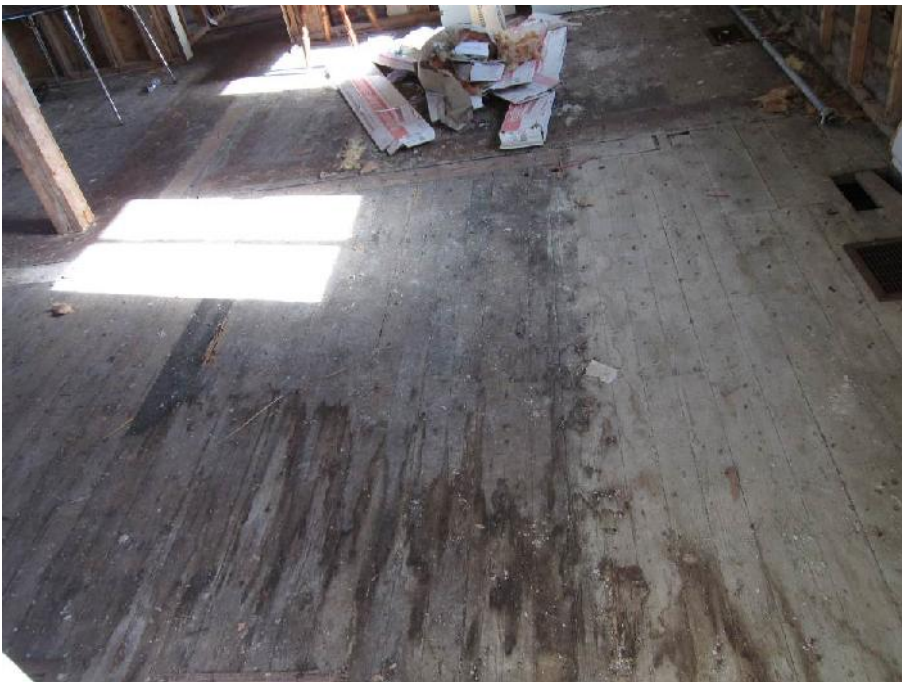
Photo 51: View of dark-coloured water staining on the surface of the wood floor in Room 3.

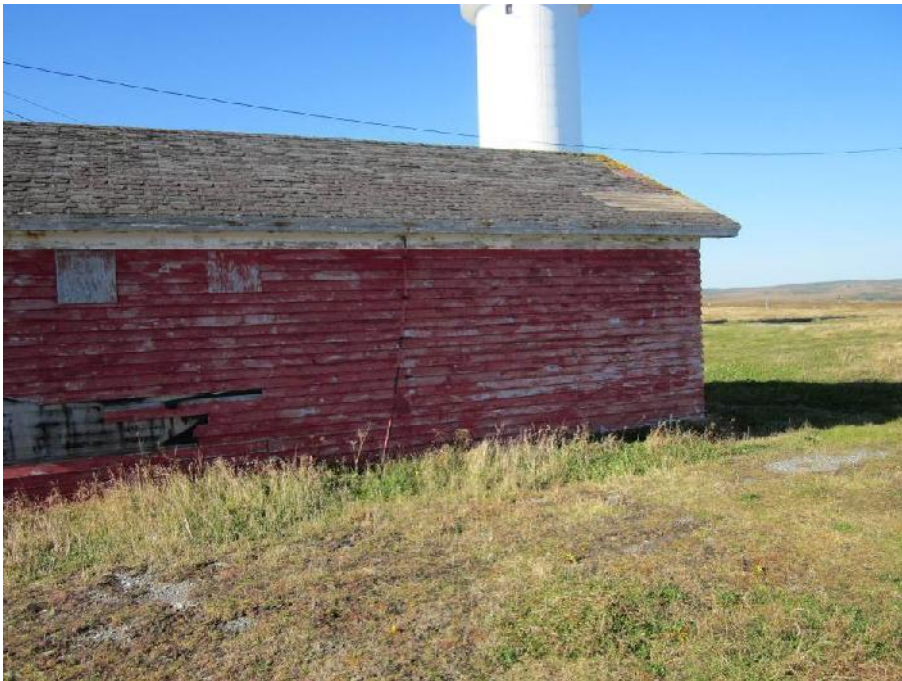
Photo 3: View of the southeast side of the Former Generator Building. Note: Missing roofing materials.

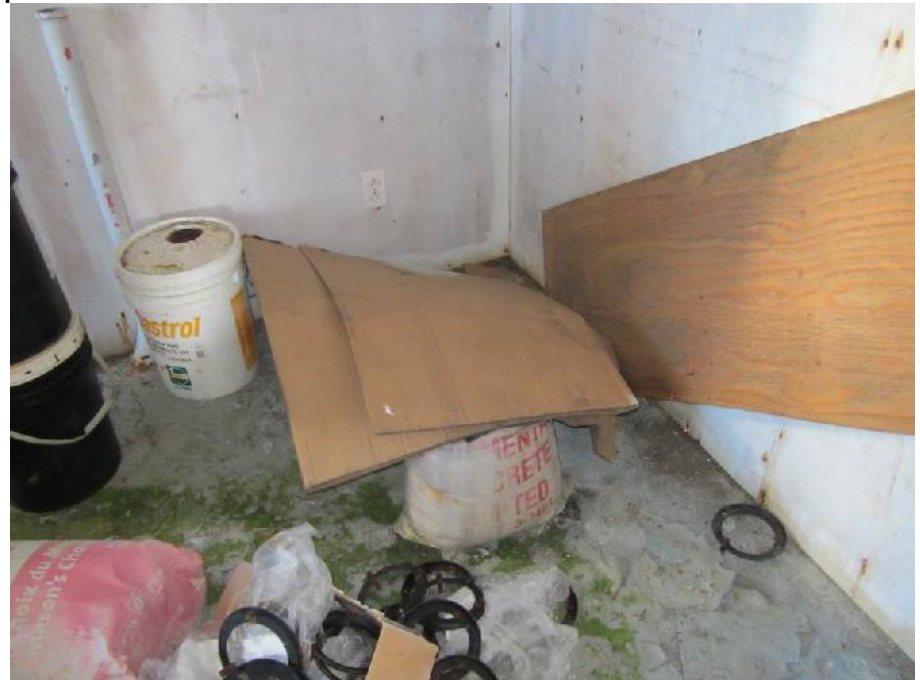
Photo 12: View of 5 gallon pails of hydraulic oil in Room 2 of the Former Generator Building. Note: Pipe in background and green staining on the floor.
