# ANNEX C: ENVIRONMENTAL REQUIREMENTS

**CFB Comox FFTA Source Control Project**

# ENVIRONMENTAL MANAGEMENT PLAN

November 2020

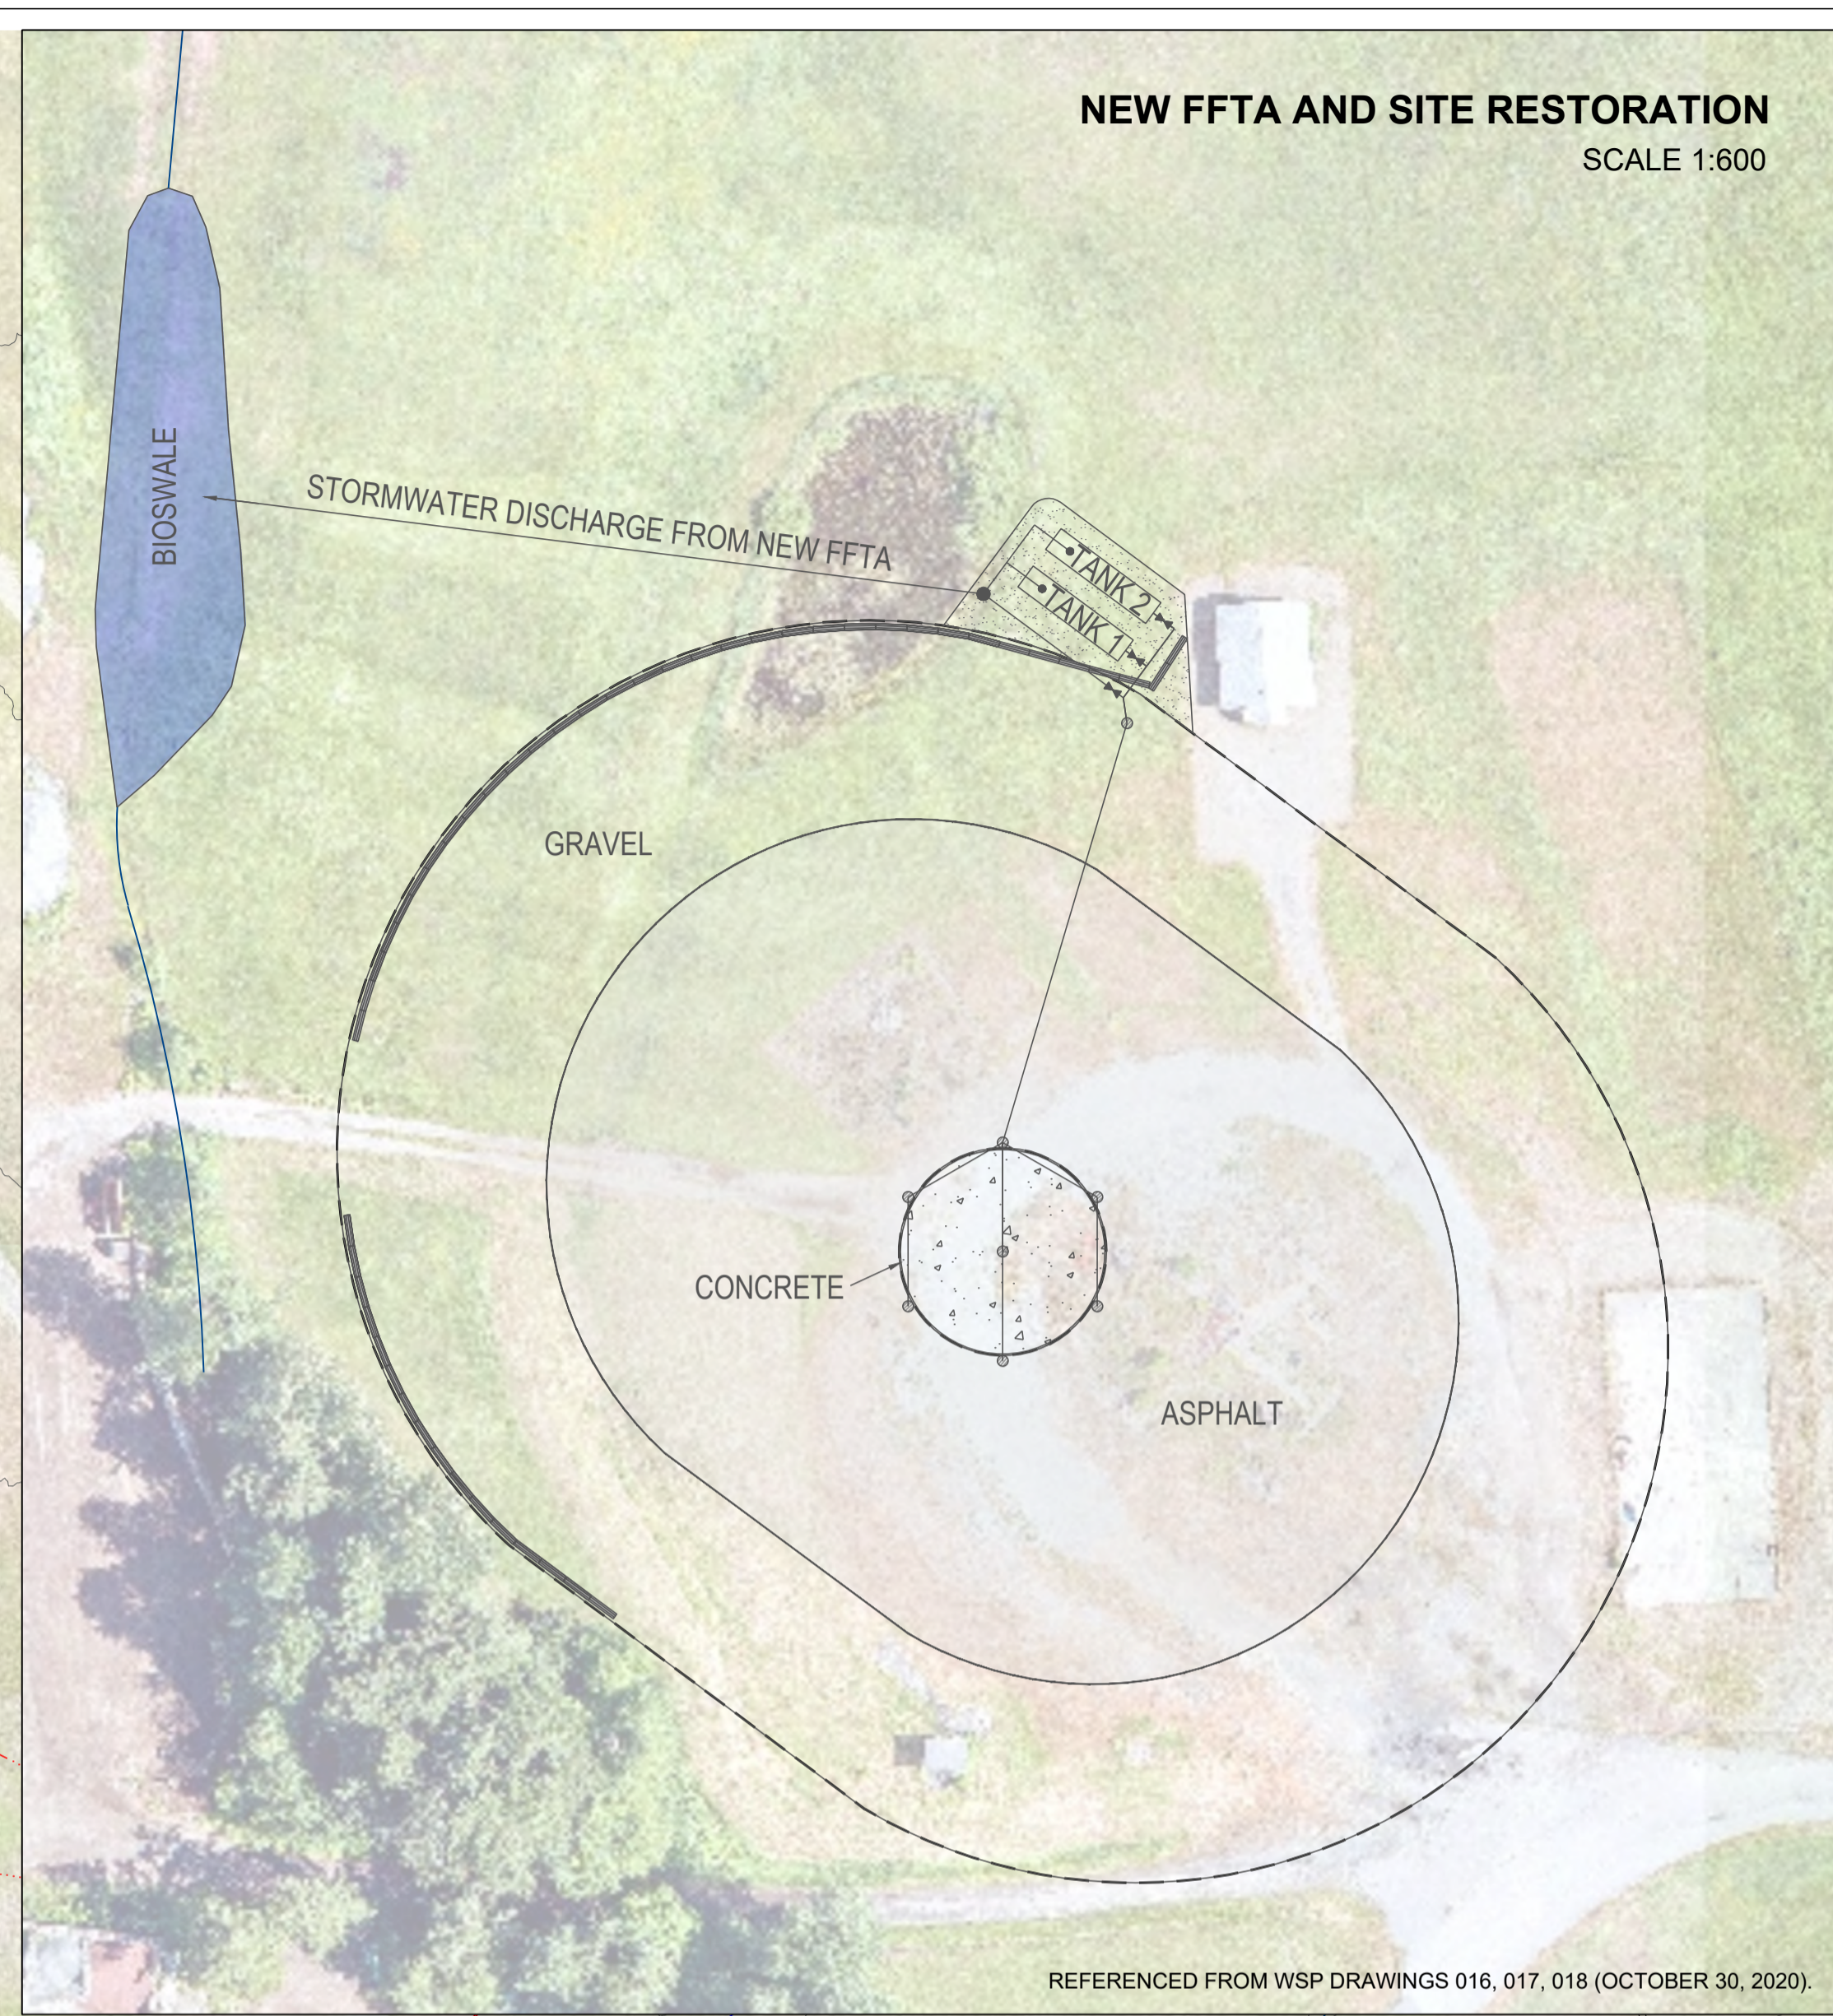
NO. SRT | WBS NO. - NO. DP | PF NO. -  
NO. DESSIN | DWG. NO. 003

**NEW FFTA AND SITE RESTORATION**  
SCALE 1:600

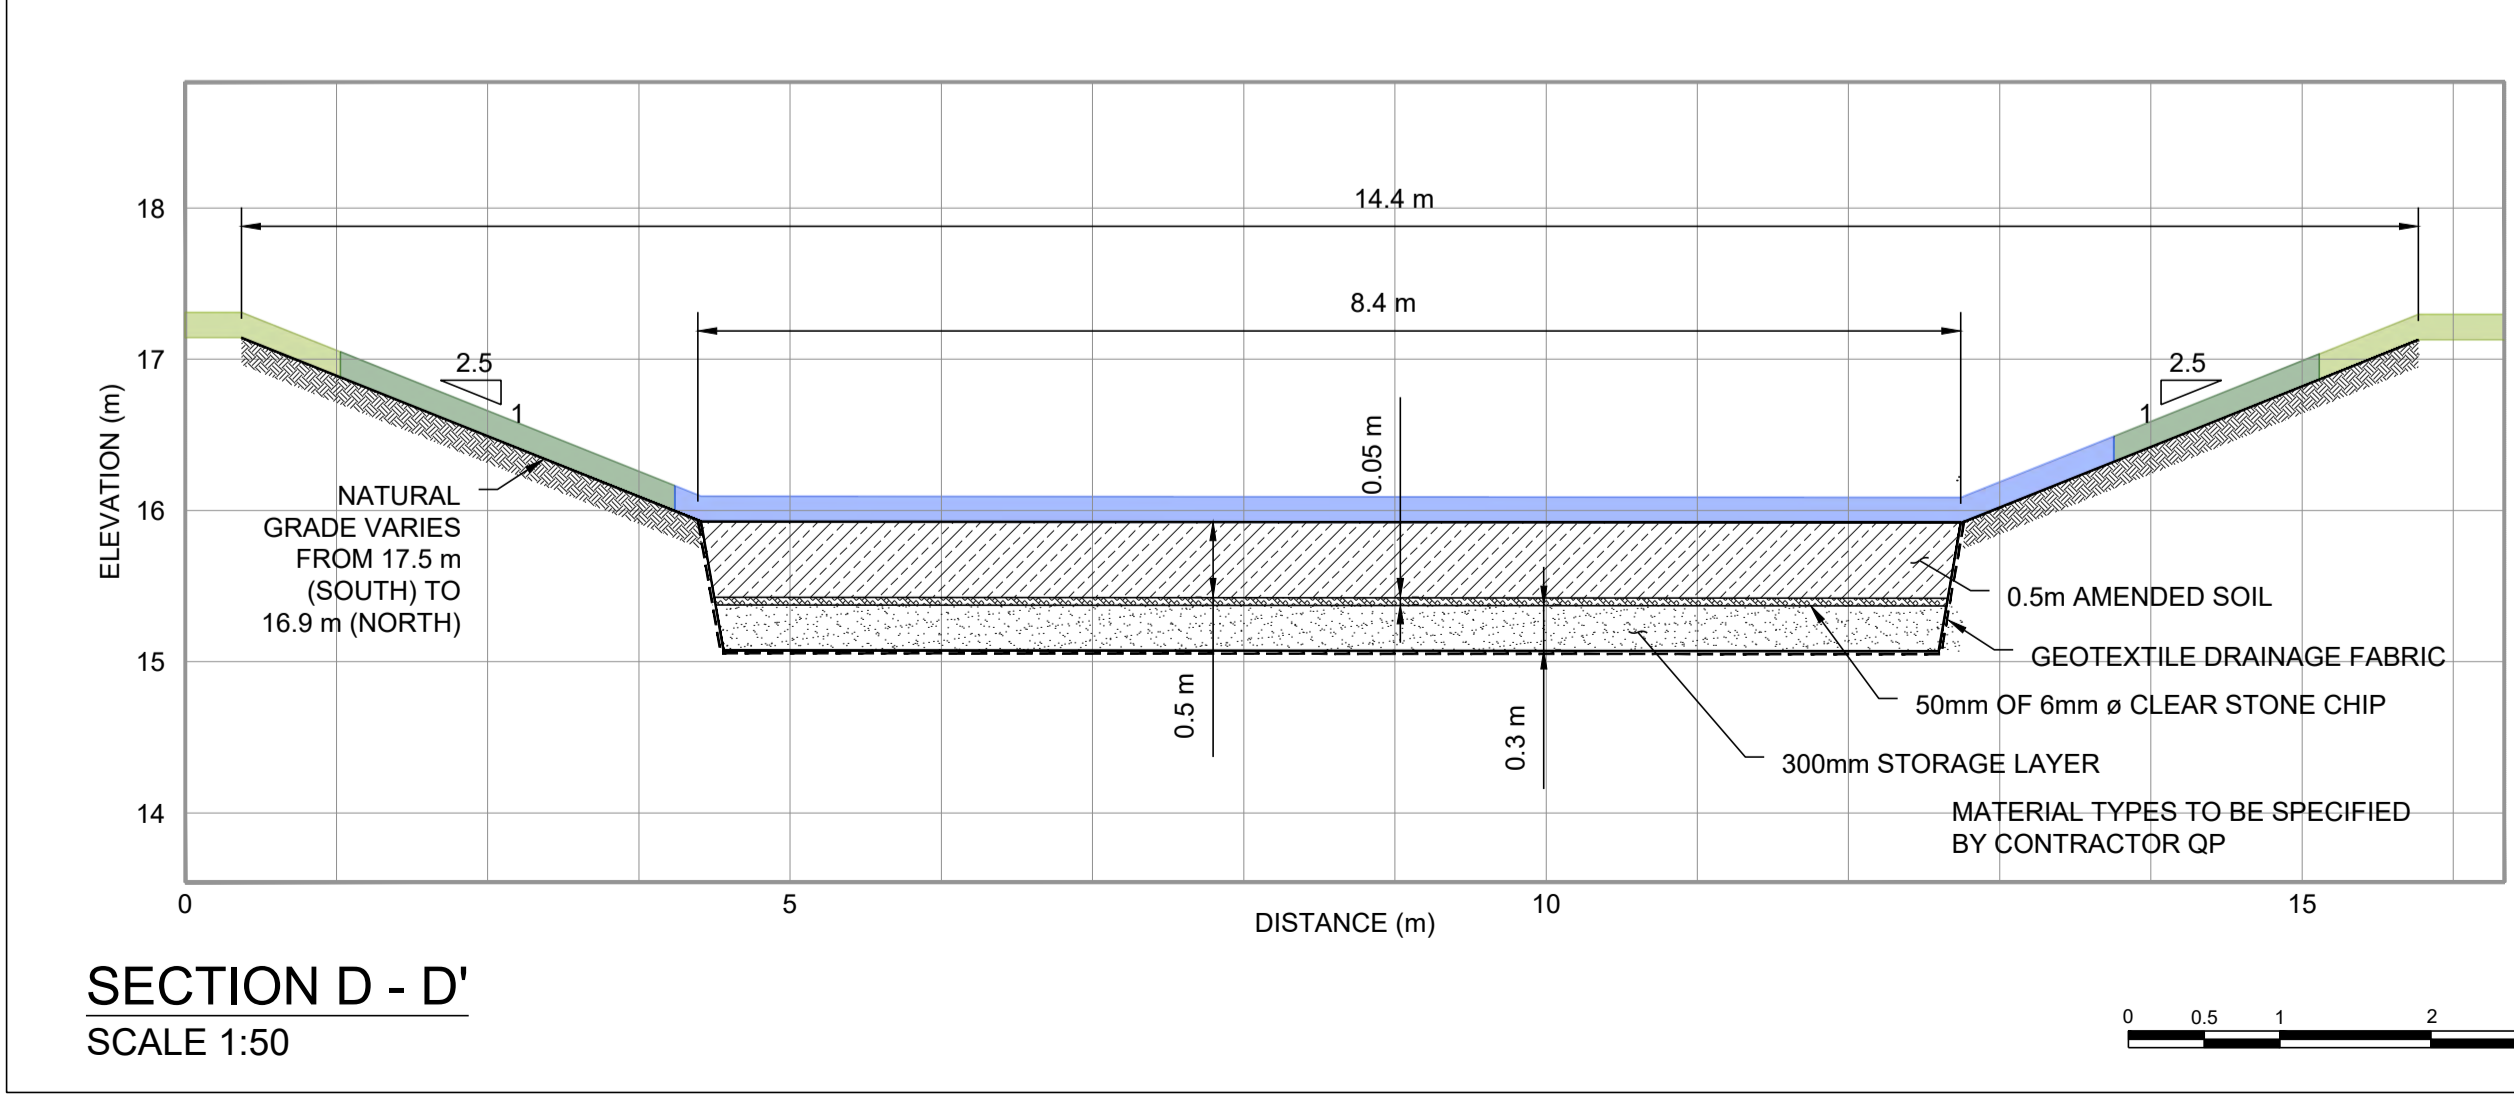
NO. DESSIN | DWG. NO. 019

- PROPOSED NATIVE PLANTING ZONE DETAILS**
- TOP OF SLOPE** Plant via hydroseeding with native grass mix per CFB Comox Specifications
- SIDE SLOPE** Locate above 0.5 m from bioswale constructed soil base; designed to be periodically submerged. Plant a combination of mature (~60%) and seedlings (~40%) of the following types at closest recommended spacing or as recommended by QP.
- willows (*Salix* sp.), pacific or sitka
  - black hawthorn (*Crataegus douglasii*),
  - saskatoon (*Amelanchier alnifolia*),
- INUNDATION ZONE** Area will be seasonally submerged. Plant a combination of mature (~60%) and seedlings (~40%) of the following types at closest recommended spacing or as recommended by QP.
- water smartweed (*Persicaria amphibia*)
  - sitka sedge (*Carex sitchensis*),
  - slough sedge (*obunupta*)
  - water sedge (*aquatilis*)
  - creeping spike-rush (*Eleocharis palustris*),

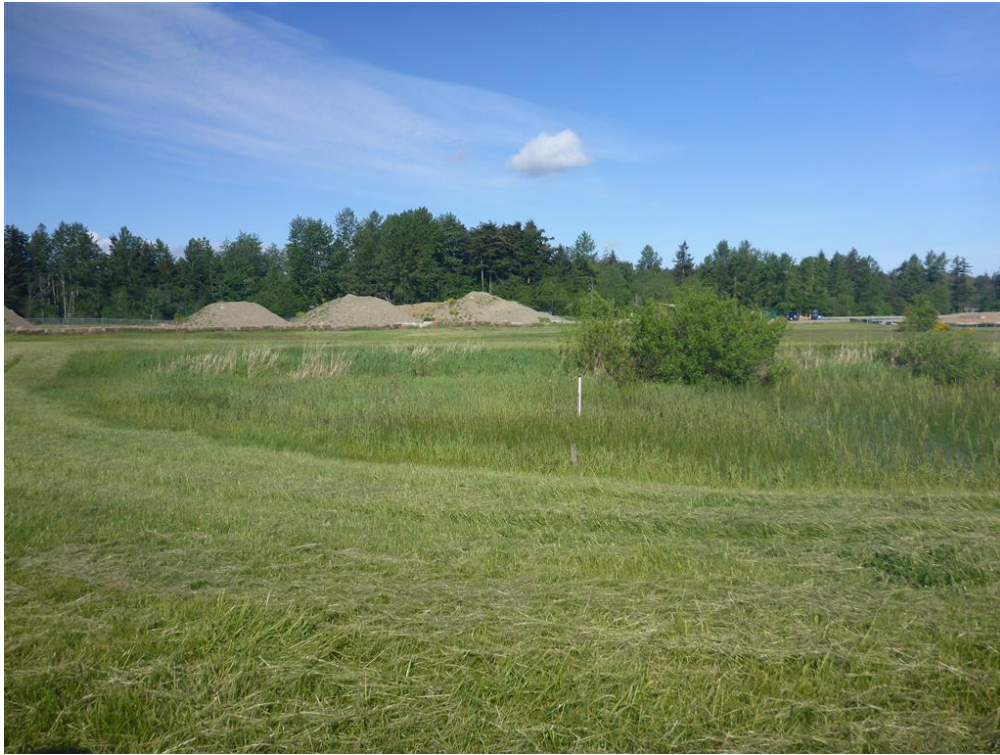
**Photo 1:** View of the retention pond within the FFTA, facing northwest.

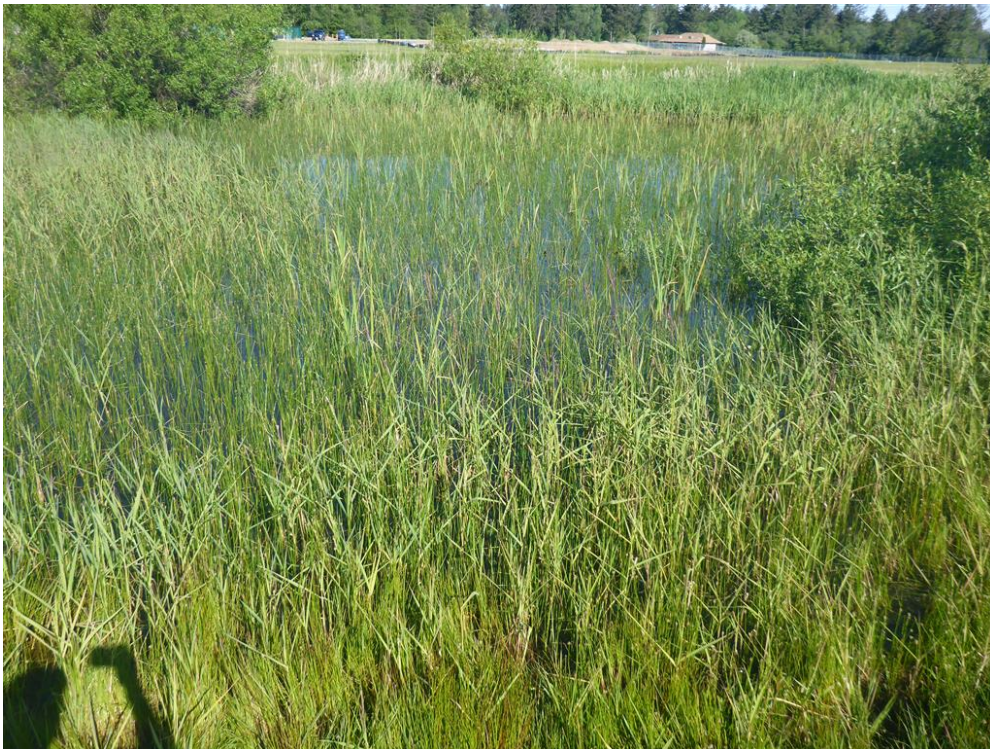
**Photo 2:** Standing water and emergent aquatic vegetation in the retention pond.

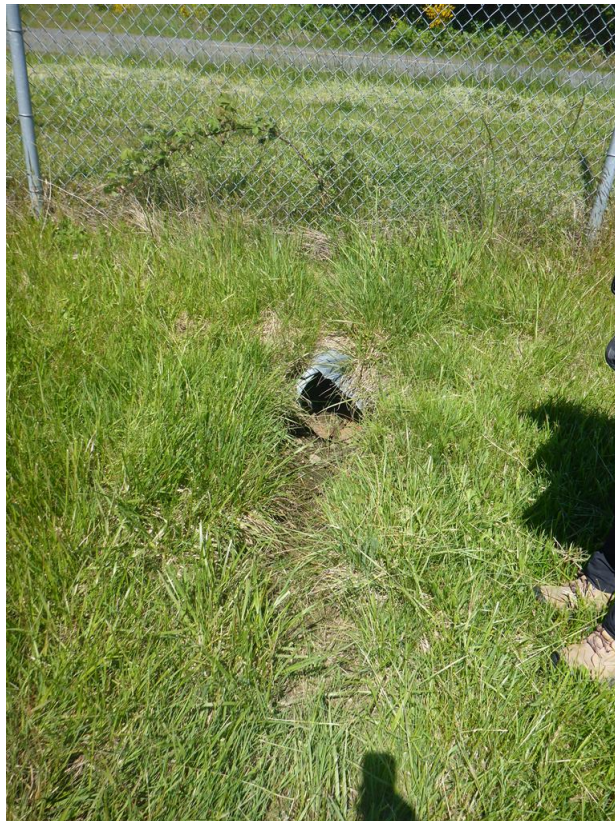
**Photo 8:** Culvert at the north end of the northwest swale.

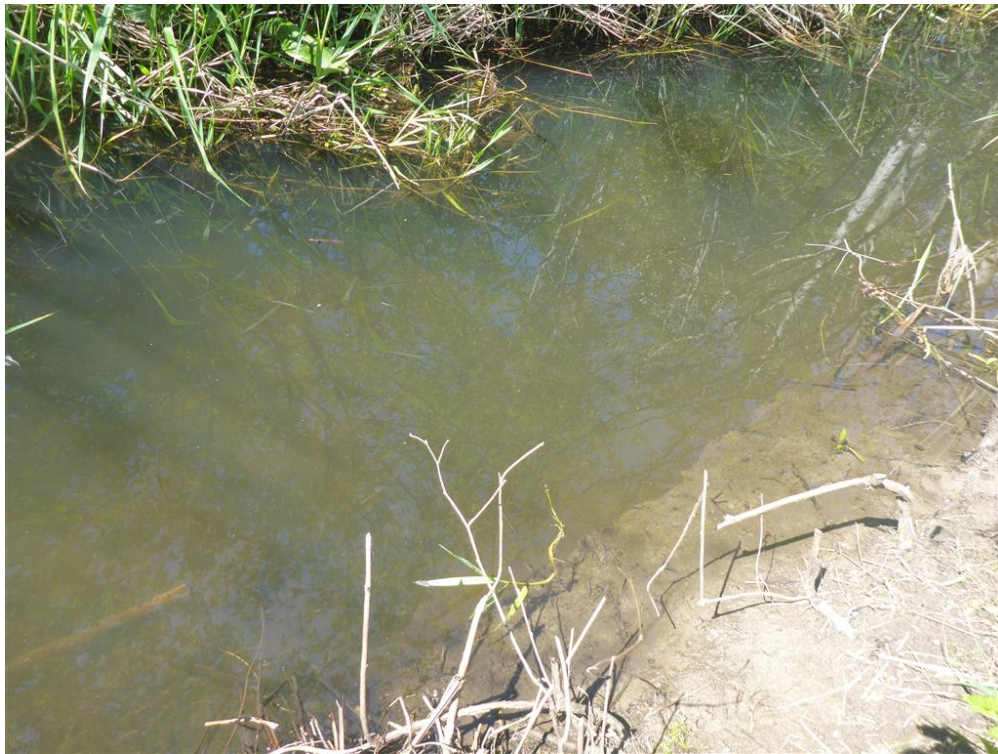
**Photo 18:** Slow moving, silty water near the culverts for the access road crossing.

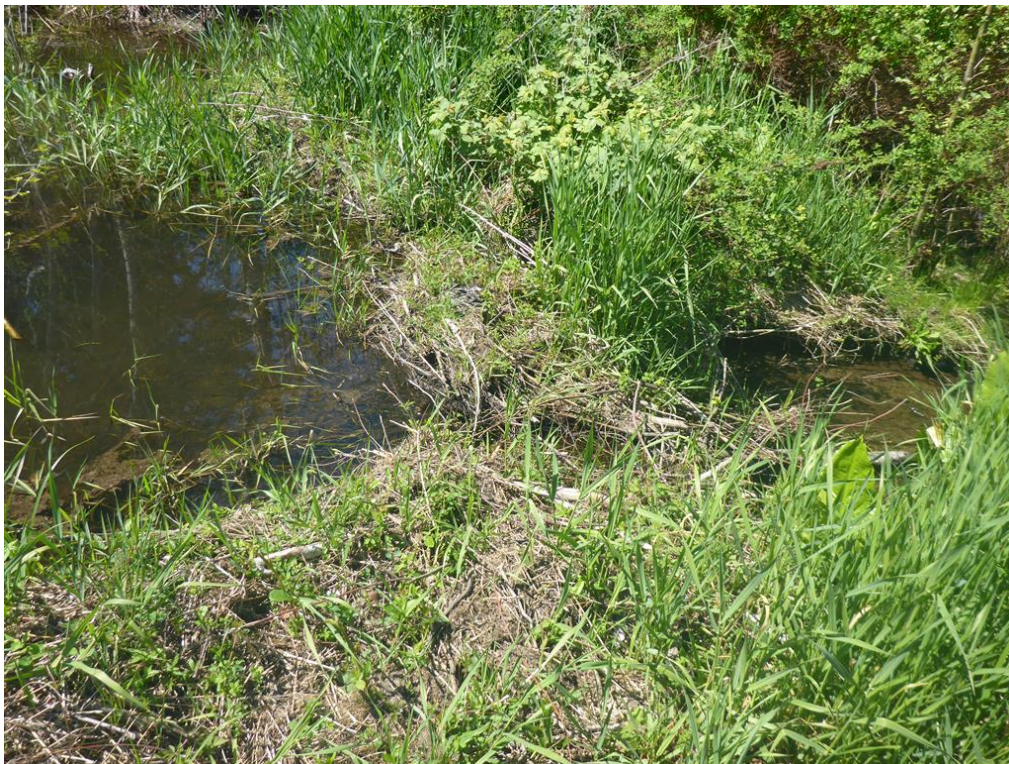
**Photo 22:** View of the dammed area along Scales Creek.

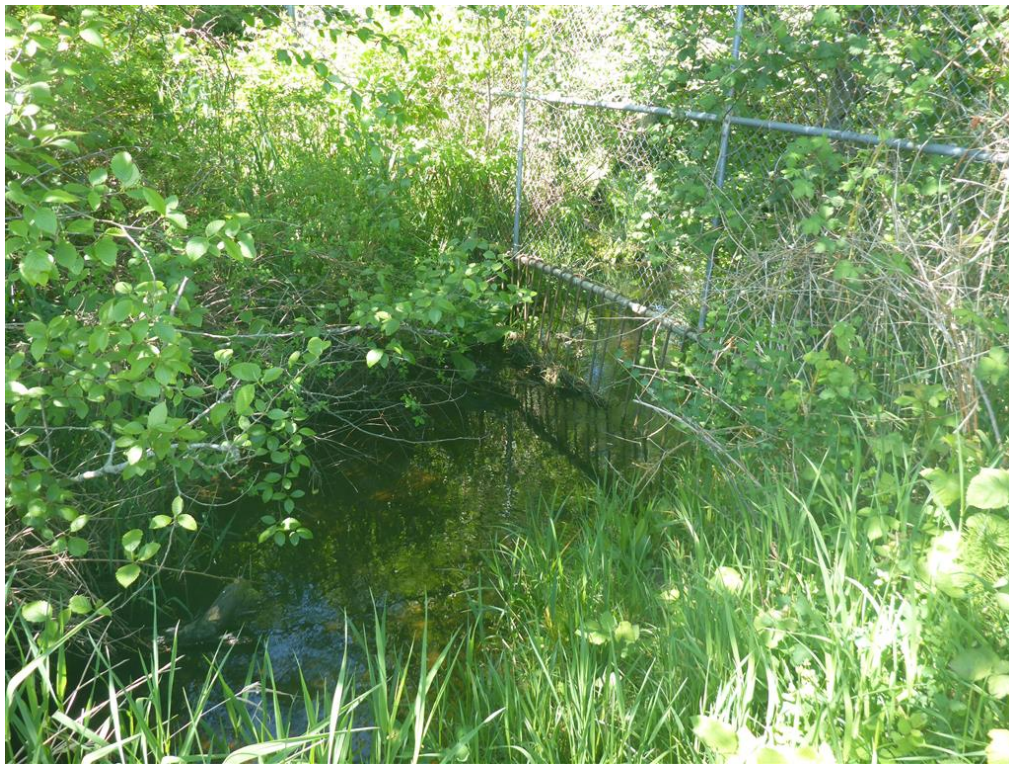
**Photo 24:** View of the in-stream barrier along the fence line.

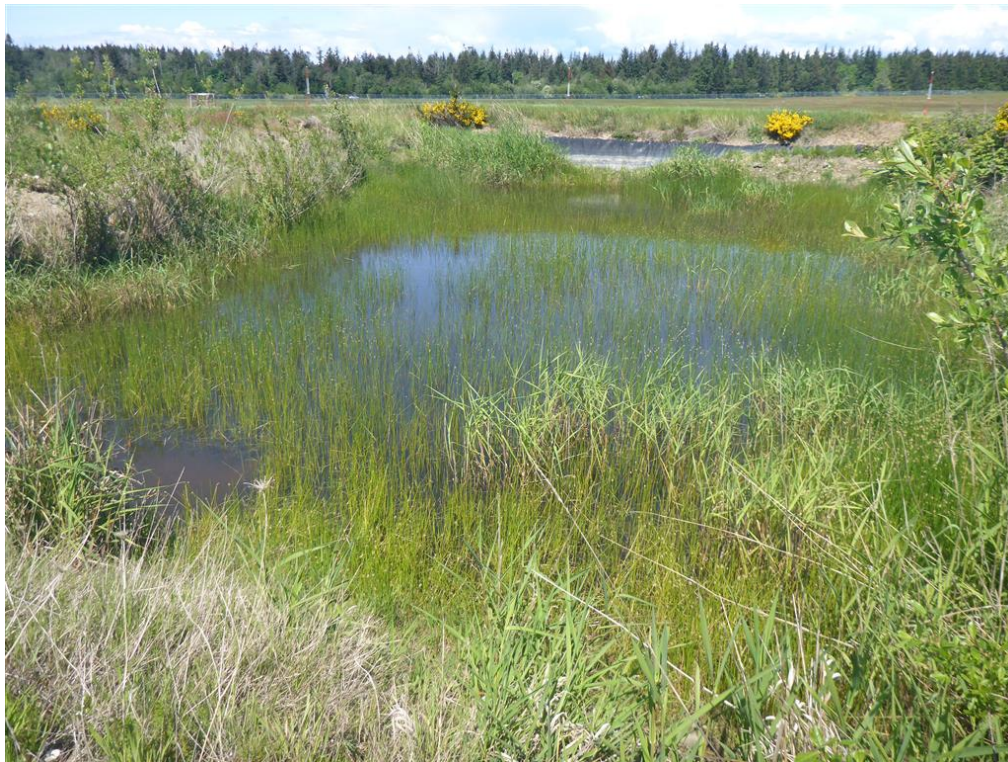
**Photo 25:** View of the soil treatment area dugout.

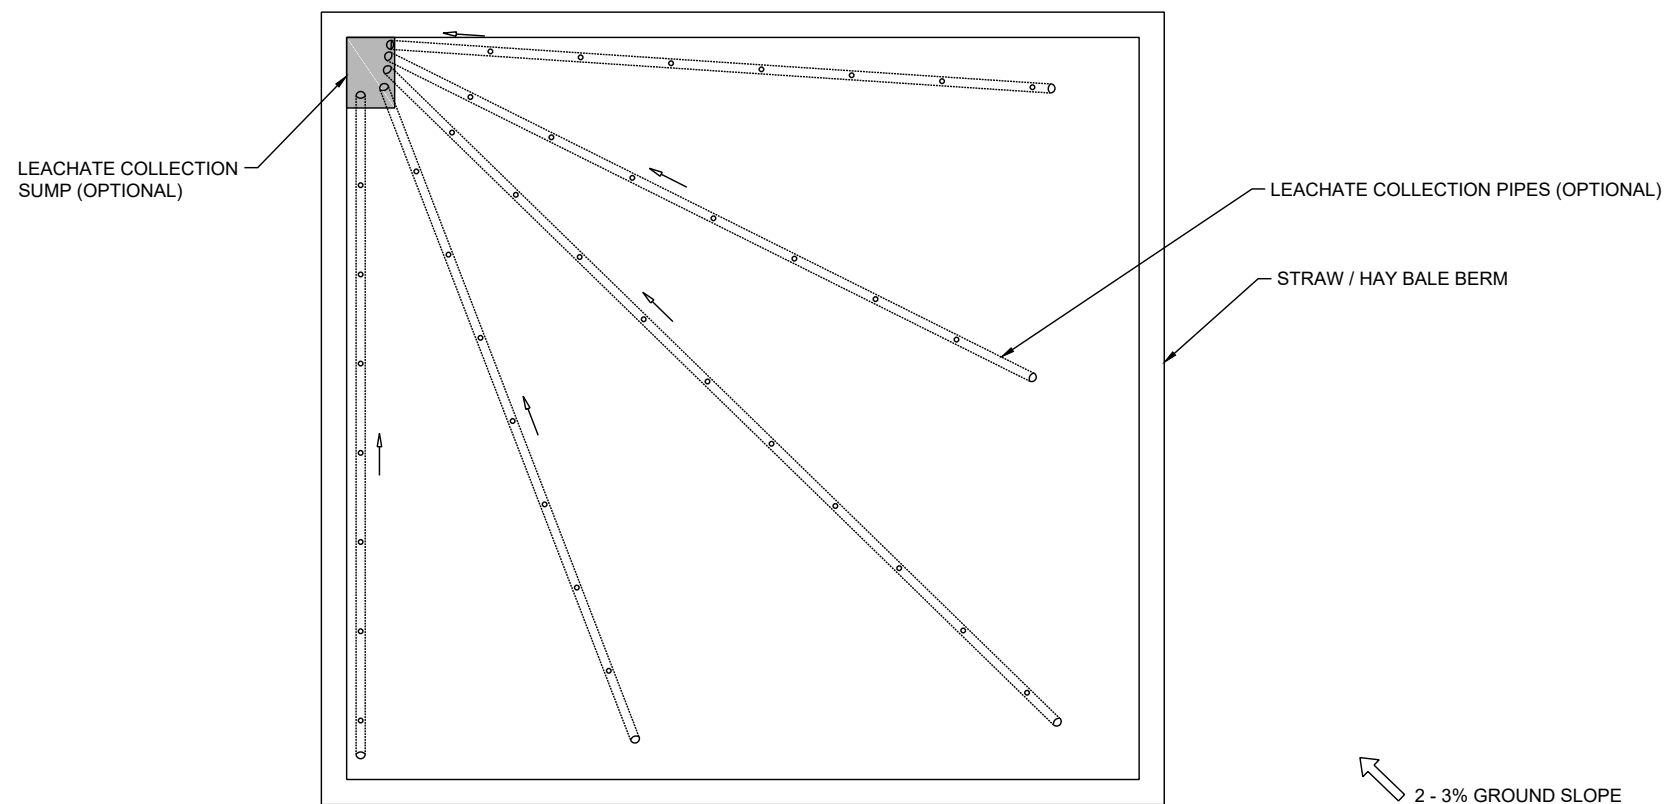
**PLAN**

STORAGE CELL DIMENSIONS AND AREA BASED ON EX-SITU SOIL VOLUMES			
Volume	Inner Dimension of Cell	Outer Dimension of Cell	Minimum Area Required*
10 m <sup>3</sup>	2 m x 3 m	4 m x 5 m	42 m <sup>2</sup>
50 m <sup>3</sup>	5 m x 6 m	7 m x 8 m	90 m <sup>2</sup>
100 m <sup>3</sup>	7 m x 8 m	9 m x 10 m	132 m <sup>2</sup>
250 m <sup>3</sup>	8 m x 17 m	10 m x 19 m	252 m <sup>2</sup>

Notes:  
 m - meters  
 dimensions referenced are for general estimates only. Final dimensions to be determined by contractor.  
 area referenced based on berm thickness of 1m and maximum cell height of 2.0m  
 \* estimated area required based on need to secure the cover and liner in place.

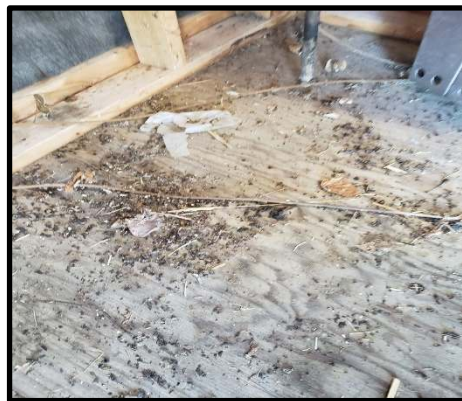
Rodent droppings were observed to be sparsely distributed on the flooring within the Subject Building. A photographic illustration of the rodent droppings is presented below.

Illustration of rodent droppings sparsely distributed throughout the floor of the Subject Building.

When removing rodent droppings, ensure a site-specific risk assessment and exposure control program are developed appropriate controls are in place. Refer to WorkSafeBC publication entitled, “*A Hantavirus Exposure Control Program for Employers and Workers*”, dated 2006.

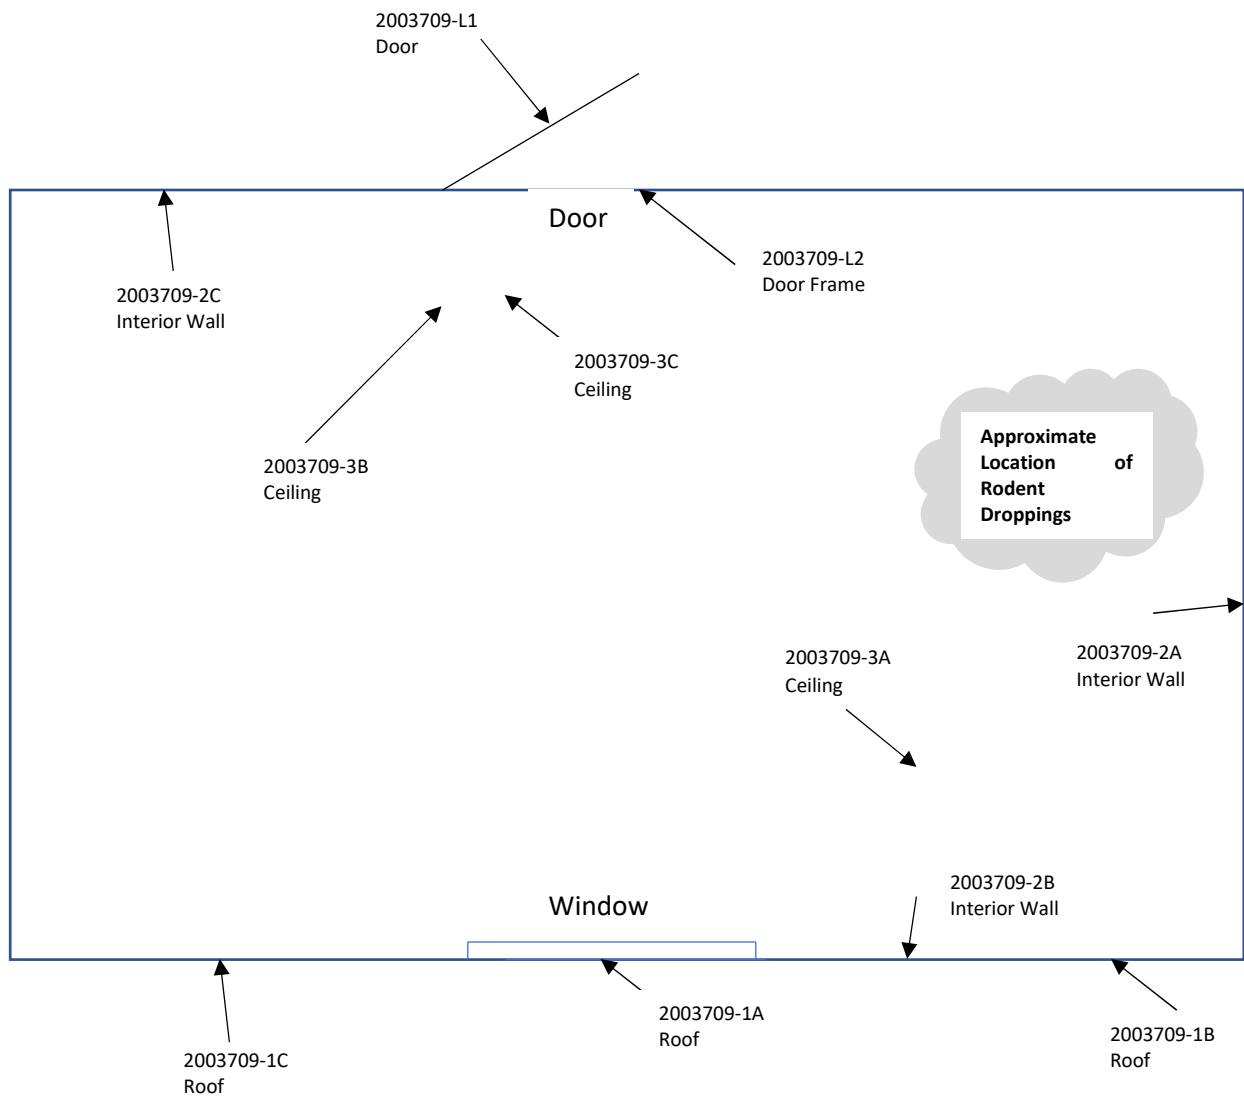
**Asbestos and Lead  
Sample Point Locations at SHED 273  
DND COMOX**

**Plan Drawing of Shed 273  
DND Comox, Comox, BC  
September 21, 2020**
