# Kwìkwèxwelhp Healing Village Environmental Effects Evaluation Access Road Repairs, Regrading and Culvert Upgrades

**Public Services and Procurement  
Canada**

**Hemmera Envirochem Inc.**

May 27, 2019

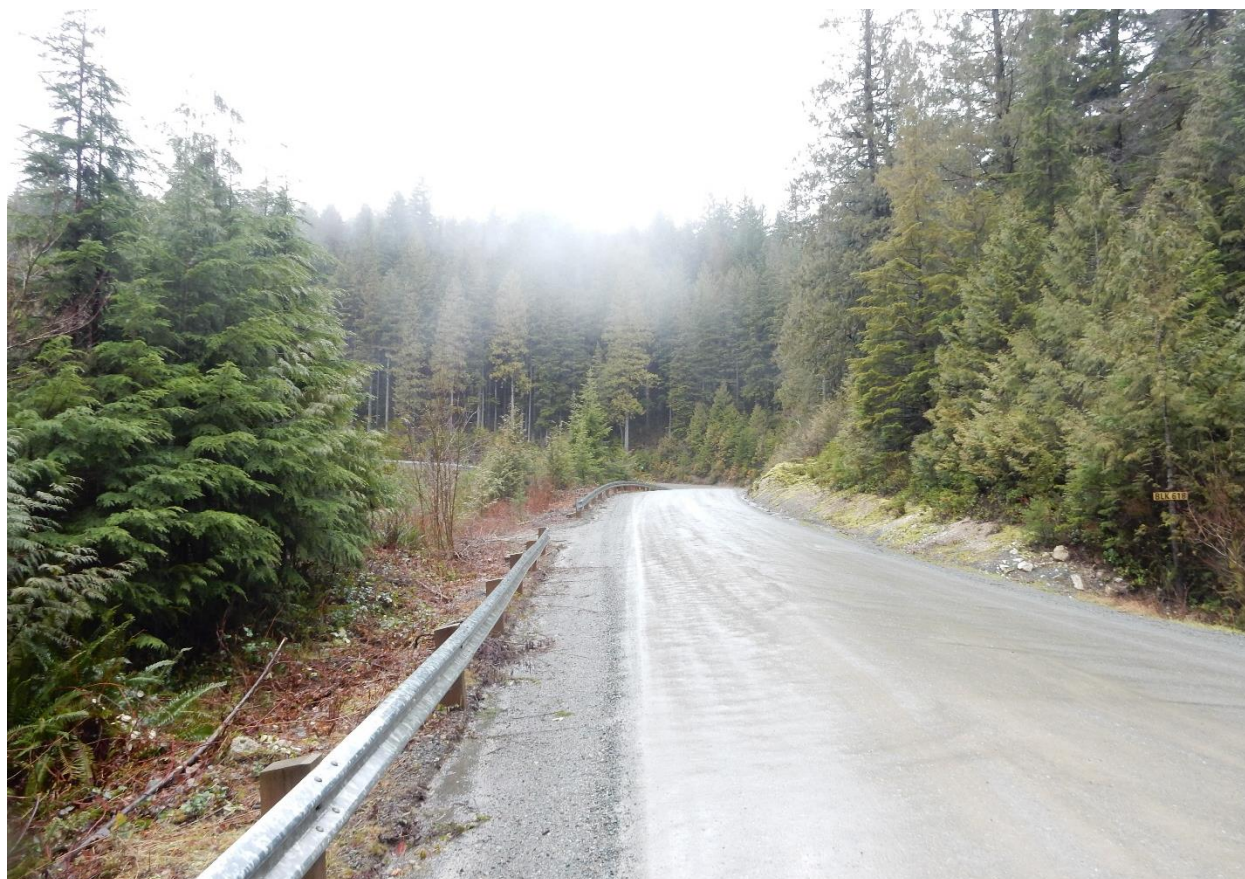
**Photo 3-1** Overview of typical vegetation communities adjacent to road

Vegetation communities varied from young trees and shrubs in recently disturbed areas and road edges, to mature forests within 20 m of the road edge. No at-risk ecosystems or wetlands were present along the road alignment.

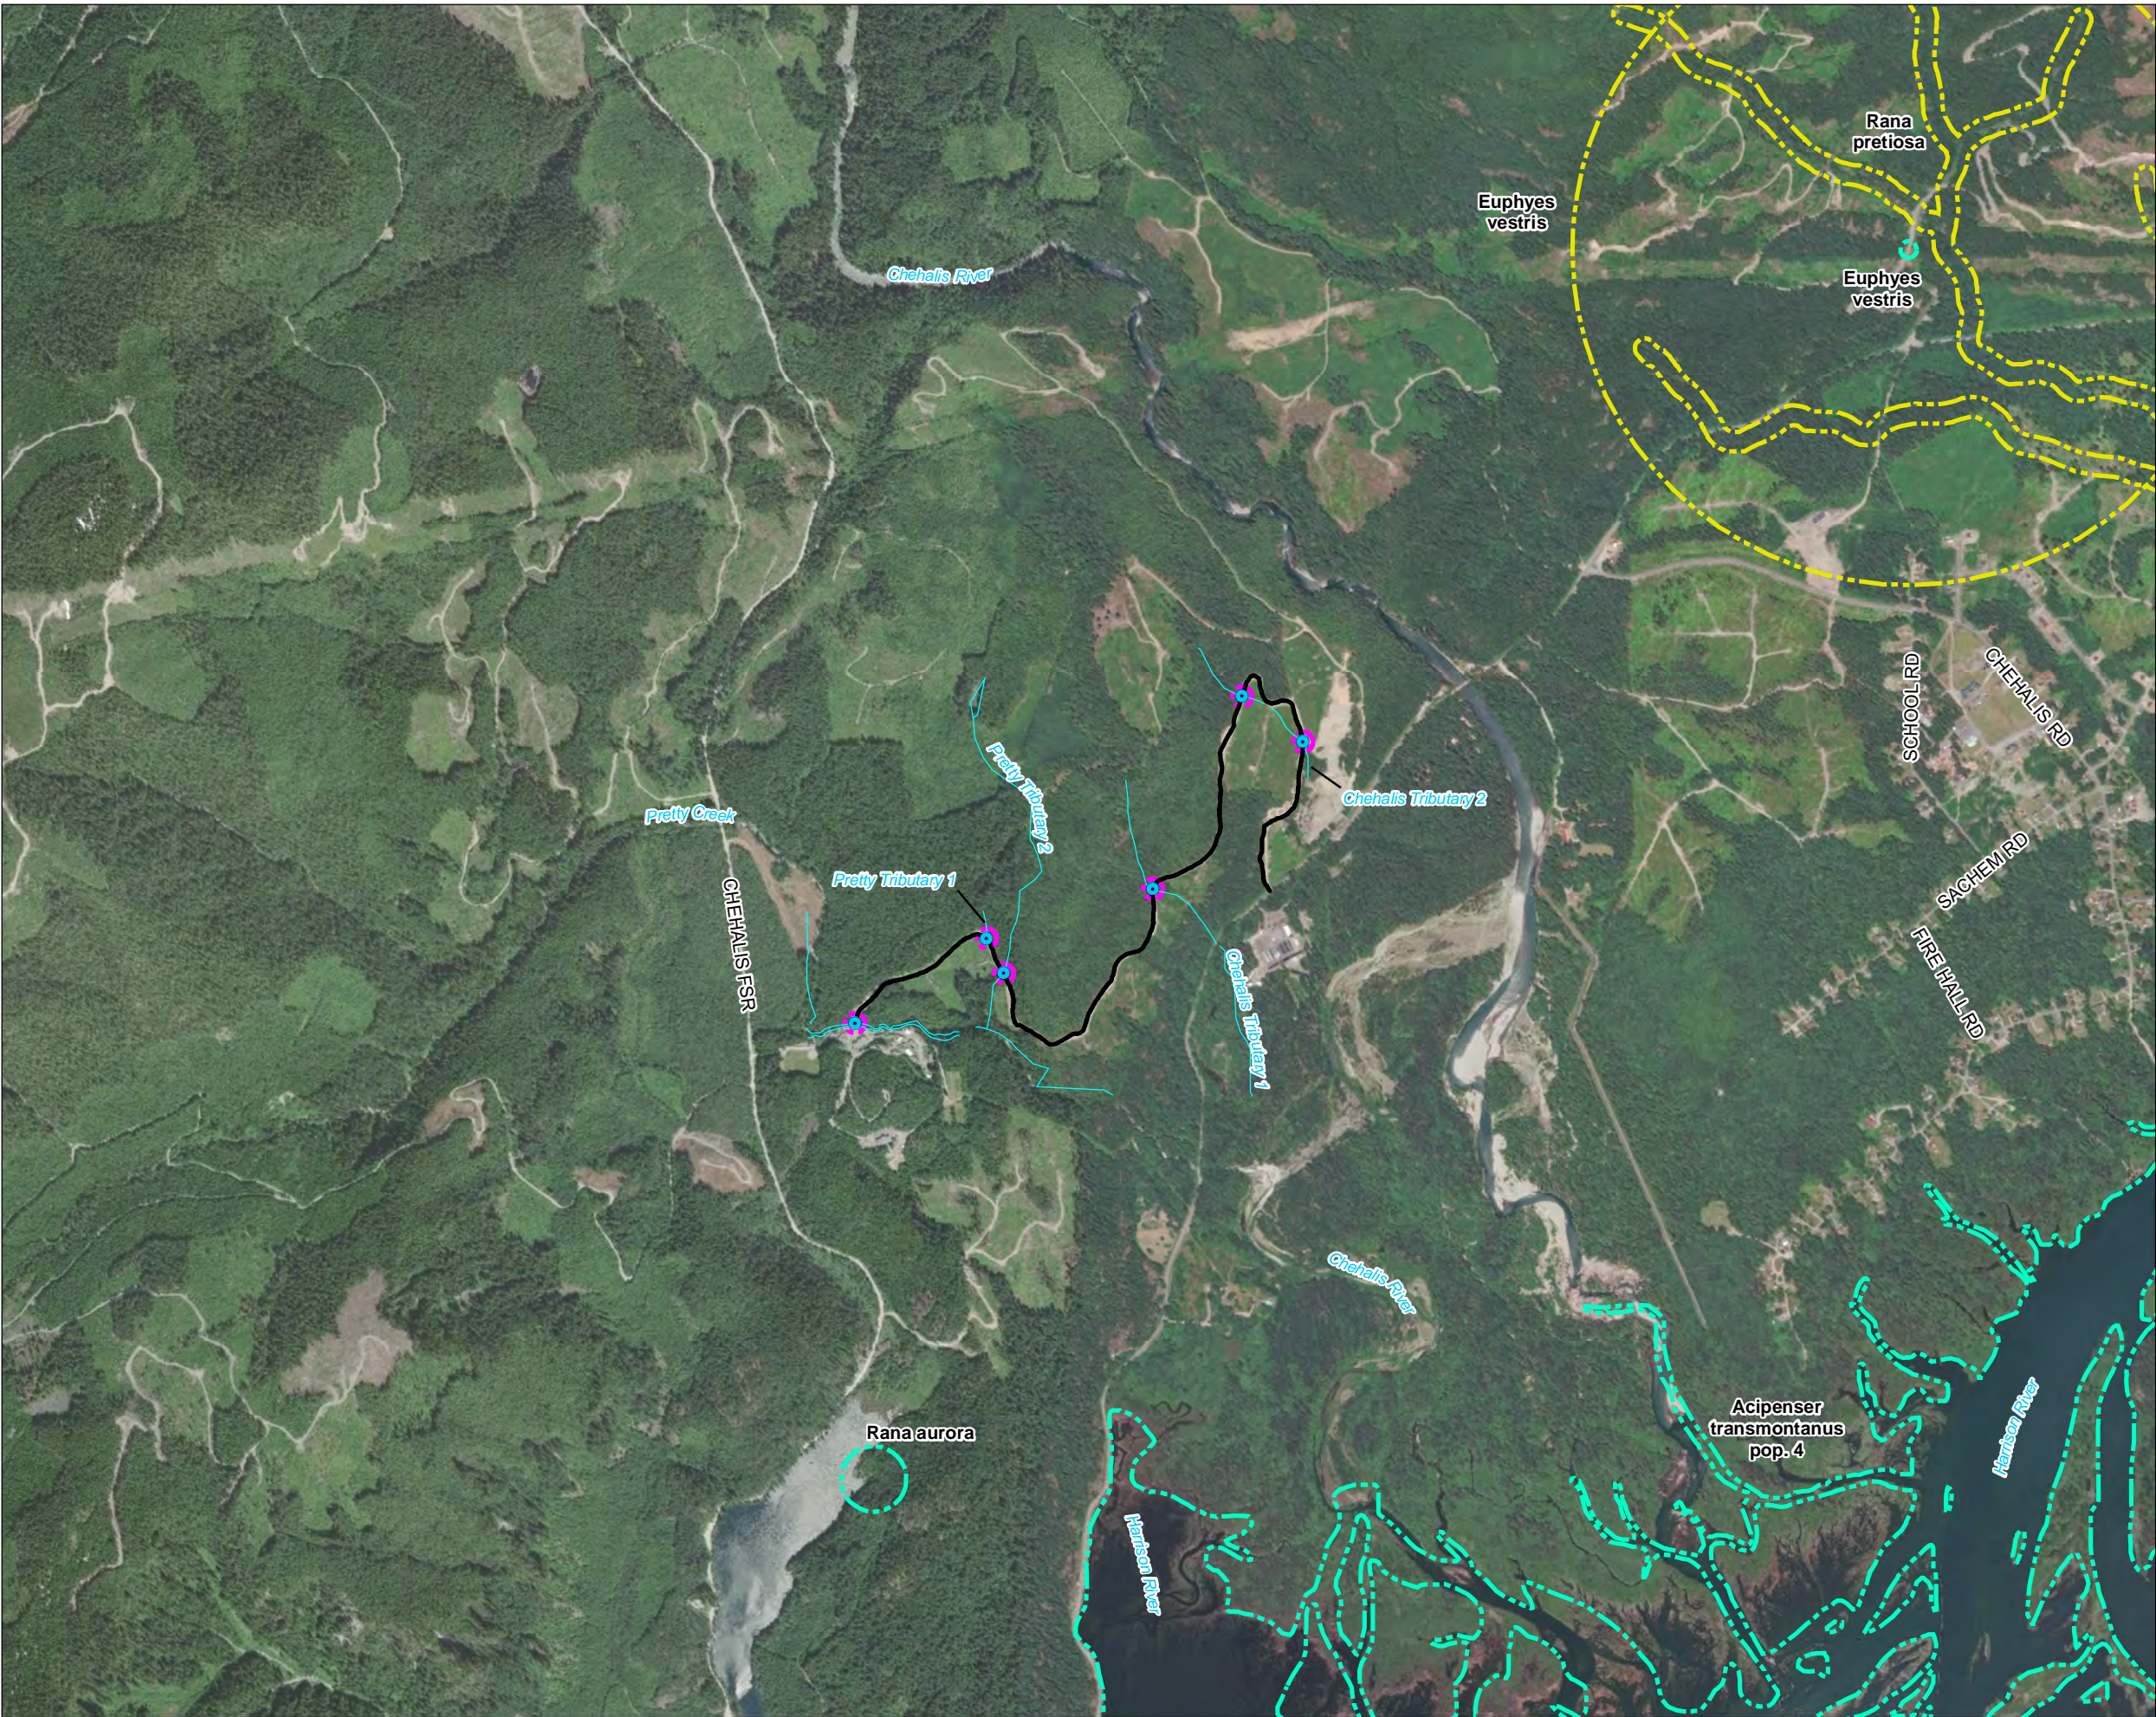
103523-01    Production Date: May 23, 2019    Figure 3-1

The eastern access road is mapped as crossing five surveyed watercourses, and additional roadside drainages within the Chehalis River watershed. The location and road crossing structures of these watercourses (relative to the October 26, 2018 survey drawings), and the distance of the crossings from the Morris Valley Road entrance, is provided in **Table 3-1** and shown in **Figure 3-1**. It should be noted that one of the watercourses (Pretty Tributary 1), was not easily discernable in the field and appeared to consist primarily of stormwater run-off along the north side of the access road. A road crossing for this watercourse was not observed during the site inspection on February 1, 2019; however, flow is likely conveyed south (downslope) via a drainage culvert located near crossing location 1+360.

Critical Habitat

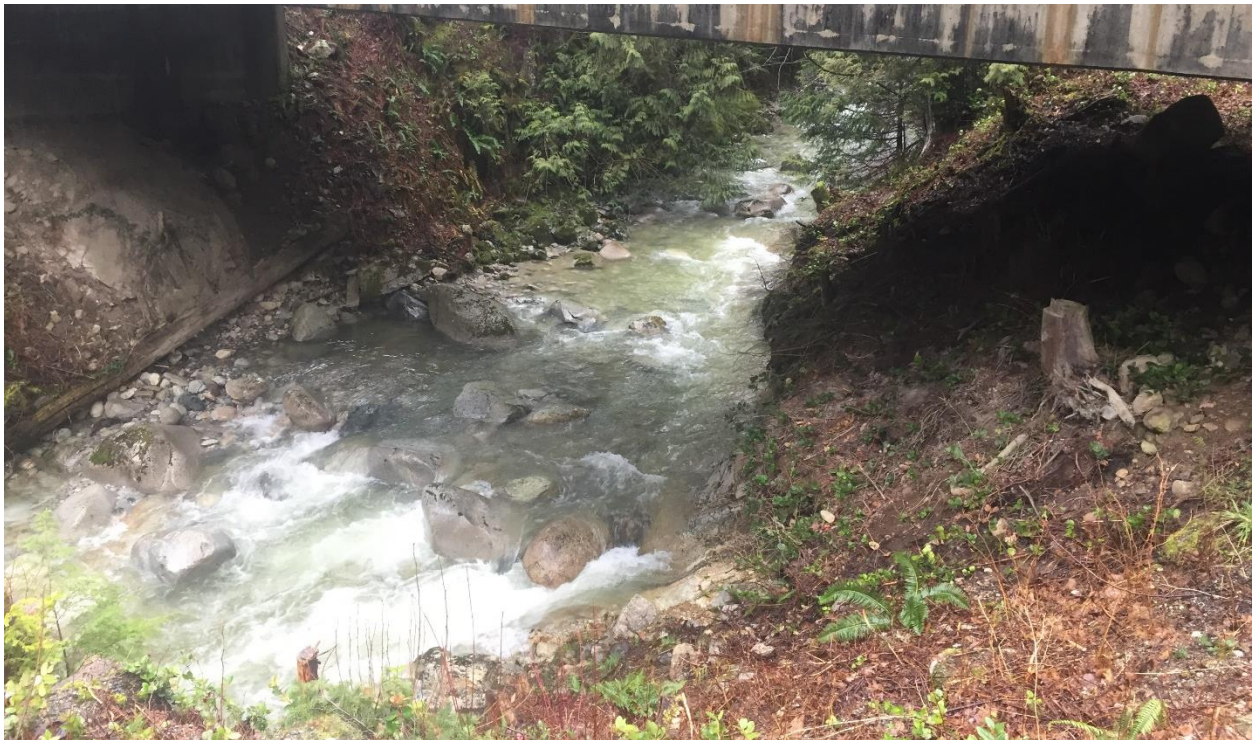
**Photo 3-2 Upstream-facing View of the Pretty Creek Crossing of the Access Road at 0+820**

Pretty Creek is a third order stream that flows into the Chehalis River approximately 1.5 km downstream of the access road (**Photo 3-2**). An approximately 6 m high impassable waterfall (Pretty Falls) is located approximately 450 m upstream from its mouth at the Chehalis River (SRS 1997). Throughout 1995 and 1996, fish assessments were undertaken in Pretty Creek by Scott Resources Services Inc. (SRS) to characterize the upstream limits of fish presence, and to assess impacts to fish habitat within the Chehalis River watershed. Pretty Creek was assessed from the mouth of the creek to 3,200 m upstream. Sampling upstream of Pretty Falls, including the reach crossing through the eastern access road, did not yield any fish, including resident species (SRS 1997). Based on the sampling and observations undertaken during this time, the lower 450 m of the creek (below Pretty Falls) supports anadromous and resident fish species including coho salmon, chum salmon, cutthroat trout, rainbow trout (*O. mykiss*), and sculpins (*Cottus* spp.) (SRS 1997) (**Photo 3-3**). Additional sampling undertaken in 2011 confirmed the presence of coho salmon and cutthroat trout, with longnose dace (*Rhinichthys cataractae*) and slimy sculpin (*C. cognatus*) also reported (EBA 2011). While spawning chum salmon were observed in 1995, this lower reach of the creek was reported to support a limited amount of spawning habitat due to high bedload movement and scouring, with higher quality rearing habitat limited by high seasonal water fluctuations in the summer and winter (SRS 1997).

Pretty Creek near the road crossing is approximately 10 m wide, and upstream of the crossing is approximately 5.6 km long. Available contour mapping (1:20,000), indicates that the average gradient of the Pretty Creek mainstem between Pretty Falls and the eastern access road crossing is approximately 9%. The substrate in the creek at the crossing consists primarily of large substrates (i.e., boulders and cobbles).

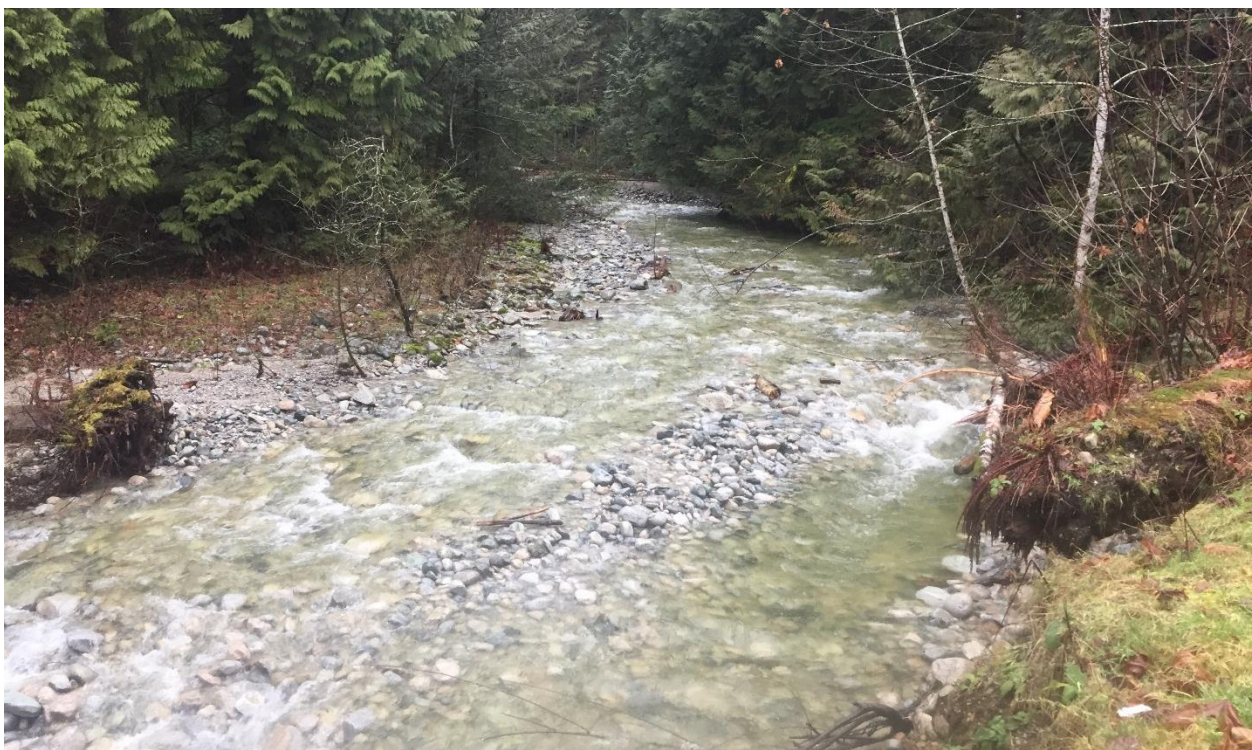
**Photo 3-3 Upstream-facing View of Pretty Creek at the Morris Valley Road Crossing  
Approximately 1.3 km Downstream of the Eastern Access Road Crossing of Pretty  
Creek**

While the gradient in this reach of Pretty Creek alone would not preclude the potential for resident fish presence, previous sampling upstream of this barrier in the mid-90s did not yield any fish, suggesting that this reach is non-fish bearing. Despite the limited potential for fish presence upstream of Pretty Falls, this reach does provide valuable food and nutrient contributions to downstream fish-bearing portions of the creek.

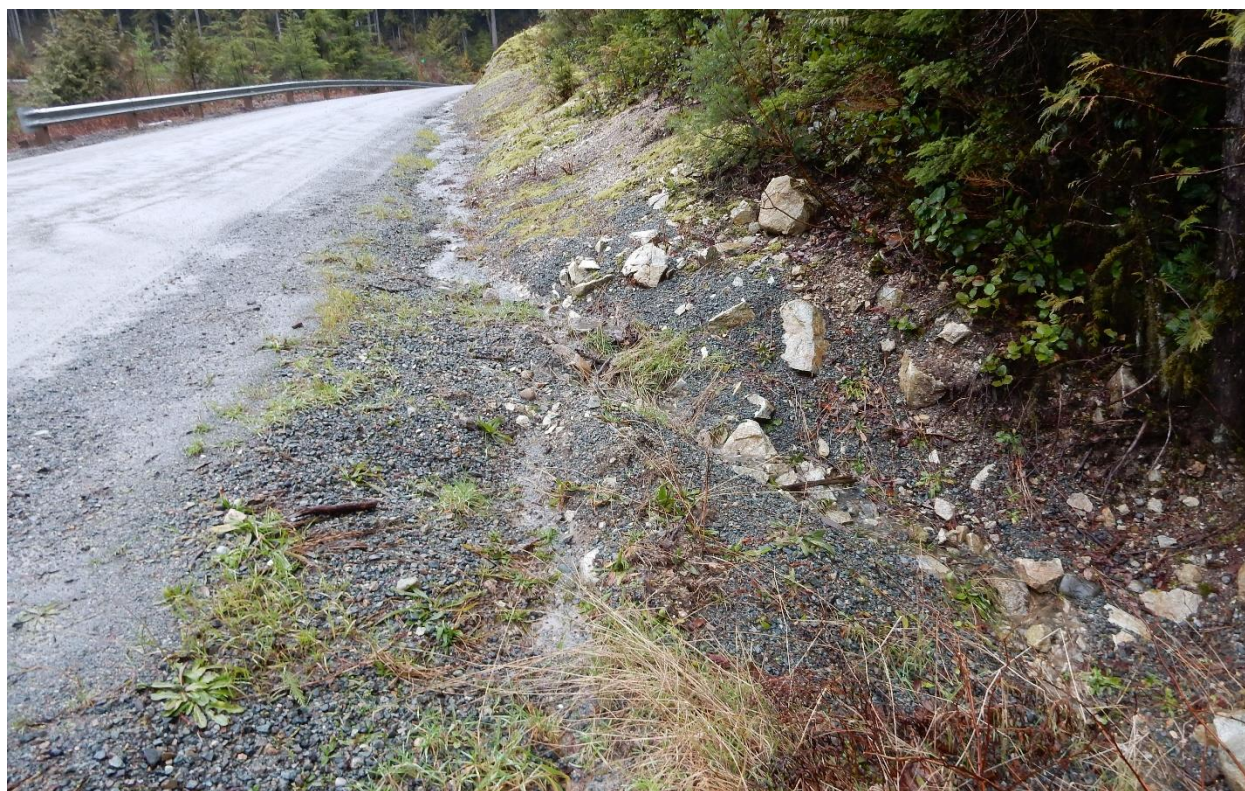
**Photo 3-4       Road Run-off Observed Downslope of the Mapped Location of Pretty Tributary 1**

Pretty Tributary 1 is mapped as being approximately 290 m long upstream of the access road, with an average gradient of 10%. Based on municipal mapping, the gradient downstream of the access road to its confluence with Pretty Creek is approximately 25%. At the time of the assessment, during a significant rain event, the Pretty Tributary 1 channel was not identifiable (**Photo 3-4**); however, based on the steep gradient, and short length of the watercourse, the channel width is anticipated to be less than 1 m. This watercourse is likely ephemeral and non fish-bearing due to its relatively low flows, lack of perennial fish habitat, steep gradient, and lack of direct connection to known downstream fish-bearing habitat.

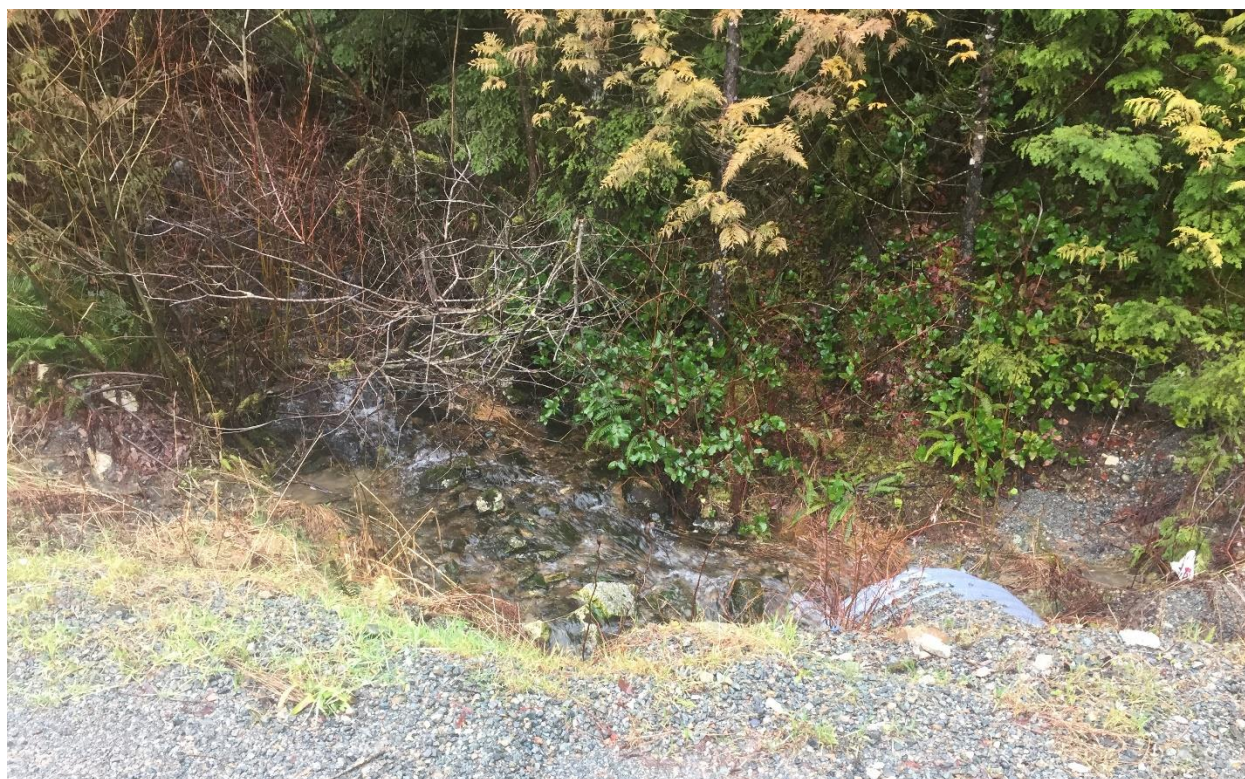
**Photo 3-5** Upstream-facing View of Pretty Tributary 2 Culvert Inlet at 1+360

Pretty Tributary 2 crosses the eastern access road near 1+440. The stream originates from a small wetted area located approximately 950 m upstream of the access road. The channel width of Pretty Tributary 2 near the road crossing ranges between approximately 1.5 to 3 m (**Photo 3-5**). Available contour mapping (1:20,000), indicates that the average gradient of the Pretty Tributary 2 upstream of the road crossing is approximately 7%, with an approximate 25% gradient downstream between the access road and the confluence with the Pretty Creek mainstem. At the road crossing the creek substrate consisted of a mixture of cobble, gravel, and sand. Downstream of the crossing the watercourse is confined within ravine banks (**Photo 3-6**). This watercourse may be ephemeral and is likely non fish-bearing due to its steep gradient preventing fish access, lack of residual deep pool habitat (e.g., to sustain resident fish populations), and its lack of direct connection to known downstream fish-bearing habitat.

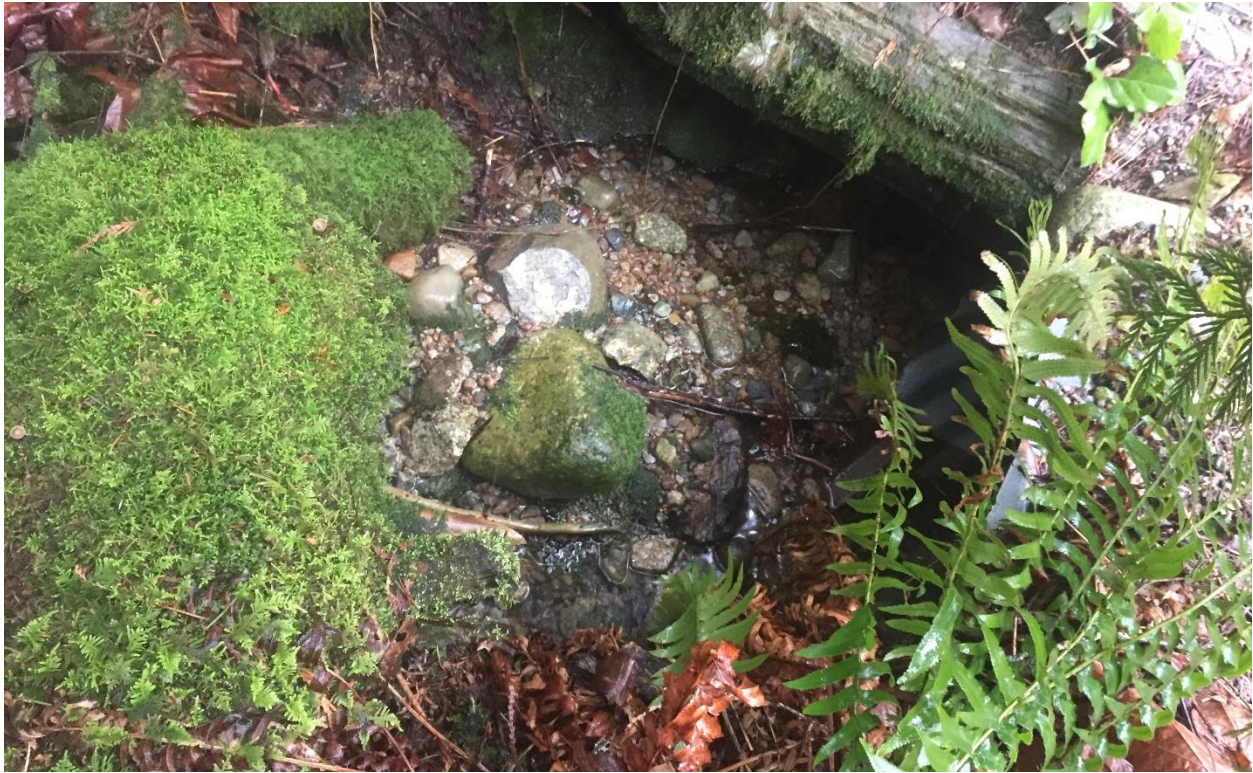
**Photo 3-7**      **View of the Existing Culvert Inlet for Chehalis Tributary 1 at 2+355**

Chehalis Tributary 1 crosses the eastern access road near 2+355 (**Photo 3-7** and **Photo 3-8**). Chehalis Tributary 1 near the road crossing is approximately 1 m wide, and upstream of the crossing is approximately 330 m long. Available contour mapping (1:20,000), indicates that the average gradient of the watercourse upstream of the road crossing is approximately 12%, while the gradient downstream of the crossing to the Morris Valley Road crossing is close to 40%. The substrate in the creek at the crossing consists primarily of cobbles and gravels with some organics observed near the upstream end of the crossing. Based on conditions observed on site, this watercourse is likely ephemeral in nature and is likely non fish-bearing due to its very steep gradient acting as a barrier to fish access, and lack of residual deep pool habitat.

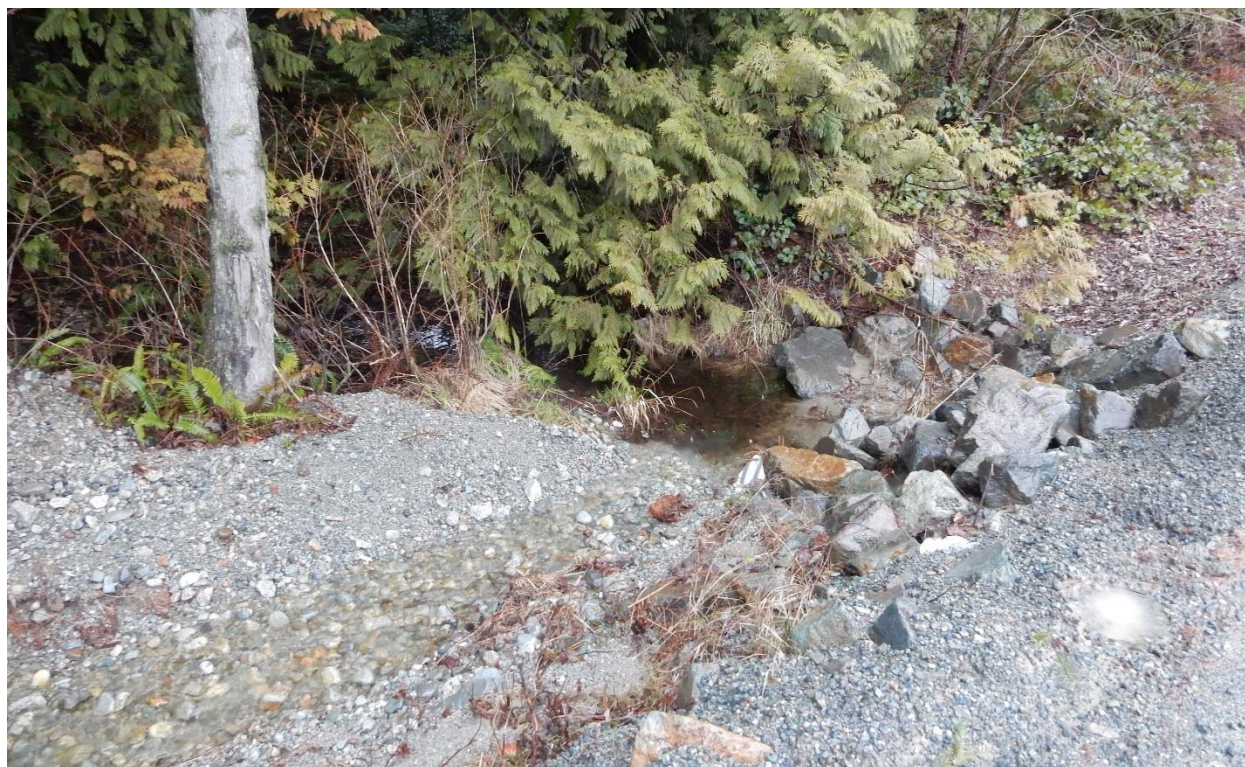
**Photo 3-9** Upstream-facing view of the Chehalis Tributary 2 Crossing at 3+055

Chehalis Tributary 2 crosses the eastern access road at two locations, near 3+055 and 3+420. Chehalis Tributary 2 near the access road crossings ranges between approximately 1 to 2 m wide, upstream of each crossing is approximately 920 m long (for the 3+055 crossing) and 1,300 m long (for the 3+420 crossing), respectively. Available contour mapping (1:20,000), indicates that the average gradient of the watercourse upstream of the first crossing is approximately 9%, while the average gradient between the first (higher) crossing and the second (lower) crossing steepens to approximately 16%. Based on field observations, the gradient downstream of the lowest crossing is steep and appears to be in excess of 20% in some areas. The substrate in the creek consists primarily of cobbles and gravels, although some organic materials were observed near the upstream crossing at 3+055 (**Photo 3-9** and **Photo 3-10**). The downstream crossing at 3+420, shows evidence of gravel road base migration into the active channel (**Photo 3-11** and **Photo 3-12**). Based on conditions observed on site, this watercourse is likely ephemeral in nature and is likely non fish-bearing due to its steep gradient, and lack of residual deep perennial fish habitat (e.g., deep pools).
