RE: Project-Specific Designated Substance Survey
9th Floor Re-fit Project, Place du Portage Phase 1
50 Victoria Street, Gatineau, Québec

DST File No.: GV-OT-034916

1.0 INTRODUCTION

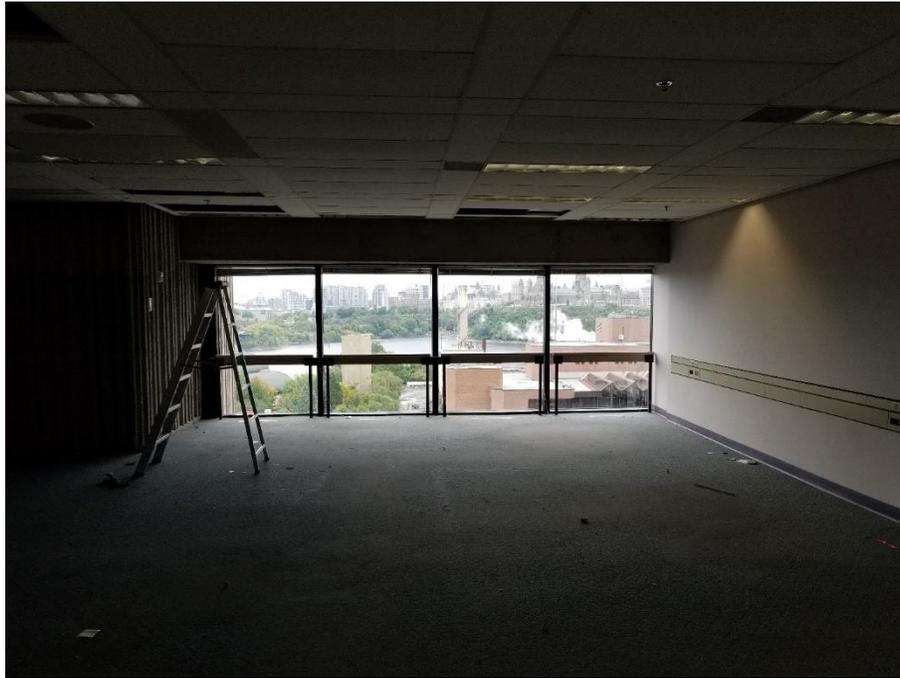
Photo 1: 9th floor east office block, typical conditions of the 9th floor office block areas.

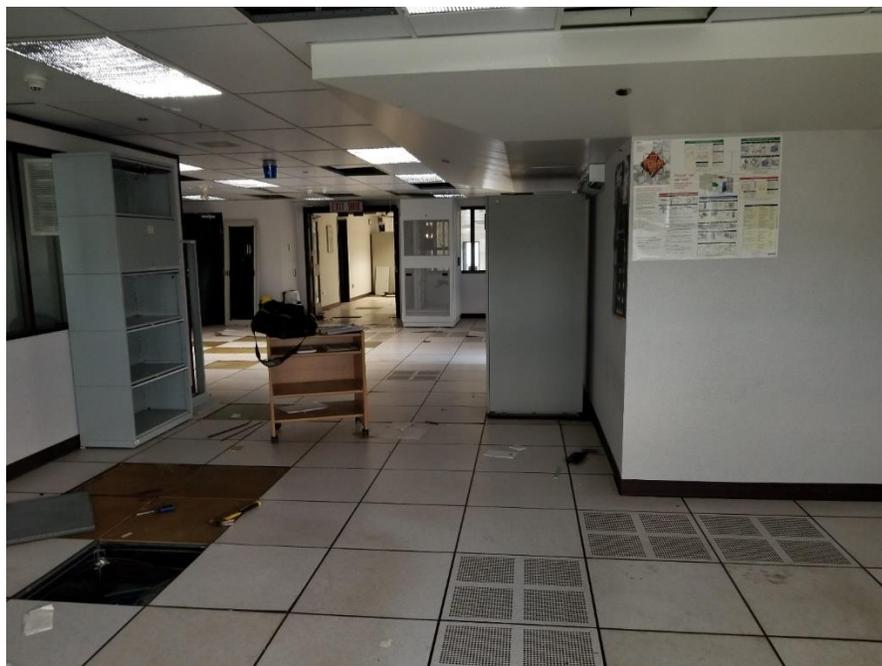
Photo 2: 9th floor, north-west computer room area.

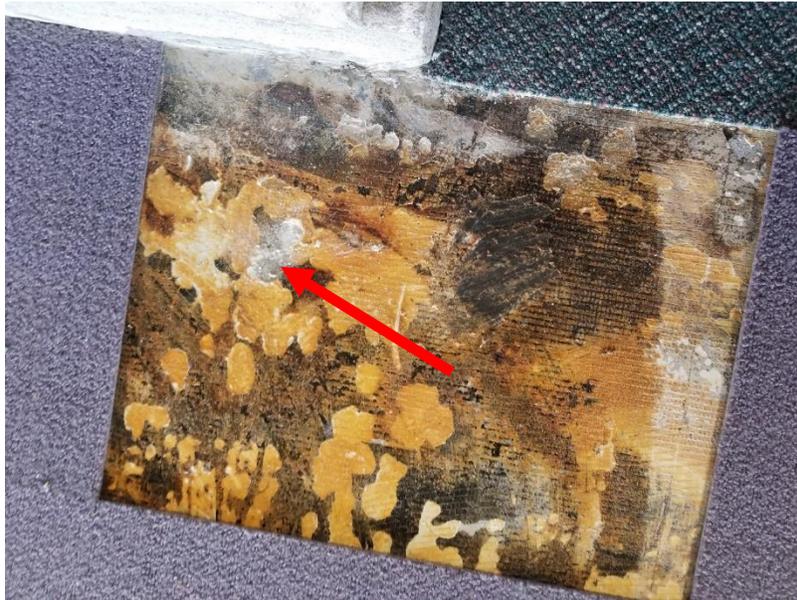
- Approximately five-hundred (500) square metres of non-friable floor leveling compound, was confirmed to contain 1% Chrysotile asbestos (DST Sample ID 34916-01B). The material was observed throughout the north, east and south office blocks often concealed under carpeting. The material was not observed under raised flooring of the north/south-west computer rooms,

Photo 3: Non-friable floor leveling compound, was confirmed to contain 1% Chrysotile asbestos (DST Sample ID 34916-01B). The material was observed throughout the north, east and south office blocks often concealed under carpeting.

Low Risk asbestos work procedures can be used for the removal or disturbance of non-friable ACMs (e.g. caulking, cementitious material, levelling compound, vinyl floor tiles), provided the materials remain in a non-friable condition and are removed with non-powered hand tools and wetting. Should these conditions not be met, then more stringent work procedures (e.g. Moderate or High Risk) are required.

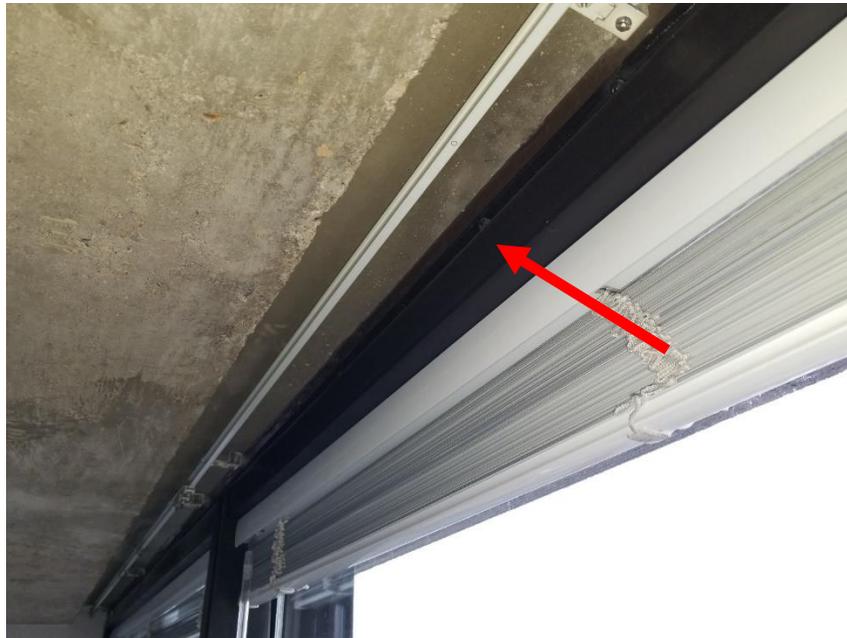
- Approximately sixty (60) linear metres of non-friable, rigid, brown joint caulking, observed at the joint between windows and the concrete bulkhead was confirmed to contain 1% Chrysotile asbestos (DST Sample ID 34916-09A). The material was observed throughout the north, east and south office blocks. The location of the material was concealed by drywall bulkheads in the south-west and north-west computer and therefore assumed to be present in those areas,

Photo 4: Non-friable, rigid, brown joint caulking, observed at the joint between windows and the concrete bulkhead was confirmed to contain 1% Chrysotile asbestos (DST Sample ID 34916-09A). The material was observed throughout the north, east and south office blocks.

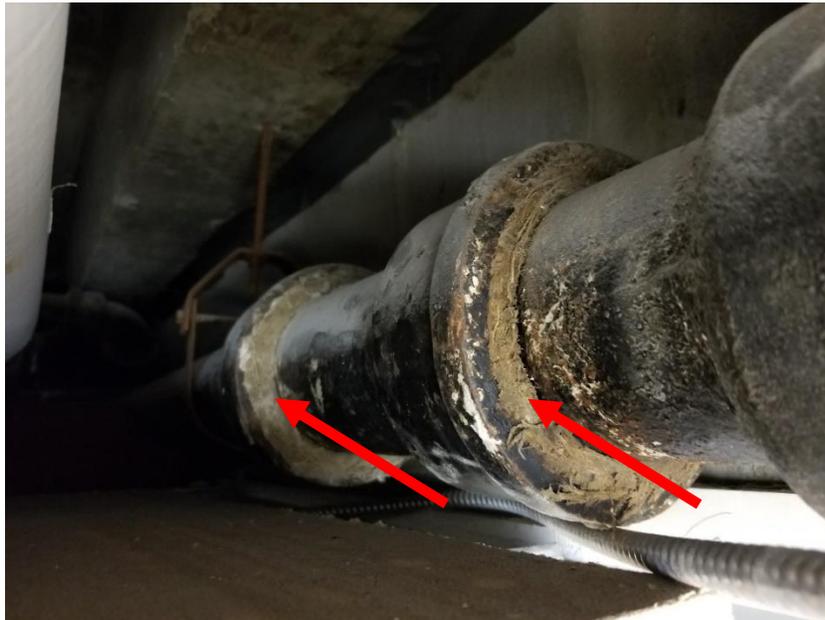
- Less than one (1) square metre of friable, drain pipe joint caulking (oakum), observed on a black, cast iron drain pipe above the dropped ceiling in men's washroom in the elevator lobby was confirmed to contain 75% Amosite asbestos (DST Sample ID 34916-25A),

Photo 5: Friable, cast iron joint filler (oakum), observed on a black, cast iron drain pipe above the dropped ceiling in men's washroom in the elevator lobby was confirmed to contain 75% Amosite asbestos (DST Sample ID 34916-25A).

Removing or disturbing identified friable ACMs (such as pipe insulation, cast iron joint caulking) with an area less than one (1) square metre must be completed using a minimum Moderate-Risk Work Procedures. The handling or removal friable material containing asbestos greater than one (1) square metre must be completed using High-Risk Work Procedures. It should be noted that the removal of good condition pipe fitting insulation can be completed using Moderate-Risk glovebag procedures, provided the glovebag seal can be maintained throughout the removal process.

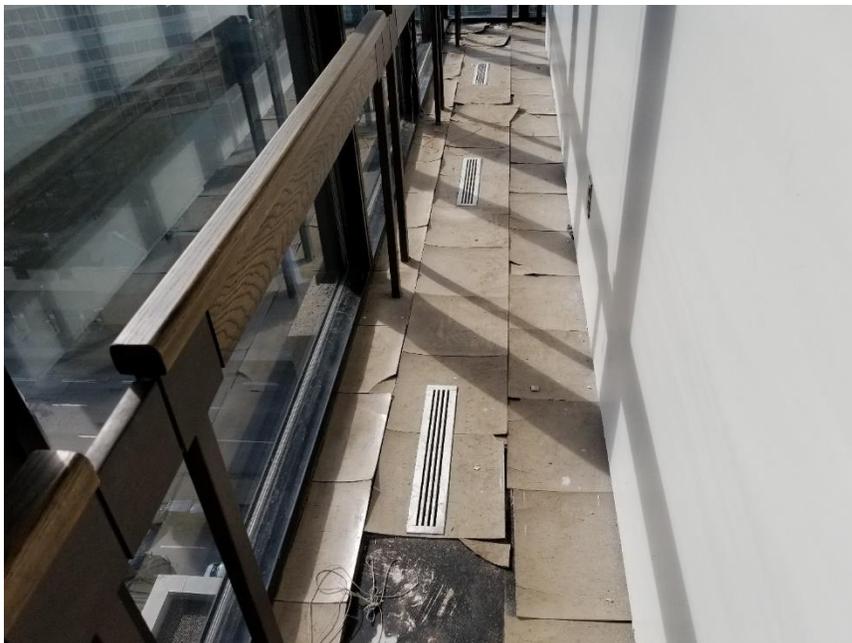
- Approximately forty-five (45) square metres of non-friable 12"x12" (30cm x 30cm) vinyl floor tiles, beige with black streaks, observed in the south-west computer rooms - conveyor room and narrow corridor around the south and north-west computer rooms were confirmed to contain 3% Chrysotile asbestos (DST Sample IDs 34916-31A-C); and

Photo 6: Non-friable 12"X12" vinyl floor tiles, beige with black streaks pictured in the observed in the narrow corridor around the south and north-west computer rooms was confirmed to contain 3% Chrysotile asbestos (DST Sample IDs 34916-31A-C).

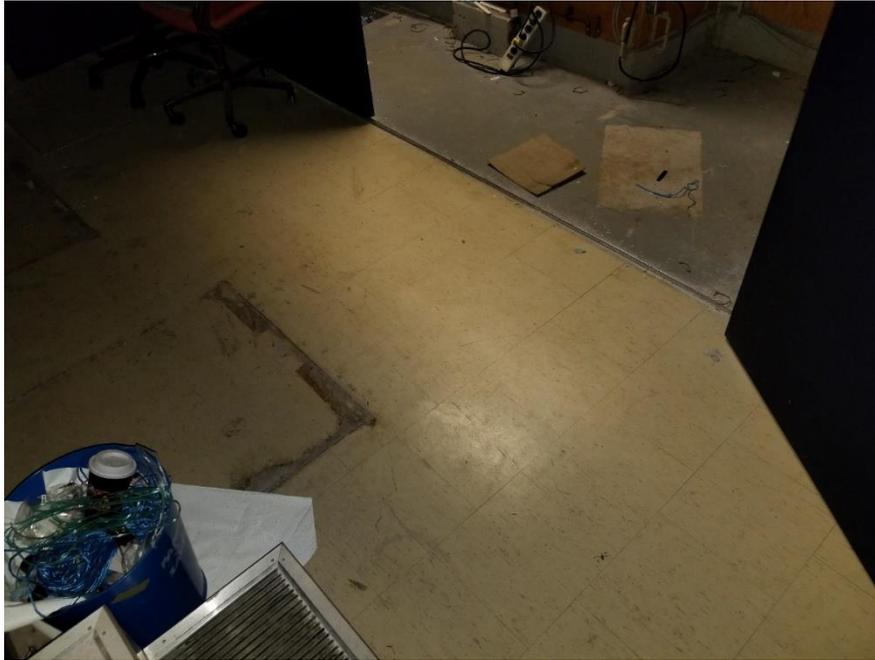
Photo 7: Non-friable 12"X12" vinyl floor tiles, beige with black streaks observed in the south-west computer room- conveyor room was confirmed to contain 3% Chrysotile asbestos (DST Sample IDs 34916-31A-C).

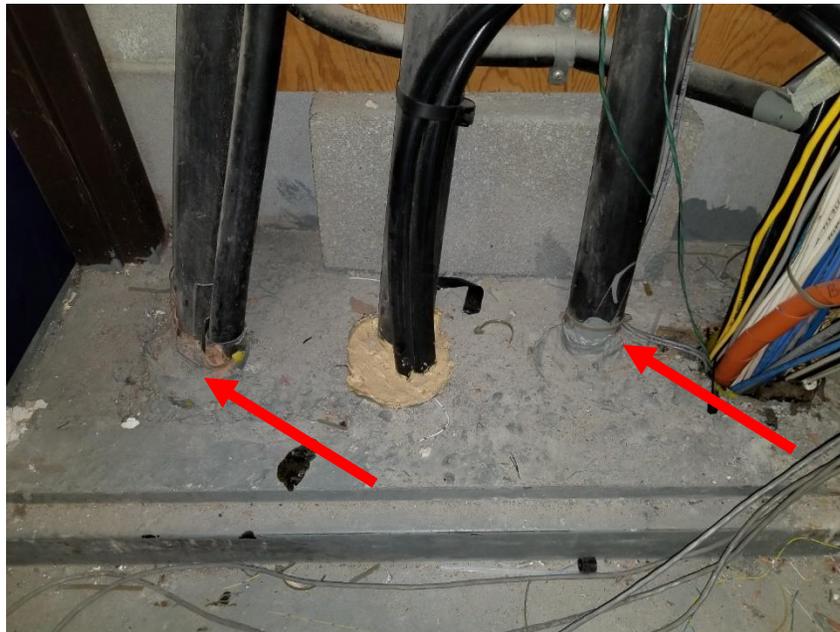
- Less than one (1) square metre of non-friable cementitious material, intermixed with peach (painted grey) coloured, soft caulking, observed in the south-west computer room-conveyor room- north end, floor level pipe penetrations was confirmed to contain 1% Chrysotile asbestos (DST Sample ID 34916-32B).

Photo 8: Non-friable cementitious material, intermixed with peach coloured (painted grey), soft caulking, observed in the south-west computer room- conveyor room north end, floor level pipe penetrations was confirmed to contain 1% Chrysotile asbestos (DST Sample ID 34916-32B).

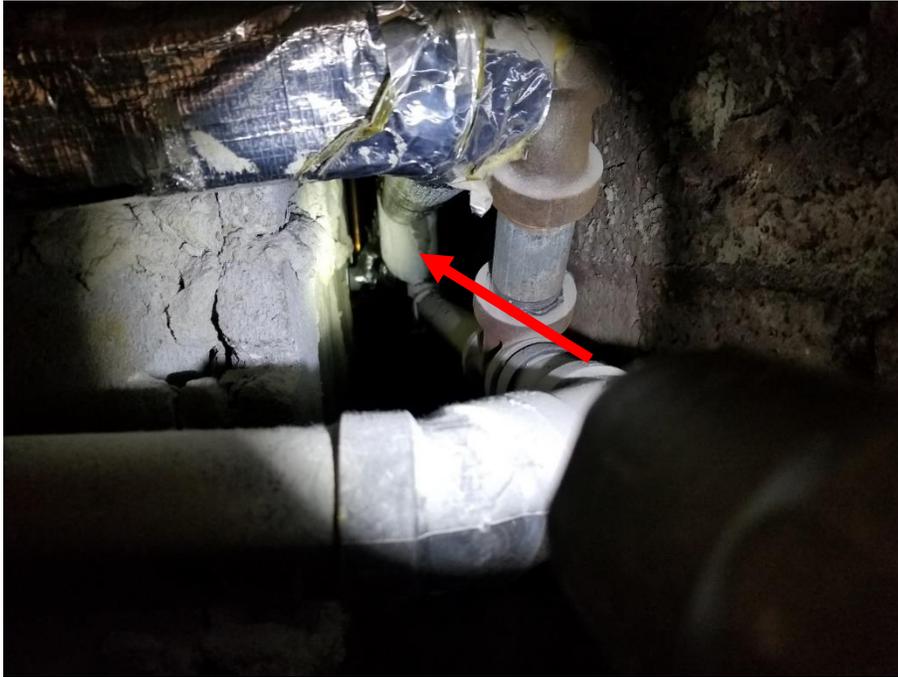
- One (1) pipe fitting with grey cement compound (GCC) insulation was observed in the pipe chase adjacent the men's washroom in the elevator lobby. The material was inaccessible for sampling and laboratory analysis but is assumed to contain asbestos based on visual appearance.

Photo 9: One (1) grey cement compound (GCC) pipe fitting was observed in the pipe chase adjacent the men's washroom in the elevator lobby. The material was inaccessible for bulk sampling, but is assumed to contain asbestos based on appearance.

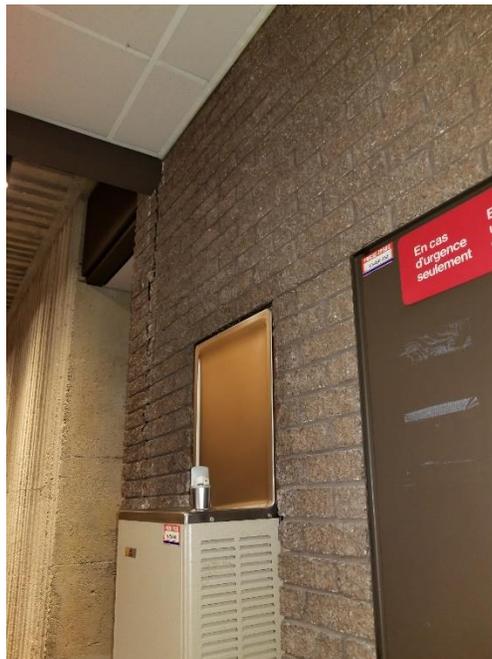
Halocarbons are suspected to be present as a coolant in water fountains observed in the elevator lobby.

Photo 10: Halocarbons are assumed to be present as a coolant in water fountains observed in the elevator lobby.

- Federal Halocarbon Regulations (FHR), 2003,
- Ozone-depleting Substances and Halocarbon Alternatives Regulations, 2016,
- Environmental Code of Practice for Elimination of Fluorocarbon Emissions from Refrigeration and Air Conditioning Systems, 2015, and
- Provincial Transport of Dangerous Substances Regulation and Federal Transport of Dangerous Goods Act.
