**Addendum
Addenda**

No./No
3

Project Description / Description de projet		
M-6 Foundation Waterproofing / Imperméabilisation des fondations		
Project No./No de projet	Departmental Representative / représentant ministériel	Date
5870	Allan Mackenzie	6-Apr-2021
Solicitation No./N° de sollicitation		
20-58127		
Notice: This addendum shall form part of the tender documents and all conditions shall apply and be read in conjunction with the original plans and specifications.		
Nota: Cet addenda fait partie intégrale des dossiers d'appel; toutes les conditions énoncées doivent être lues et appliquées en conjonction avec les plans et les devis originaux.

RE: Building M-6 Paint and Tar Sampling
M-6 Foundation Waterproofing Project
1200 Montreal Road, Ottawa, ON

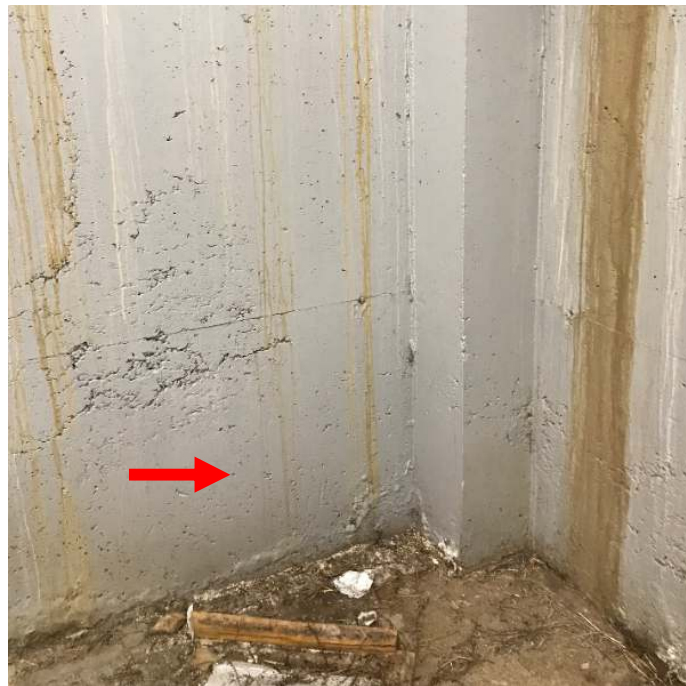
Photographie 1. Intérieur, mur du local des installations mécaniques : il est confirmé que la peinture grise renferme 20 ppm de plomb (ID de l'échantillon prélevé par DST : 2759-LP01).

- Il est confirmé que l'échantillon de peinture grise prélevé sur le mur du local des installations mécaniques a une teneur en plomb de 20 ppm (ID de l'échantillon prélevé par DST : 2759-LP01).

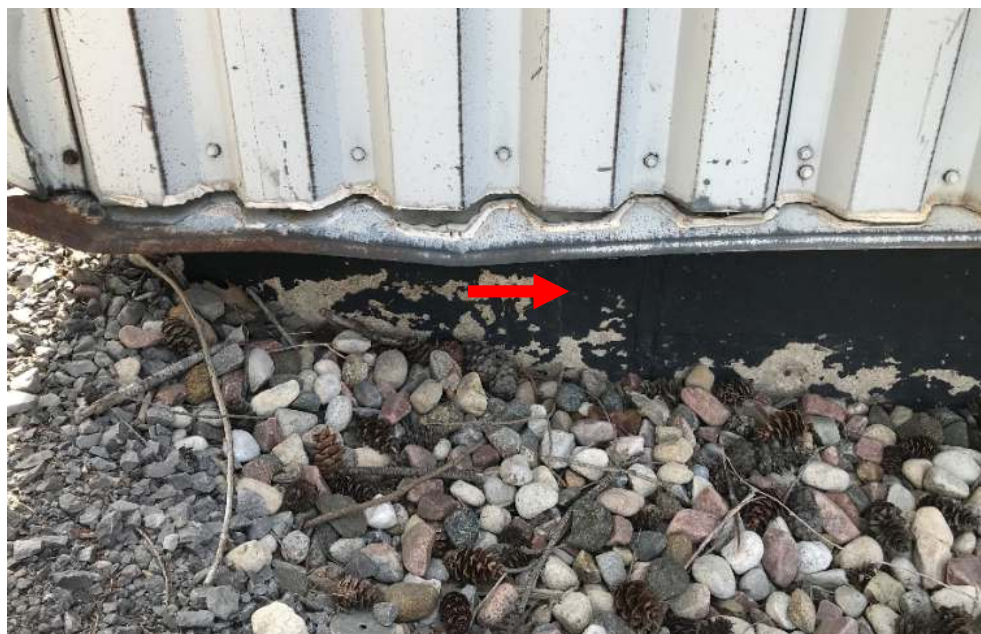
Photographie 2. Extérieur, fondation : il est confirmé que le goudron noir ne renferme pas d'amiante (ID de l'échantillon prélevé par DST : 2759-ACM1-3). Il est confirmé que le matériau renferme <5 ppm de BPC (ID de l'échantillon prélevé par DST : 2759-PCB1).

- Échantillon de goudron noir prélevé sur la fondation extérieure (ID de l'échantillon prélevé par DST : 2759-ACM1-3).

- Échantillon de goudron noir prélevé sur le mur de la fondation extérieure (ID de l'échantillon prélevé par DST : 2759-PCB1).

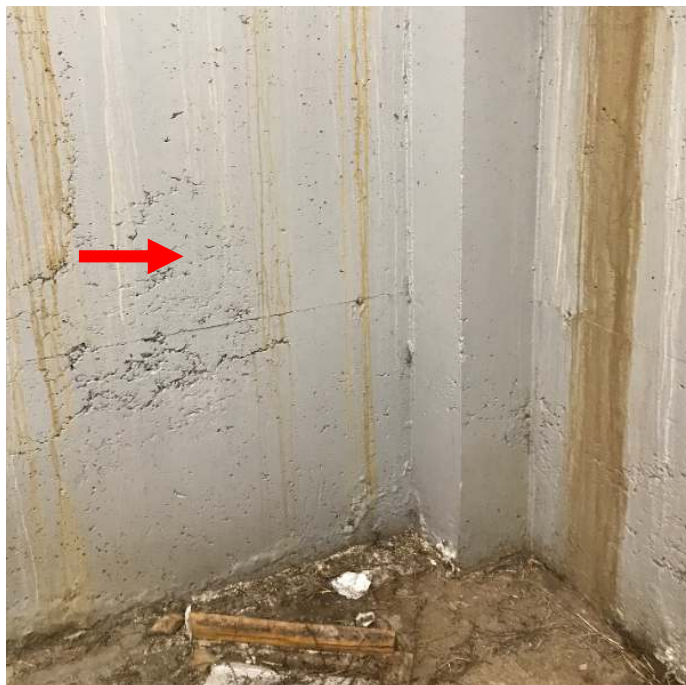
Photo 1. Interior, Mechanical Room Wall: Grey paint was confirmed to contain 20 ppm lead (DST Sample ID 2759-LP01).

- Grey paint sampled from the mechanical room wall was confirmed to contain 20 ppm lead (DST Sample ID 2759-LP01).

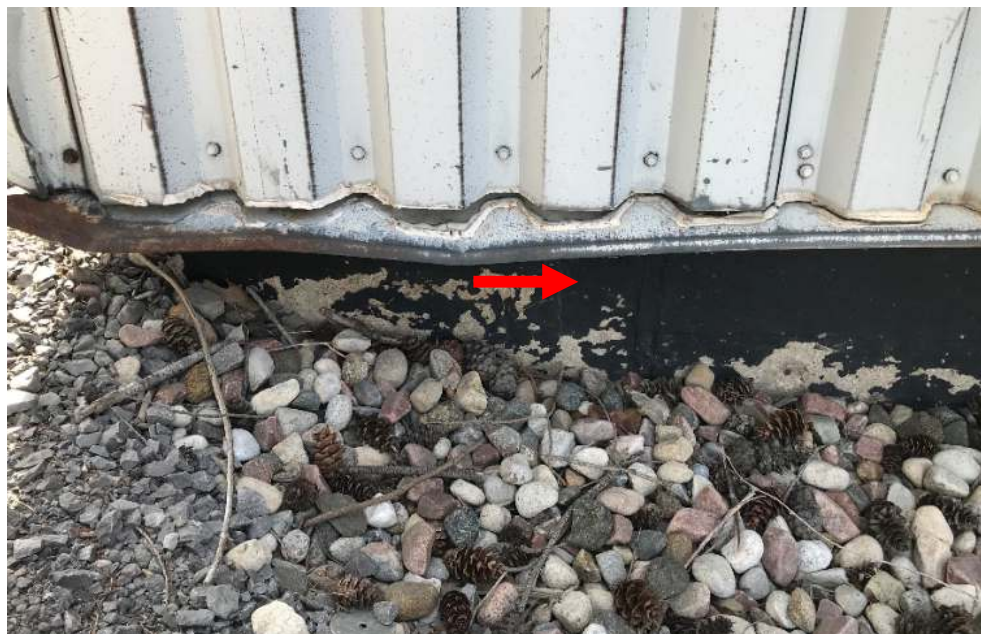
Photo 2. Exterior, Foundation: Black tar was confirmed to be non-asbestos containing (DST Sample ID 2759-ACM1-3). This material was confirmed to contain <5 ppm PCBs (DST Sample ID 2759-PCB1).

- Black tar sampled from the exterior foundation (DST Sample ID 2759-ACM1-3).

- Black tar sampled from the exterior foundation wall (DST Sample ID 2759-PCB1).
