Project Number: R. 099350.002

# **Lasalle Causeway Bascule Bridge Main Trunnion Rehabilitation Study - Structural Evaluation Report**

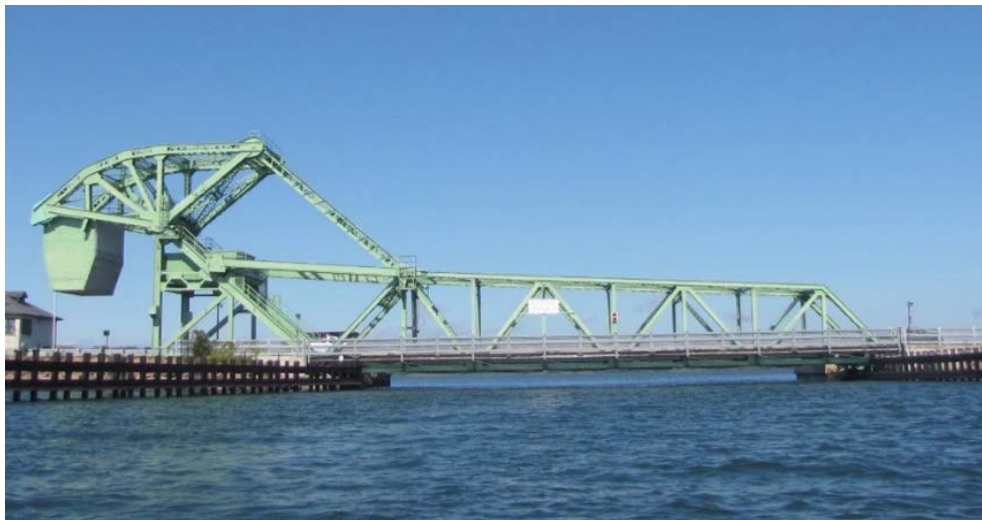
Figure 1 - South elevation

The Bascule Bridge is a single-leaf Strauss heel trunnion bascule bridge, designed by The Strauss Bascule Bridge Co. of Chicago (Figure 1 and Figure 2). Construction of the bridge was completed in April 1917. The structure is supported on two concrete abutments (also known as piers) founded on timber piles (based on available original drawings), the front faces of which are protected with steel sheet piling.

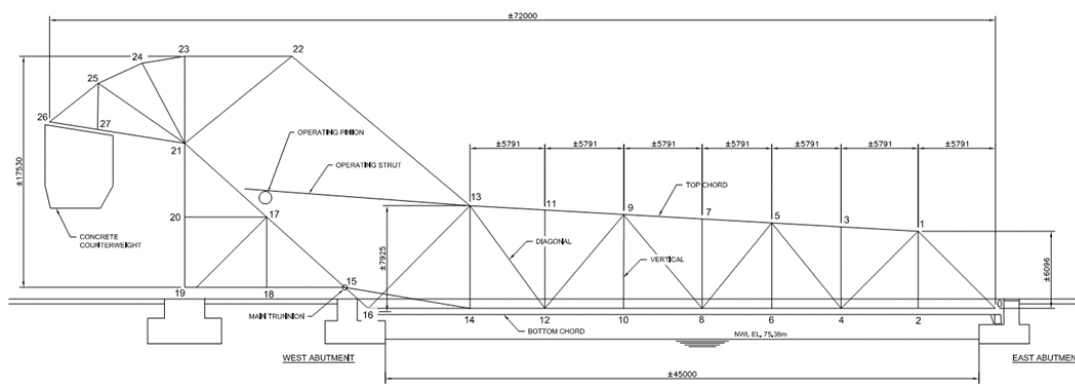
Figure 2 - Dimensions and Truss Member Designation

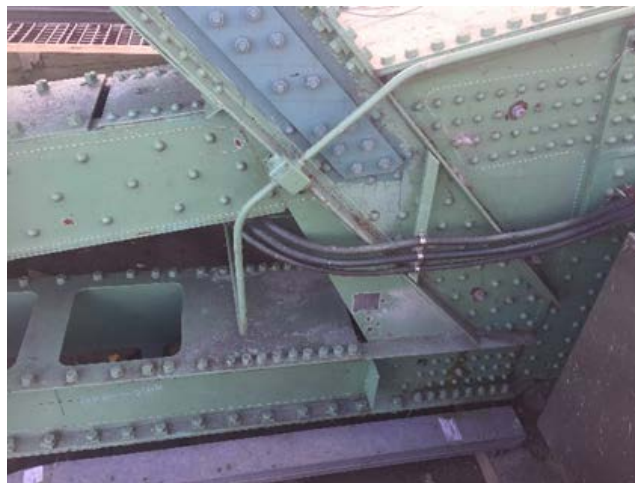
Perforated cover plates were installed on members 14-15 and 14-16 in 1997. Even though the CHBDC does not state it explicitly, it is well established in practice [8], [9], [10] that the net area of the cover plates can be considered in the total area of the member to calculate its compressive resistance. Unfortunately, it has not been possible to take full advantage of them in this evaluation. Firstly, it was found the cover plates do not meet one of the criteria of Clause 10.14.2.3, which is that the minimum longitudinal distance between the openings must be larger than the distance between the connecting members. Considering the number of bolts connecting each component to the cover plates, it appears reasonable to still consider the benefit of the net area of the cover plates in the member’s resistance. Secondly, the 3D model results clearly showed that the critical locations of these members are near their ends where larger bending moments occur. As shown on Figure 4, the new cover plates do not reach the member ends so all the forces must be transmitted through the original section making these locations the critical D/C ratios.

Figure 4 - Discontinuity in cover plates of members 14-15 and 14-16 near main trunnion plate

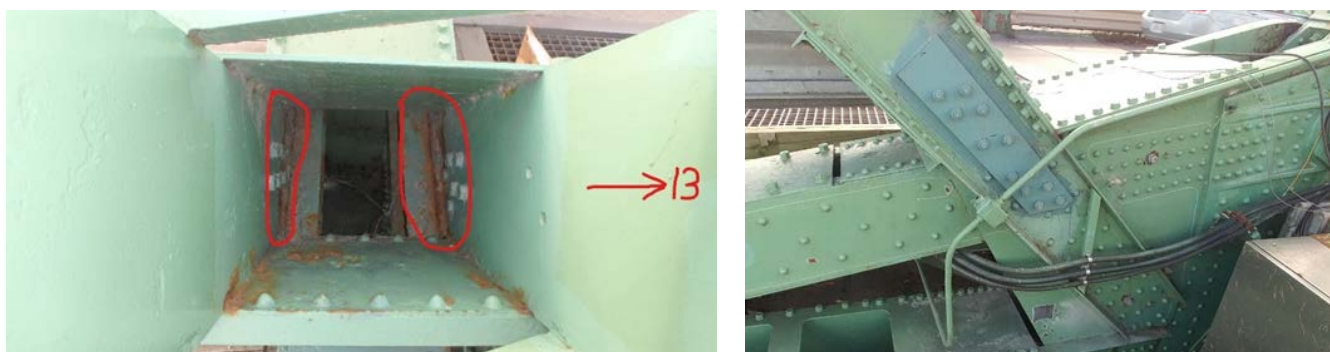
As shown in Figure 5, a significant area of section loss is present on the interior face of both webs of the diagonal 13-16, just above strut 14-15. This section loss was visually estimated to represent 25% of the web thickness. However, this section loss is assumed to be compensated by the additional plates installed on the outside in 2011.

Figure 5 - Diagonal 13N-16N  
a) Left: Section loss of  $\pm 25\%$  on the webs of both channels (b) Right: Existing strengthening on the outside

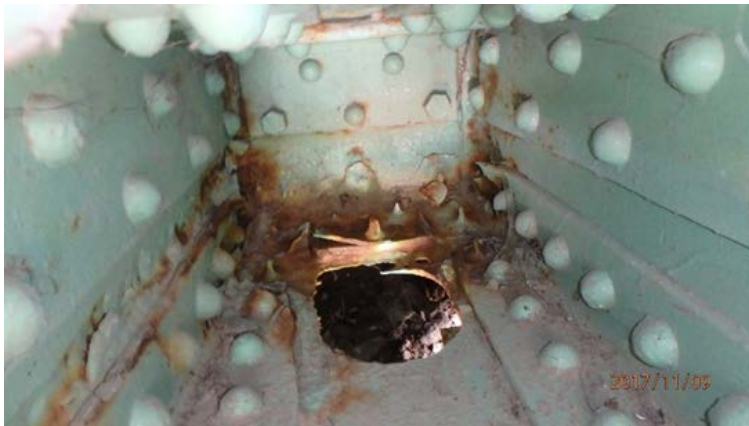
Figure 6 - Local deterioration at member 15-17

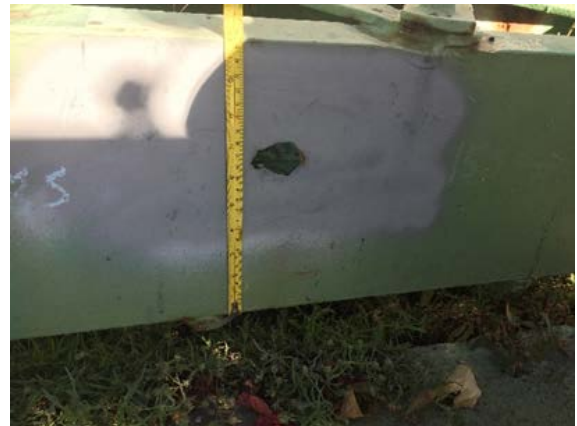
Figure 7, two perforations representing approximately 10% loss of the section were found on the 15S-18S and were considered at their specific location in the evaluation.

Figure 7 - Localized section loss near the middle of member 15S-18S

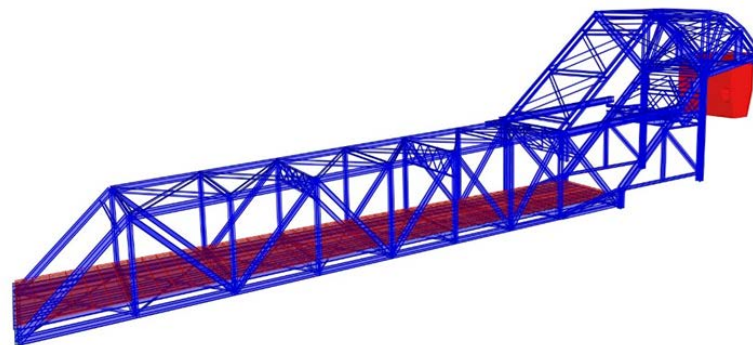
The three-dimensional finite element model of the Bascule Bridge created in CSI-Bridge during the 2017 Parsons Structural Evaluation was re-used for this evaluation. It should be noted that some modifications have been made to the model by the authors of the current study. The model was run in CSiBridge® version 21.1.0 and it was used to determine the forces in all the frame elements. A thorough description of the global model is available in the 2017 report and will not be reproduced herein. The global model was used to determine the concomitant forces in the members. Five (5) global models were used: one model when the bridge in the closed position (open to vehicular traffic) and four models when the bridge is in the open positions at various angles: 0°, 21°, 42° and 63°. The difference between the closed position and the 0-degree open position is that, for the latter, there is no support at the end of the leaf span, which is retained by the motors and therefore considered as cantilevered. In addition, special load combinations from the CHBDC apply for the open positions and not for the closed one. Figure 8 shows a 3D view of the global bridge model in the closed position.

Figure 8 - Global bridge model

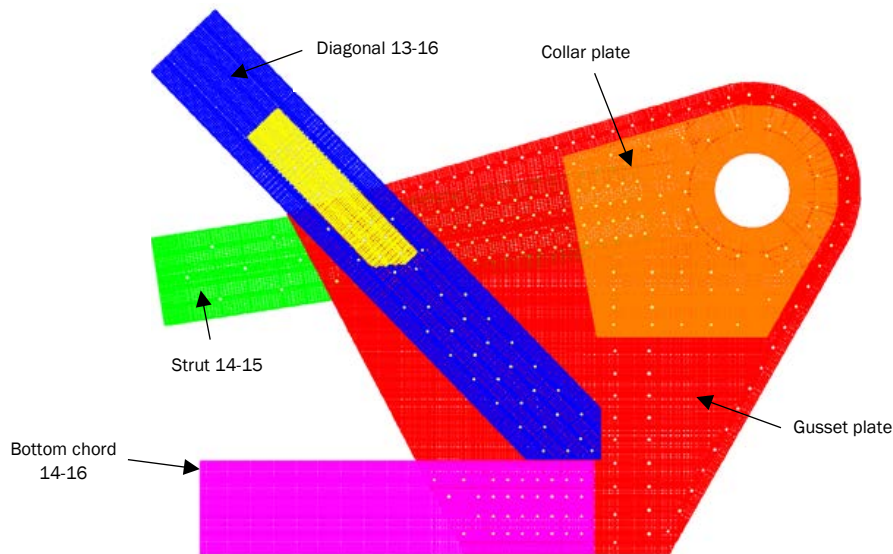
A 2D model of the main trunnion assemblies has been made using shell elements. This finite element modeling consists of one gusset plate, one outside collar plate, one interior-side plate, the webs of the three connected members (diagonal 13-16, strut 14-15 and bottom chord 14-16) as shown in Figure 9. Meshing consists mainly of four-node quadrilateral shell elements of a size of approximately 10 mm by 10 mm. This dimension is very close to the thickness of the thinnest plate and was found to be a good compromise between accuracy and analysis time. Some three-node triangular shell elements were used to connect quadrilateral elements in areas of transition. Figure 10 shows the meshing used for the main trunnion gusset plate. Moreover, as shown on Figure 11, the plates are connected to each other with link elements that represent the existing fasteners (rivets and bolts).

Figure 9 - 2D model of the Main Trunnion Plate

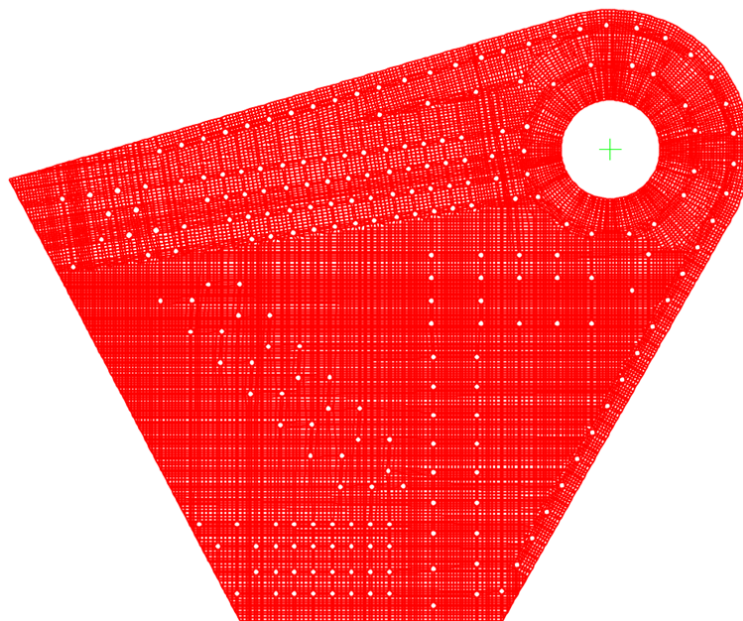
Figure 10 - Meshing of the Main Trunnion Gusset Plate

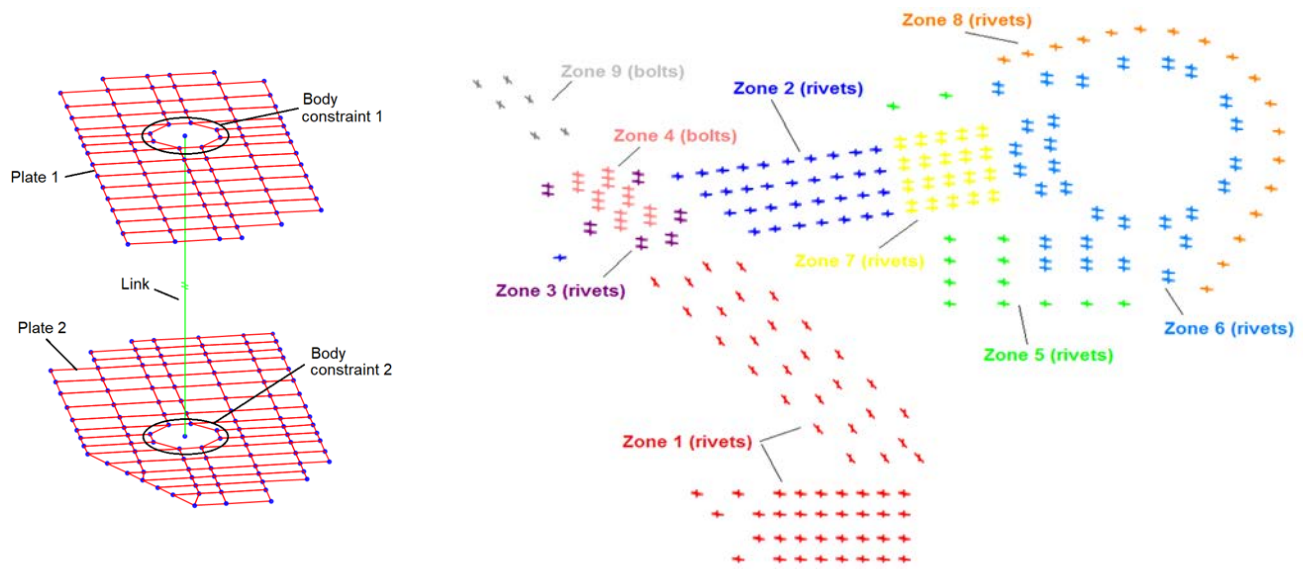
The holes for the rivets are generally 21 mm in diameter (19+2mm) while bolt holes are 24 mm in diameter (22+2mm). Links are located in the center of each hole. A body constraint was assigned to the end-node of the link and to all the nodes located at the perimeter of the hole to transfer the force from the plate to the link to reduce possible stress concentrations in one node (Figure 12 (a)). This modeling technique doesn't capture any hole ovalization behavior due to bearing but we consider it acceptable because linear analyses are performed.

Figure 12 - (a) Left: Modeling example of the fasteners (b) Right: Identification of the fastener's zones

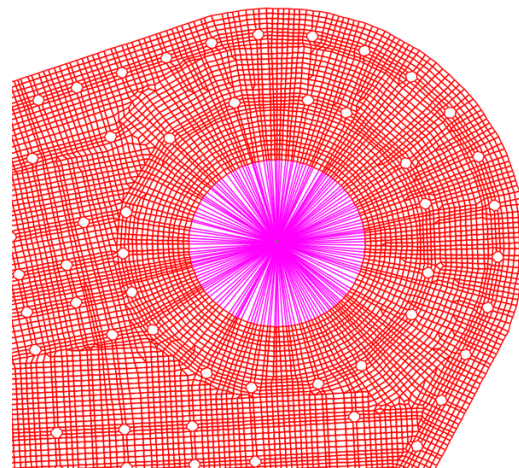
The possibility to use compression-only axially rigid frame elements has been studied in order to model more accurately the stress distribution in the plates around the pin (i.e. with contact elements, no tension induced behind the pin). However, it was found that this modeling technique slightly changes the stresses but not enough to change the findings. Because this would require a non-linear analysis, it has been decided to keep linear axially rigid frame elements to model the contact between the plates and the pin.

Figure 13 - Boundary conditions at the trunnion pin (Gusset plate shown only)

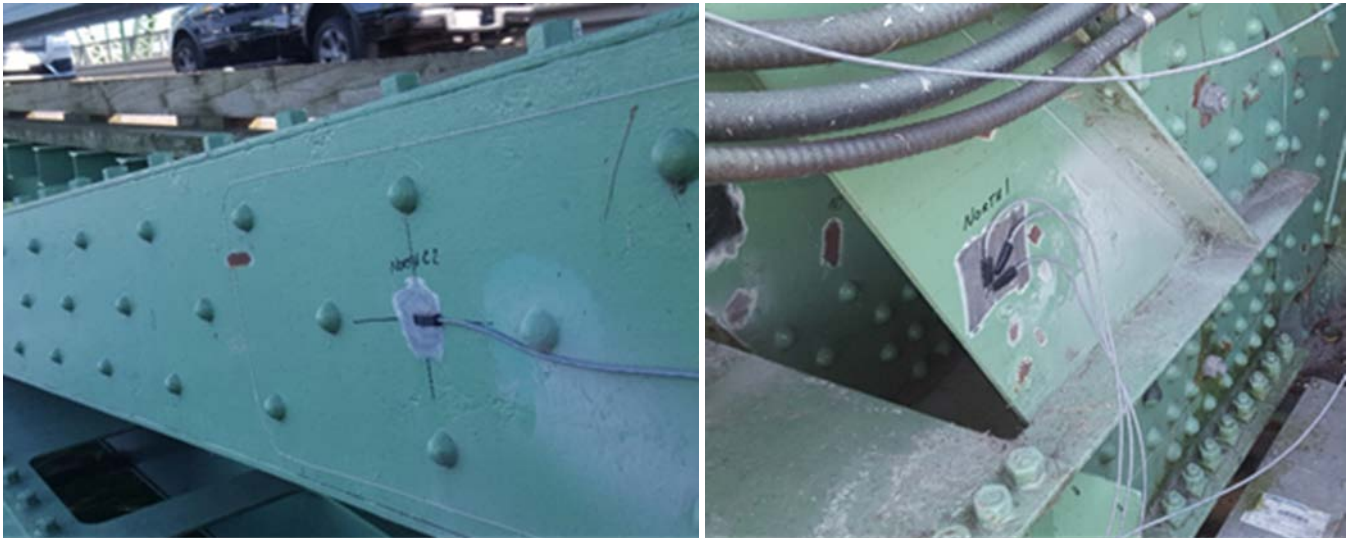
Figure 14 – Strain gauge configurations  
(a) Left: Uni-axial (b) Right: Tri-axial

Figure 17 presents a comparison for the tri-axial gauge shown in Figure 14 (b). This gauge was placed on the north exterior gusset plate. Measured strains were converted in *von Mises* stresses and then compared to the results of the localized 2D model (FE model) in which the dead loads coming from each connecting member were applied for each bridge position. These dead loads were obtained with the global bridge models for each different position before being integrated into the 2D model.

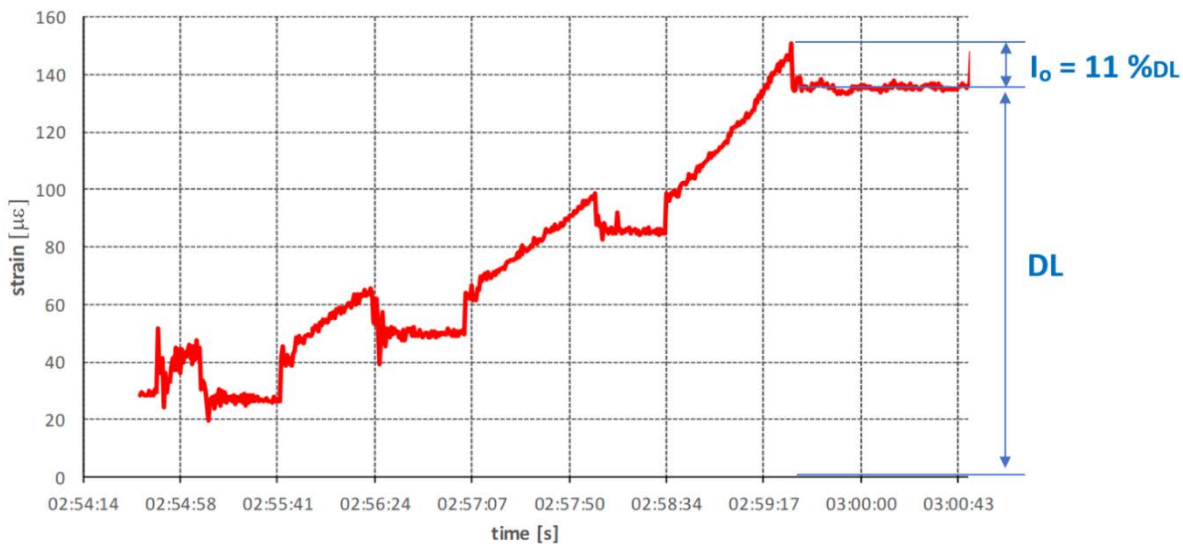
Measured strains for all members and plates, for several speeds and for several types of braking have been analyzed and the highest value recorded for  $I_o$  is 11 % of dead load (see Figure 15). The maximal value was recorded during the scenario (Scenario 6) when the emergency brake was applied. Compared to the theoretical value of 20% from the CHBDC, this value confirms that the CHBDC factor is conservative.

Figure 15 - Strains on inner face of member 15-17 during Scenario 6 with maximal impact factor recorded

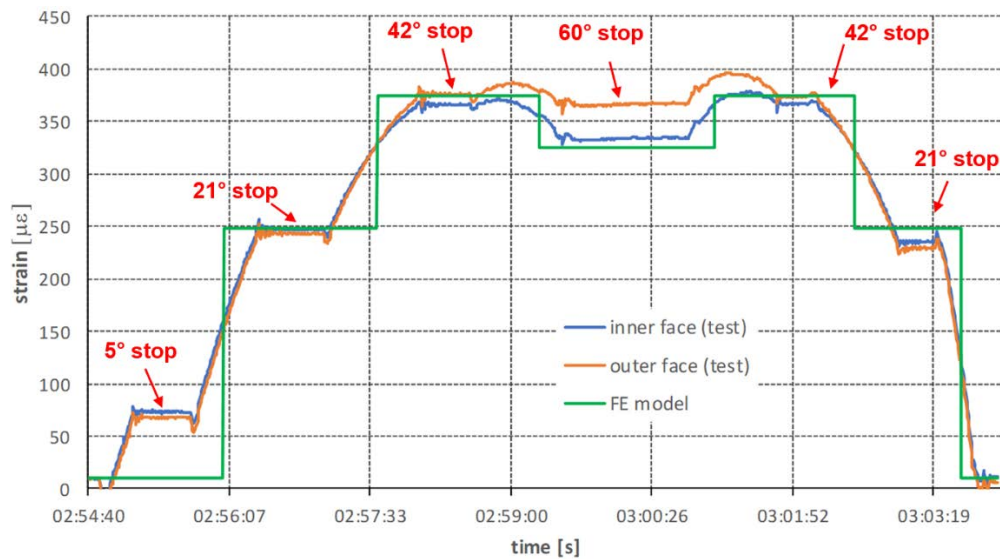
at closed position, which means that at 42° the diagonal sees a much lower axial tensile stress than 80 MPa under dead load.

Figure 16 - Strains on diagonal 13-16 during Scenario 6 compared to global bridge model results

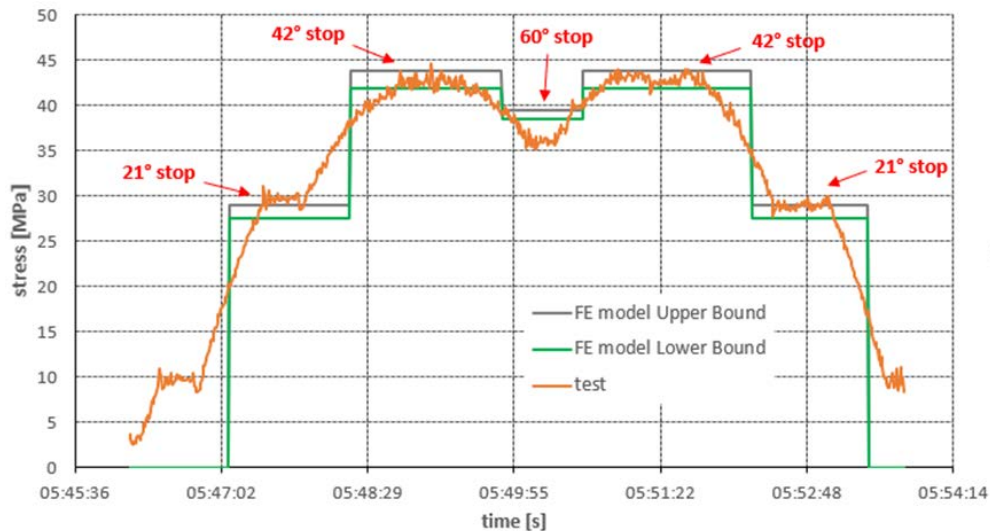
Figure 17 - *von Mises* stresses on north exterior gusset plate during Scenario 6 compared to localized 2D model results

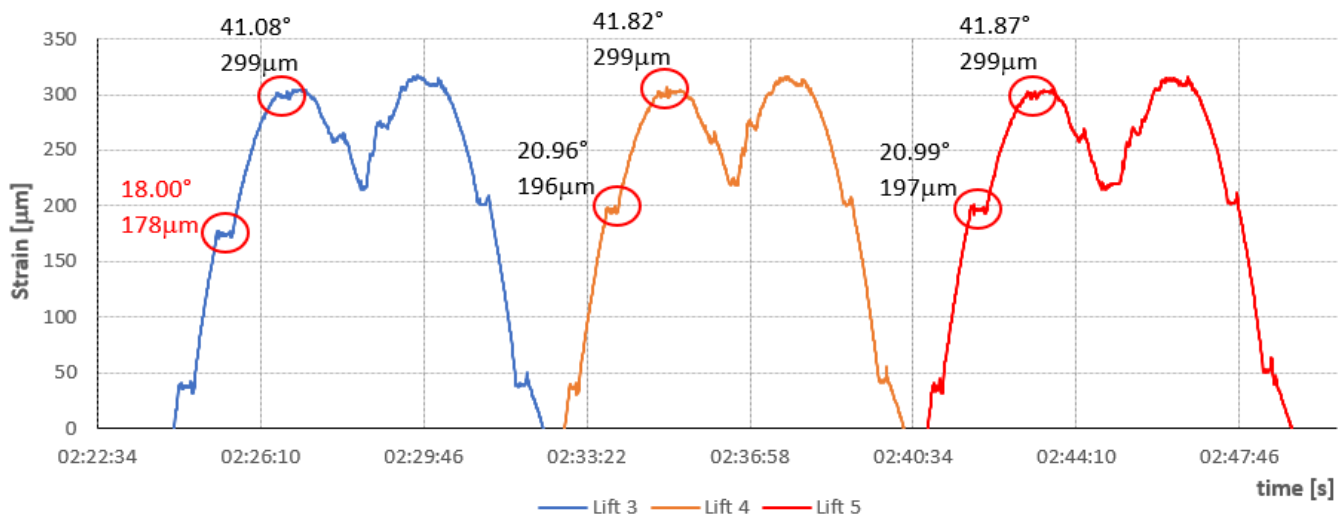
For example, Figure 18 shows the strain measurements on bottom chord (13N-16N) during lifts 3, 4 and 5. Stops planned at 21° and 42° are highlighted. On the one hand, it can be noted that when the stop angles are sufficiently close, the strain measurements are practically identical. On the other hand, for the stop at 18° during lift 3, which was the furthest during the whole test from the planned angle (21°), we can notice that the difference with the equivalent readings is about 10%. However, this difference between the stop angle and the planned angle is known, it is therefore possible to discard this reading.

Figure 18 - Strain measurements on bottom chord (13N-16N) during lifts 3, 4 and 5

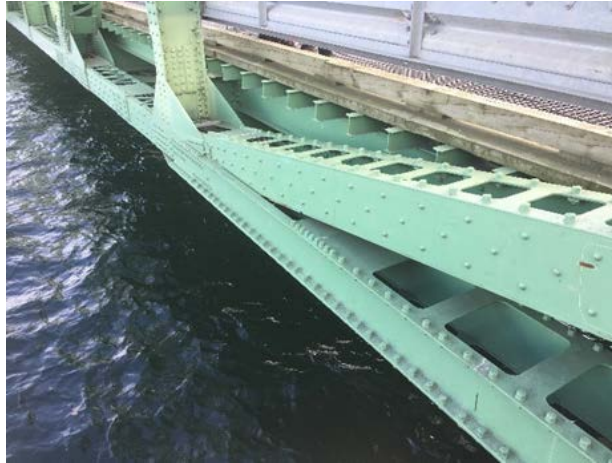
Figure 19 - Intersection between members 14-15 and 14-16

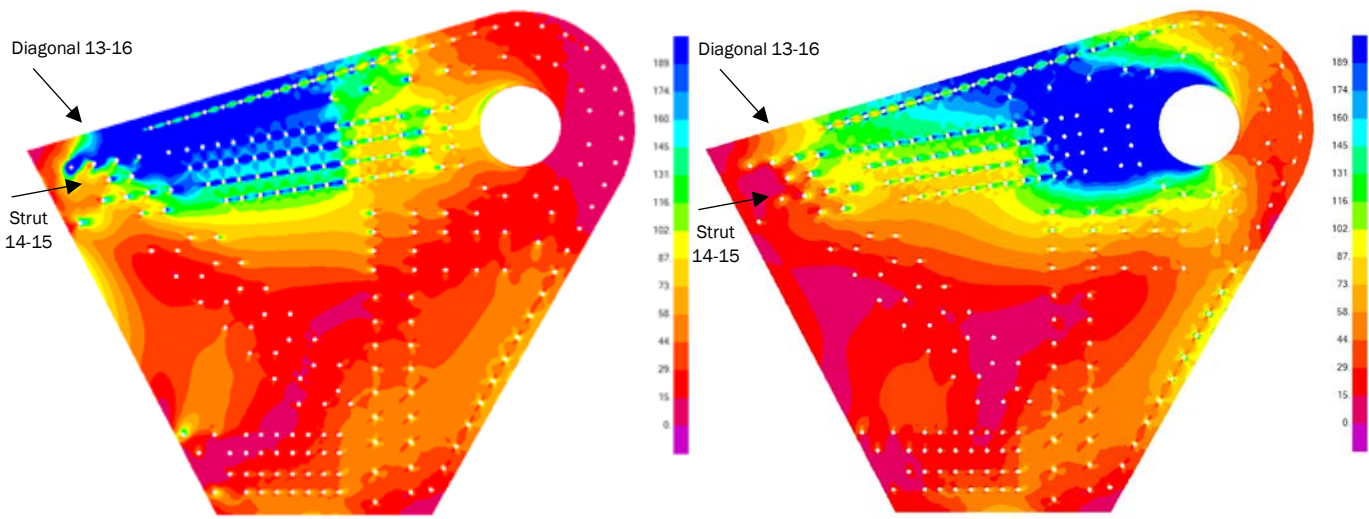
Figure 20 - *von Mises* stresses at undeteriorated state for maximum compression in strut 14-15 (ULS B2)  
 (a) Left: Upper bound case (b) Right: Lower bound case

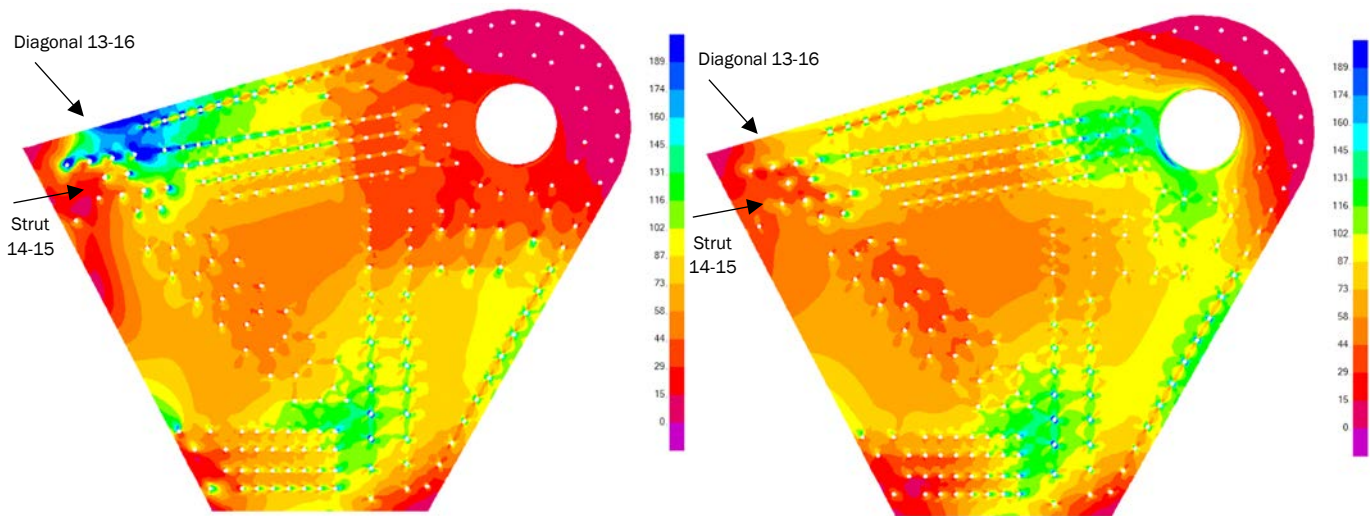
Figure 21 - von Mises stresses at undeteriorated state for maximum tension in diagonal 13-16 (ULS B2)  
(a) Left: Upper bound case (b) Right: Lower bound case

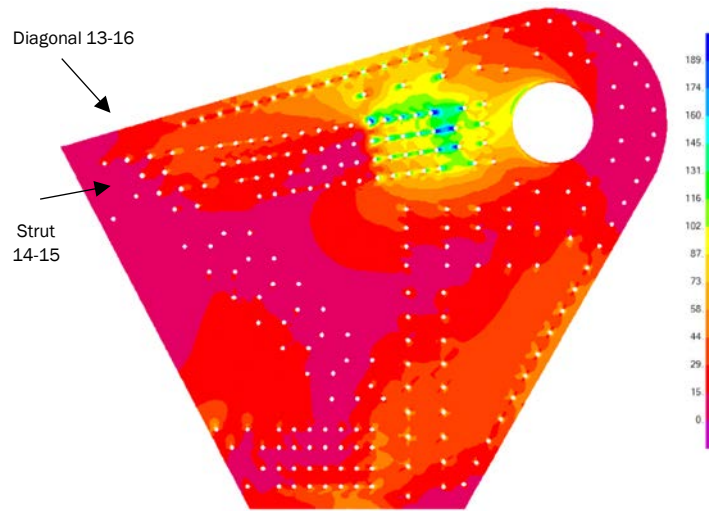
Figure 22 - *von Mises* stresses at undeteriorated state for maximum compression in strut 14-15 (ULS B2) with modified lower bound fastener stiffness

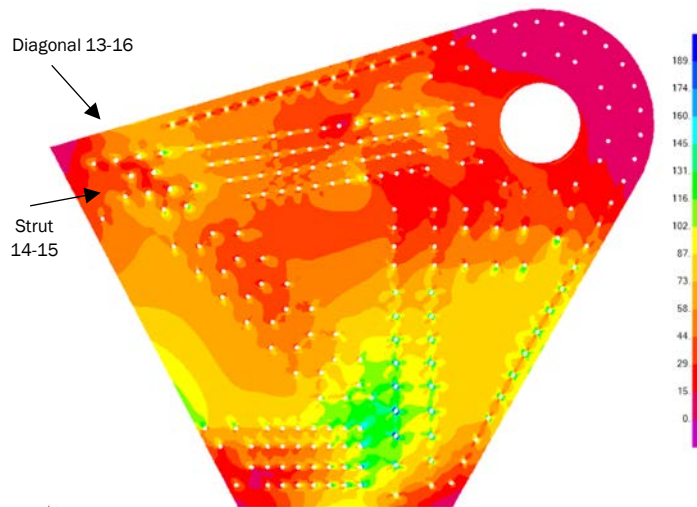
Figure 23 - *von Mises* stresses at undeteriorated state for maximum tension in diagonal 13-16 (ULS B2) with modified lower bound fastener stiffness

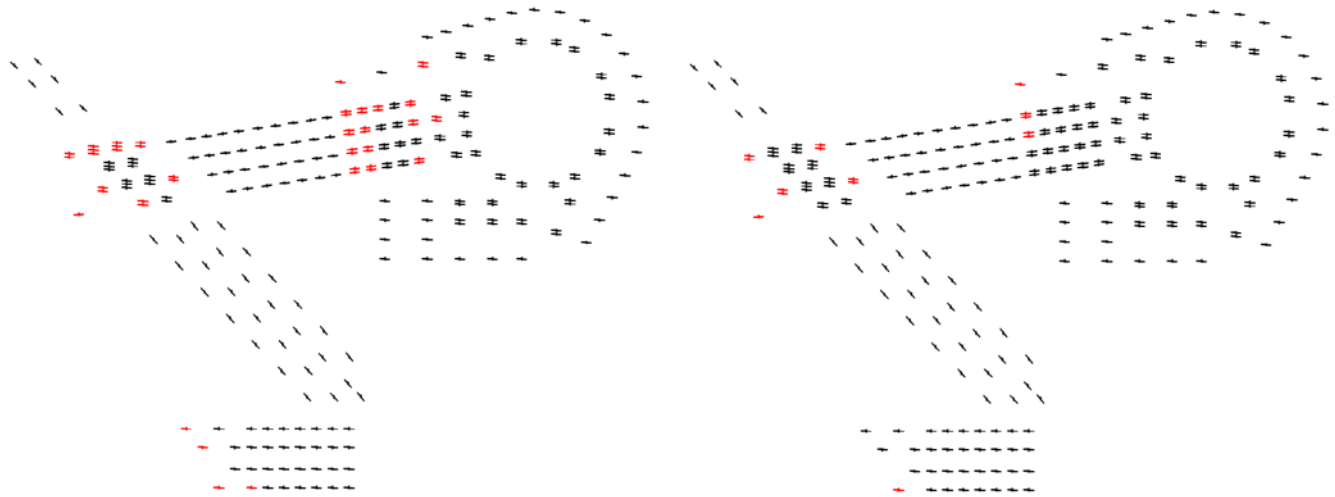
Figure 24 - Fasteners with insufficient shear resistance at undeteriorated state for upper bound fastener stiffness  
 (a) Left: ULS B1 to ULS B3 (b) Right: ULS 1

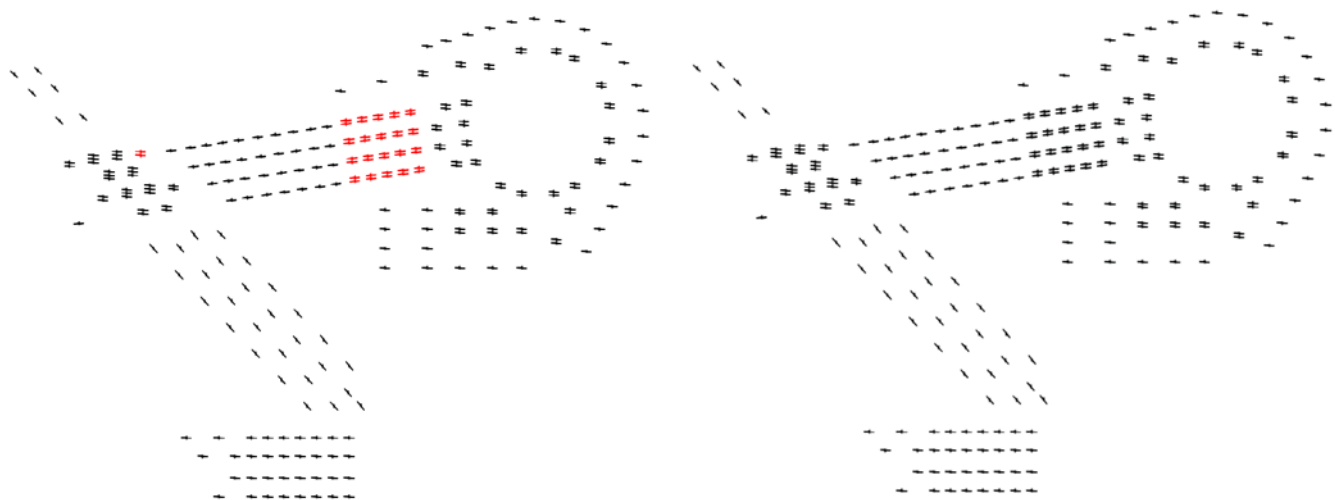
Figure 25 - Fasteners with insufficient shear resistance at undeteriorated state for lower bound fastener stiffness  
 (a) Left: ULS B1 to ULS B3 (b) Right: ULS 1

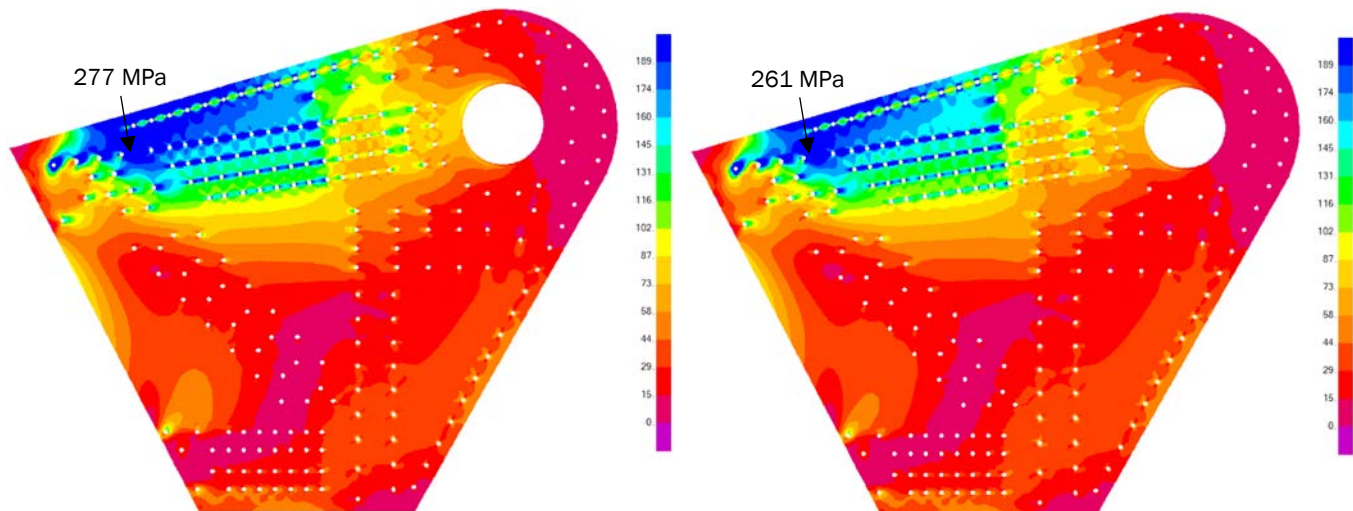
Figure 26 - *von Mises* stresses at undeteriorated state for maximal compression in strut 14-15 (ULS B3)  
 (a) Left:  $I_0$  taken as per S6-14 (b) Right:  $I_0$  taken as zero

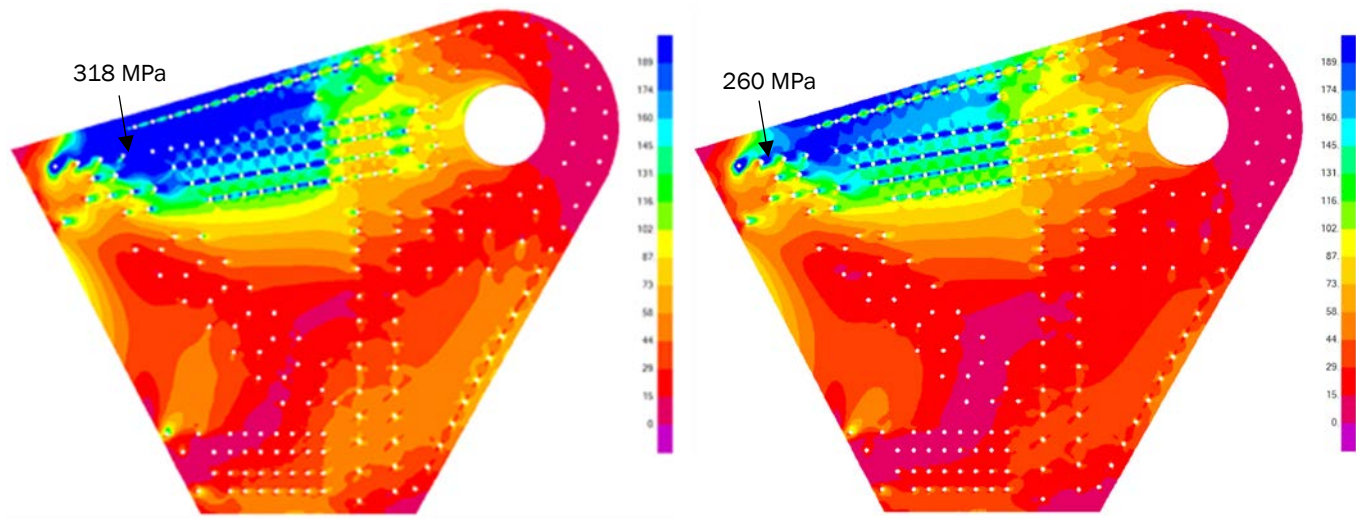
Figure 27 - *von Mises* stresses at undeteriorated state for maximal compression in strut 14-15 (ULS B2)  
 (a) Left: with  $M_0$  level 3 (b) Right: with  $M_0$  level 1

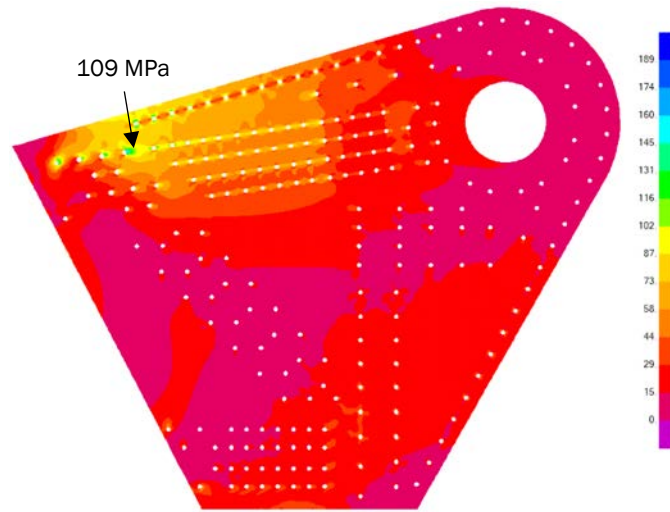
Figure 28 - *von Mises* stresses at undeteriorated state caused by unfactored  $W_0$

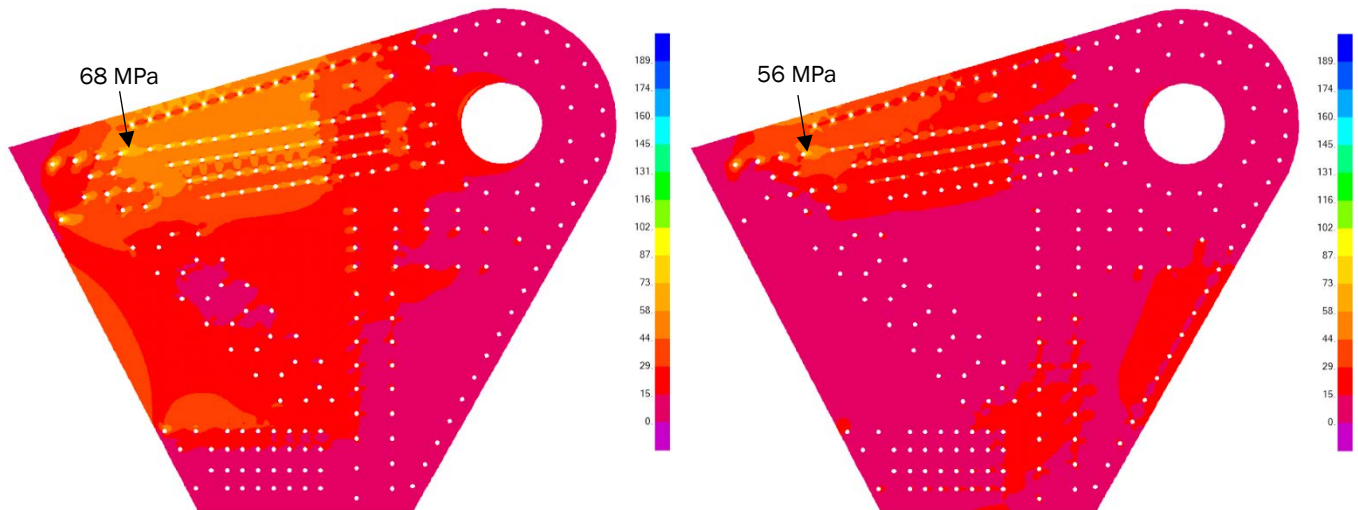
Figure 29 - *von Mises* stresses at undeteriorated state caused by  
 (a) Left: unfactored dead loads (b) Right: unfactored  $M_0$  level 3

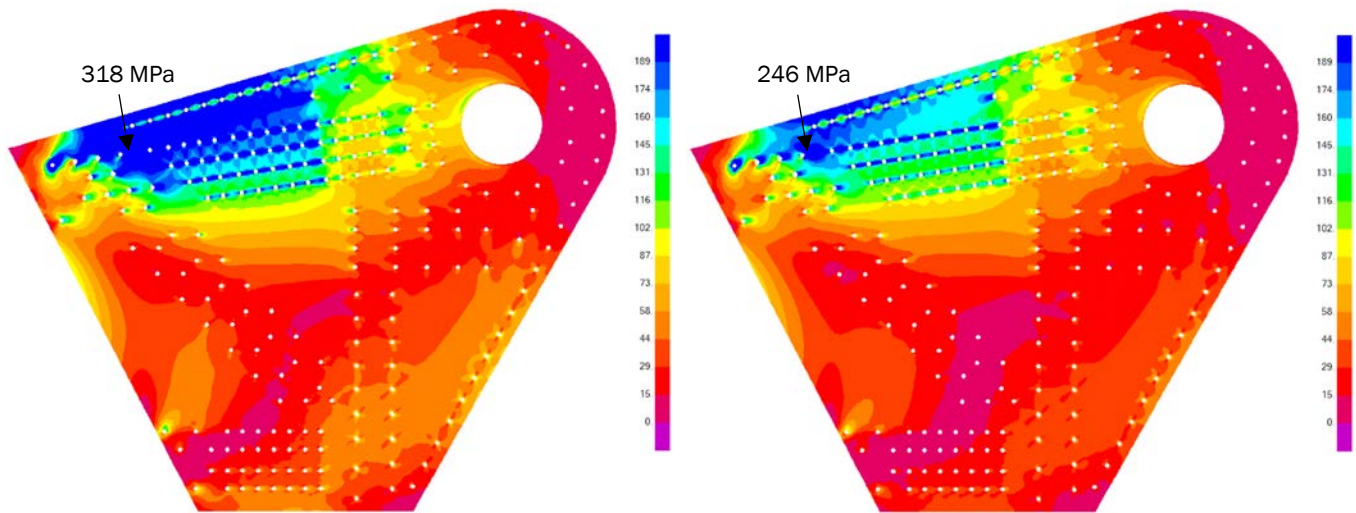
Figure 30 - *von Mises* stresses at undeteriorated state for maximal compression in strut 14-15 (ULS B2)  
 (a) Left: with  $W_0$  according to S6-14 (1.5 kPa) (b) Right: with reduced  $W_0$  (0.75 kPa)

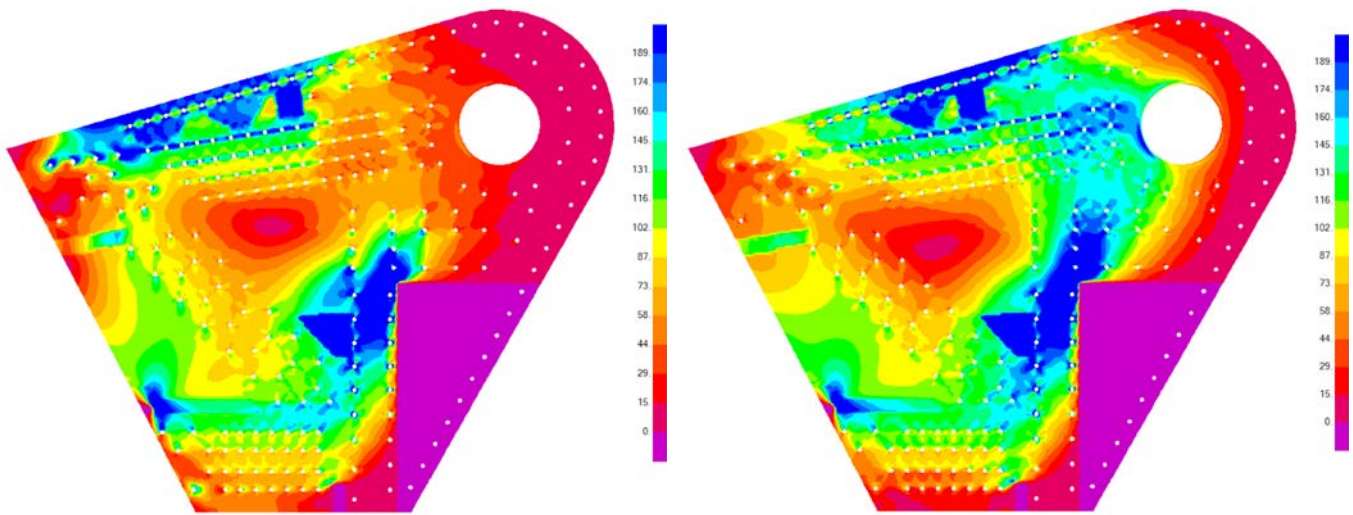
Figure 31 - *von Mises* stresses for maximal tension in diagonal 13-16 (ULS B2) in south interior gusset plate without triangle reinforcement plate  
 (a) Left: Upper bound fastener stiffness (b) Right: Lower bound fastener stiffness

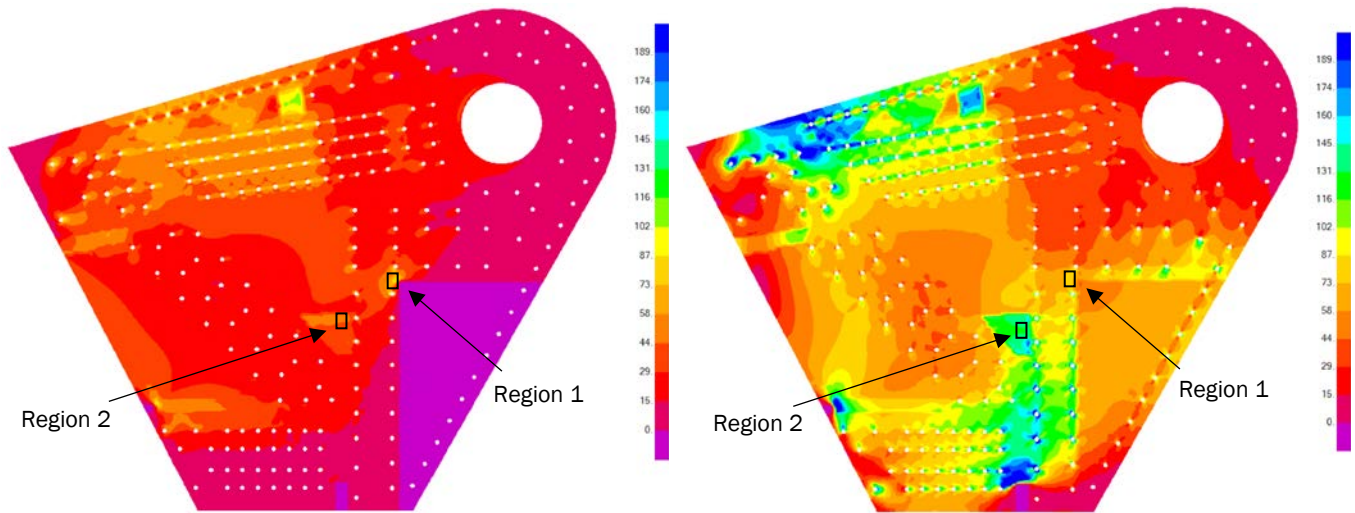
Figure 32 - *von Mises* stresses in south interior gusset plate due to  
 (a) Left: dead loads in model A (b) Right: maximal tension in diagonal 13-16 (ULS B2) in Model B

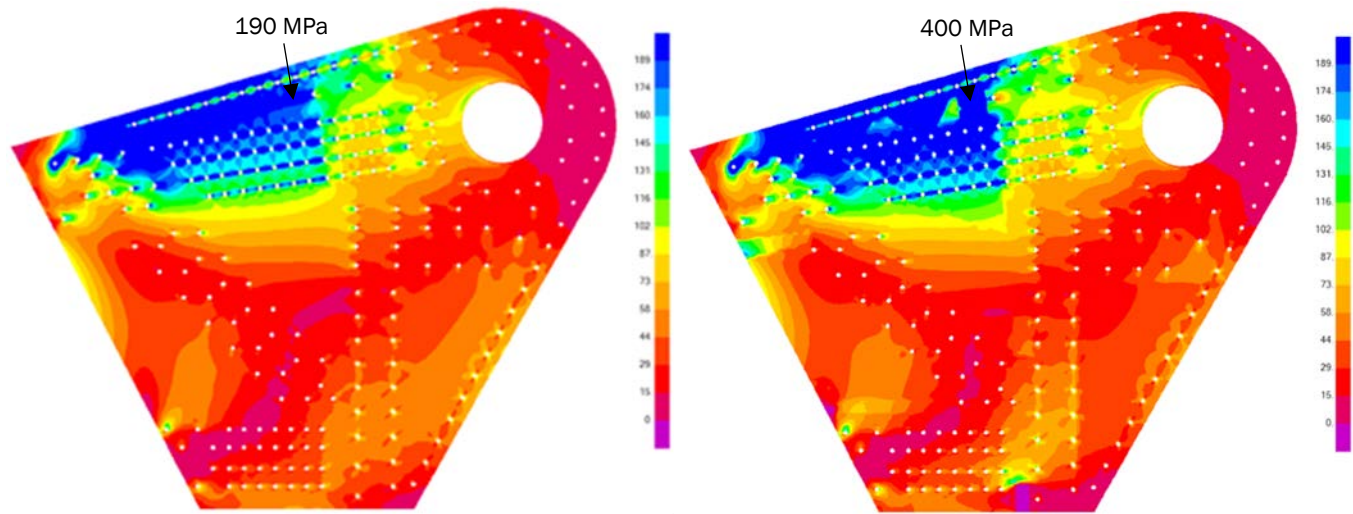
Figure 33 - *von Mises* stresses in south interior gusset plate for maximum compression in strut 14-15 (ULS B2)  
(a) Left: at undeteriorated state (b) Right: with deterioration

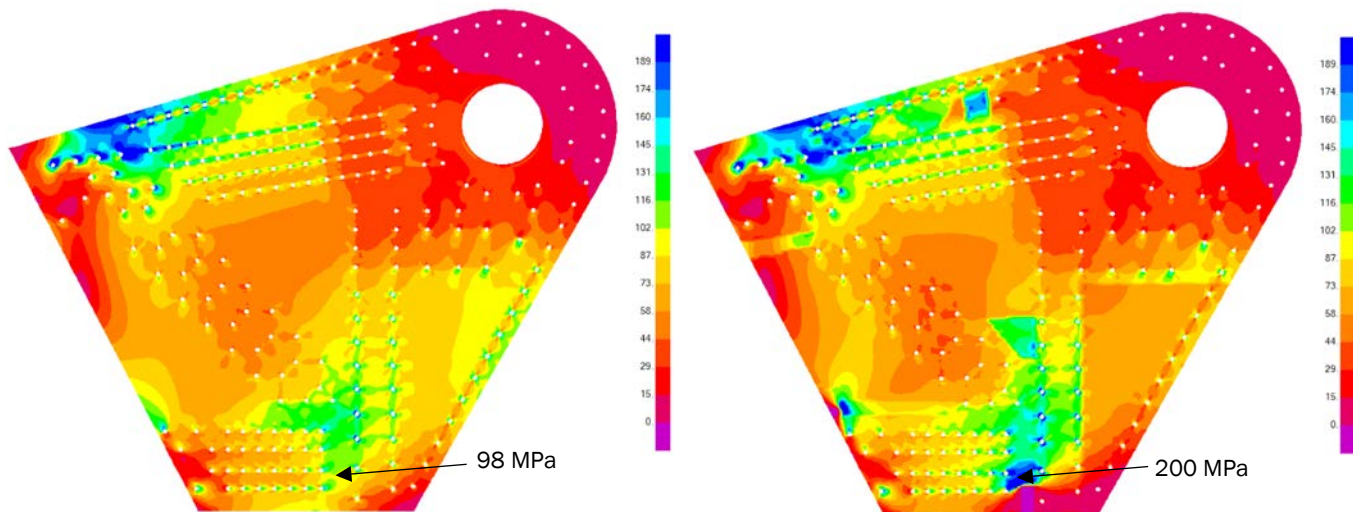
Figure 34 - *von Mises* stresses in south interior gusset plate for maximum tension in diagonal 13-16 (ULS B2)  
(a) Left: at undeteriorated state (b) Right: with deterioration

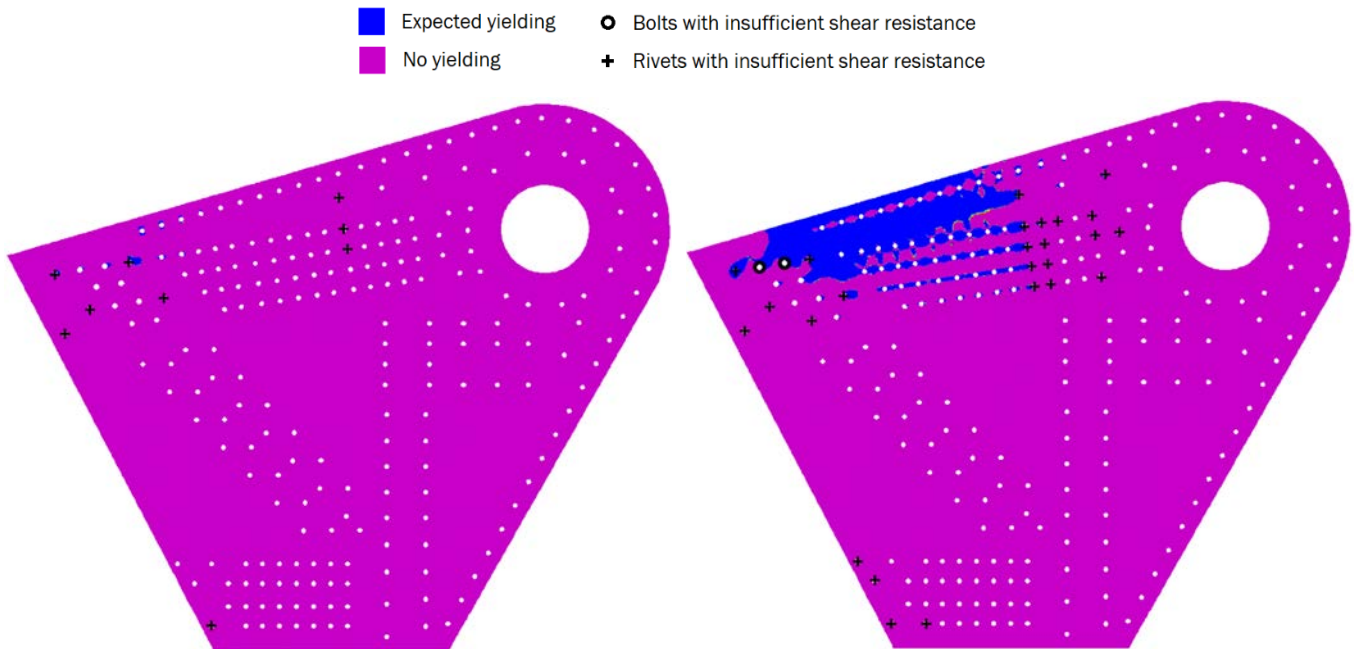
Figure 35 - Gusset plate expected yielding and fasteners with insufficient resistance at undeteriorated state according to S6-14  
 (a) Left: ULS 1 (b) Right: ULS B1 to B3

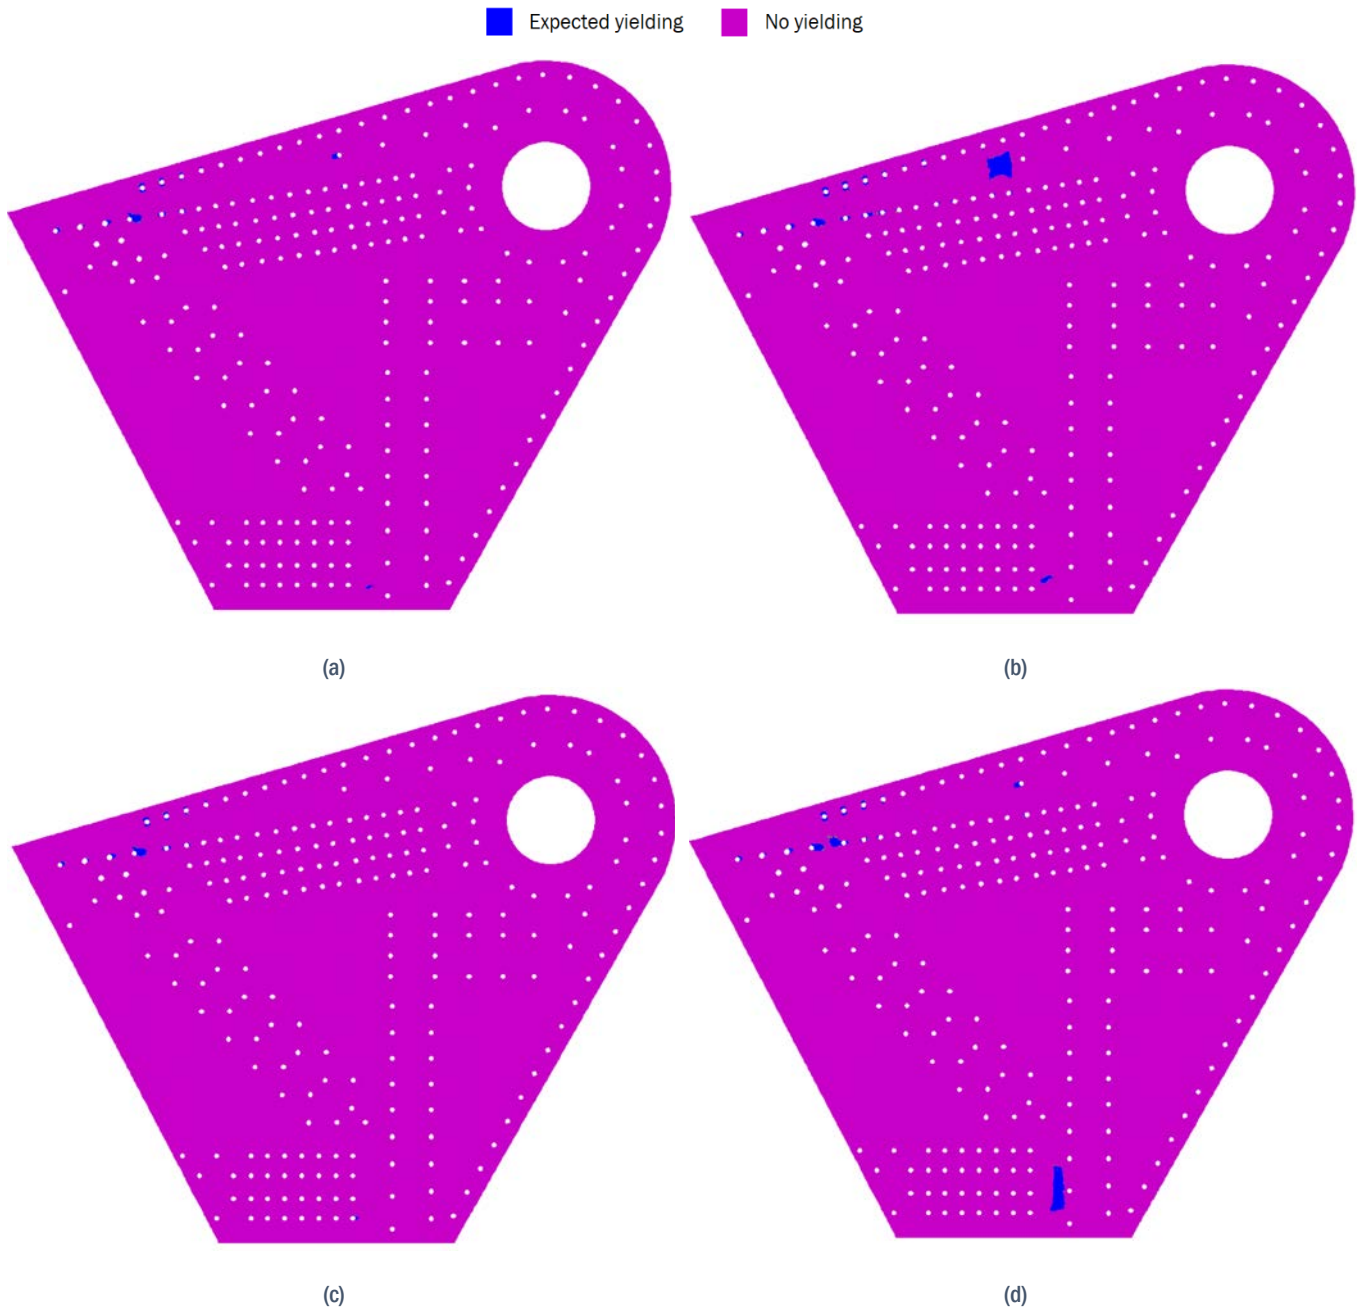
Figure 36 - Gusset plate expected yielding for ULS 1 considering deterioration  
(a) South exterior plate (b) South interior plate  
(c) North exterior plate (d) North interior plate
