Project Number: R. 099350.002

# **Lasalle Causeway Bascule Bridge Main Trunnion Rehabilitation Study - Structural Evaluation Report**

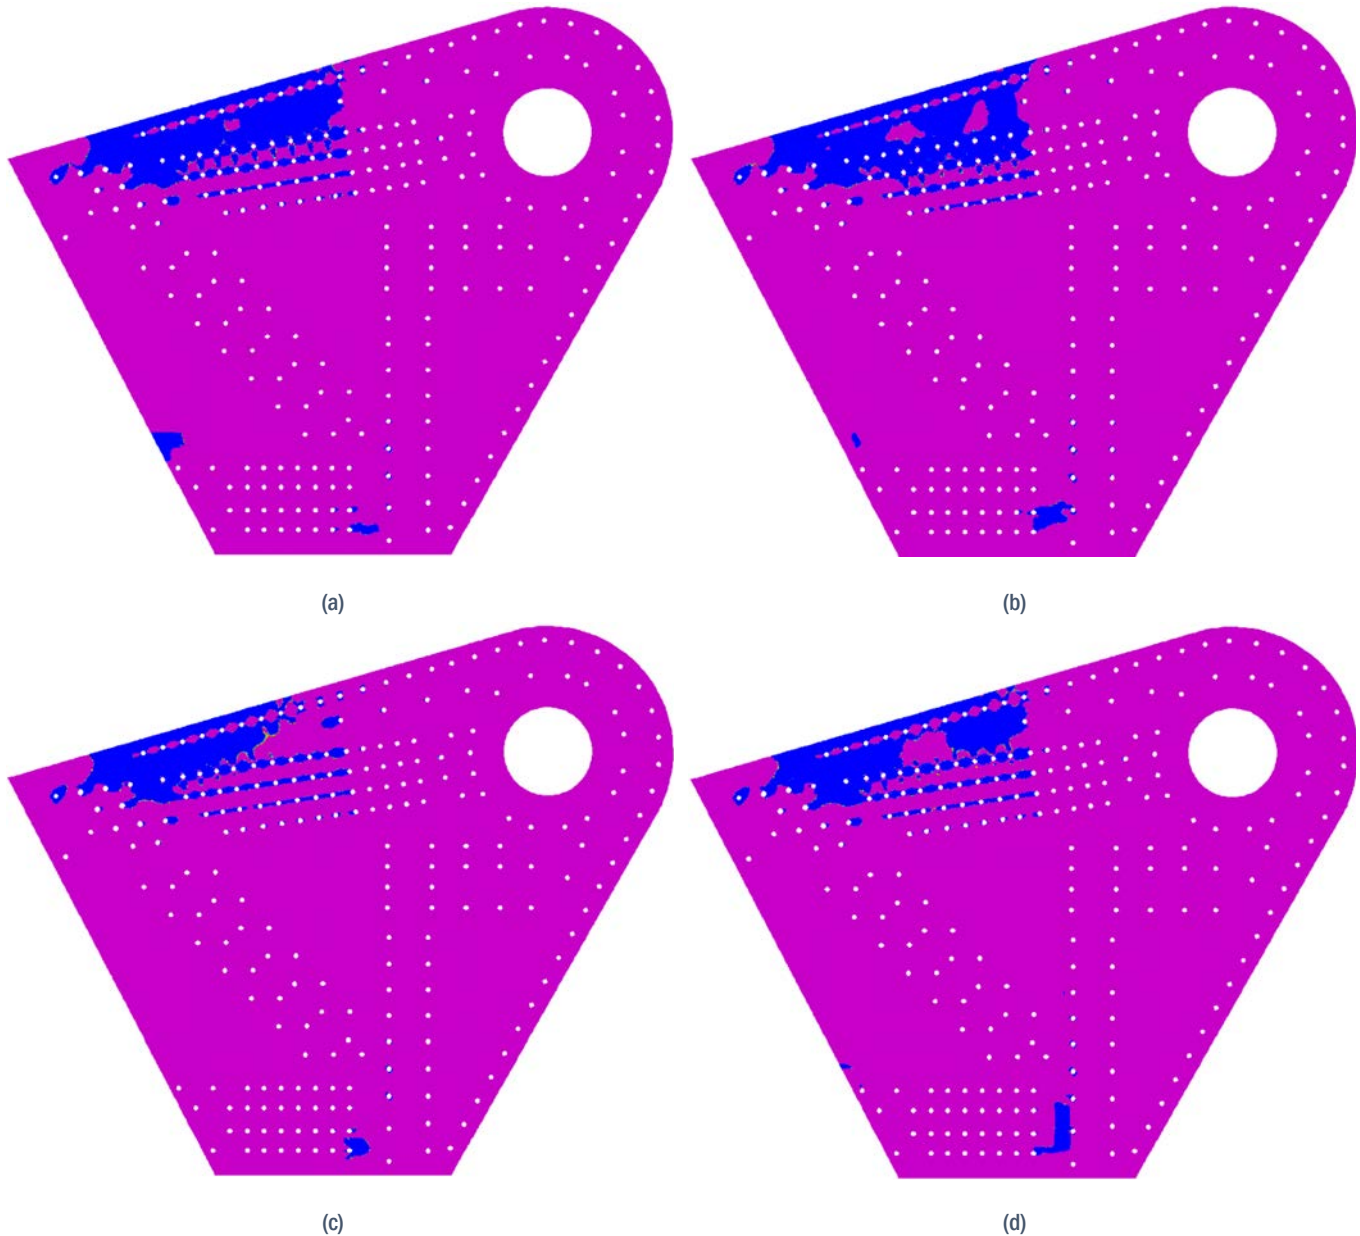
Figure 37 - Gusset plate expected yielding for ULS B1 to B3 according to S6-14 considering deterioration  
 (a) South exterior plate (b) South interior plate  
 (c) North exterior plate (d) North interior plate

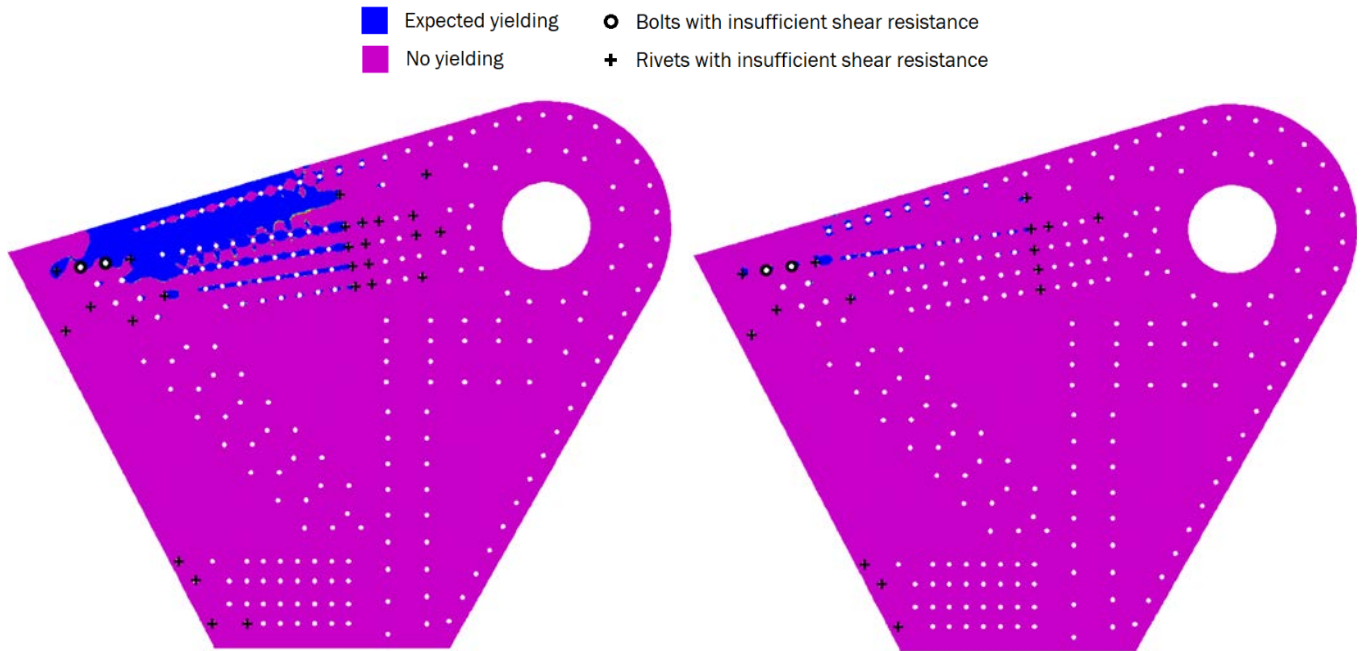
Figure 38 - Gusset plate expected yielding and fasteners with insufficient resistance at undeteriorated state for ULS B1 to B3  
(a) Left: with loads taken according to S6-14 (b) Right: with restrictions during bridge operation

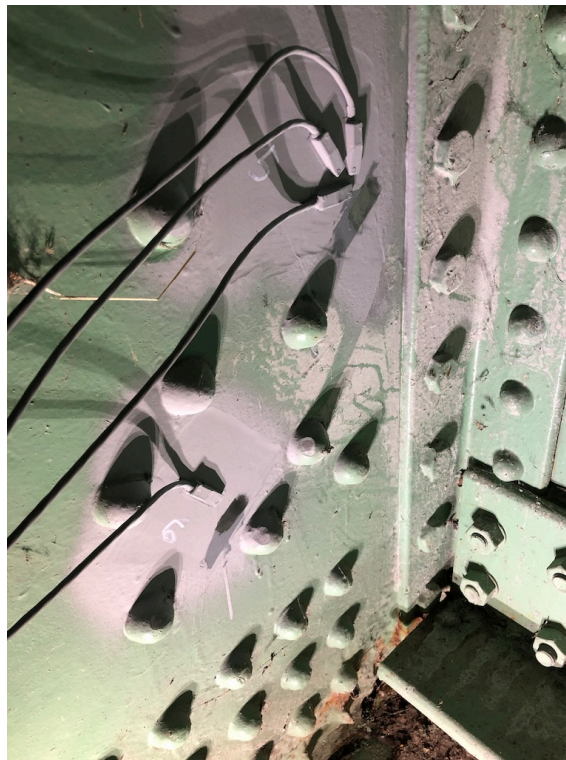
Figure1: Test Locations 5 and 6 at North Trunnion Plate Interior Plate at Strain Gauge Locations (Readings Taken from Inside surface of Plate)

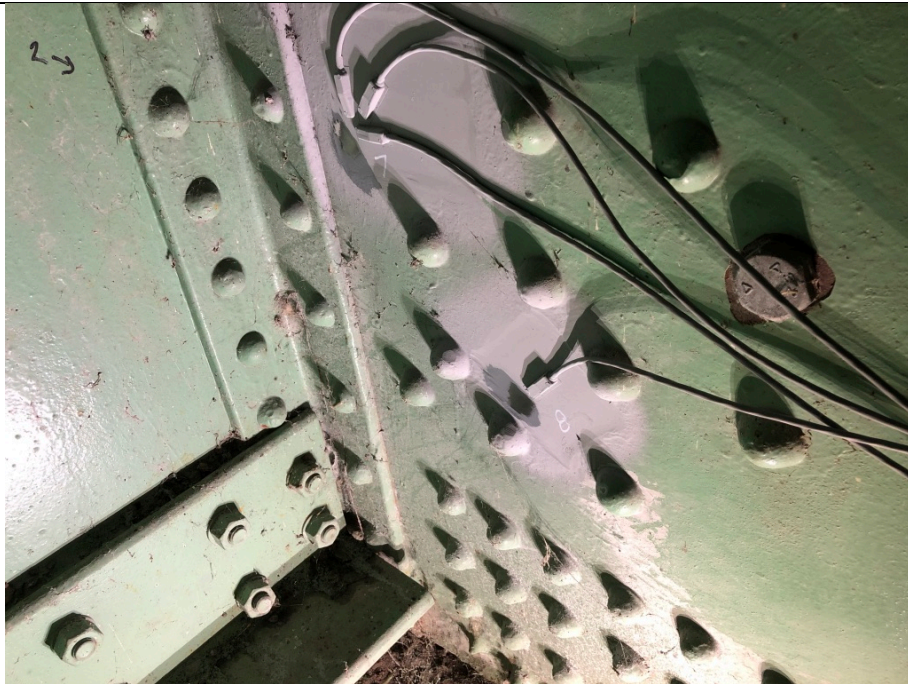
Figure2: Test Locations 7 and 8 at North Trunnion Plate Exterior Plate at Strain Gauge Locations (Readings Taken from Inside surface of Plate)

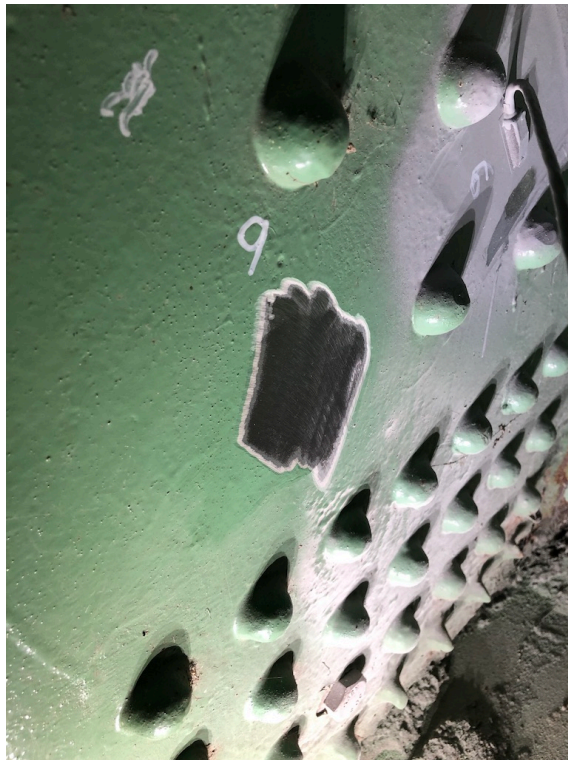
Figure3: Test Locations 9a and 9b at North Trunnion Plate Interior Plate (Readings Taken from Inside surface of Plate)

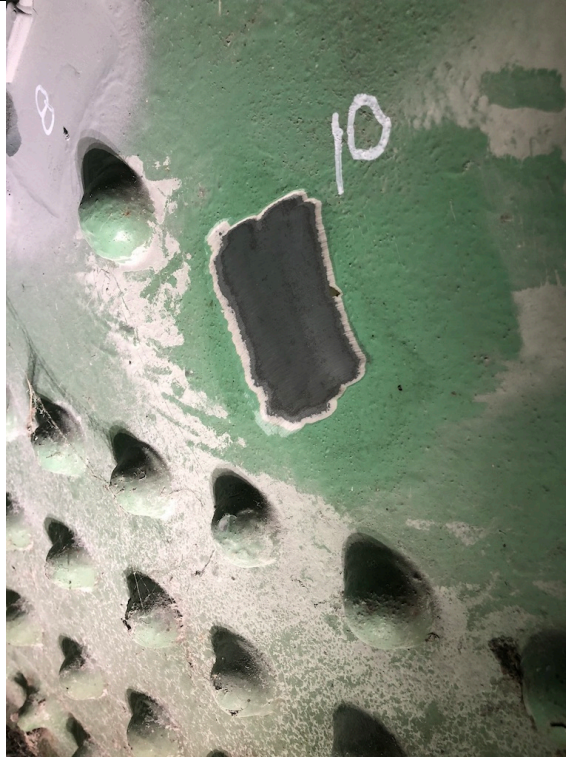
Figure4: Test Location 10 at North Trunnion Plate Exterior Plate (Readings Taken from Inside surface of Plate)

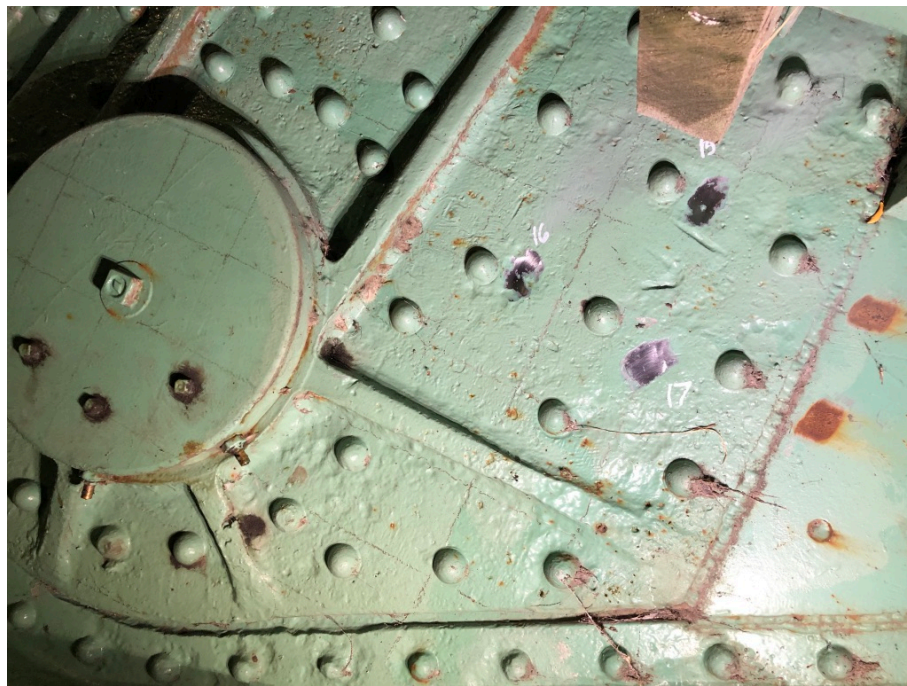
Figure4: Test Locations 15, 16, and 17 at North Trunnion Plate Interior Plate

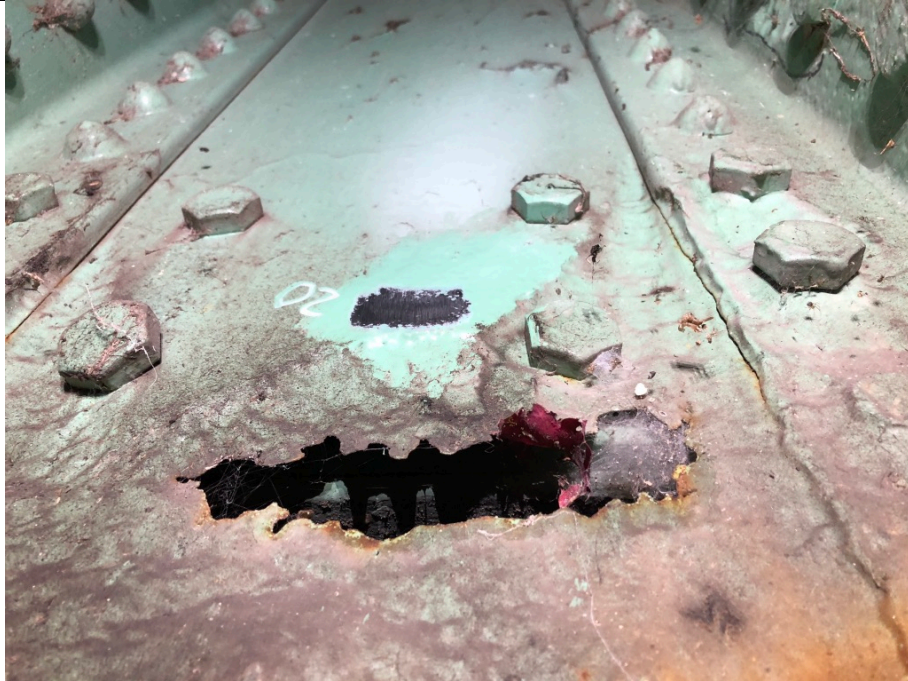
Figure5: Test Location 20 at North Trunnion Location, Batten Plate

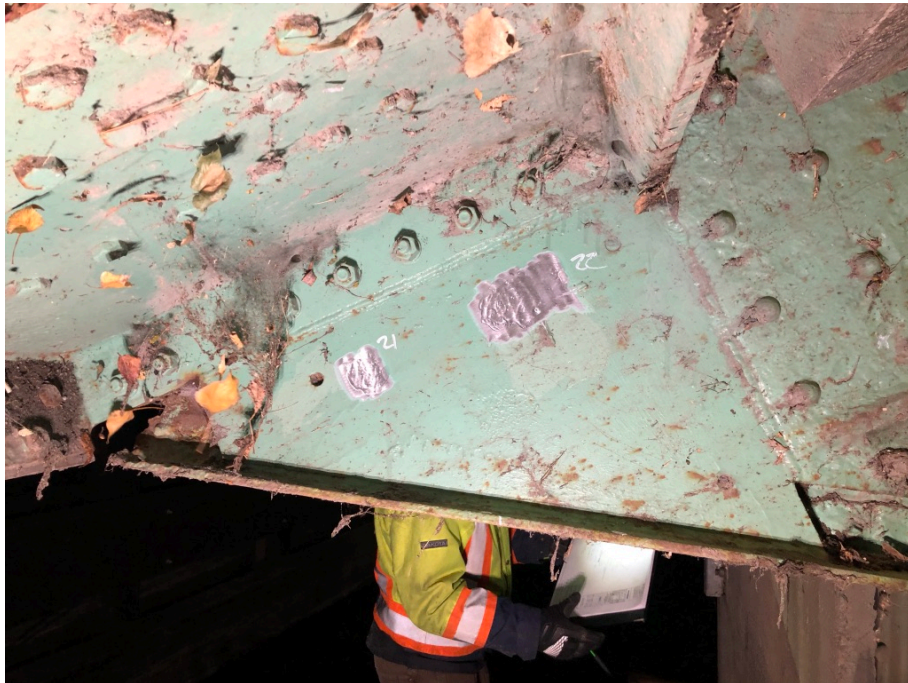
Figure6: Test Locations 21 and 22 at South Trunnion Plate Interior Location (Readings Taken on Exterior Plate Surface)

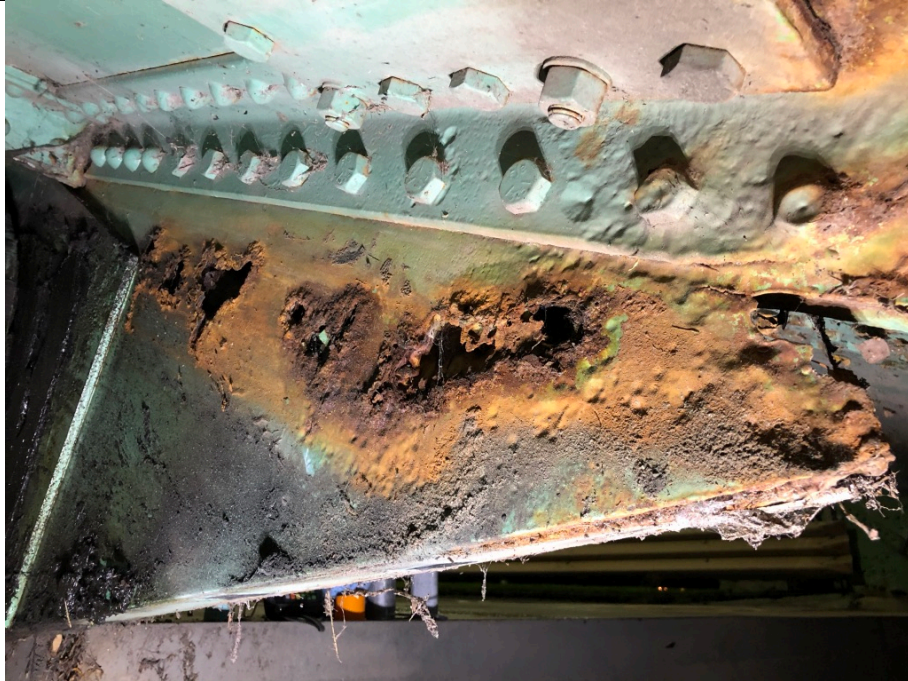
Figure7: Opposite Side of South Trunnion Plate Interior Location (Inside Plate Surface, see Figure 6 for Exterior Plate Surface)

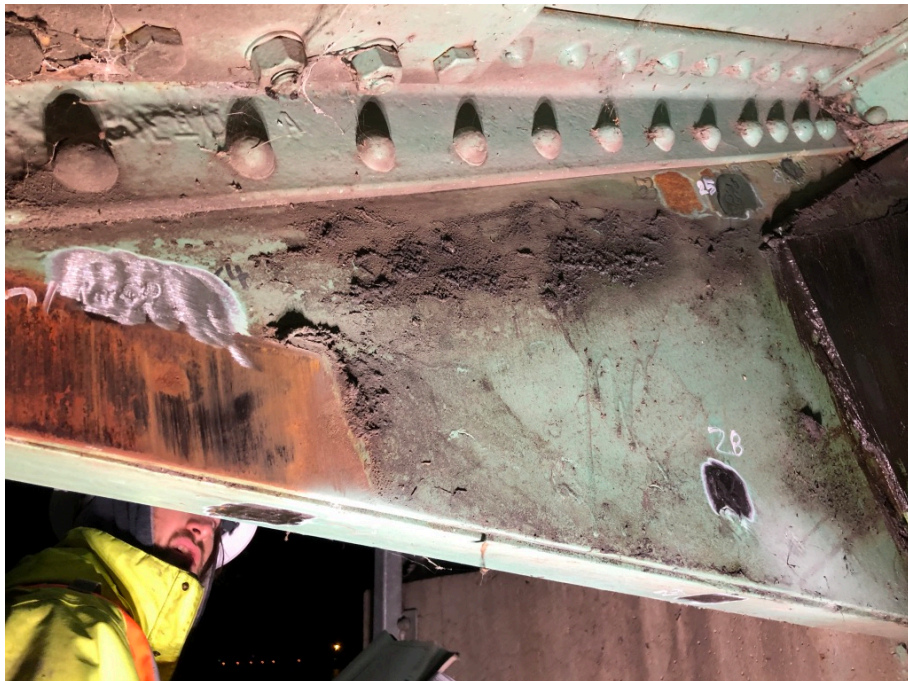
Figure8: Test Locations 25, 26 and 28 at South Trunnion Plate Exterior Location (Readings Taken from Inside Surface)

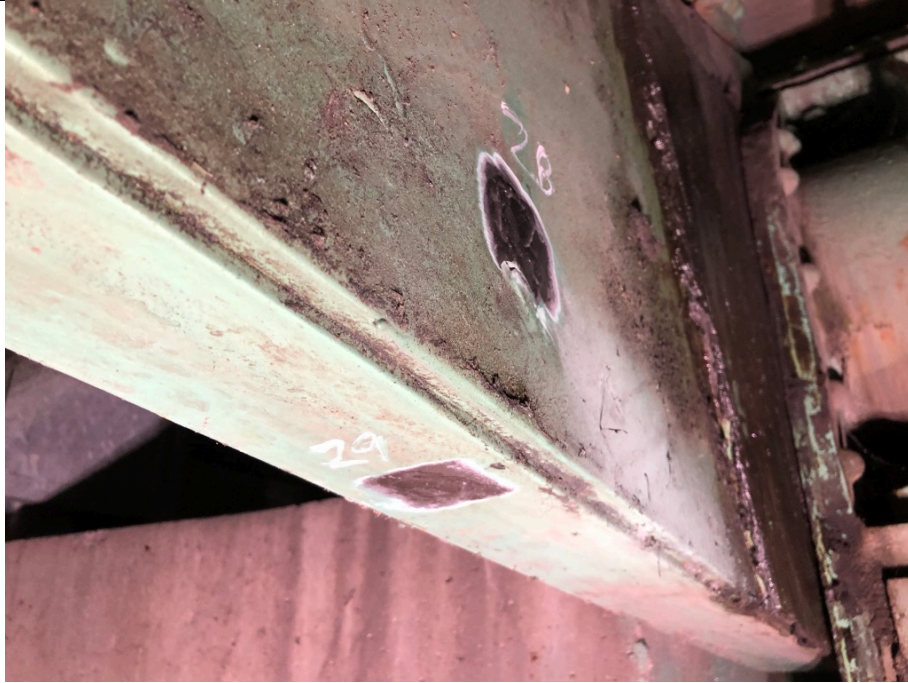
Figure9: Test Locations 28 and 29 at South Trunnion Plate Exterior Location (Readings Taken from Inside Surface and Bottom Surface of Angle)

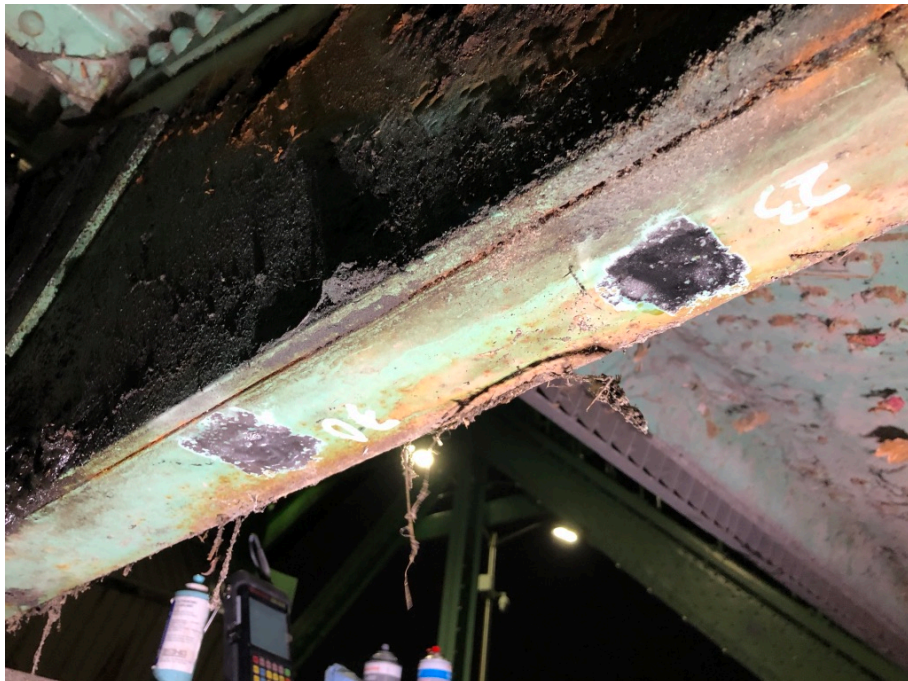
Figure10: Test Locations 23 and 30 at South Trunnion Plate Interior Location (Readings Taken from Inside Bottom Surface of Angle)

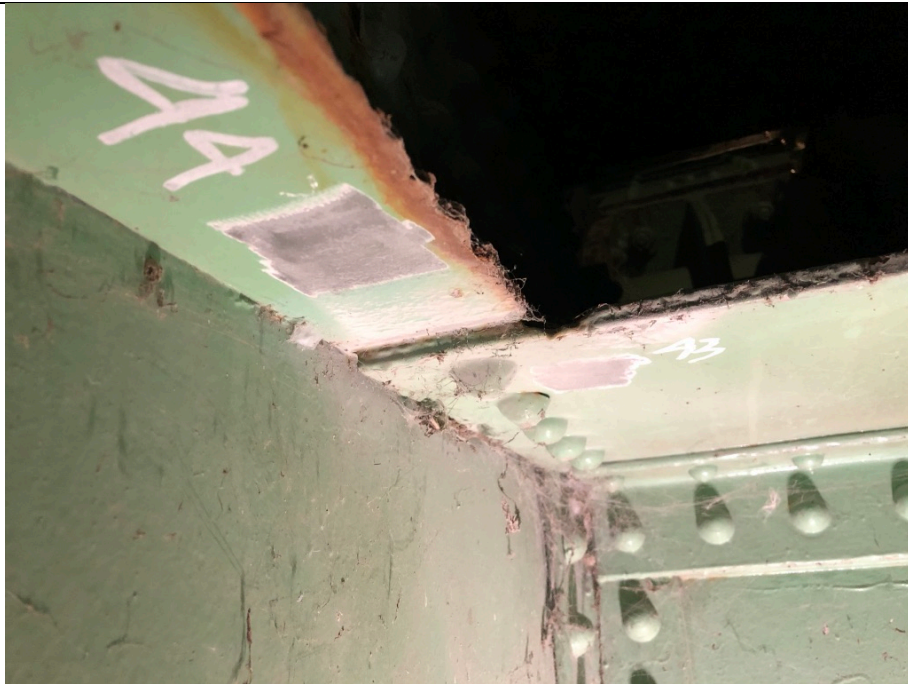
Figure11: Test Locations 43 and 44 at South Trunnion Exterior Plate at Interior Batten Plate and Angle

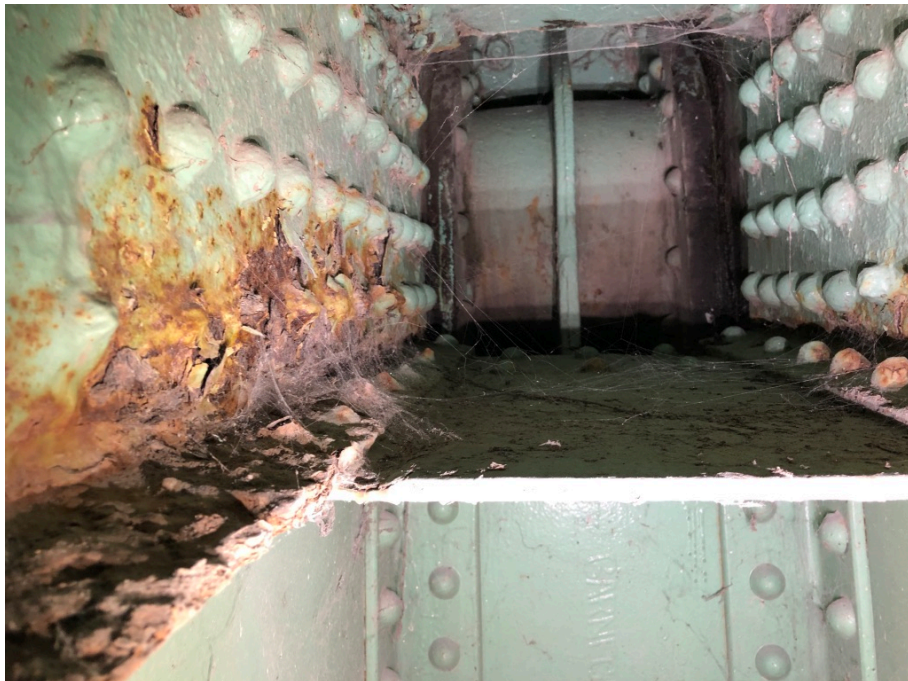
Figure12: Test Locations 43 and 44 at South Trunnion Exterior Plate at Interior Batten Plate and Angle

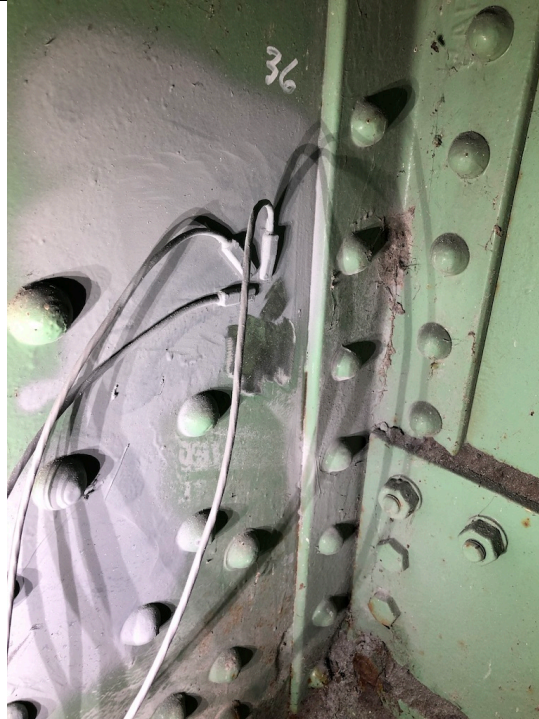
Figure13: Test Location 36 at South Trunnion Exterior Plate Location (Readings Taken on Interior Surface of Plate)

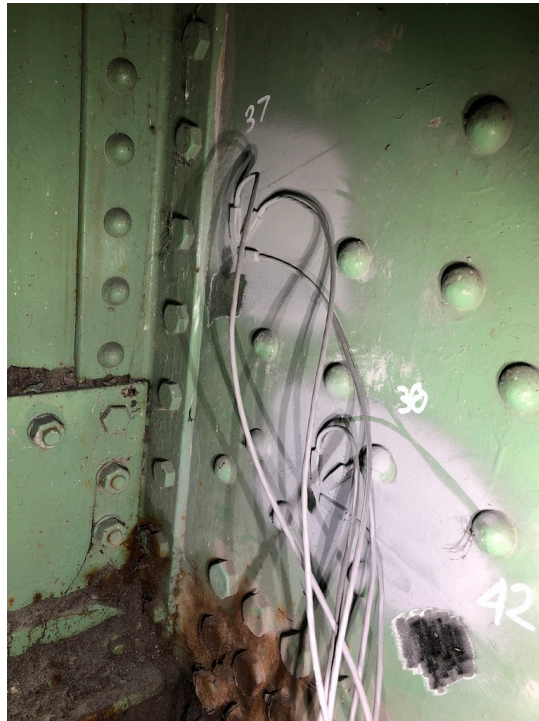
Figure14: Test Locations 37, 38, and 42 at South Trunnion Interior Plate Location (Readings Taken on Interior Surface of Plate)

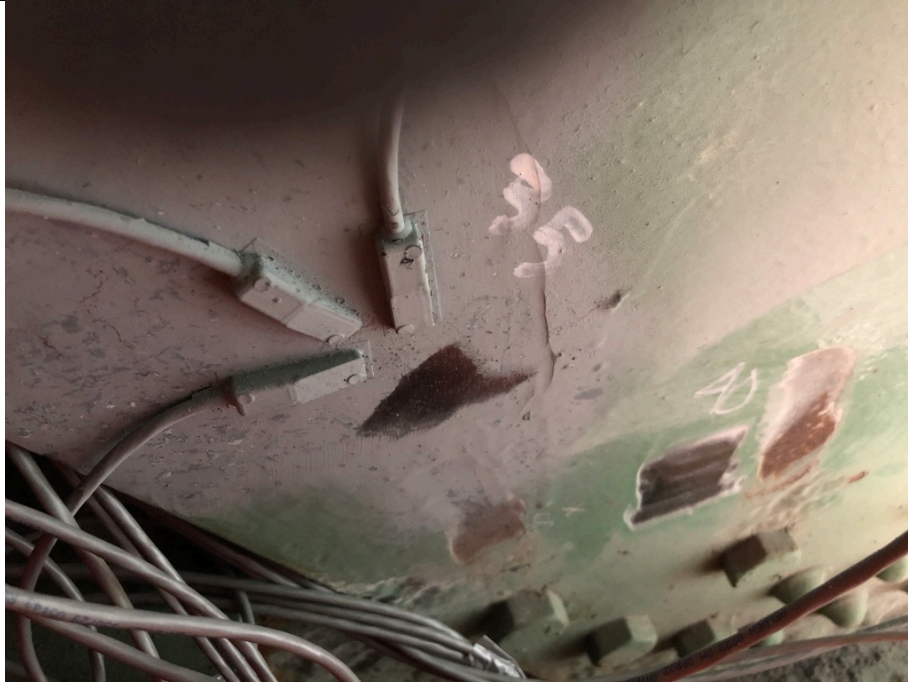
Figure15: Test Locations 35, and 40 at South Trunnion Exterior Plate Location (Readings Taken on Interior Surface of Plate)

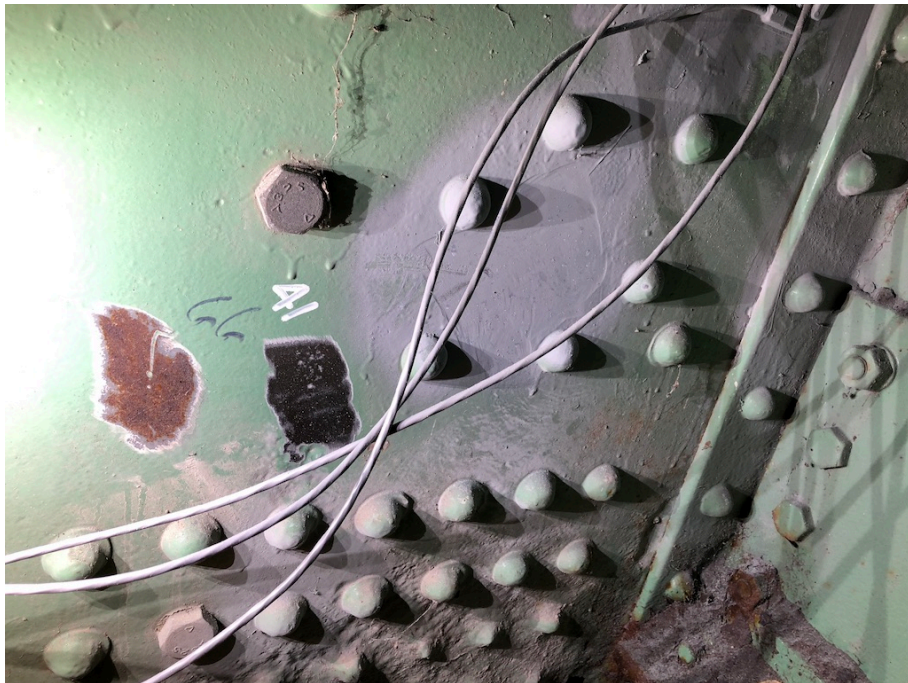
Figure16: Test Location 41 at South Trunnion Exterior Plate Location (Readings Taken on Interior Surface of Plate)

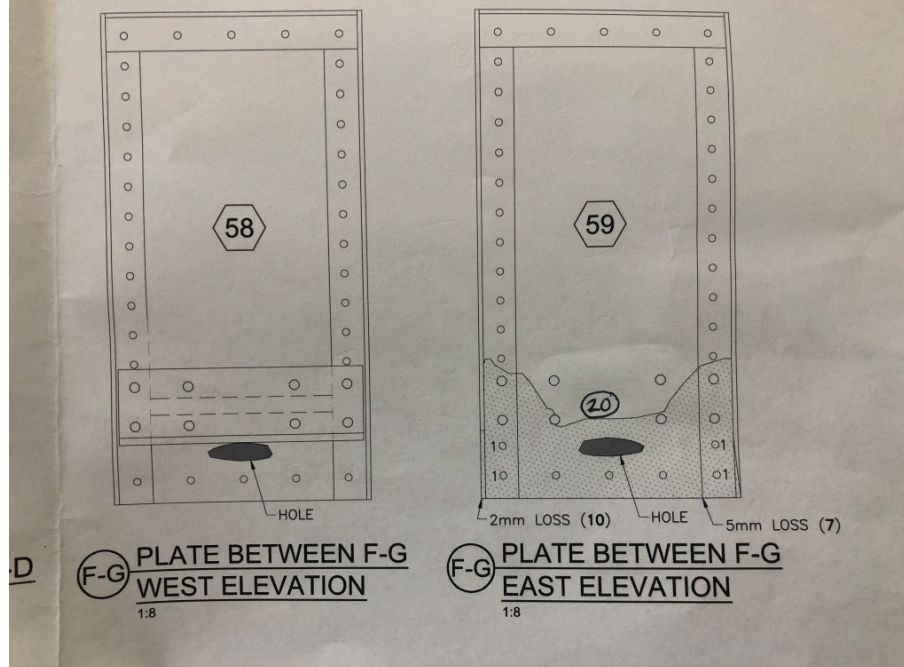
Figure19: North Trunnion Location, Batten Plate Test Location
