PARSONS

LaSalle Causeway Bascule Bridge
2018 Fatigue Inspection and Evaluation Report

March 1st 2019

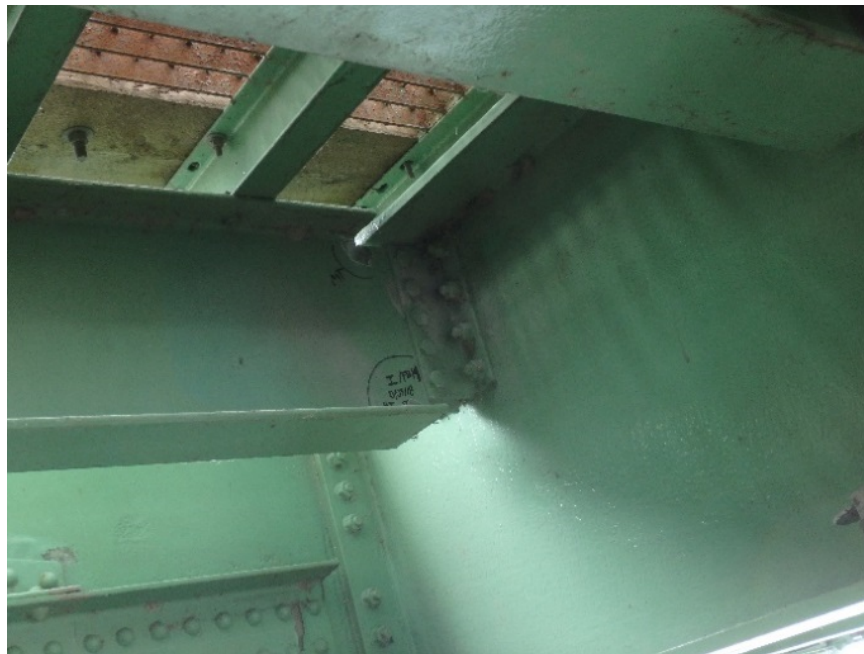
Figure 3: Potential Distortion-Induced Fatigue Detail

Floorbeams are connected to the main trusses by a moment rigid connection. An end plate is welded to the web and flanges of the floorbeam and bolted to the main trusses. At the web, flange and base plate joint, the WWF flange-web welds intersect with the base plate welds, creating an intersection of 3 welds (see figure 108 of Appendix C and [Figure 4: Potential Constraint-Induced Fatigue Detail](#) of this report). This detail could be constraining the web into a tri-axial state of stress (tension in the truss bottom chord, tension in the floorbeam flange, tension in half of web height and shear load in the web). All such locations were subject to hands-on

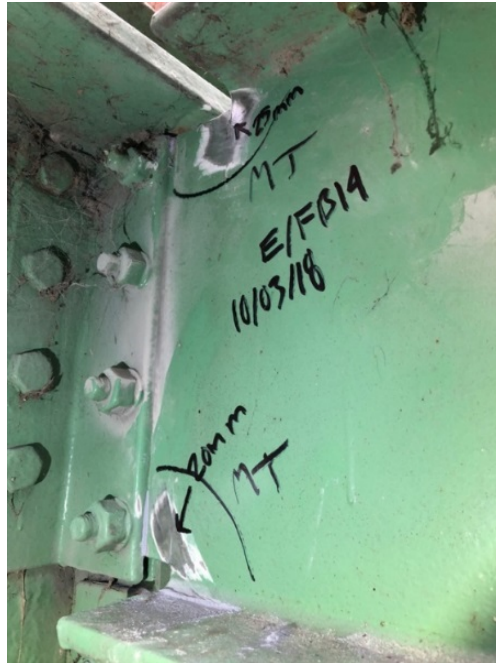
A total of 39 cracks were found in the coped end of stringers. The exact location and length of cracking can be found in Appendix B.

Many of the locations tested randomly were found to be cracked, even there was no crack visible in the coating. In total, 39 cracks were identified, of which only 16 were found in previous inspections. Several adjacent stringers were found to be cracked, with crack lengths up to 25mm and, in some locations, cracks at both top and bottom copes (combined length of up to 45mm). Rotation of the stringers under live load can create a stress condition favorable to bottom cope crack growth, while restraint provided by the stringer-to-floorbeam bolted connection can create a condition favorable to top cope crack growth. Rotational rigidity of the bolted connection probably varies from one stringer to the other (bolt tension, bolt hole alignment, etc.), thus the level of rotation restraint is probably also variable. Given that most of the cracks were found on the bottom cope, it seems the condition favorable to bottom cope growth are more prevalent.

Figure 5: Typical Stringer Coped Ends Cracking – Stringer E, Floorbeam 14, Bay 14-16

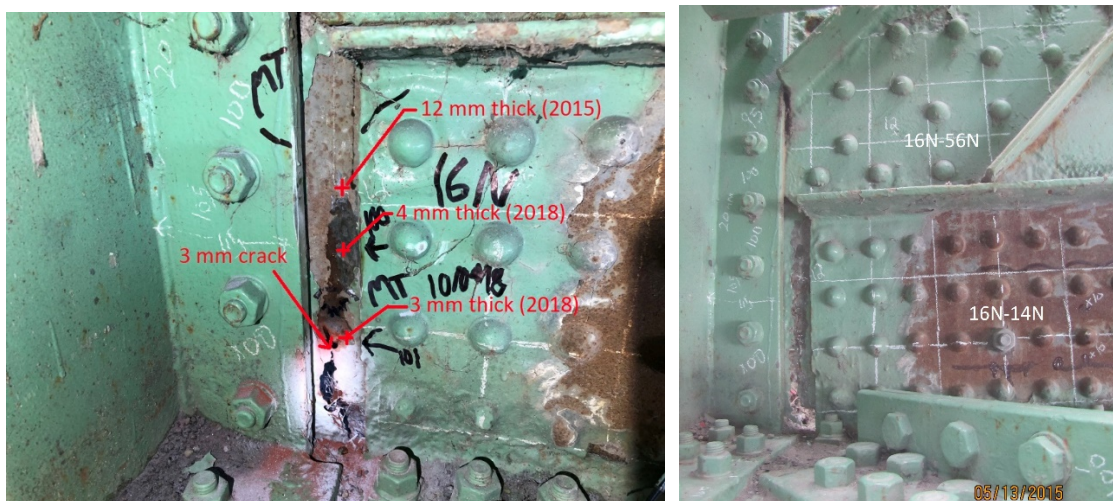
Figure 6: Linear Perforation in 16N Interior Plate, with Possible Crack

Monitor the location yearly to assess the efficiency of crack grinding **BIM Priority Code D**

Reinforce corroded element with slip critical bolted steel element **BIM Priority Code B**

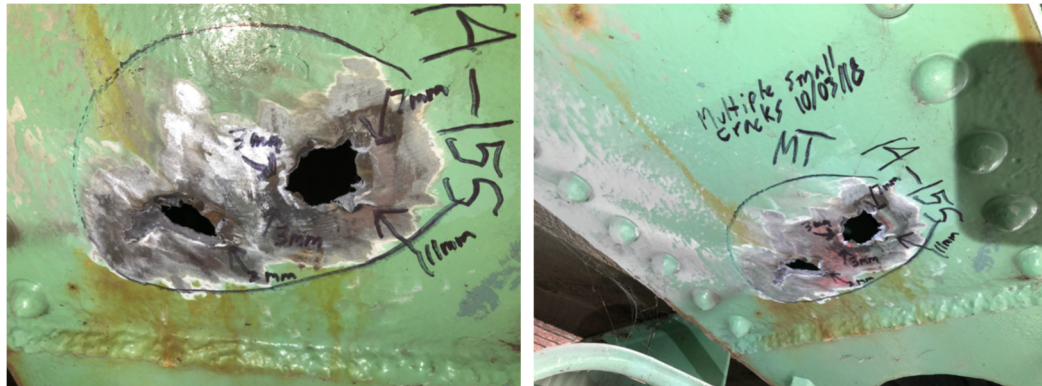
- **Main truss bottom chord 14S-15S:** Multiple cracks originating from perforation in batten plate near 15S. Crack lengths range from 3mm to 11mm in length. Crack are in secondary element of the member (batten plate) and cannot propagate to main elements of the members, because of the rivetted nature of the built-up section.

Figure 7: Cracks Originating from Perforation in Batten Plate of 14S-15S

Monitor the location yearly to assess the efficiency of crack grinding **BIM Priority Code D**

Reinforce corroded element with slip critical bolted steel element **BIM Priority Code C**

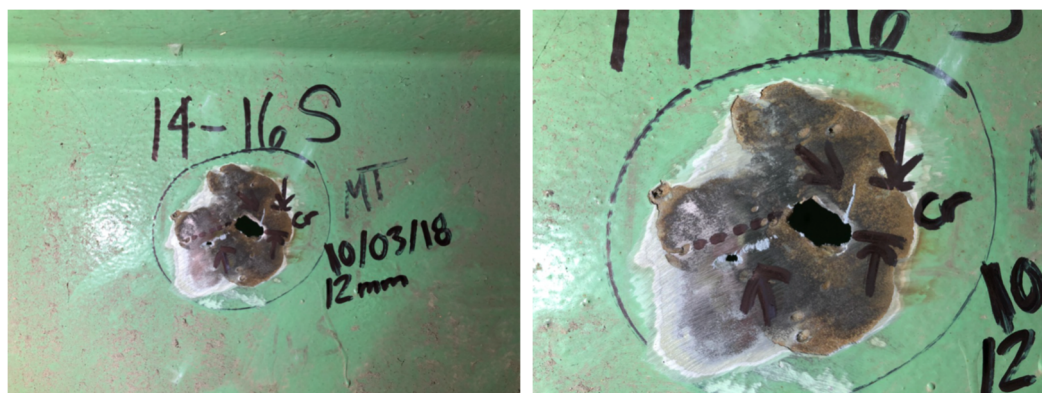
- **Main truss bottom chord 14S-16S:** 12mm long crack originating from perforation in web of inside Channel. Crack is perpendicular to main stress in member. Member composed of only 2 channels. Original 1916 steel, unknown toughness. Member undergoes stress reversal and tension under traffic load case, with moderate stress range (36 MPa under truck loading and it stays under compression for any current opening case). In our opinion, member 14S-16S is not a fracture critical member; it is a primary tension member, given the presence of member 14S-15S. Hence, the risk associated with the observed crack is reduced by the redundant load path.

Figure 8: 12mm Crack in 14S-16S Interior Channel's Web, Perpendicular to Main Stress and Near Perforation/Crack Like Indication, Parallel to Main Stress

Monitor the location yearly to assess the efficiency of crack grinding **BIM Priority Code D**

Reinforce corroded element with slip critical bolted steel element **BIM Priority Code A**

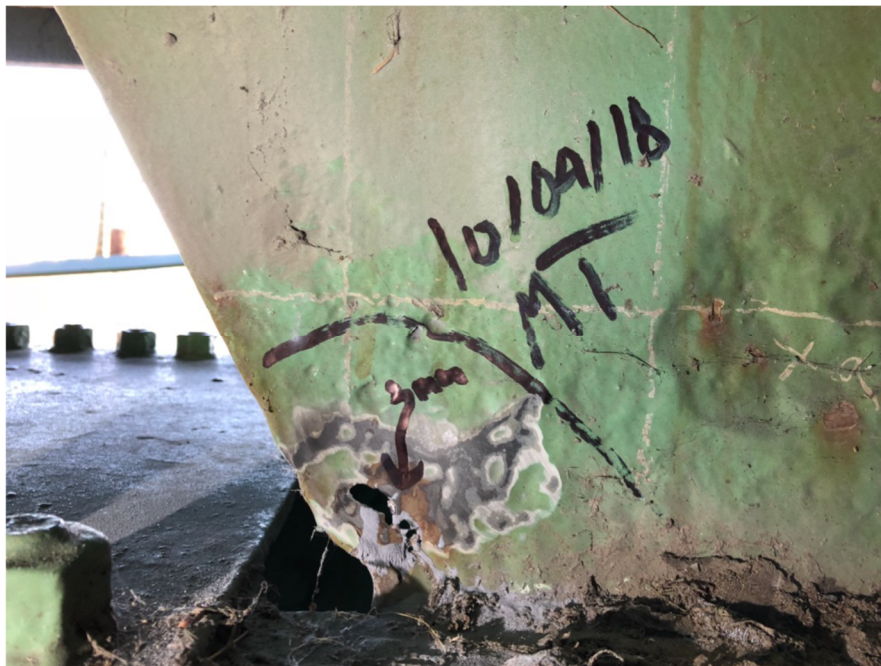
- **Gusset 16S:** 3mm long crack, perpendicular to main stress on inside gusset plate, originating from a perforation in the plate. The member attached to gusset 16S (13S-16S) sees high stress range under bridge opening (126MPa at 63°) and moderate stress range under traffic loading (38MPa)

Figure 9: 3mm Crack in 16S Interior Plate, Perpendicular to Main Stress

Monitor the location yearly to assess the efficiency of crack grinding **BIM Priority Code D**

Reinforce corroded element with slip critical bolted steel element **BIM Priority Code C**

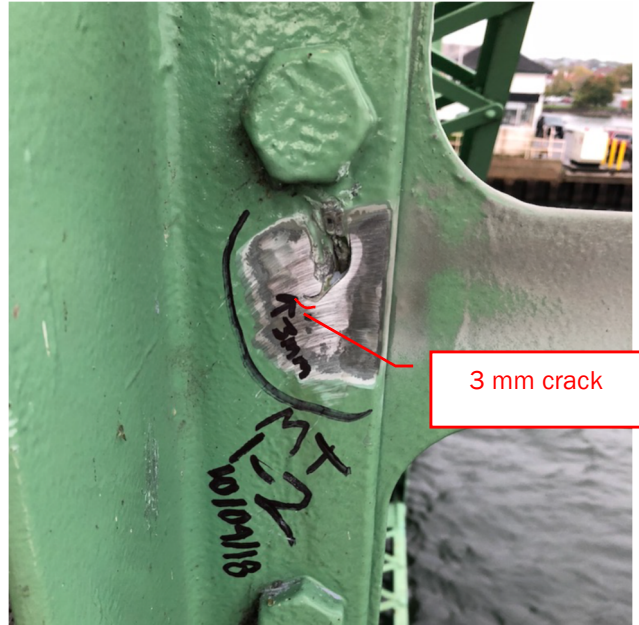
- **Main truss vertical 1N-2N:** 3mm crack, perpendicular to main stress, in flame cut hole. Member sees stress range of less than 6MPa under bridge opening to 63° and of 25MPa under vehicular loading. Member is made of 5 elements (4 angles and one cut-out plate).

Figure 11: 3mm Crack Suspected, Perpendicular to Main Stress

Grind smooth the suspected crack or drill crack tip and install tensioned ASTM A325 bolt. **BIM Priority Code A**

Monitor the location yearly to assess the efficiency of crack grinding **BIM Priority Code D**

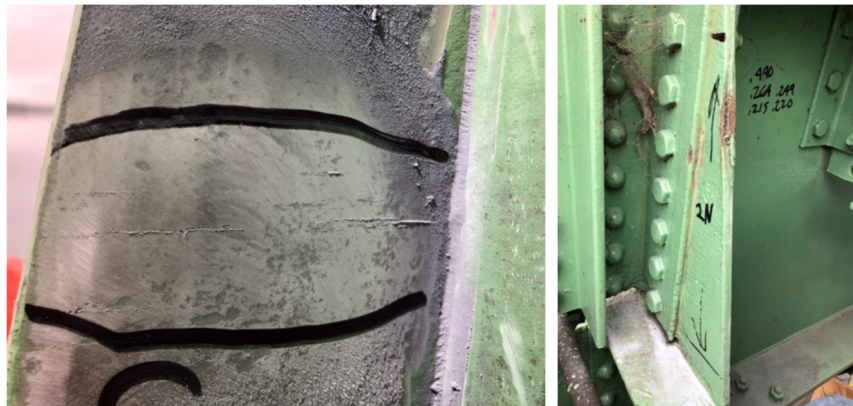
- **Main truss vertical 2N gusset:** Full width horizontal hairline crack and multiple laminations in interior gusset. One lamination was found during the 2015 UT testing by Parsons. 2018 UT testing has revealed many laminations in the depth of the gusset plate and MT on the surface of the gusset has revealed a thin hairline crack on both visible (east and west) sides of the inside face. The location of the crack in the gussets is such that several bolts of the floorbeam end plate are located on each side of the cracked plane. Multiple laminations through the plate thickness makes retrofit by grinding impractical. Refined FEM analysis could indicate if strengthening of 2N interior gusset plate is necessary. Vertical member 1N-2N attached to gusset 2N sees stress range of less than 6MPa under bridge opening at 63° and of 25MPa under vehicular loading.

Figure 12 and Figure 13: Laminations and Hairline Crack, Perpendicular to Main Stress, in Interior Gusset Plate at 2N

Perform refined FEM analysis of the node to assess the need for strengthening. Assume inside gusset cracked at 100% in analysis. **BIM Priority Code A**

Repair gusset by plating, if required. **BIM Priority Code A**

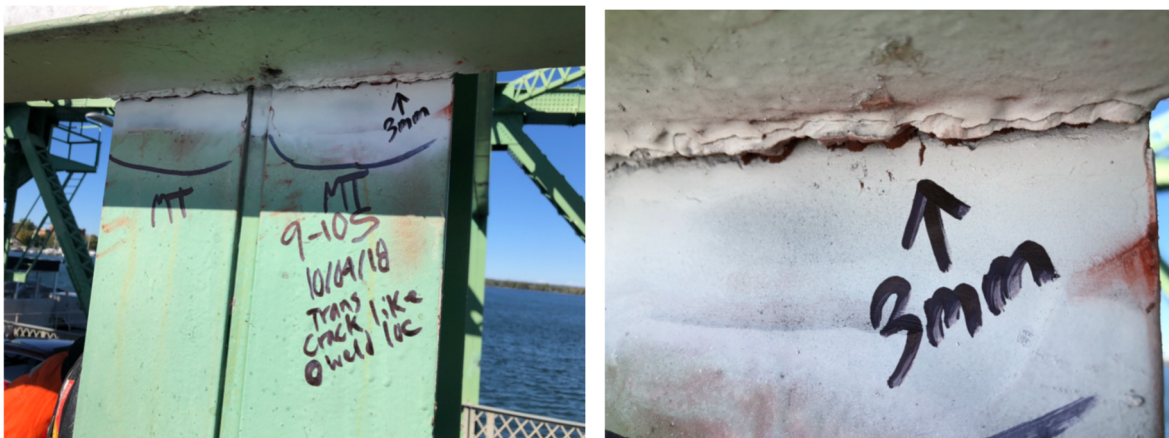
- **Vertical 9S-10S:** 3mm crack, parallel to main stress, found in the heat affected zone (HAZ) of a removed weld (angle holding navigation sign).

Figure 14 and Figure 15: 3mm Crack in HAZ Of Removed Weld on 9S-10S

Perform Magnetic Particles testing of the HAZ zone, to check for cracking. Reinstate appropriate coating. **BIM Priority Code B**

Monitor the location yearly to assess the efficiency of crack grinding **BIM Priority Code A**

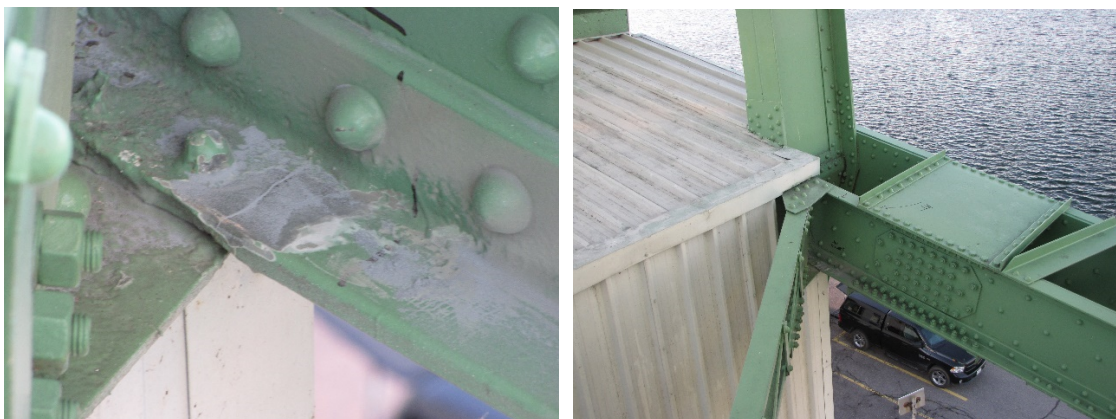
- **Counterweight truss bottom chord 21N-27N:** Full width 100mm cracking of the horizontal flange of bottom interior angle. Crack is perpendicular to main stress. Appears to be through thickness. Crack was lost at inside radius when trying to find its end with MT testing. Angle is riveted to member's web plates, so direct crack propagation to web is impossible. Original 1916 steel, unknown toughness. Initiation might have been caused by corrosion. Member sees large stress ranges when bridge opens (157 MPa at 63°). Section loss due to cracking should be considered as the entire angle affected, because of high possibility of fracture of yet uncracked vertical leg of the angle. Strength calculations at ULS shows that the section 21N-27N at the location of the crack is overloaded under case B4 (CHDBC section 13.6.10.2). While the bridge is the closed position, member 21N-27N is under compression. Member is in tension when the bridge is open. Given the results of the demand to capacity calculations for the opening case (D/C of 1.09 for corresponding bending and tensile stresses under ULS B4 with fully cracked angle), yielding of other elements at the cracked section is possible under an extreme event. Furthermore, the increase in stress range caused by the loss of one angle could initiate new cracks or propagate existing cracks yet undetected. Hence, repair is recommended before the beginning of the new navigation season, in May 2019, to limit the number of opening with a damaged section in 21N-27N.

Figure 16 and Figure 17: Crack in 21N-27N Horizontal Flange of Bottom Interior Angle

Reinforce affected angle with slip critical bolted steel element **BIM Priority Code A**

Monitor defect monthly (if not repaired before May 2019) **BIM Priority Code A**

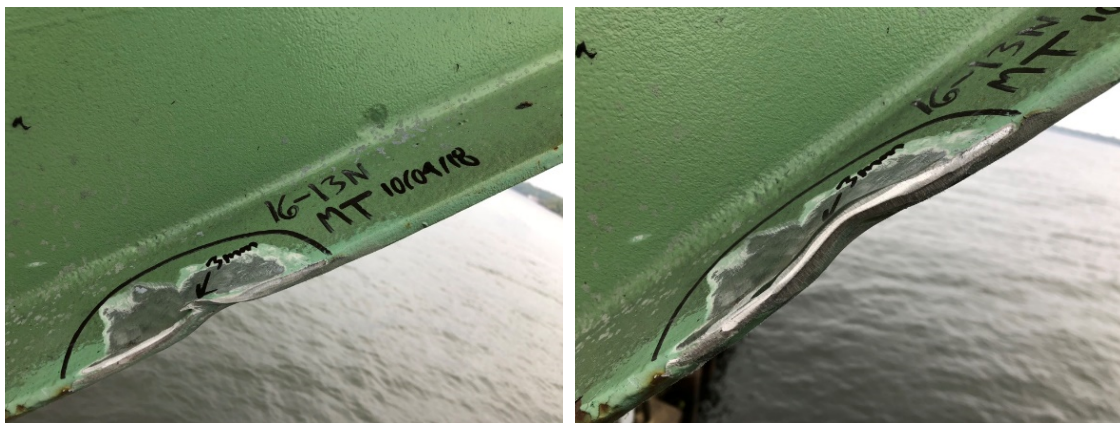
- **Main truss diagonal 13N-16N:** 3mm crack found at impact damage, removed by grinding. Member susceptible to fatigue (see the Evaluation Section of this report). Crack was successfully removed by light grinding under the supervision of the Structural Engineer in charge of the fatigue inspection. MT testing was performed after grinding and no crack were found.

Figure 18 and Figure 19: 3mm Crack at Impact Damage (left), Removed by Light Grinding (right)

Monitor the location annually to assess the efficiency of crack grinding. **BIM Priority Code D**

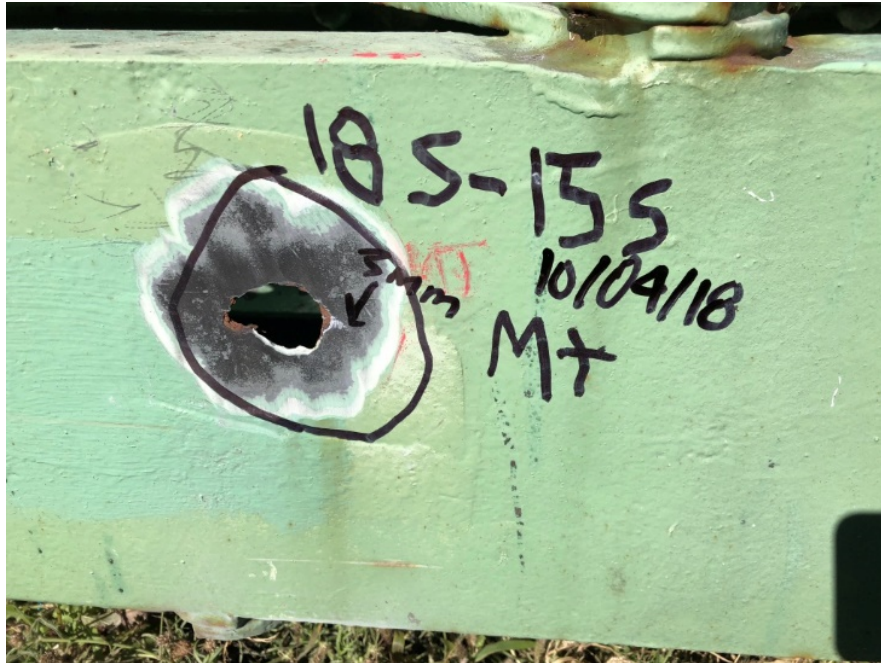
- **Tower truss horizontal member 15S-18S:** 3mm horizontal indication at the edge of channel's web perforation, possibly a crack initiation. Defect parallel to main stress. This member is composed of only 2 channels. Original 1916 steel, unknown resilience. Crack probably initiated by corrosion. Member sees limited tension stress range under bridge opening (6MPa at 63°) and vehicular traffic (3MPa).

Figure 20: Perforation in 15S-18S Exterior Channel, with Possible 3mm Crack

Monitor the location yearly to assess the efficiency of crack grinding. **BIM Priority Code D**

Reinforce corroded element with slip critical bolted steel element. **BIM Priority Code B**

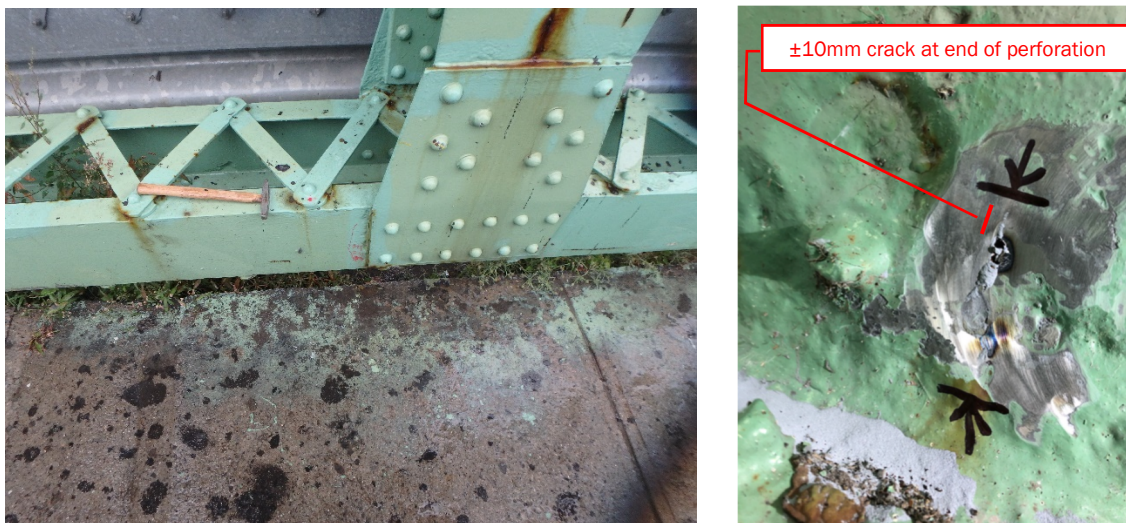
- **Tower truss horizontal member 18S-19S:** 60mm vertical perforation with crack in the remaining material, perpendicular to main stress, at node 18S. This member is composed of only 2 channels. Original 1916 steel, unknown toughness. Crack probably initiated by corrosion. Member sees limited tension stress range under bridge opening (6MPa at 63°) and vehicular traffic (3MPa).

Figure 21: Linear Perforation in 18S-19S Exterior Channel, with Possible Crack

Monitor the location yearly to assess the efficiency of crack grinding. **BIM Priority Code D**

Reinforce corroded element with slip critical bolted steel element. **BIM Priority Code A**

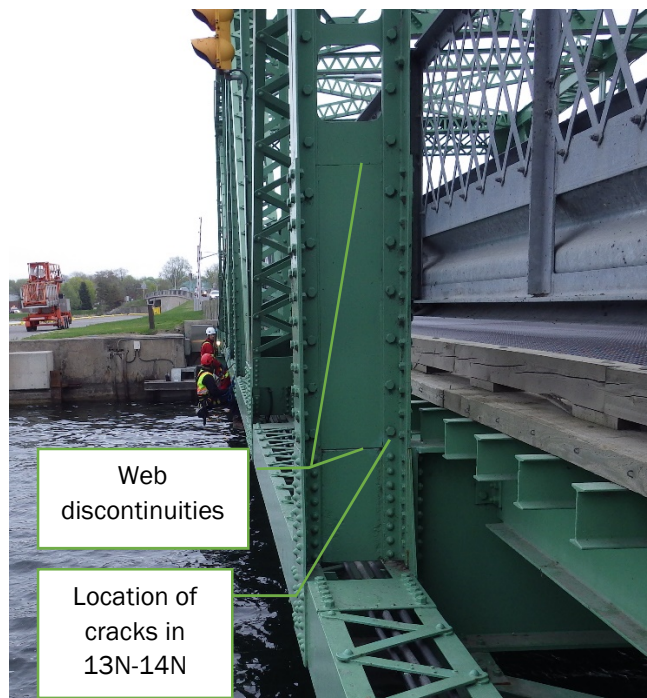
- Verticals 1-2, 5-6, 9-10, and 13-14, North and South

Figure 22: Discontinuity in Verticals Webs

Reinforce the verticals 1-2, 5-6, 9-10 North and South to create continuity in web plate at lower end of member.

BIM Priority Code C

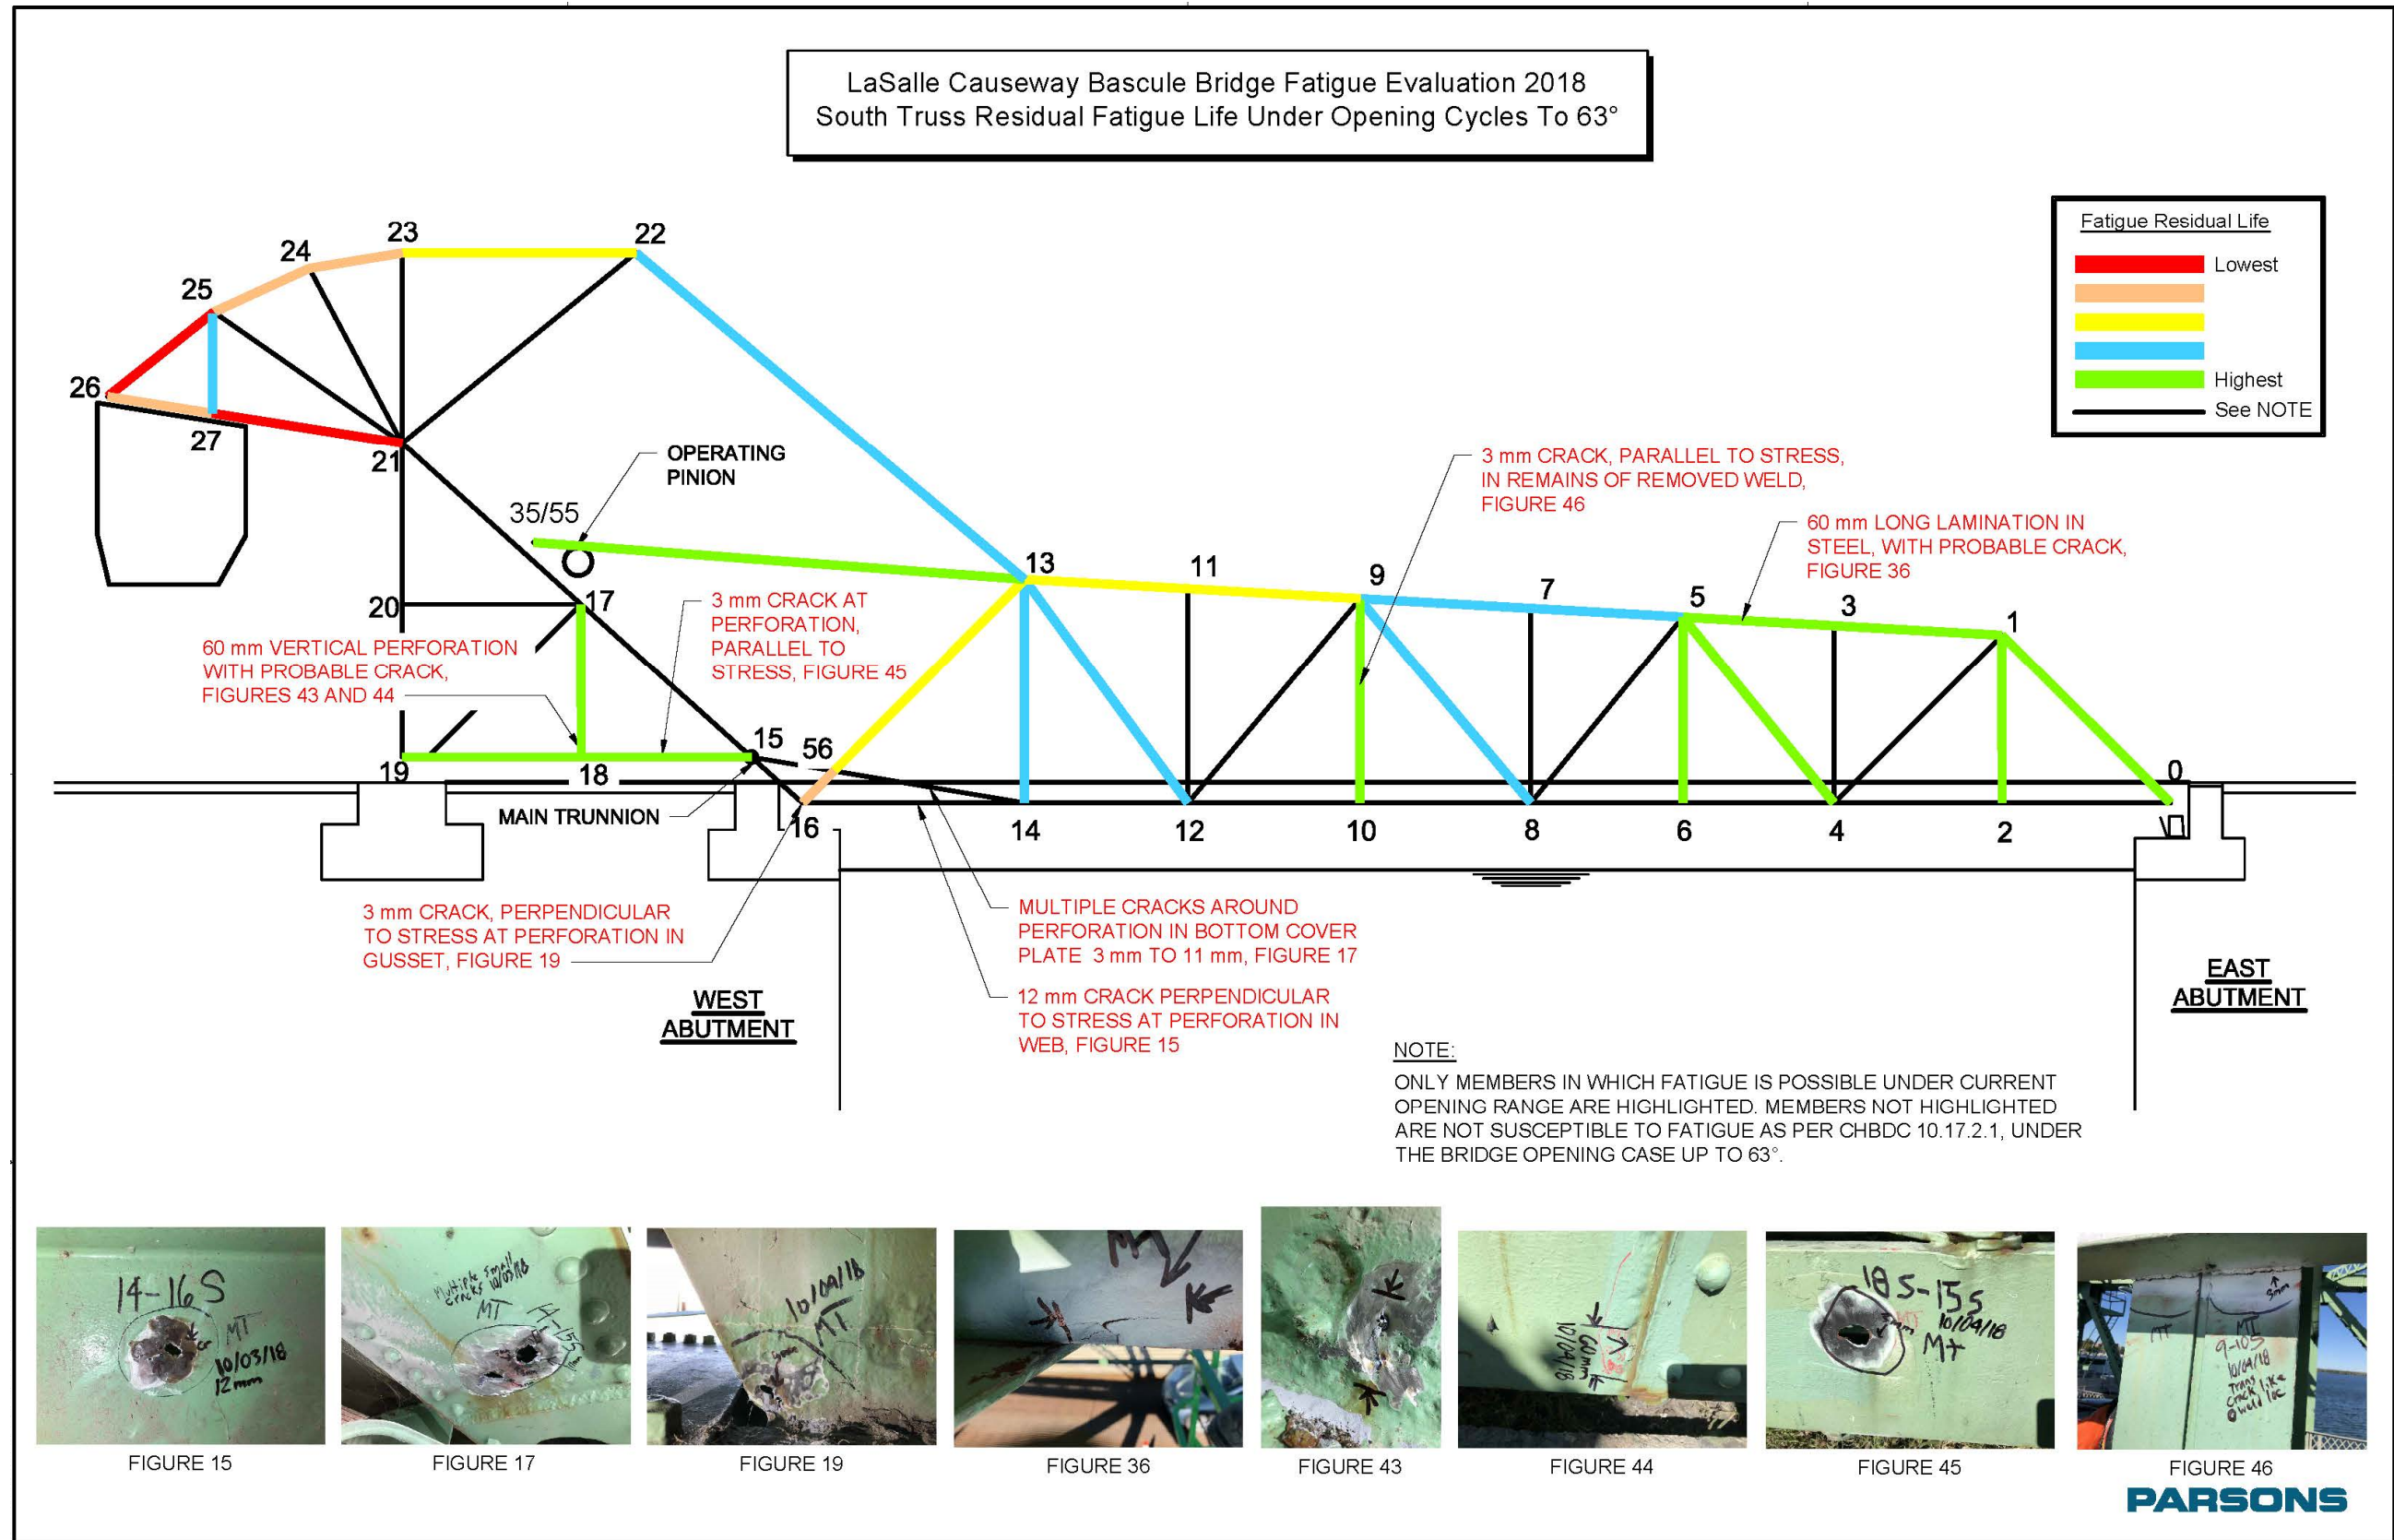
Figure 32: Fatigue Residual Life Under Bridge Opening Cycle - South Truss
