LASALLE CAUSEWAY BASCULE BRIDGE

COUNTERWEIGHT REHABILITATION STUDY Technical Memorandum | DRAFT

PSPC Project No. R.108246.001 March 31, 2021

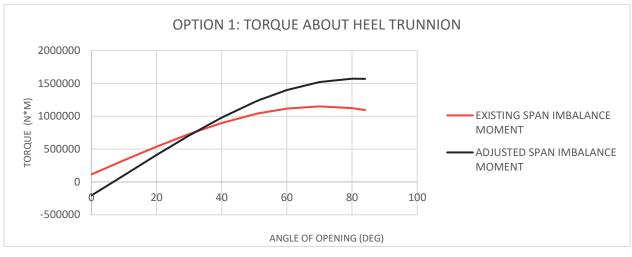
The total weight of adjustable balance blocks on the existing span is approximately 31,000 kg. If all balance blocks and plates were removed when the concrete is replaced, there would still be a net total 8,000 kg added to the counterweight. span would become counterweight heavy and the alpha angle would not be maintained. This is shown in the table and graph below.

MX	WR	STRUT EFFECT	TOE REACTION	ALPHA ANGLE	
	(N*M)	(N*M)	(N*M)	(N)	(Degrees)	
Initial Condition	-246,126	1,645,936		2,349	-98.6	
Recommended Acceptable*	-	-	360,697	0 to 8896	-97 to -100	
Final Balance	-567,188	2,213,438		-4,234	-104.8

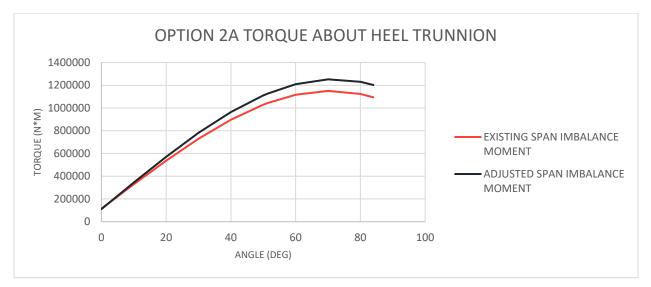
There is 31,000 kg of existing adjustable balance blocks and plates. The existing adjustable ballast can completely account for the added weight from the concrete replacement. Therefore, no modifications to the existing counterweight design are required.

МХ	WR	STRUT EFFECT	TOE REACTION	A ANGLE
	(N*M)	(N*M)	(N*M)	(N)	(Degrees)
Initial Condition	-246,126	1,645,936		2,349	-98.6
Recommended Acceptable*	-	-	360,697	0 to 8896	-97 to -100
Final	-250,222	1,755,025		2,265	-98.2
