TECHNICAL SPECIFICATIONS

- .1 Work of this Contract comprises completion of the Site works associated with removal of asbestos-containing building material debris and the soil remediation of the former Sayisi Dene Village Site located in Churchill, Manitoba; and further identified as the Work. The Work includes, but is not limited to, the following: Mobilization and demobilization to Site; Site preparation; abatement of asbestos-containing building materials debris; non-hazardous debris removal; removal and off-site disposal of existing coal piles; management, excavation and off-site disposal of petroleum hydrocarbon, polycyclic aromatic hydrocarbon, volatile organic compound and metal contaminated soil; backfilling excavation areas with clean fill; and Site restoration.

- .2 The scope of Work is detailed within the Remedial Action Plan, Former Sayisi Dene Village, Churchill, Manitoba dated March 2021.
- .3 The project is identified as PSPC Project Number R.089501.

Phase I/II Environmental Site Assessment

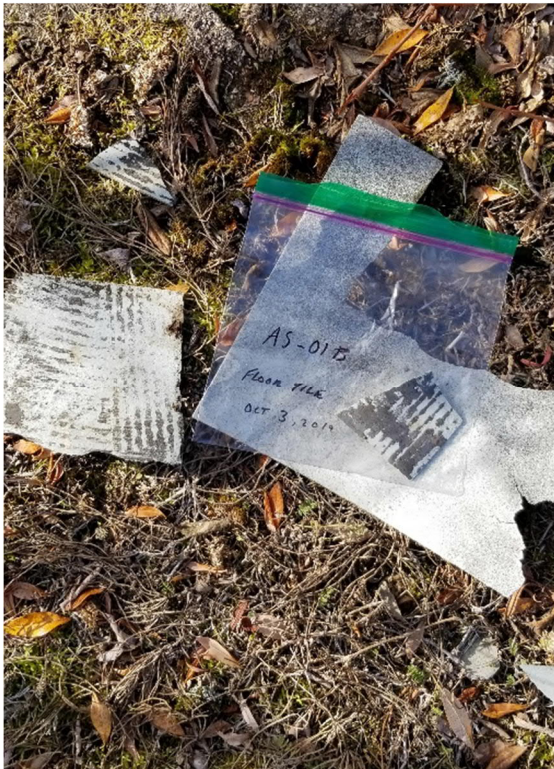
Photo 14: Samples AS-01 – Vinyl Floor Tiles and Associated Mastic

Asbestos (0.63% to 1.2% Chrysotile) was found to be present vinyl floor tiles. Three of the five associated mastic samples were determined to contain asbestos (1% to 4% Chrysotile).

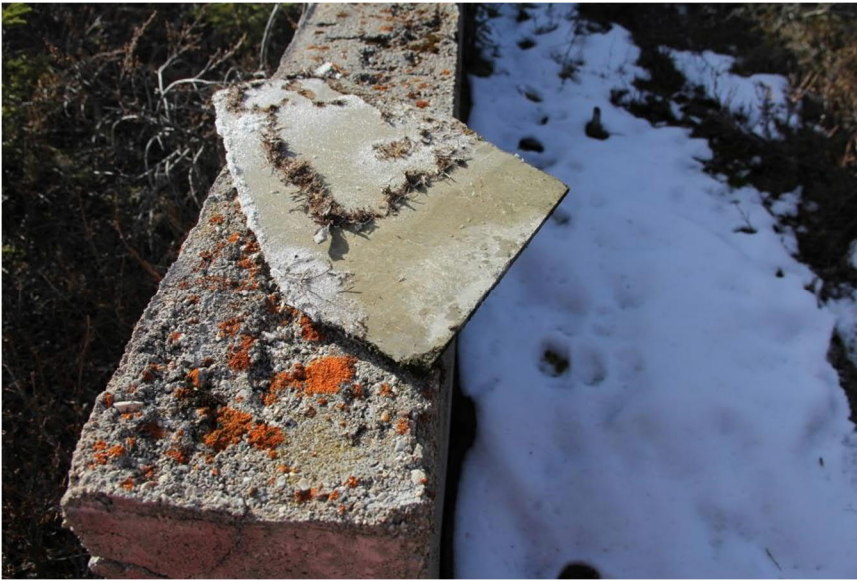
Photo 15: Sample AS-02 – “Transite” Cement Board

Asbestos (15% Chrysotile) was found in one sample and a positive stop was applied to the other two samples.

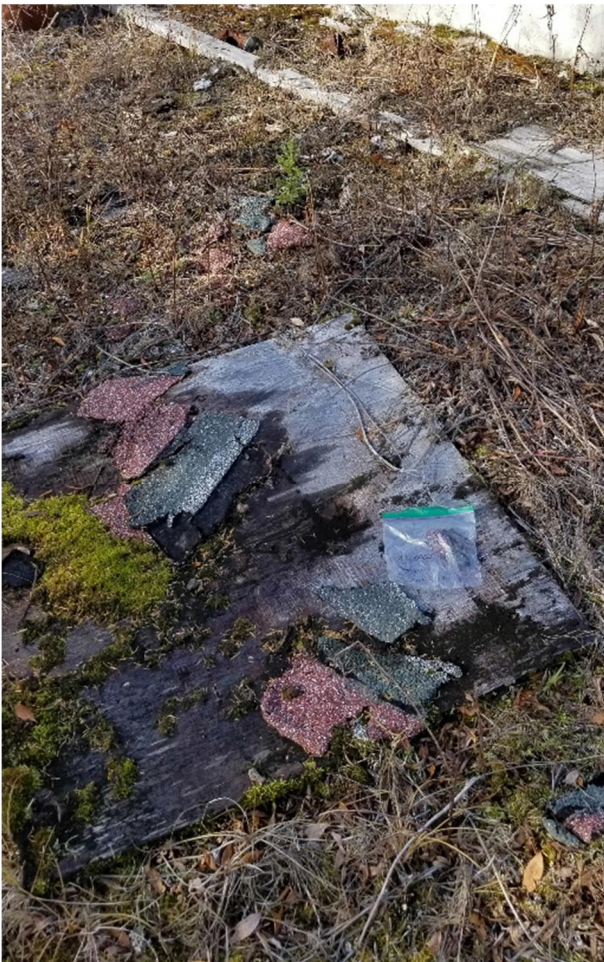
Photo 16: Sample AS-03B – Asphalt Roof Shingles

No asbestos was identified in the samples of this material.
