KEOGH (GIUYUX) RIVER

TRANSPORT CANADA BRIDGE REPLACEMENT PROJECT FISH HABITAT ASSESSMENT

**PSPC TA: 700559357; Project #: R.109401.002
AquaTerra Project No. 2016425 (10-01)
REV.0 Submitted: 31 March 2021
REV.1 Submitted: 15 May 2021**

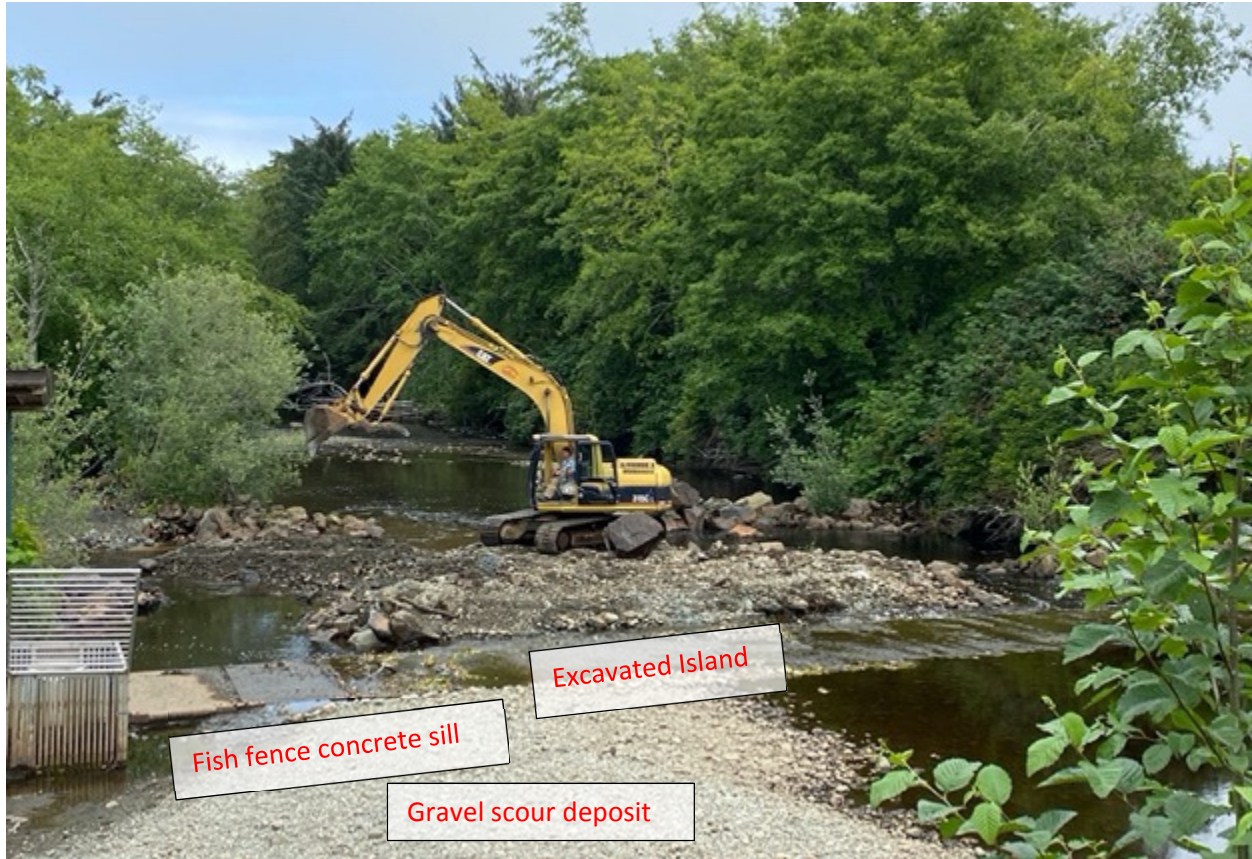
Figure 3: 2020 Outflow Channel Restoration Works – adapted from Instream Fisheries Research Inc. Report.

On 01 September 2020, Instream Fisheries Research Inc., issued a report to DFO, Transport Canada, and MFLNRORD relating to the summer 2020 progress associated with the spring 2020 works to restore a historic overflow channel in the lower reaches of the Keogh River. The historical overflow channel was originally constructed along with the Port Hardy Airport with the intended function of distributing water during high flow events that were creating an oxbow and putting airport infrastructure at risk.

The resulting overflow channel was not maintained and became infilled with gravel, large woody debris and vegetation. Over time, a 1.5 m high gravel berm accumulated at the upstream end of the bypass channel, resulting in the resumption of scour and gravel transport in the mainstem during high flow events. Channel restoration efforts were undertaken between 21 July and 26 August 2020. Works included reducing the accumulated gravel within the overflow channel, excavation of the 'gravel island' at the fish fence concrete sill (**Figure 3**), reconfiguring large boulders downstream of the fish fence, and restoring the historic channel between the counter site and fish fencing.

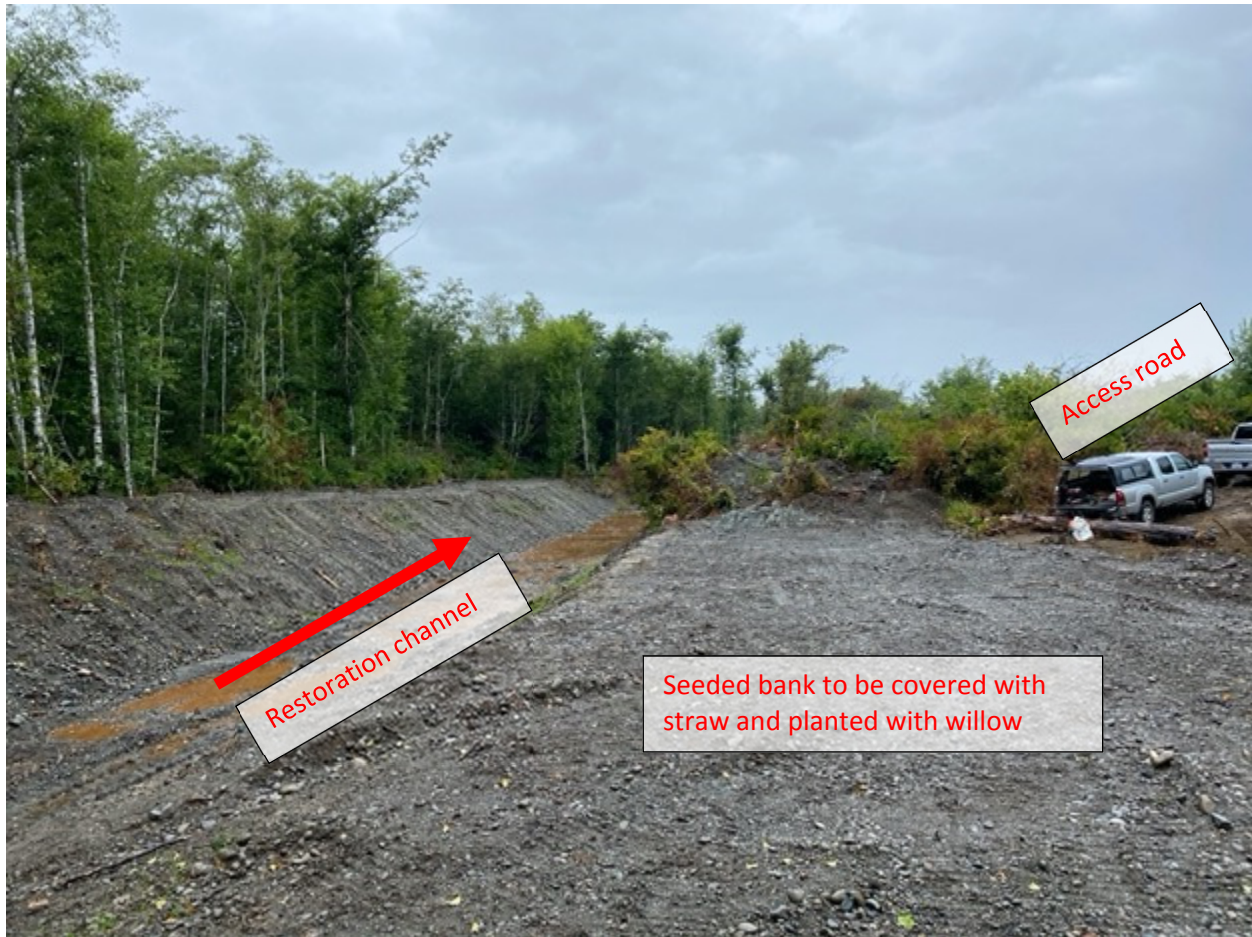
Figure 4: 2020 Overflow Channel Restoration Details – adapted from Instream Fisheries Research Inc. Report.

Following completion of the works near the bridge, the overflow channel was constructed, commencing with excavation of the overflow channel at the downstream end with a slight increase in elevation relative to the mainstem to ensure the channel is only active during high flow events (**Figure 4**). The entrance to the restoration channel is to be reinforced with boulders and a rock groyne pending funding in 2021.

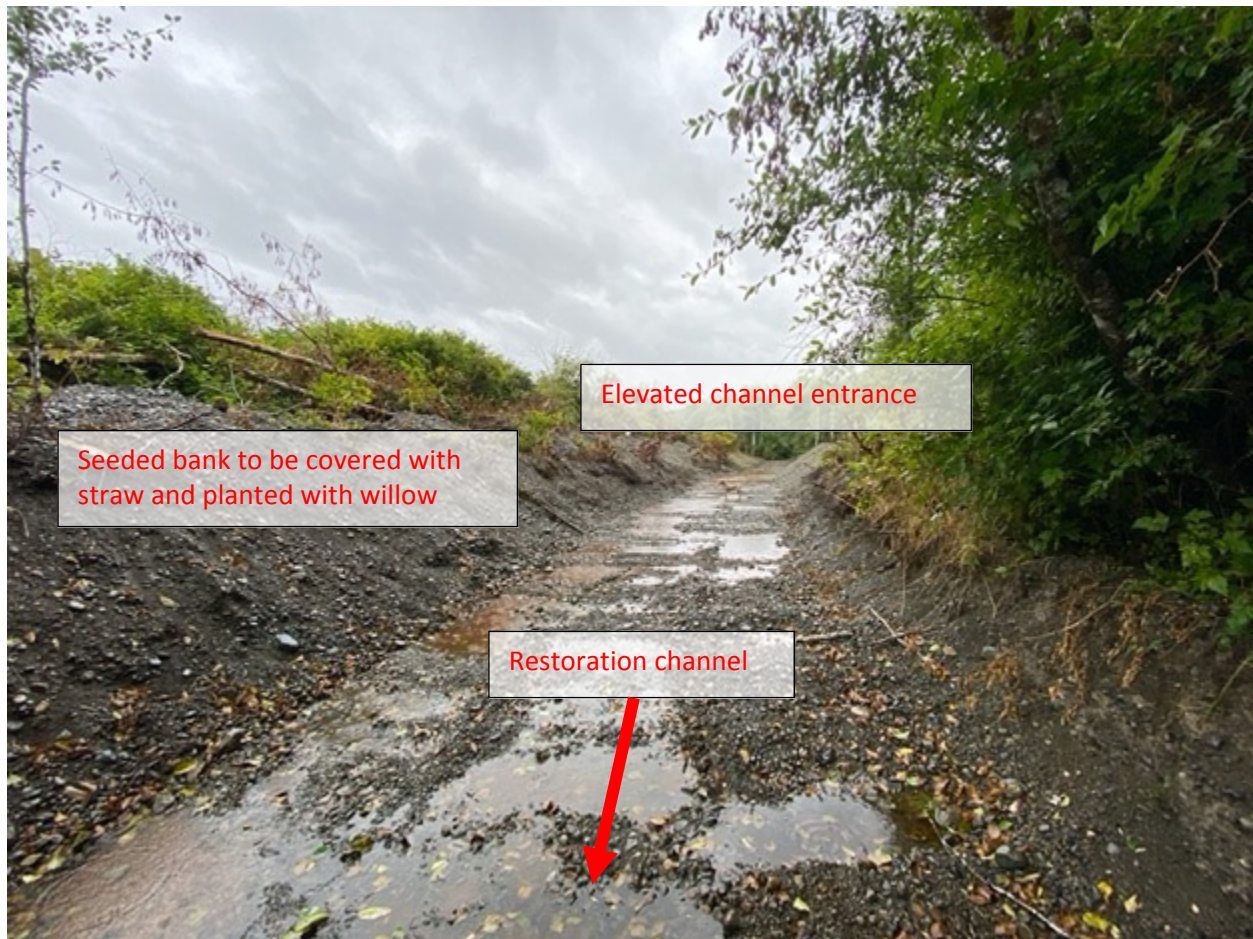
Figure 5: Restored Channel looking Upstream – adapted from Instream Fisheries Research Inc. Report.

The channel was reportedly completed as a flat-bottomed U-shaped channel with limited channel complexity (**Figure 5**). Presumably this was intended to provide flow conveyance and localized detention capacity only and to reduce the potential for fish stranding. The report confirms this assertion noting that the channel was excavated with a steady downstream gradient to mitigate potential risks associated with stranding and to facilitate fish returning to the mainstem following high flow events.

During channel restoration works, concrete material was uncovered and excavated, which was reportedly used for original channel construction. The material was broken up and re-purposed as bank stabilization along the left bank of the excavated overflow channel. Grass seed and willow (*Salix* sp.) whips were installed to enhance bank stabilization and recruitment of pioneer species.

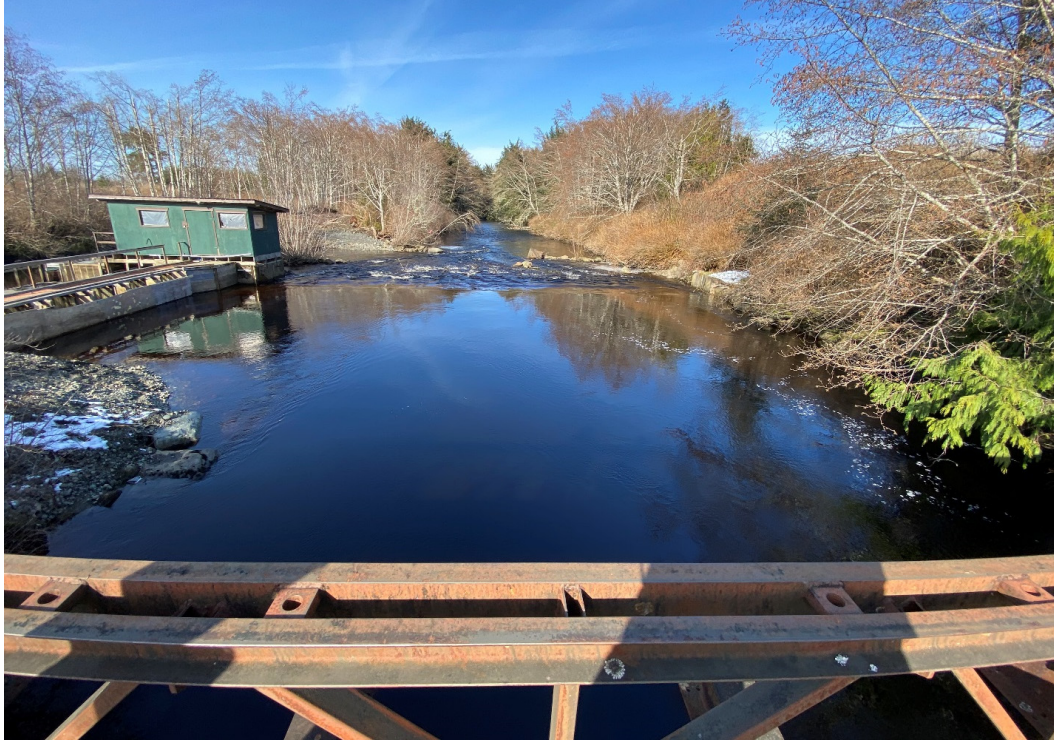
On 15-16 March 2021, AquaTerra and Kwakiutl personnel attended the site to evaluate Keogh River fish, aquatic and riparian habitat parameters as well as to evaluate existing bridge conditions, potential impacts associated with the prospective alignment(s), and to collect samples of the bridge and abutments for lead paint and creosote, respectively. Initially, the river was assessed from the bridge deck, evaluating the river flow dynamics, morphology, banks, and riparian vegetation assemblage downstream and upstream of the existing bridge (Photos 1 & 2).

Photo 1: Keogh (Giuuyux) River looking downstream from the existing bridge.

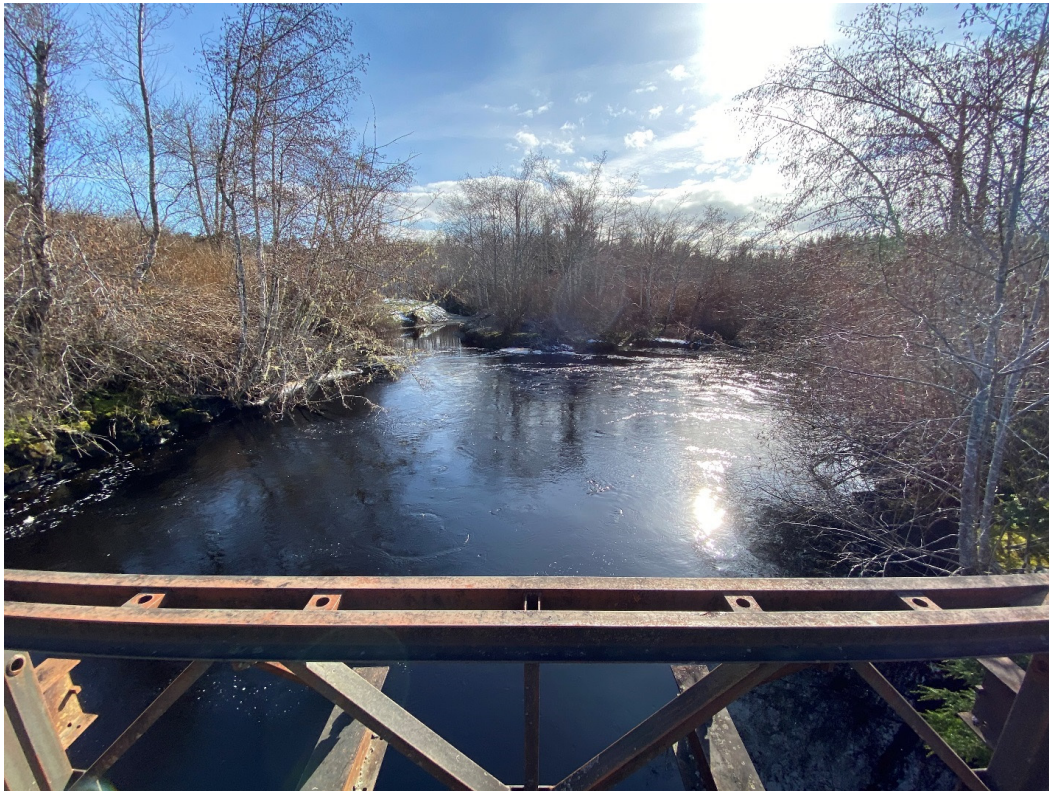
Photo 2: Keogh (Giuuyux) River looking upstream from the existing bridge.

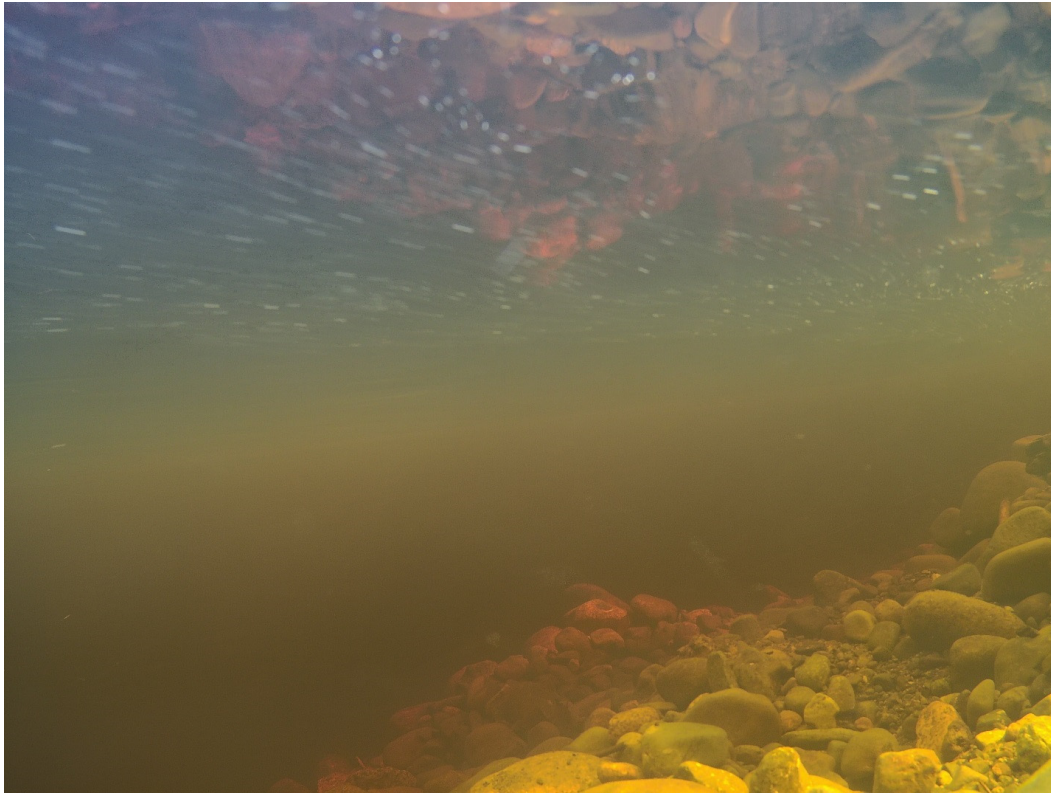
A Remotely Operated Vehicle (RoV) was deployed to the northwest of the bridge. Given the depth and elevated flow rate of the river, the intent of deploying the RoV was to evaluate substrate composition in the vicinity of the bridge. The RoV was fitted with LED lights given the heavily tannin stained water (Photo 3), which limited substrate composition visibility from upland areas and the existing bridge.

Photo 3: Visibility of Water Column near Existing Bridge.

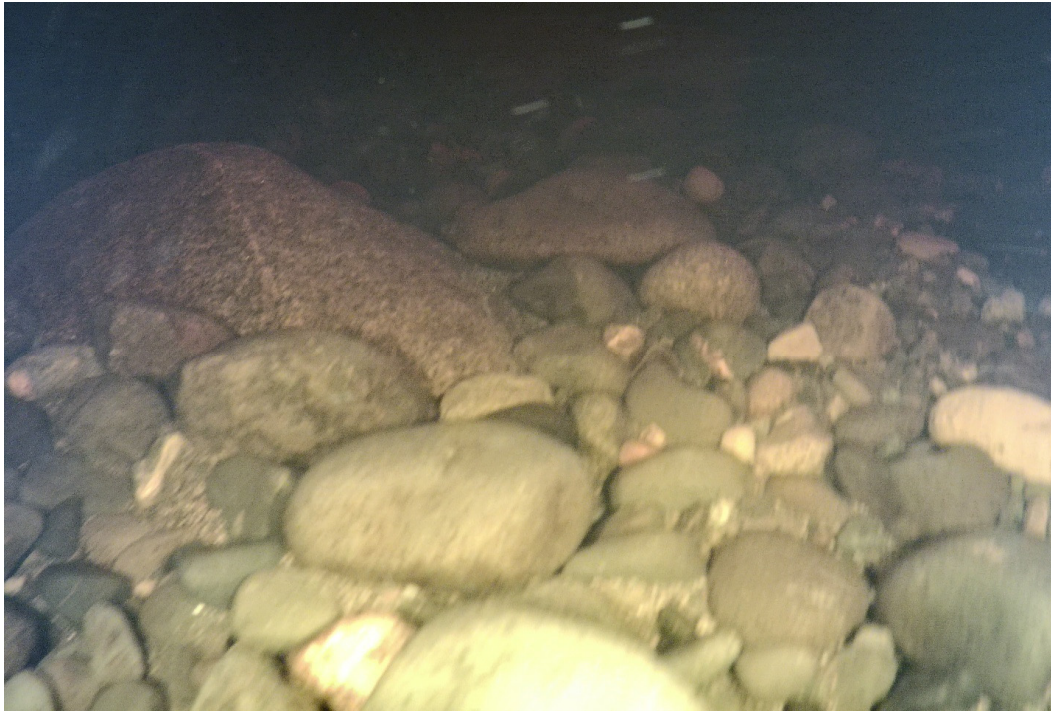
Substrate downstream of the bridge included isolated boulders (<5%) with cobble (70%) and gravel (25%) (Photo 4). Within the northwestern corner of the bridge, substrate was dominated by coarser cobble (40-50%) with lesser gravel (20-30%) and fines (20-30%) (Photo 5). Kwakiutl personnel noted that some of this material had been reportedly imported to facilitate access to the bridge for pre-construction survey work. Under the bridge (west side), the material was dominated by gravel (60-70%) with 10-20% cobble and fines (Photo 6). To the southwest of the bridge is a localized backwater area where flow is reduced. At this location, substrate was dominated by fines and gravel with some minor Small Woody Debris (SWD). Similarly, the substrate beneath the east side of the bridge was comprised of cobble (10-20%), gravel (40-60%) and fines (20-30%) with SWD present sporadically (Photo 7).

Photo 4: Substrate Downstream of the Existing Bridge - <5% boulders, 70% cobble and 25% gravel.

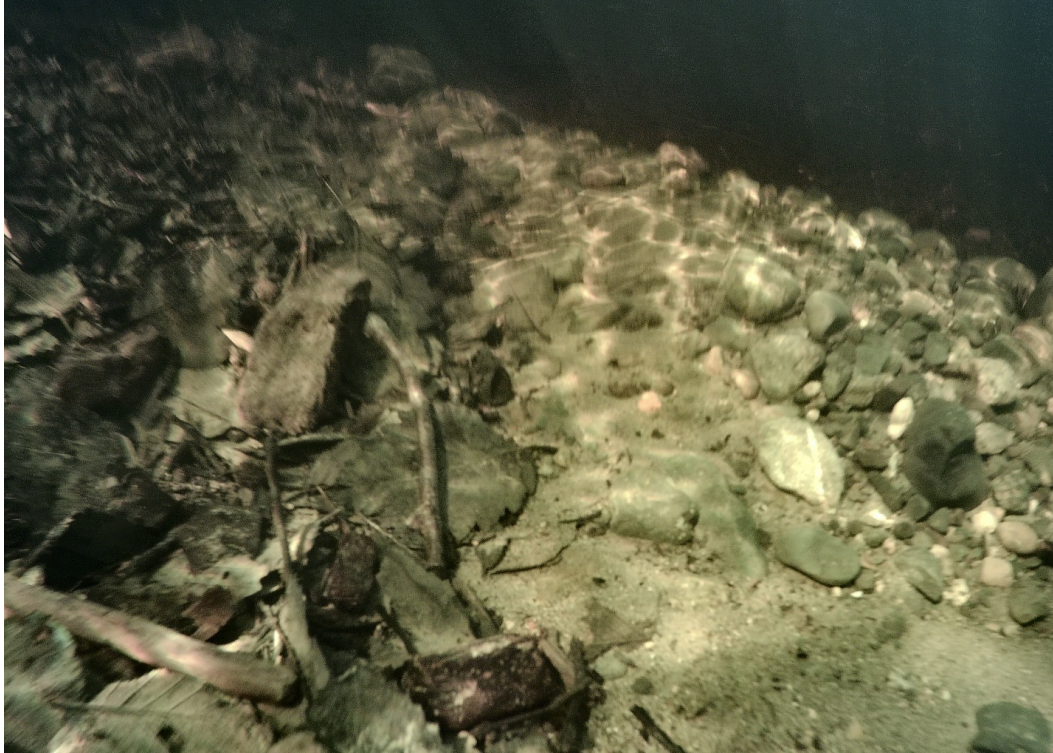
Photo 6: Substrate Under the Bridge – West Side. 60-70% gravel, 10-20% cobble and fines.

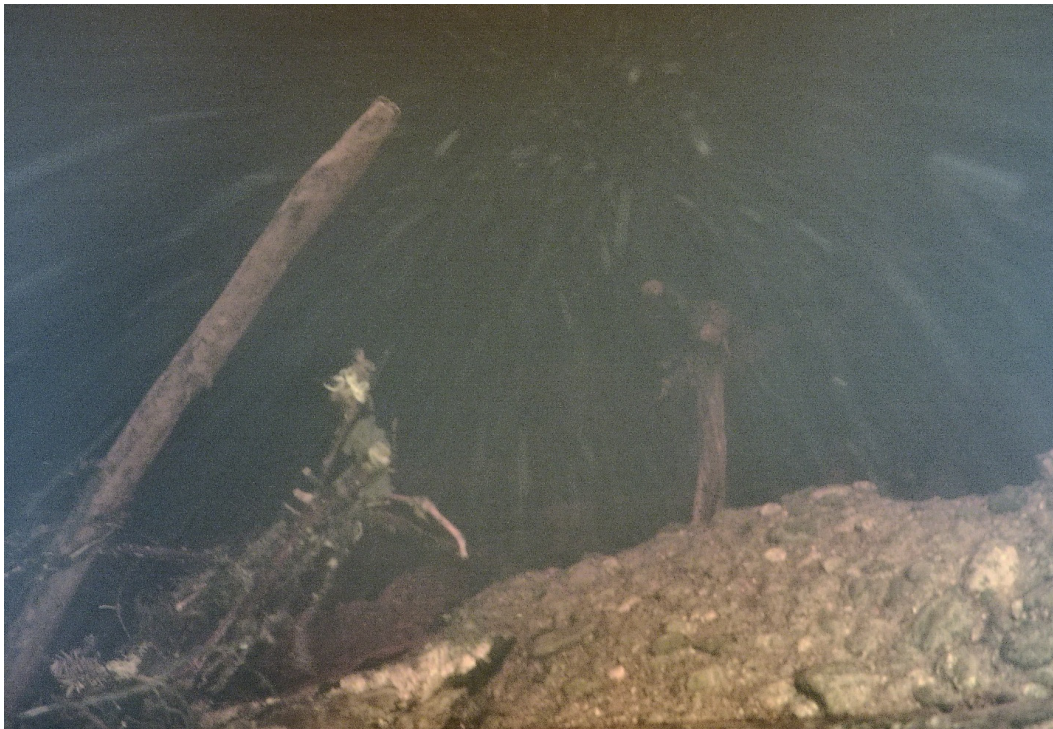
Photo 7: Substrate Under the Bridge – East Side. 10-20% cobble, 40-60% gravel and 20-30% fines.

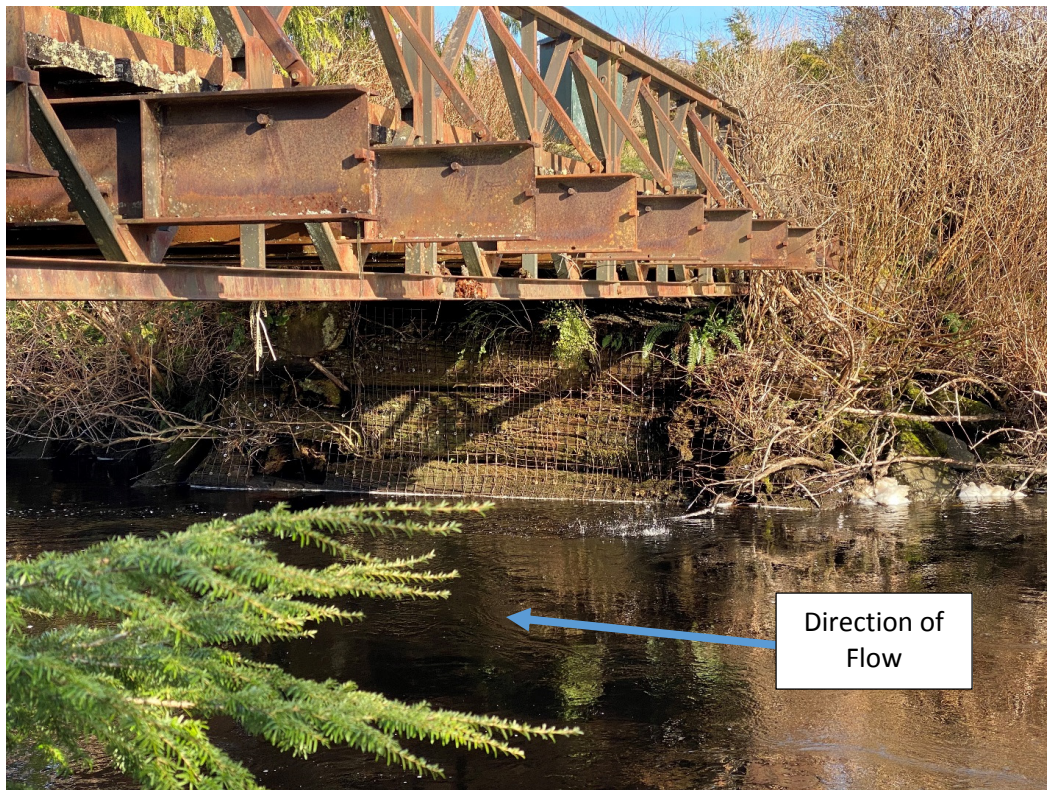
Riparian vegetation in proximity to the bridge (i.e., from the interface of the water to those areas 15 m beyond the top of bank), included Red Alder (*Alnus rubra*), Western Hemlock (*Tsuga heterophylla*), Western Redcedar (*Thuja plicata*), Salmonberry (*Rubus spectabilis*), Hardhack (*Spiraea douglasii*), Willow (*Salix* sp.) and Swordfern (*Polystichum munitum*) (Photo 8). Given the time of the assessment (15-16 March 2021), some dormant species may also be present that weren't readily observed.

Photo 8: Riparian Area Adjacent to the Bridge. Western Hemlock in Foreground and Salmonberry on Right (East) Bank with Sporadic Swordfern Beneath Bridge Deck.

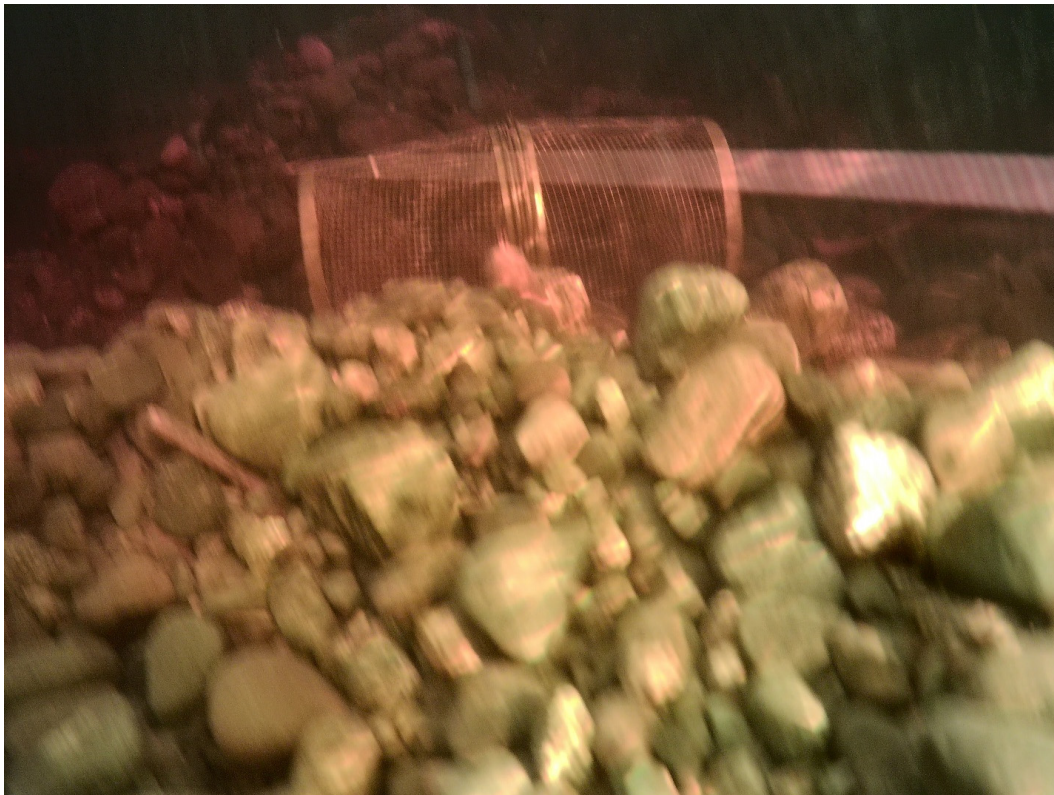
Four (4) Gee / minnow traps were installed on each of the four corners of the bridge (Photo 9) in lower velocity flow areas, and were baited with salmon roe. Traps were set on 15 March 2021 and left to soak overnight and retrieved the following day, after approximately 24 hours. Each trap was slowly retrieved; however, none of the traps resulted in any captures (Photo 10). The timing of the trapping, coinciding with cold water temperatures (4°C on March 15 and 3.5°C on March 16), and occurring prior to salmon fry emergence and smolt/parr outmigration and during a low salmonid productivity/activity period, are anticipated to be the predominant factors contributing to the null captures, and does not indicate an absence of fish utilizing the river at the existing bridge location.

Photo 9: Deployed Gee / Minnow Trap

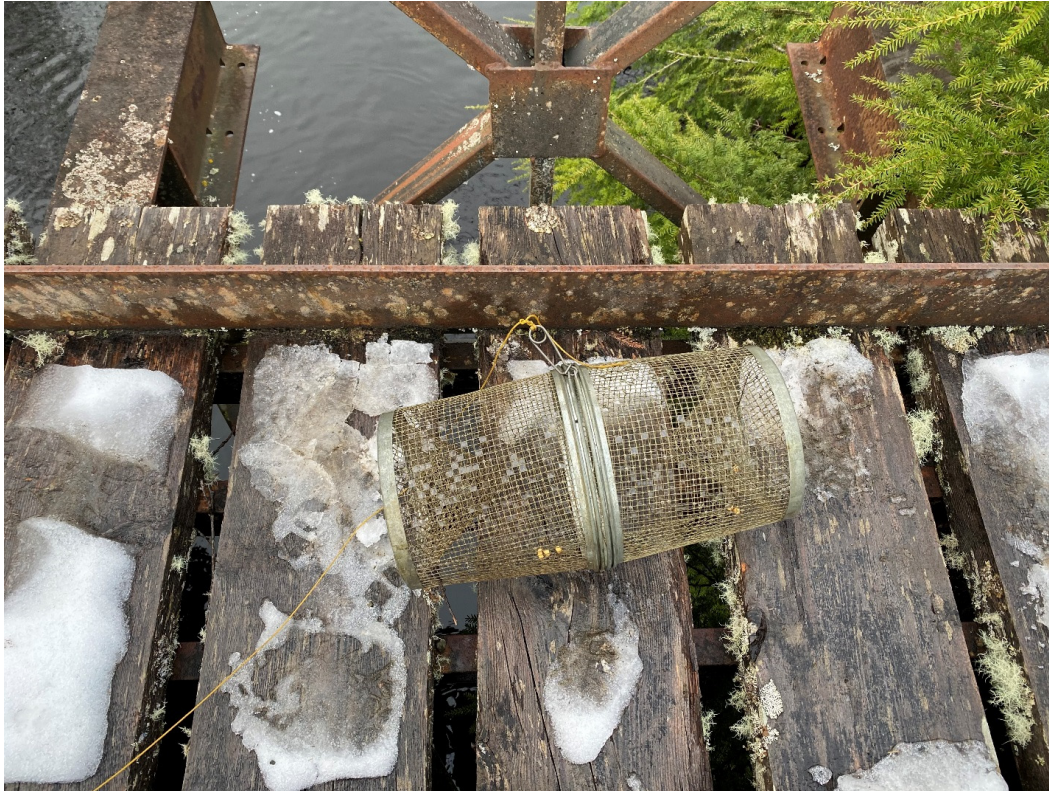
Photo 10: Empty Retrieved Trap Upstream of the Bridge.

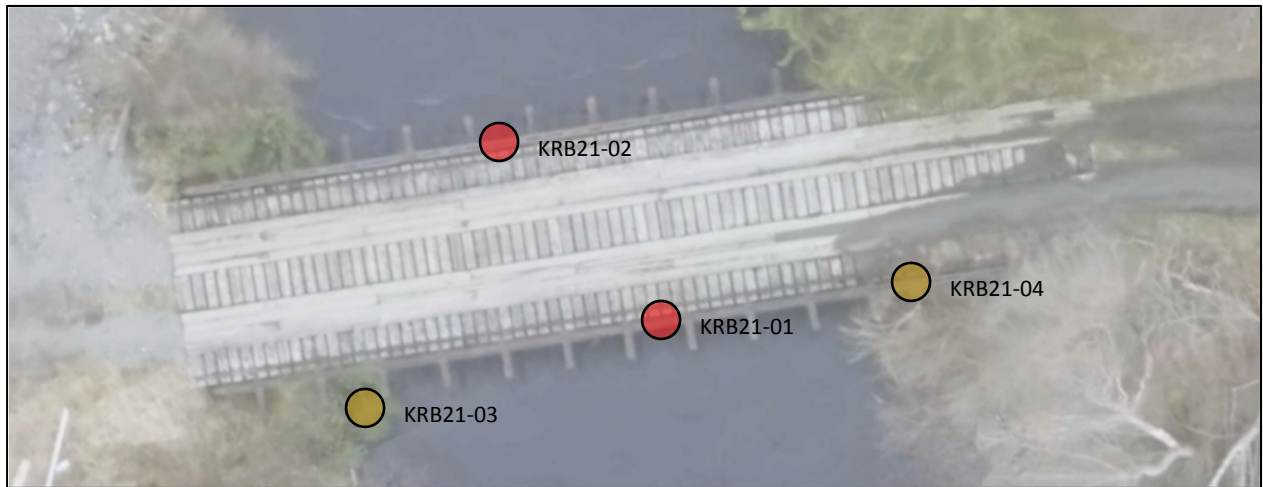
Figure 6: Paint (Red Icon) and Wood (Orange Icon) Sampling Locations

The bridge railings were sampled for lead paint at two locations (**Figure 6**). Additionally, the abutments were sampled at two locations for creosote (**Figure 6**). The sampling methodology for lead paint consisted of using nitrile gloves and a paint scraping tool to loosen and remove paint from the bridge railings. The resulting paint chips were placed into laboratory-provided sampling bags and subsequently labelled and sealed.

To collect wood samples from the bridge abutments, AquaTerra personnel wore Personal Floatation Devices (PFDs) and located portions of the abutments above the typical High Water Mark (HWM) given that prolonged submergence could reduce the prevalence of creosote at the wood surface-water interface, over time. A boring tool was used to remove the top layer of wood so that the underlying, dry layer could be sampled. Wood samples were collected from the east abutment and the end of the abutment on the west abutment. Approximately 10-20 grams (g) of material were placed into laboratory-provided sampling bags and subsequently labelled and sealed.

Table 1 summarizes the analytical results for the paint sample (KRB21-01 and KRB21-02) tested for lead and the wood samples (KRB21-03 and KRB21-04) tested for creosote. Results were compared to the BC Contaminated Sites Regulation Residential Land-use (RL) standard. The results confirm an elevated concentration of lead in the paint samples, approximately 58-60x the RL threshold. With the exception of 2-Methylphenol in sample KRB21-03, the components of creosote were all below detection limits. 2-Methylphenol is also known as *o*-Cresol, and can be a natural component of cedar, or may result from burning or from dipping the ends of wooden abutments in a creosote product. Given that the other constituents were below the detection limits for constituents associated with creosote, the potential for creosote in the wooden abutments are deemed to be 'low'. Although creosote may have been washed away from the surface layers of the wood over time, wood samples were collected above the typical HWM and below the surface of the wood and are therefore anticipated to be representative. Contingent on the ultimate use-case for the wooden abutments, a follow-up sampling event(s) may be warranted at currently inaccessible portions of the abutments.

9. Contractor shall provide a debris containment system (if required) during removal of the existing bridge to reduce the risk of paint chips or debris from entering the watercourse. Any resulting paint chips and paint on the bridge span should be appropriately managed and disposed of off-site.

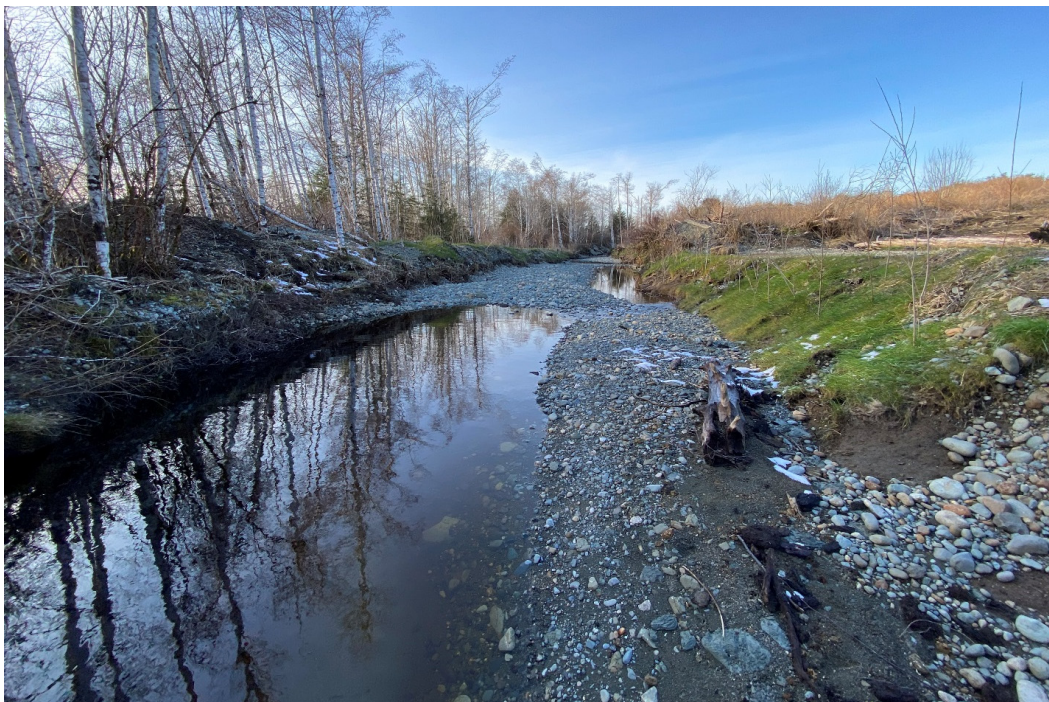
The high flow bypass channel is designed to receive flow predominantly during high flow events, increasing instantaneous flow capacity for the system locally and reducing erosive forces via the dissipation of flow energy between the main stem and bypass channel (Photo 11). During the assessment, only a minor inflow into the channel was observed, with a uniform gradient from the upstream-to-downstream portion of the bypass. Observed pools were assessed for fish presence; however, no fish were observed. There is a potential that during summer low-flow events, the bypass channel will become dewatered, resulting in fish stranding, given a number of isolated shallow pools (Photo 12). Although the channel appears to have been designed to minimize this potential, changes in channel morphology over time, and the natural sorting and erosion/deposition within the channel may increase stranding risk.

The upstream end of the bypass channel is not armoured, which poses a risk for erosion during high flow events. Willow had been staked along the right bank and localized portions of the left bank near the top-of-bank and appeared viable. Near the bottom of the bypass channel, AquaTerra and Kwakiutl personnel noted concrete debris placed along the right bank, which was reportedly excavated from the channel and part of the original ‘flume’ design. As a cost-savings measure, the rip-rap was broken up and used as bank armouring (Photo 12).

Photo 11: High Flow Bypass Channel looking downstream (northward).

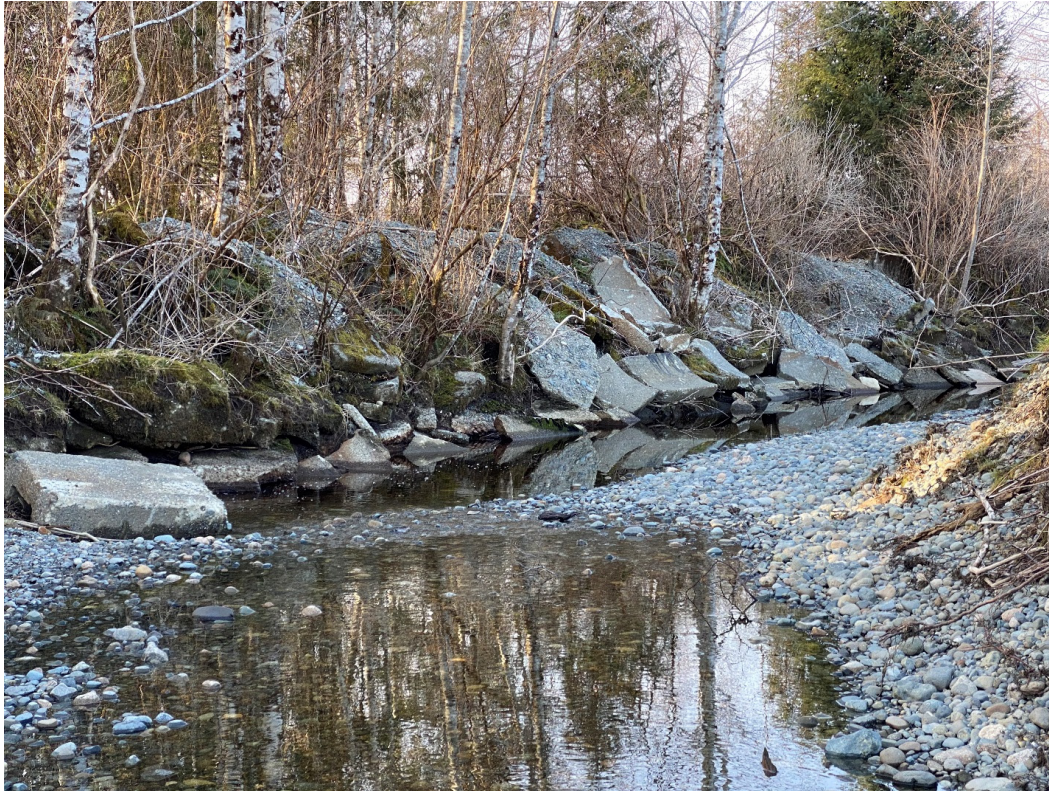
Photo 12: Broken concrete from the original bypass channel used to armour the banks near the downstream end of the bypass channel.
