R.113311.001, S.S. Klondike Remediation, Whitehorse YT

Section No.	Section Title
01 11 00	Summary of Work
01 11 55	General Instructions
01 25 20	Mobilization and Demobilization
01 31 19	Project Meetings
01 32 16.07	Construction Progress
01 33 00	Submittal Procedures
01 35 13.43	Special Project Procedures for Contaminated Sites
01 35 29.14	Health and Safety for Contaminated Sites
01 35 43	Environmental Procedures
01 52 00	Construction Facilities
02 61 00.03	Contaminated Sites Excavation
02 61 00.04	Contaminated Sites Soil Transportation
02 61 00.06	Contaminated Sites Soil Disposal
02 83 12	Lead Abatement - Maximum Precautions
09 91 23	Exterior Repainting

Drawing No.	Drawing Title
101	Site Location
102	Existing Infrastructure and Access
103	Soil Physical Data
104	Contamination Extent – Plan View
105	Cross-Sections
106	Site Restoration

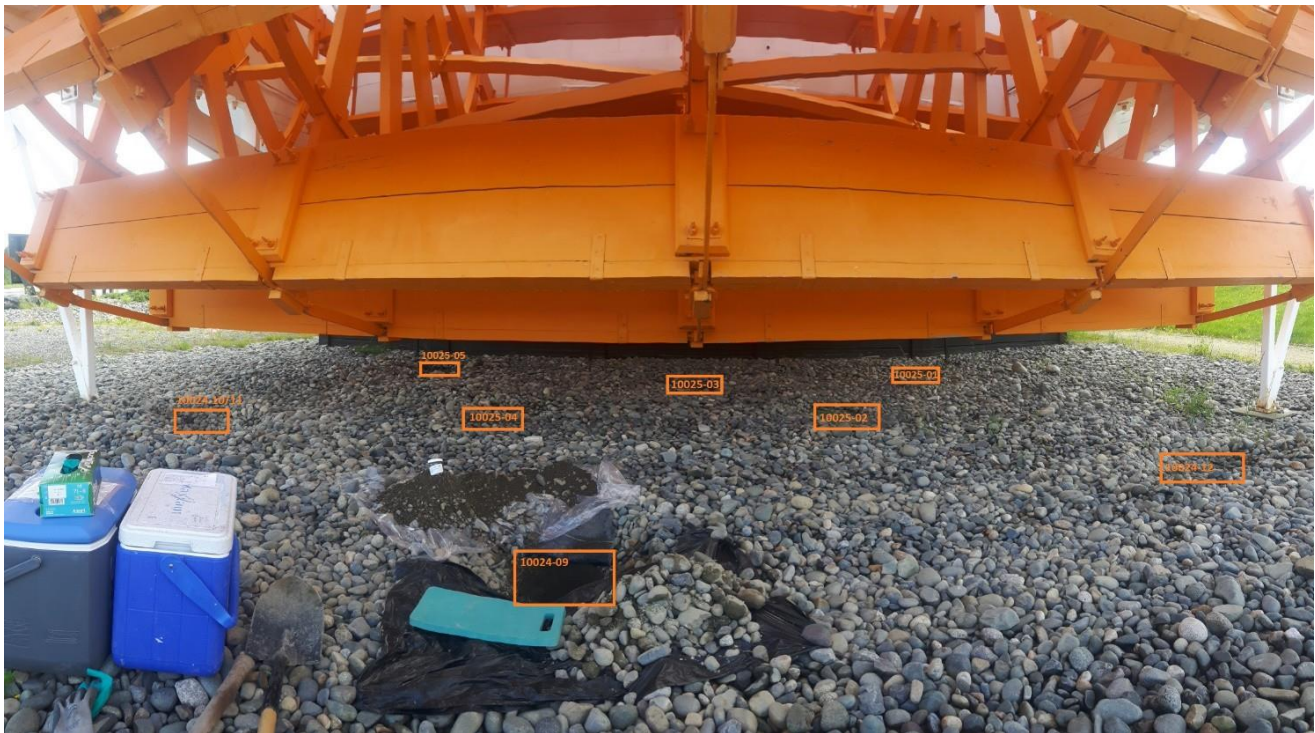
Photo 9: Paddlewheel soil sample locations

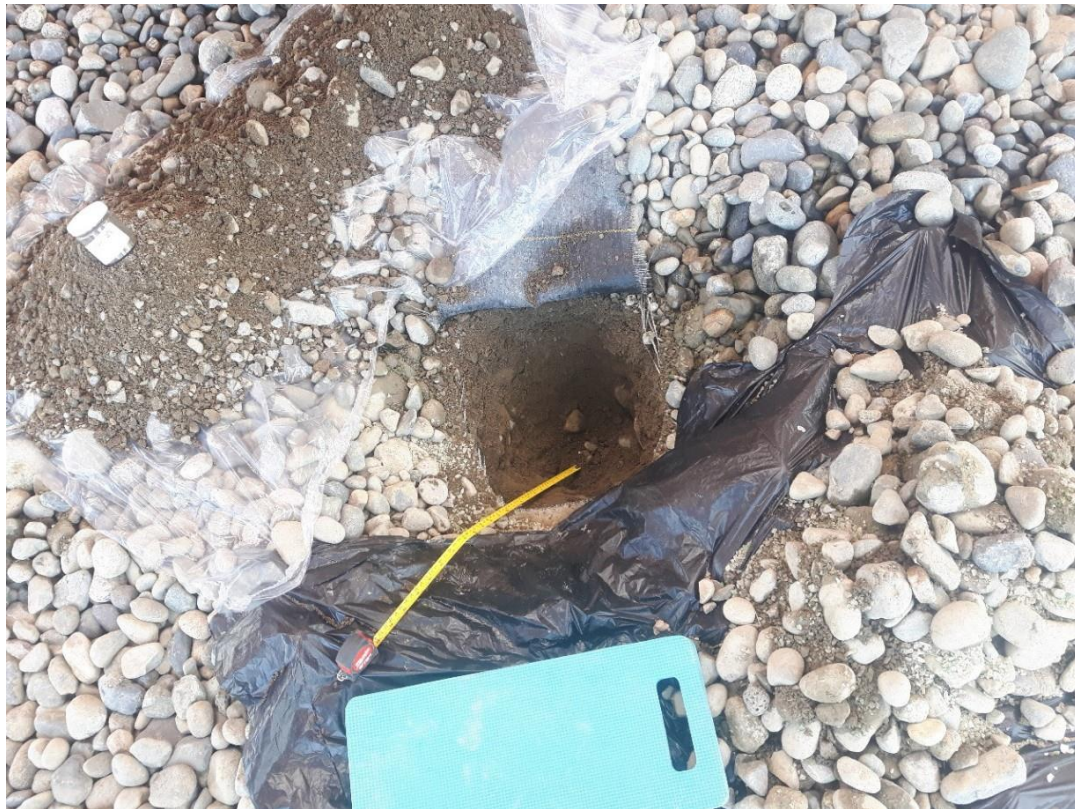
Photo 10: Paddlewheel soil sample 10024-09 at 30 cm depth, sand and gravel, some fines.

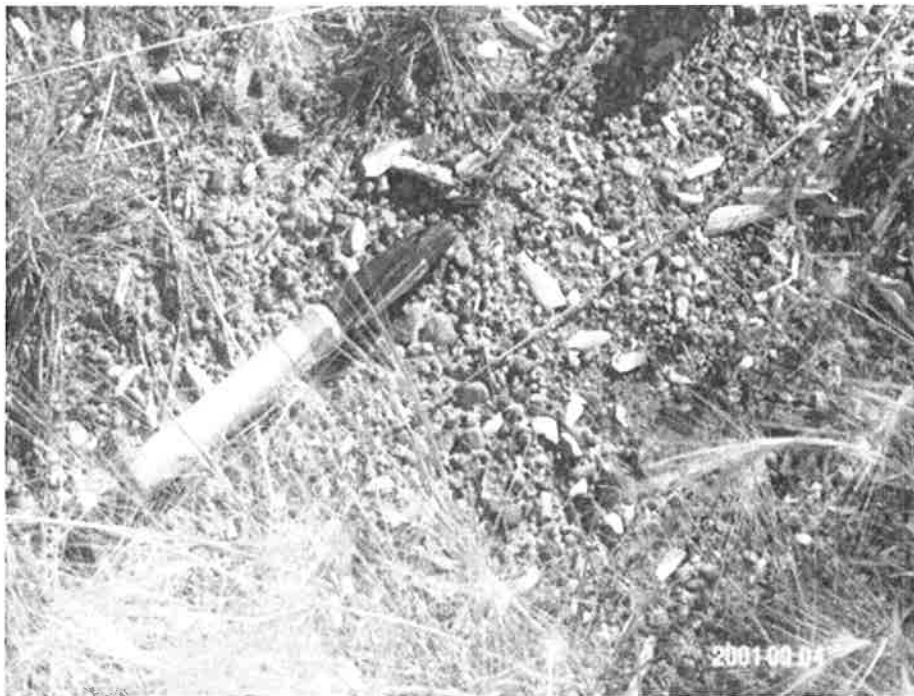
Figure 4: Typical Surface Paint Chip Deposition at the Takhini Site

Site visits were made coinciding with site sampling during the course of the assessment. Lead paints were visually observed at both sites. The ground surface at the SS Klondike contained sporadic depositions of paint chips under painted areas and at approximately a three metre offset around the ship. The area with the highest concentration of paint chips was the area under the paddlewheel. The highest concentration of paint chips visually observed was at the Takhini Complex. These areas of high deposition were situated immediately in and around areas where deteriorating parts of the SS Klondike were stored. Figure 4 shows typical surface paint chip deposition at the Takhini site, and corresponds with sample 15178-N31W42 (refer to Figure 6 for the exact location).

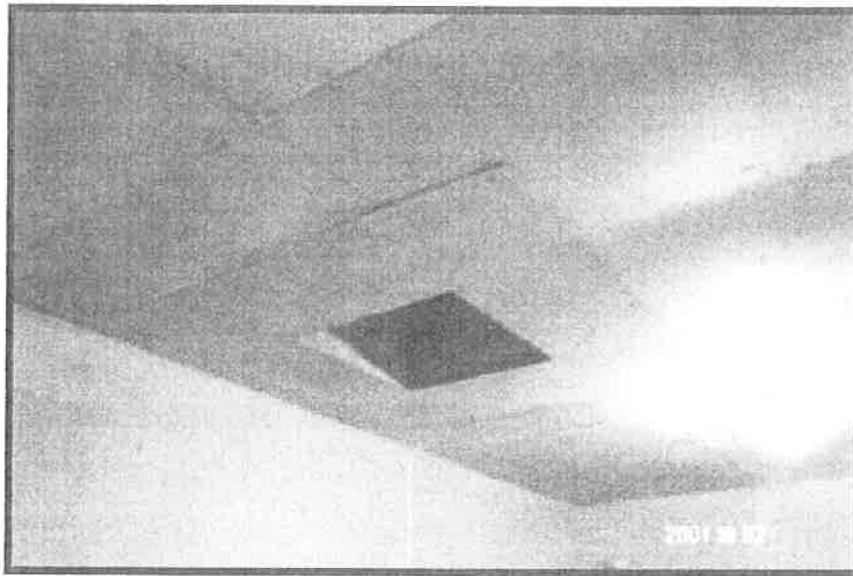
Figure 7: Asbestos Slate Board in the Cold Storage Building

Possible asbestos insulation was noted in the Main Carpenter's Shop in what appeared to be an old steam pipe conduit located below the floor, along the eastern side of the building. A sample was sent to ALS in Vancouver for laboratory analysis, the result confirmed that it was not asbestos (refer to Appendix A). Asbestos was also observed in the Green Cold Storage Building as asbestos slate board surrounding an opening in the ceiling (see Figure 5). A sample of this slate board could not be collected; however, experience at other sites suggests that it most likely contains asbestos. Exposure to asbestos fibres can cause lung damage (asbestosis), however, at this site the potential for airborne particles appears limited. The asbestos in the cold storage building is exposed; the slate board is not friable and, therefore, is not expected to have contributed significant quantities of airborne particle. However, since the asbestos is no longer performing a useful function it could be removed and disposed of accordingly.

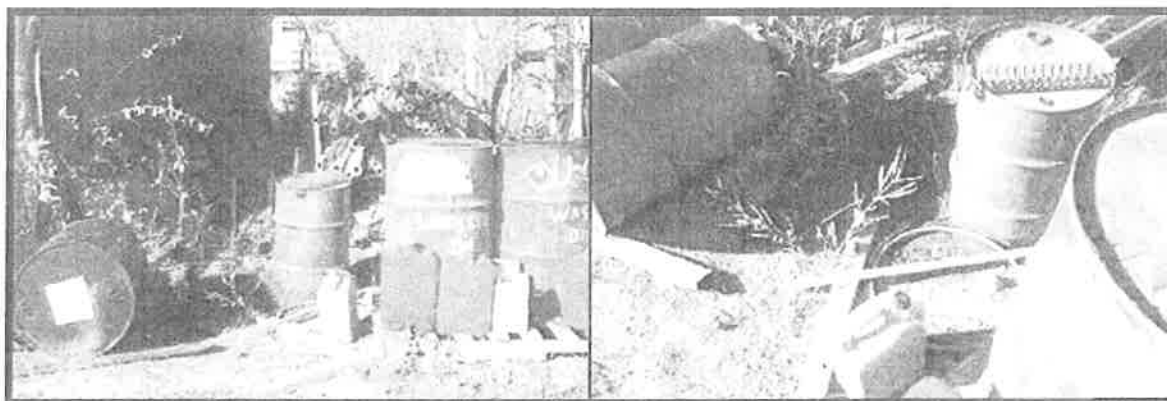
Figure 8: Area of Hydrocarbon Staining

practices appear to have contributed to the spillage of the waste oil. A surface test hole was excavated in the middle of the affected area. It is estimated that the volume of affected soil is under one cubic metre, and is not considered to be an environmental concern. This small amount of contaminated soil will be naturally attenuated over time, barring future spillage at this location. If a more timely solution is sought, the other option is to excavate and dispose of the affected soil at a local commercial soil treatment facility.

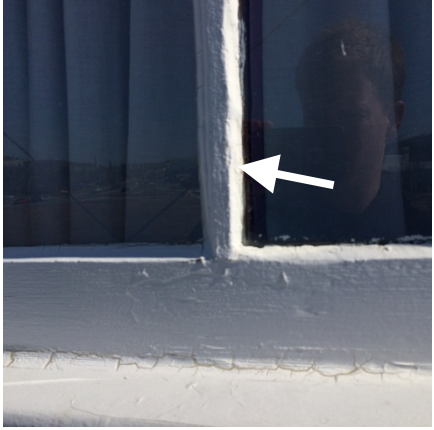
Identified ACM Description and Condition Information		Photo
White window caulking applied to the exterior of windows throughout

Friability	Non-friable	
Condition	Good	
Content	0.25% Chrysotile	
Mechanical gaskets in pipe flanges throughout

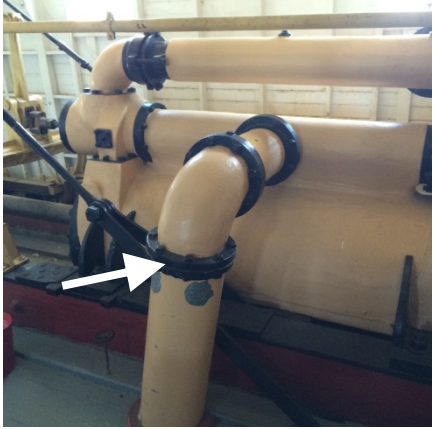
Friability	Non-friable	
Condition	Good	
Content	41.6% Chrysotile

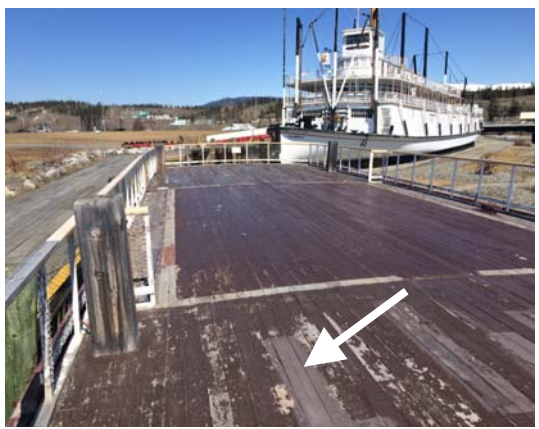
Identified LCP Description	Photo
<p>Brown paint on both the old and new deck areas (both shades of brown) is lead-containing. Although worn in some locations, this paint was observed to be in good condition (not bubbling, flaking or peeling).</p>

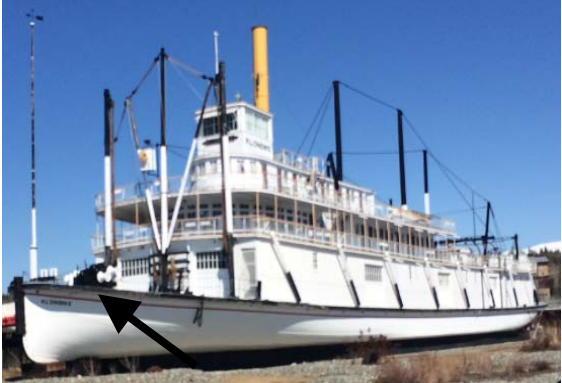
Identified LCP Description	Photo
<p>Black coloured paint on trim of Main Deck. This paint was observed to be in good condition (not bubbling, flaking or peeling).</p>

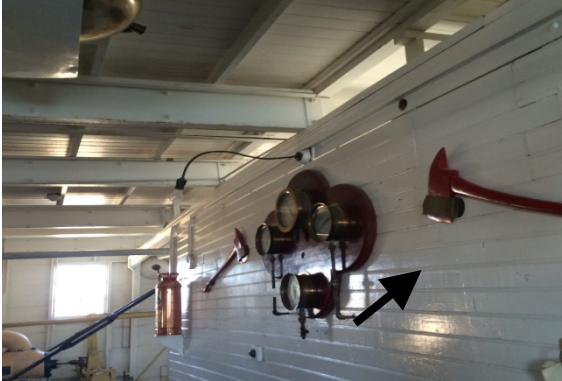
<p>White coloured paint on interior walls. This paint was observed to be in good condition (not bubbling, flaking or peeling).</p>

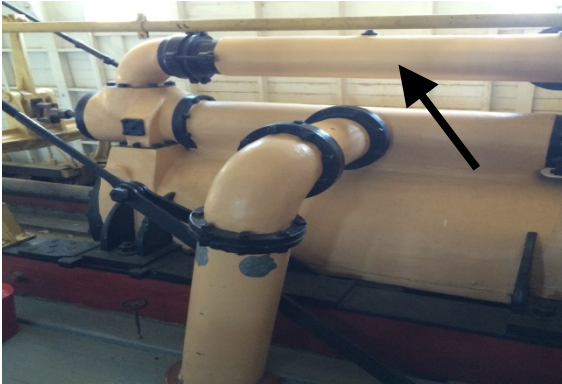
<p>Yellow coloured paint on pipes in the engine room. This paint was observed to be in good condition (not bubbling, flaking or peeling).</p>

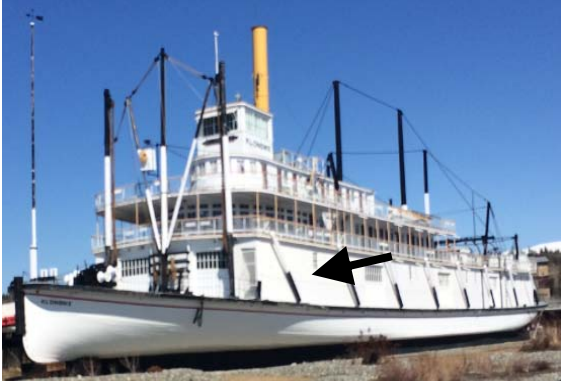
Identified LCP Description	Photo
White coloured paint on exterior. This paint was observed to be in good condition (not bubbling, flaking or peeling).

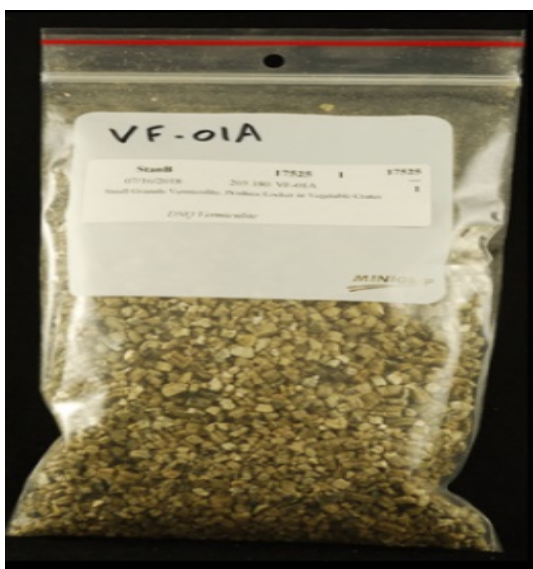
Photo 1 Typical Asbestos-Containing
“Small Granule” Vermiculite

- NOTE: That “larger granule” vermiculite was observed in various containers but was determined by analytical testing to be non-ACM. Representative photos for example are provided below:

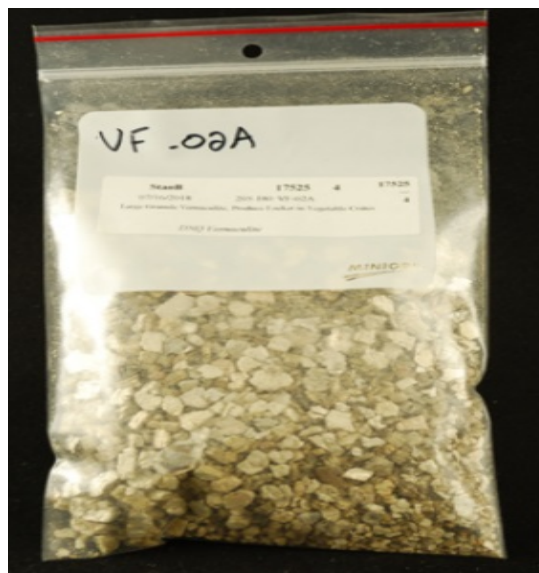
Photo 2 Typical Non-ACM “Large Granule”
Vermiculite

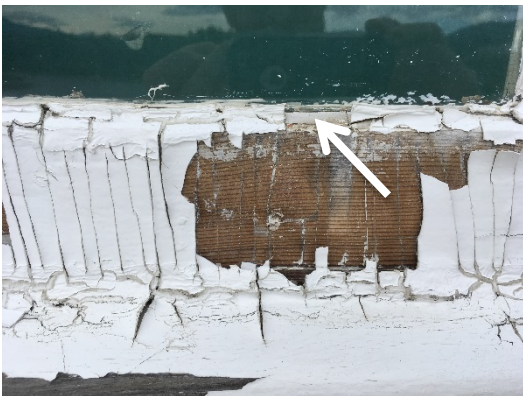
Identified ACM Description and Condition Information	
<p>White window caulking applied to the exterior of windows throughout.</p>	
Friability	Non-friable
Condition	Good
Content	Current Assessment—1.2% Chrysotile Previous Assessment—0.25% Chrysotile

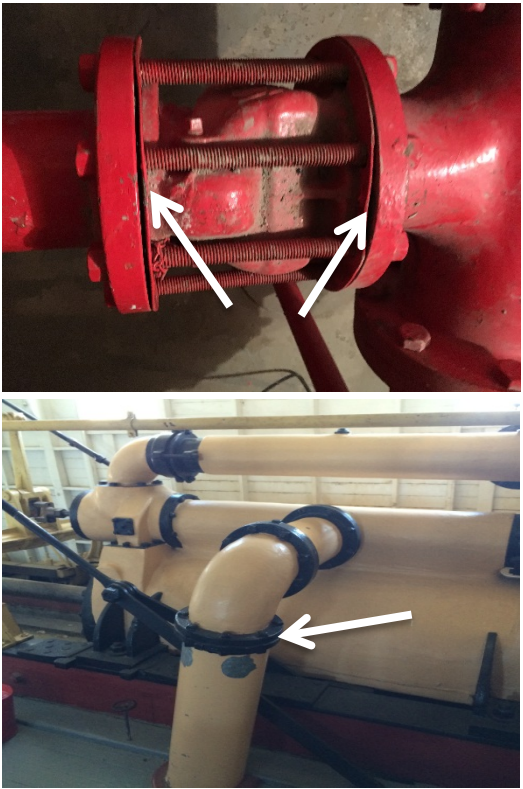
<p>Fibrous mechanical gaskets in various pipe flanges throughout (interspersed with various types of non-ACM gaskets as described in the table in Appendix B) including the majority of gaskets present in the valve house.</p>	
Friability	Non-friable
Condition	Good
Content	Current Assessment—45.8% Chrysotile Previous Assessment—41.6% Chrysotile

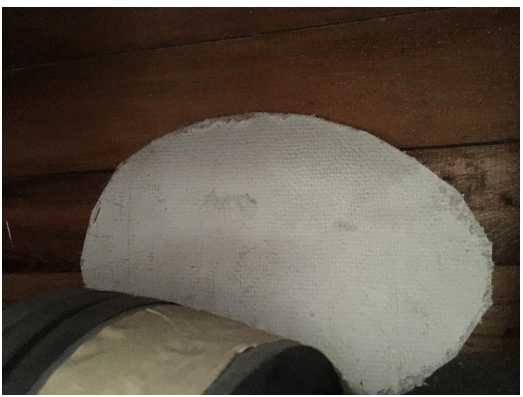
Identified ACM Description and Condition Information		
One small piece of white of cement panel present in the engine room parts storage area.

Friability	Non-friable	
Condition	Good	
Content	45% Chrysotile	
Brown fibrous debris below the main deck in the boiler room around the base of the mast.

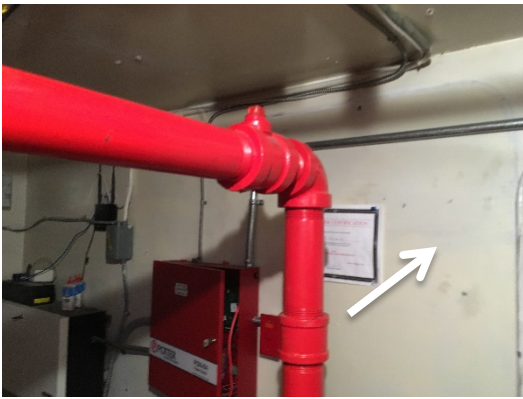
Friability	Friable	
Condition	Poor (debris)	
Content	<0.66% Chrysotile	
Joint compound applied to drywall walls and ceilings throughout the valve house.

Friability	Non-friable in situ; potentially friable during removal	
Condition	Good	
Content	1% Chrysotile

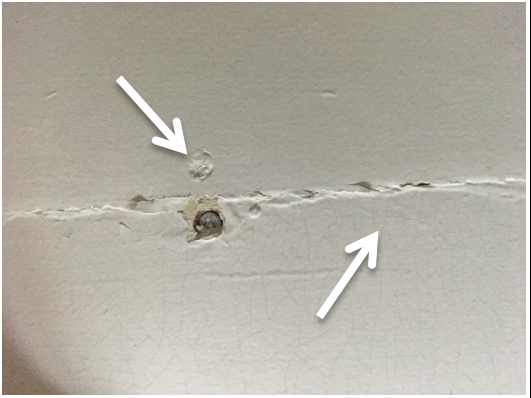
Identified ACM Description and Condition Information	
<p>Joint compound applied to seams and screw heads of particle board walls throughout, including patch compound applied to the kitchen storage room walls on the saloon deck.</p>	
Friability	Non-friable in situ; potentially friable during removal
Condition	Good
Content	2% Chrysotile

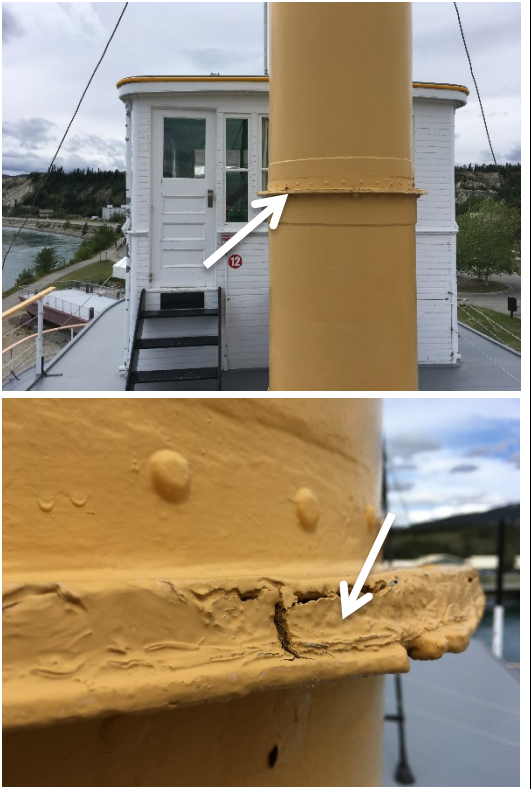
<p>Large brown mechanical gasket present in the flange on the main boiler stack and the white seam sealant applied to this gasket.</p>	
Friability	Non-friable
Condition	Good
Content	Gasket—<0.25% Chrysotile Sealant—<0.25 to 0.37% Chrysotile

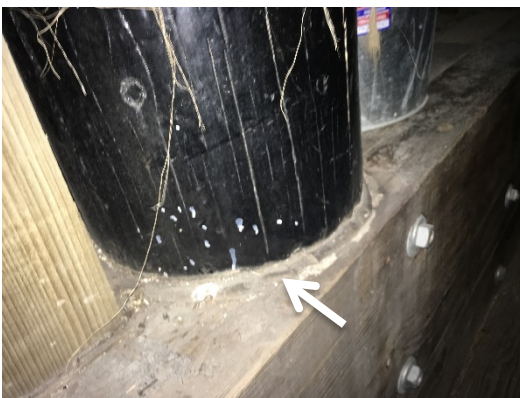
Identified ACM Description and Condition Information	
<p>Grey seam sealant applied around the bottom of the mast below the main deck in the boiler room.</p>	
Friability	Non-friable
Condition	Good
Content	<0.25 to 0.30% Chrysotile

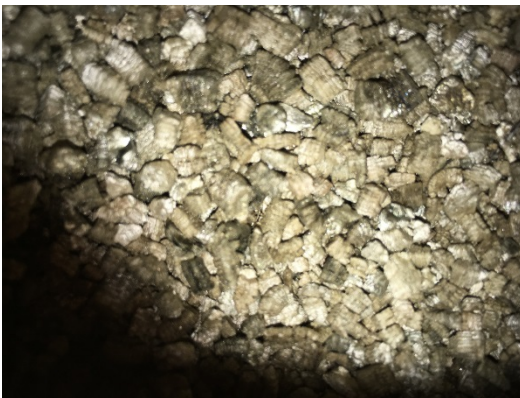
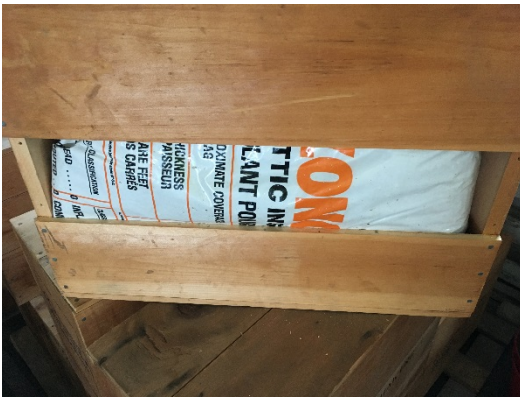
<p>Small granule vermiculite filling material inside various crates, bags and barrels as follows:</p> <ul style="list-style-type: none"> • Eight crates labeled vegetables and fruits in the produce locker • One small barrel labeled powdered milk in the pantry • 31 bags labeled sugar in the main deck storage area • Nine small barrels labeled powdered milk or unlabeled in the main deck storage area • Seven crates labeled shredded whole wheat in the main deck storage area • Nine crates labeled vegetables and fruits in the main deck storage area • 16 crates labeled SWIFT in the main deck storage area • 50 crates labeled in various different ways in the main deck storage area • 12 crates labeled dry gin in the main deck storage area • 71 crates labeled gasoline in the main deck storage area • 100 large barrels labeled beer or unlabeled in the main deck storage area <p>Any containers filled with unknown materials should be presumed to containing ACM vermiculite until confirmed otherwise.</p> <p>Note that large granule vermiculite was observed in various containers, but it was determined by analytical testing to be non-ACM.</p>

Friability	Friable
Condition	Friable filling material
Content	Asbestiform Amphibole (Detected Not Quantified)

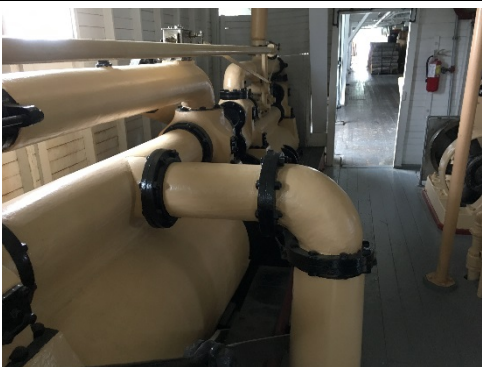
Substrate	Cast iron and canvass pipe wrap	
Location/approx. extent	Pipes in the engine room	
Lead content	71,000 (Previous Assessment)	
Condition	Good

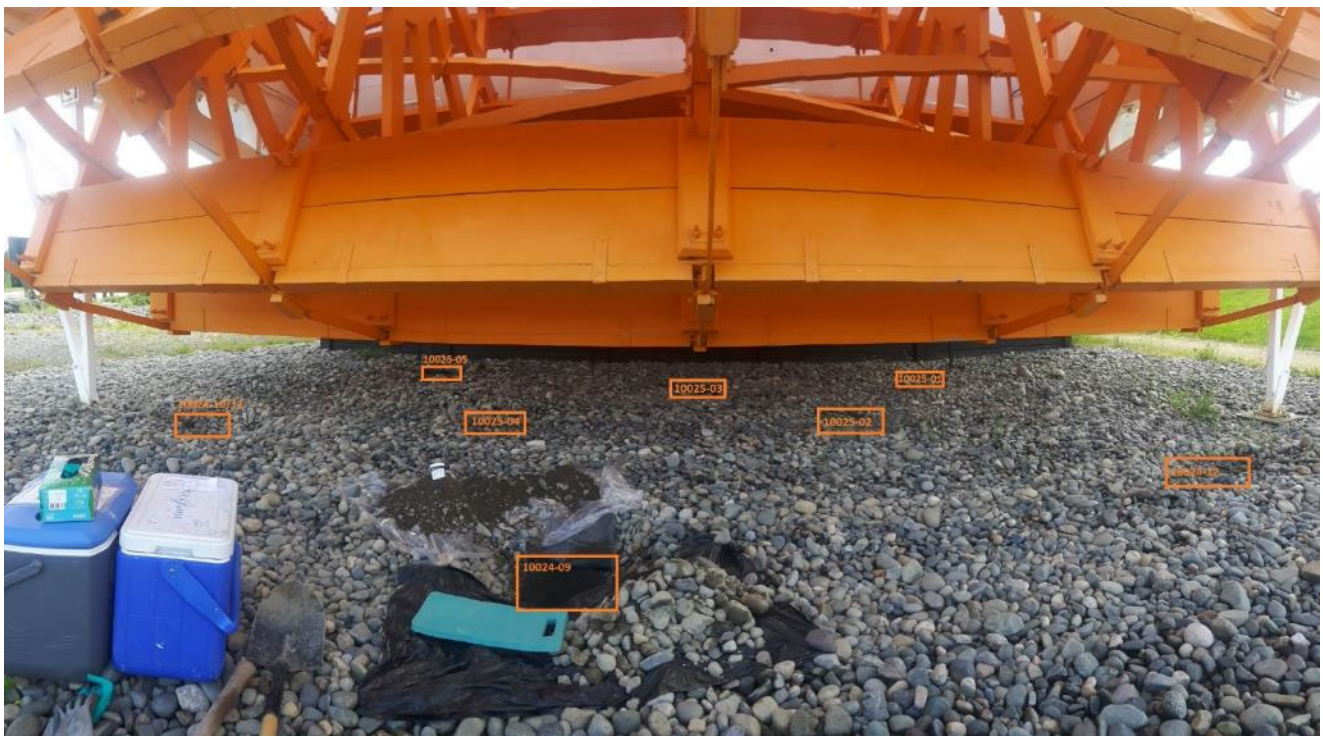
Photo 4: Sample locations below the Paddlewheel
