Appendix B: Previous Diving Report

Project:	Grand Bank Wharf Inspection	Page:	1 of 18
	Document No.:	Project Reference Number: 18245-16	Date:	May 18th 2016
			Revision:	0

Grand Bank Wharf Inspection

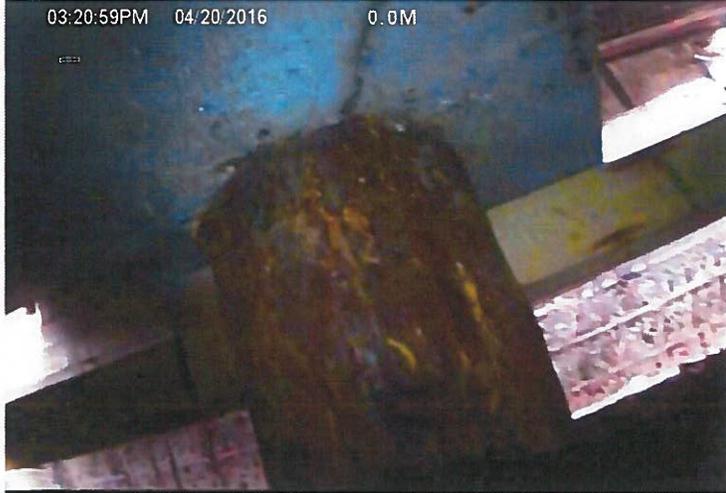
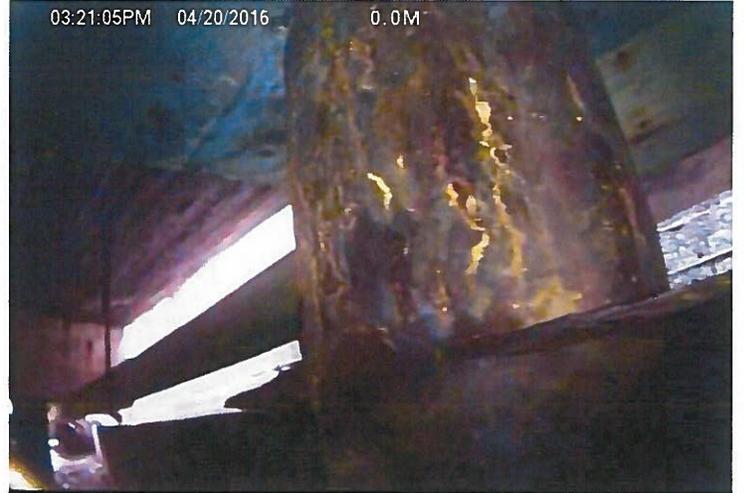
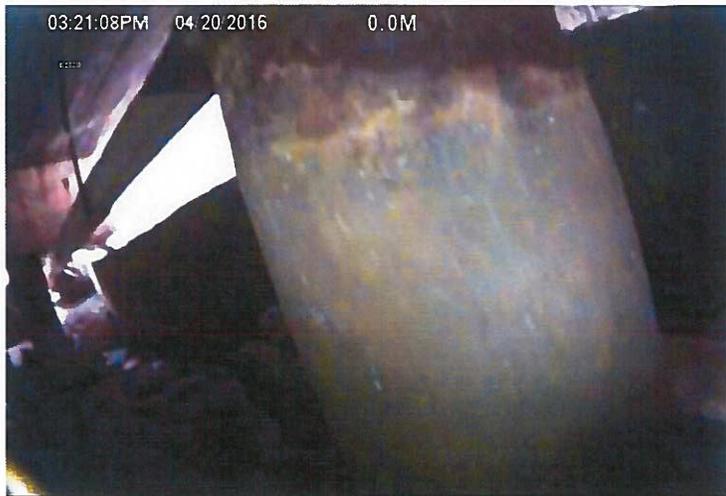
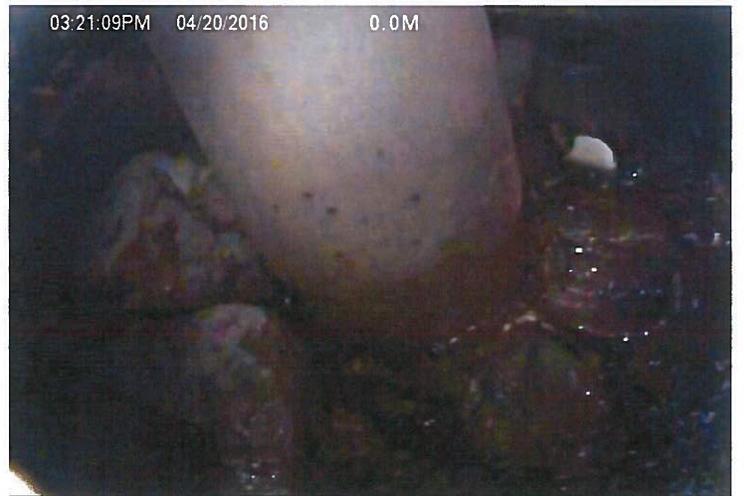
10/5/2016
36C-001.jpg

Piles that are not encased and have exposed steel are deteriorated. Deterioration began to be progressively worse starting at bent 36 for piles adjacent to the retaining wall. *For the purpose of this report piles as part of the retaining wall structure were not designated a label (i.e. 2D). The drawing provided prior to the inspection was found to be accurate in regards to pile encasements.*

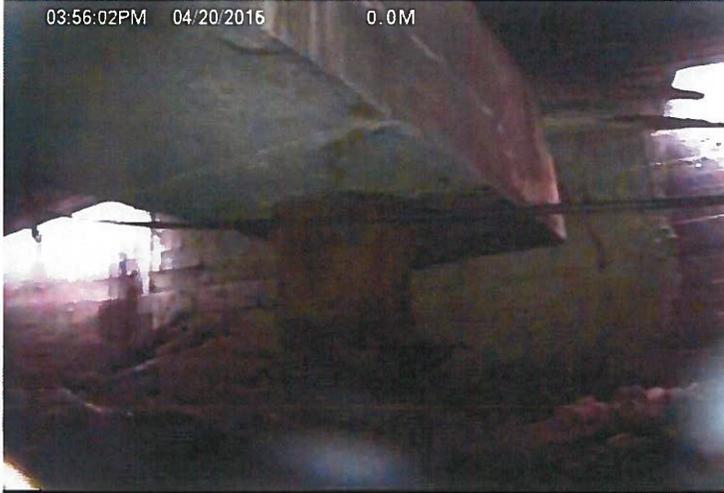
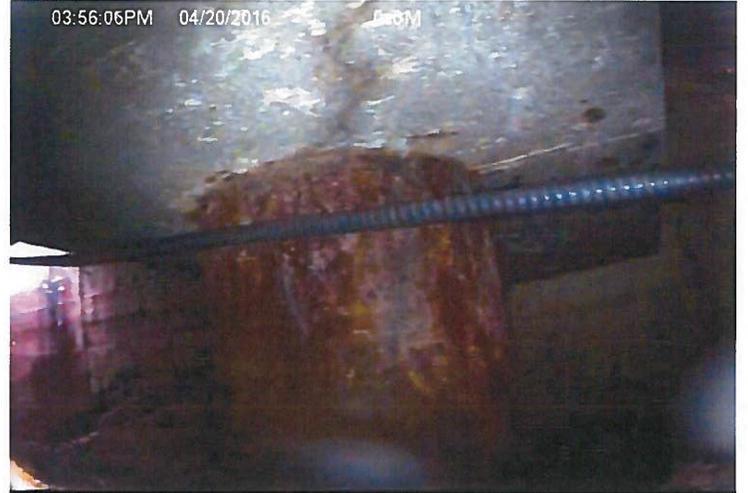
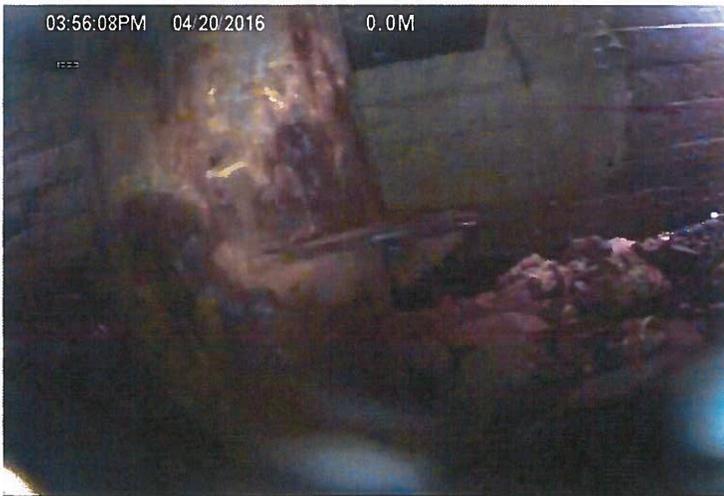
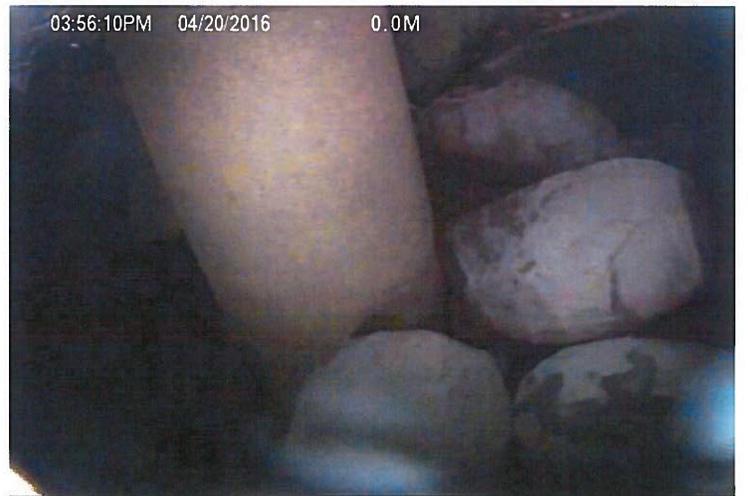
10/5/2016
50C-001.jpg

Figure 9-3 Anomaly Report		
Video File Reference: 09.02.00-09.12.11		
Time	Pile	Comments
9:08	6C	Showing Deterioration
9:21	9C	Showing Deterioration
Figure 9-4 Anomaly Report		
Video File Reference: 09.18.50-09.44.19		
Time	Pile	Comments
9:23	10C	Showing Deterioration
9:30	12C	Showing Deterioration
Figure 9-5 Anomaly Report		
Video File Reference: 15.13.51-15.37.14		
Time	Pile	Comments
15:20	36C	Poor Condition on Bottom
15:23	38C	Poor Condition on Top
15:31	44C	Poor Condition
15:34	46C	Poor Condition on Top
Figure 9-6 Anomaly Report		
Video File Reference: 15.54.10-16.17.32		
Time	Pile	Comments
15:56	50C	Poor Condition on Top
15:58	52C	Poor Condition on Top
15:31	54C	Poor Condition
16:02	56C	Poor Condition
16:04	58C	Poor Condition
16:15	Retaining wall	Poor Condition

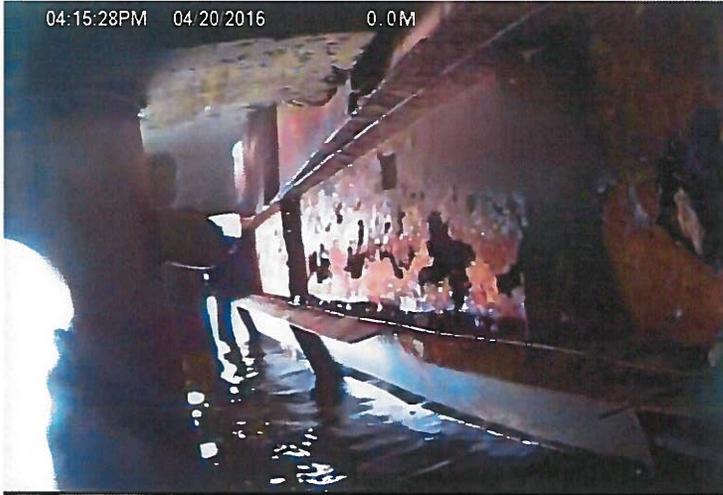
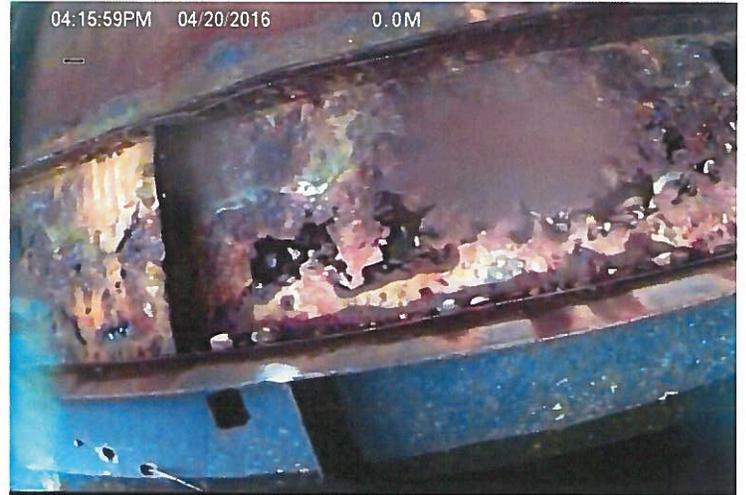
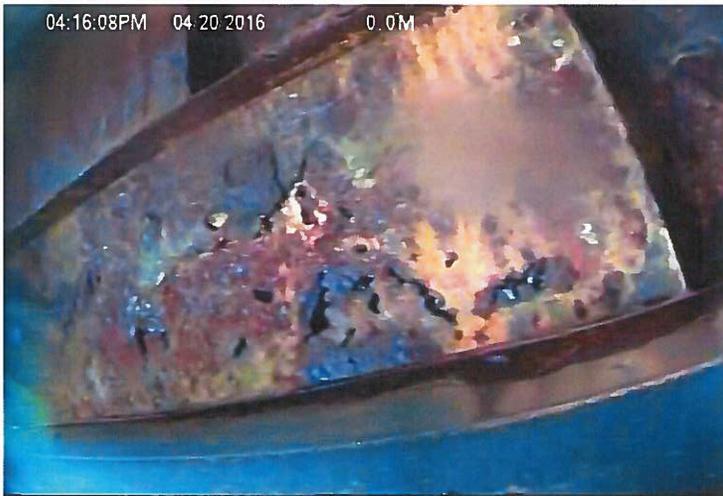
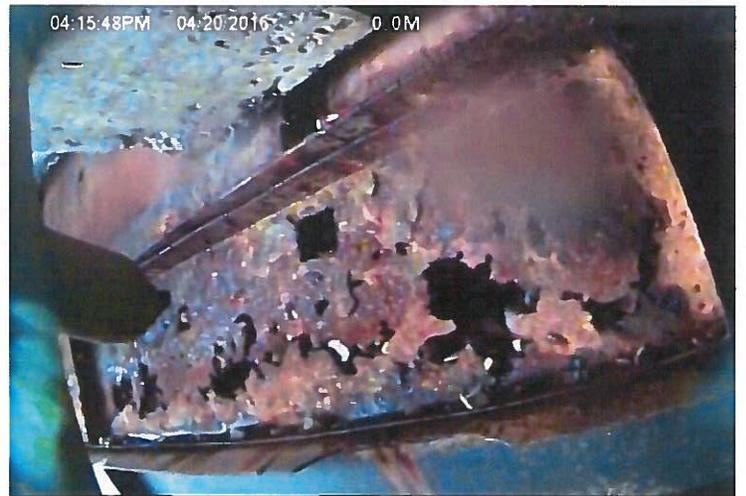
10/5/2016
STR_15.54.10-16.17.32[F][0@0][0]-001.jpg

The retaining wall condition varied by section and material. Between bents 1-7 there is a timber retaining wall structure, for bents 7-28 the timber retaining wall has reinforced bagged concrete, for bents 28-62 the foundations of the adjoining buildings are part of the retaining wall but did not include piles as part of their structure, and bents 62-66 are constructed with a steel retaining wall. The timber and concrete sections were in good condition, and the steel section is in poor condition showing severe deterioration.

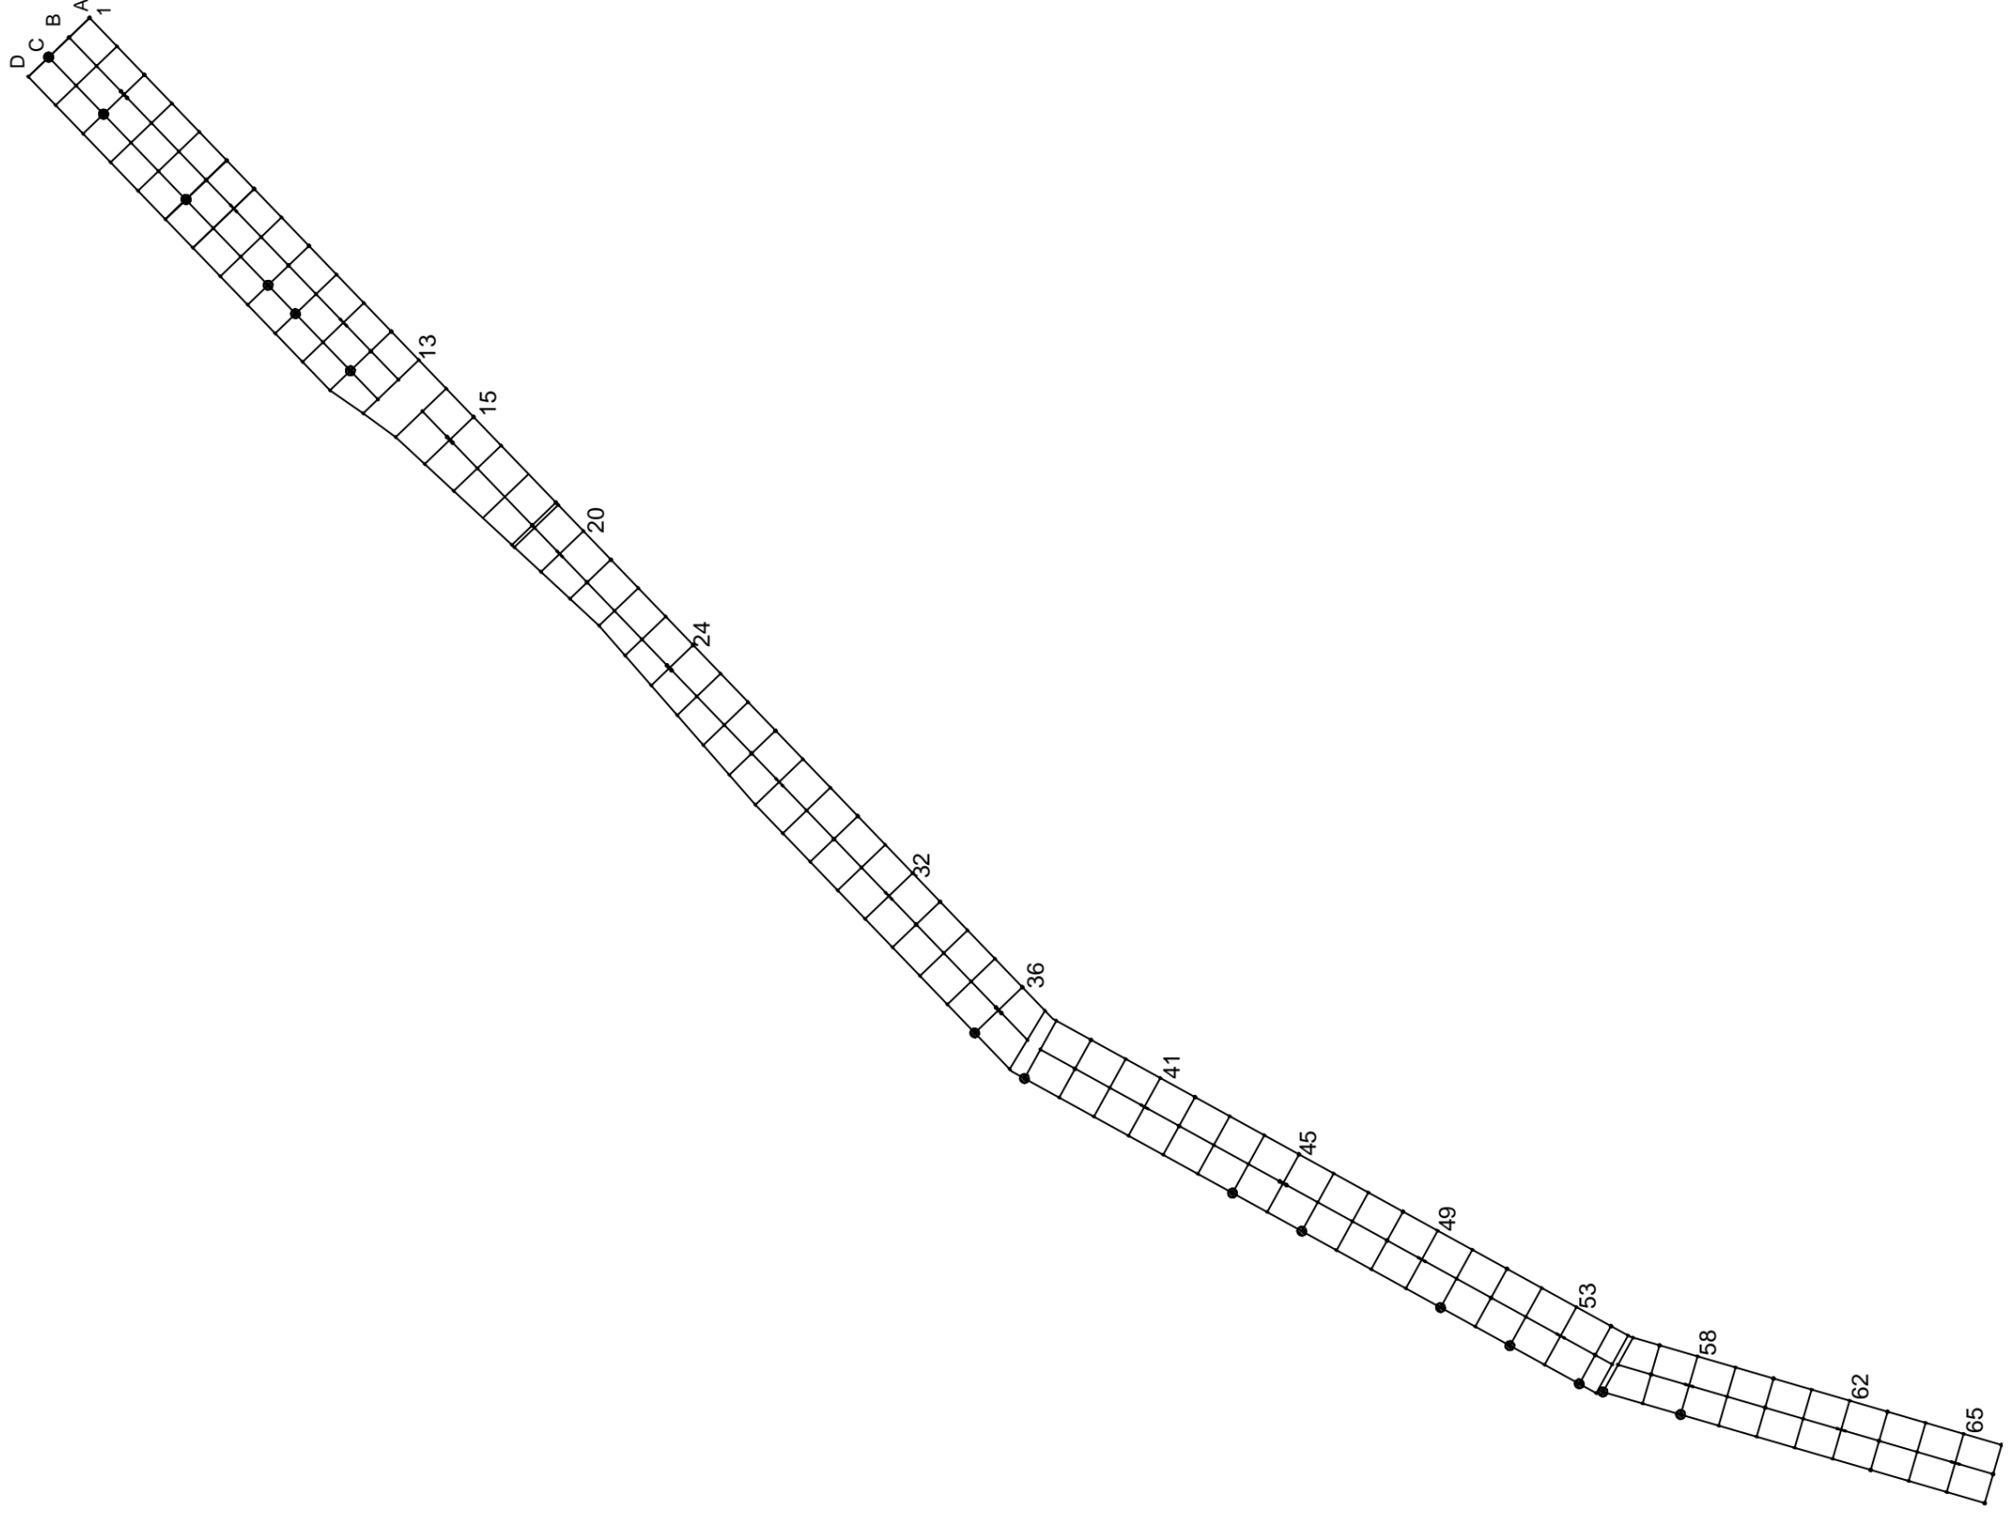
Wharf Inspector
Grand Bank, NL
Overview

Notes:

- 1. Enlarged circles around piles highlight areas of concern in report.

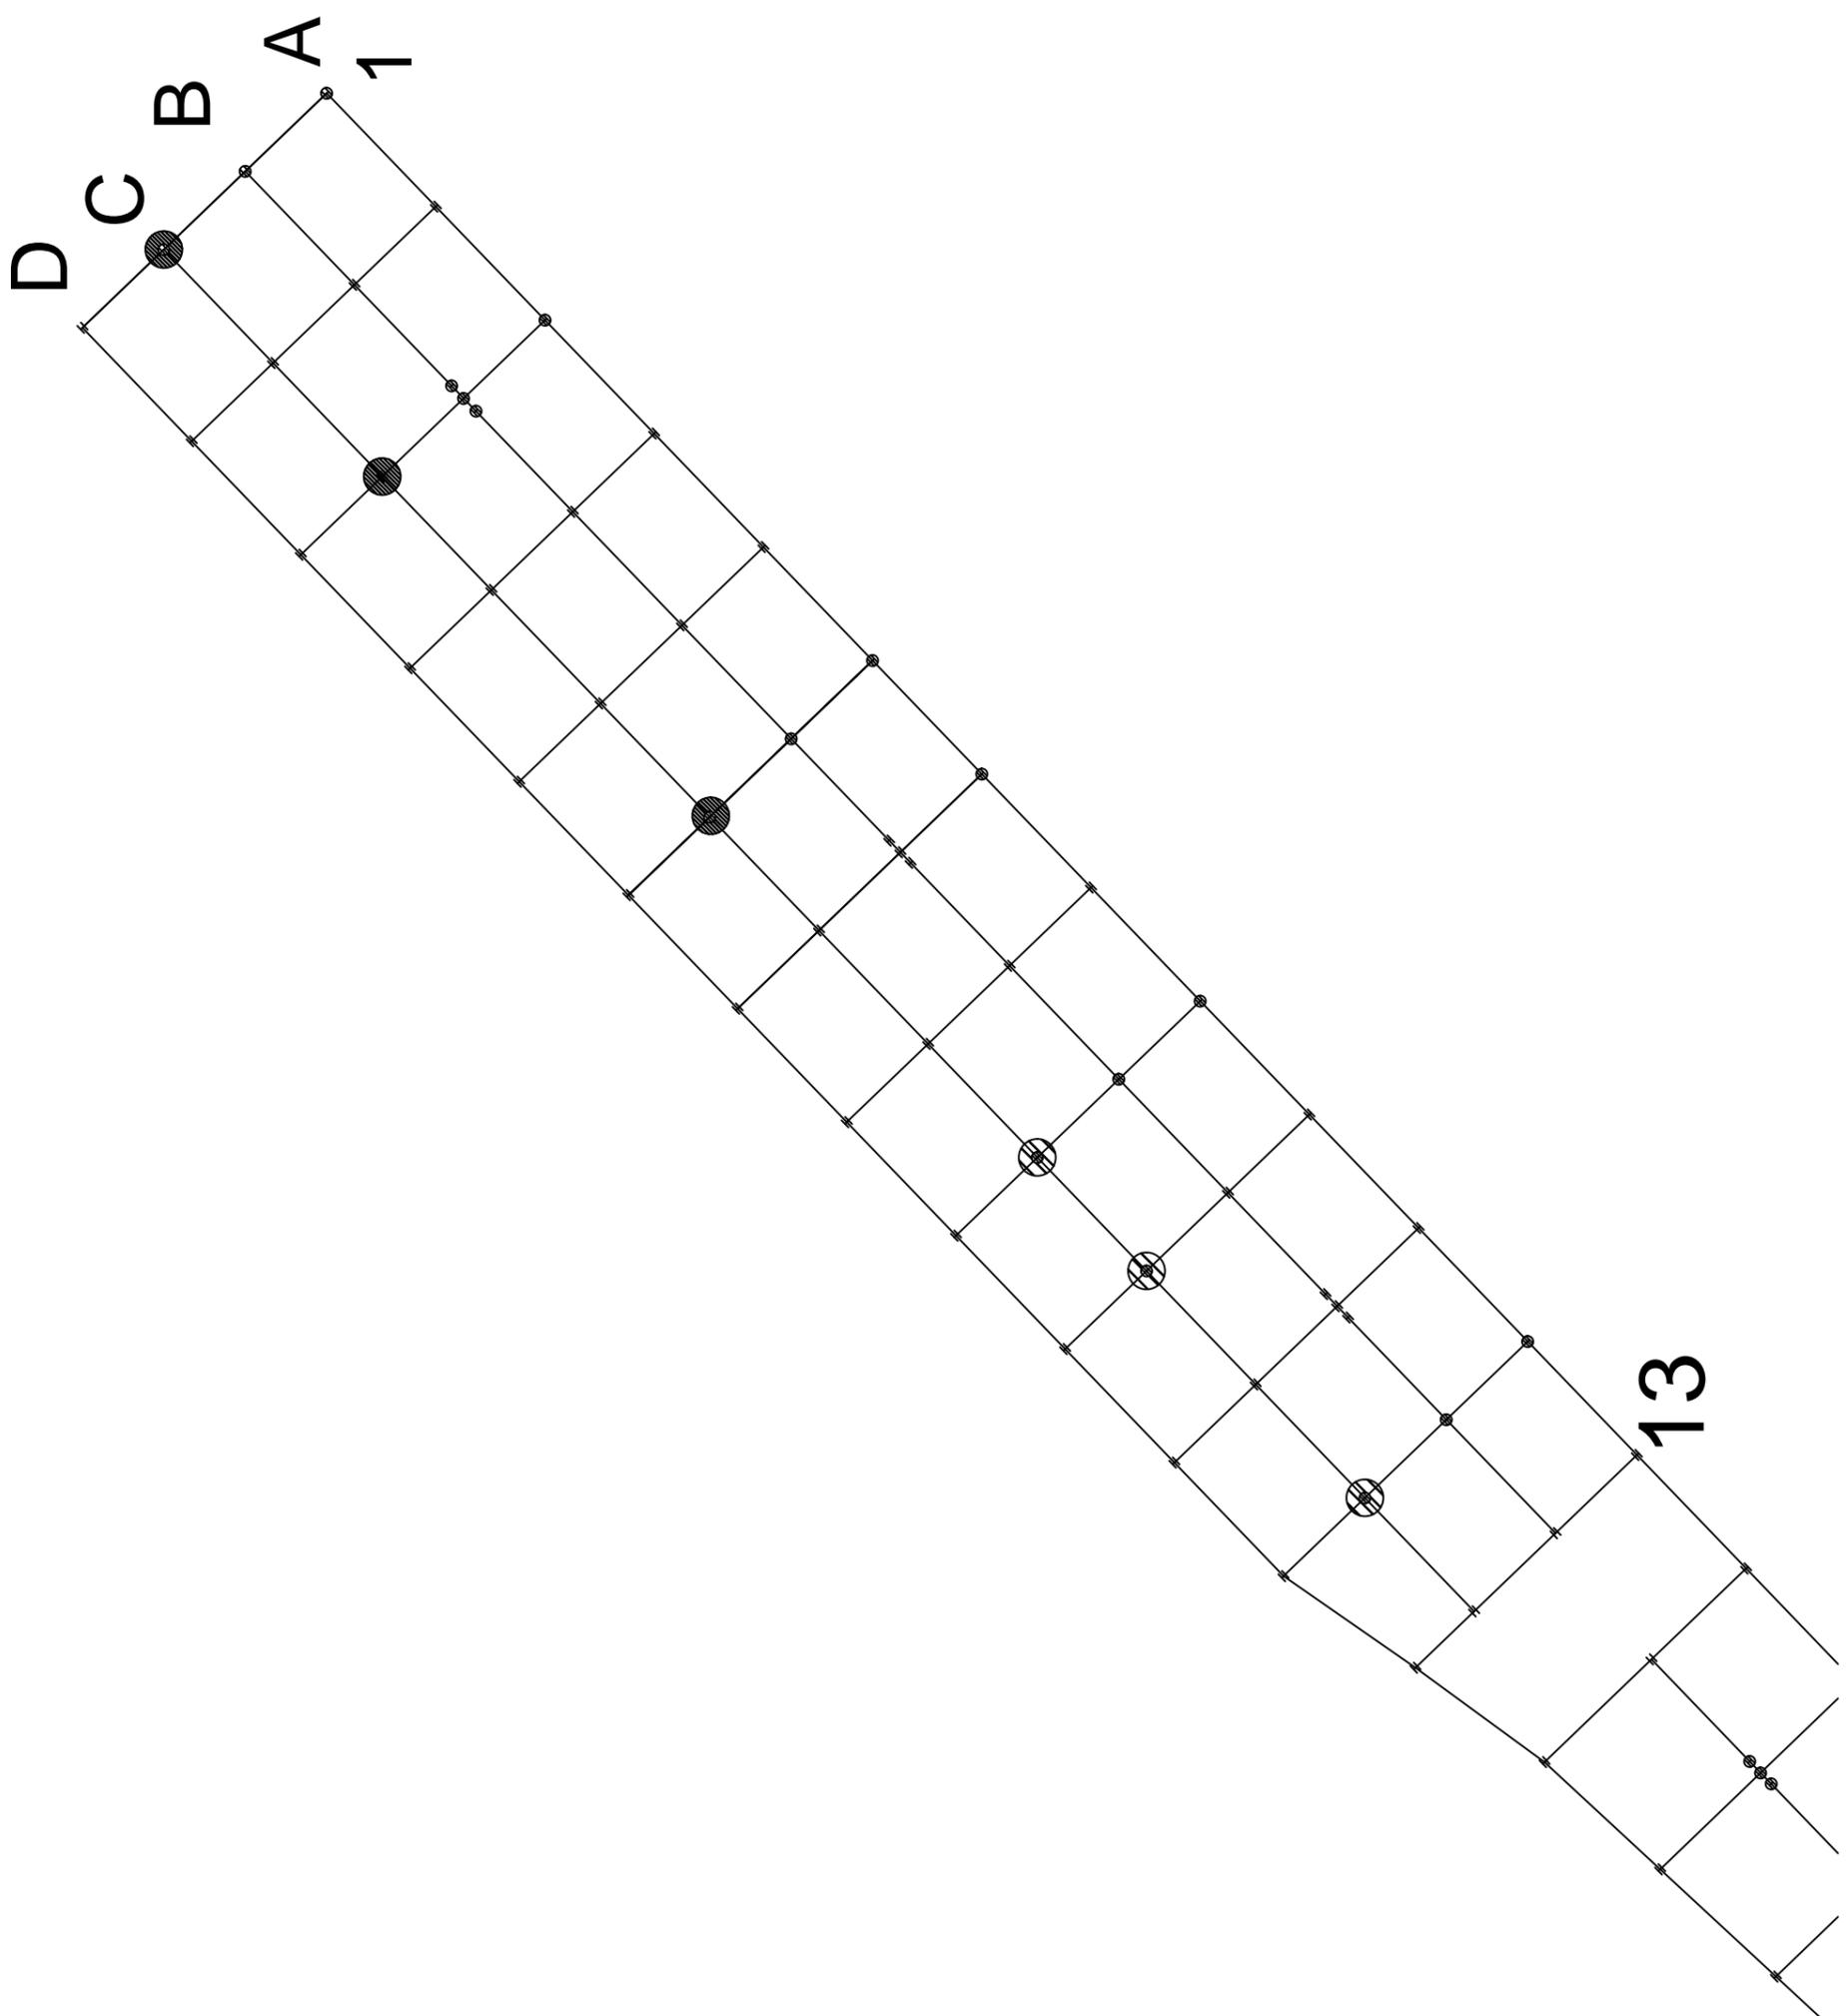
Wharf Inspector
Grand Bank, NL
Bents 1-13

Notes:
1. Enlarged circles
around piles highlight
areas of concern in
report.

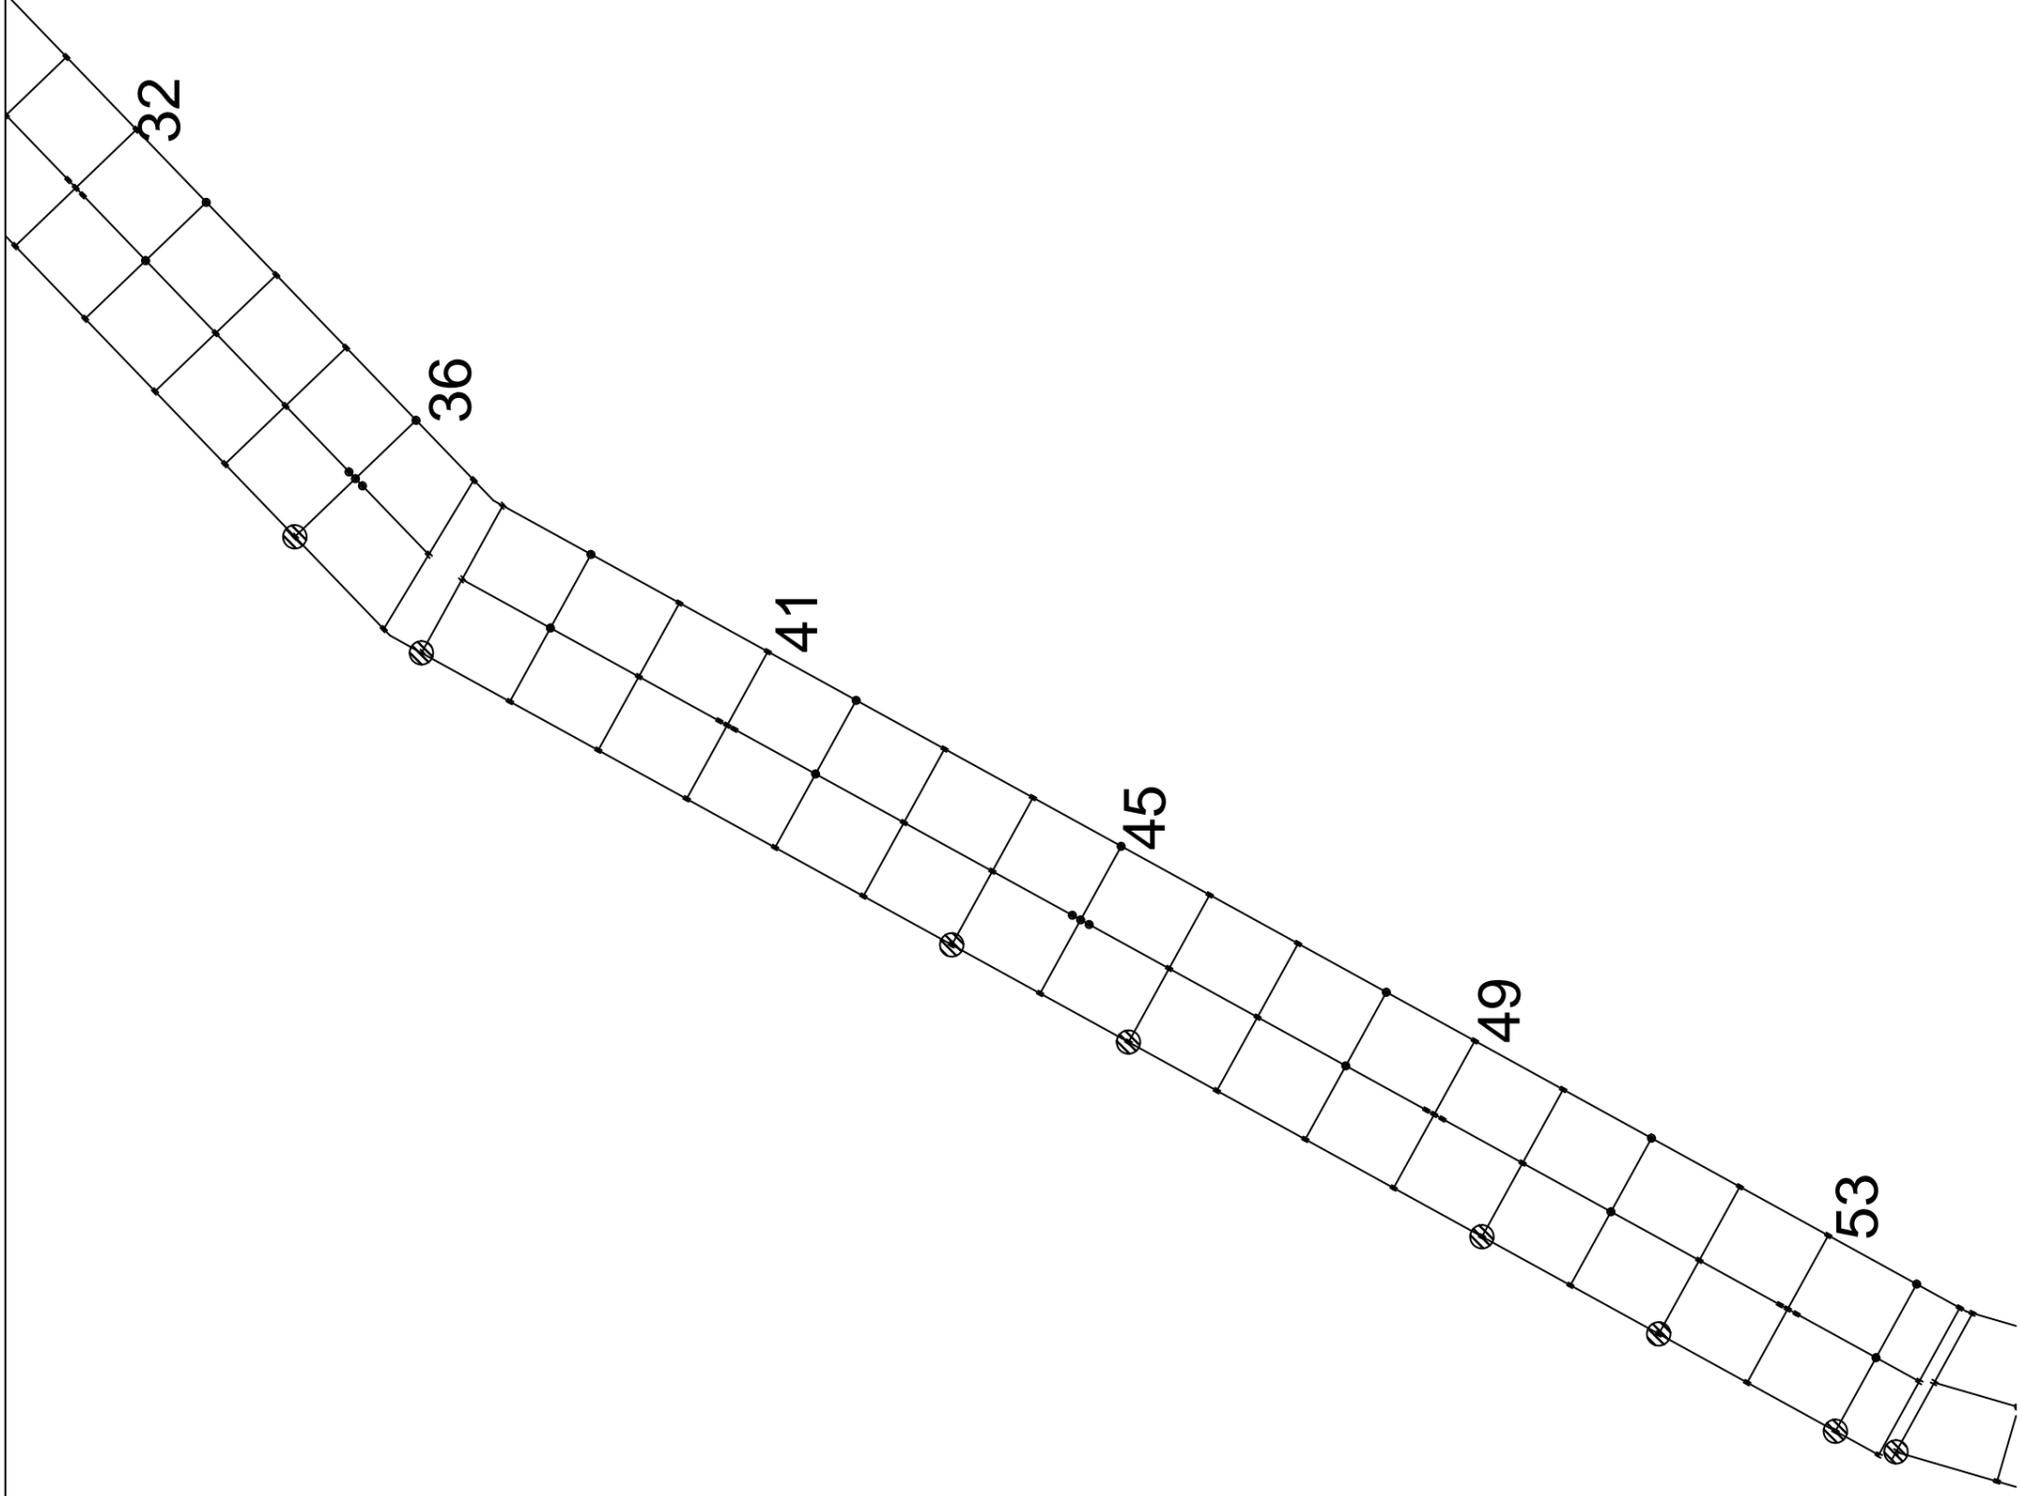
Wharf Inspector
Grand Bank, NL
Bents 32-55

Notes:

- 1. Enlarged circles around piles highlight areas of concern in report.

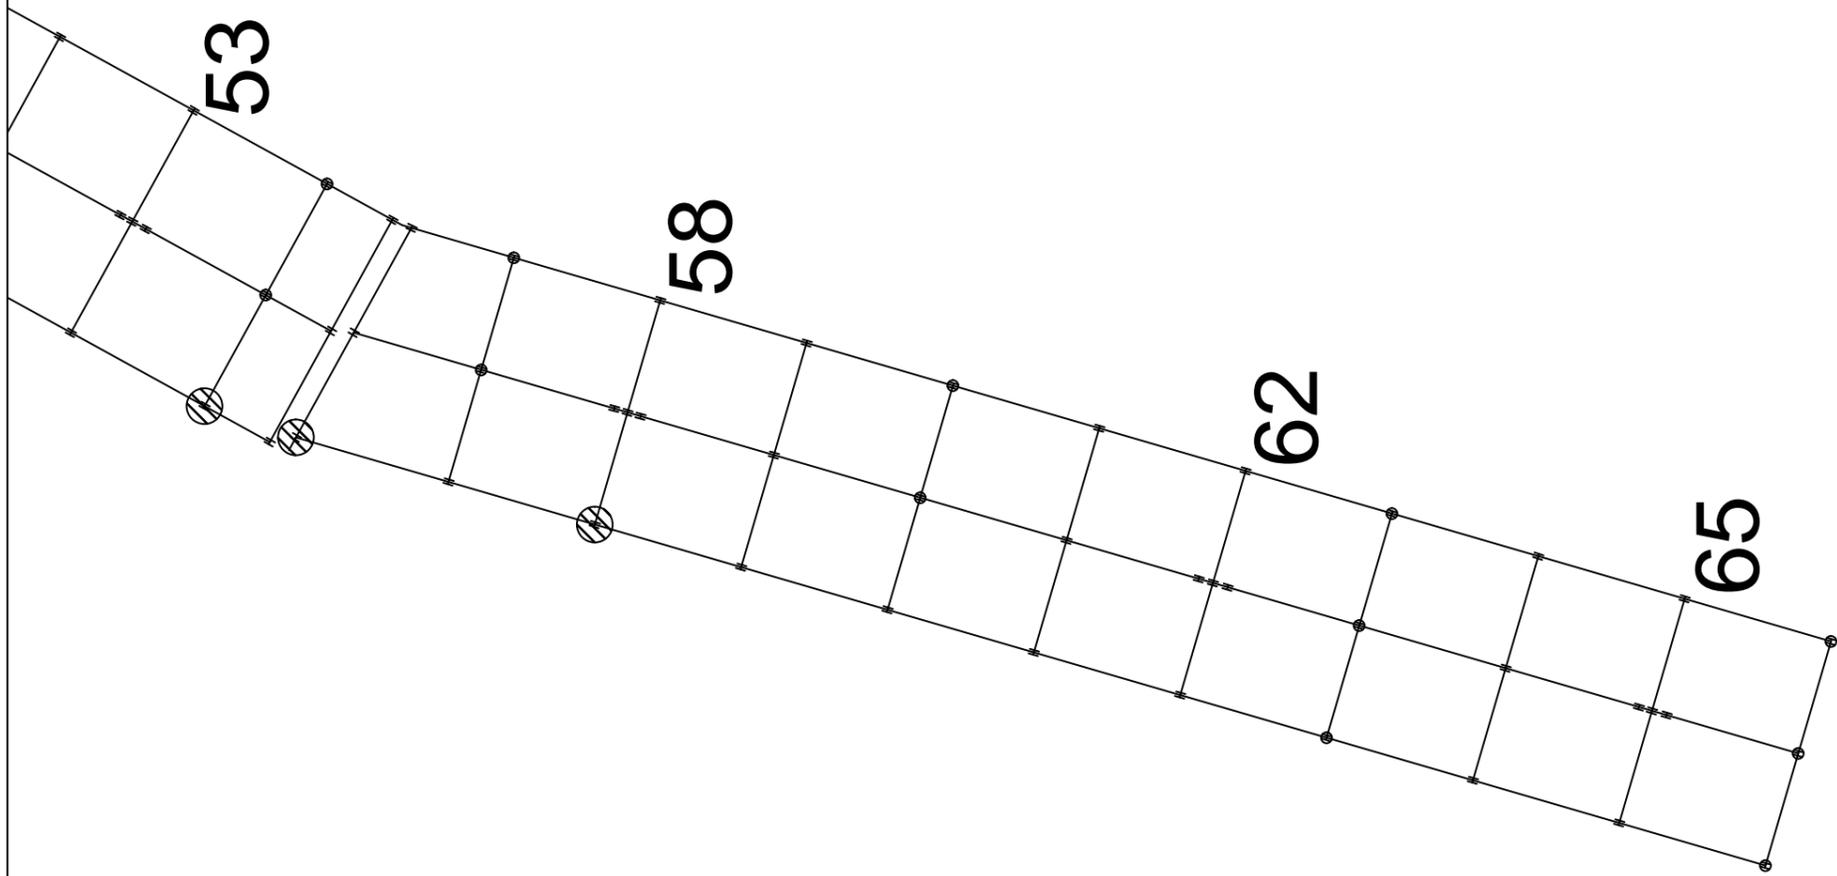
Wharf Inspection
Grand Bank, NL
Bents 53-66

Notes:
1. Enlarged circles are
piles highlight areas of
concern in report.
