GEOTECHNICAL FACTUAL REPORT GRAND BANK, NL

(FFC File: 3087)

June 2016

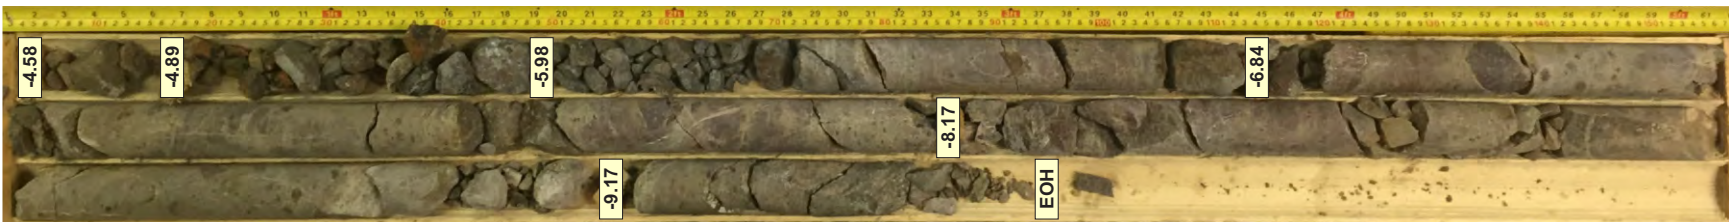
Figure 4.1 Photographs of core recovered during drilling from boreholes BH1, BH2, BH3, and BH4 (elevations shown in m LNT).

Two (2) distinct bedrock types were encountered in the boreholes. At the northern end of the wharf (BH1 to BH5, BH8, and BH21 to BH23) bedrock was a volcanic tuff with Rock Quality Designations (RQDs) ranging from 0% to 84% (average of 21%). At the southern end of the wharf (BH10 to BH20, BH25 to BH28) bedrock was a volcanic flow with RQDs ranging from 0% to 83% (average of 17%). Very fractured bedrock was encountered in boreholes BH10, BH11, BH13, BH20, BH25, BH26, and BH28.

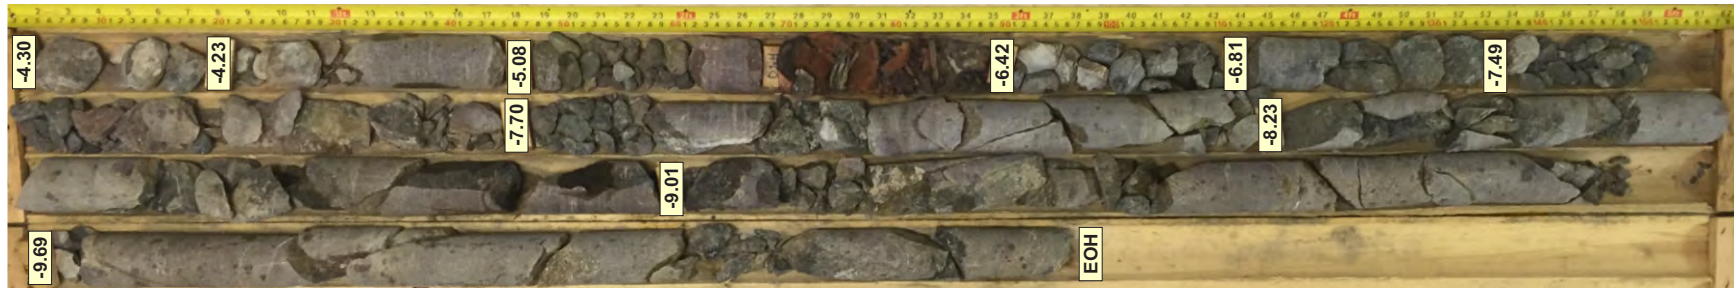
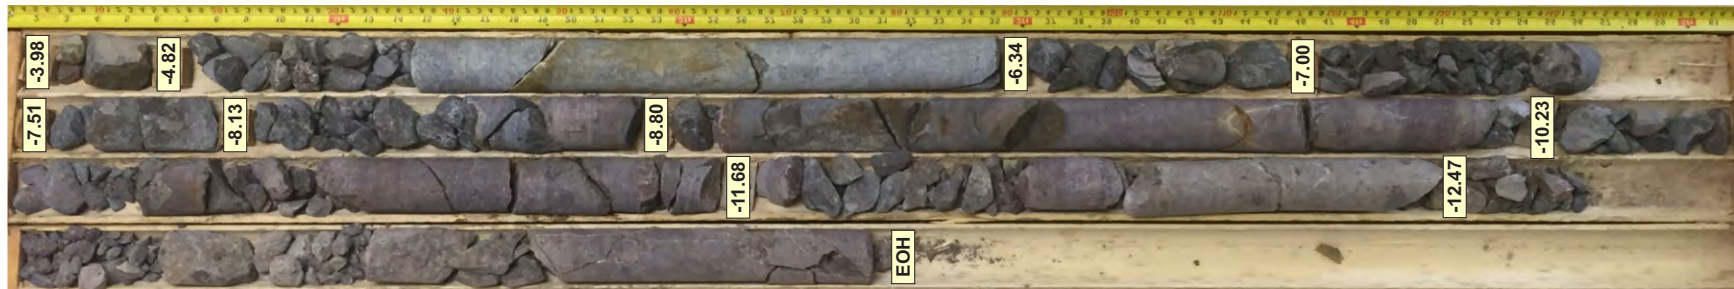
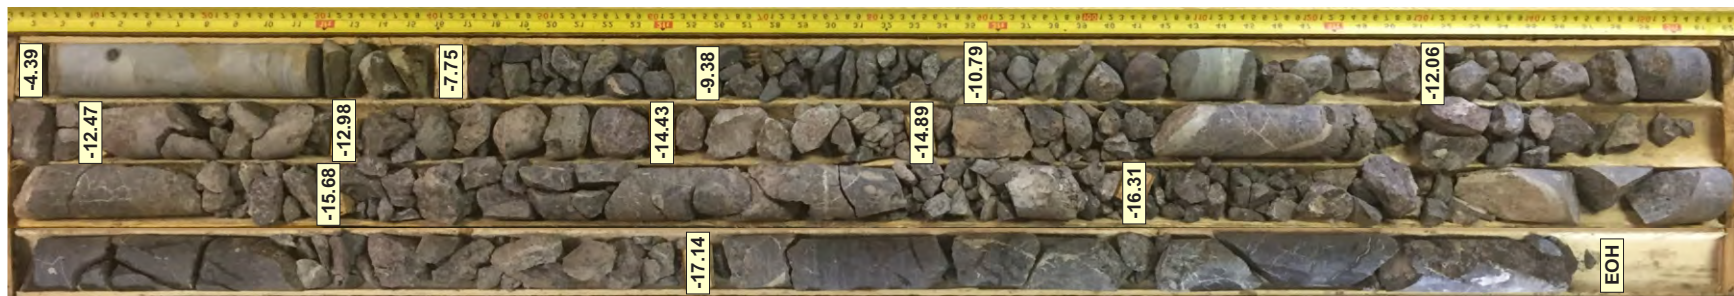
Figure 4.2 Photographs of core recovered during drilling from borehole BH5, BH8, and BH10 (elevations shown in m LNT).

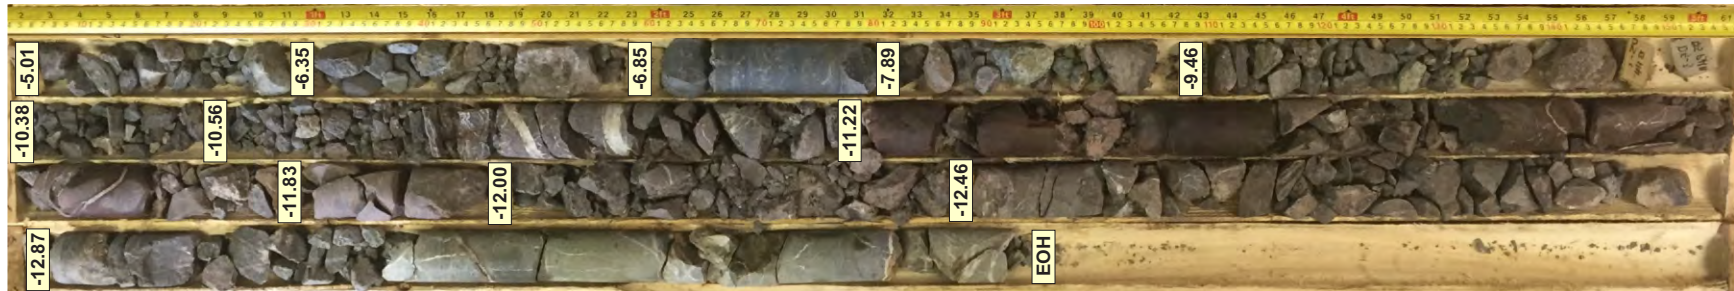
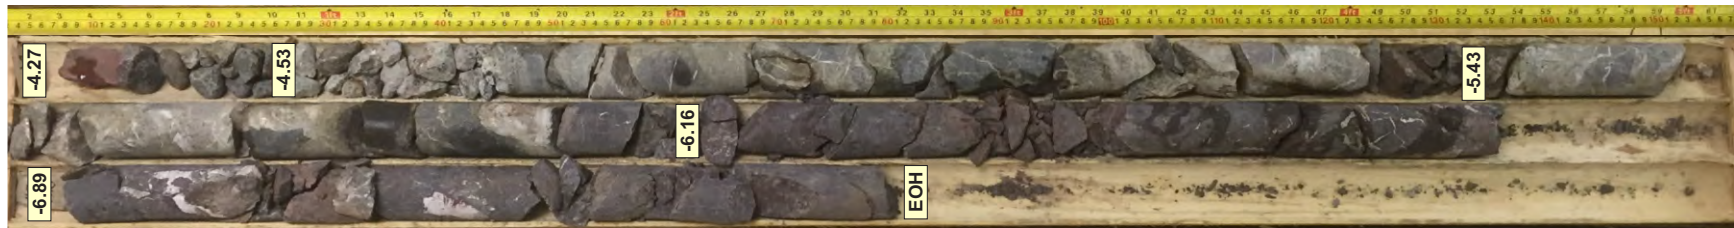
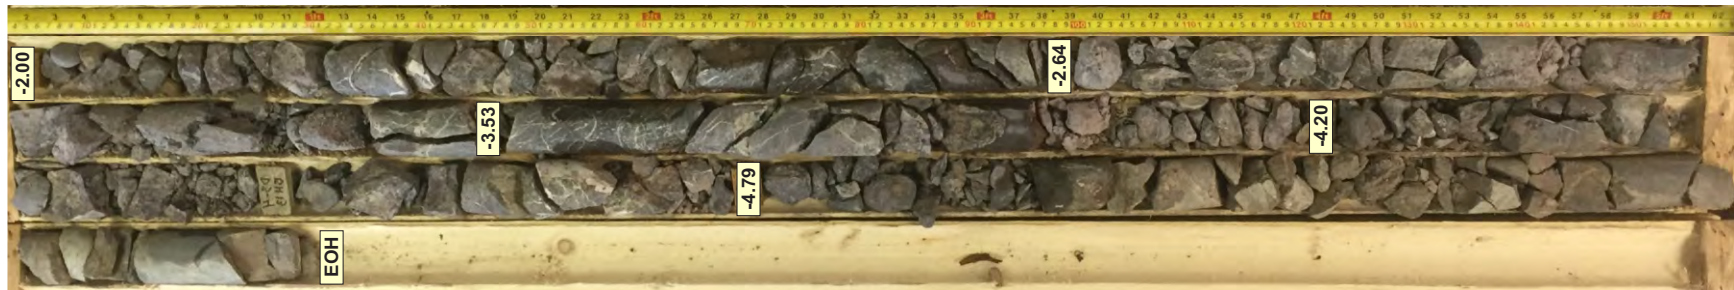
Figure 4.3 Photographs of core recovered during drilling from boreholes BH11, BH12, and BH13 (elevations shown in m LNT).

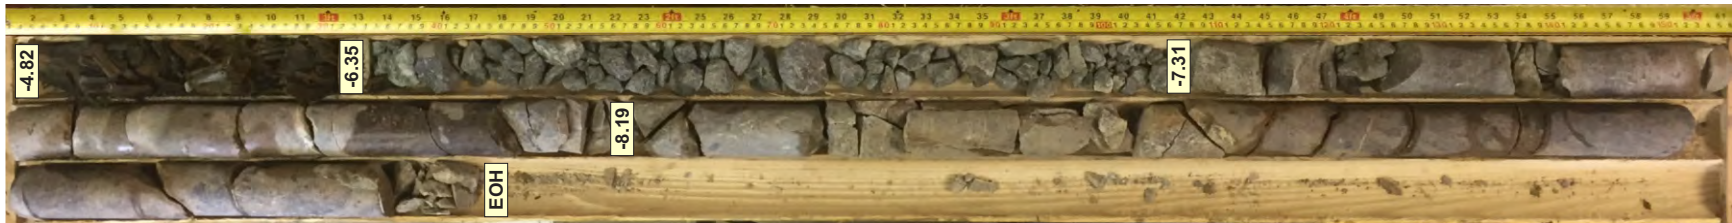
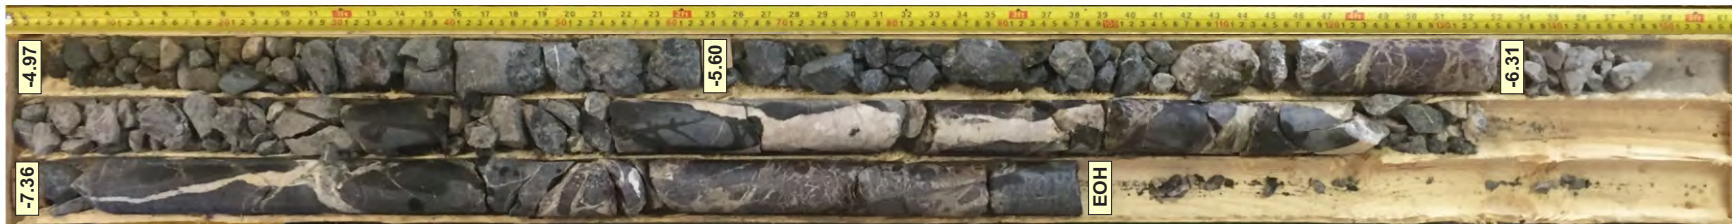
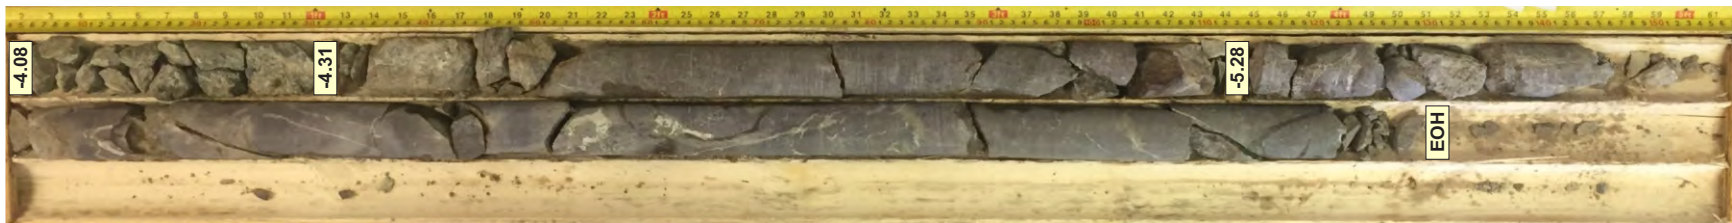
Figure 4.4 Photographs of core recovered during drilling from boreholes BH14, BH15, BH16, and BH17 (elevations shown in m LNT).

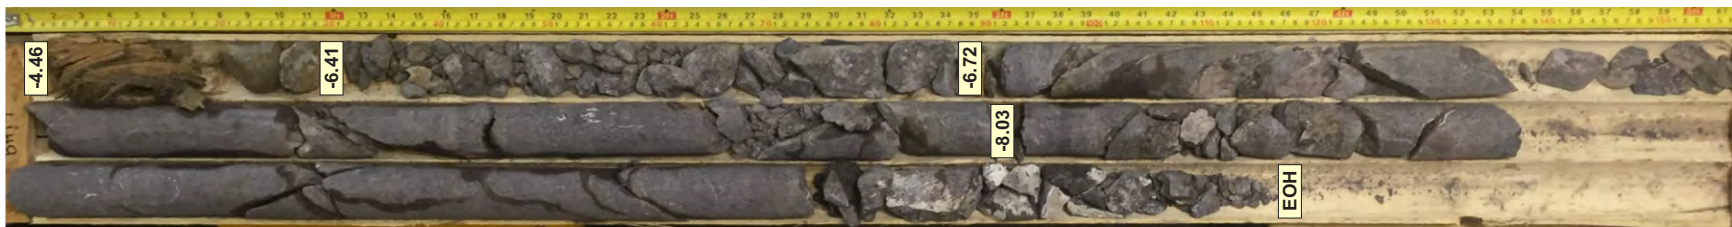
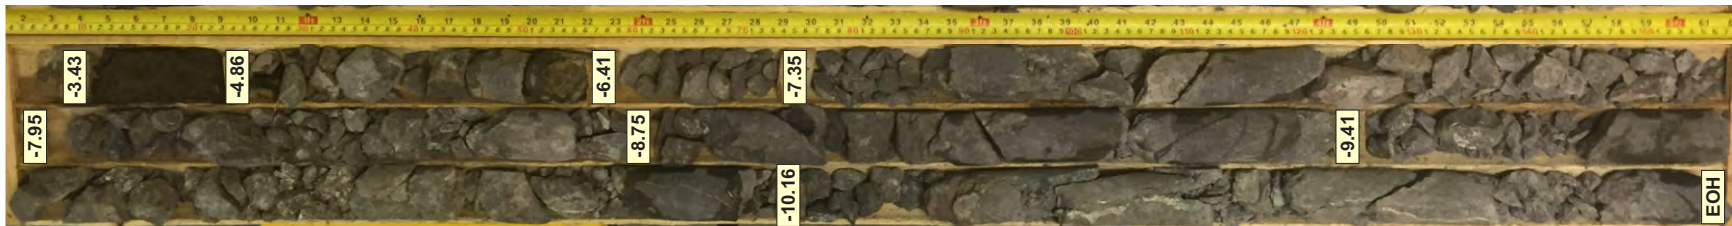
Figure 4.5 Photographs of core recovered during drilling from boreholes BH18, BH19, and BH20 (elevations shown in m LNT).

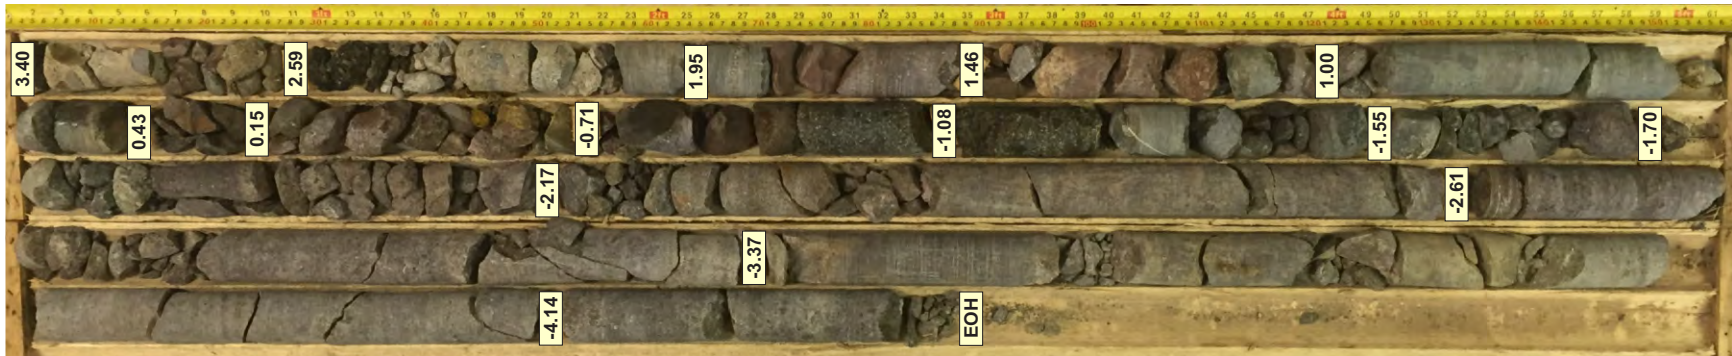
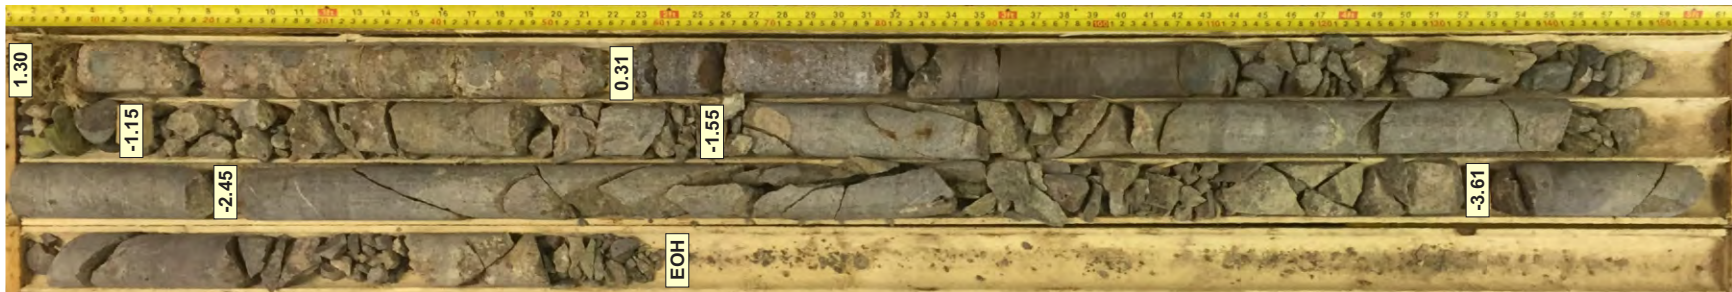
Figure 4.6 Photographs of core recovered during drilling from boreholes BH21, BH22, and BH23 (elevations shown in m LNT).

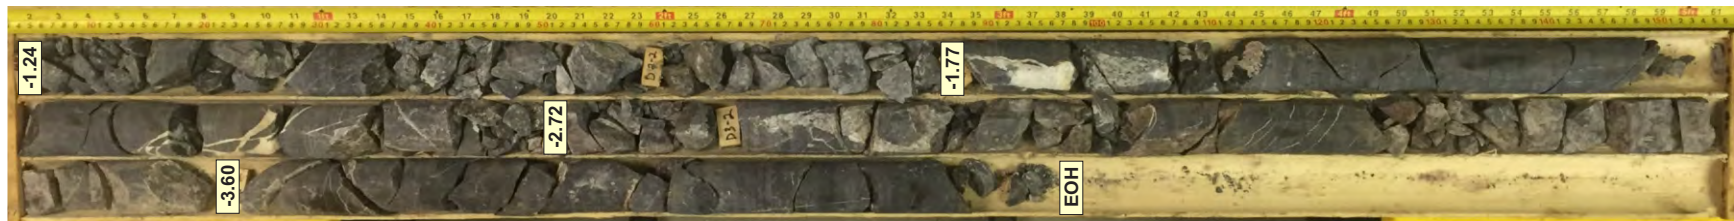
Figure 4.7 Photographs of core recovered during drilling from boreholes BH24, BH25, and BH26 (elevations shown in m LNT).

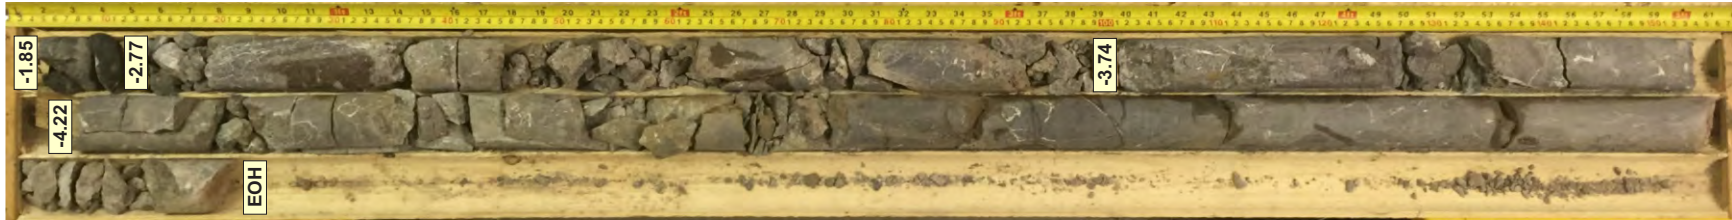
Figure 4.8 Photographs of core recovered during drilling from boreholes BH27 and BH28 (elevations shown in m LNT).

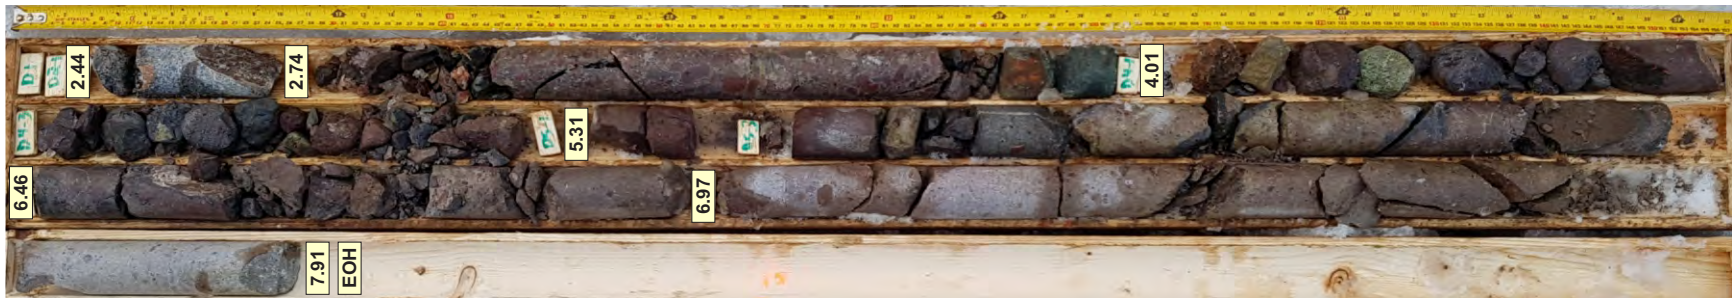
Figure 4.1 Photographs of core recovered during drilling from inclined boreholes INCL4 to INCL7 (depths shown as metres along inclined hole).

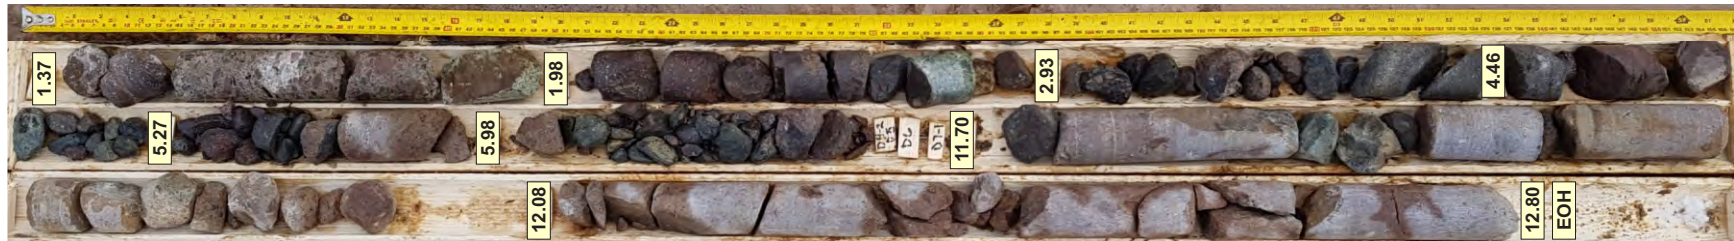
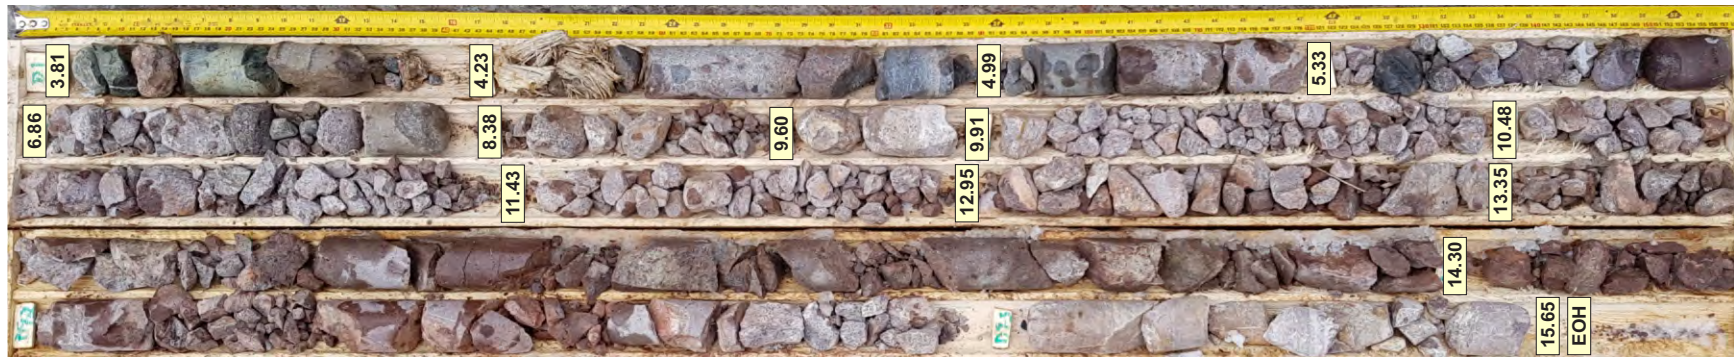
Figure 4.2 Photographs of core recovered during drilling from inclined boreholes INCL8 and INCL9 (depths shown as metres along inclined hole).

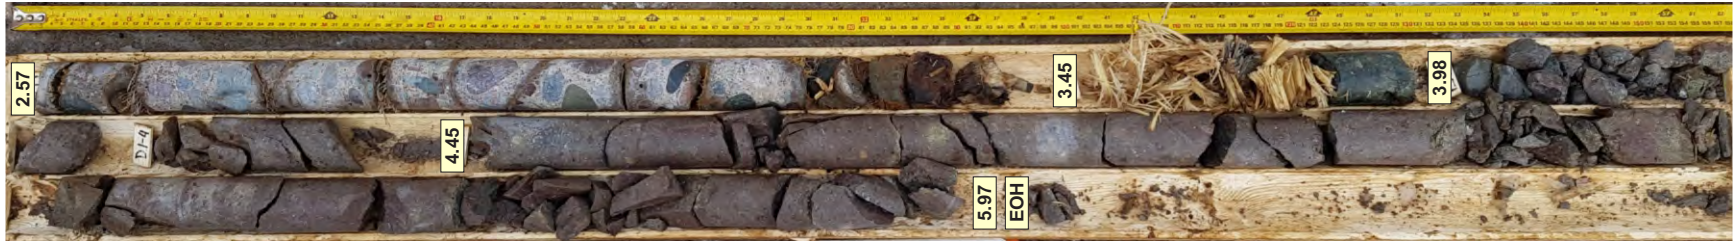
Figure 4.3 Photographs of core recovered during drilling from inclined boreholes INCL10 and INCL11 (depths shown as metres along inclined hole).
