**PEC Site Road Routing and
Health & Safety Features**

Remedial Excavations

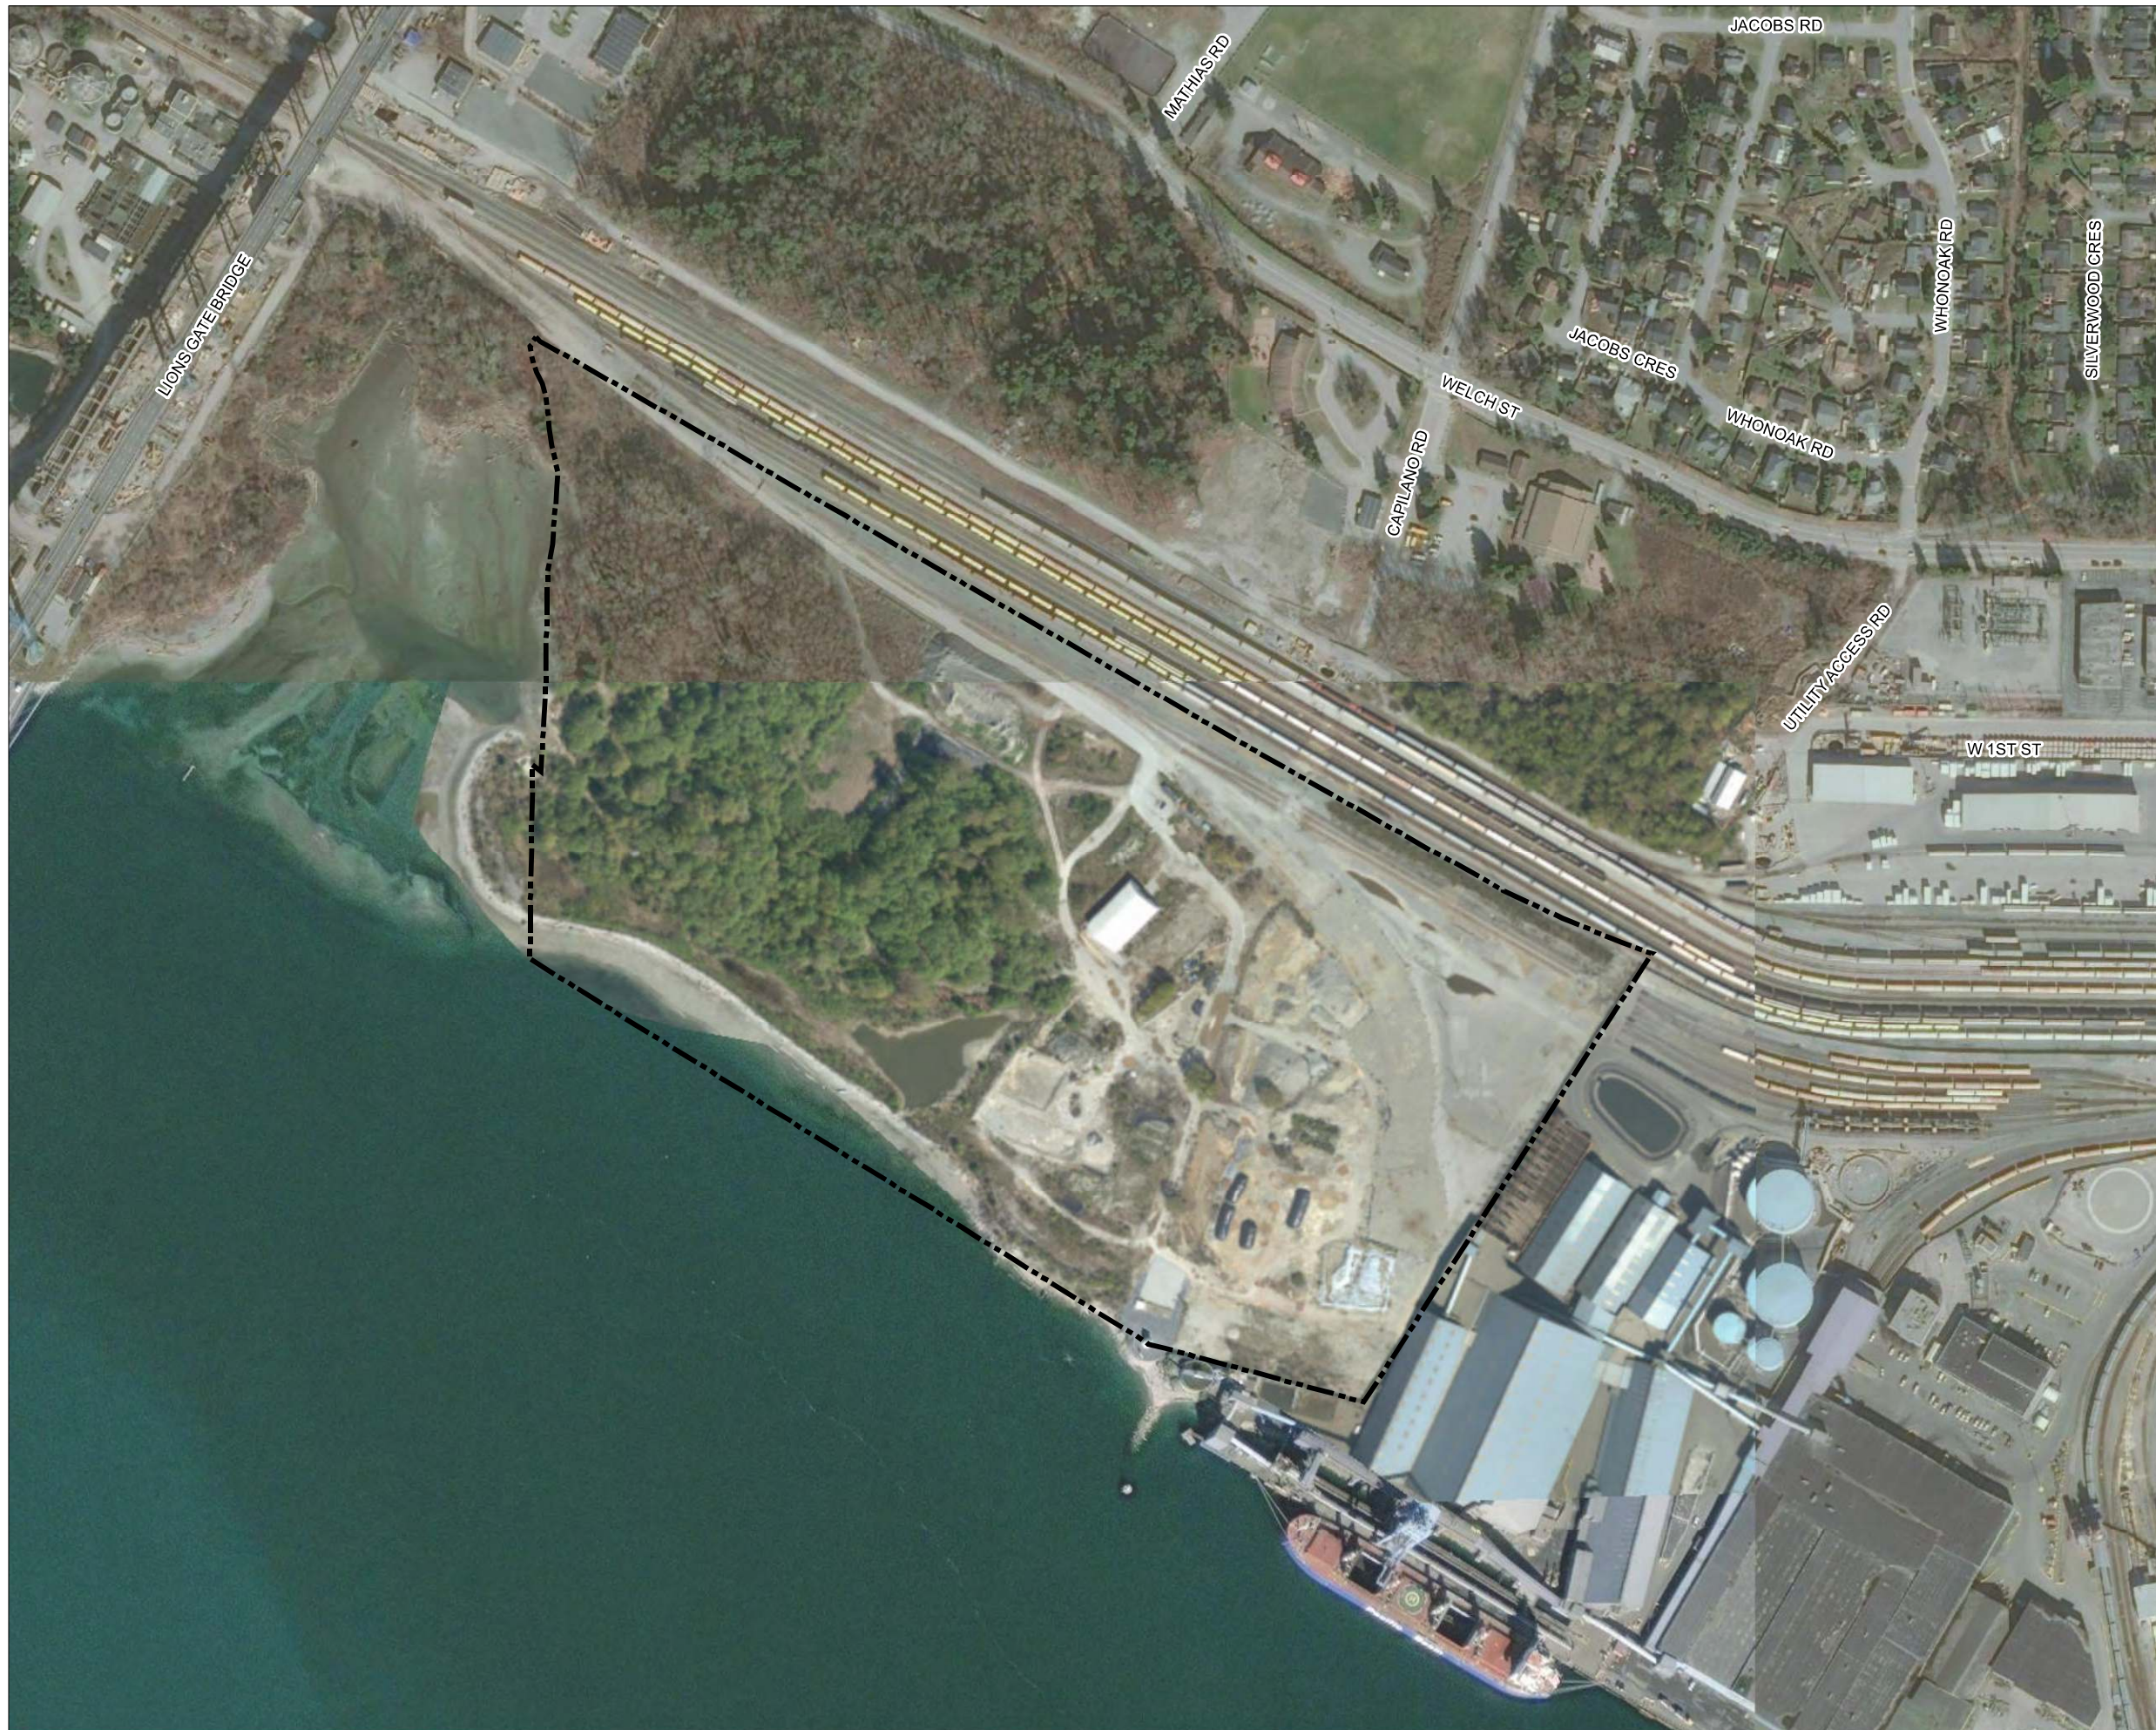
Site Location

Site Boundary

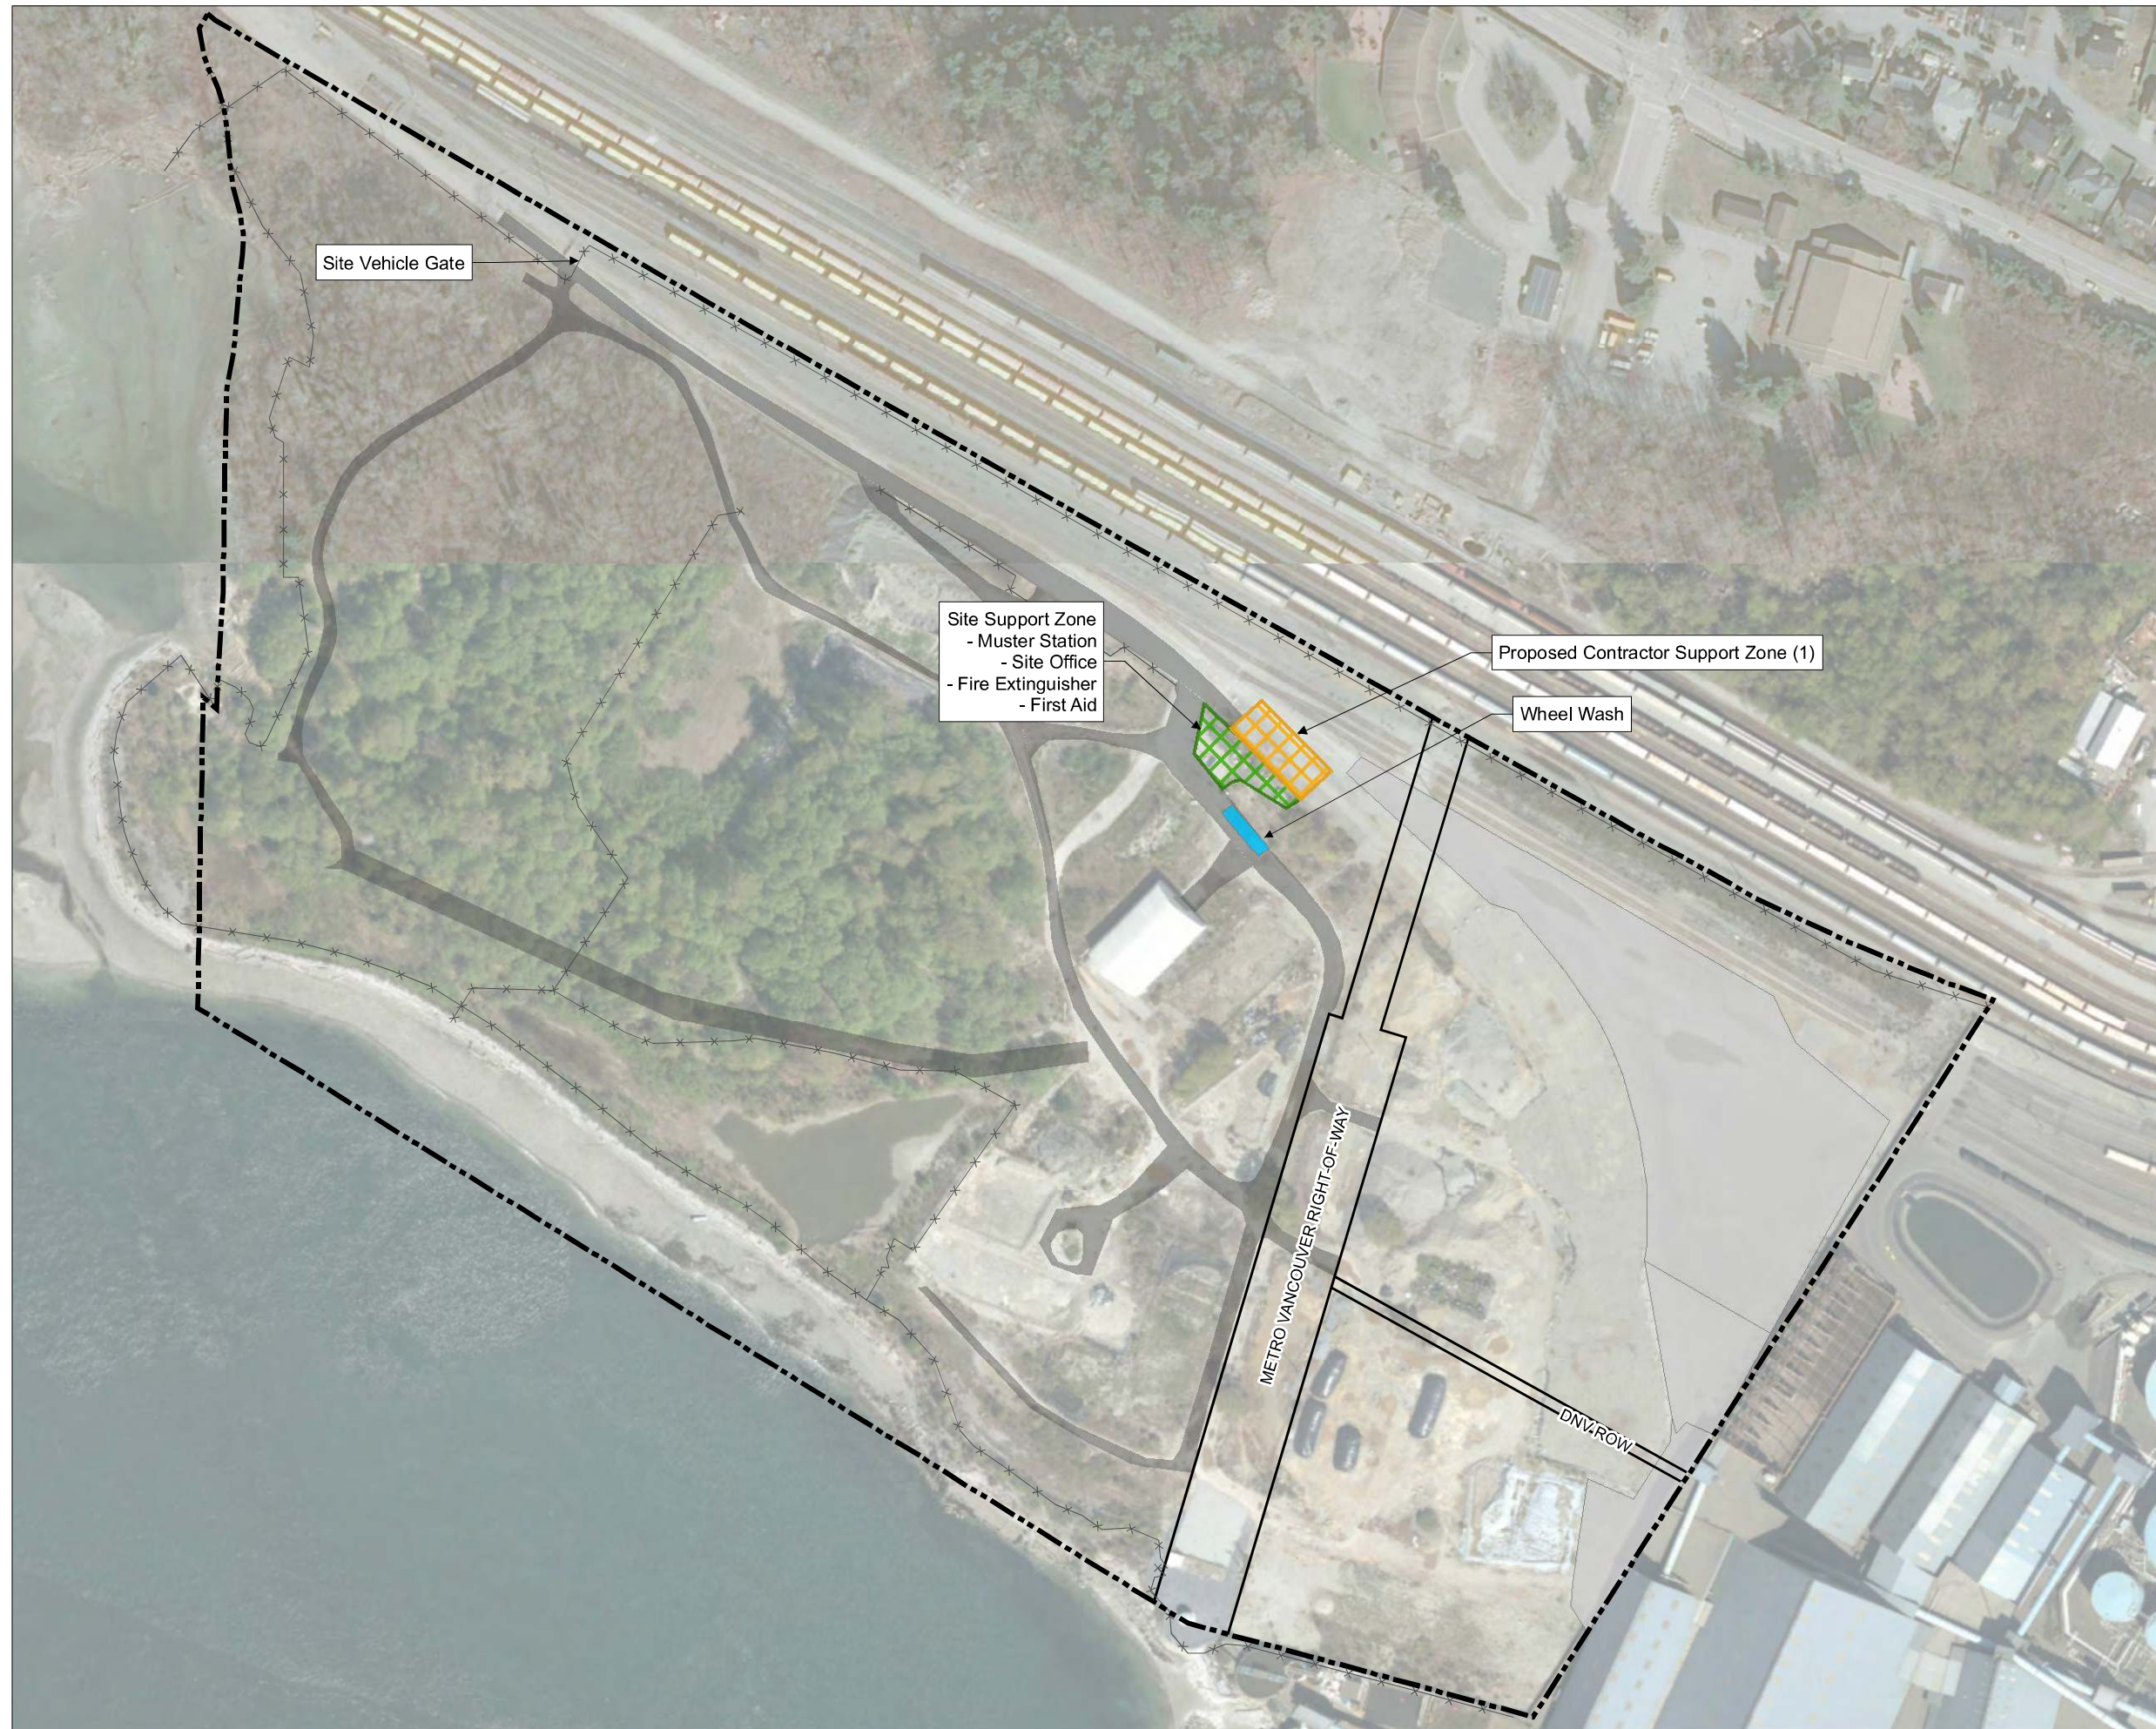
- ××× Fence
- Site Boundary
- Proposed Contractor Support Zone
- Site Support Zone
- Paved Area
- Wheel Wash
- Access Road

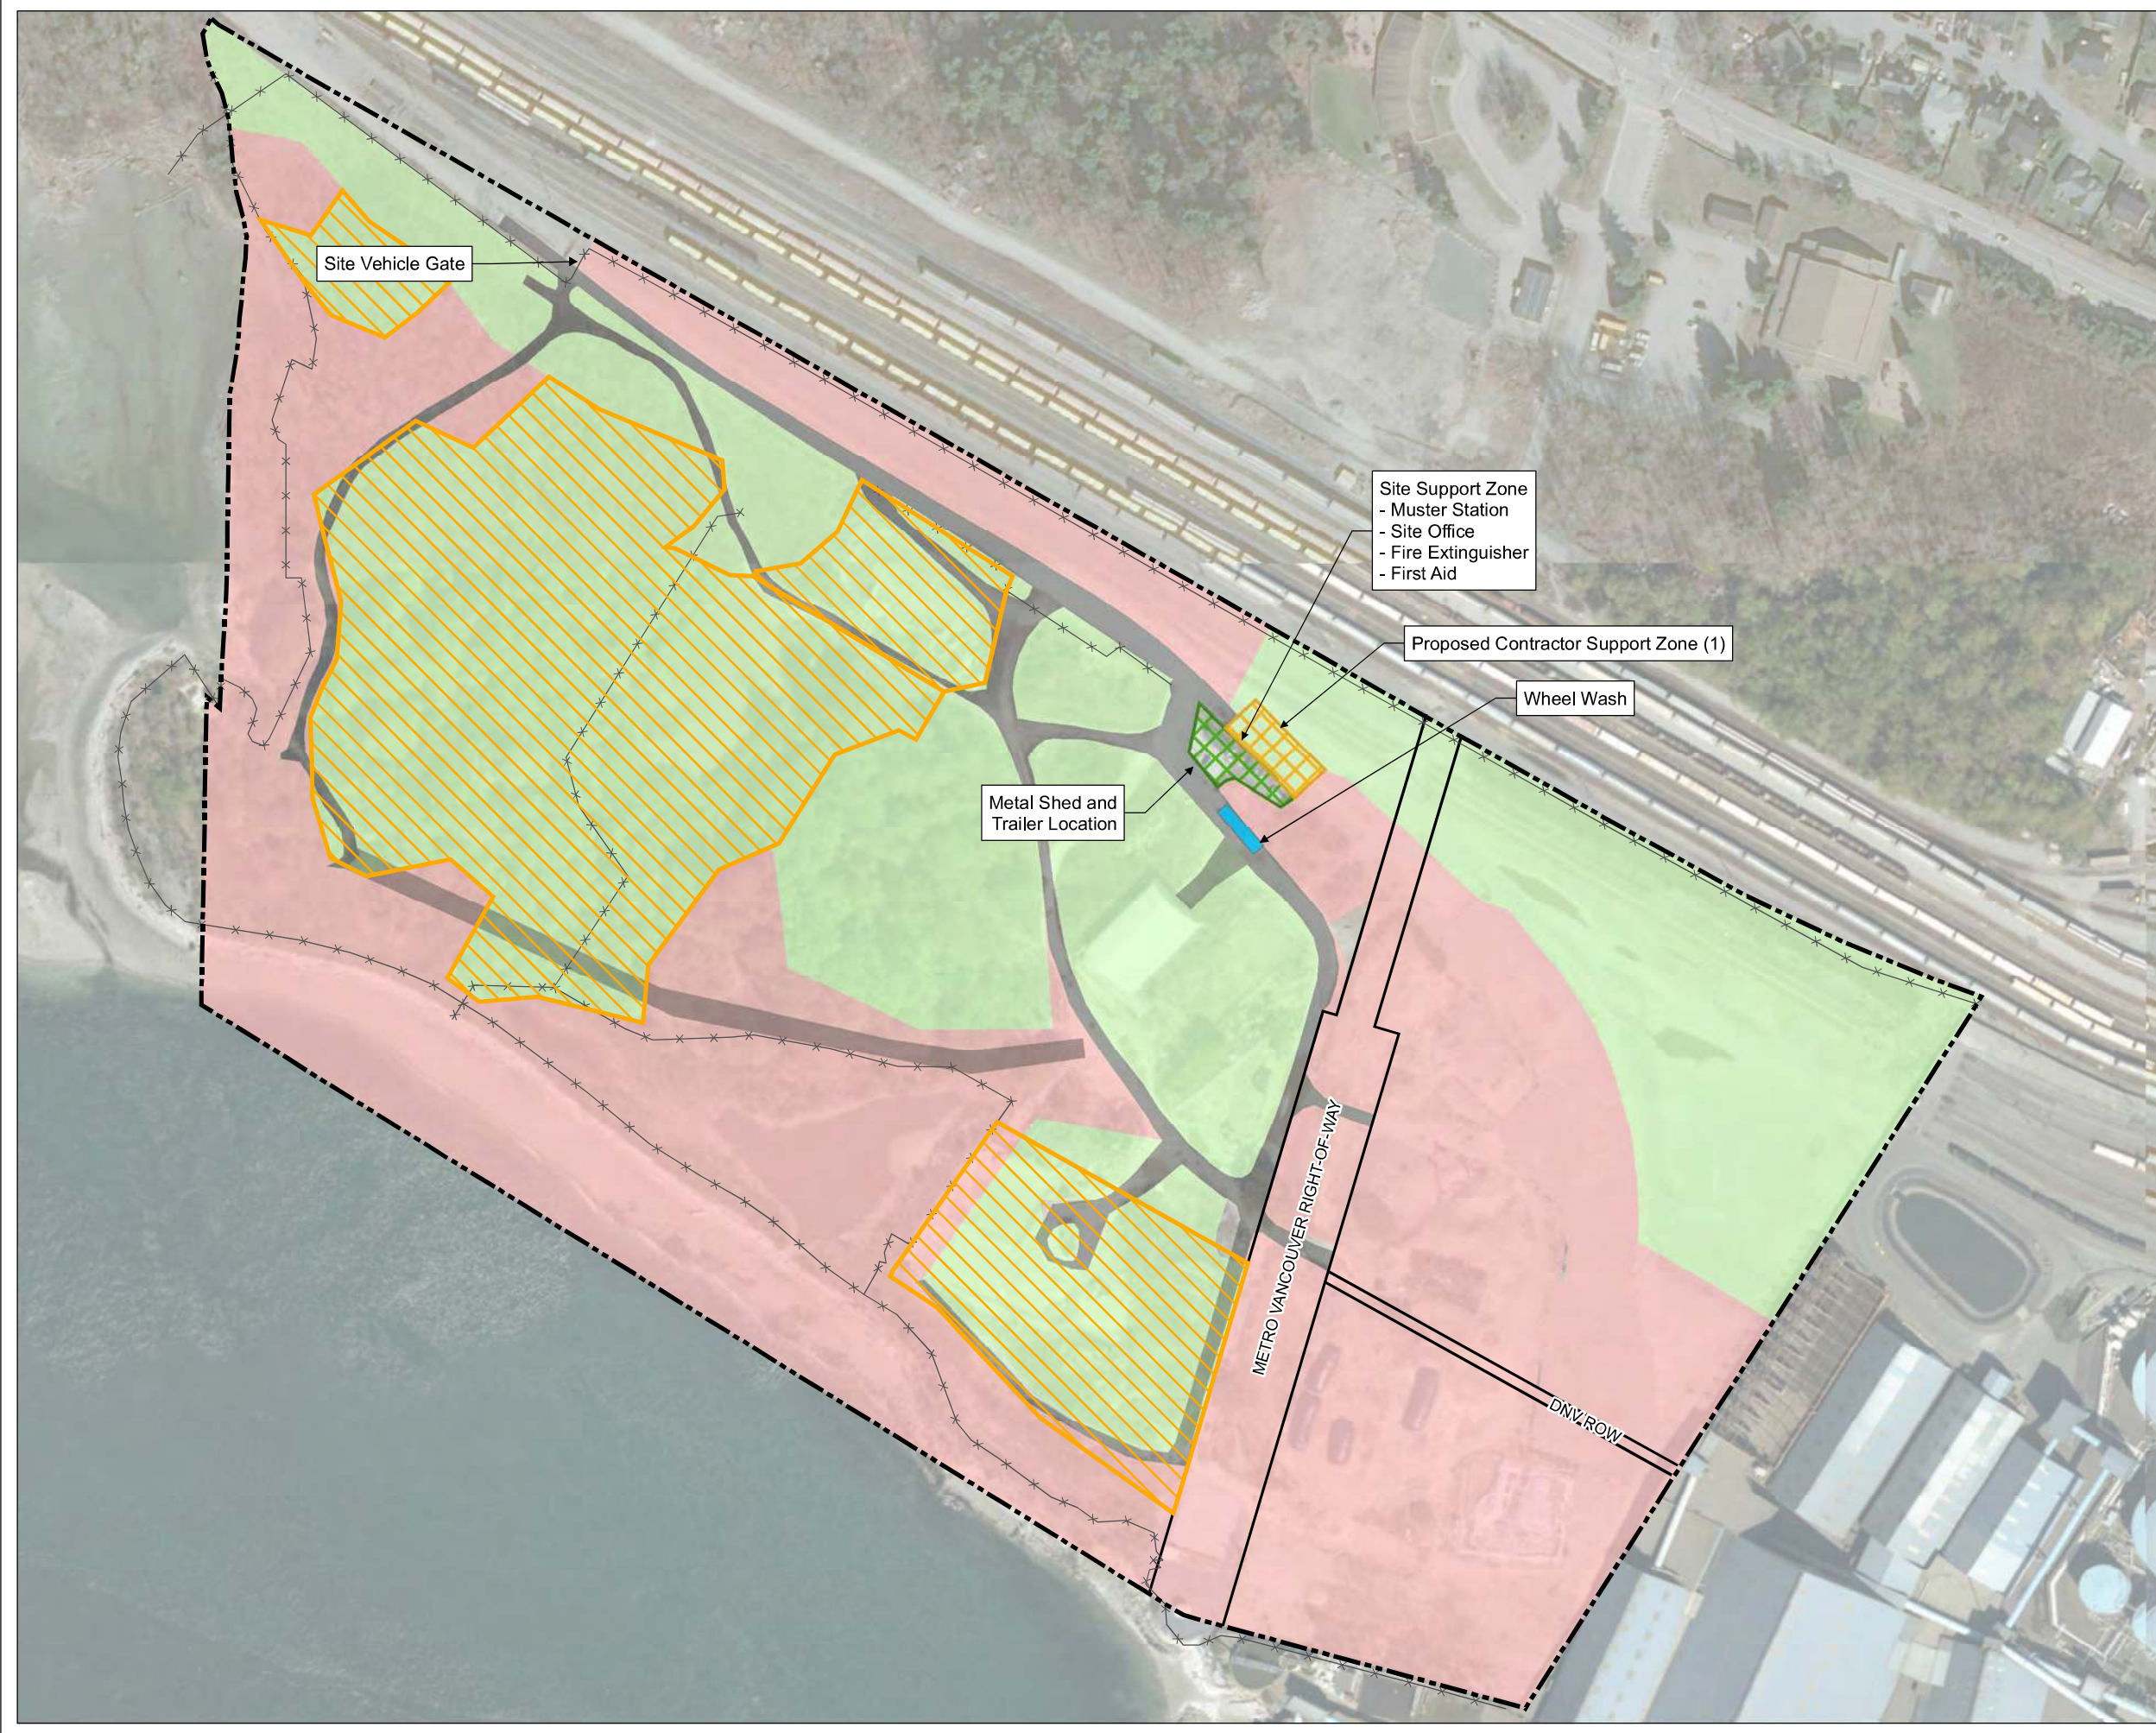
Site Control Zones

- ✕ Fence
- ⬛ Site Boundary
- ▨ FY21/22 Proposed Remediation Area
- Work Exclusion Zone
- Work Zone
- ▨ Proposed Contractor Support Zone
- ▨ Site Support Zone
- Wheel Wash
- Access Road

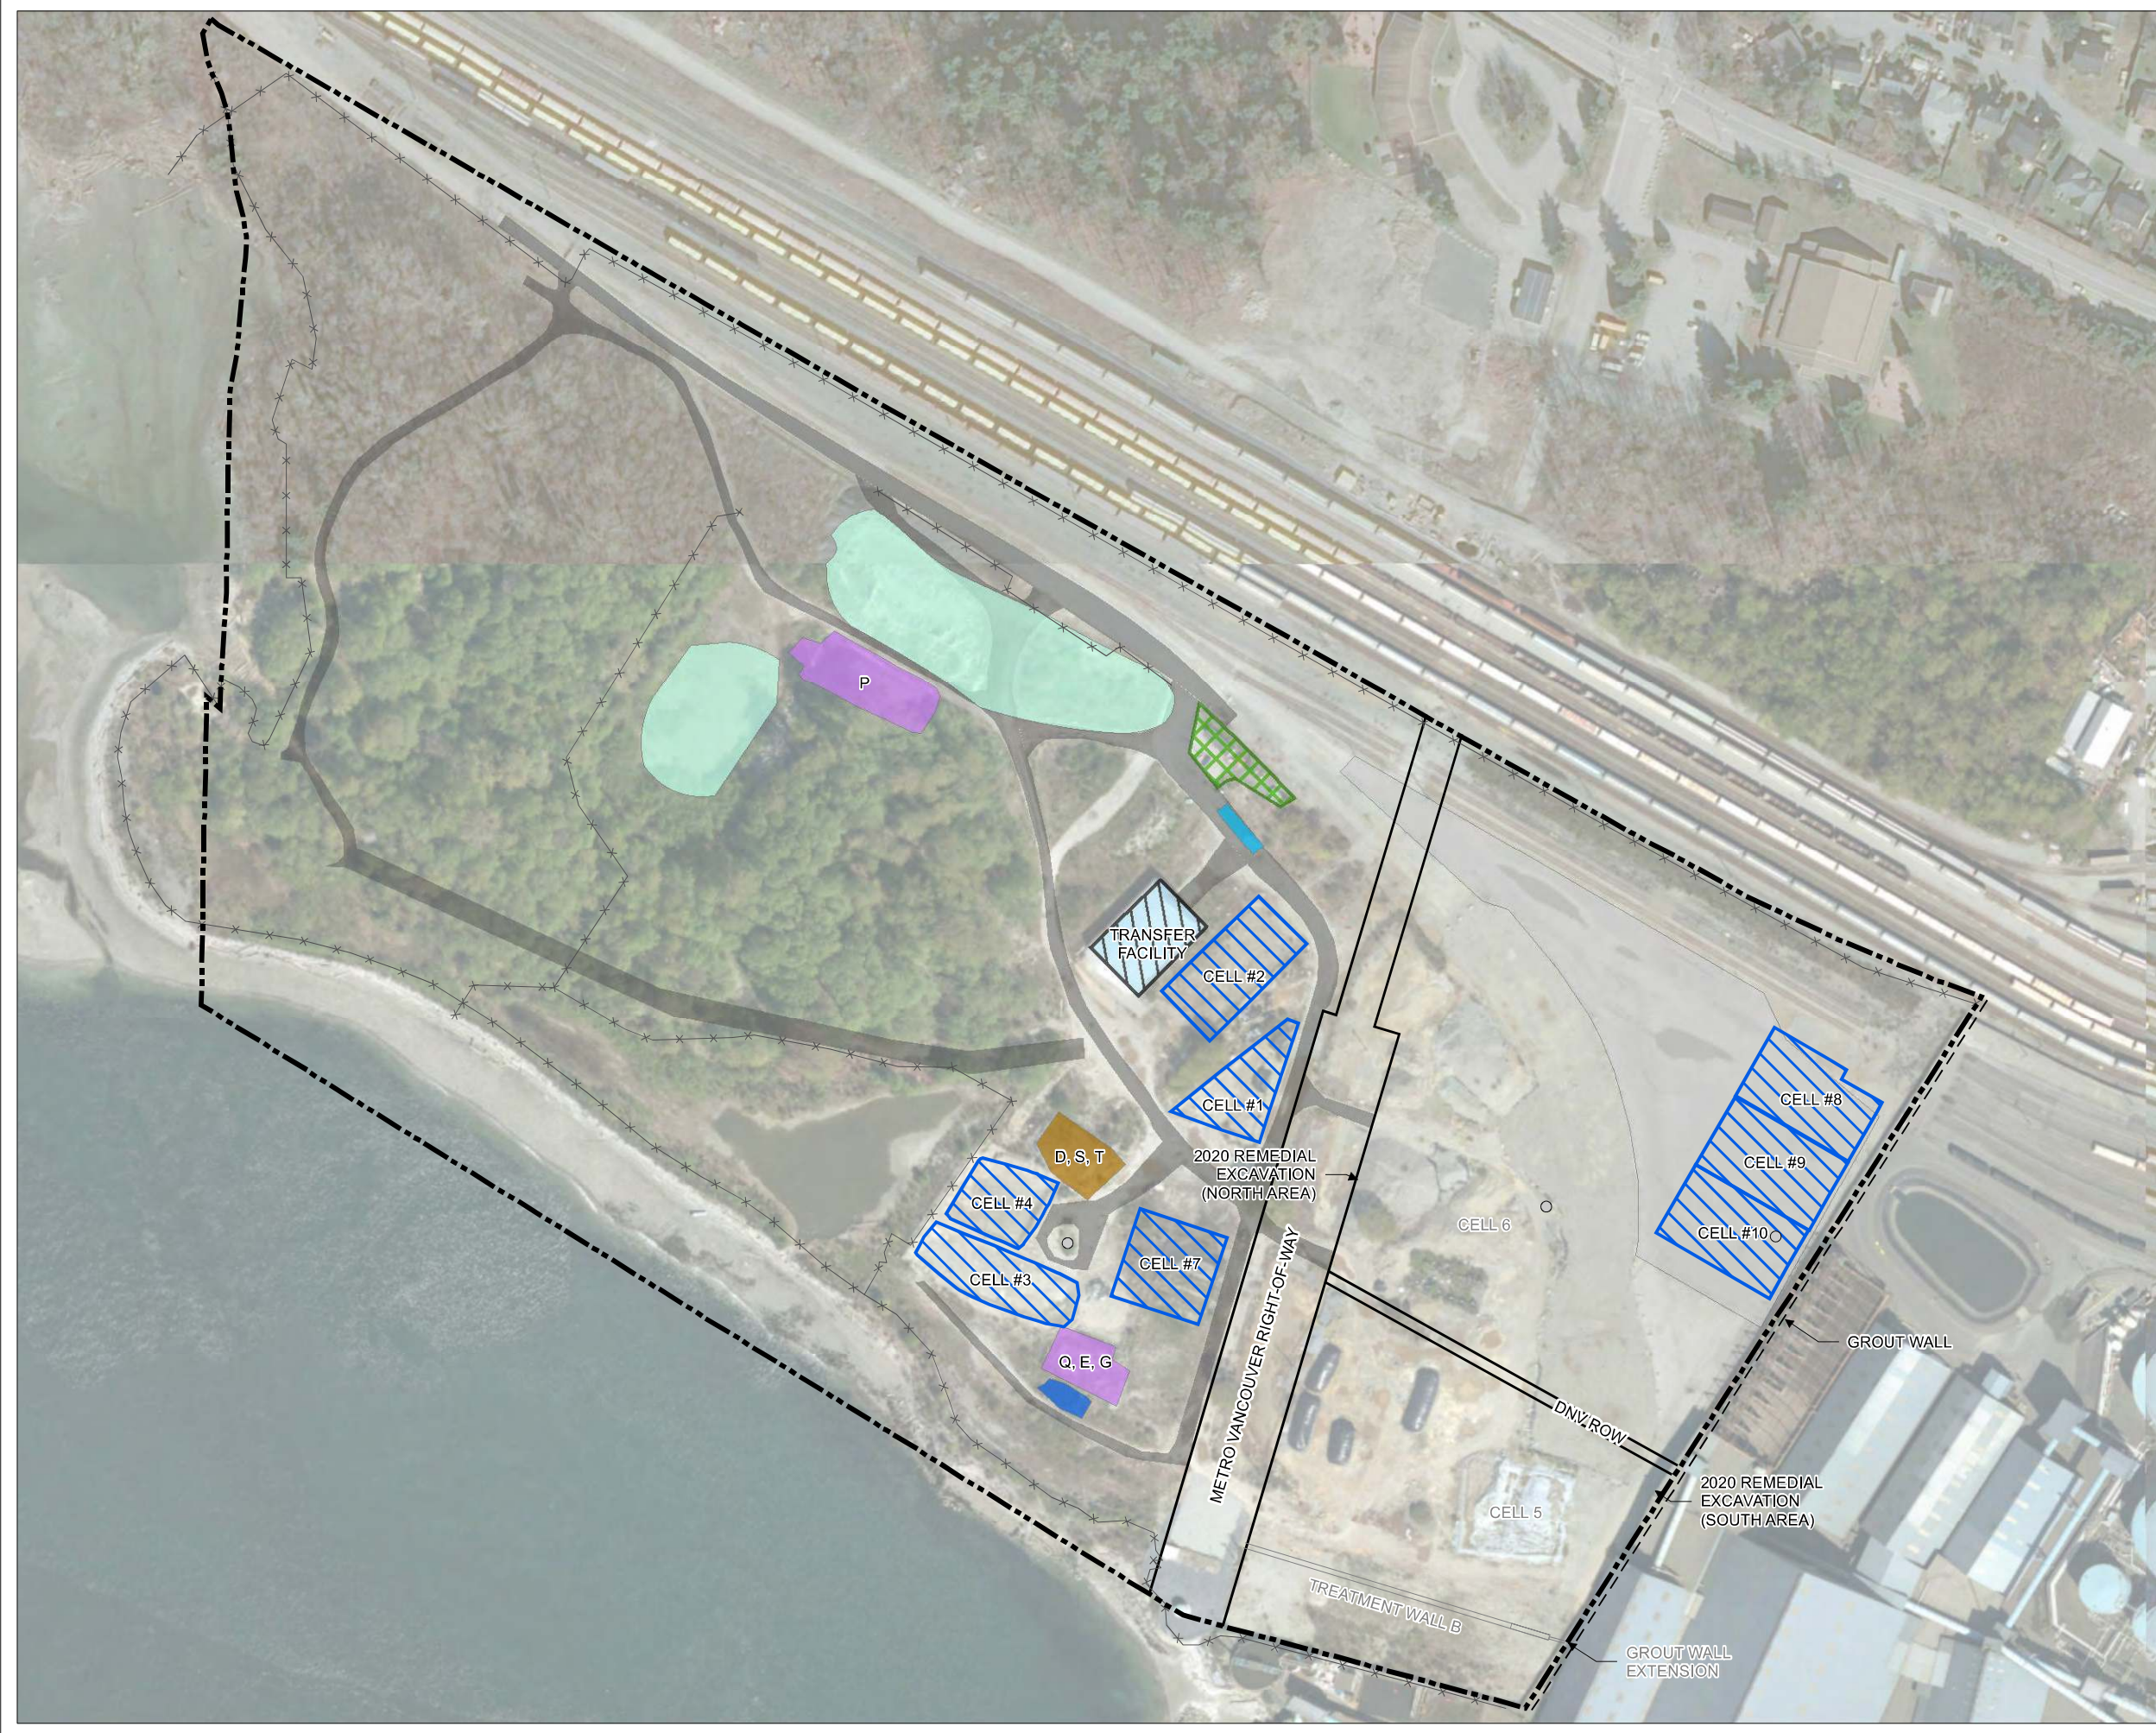
Site Plan

- Dismantled Utility Pole
- ××× Fence
- Grout Wall
- Treatment Wall B and Grout Wall Extension
- ▭ Site Boundary
- ▨ Soil Storage Cell
- ▨ Transfer Facility
- ▨ Site Support Zone
- Wheel Wash
- Water Holding Cell
- Existing Owner Supplied Backfill
- Gravel and Cobble Stockpile
- Metals Contaminated Soil Stockpile
- Access Road
- Paved Area

3. All measurements displayed on the figure are approximate and are to be verified in the field.
4. Where the Heede Crane Option Work Excavation Area overlaps the DNV ROW the upper 1 m of soil was excavated (and subsequently backfilled) over top of the DNV water line, with the water line and surrounding soil still in place below. Where the 2020 Remedial Excavation Area overlaps the DNV ROW, excavation (and subsequent backfilling) occurred to the groundwater table at approximately 3.5 m below ground, and the deactivated water line was cut and removed from the ground.
