Addendum No.1

Description: F521A-210346/A CCG Base Buoy Maintenance Building HVAC

**BULK MATERIAL SAMPLING AND ANALYSIS
FOR ASBESTOS, BUOY MAINTENANCE
BUILDING, CCG BASE VICTORIA, BC.**

FISHERIES AND OCEANS CANADA
PROJECT NO. 181-06946-00
MAY 2018

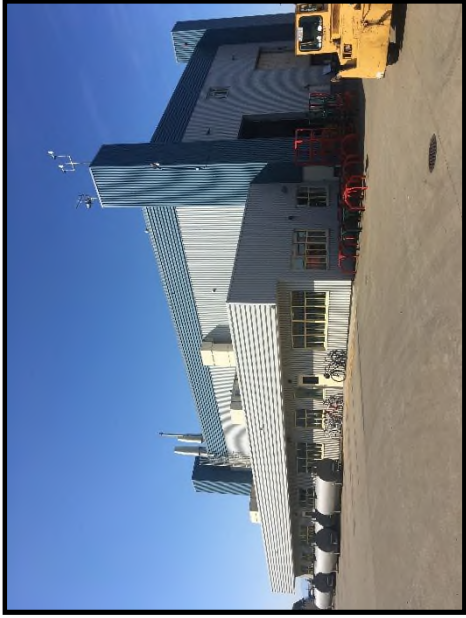
North Wall West End Penetration Grey Concrete Parging Sample 18A-Corr1206-01 was 'None Detected' for asbestos.

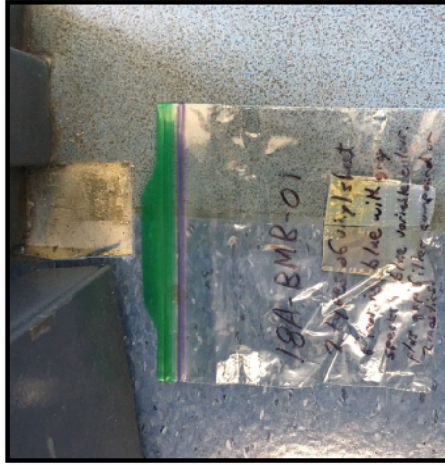
Enviro. Crew Workshop & Corridor Vinyl Sheet Flooring Materials. Blue with Grey Specks with Mastic (right); Blue Variable Shades with Mastic (left); and Gap Filler. Sample 18A-BMB-01 layers were 'None Detected' for asbestos.

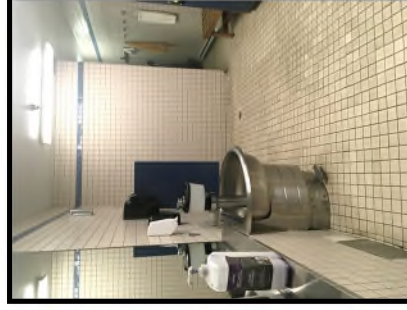
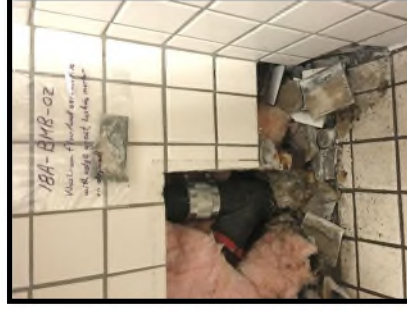
Locker Room Floor & Wall Tiling Materials 3" Ceramic Tile; Edging Grout; and Backing Mortar Sample 18A-BMB-02 layers were 'None Detected' for asbestos.

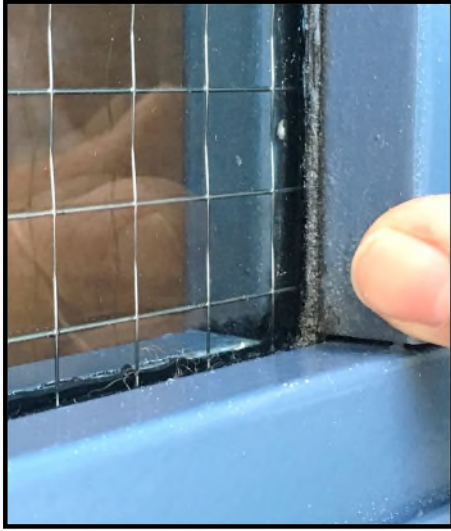
Reinforced Glazing Interior Windows in Steel Framing
Black Mastic

Sample 18A-BMB-03 was 'None Detected' for asbestos.

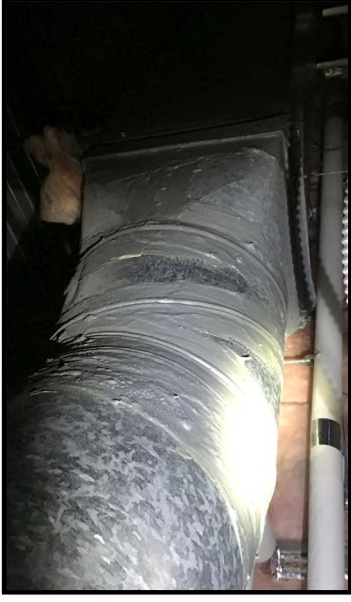
Locker Room Ceiling Plenum Ducting
Grey Mastic

Sample 18A-BMB-04 was 'None Detected' for asbestos.

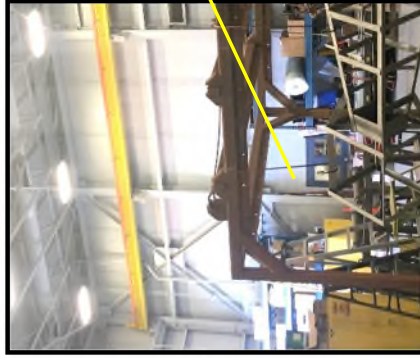
General Body Maintenance Wall Drywall Over
Entrance to Paint Shop Office

Drywall Joint Compound Sample 18A-BMB-11 was
'None Detected' for asbestos.

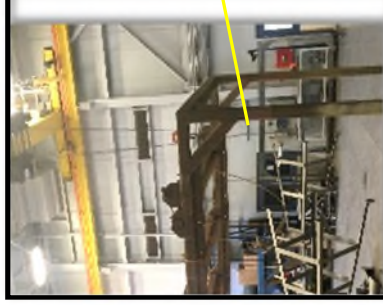
General Body Maintenance Wall Drywall Over
Entrance to Paint Shop Office

Drywall Joint Compound Sample 18A-BMB-10 was
'None Detected' for asbestos.

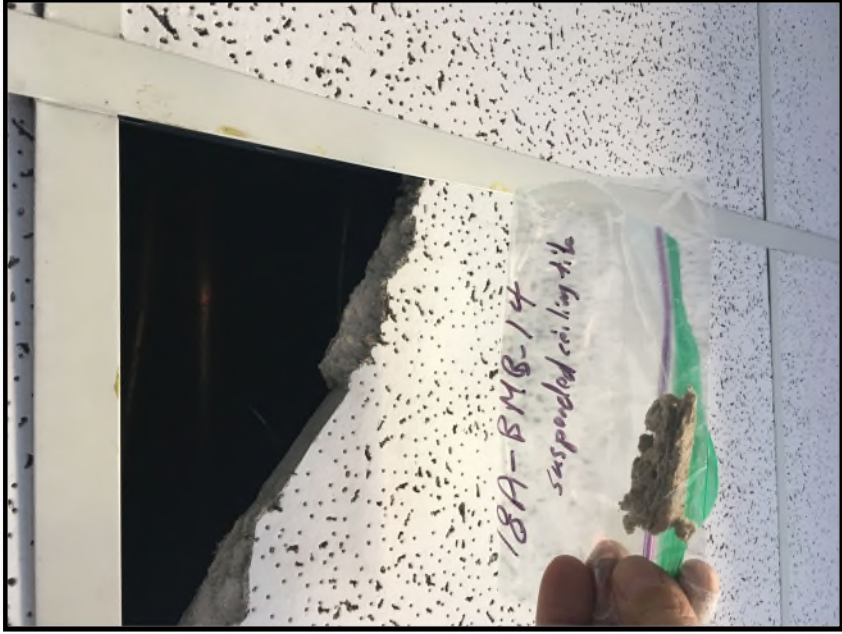
Corridor Ceiling, Suspended Ceiling Tile Sample 18A-BMB-14 was 'None Detected' for asbestos.
