Date
October 14, 2021

Project #
60608868

**Subject: Kwet̓iṭṭaà (Rayrock) Remediation Project
2021 Field Investigation Summary – Mill Lake Water and Sediment Thickness Measurements**

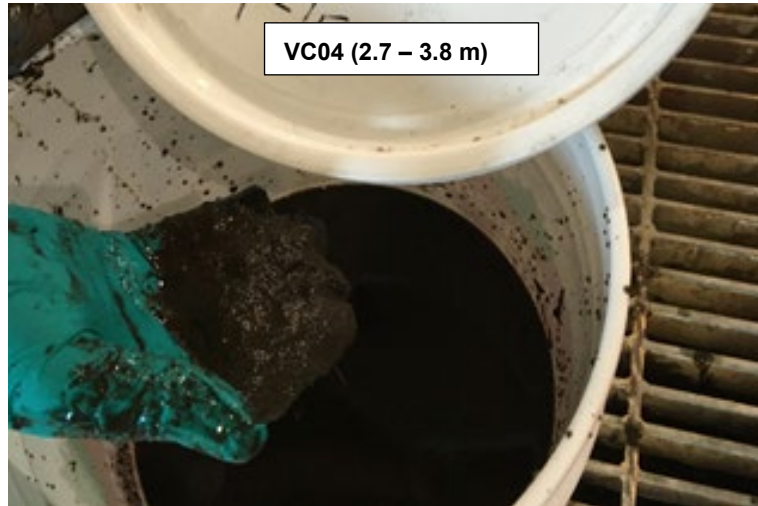
Loose Organic Sediment

- Average Thickness of 1.3 m
- These dark brown hydrous organic sediments had a very soft “oozing” quality and a very high water content. The material was not cohesive.

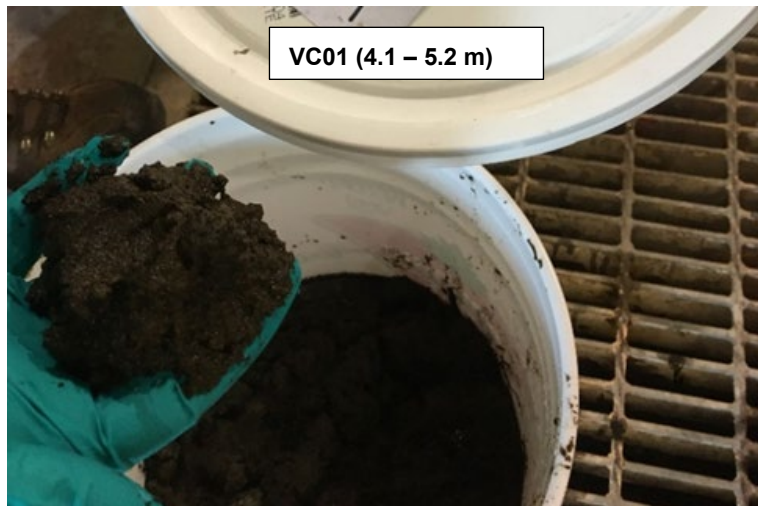
Consolidated Organic Sediment

- Average Thickness of 1.4 m
- Generally, the same material as above, but with a gradual increase with depth in compactness and competence.

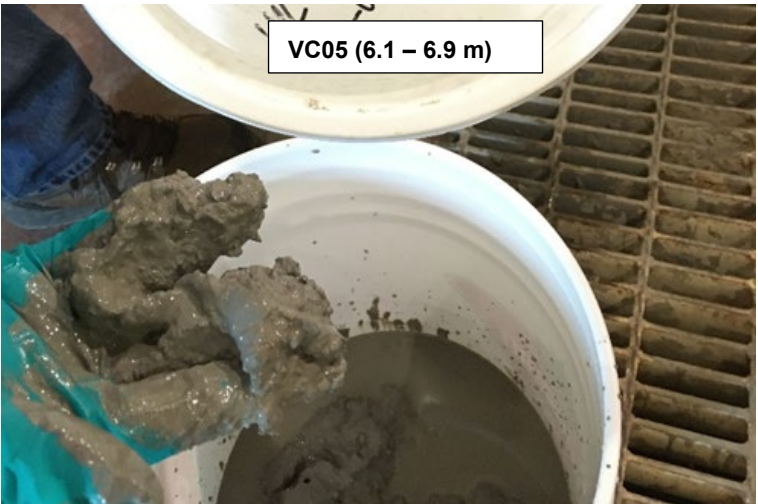
Clay

- Grey, medium stiff-to-stiff lacustrine clay, some silt, trace gravel.

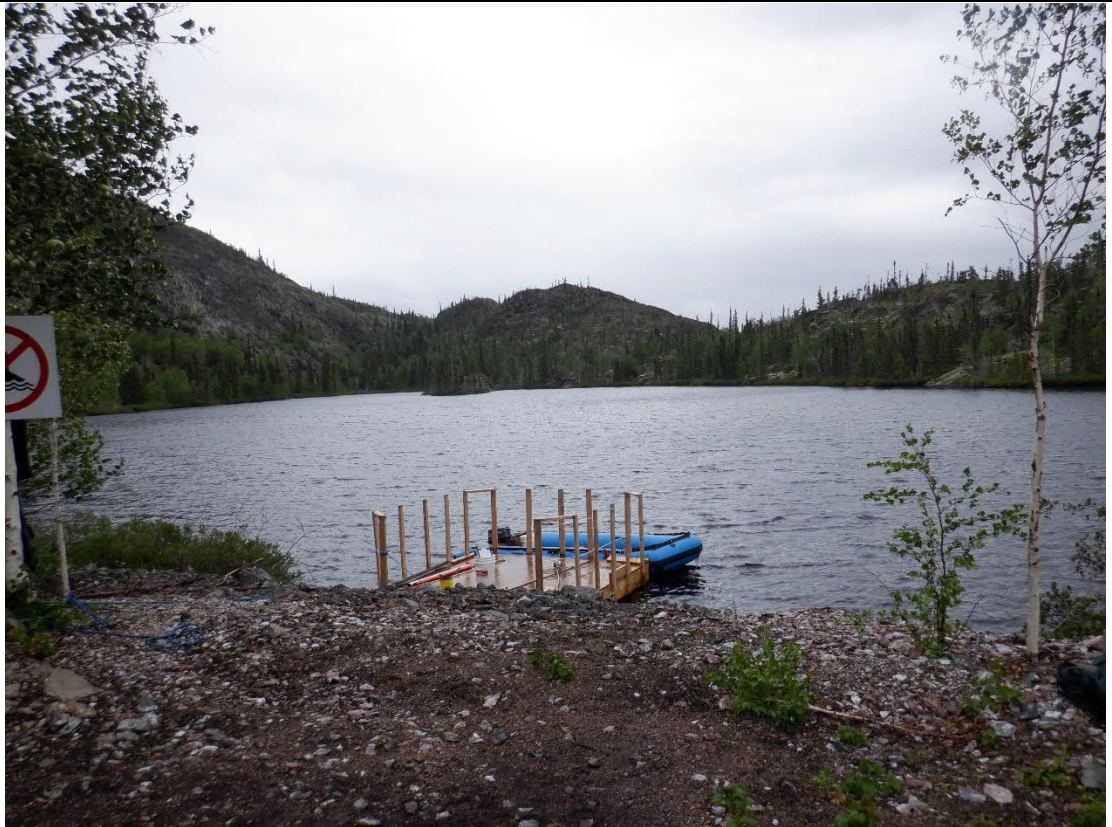
Photo No. 1	Date 7/15/2021
Direction Photo Taken Northwest	
Description Zodiac boat and barge on Mill Lake.

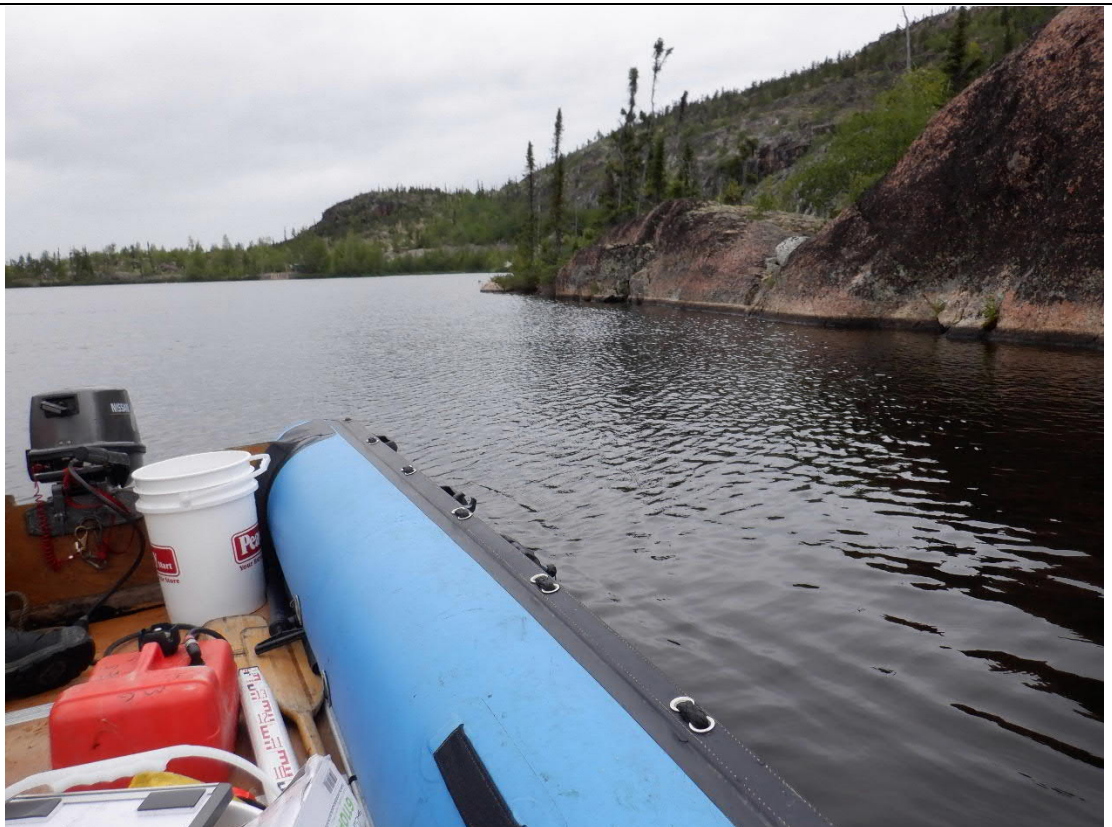
Photo No. 2	Date 7/15/2021
Direction Photo Taken West	
Description Travelling across Mill Lake to measure sediment thickness at the lake bottom.

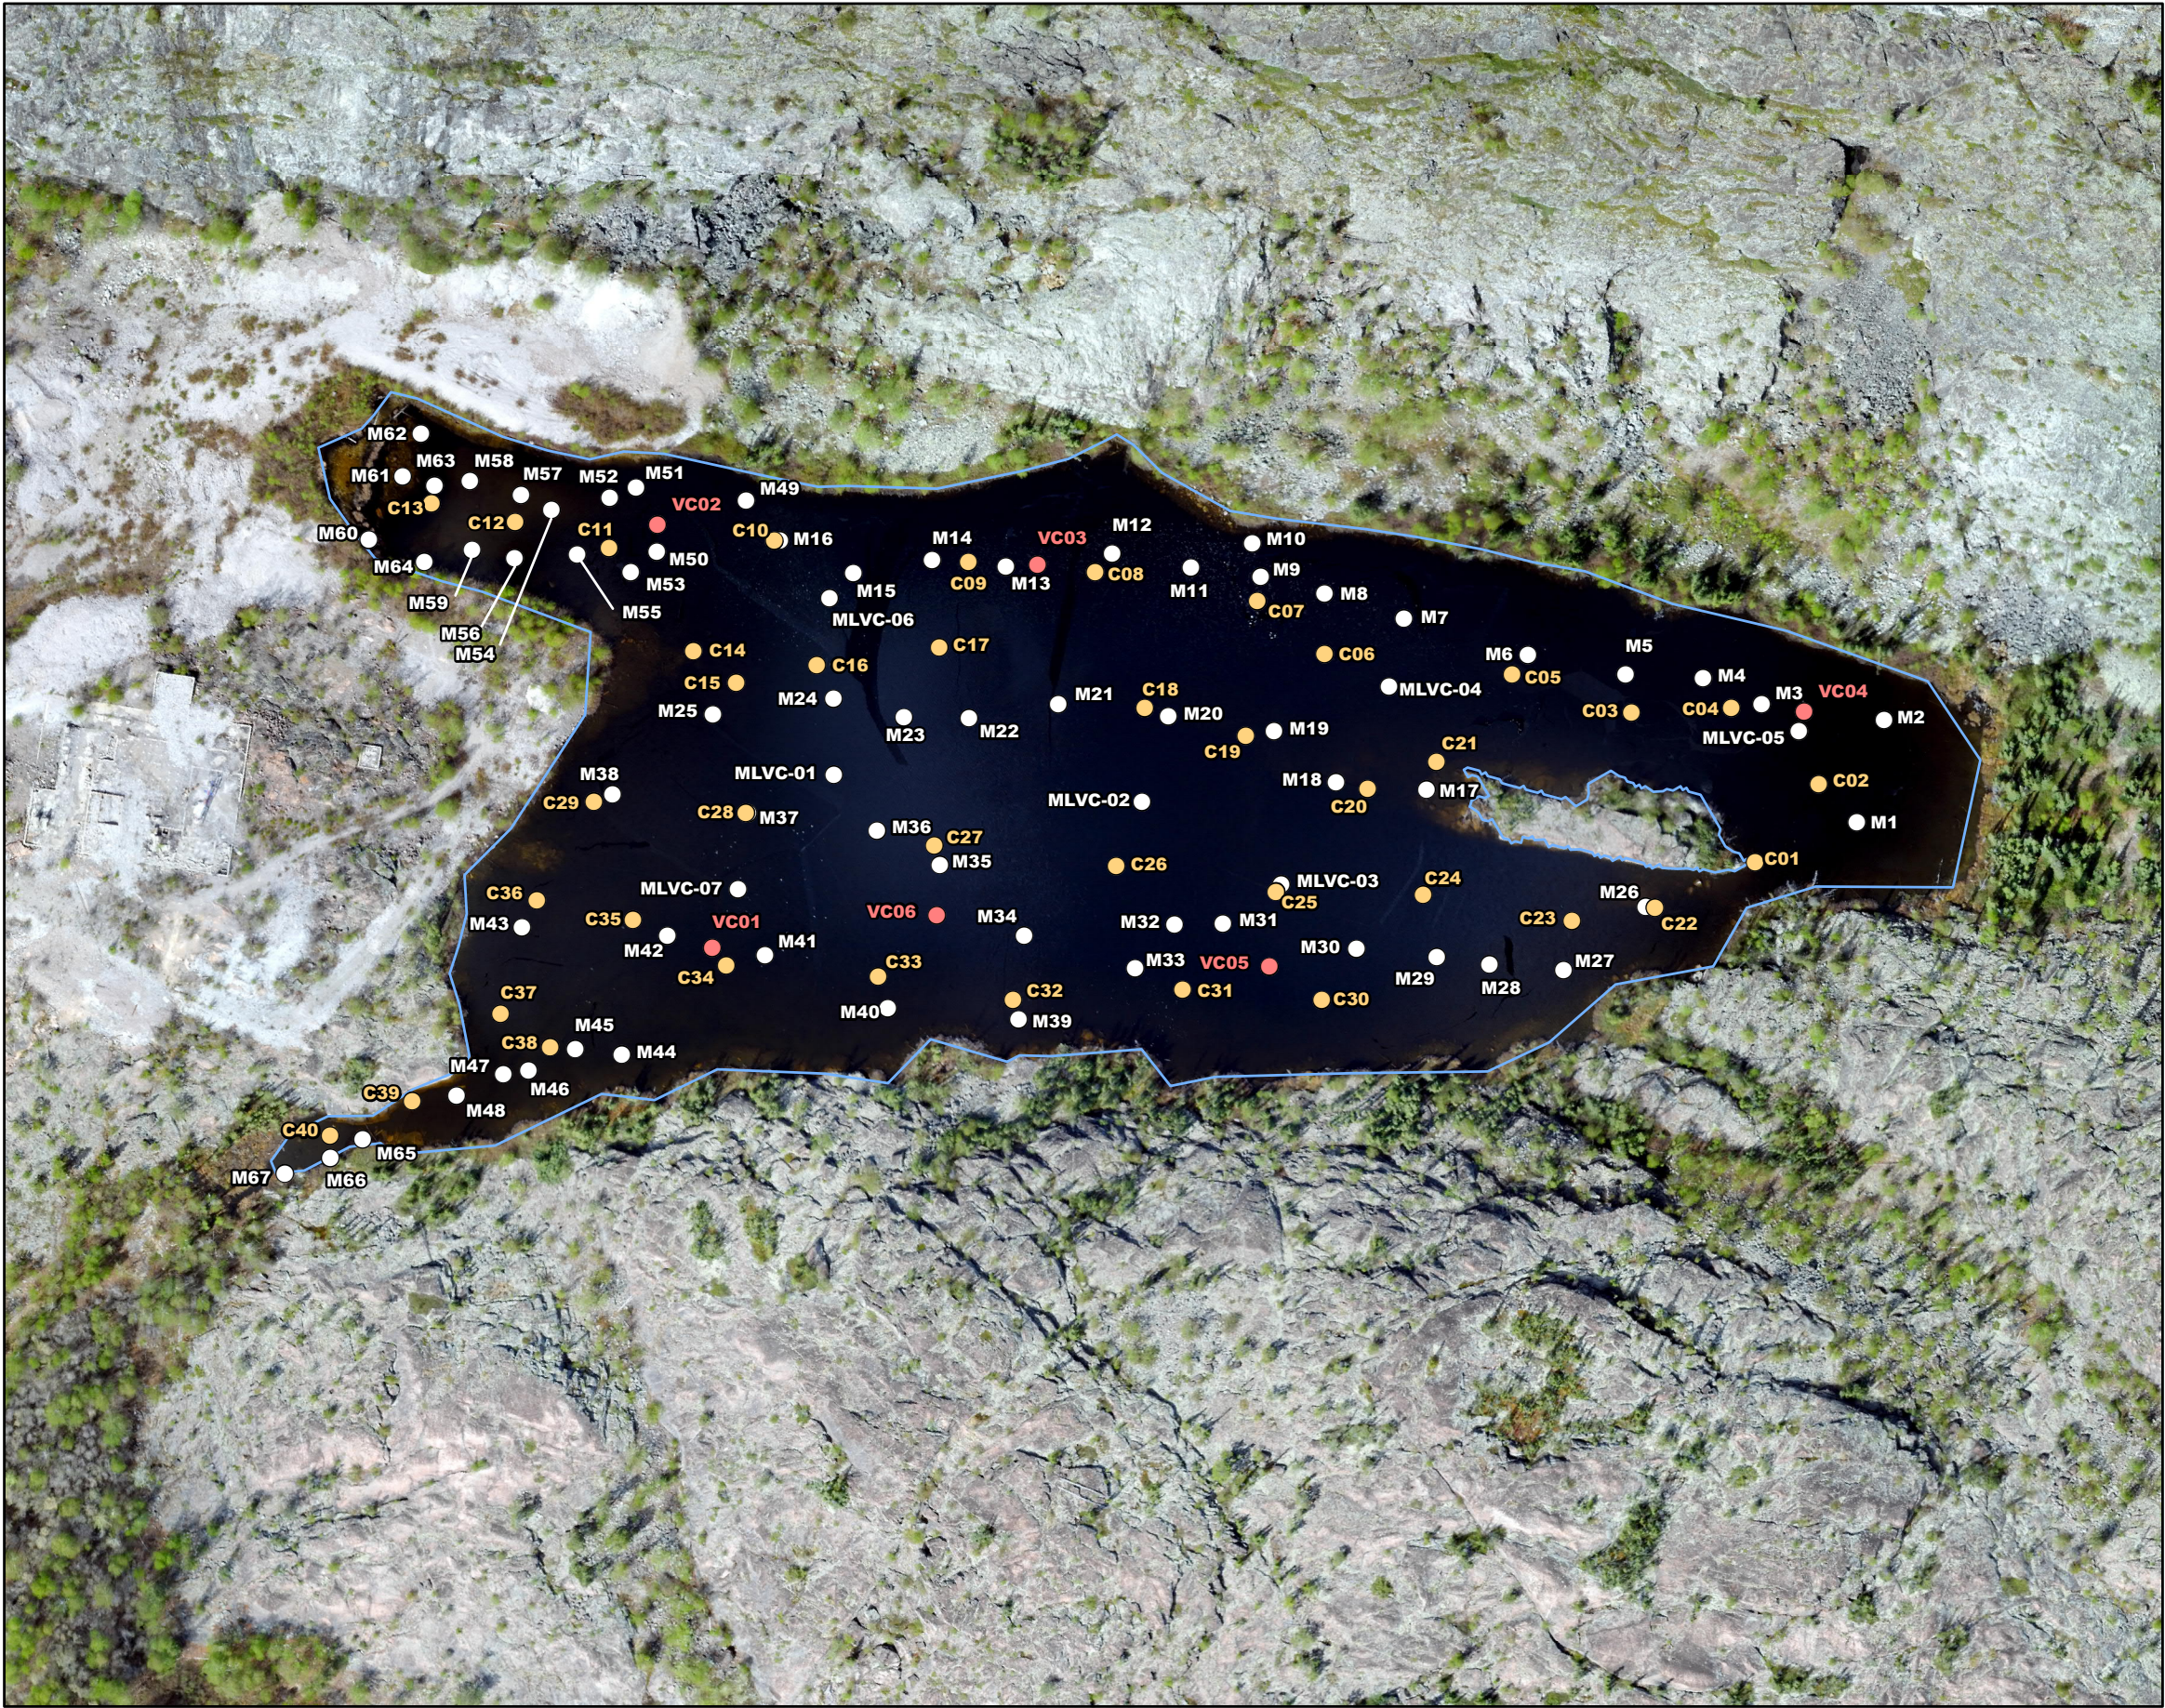
Measurements and observations were recorded at sixty-seven locations throughout Mill Lake. A summary table identifying the coordinates, water surface elevation, top of sediment elevation, elevation of first resistance and depth to refusal are provided in **Table 1 (Appendix B)**. Table 1 also includes field data from the fall 2019 and winter 2020 field programs. The measurement locations along with the top of sediment elevations (depth of water) are shown on **Figure 1 (Appendix C)**.
