Project #
60608868

**Subject: Kwet'it'wàà (Rayrock) Remediation Project
July 2021 Sherman Lake Water Depth Measurements**

AECOM Canada Ltd. (AECOM) is pleased to provide Public Services and Procurement Canada (PSPC) this report summarizing the results of water depth measurements completed in Sherman Lake at a location proximate to proposed treatment water discharge for the upcoming Rayrock Remediation Project.

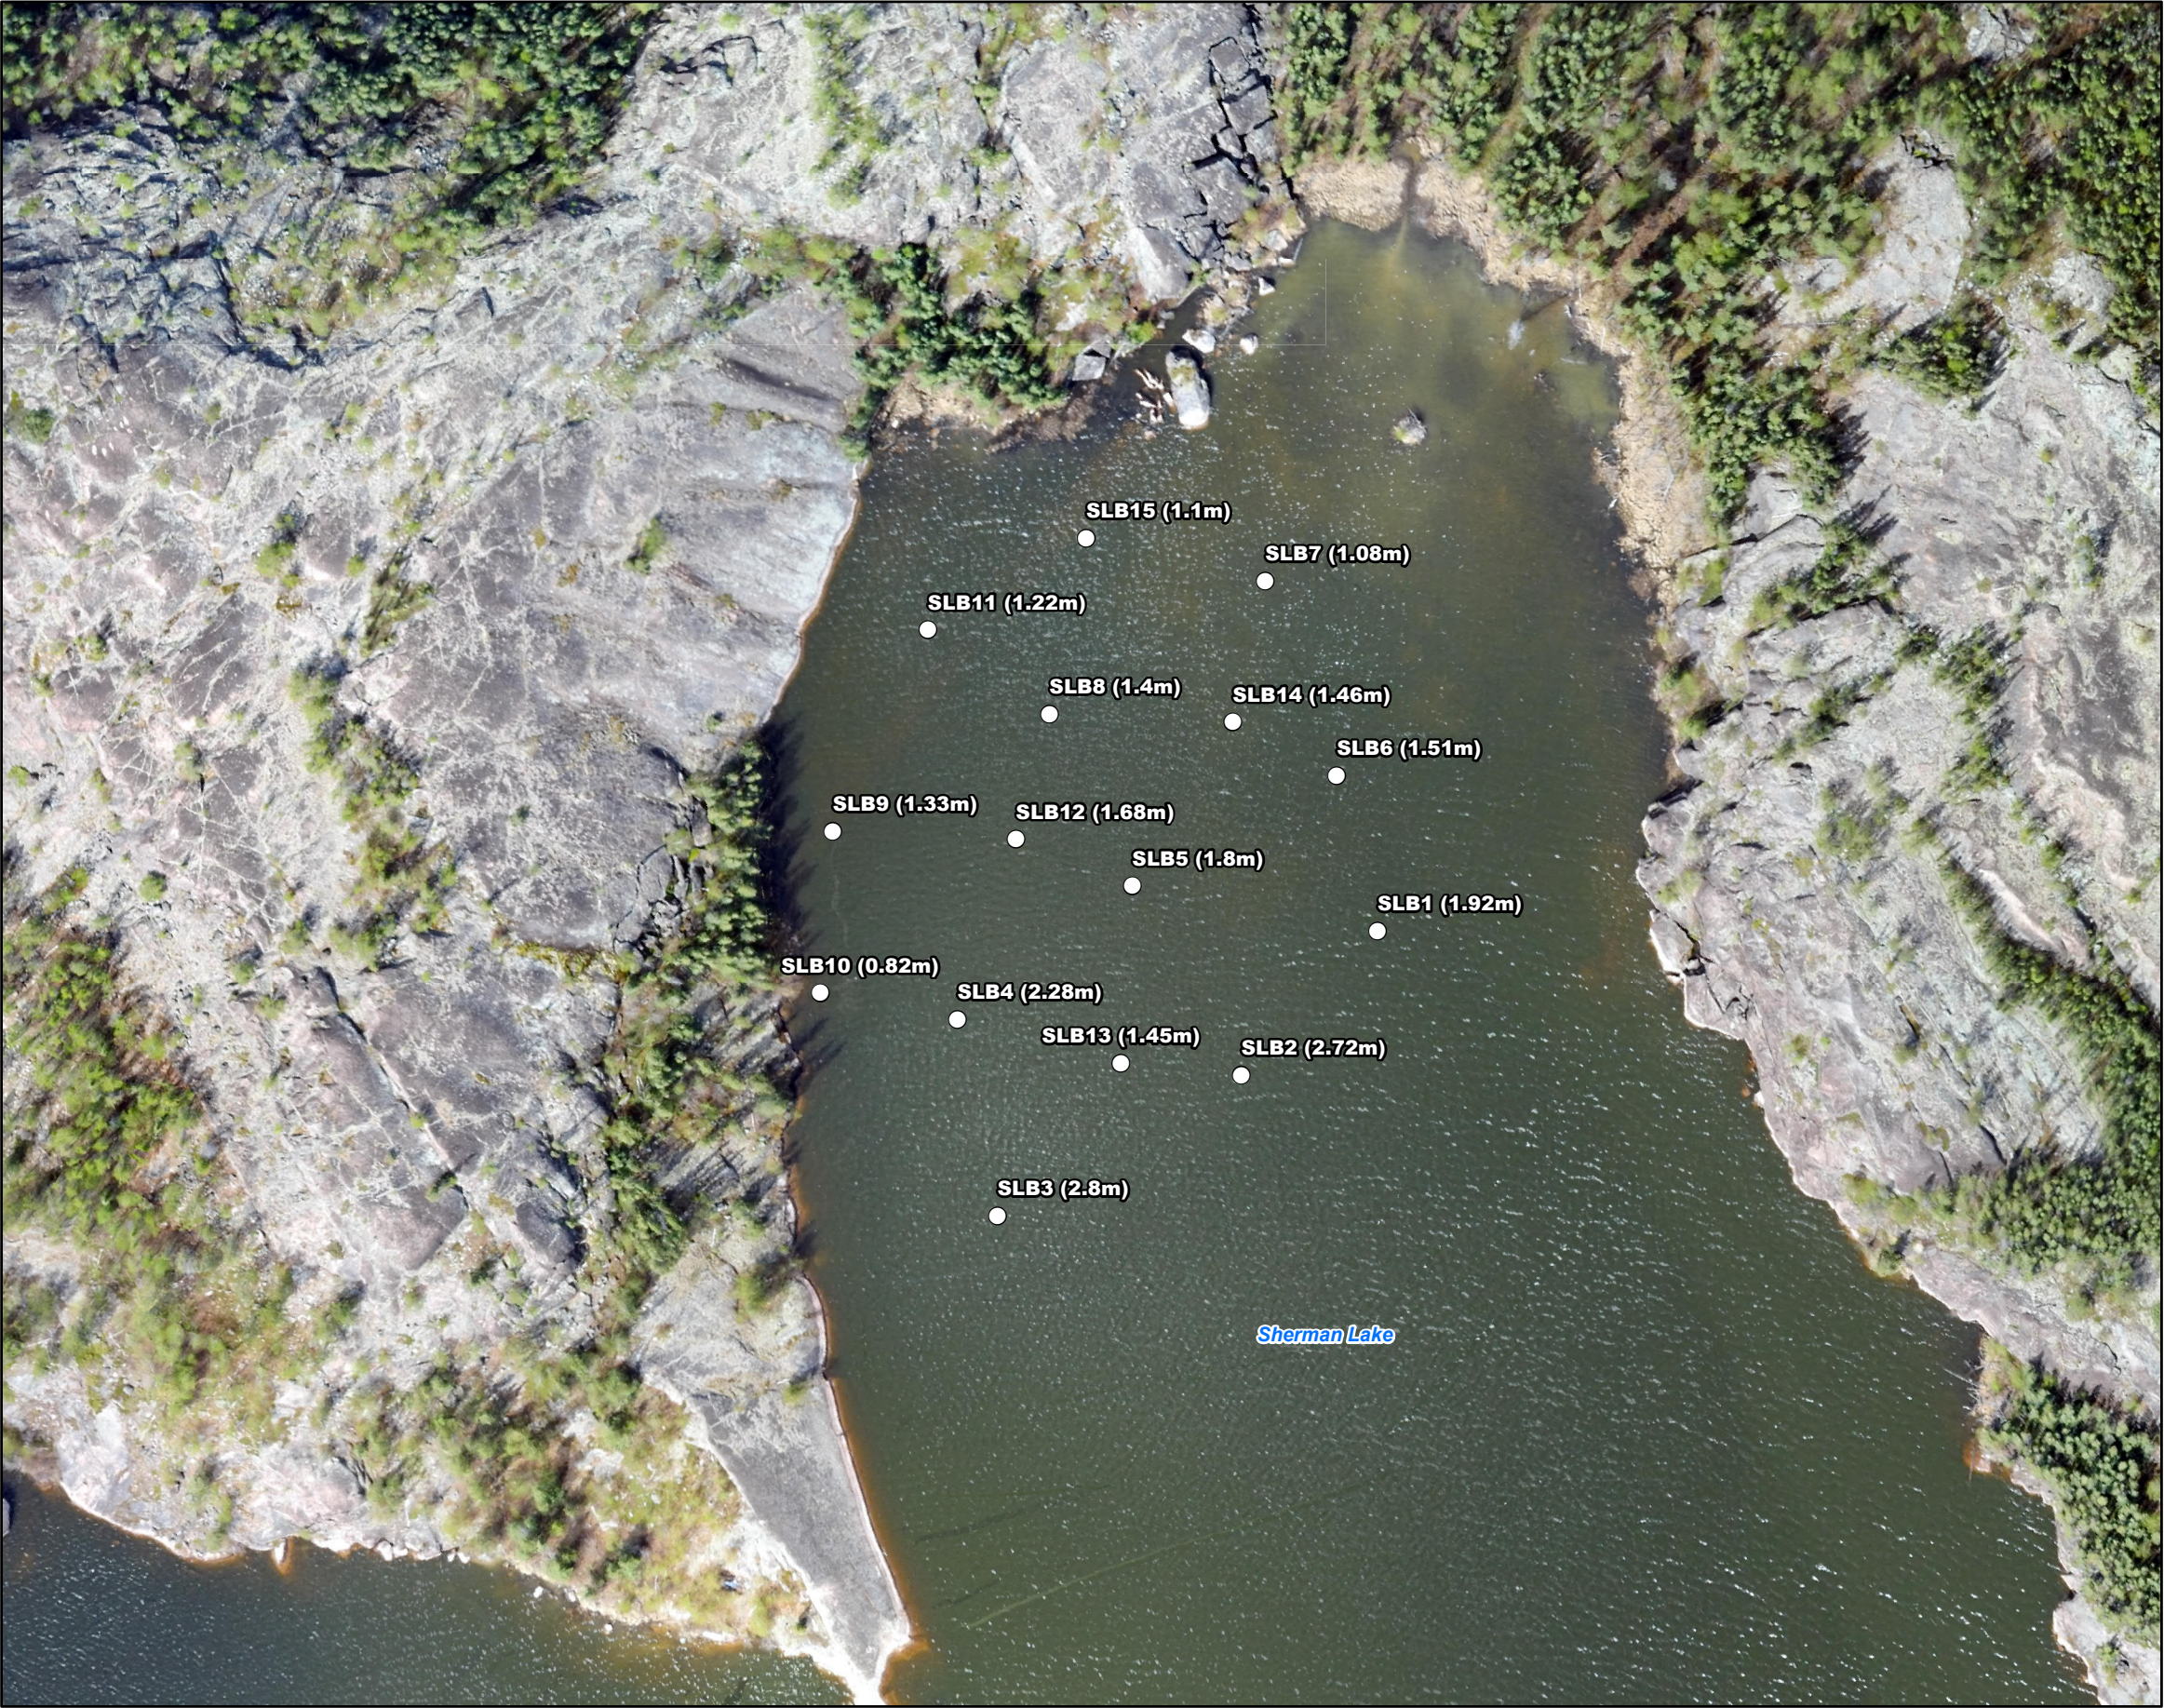
The measurement results are tabulated in Table 1, attached and depicted on an aerial photograph (Figure 1, also attached). Photographs collected during the field work are further attached.

○ 2021 Water Depth Measurement Location

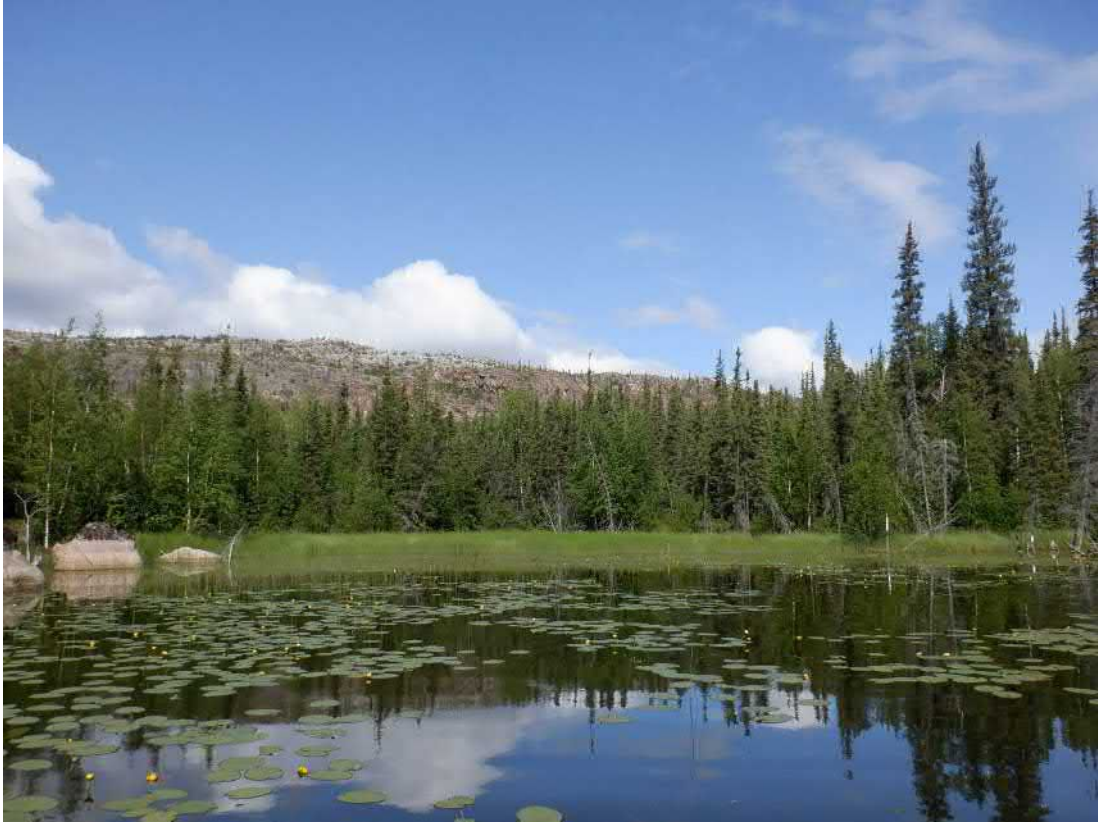
Photo No. 3	Date 7/16/2021

Direction Photo Taken Northwest		
Description Image taken from the zodiac boat while recording water depth measurements on Sherman Lake.
