Tunnel Mountain Campground Operations Area Shallow Utilities Rehabilitation – Phase 1

APPENDIX A

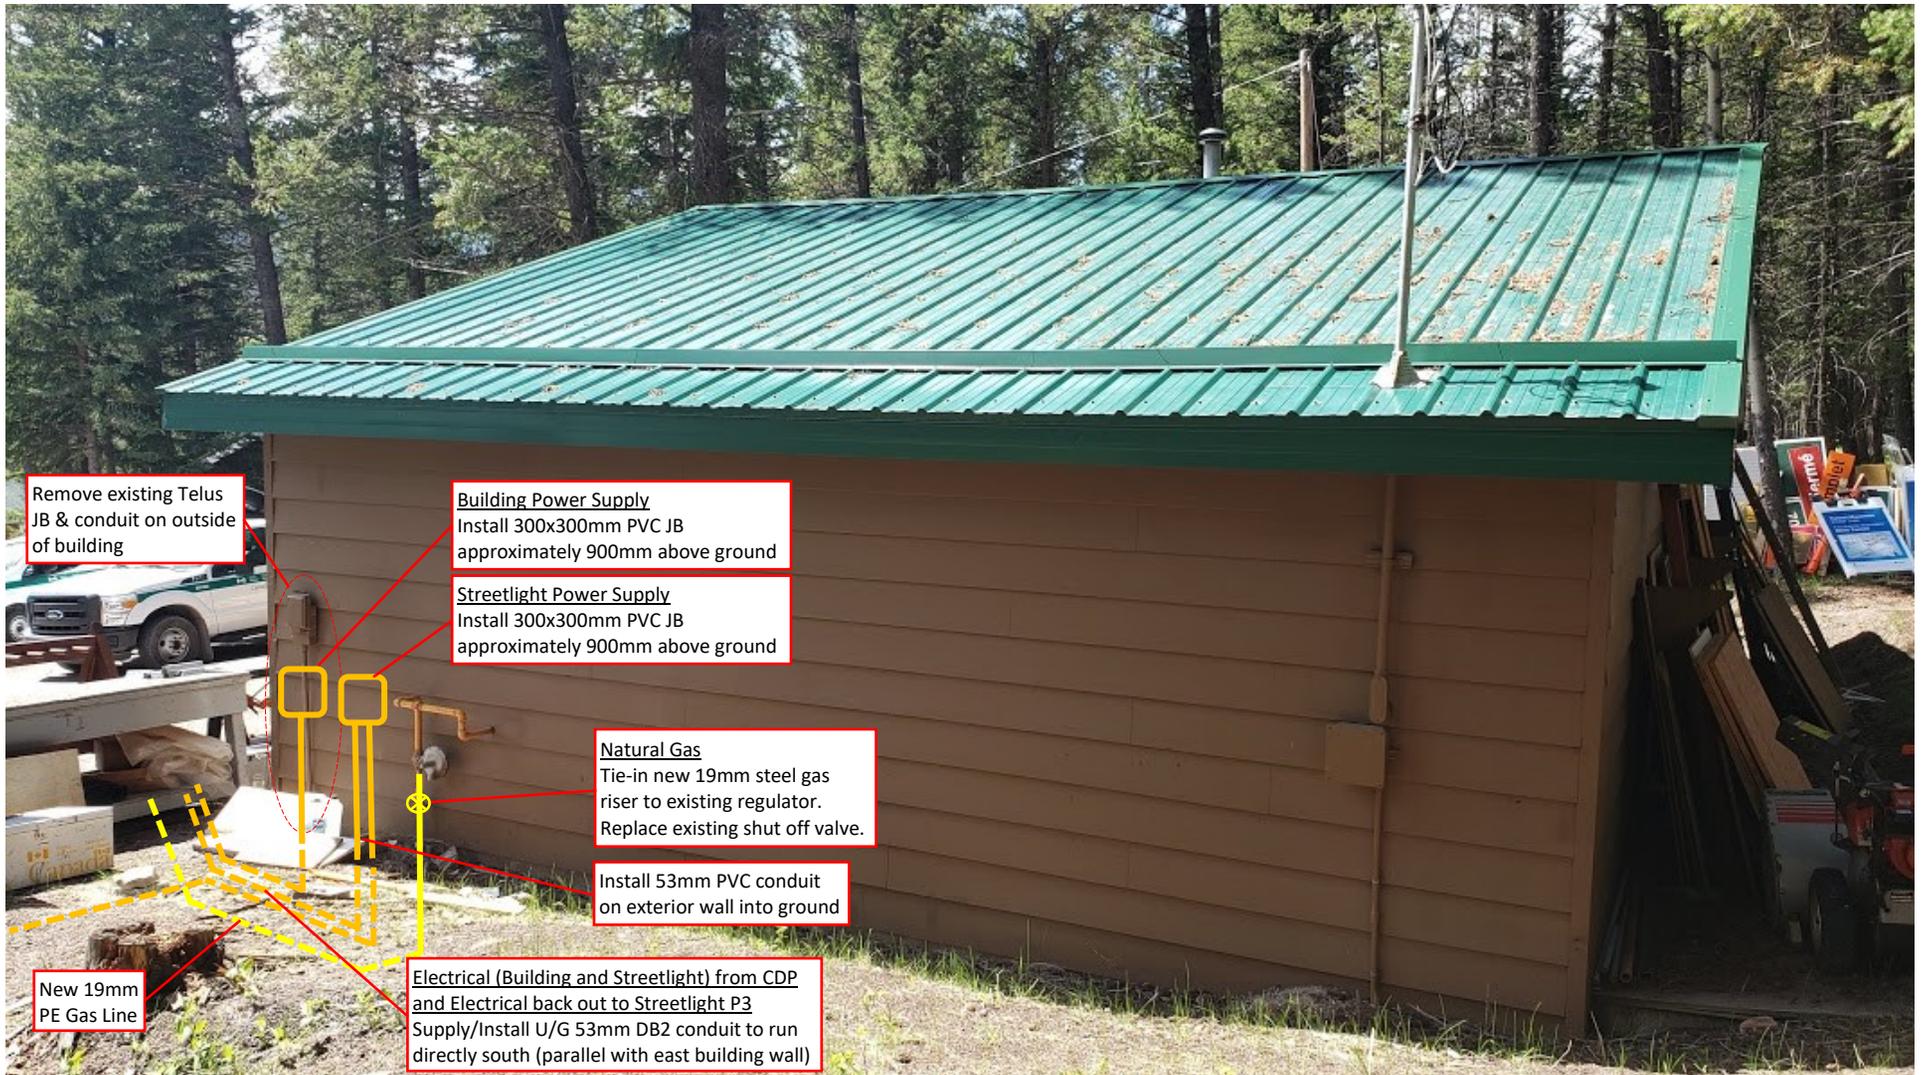
FIGURE 1 - Garage A Utility Tie-In Details (East Side of Building)

1. Contractor is required to repair all holes in siding resulting from removal of existing utilities from side of building.
2. See Drawing E1.3 for DB2 U/G conduit installation details. DB2 conduit to transition to PVC on CDP side of vertical bend.
3. New gas line is to run parallel to new U/G electrical conduit from CDP to building. See Drawing M1.0 for new gas service installation details.

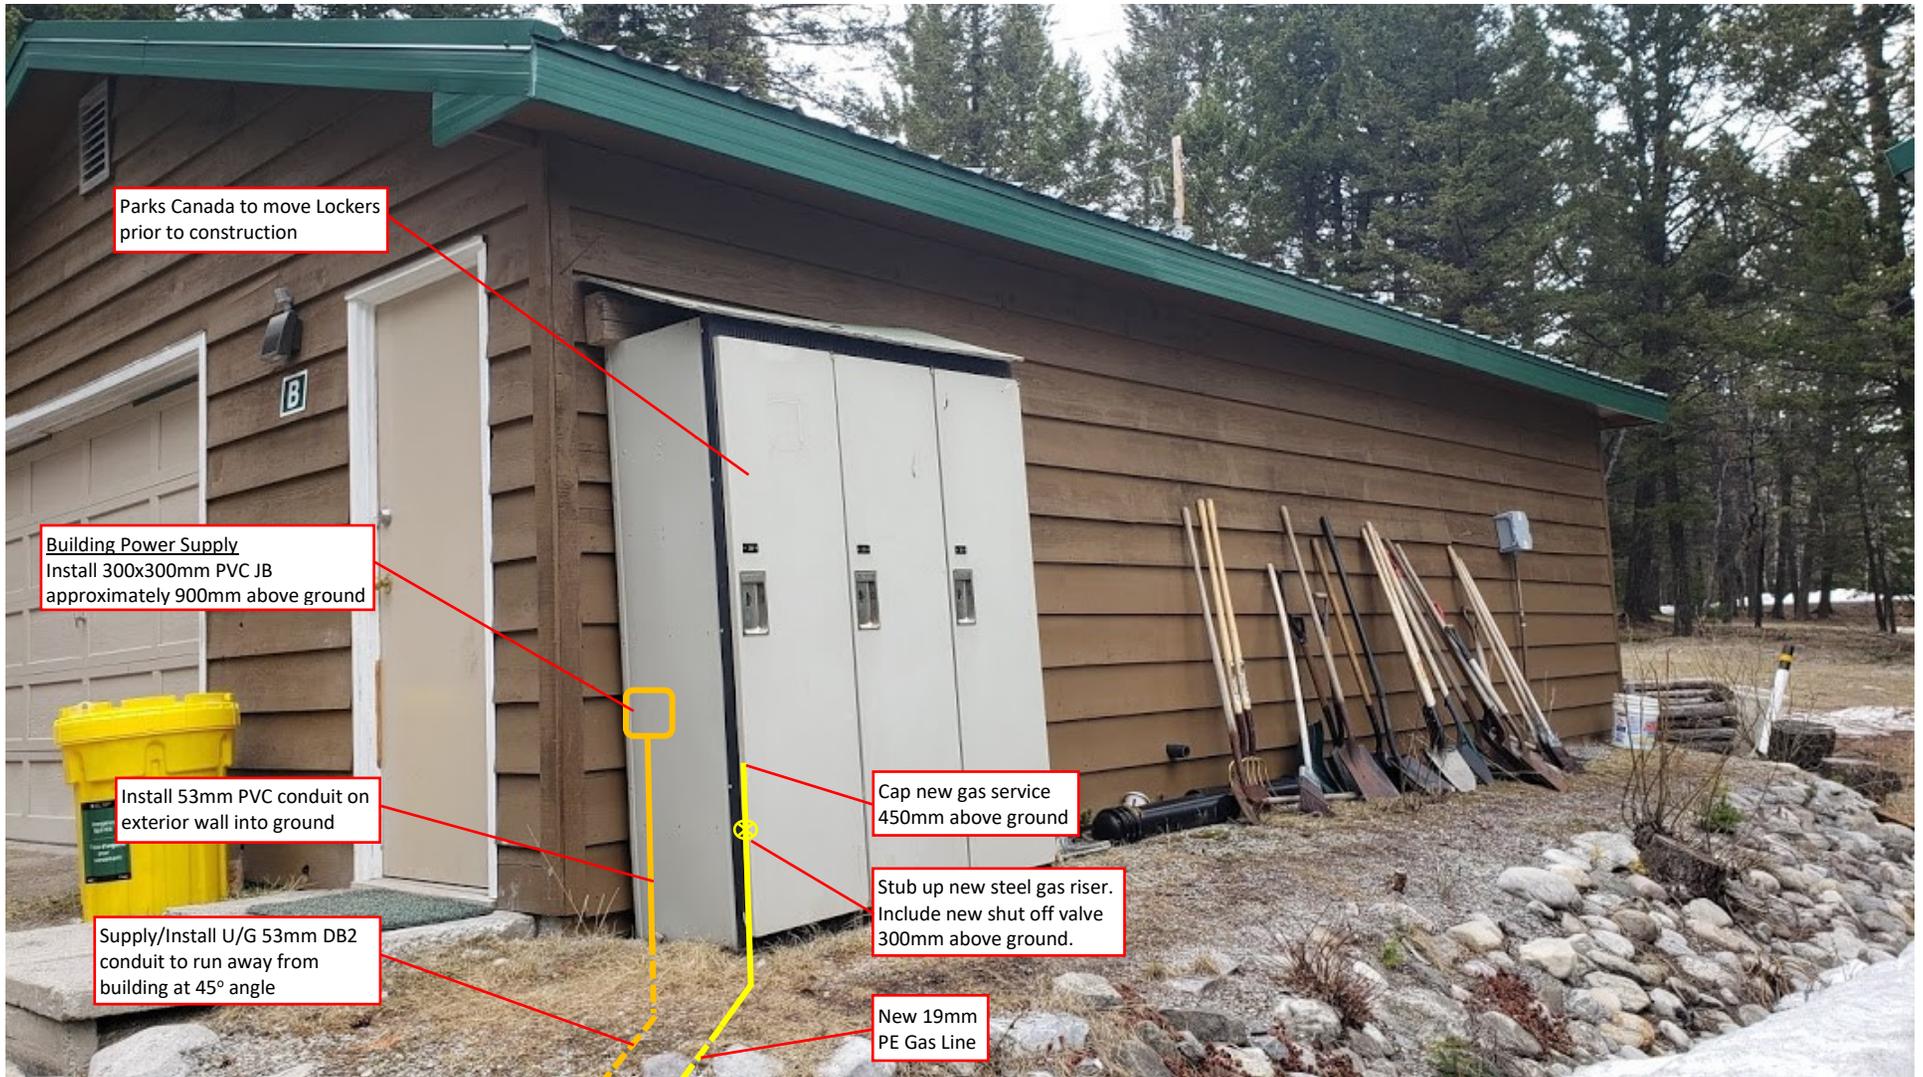
FIGURE 2 - Garage B Utility Tie-In Details (South Side of Building)

1. See Drawing E1.3 for DB2 U/G conduit installation details. DB2 conduit to transition to PVC on CDP side of vertical bend.
2. New gas line is to run parallel to new U/G electrical conduit from CDP to building. See Drawing M1.0 for new gas service installation details.

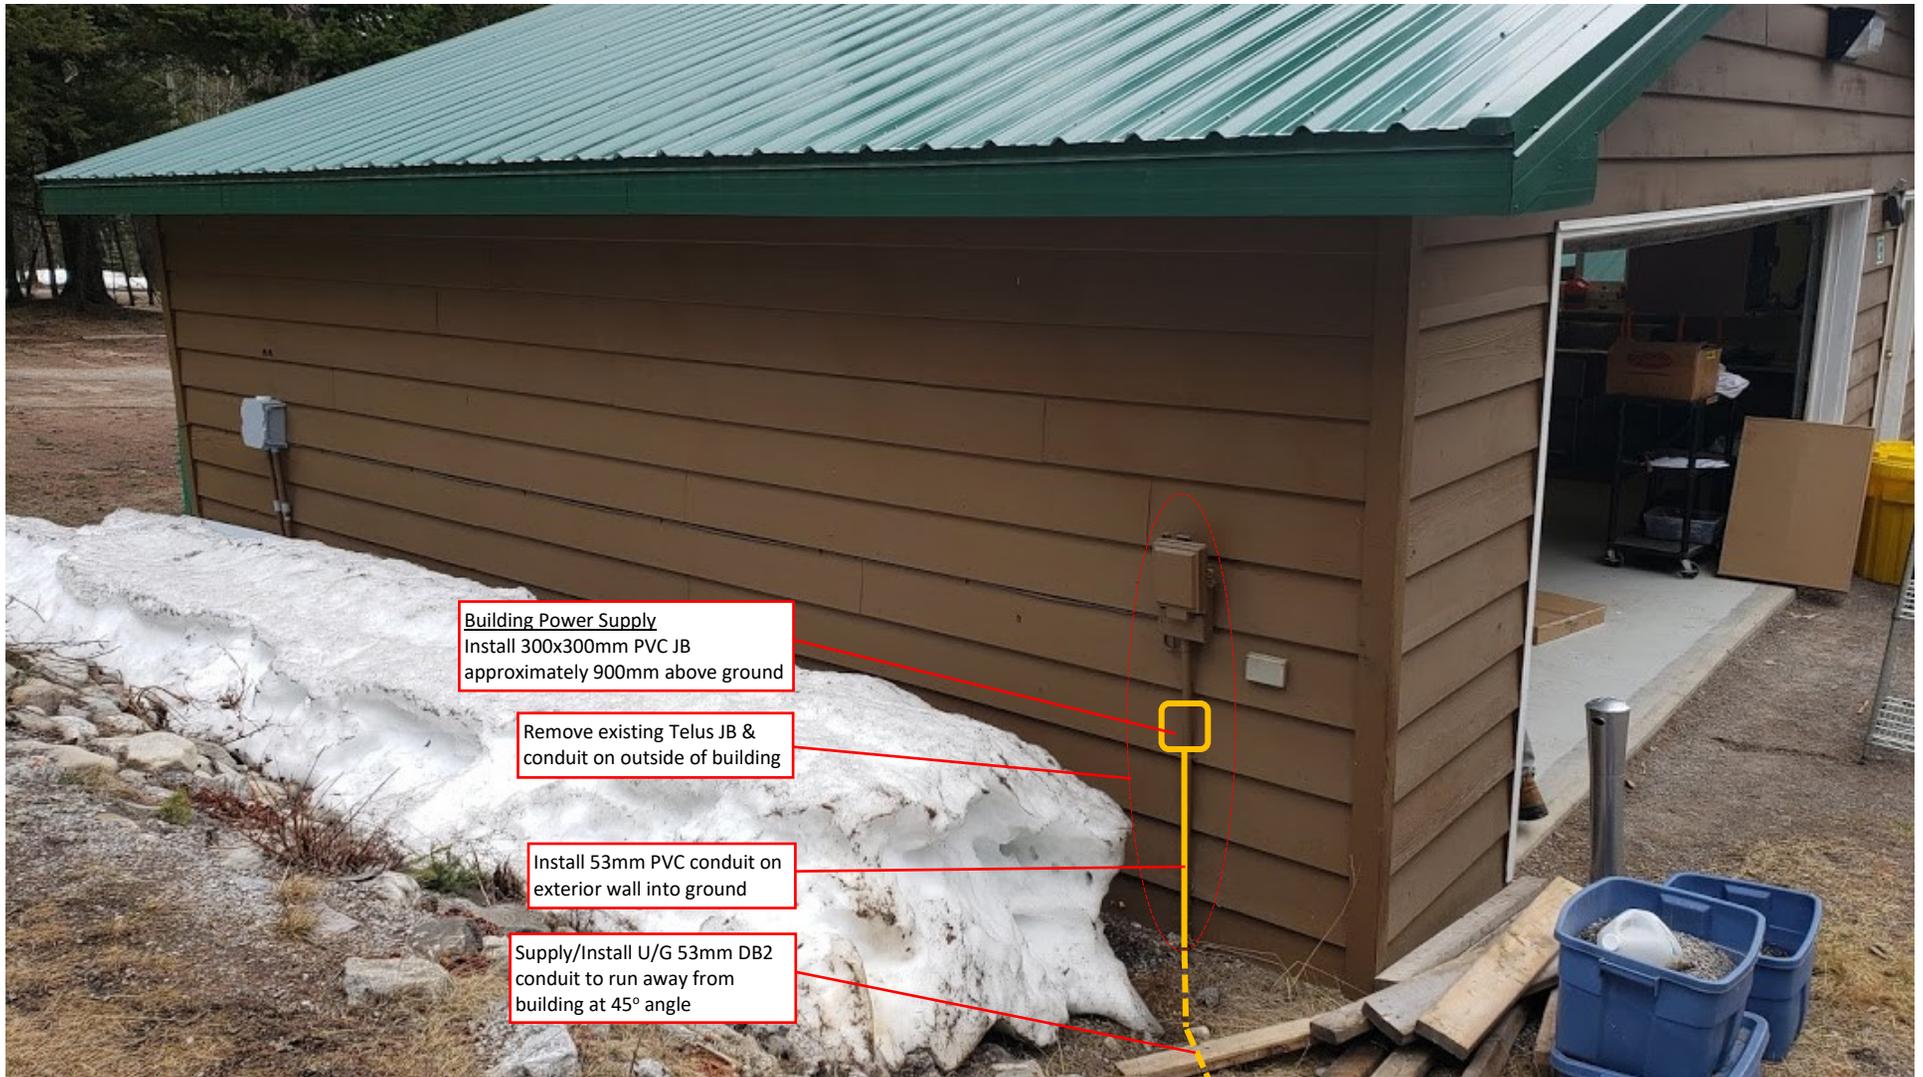
FIGURE 3a - Garage C Utility Tie-In Details (North Side of Building)

1. Contractor is required to repair all holes in siding resulting from removal of existing utilities from side of building.
2. See Drawing E1.3 for DB2 U/G conduit installation details. DB2 conduit to transition to PVC on CDP side of vertical bend.

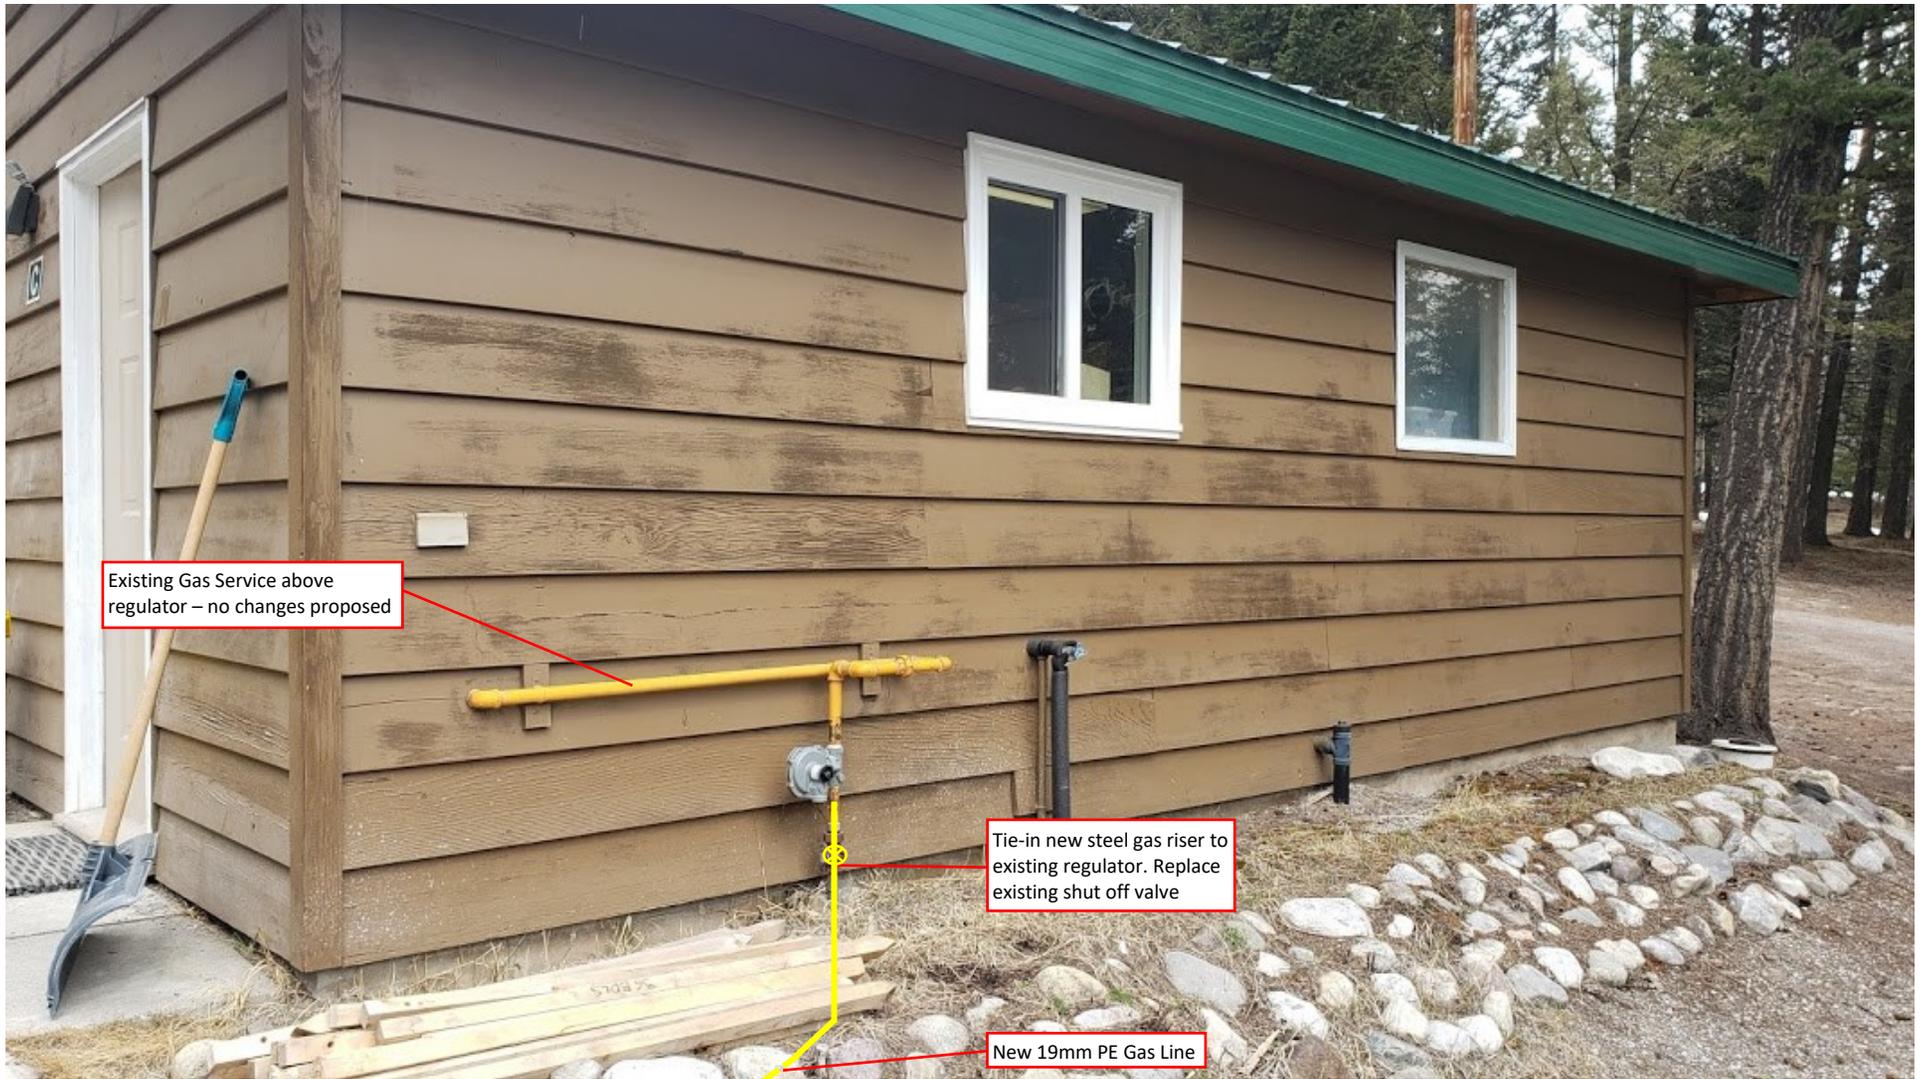
FIGURE 3b - Garage C Utility Tie-In Details (South Side of Building)

1. No electrical or communication services work planned for south wall of Garage C. Image is to show existing gas service only.
2. New gas line is to run on 45-degree angle away from wall to 1.5m away from wall then parallel to wall to new gas main perpendicularly. See Drawing M1.0 for new gas service installation details.

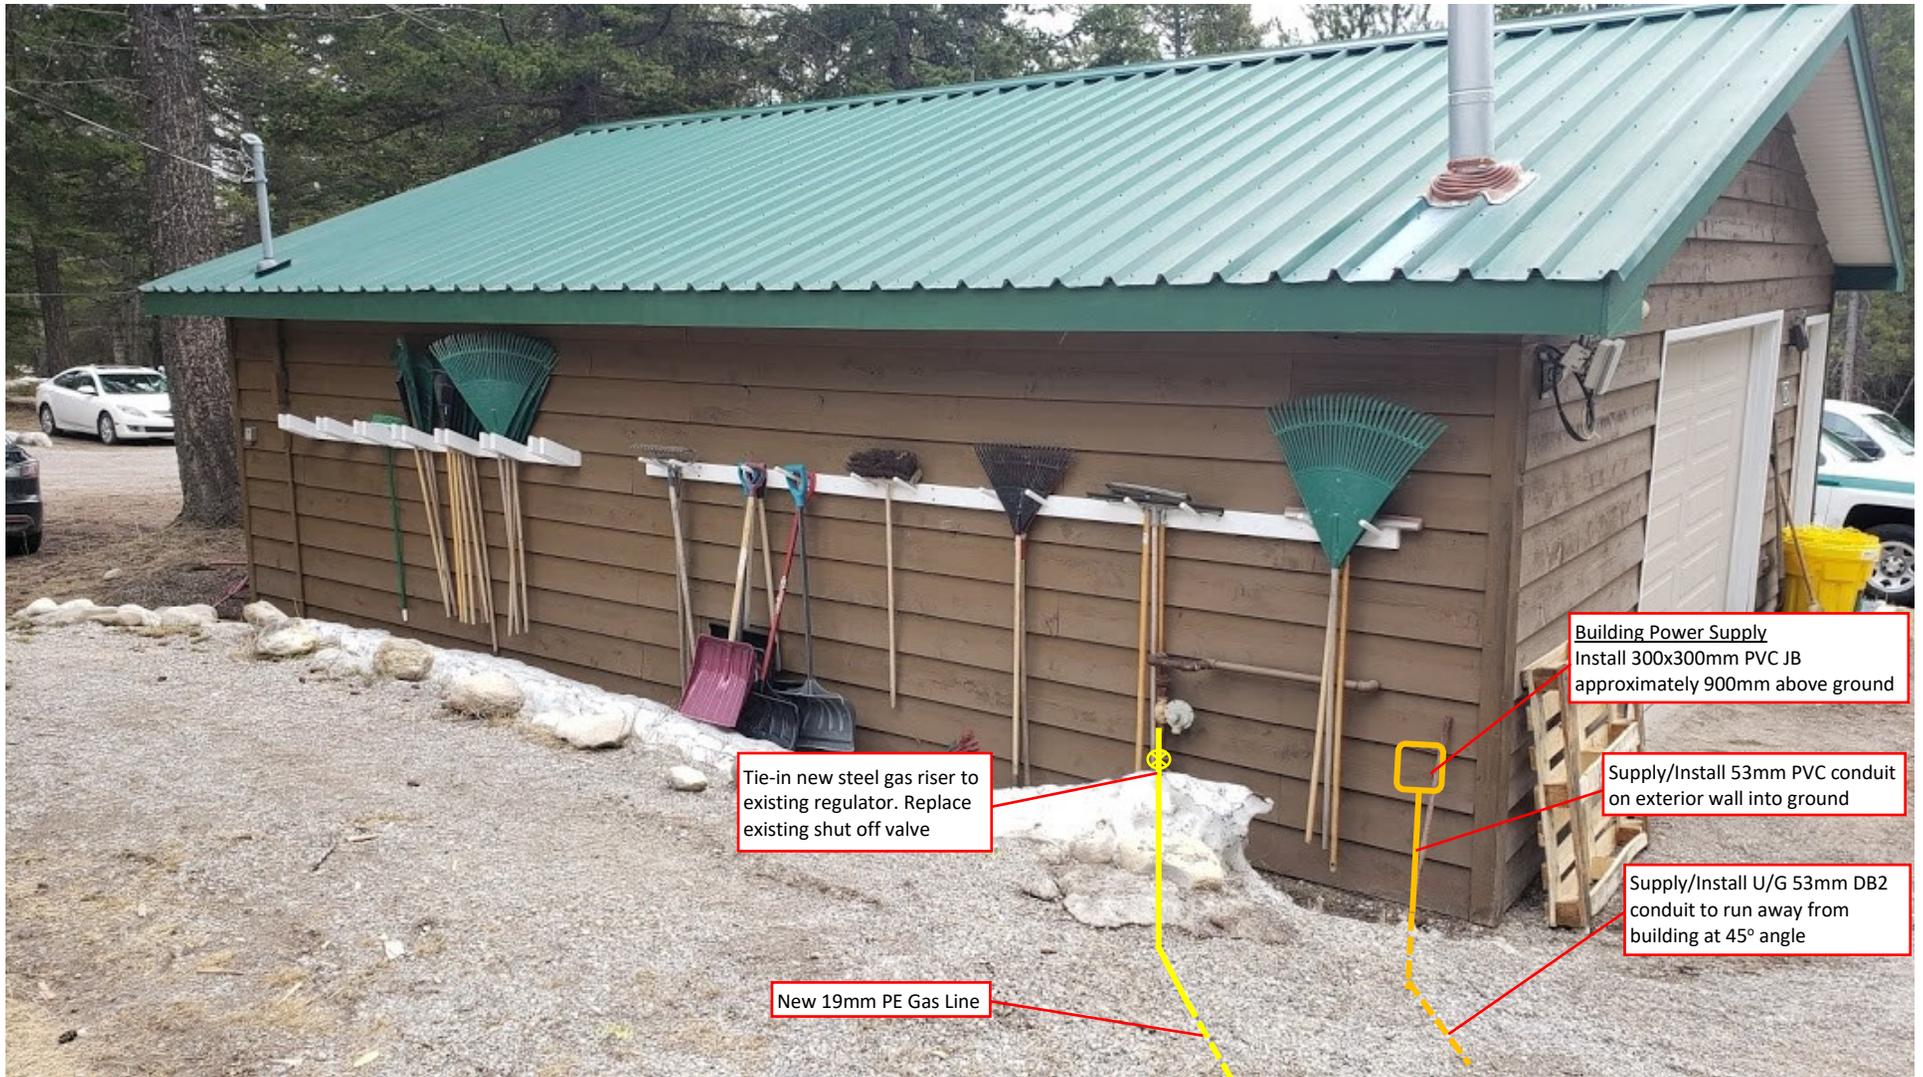
FIGURE 4a - Garage D Utility Tie-In Details (North Side of Building)

1. Contractor is required to repair all holes in siding resulting from removal of existing utilities from side of building.
2. See Drawing E1.3 for DB2 U/G conduit installation details. DB2 conduit to transition to PVC on CDP side of vertical bend.
3. New gas line is to run parallel to new U/G electrical conduit from CDP to building. See Drawing M1.0 for new gas service installation details.

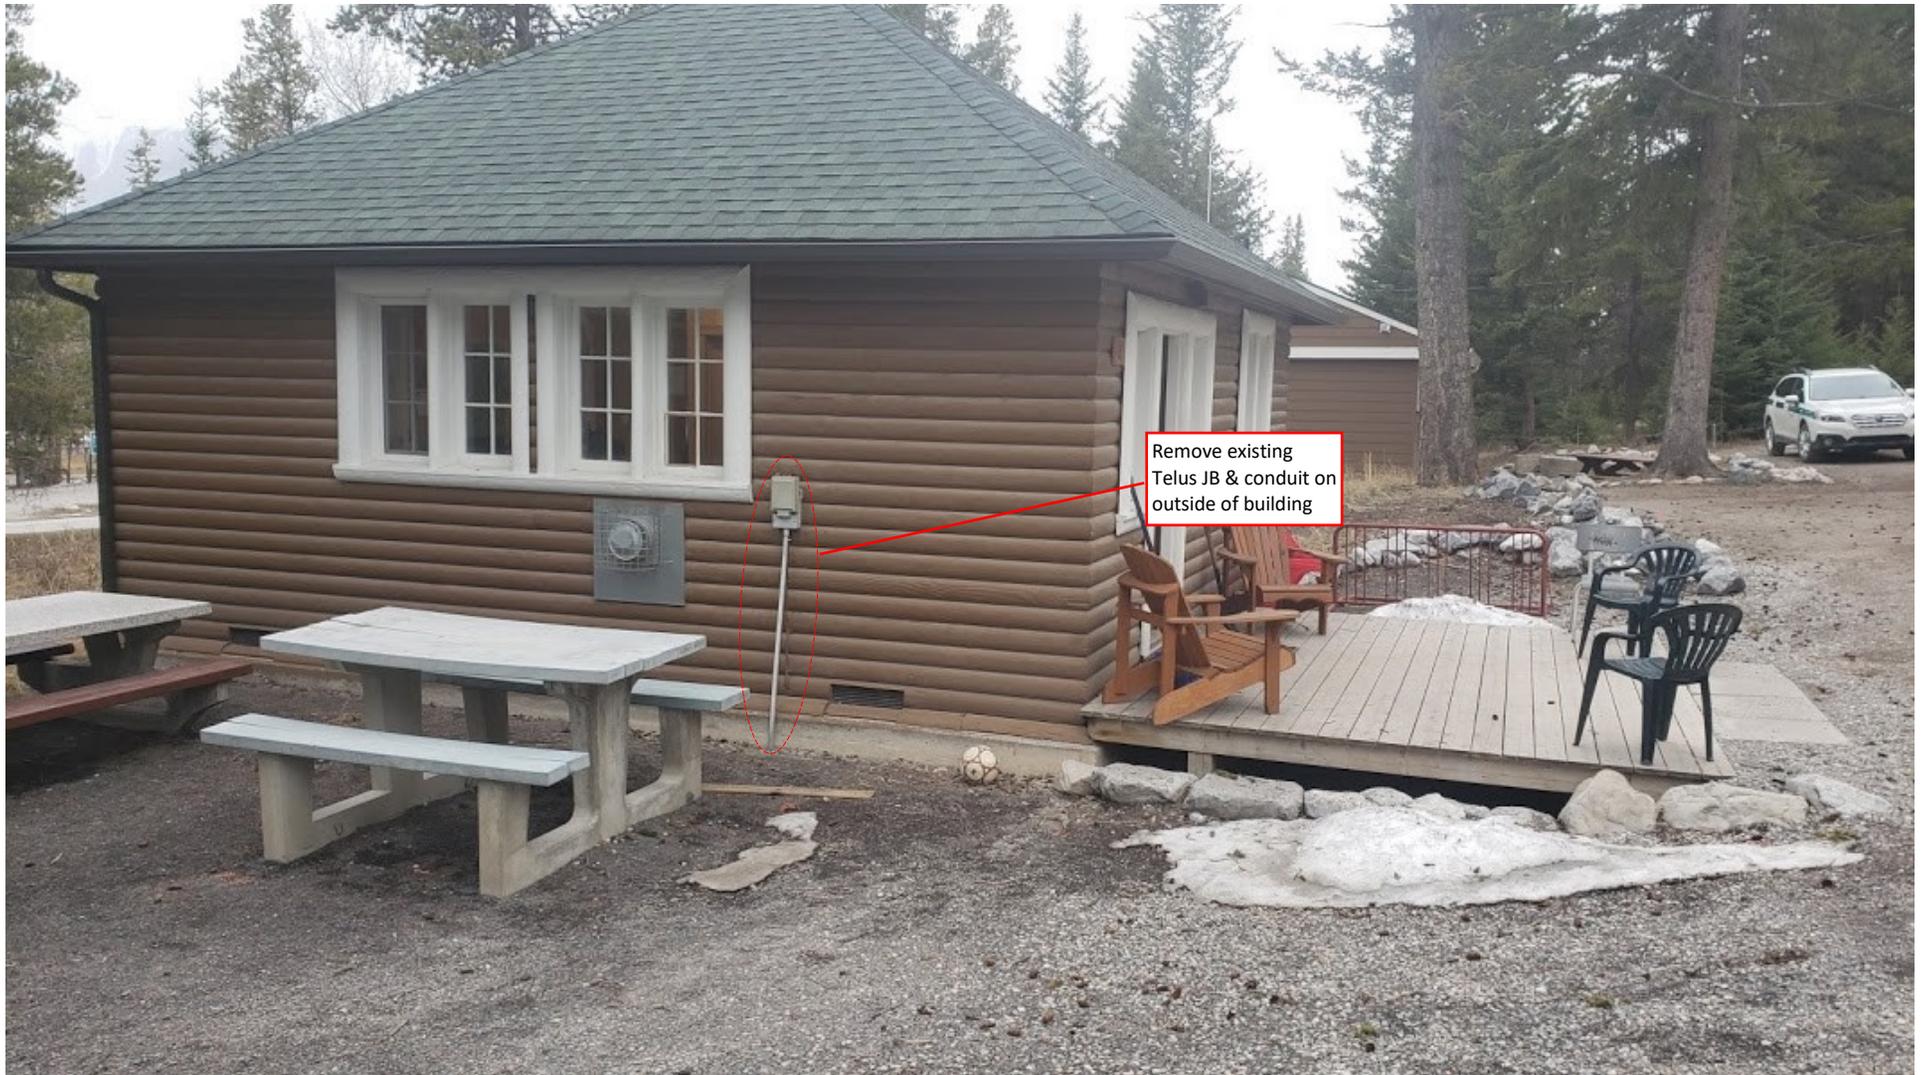
FIGURE 6b – Office #2 Utility Tie-In Details (East Side of Building)

1. Contractor is required to repair all holes in siding resulting from removal of existing utilities from side of building.

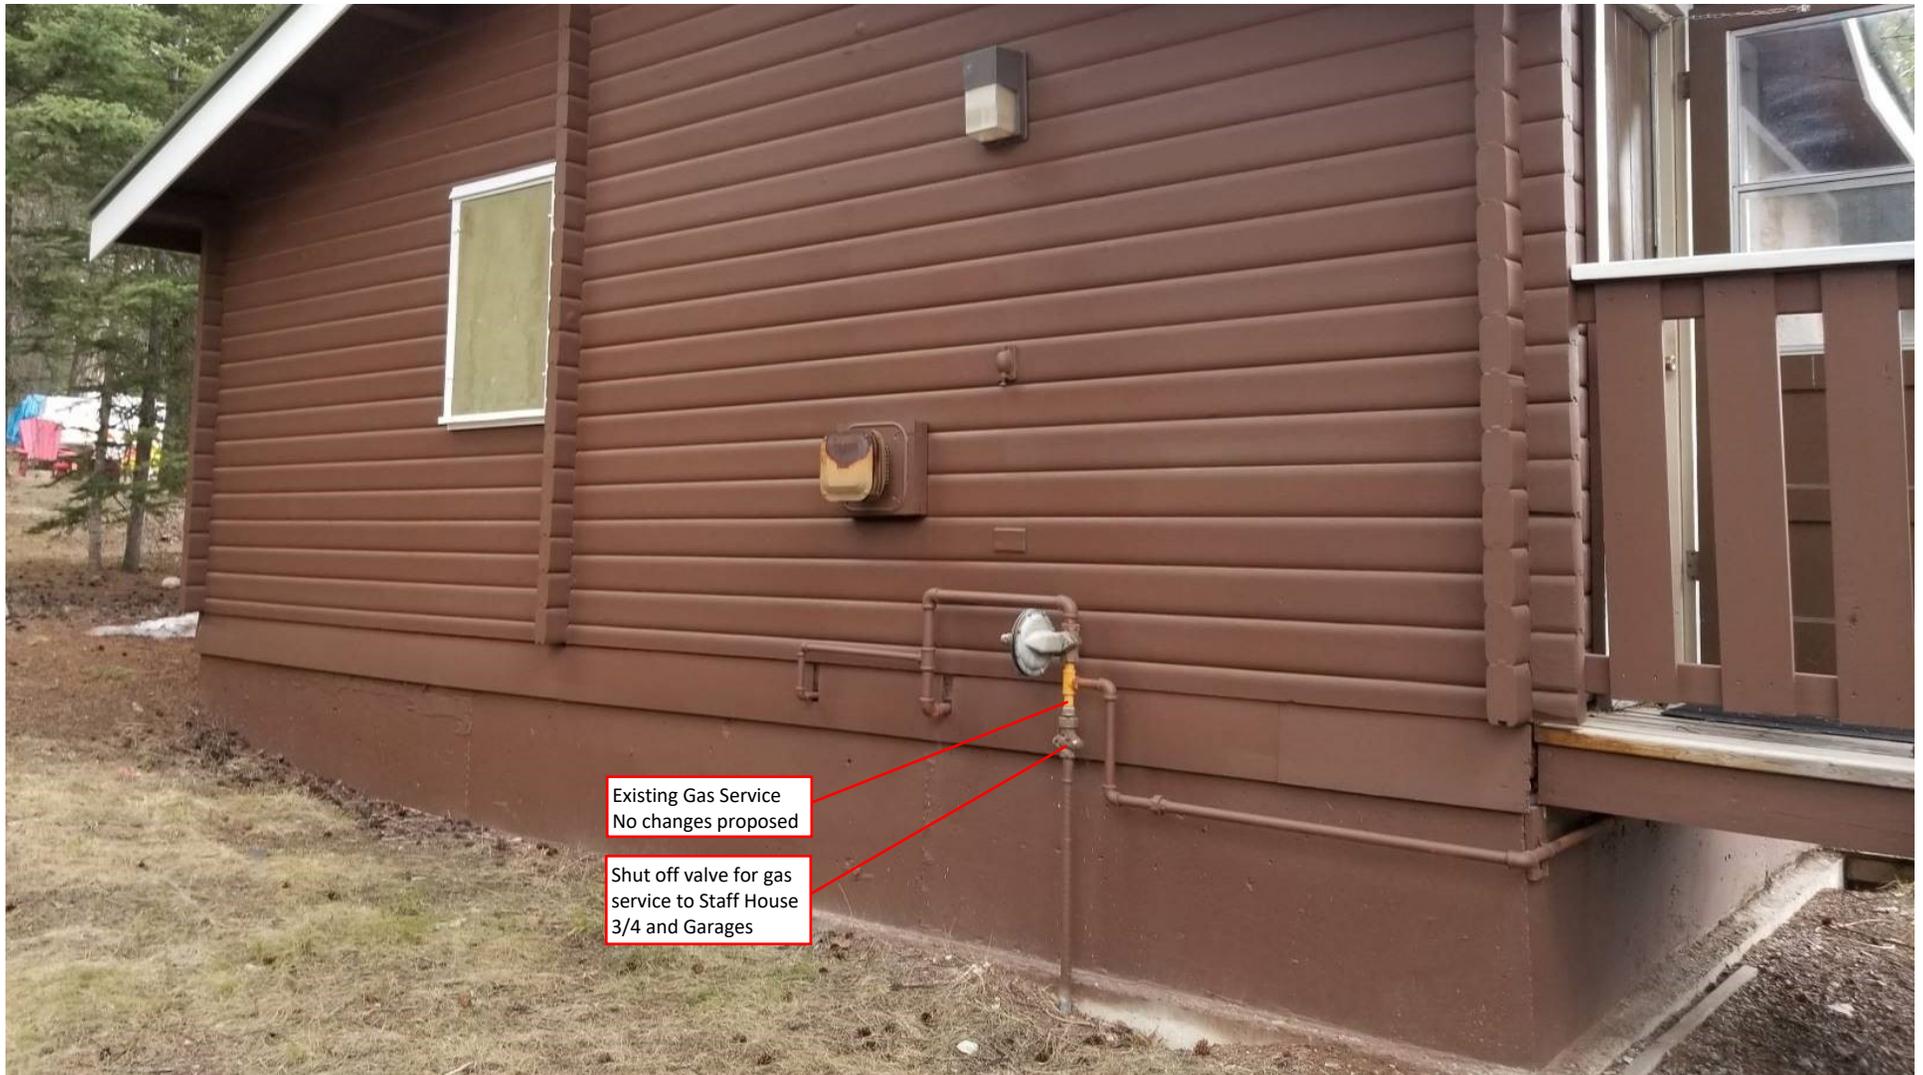
FIGURE 7b – Staff House 3/4 Utility Tie-In Details (West Side of Building)

Existing Gas Service
No changes proposed

Shut off valve for gas
service to Staff House
3/4 and Garages

1. No work is proposed to take place along the north, south and west sides of Cabin 3/4.

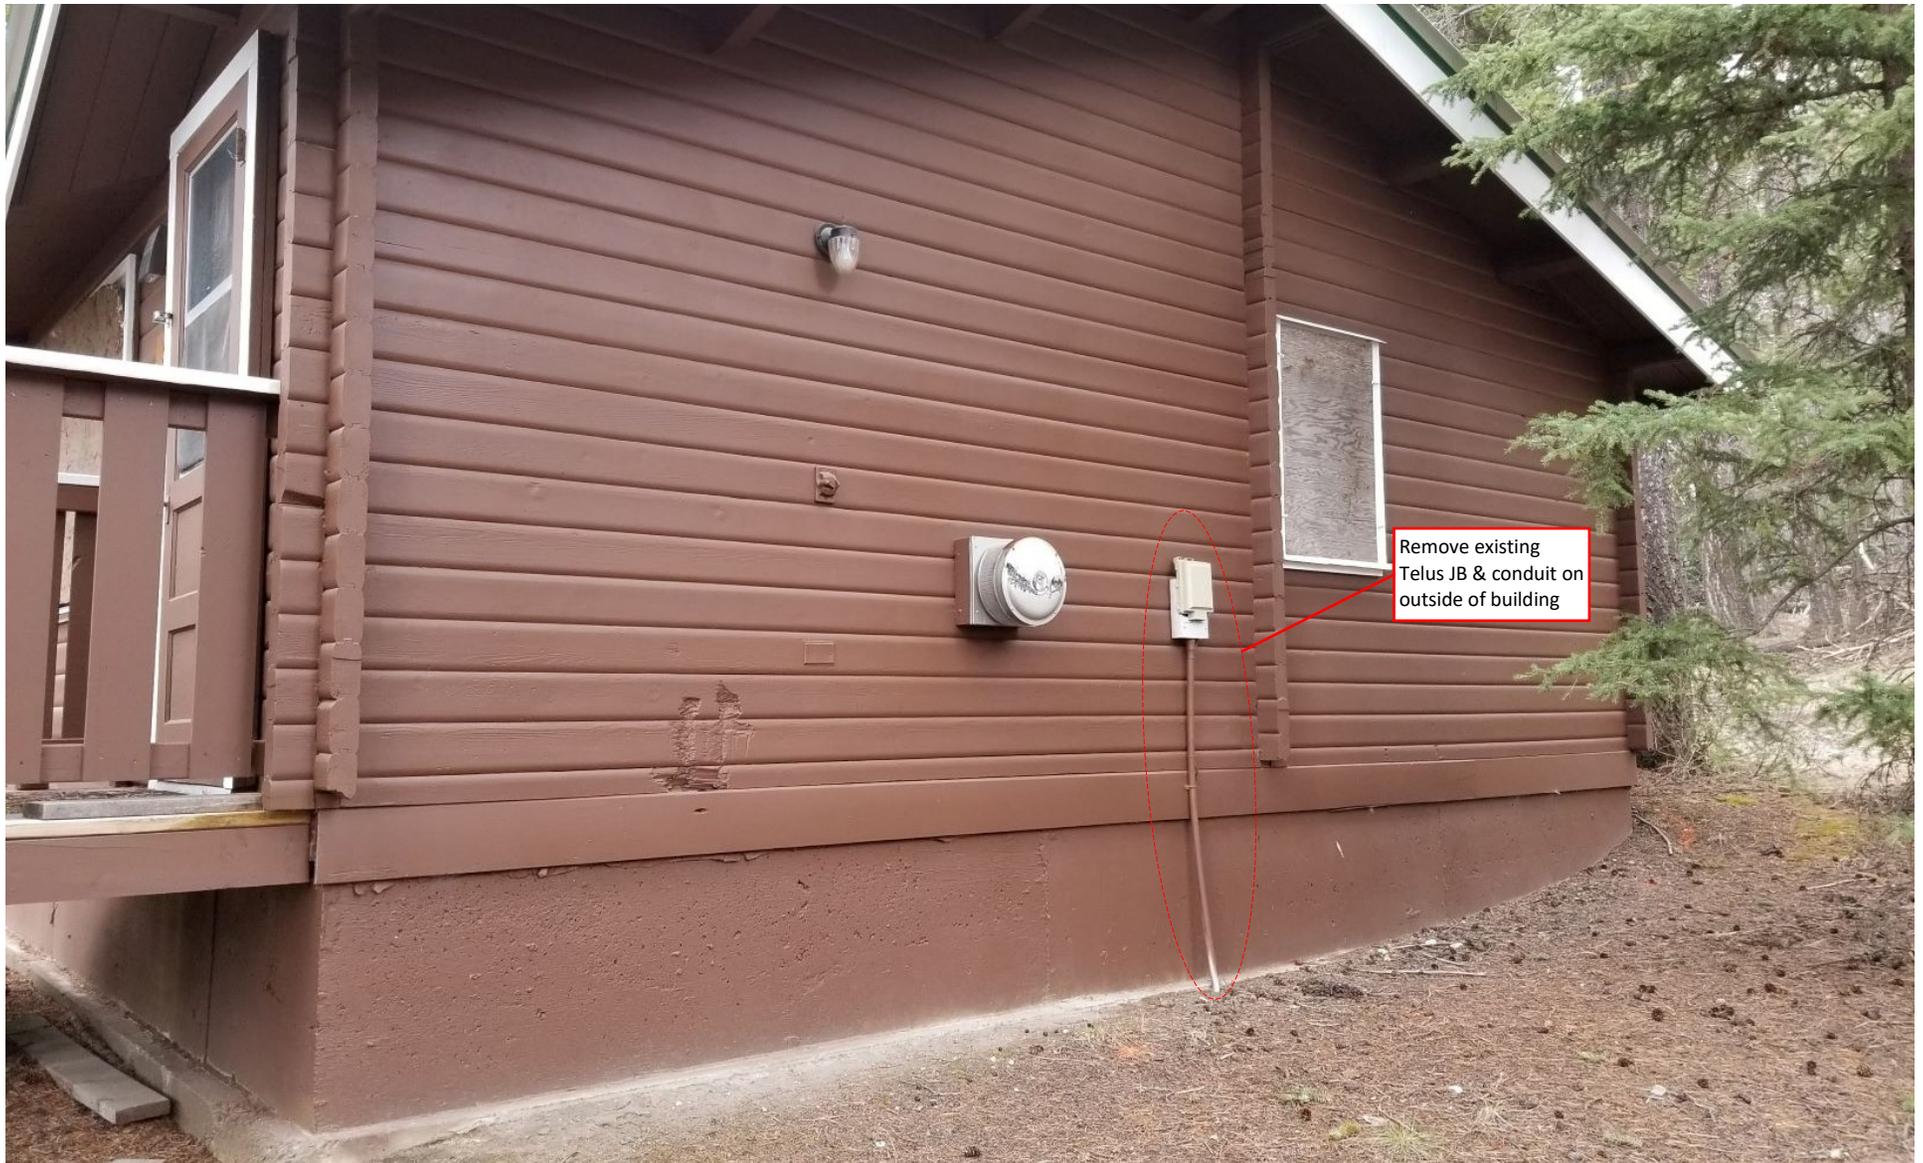
FIGURE 8a – Staff House 5/6 Utility Tie-In Details (East Side of Building)

1. Contractor is required to repair all holes in siding resulting from removal of existing utilities from side of building.

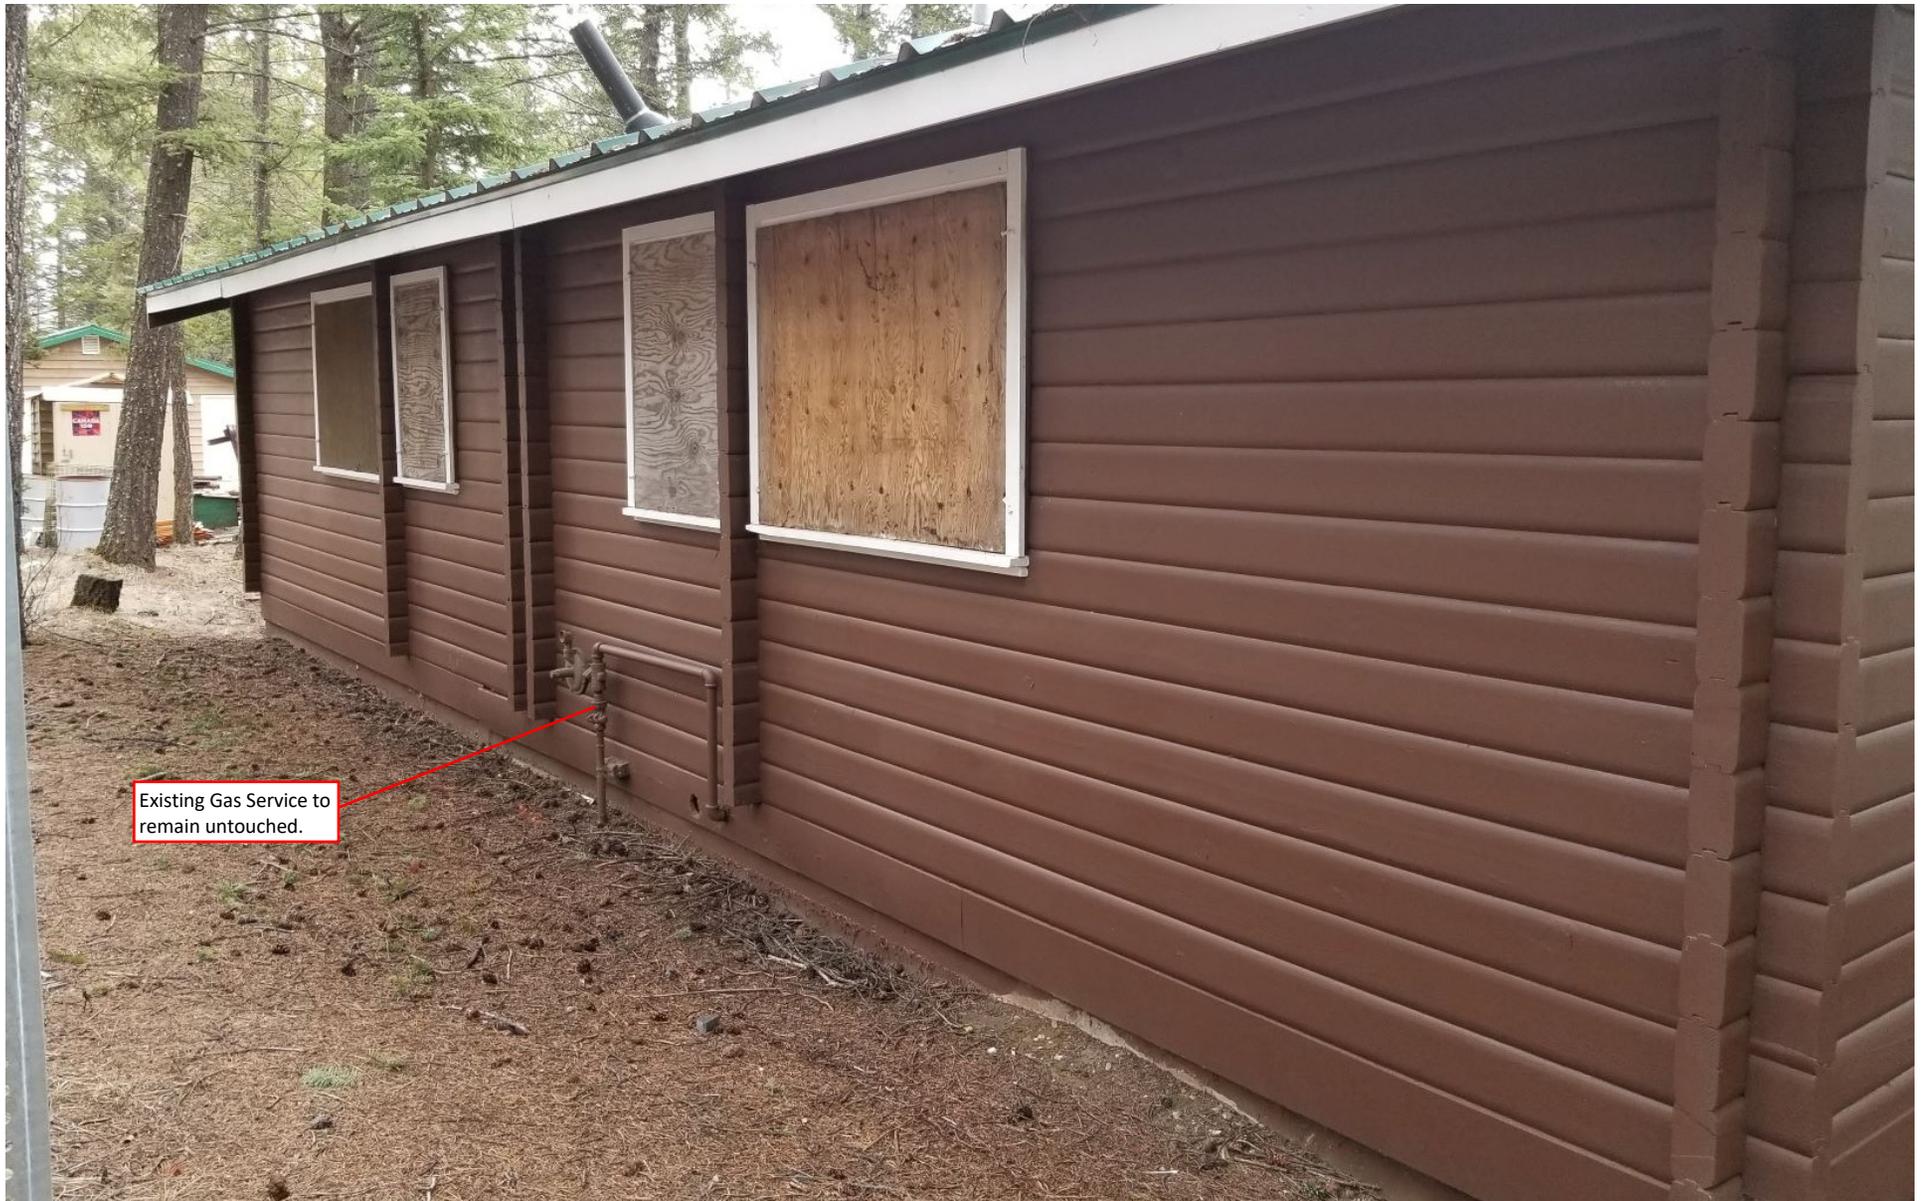
FIGURE 8c – Staff House 5/6 Utility Tie-In Details (North Side of Building)

1. No work is proposed to take place along the north and south sides of Cabin 5/6.

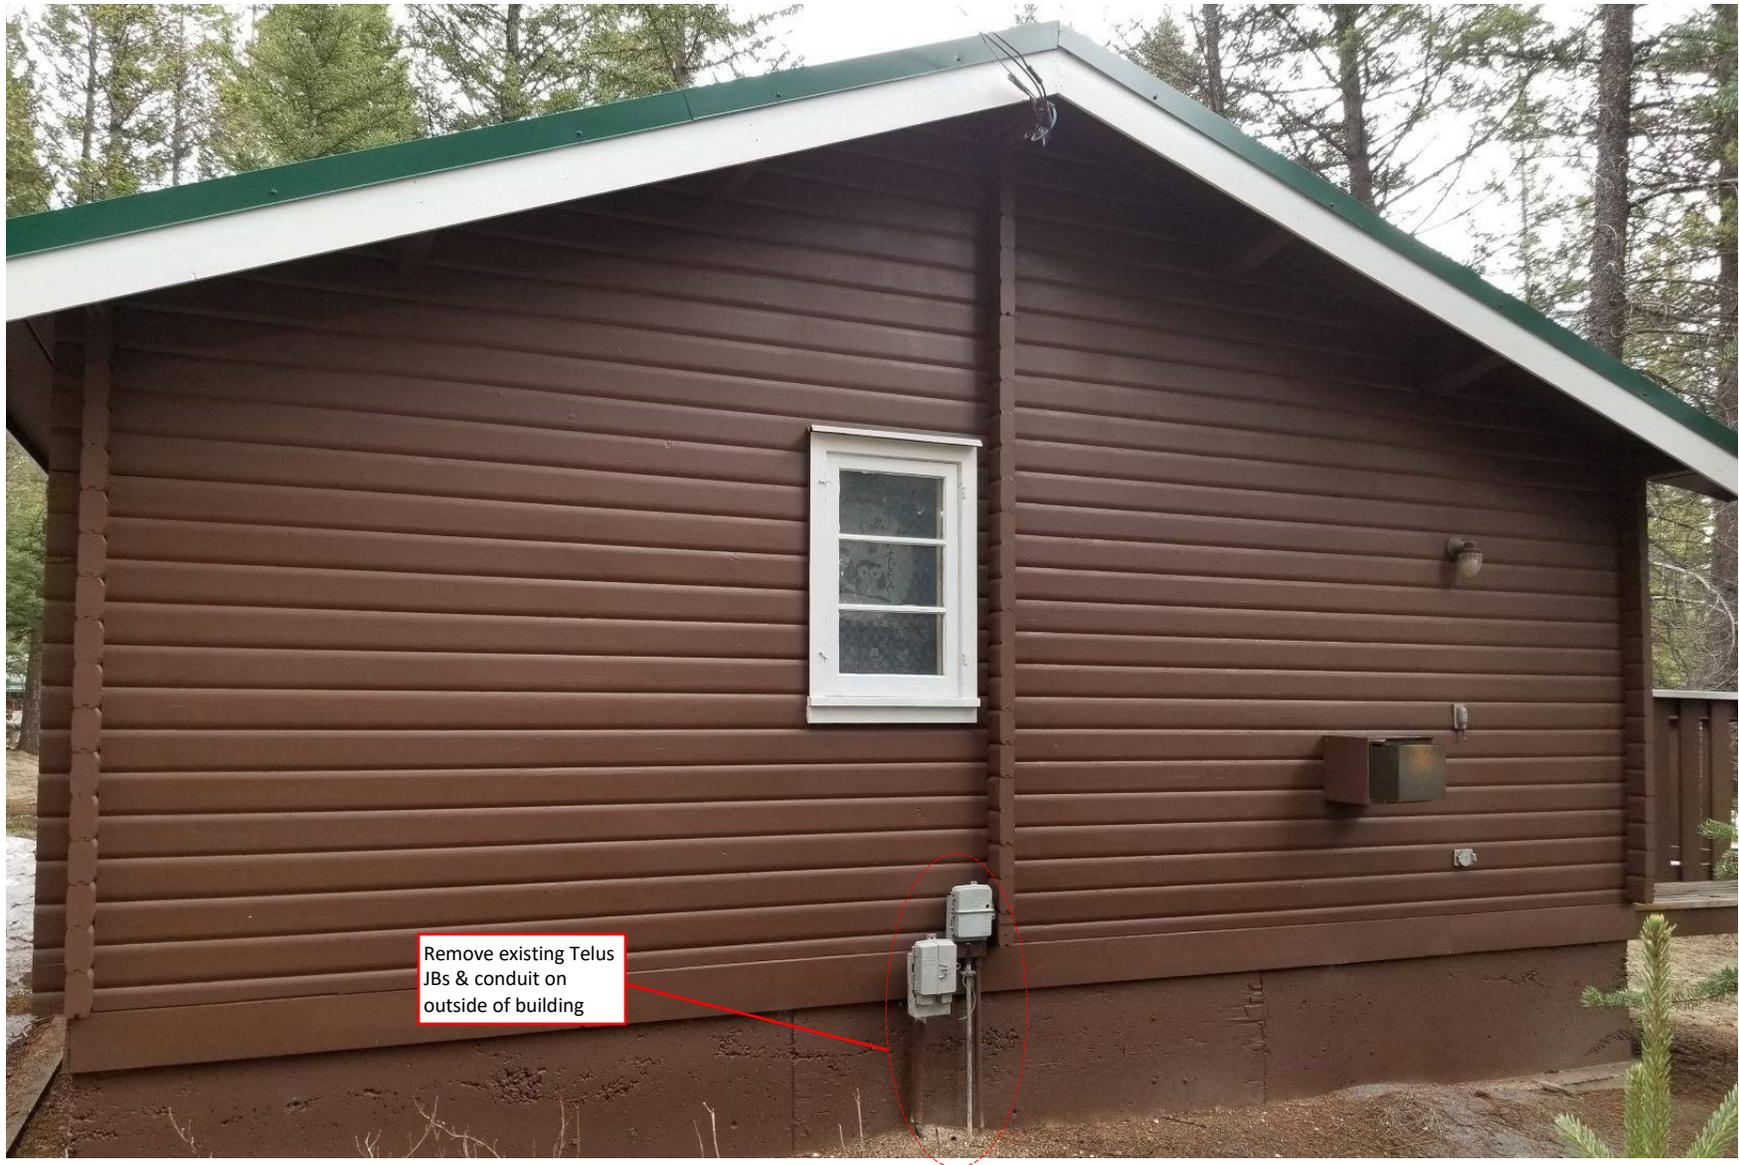
FIGURE 9a– Staff House 7/8 Utility Tie-In Details (West Side of Building)

1. Contractor is required to repair all holes in siding resulting from removal of existing utilities from side of building.
