Tunnel Mountain Campground Operations Area Shallow Utilities Rehabilitation – Phase 1

APPENDIX A

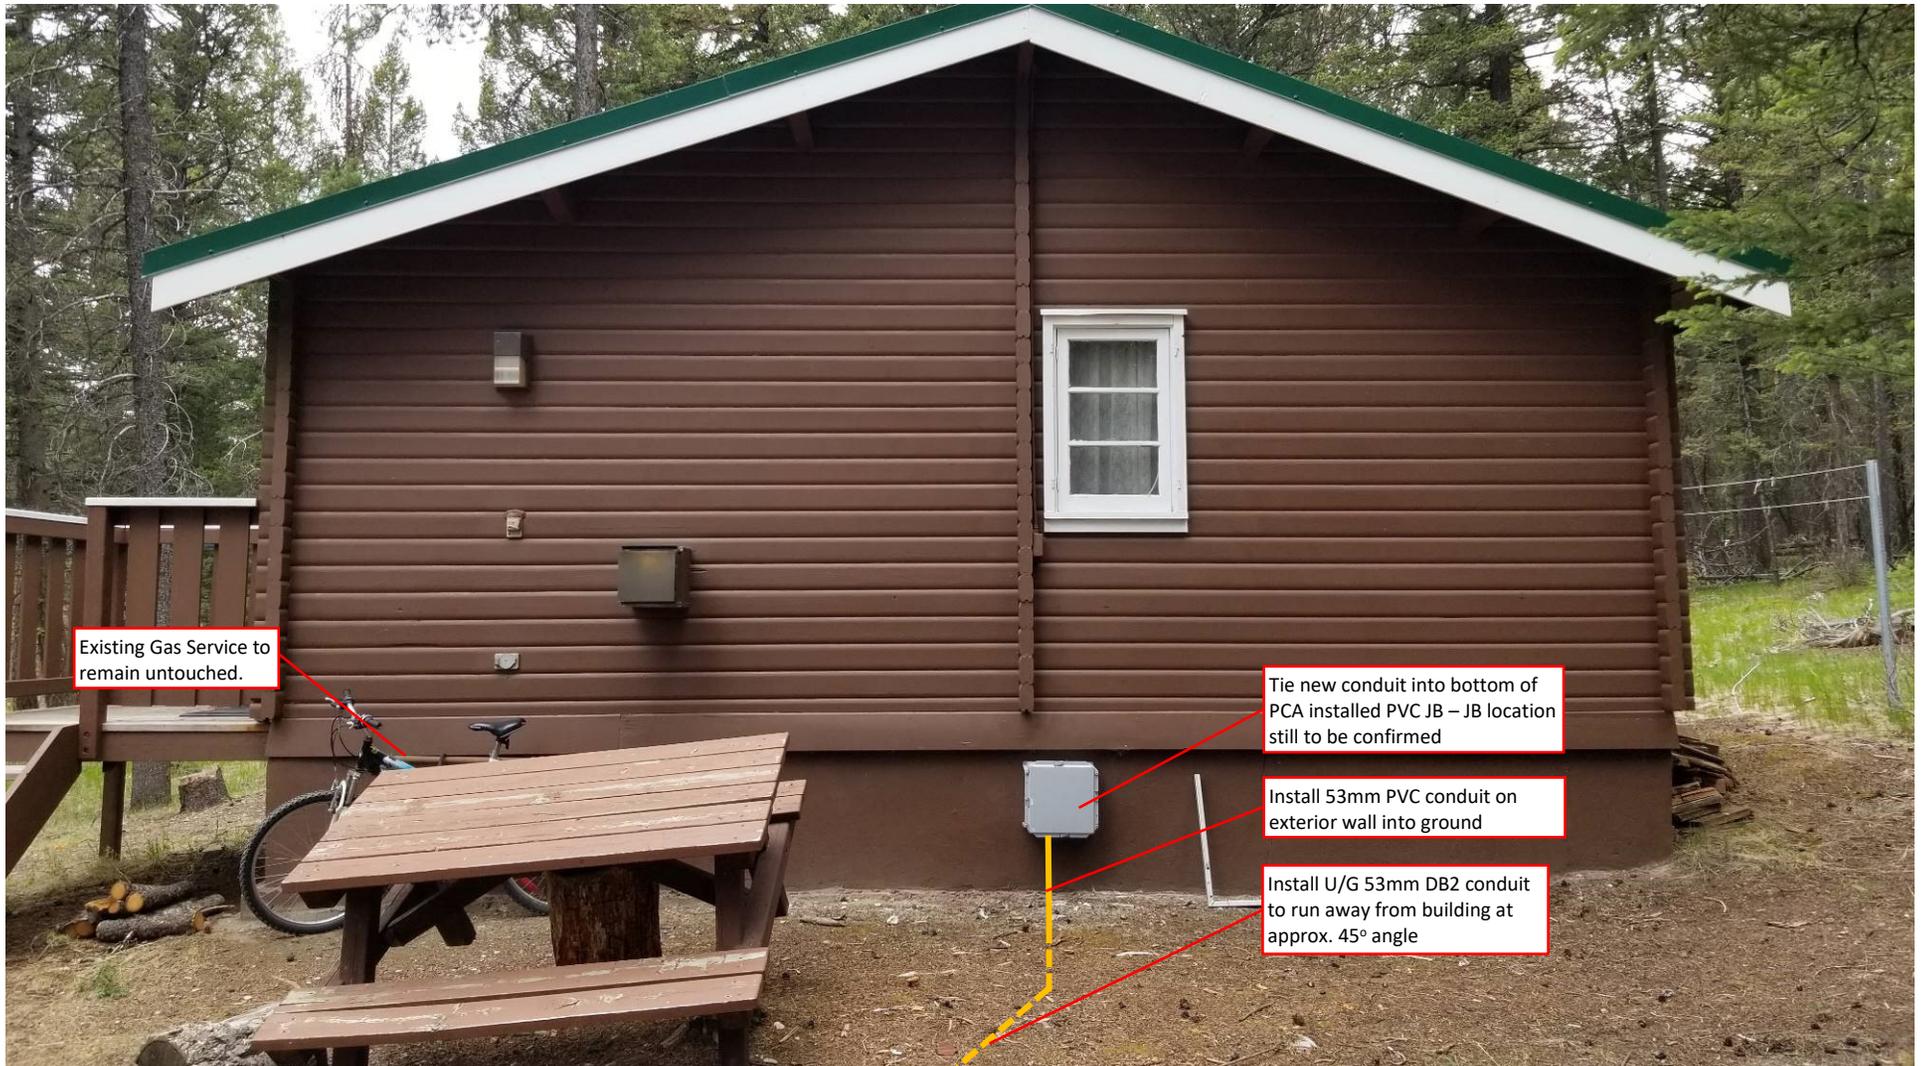
FIGURE 9b– Staff House 7/8 Utility Tie-In Details (East Side of Building)

1. See Drawing E1.3 for DB2 U/G conduit installation details. DB2 conduit to transition to PVC on CDP and U/G JB side of vertical bend.
2. Contractor is to tie new 53mm PVC conduit into bottom of existing PVC JB previously installed by PCA.
3. Contractor is required to expose U/G gas line as required to allow for new U/G electrical to be installed in vicinity of existing U/G gas line.

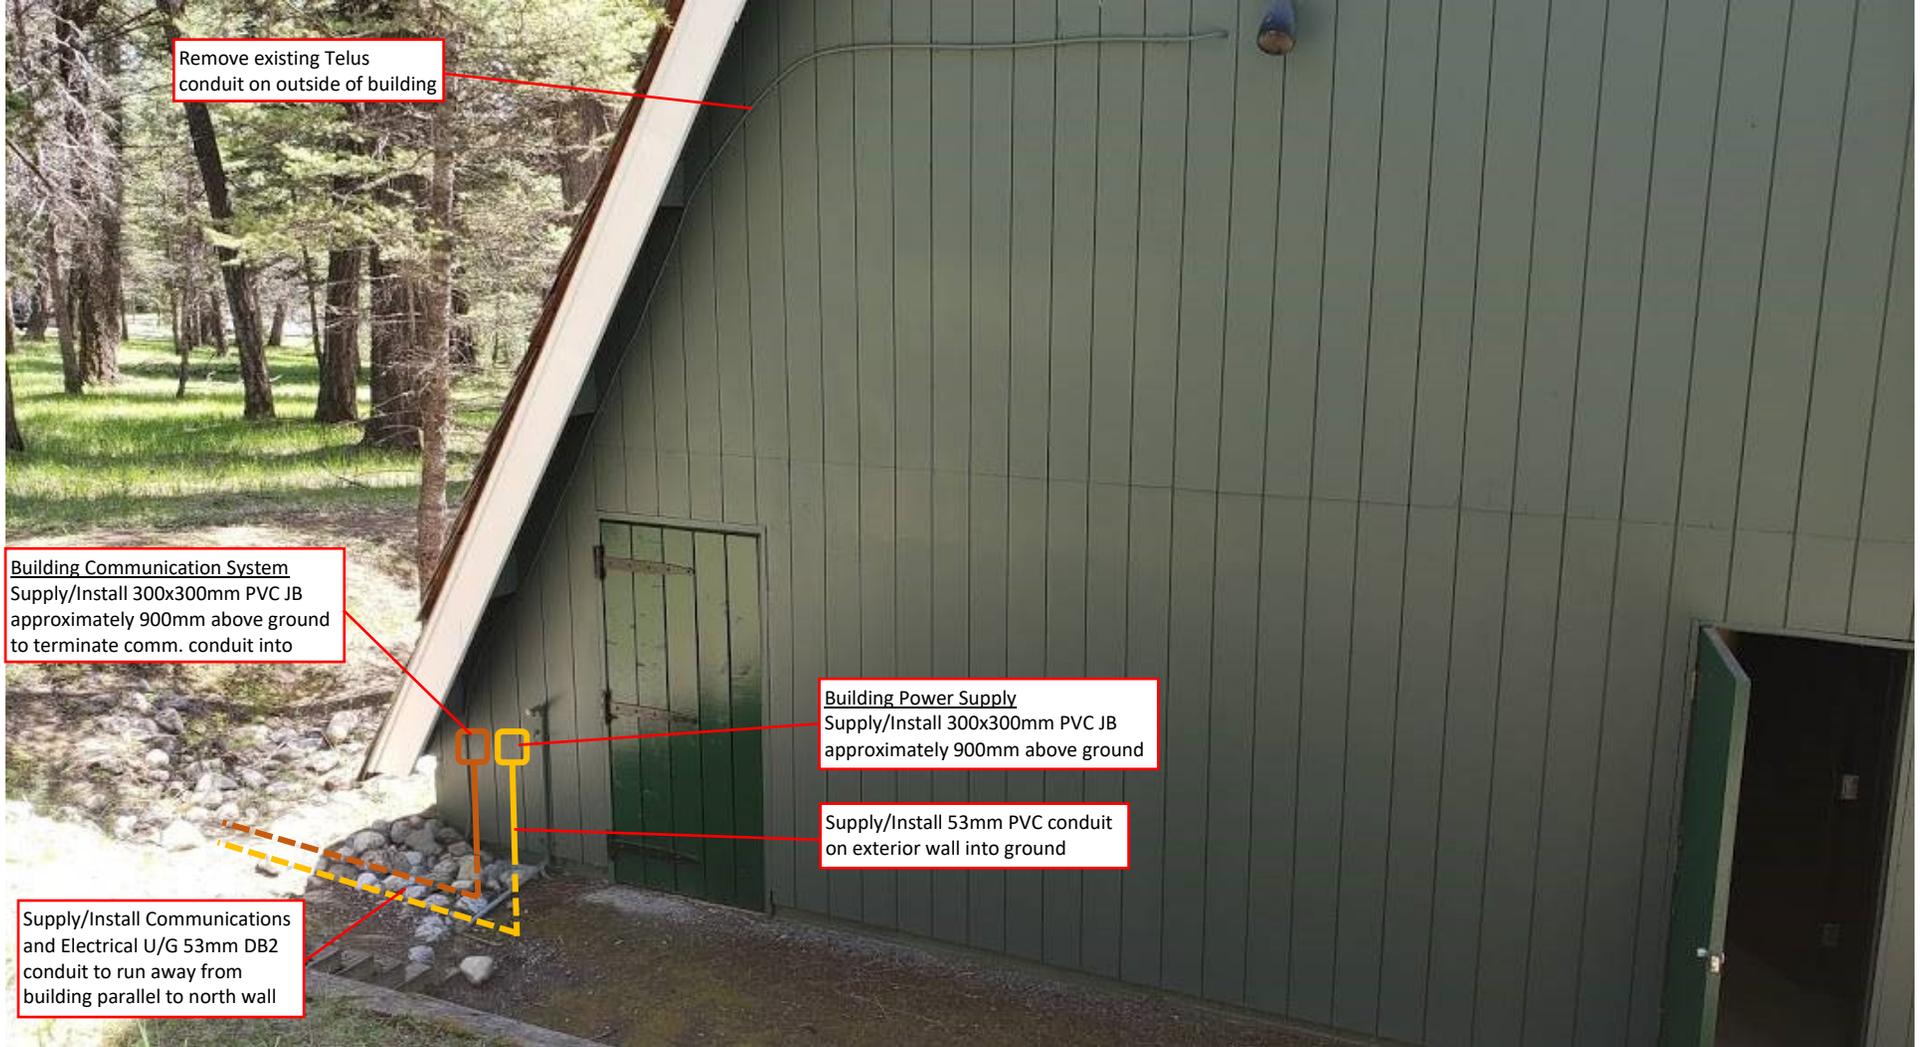
Figure 10 – Theatre Building Utility Tie-in Details (North Side of Building)

1. Contractor is required to repair all holes in siding resulting from removal of existing utilities from side of building.
2. See Drawing E1.3 for DB2 U/G conduit installation details. DB2 conduit to transition to PVC on CDP side of vertical bend.
3. Existing waterline in area to be left in place; waterline is currently not in service.
