Conférence des soumissionnaires – DP pour les services de surveillance environnementale du projet d’assainissement de la mine Faro EZ897-220593/A

Projet d’assainissement la mine Faro

Région du Pacifique de SPAC

14 décembre 2021

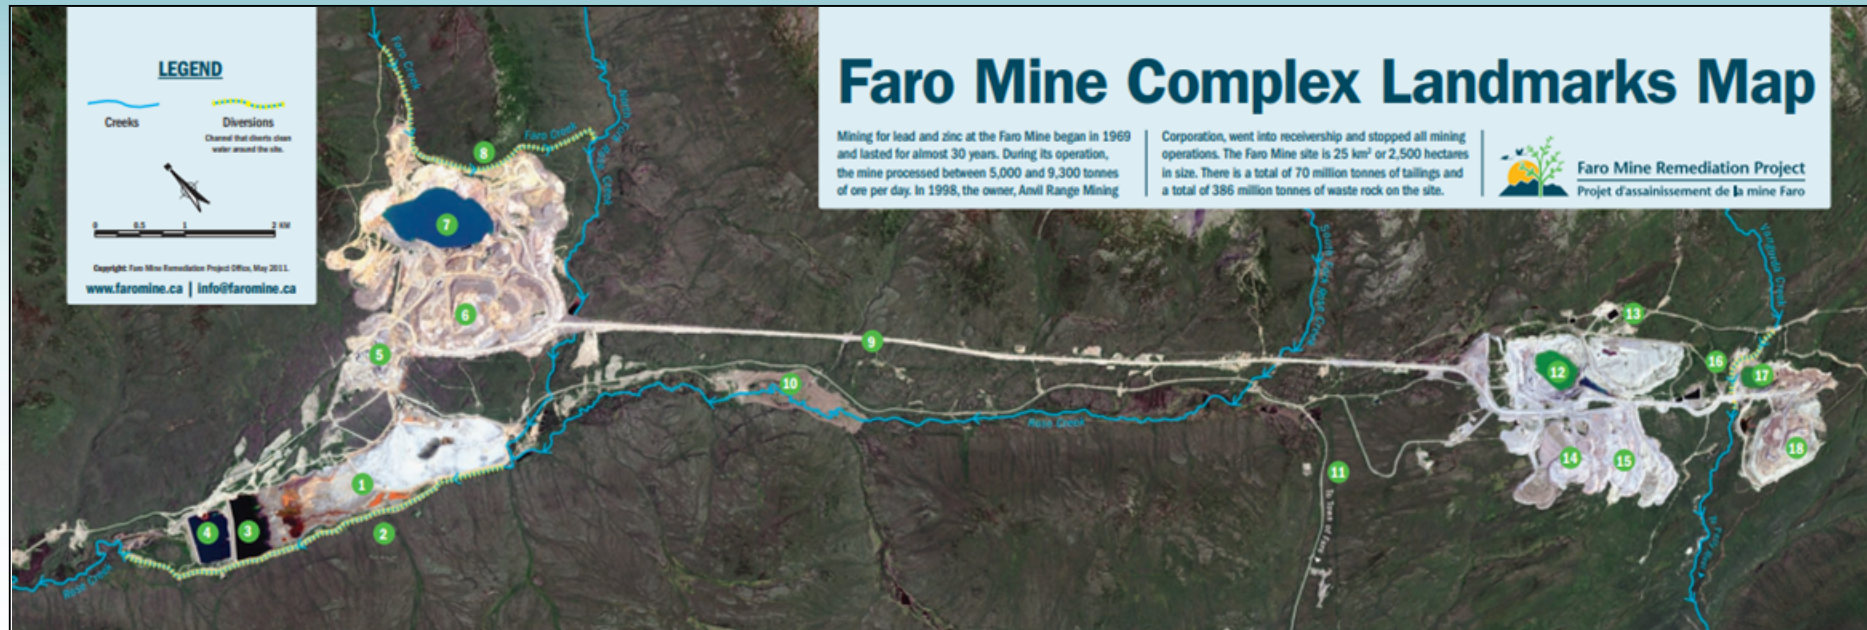
Faro Mine Complex Landmarks Map

Mining for lead and zinc at the Faro Mine began in 1969 and lasted for almost 30 years. During its operation, the mine processed between 5,000 and 9,300 tonnes of ore per day. In 1998, the owner, Amal Range Mining

Corporation, went into receivership and stopped all mining operations. The Faro Mine site is 25 km² or 2,500 hectares in size. There is a total of 70 million tonnes of tailings and a total of 386 million tonnes of waste rock on the site.

1. Rose Creek Tailings Area

This area is 4 km long and up to 1 km wide and located at the base of Rose Creek Valley. It holds over 55 million tonnes of tailings. Three dams (original, secondary and intermediate) hold the tailings in place. A fourth dam, the Cross Valley Pond, holds treated water.

3. Intermediate Pond & Dam

Pond where contaminated water is collected and pumped to the Faro Water Treatment Plant.

4. Cross Valley Pond & Dam

Pond where treated water is stored and tested. Water meeting acceptable standards is discharged into Rose Creek.

5. Mill Area - Faro Water Treatment Plant

The original mill structure was modified and is now used as a water treatment plant. Contaminated water from the Faro Pit is collected and treated at this plant.

7. Faro Pit

The pit is approximately 1,675 m long, 975 m wide and 335 m deep. It covers an area approximately 1.6 km² or 106 hectares.

12. Grum Pit

The pit is approximately 1,100 m long, 700 m wide and 200 m deep. It covers an area approximately 0.77 km² or 77 hectares. A bio-treatment program occurs in the pit to treat the water.

13. Vangorda Water Treatment Plant

Contaminated water from the Vangorda Pit is collected and treated at this plant. Water meeting acceptable standards is discharged into Vangorda Creek.

17. Vangorda Pit

The pit is approximately 1,150 m long, 350 m wide and 150 m deep. It covers an area approximately 0.42 km² or 42 hectares.
