Q&A #2 and ADDENDUM #2

Project: Renovation of Building 26 – Accommodation Fit-Up – Central Experimental Farm

PROJECT-SPECIFIC PAINT AND MORTAR ASSESSMENT AT BUILDING 26 OF THE CENTRAL EXPERIMENTAL FARM, IN OTTAWA, ONTARIO

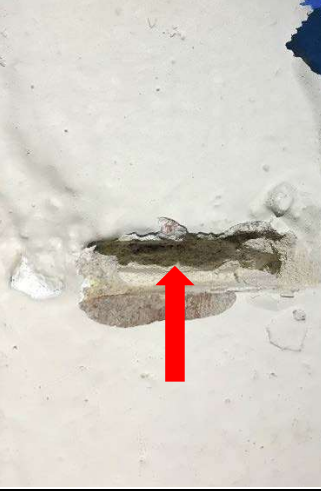
Material Description	Material Location	Observed Estimated Quantity	Condition	Friable (Yes / No)	Accessibility	Sample Number	Asbestos Concentration (%) and Type	Photograph
Mortar	Basement wall between storage rooms B-5 and B-6	N/A ⁽¹⁾	N/A	N/A	N/A	A-001A to A-001C	None Detected

(1) "N/A" indicates not applicable. Sampled material contains less than 1% and less than 0.5% of asbestos by weight and is not considered to be an ACM in accordance with the COHSR and O. Reg. 278/05, respectively.

Based on the analytical results, the mortar of the brick wall located between the basement storage rooms B-5 and B-6 is not considered to be an ACM. There is a possibility that additional ACMs may be present in concealed and inaccessible spaces that may not have been observed or assessed as part of the scope of work. If additional suspected ACMs that were not previously identified are encountered during repair, renovation, construction, or demolition operations that are not included in this report, work must be stopped, and further investigation must be conducted at that time. In the case where suspected ACMs cannot be tested, they must be treated as ACMs in accordance with the by the COHSR, O. Reg. 278/05 and the PSPC *Asbestos Management Standard* until tested and proven otherwise by laboratory analysis.

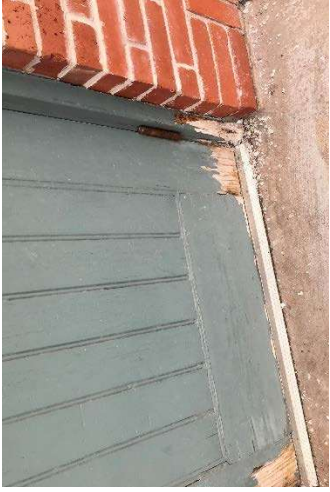
- Green paint on the exterior front door frame, containing lead at 3,300 ppm.
- Dark green paint on the front door overhang, containing lead at 67,000 ppm.

Green paint / Exterior front door frame	Good to poor	3,300		L-011	Yes

- Disturbance of LCMs during demolition operations must be conducted in accordance with the COHSR, the OHSA and the Ministry of Labour, Training and Skills Development (MLTSD) Lead Guideline¹.
- If LCMs are to be removed, they must be sent to a Ministry of the Environment Conservation and Parks (MECP) licensed recycling or disposal facility. The abatement/demolition contractor must be responsible to recover this material and prevent it from going to a landfill. If recycling of the lead is not completed, then it must be disposed of in an approved landfill.
- If additional materials not listed in this report that may contain lead are identified during abatement/demolition operations (e.g., lead sheeting, flashing, or solder), they must be treated as LCMs until tested and proven otherwise.

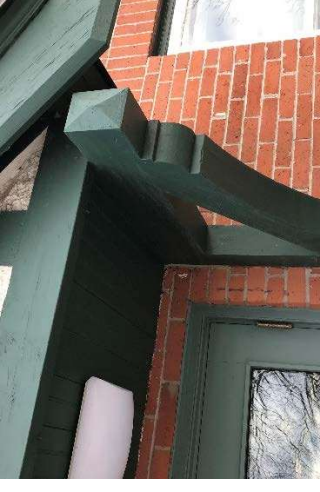
Dark green paint / Front door overhang	Good	67,000		L-012	Yes
