Tunnel Mountain Campground Operations Area Shallow Utilities Rehabilitation – Phase 1

APPENDIX A

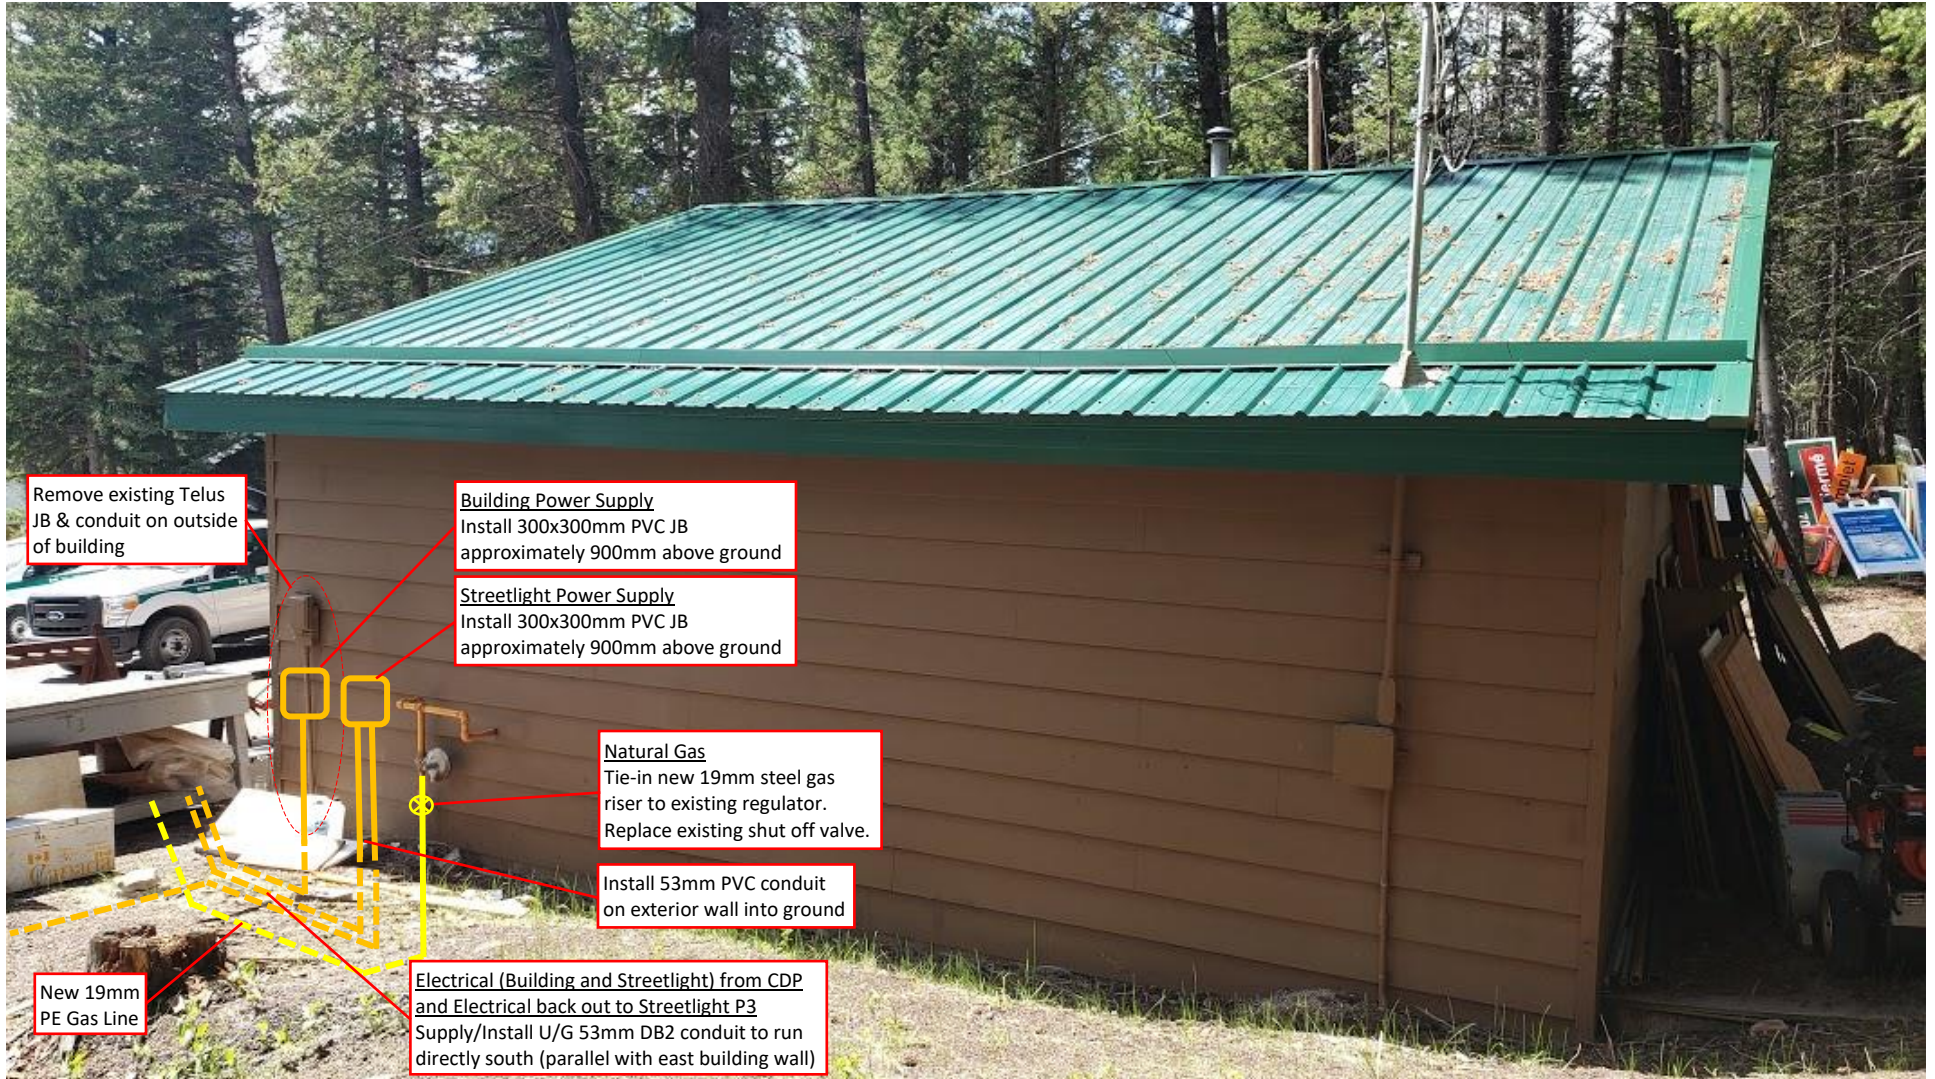
FIGURE 1 - Garage A Utility Tie-In Details (East Side of Building)

1. Contractor is required to repair all holes in siding resulting from removal of existing utilities from side of building.
2. See Drawing E1.3 for DB2 U/G conduit installation details. DB2 conduit to transition to PVC on CDP side of vertical bend.
3. New gas line is to run parallel to new U/G electrical conduit from CDP to building. See Drawing M1.0 for new gas service installation details.

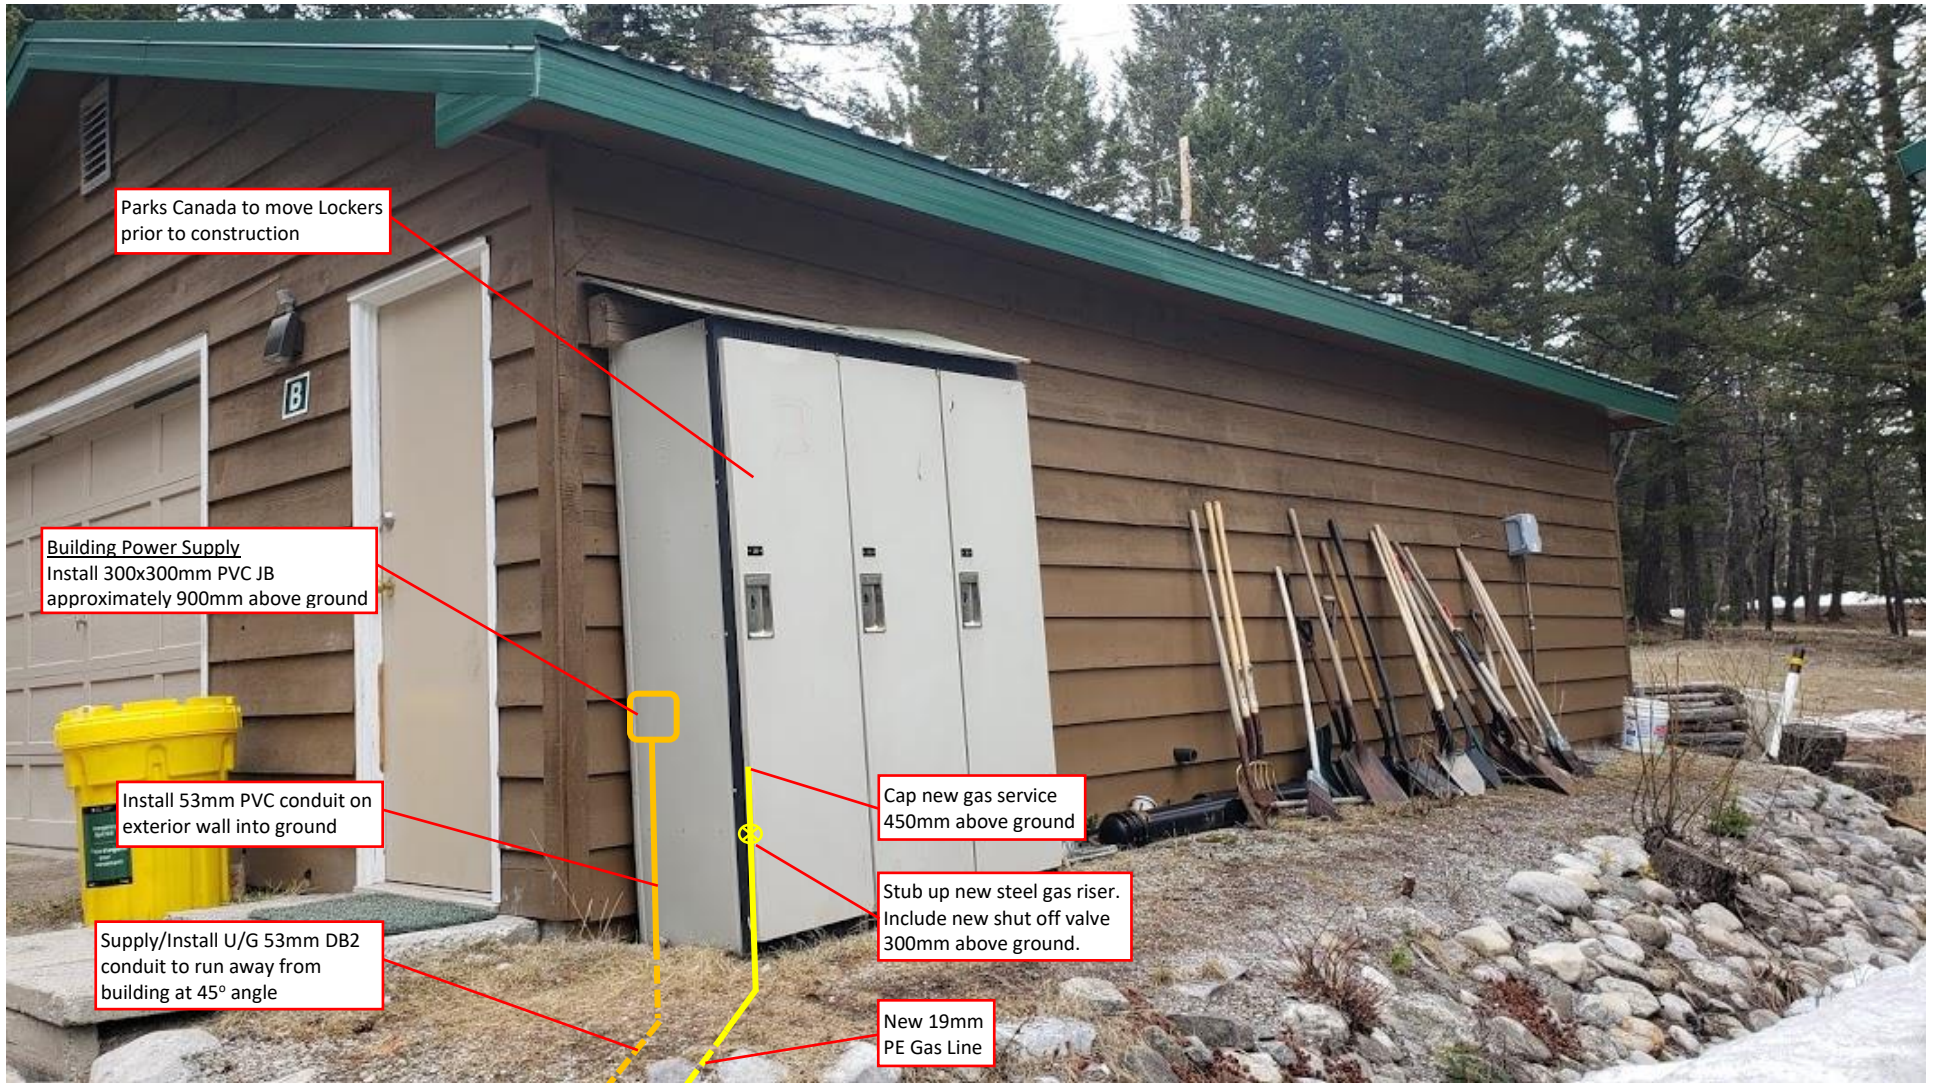
FIGURE 2 - Garage B Utility Tie-In Details (South Side of Building)

1. See Drawing E1.3 for DB2 U/G conduit installation details. DB2 conduit to transition to PVC on CDP side of vertical bend.
2. New gas line is to run parallel to new U/G electrical conduit from CDP to building. See Drawing M1.0 for new gas service installation details.

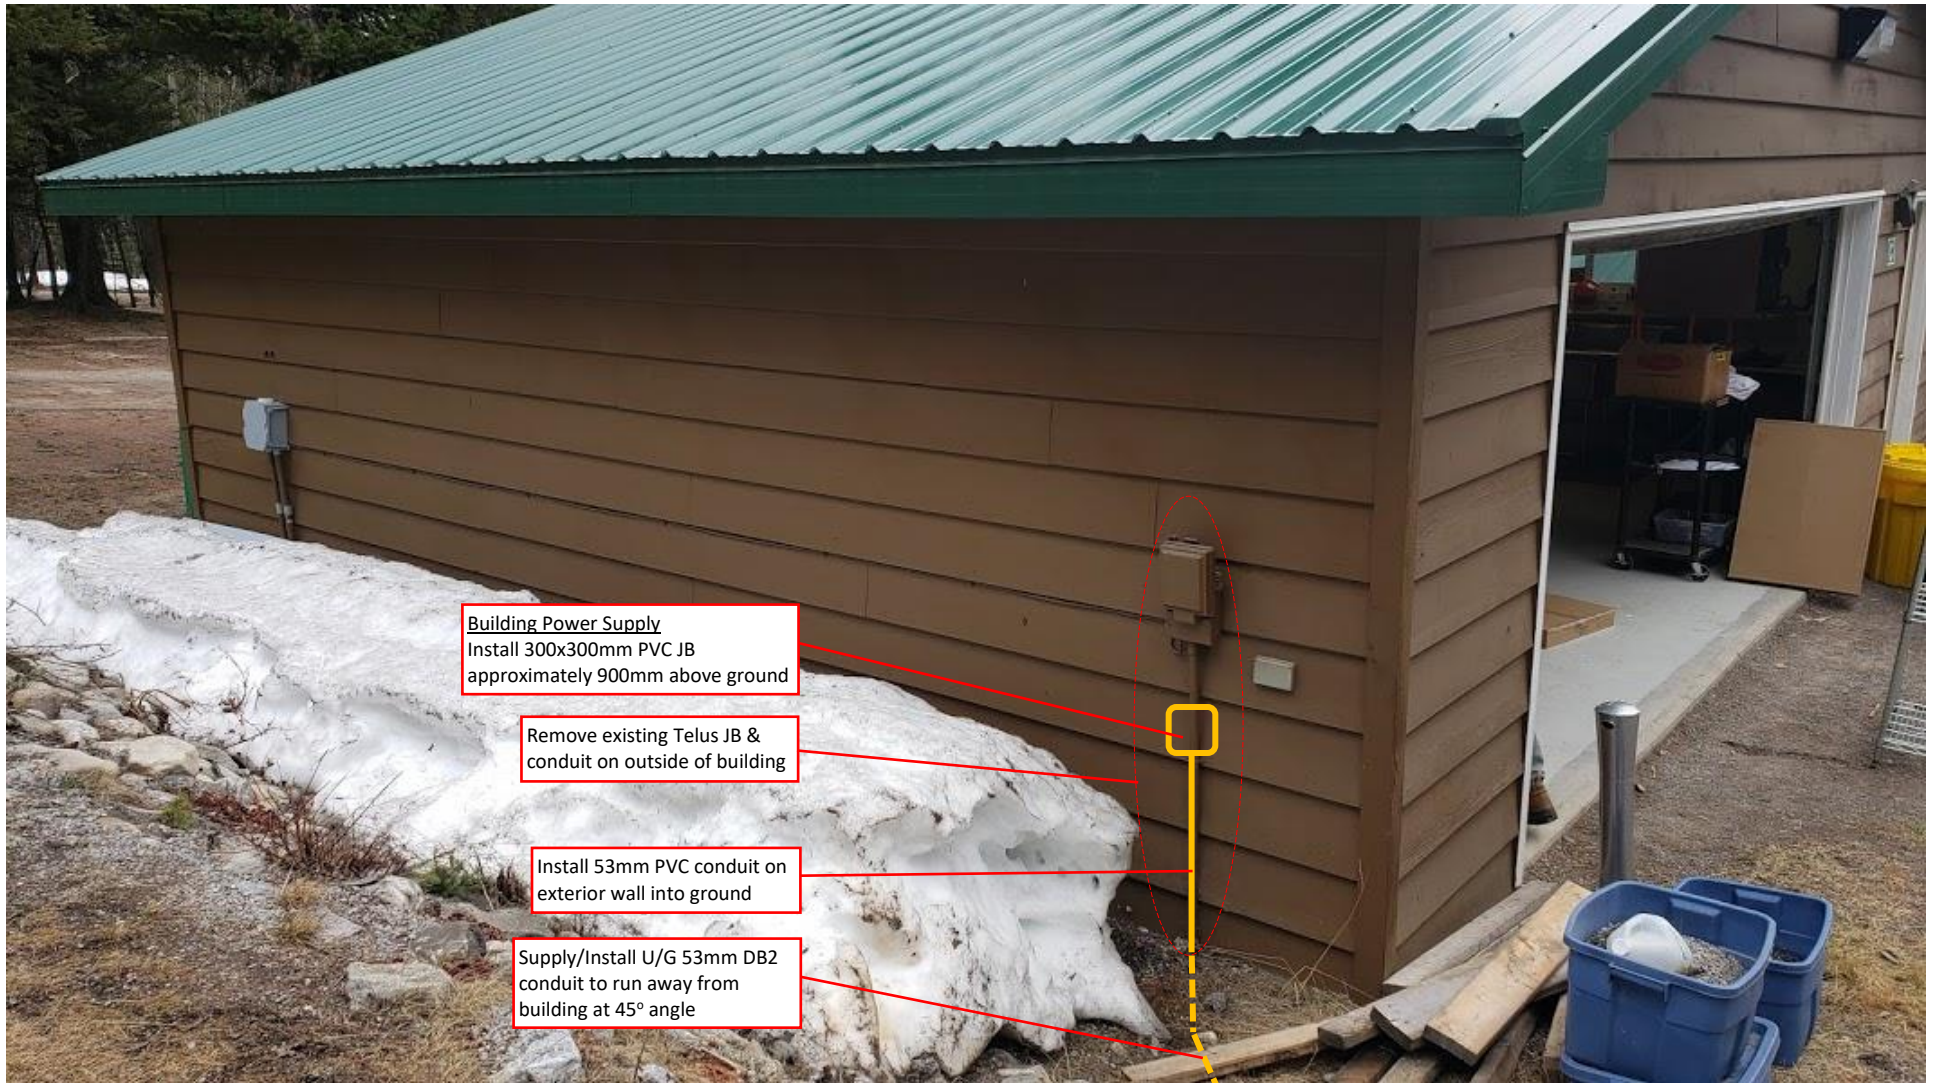
FIGURE 3a - Garage C Utility Tie-In Details (North Side of Building)

1. Contractor is required to repair all holes in siding resulting from removal of existing utilities from side of building.
2. See Drawing E1.3 for DB2 U/G conduit installation details. DB2 conduit to transition to PVC on CDP side of vertical bend.

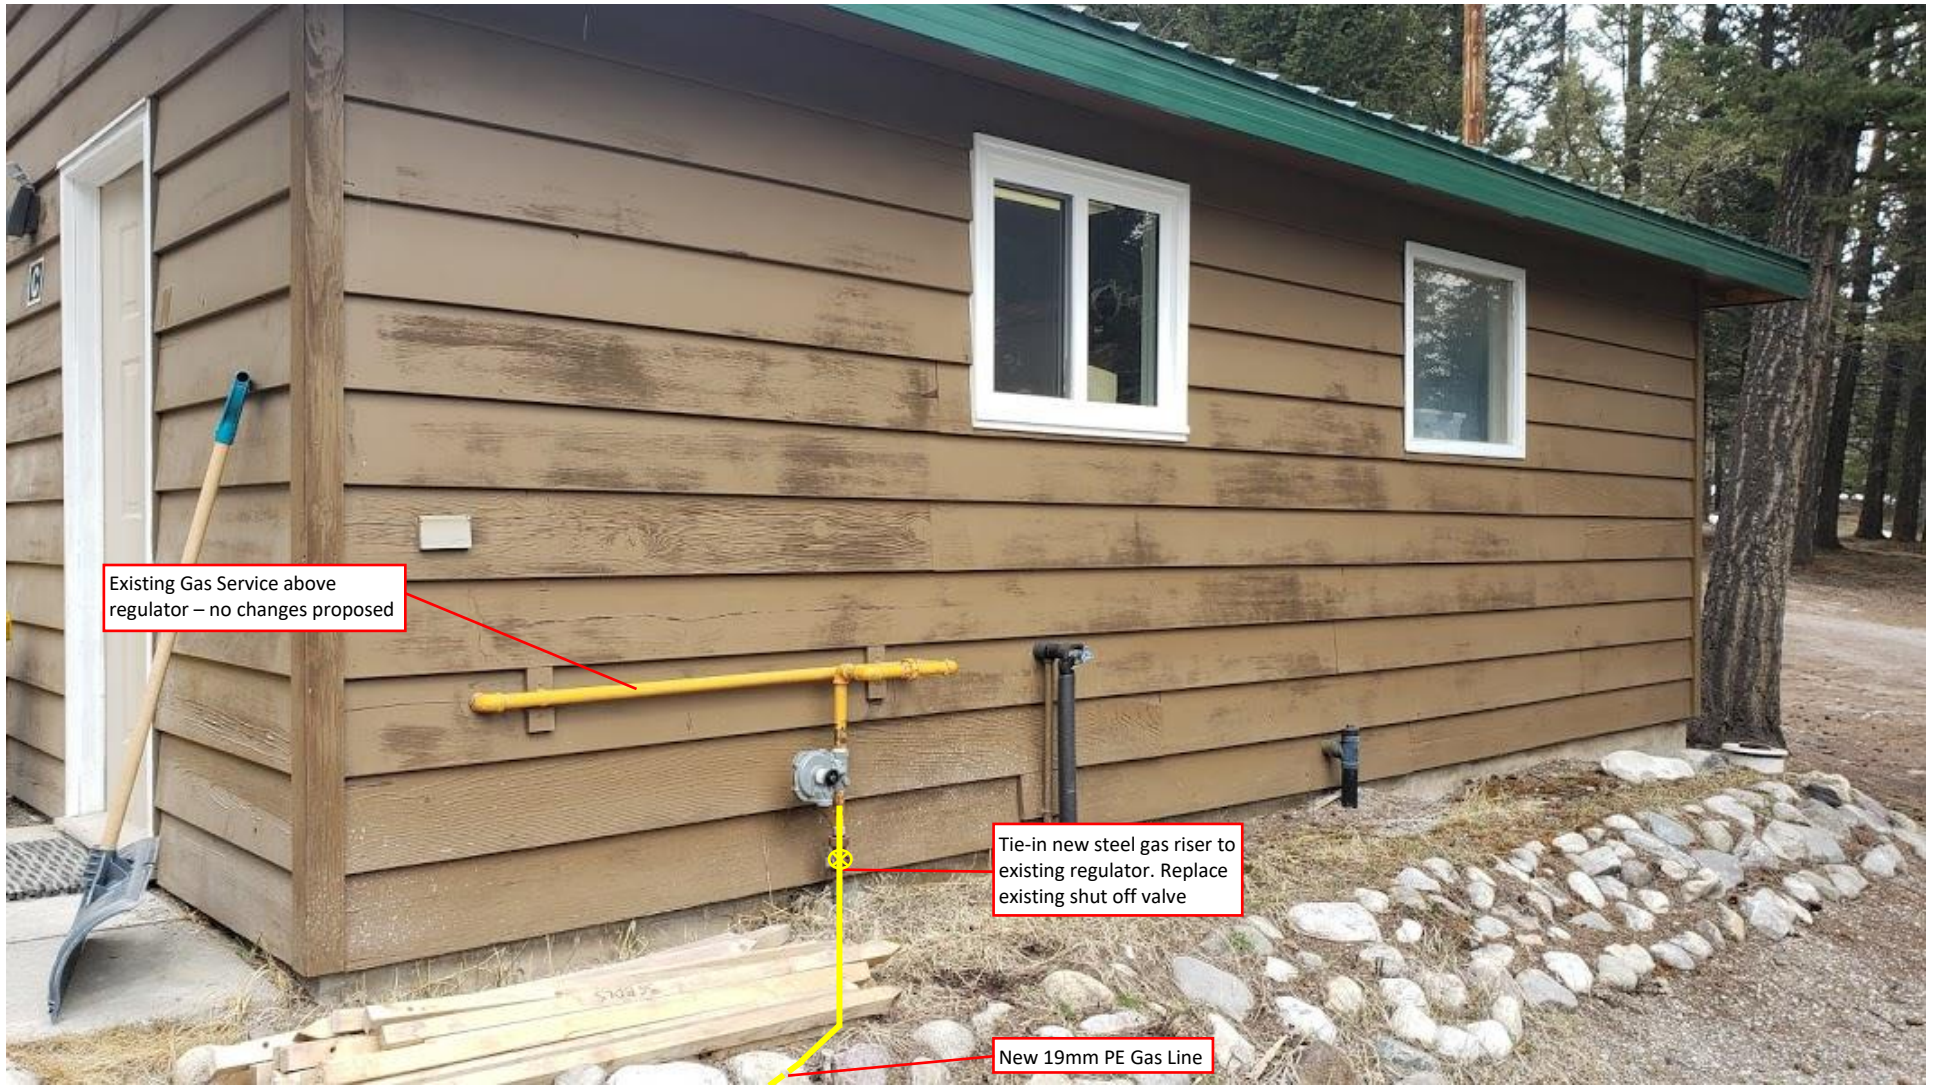
FIGURE 3b - Garage C Utility Tie-In Details (South Side of Building)

1. No electrical or communication services work planned for south wall of Garage C. Image is to show existing gas service only.
2. New gas line is to run on 45-degree angle away from wall to 1.5m away from wall then parallel to wall to new gas main perpendicularly. See Drawing M1.0 for new gas service installation details.

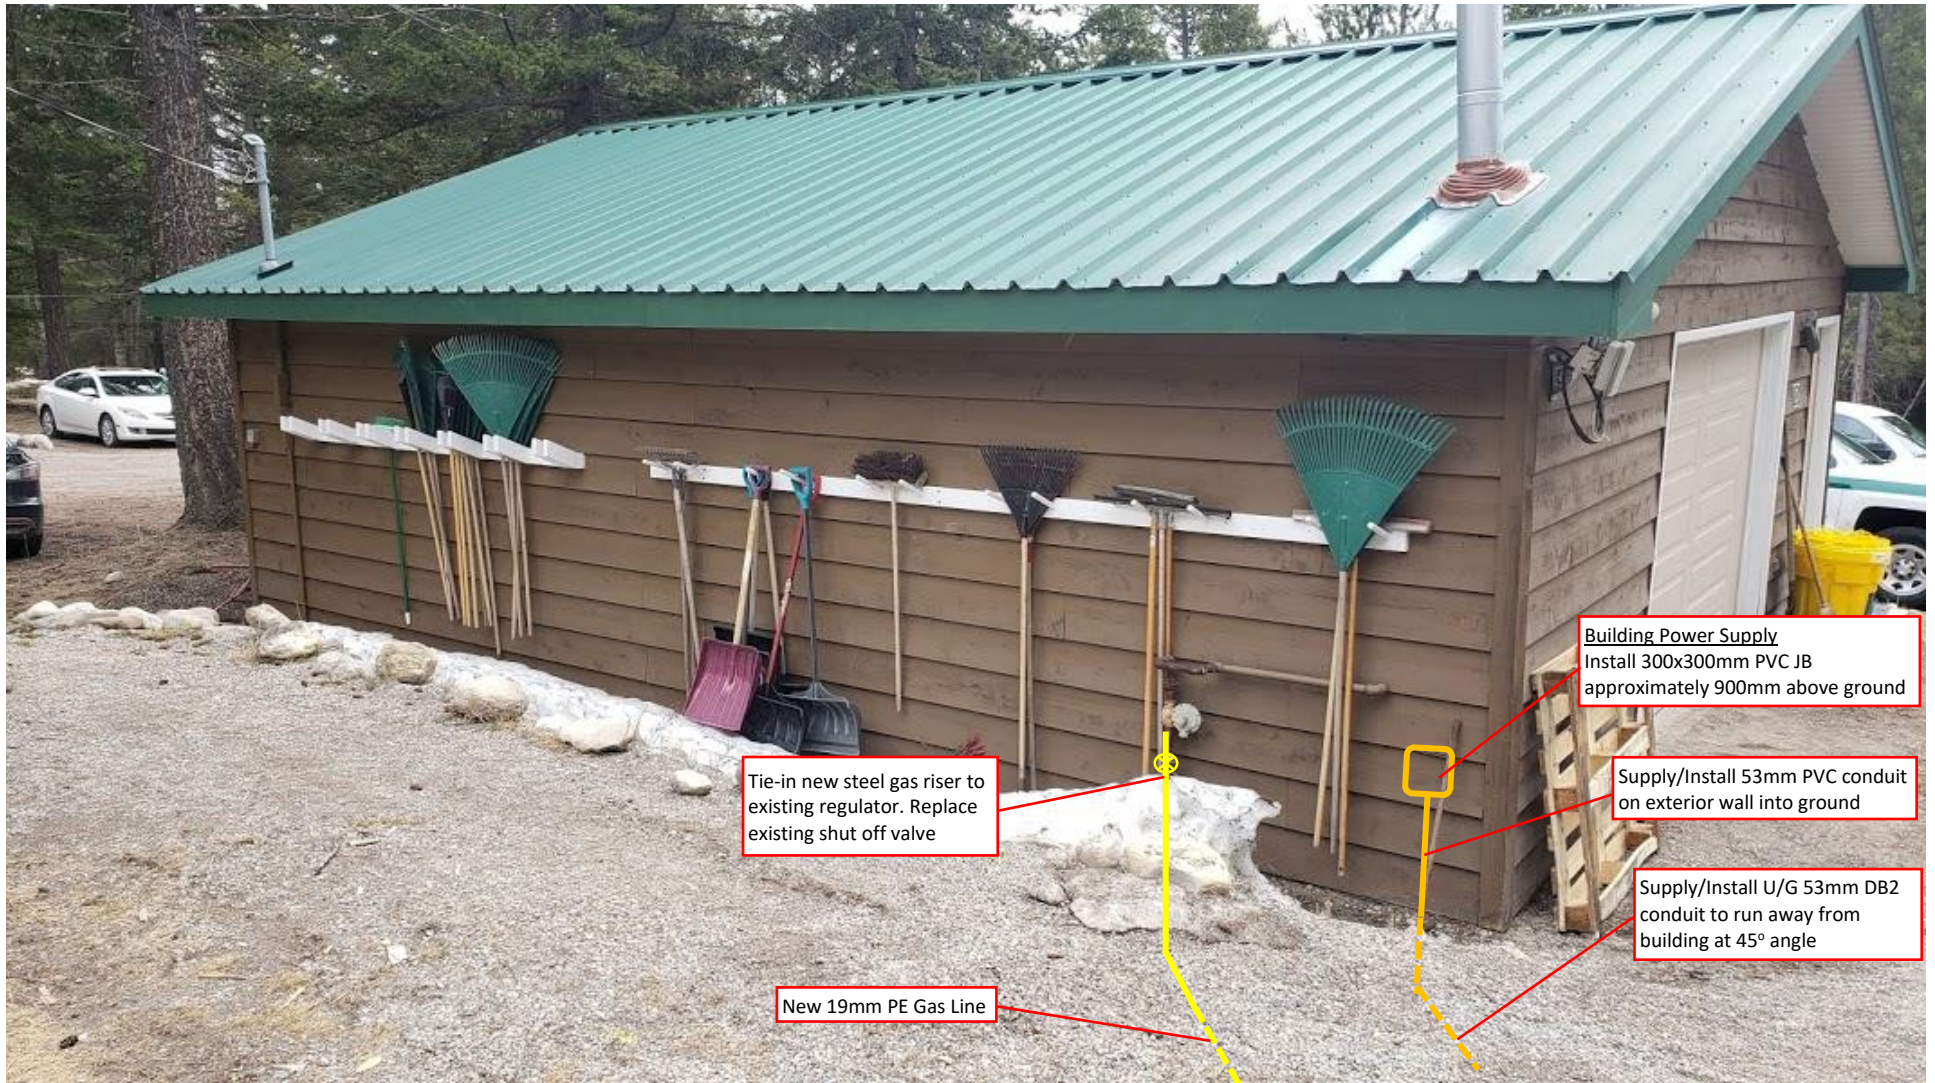
FIGURE 4a - Garage D Utility Tie-In Details (North Side of Building)

1. Contractor is required to repair all holes in siding resulting from removal of existing utilities from side of building.
2. See Drawing E1.3 for DB2 U/G conduit installation details. DB2 conduit to transition to PVC on CDP side of vertical bend.
3. New gas line is to run parallel to new U/G electrical conduit from CDP to building. See Drawing M1.0 for new gas service installation details.

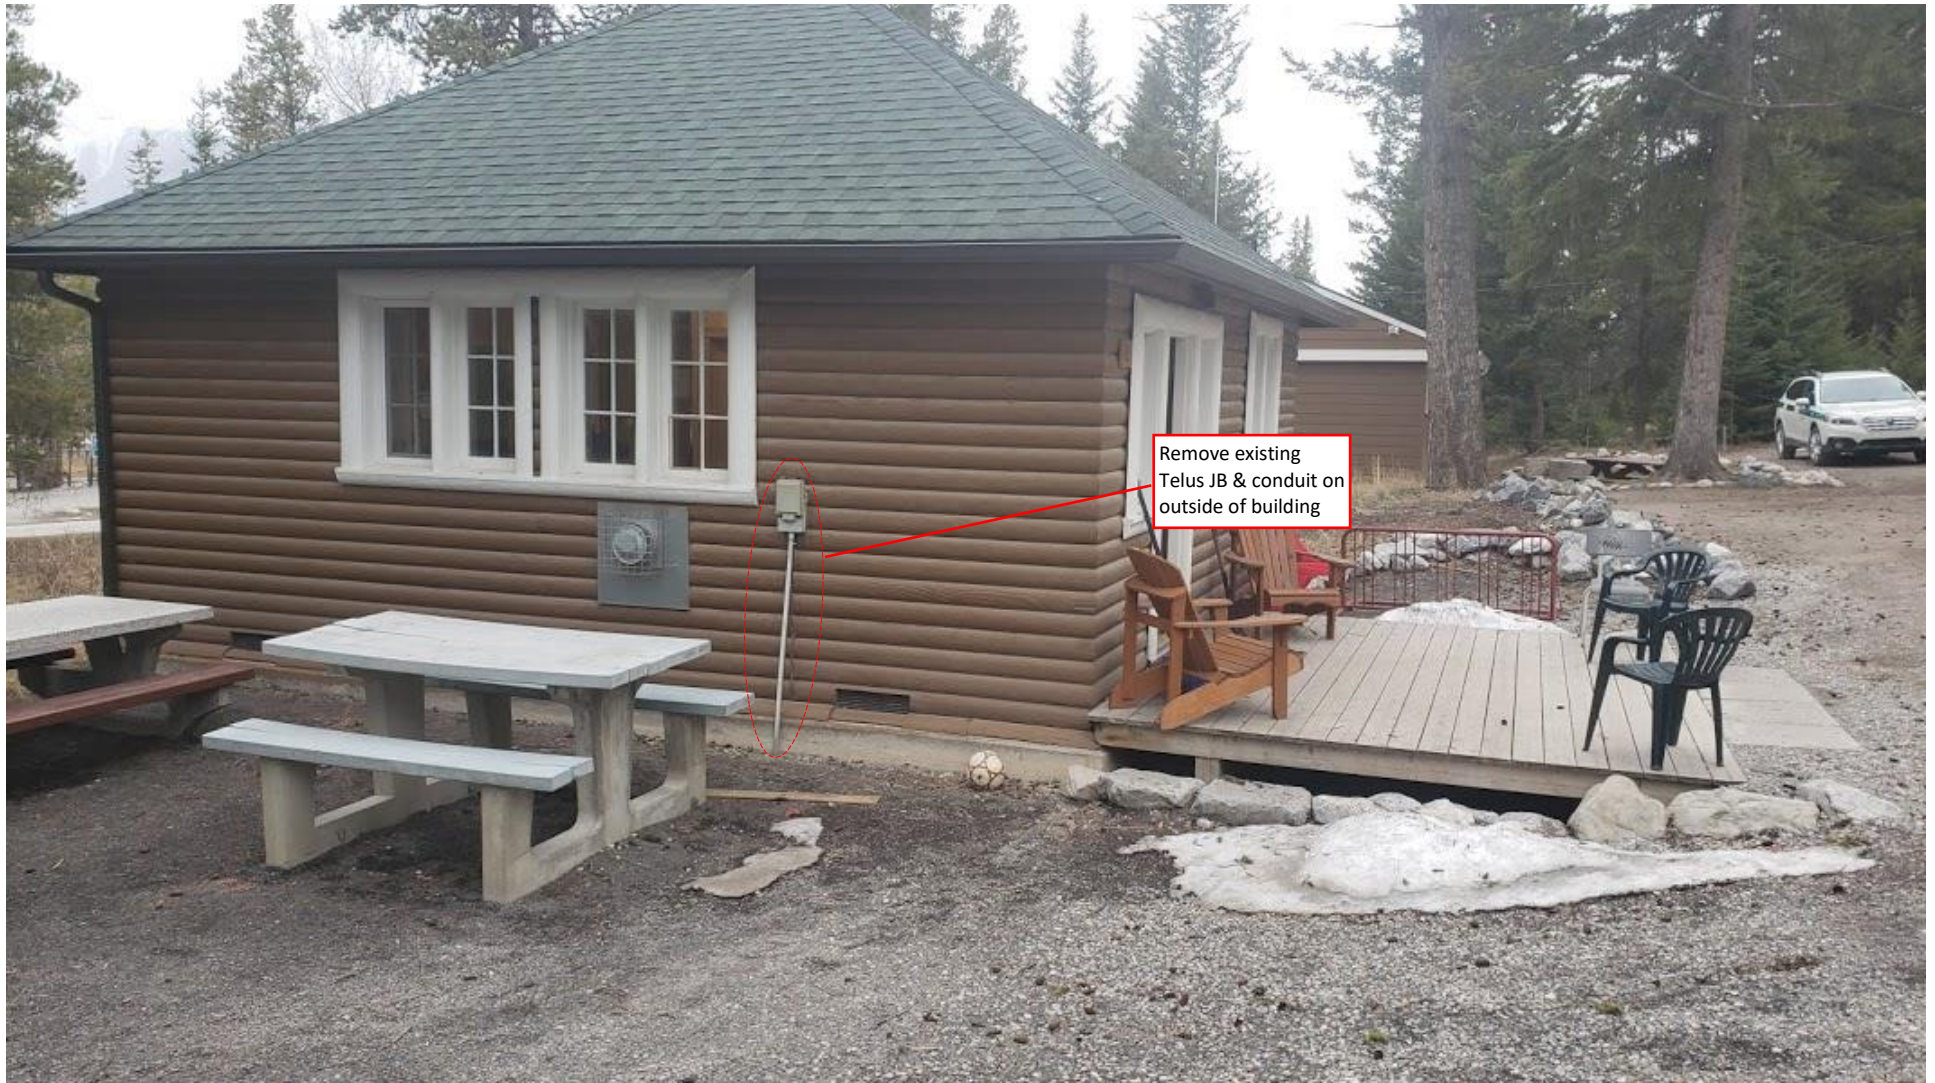
FIGURE 6b – Office #2 Utility Tie-In Details (East Side of Building)

1. Contractor is required to repair all holes in siding resulting from removal of existing utilities from side of building.

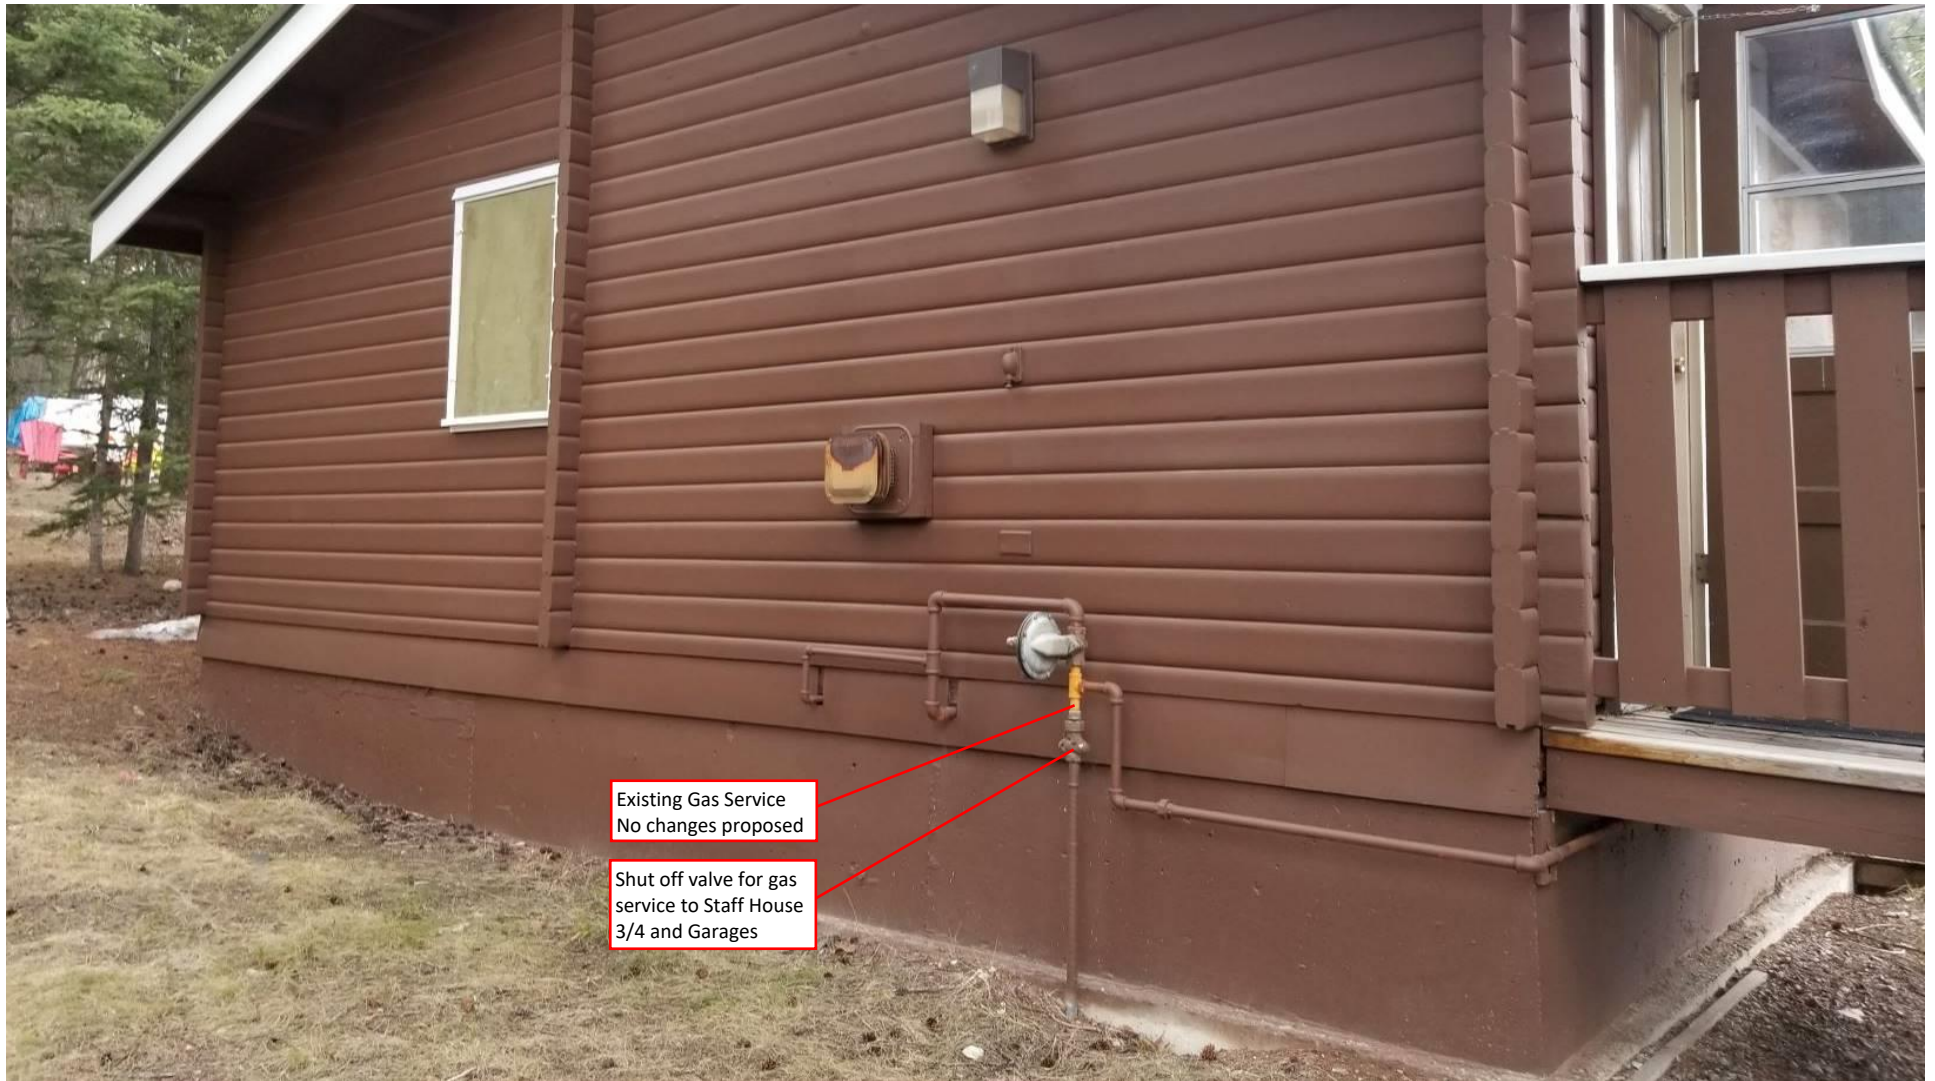
FIGURE 7b – Staff House 3/4 Utility Tie-In Details (West Side of Building)

1. No work is proposed to take place along the north, south and west sides of Cabin 3/4.

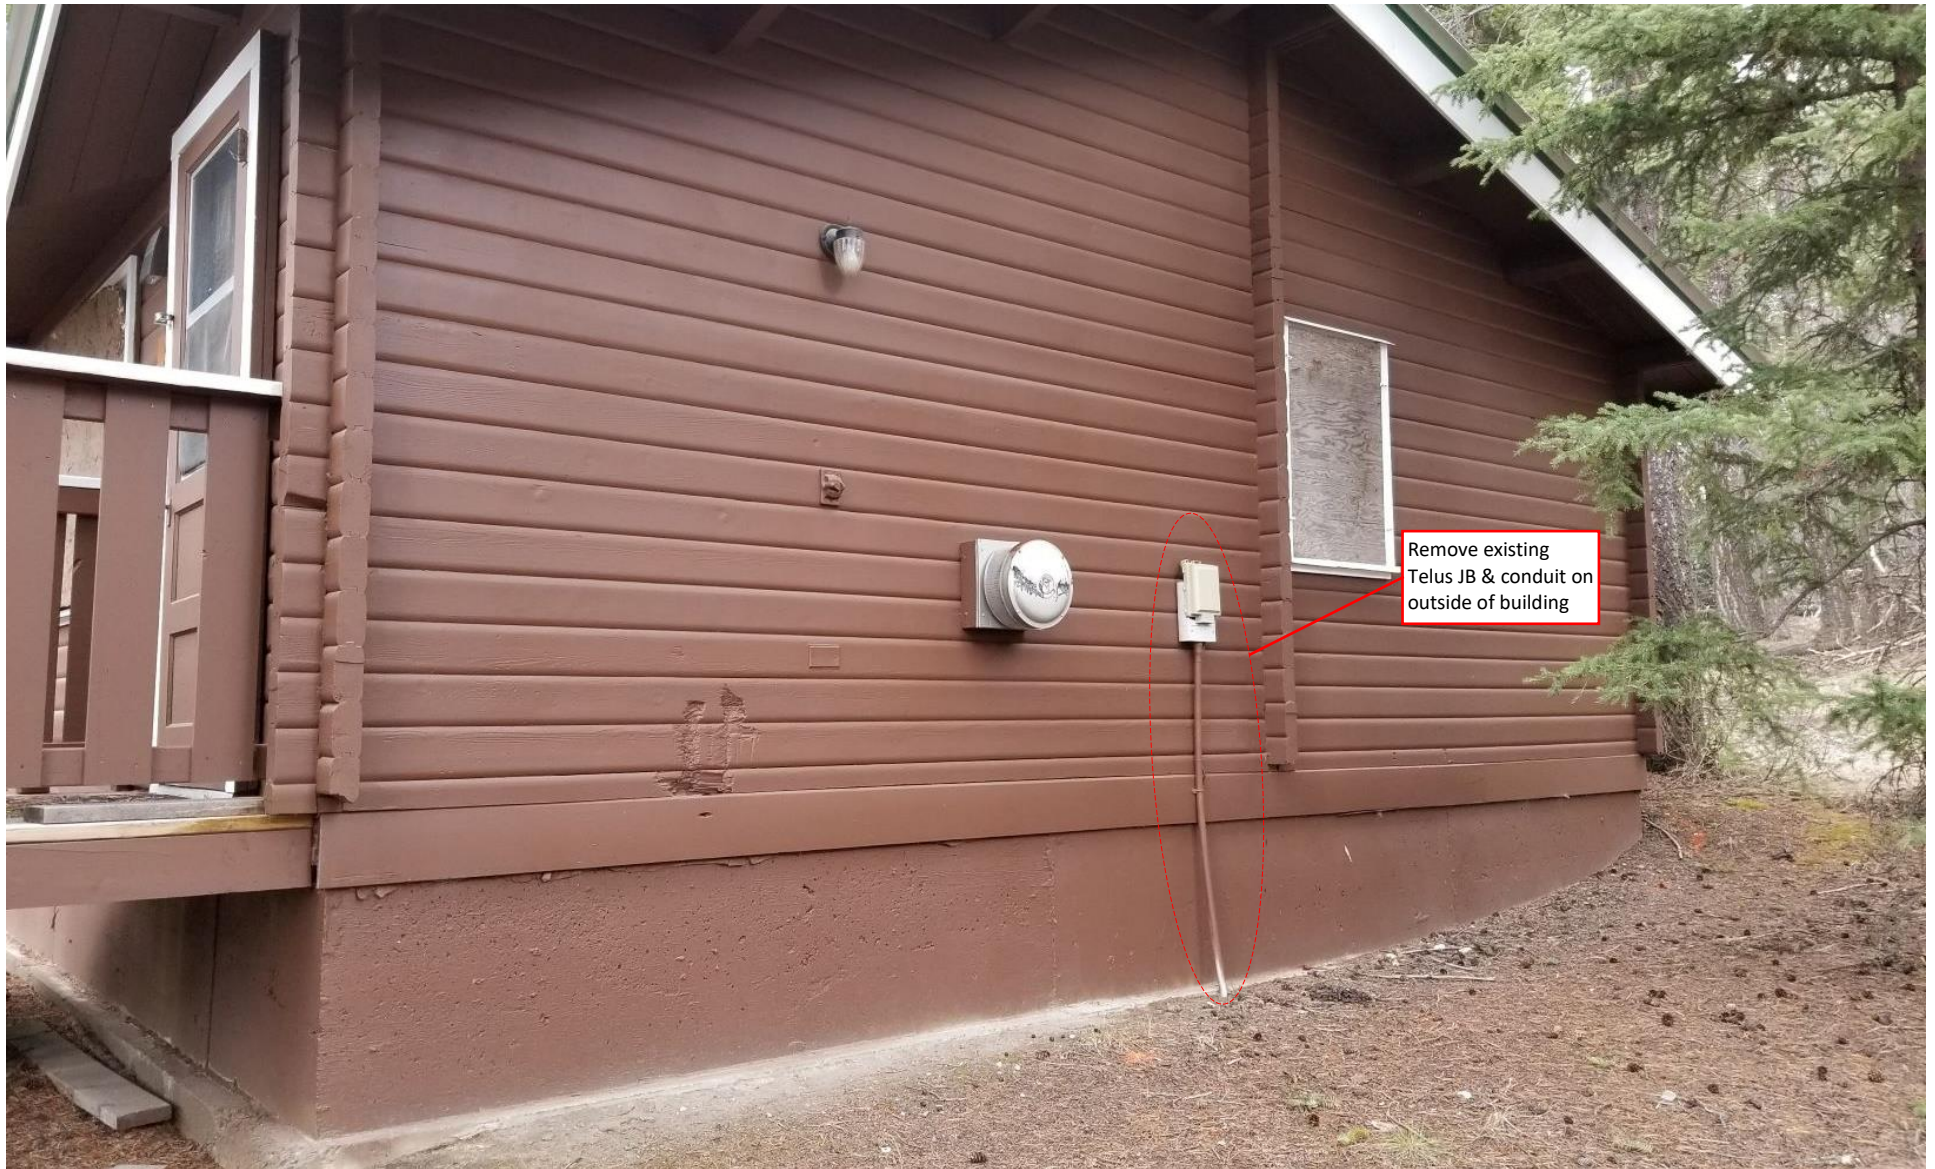
FIGURE 8a – Staff House 5/6 Utility Tie-In Details (East Side of Building)

1. Contractor is required to repair all holes in siding resulting from removal of existing utilities from side of building.

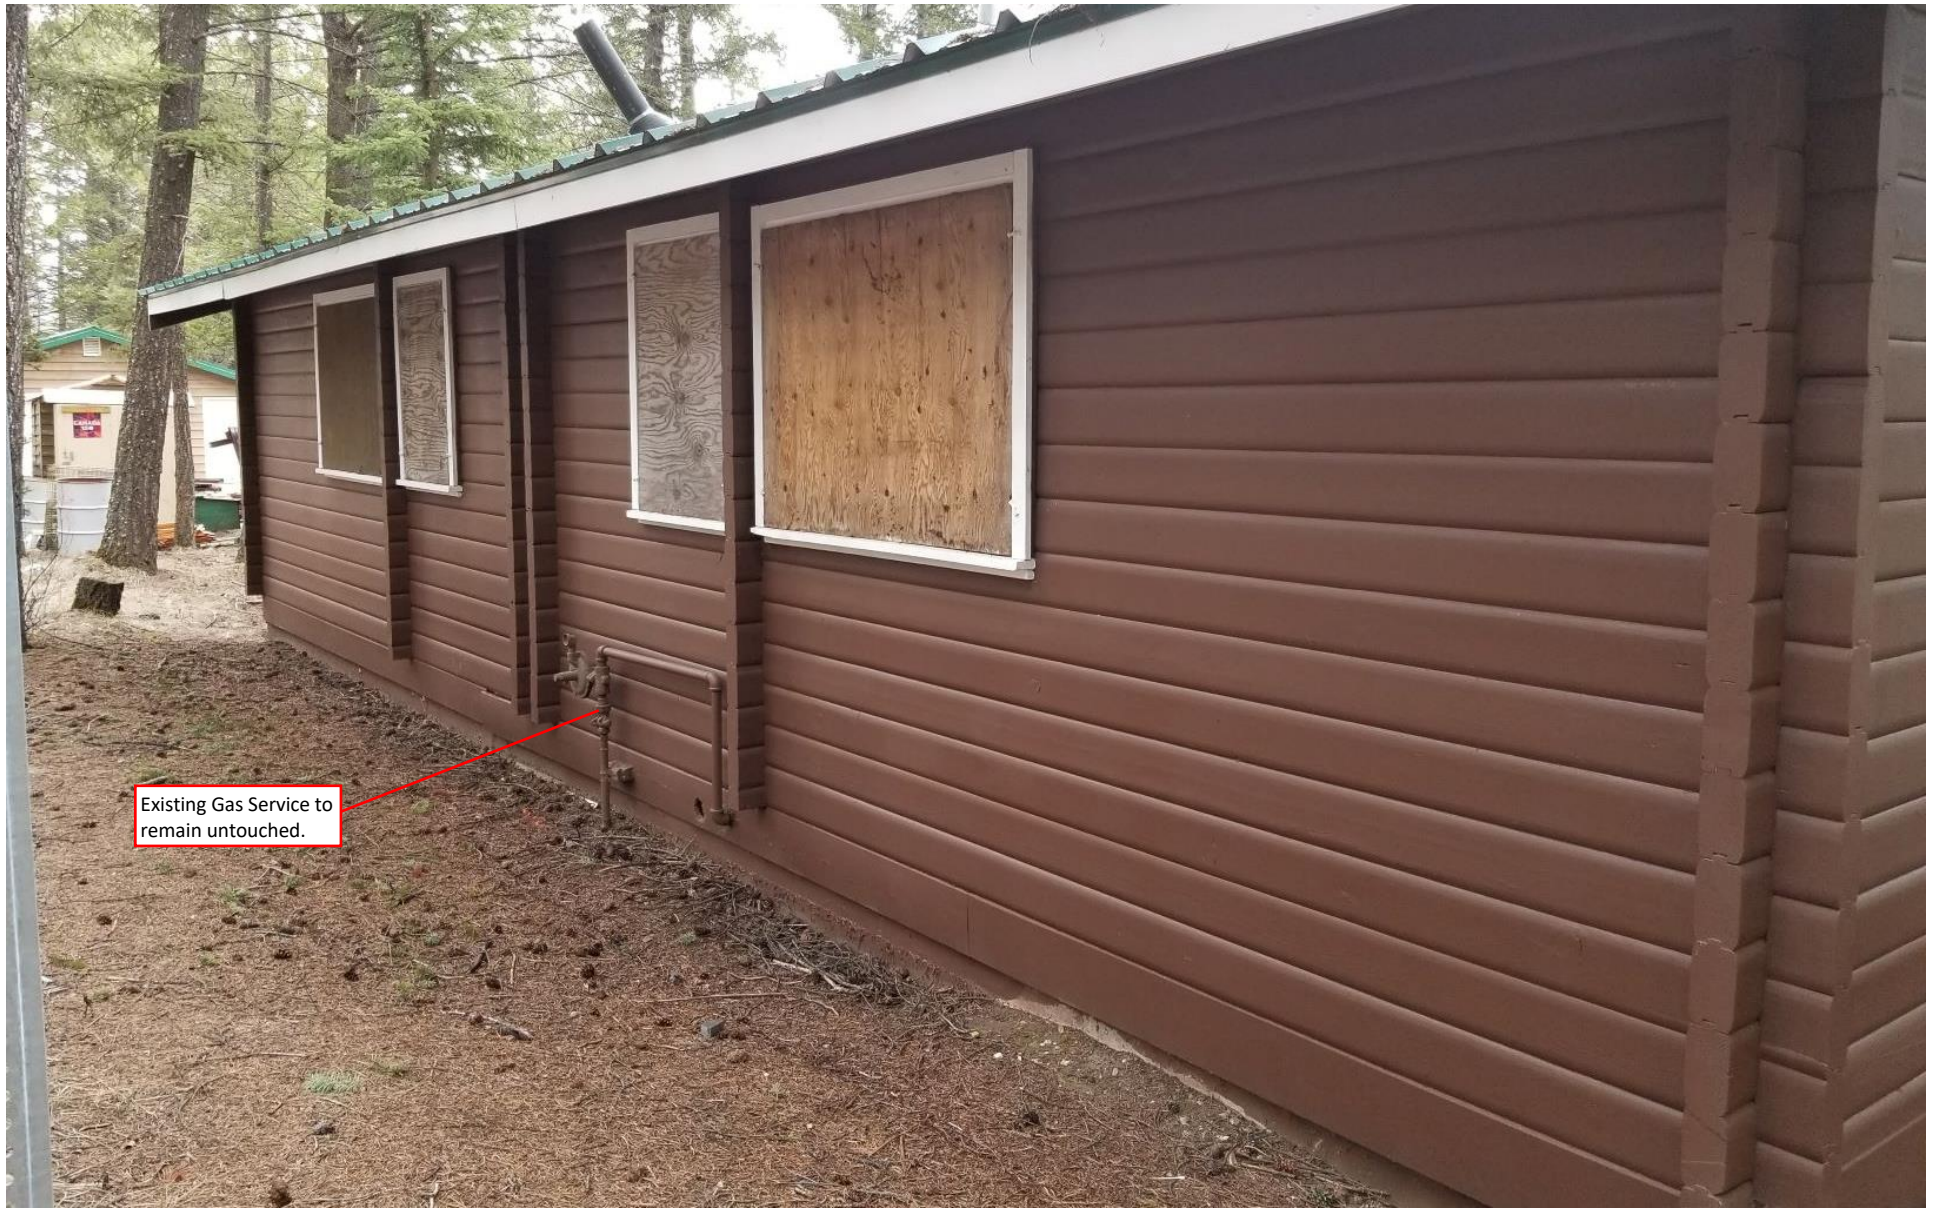
FIGURE 8c – Staff House 5/6 Utility Tie-In Details (North Side of Building)

Existing Gas Service to remain untouched.

1. No work is proposed to take place along the north and south sides of Cabin 5/6.

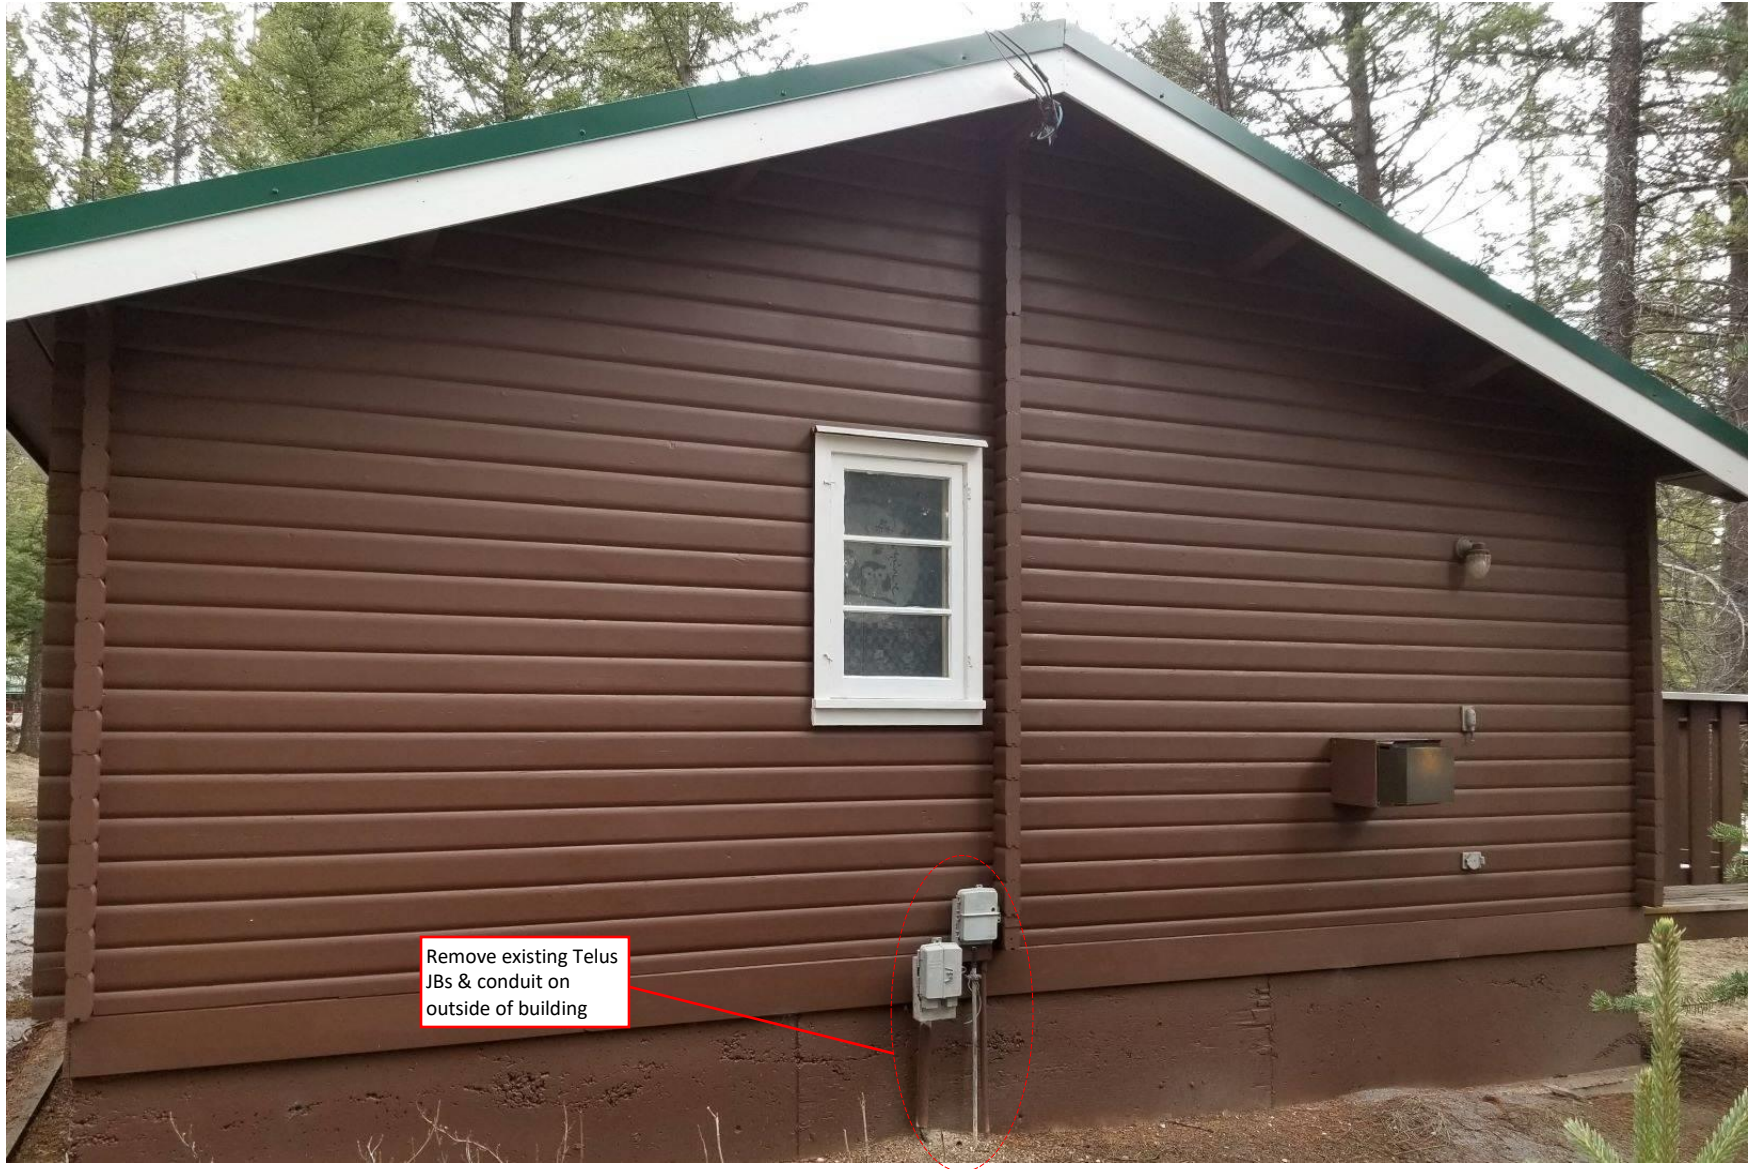
FIGURE 9a– Staff House 7/8 Utility Tie-In Details (West Side of Building)

1. Contractor is required to repair all holes in siding resulting from removal of existing utilities from side of building.
