Tunnel Mountain Campground Operations Area Shallow Utilities Rehabilitation – Phase 1

APPENDIX A

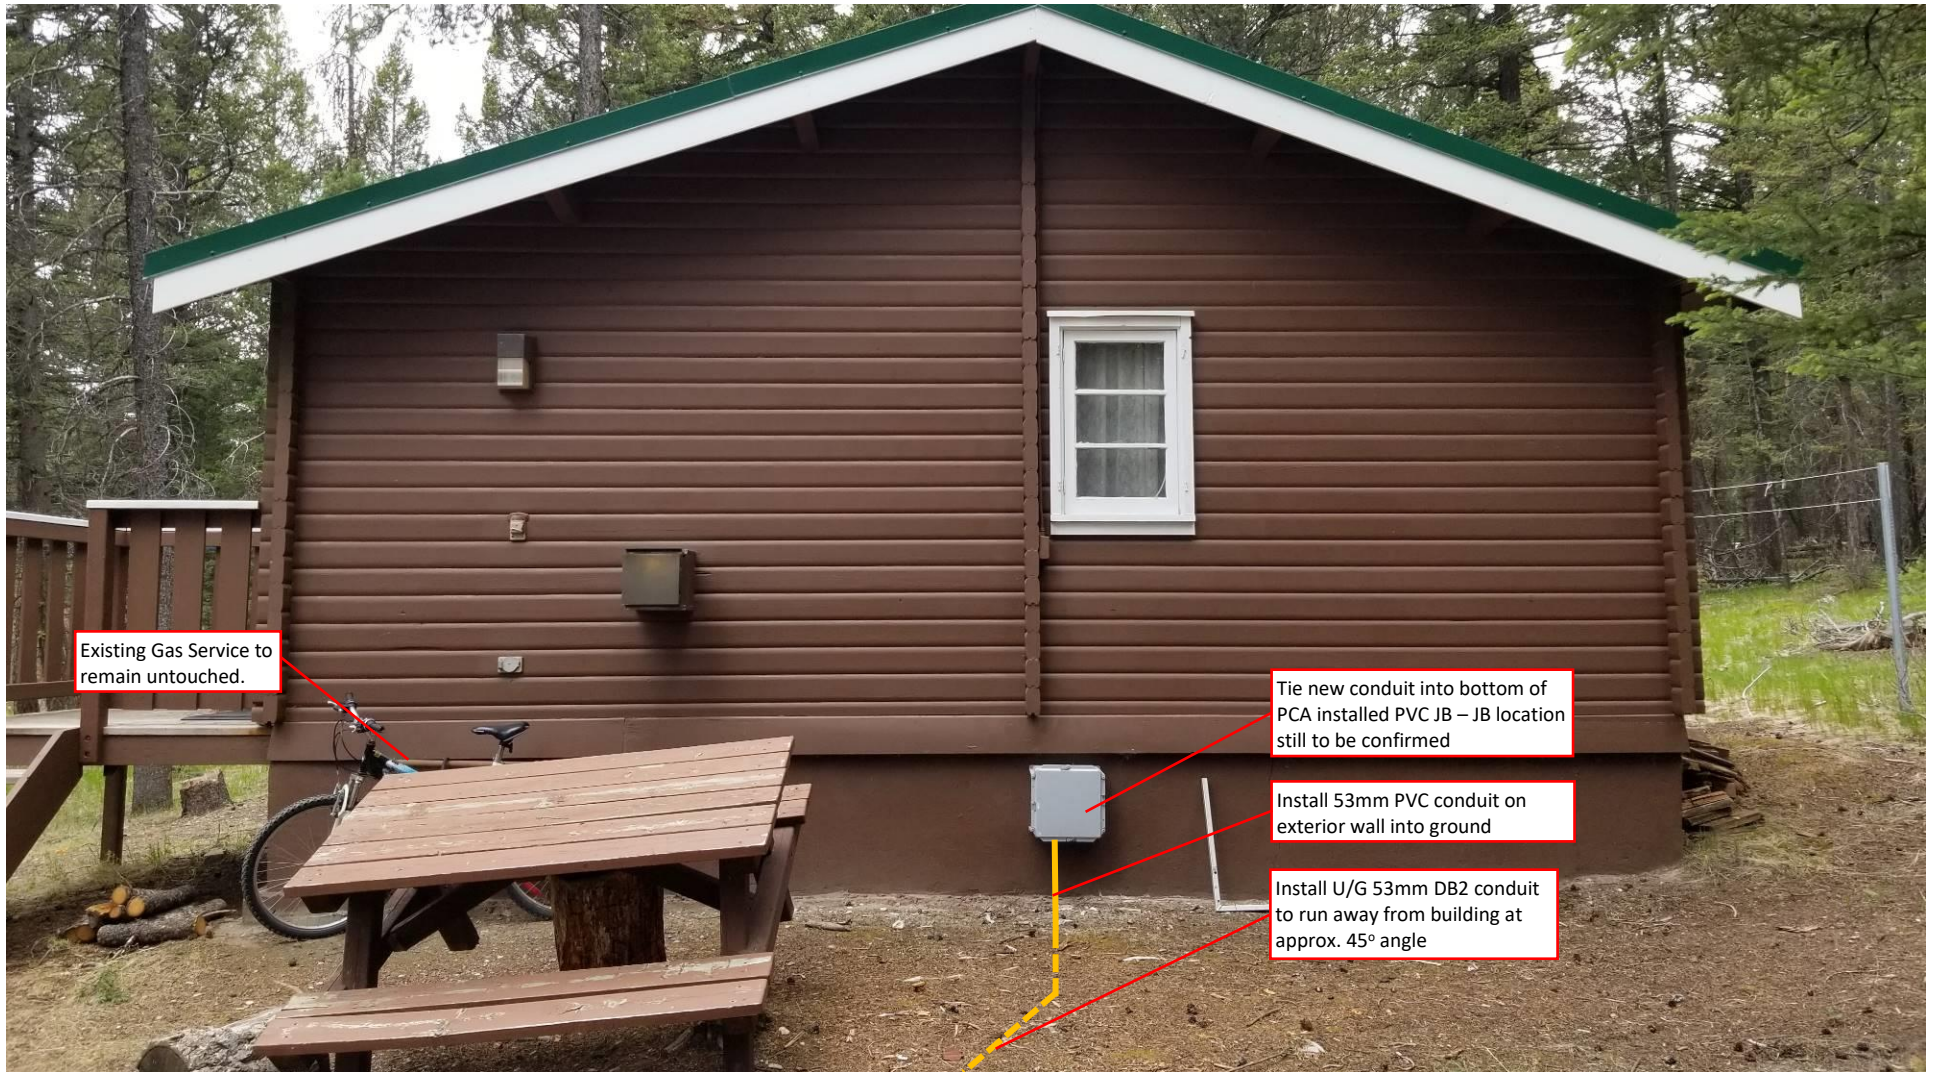
FIGURE 9b– Staff House 7/8 Utility Tie-In Details (East Side of Building)

1. See Drawing E1.3 for DB2 U/G conduit installation details. DB2 conduit to transition to PVC on CDP and U/G JB side of vertical bend.
2. Contractor is to tie new 53mm PVC conduit into bottom of existing PVC JB previously installed by PCA.
3. Contractor is required to expose U/G gas line as required to allow for new U/G electrical to be installed in vicinity of existing U/G gas line.

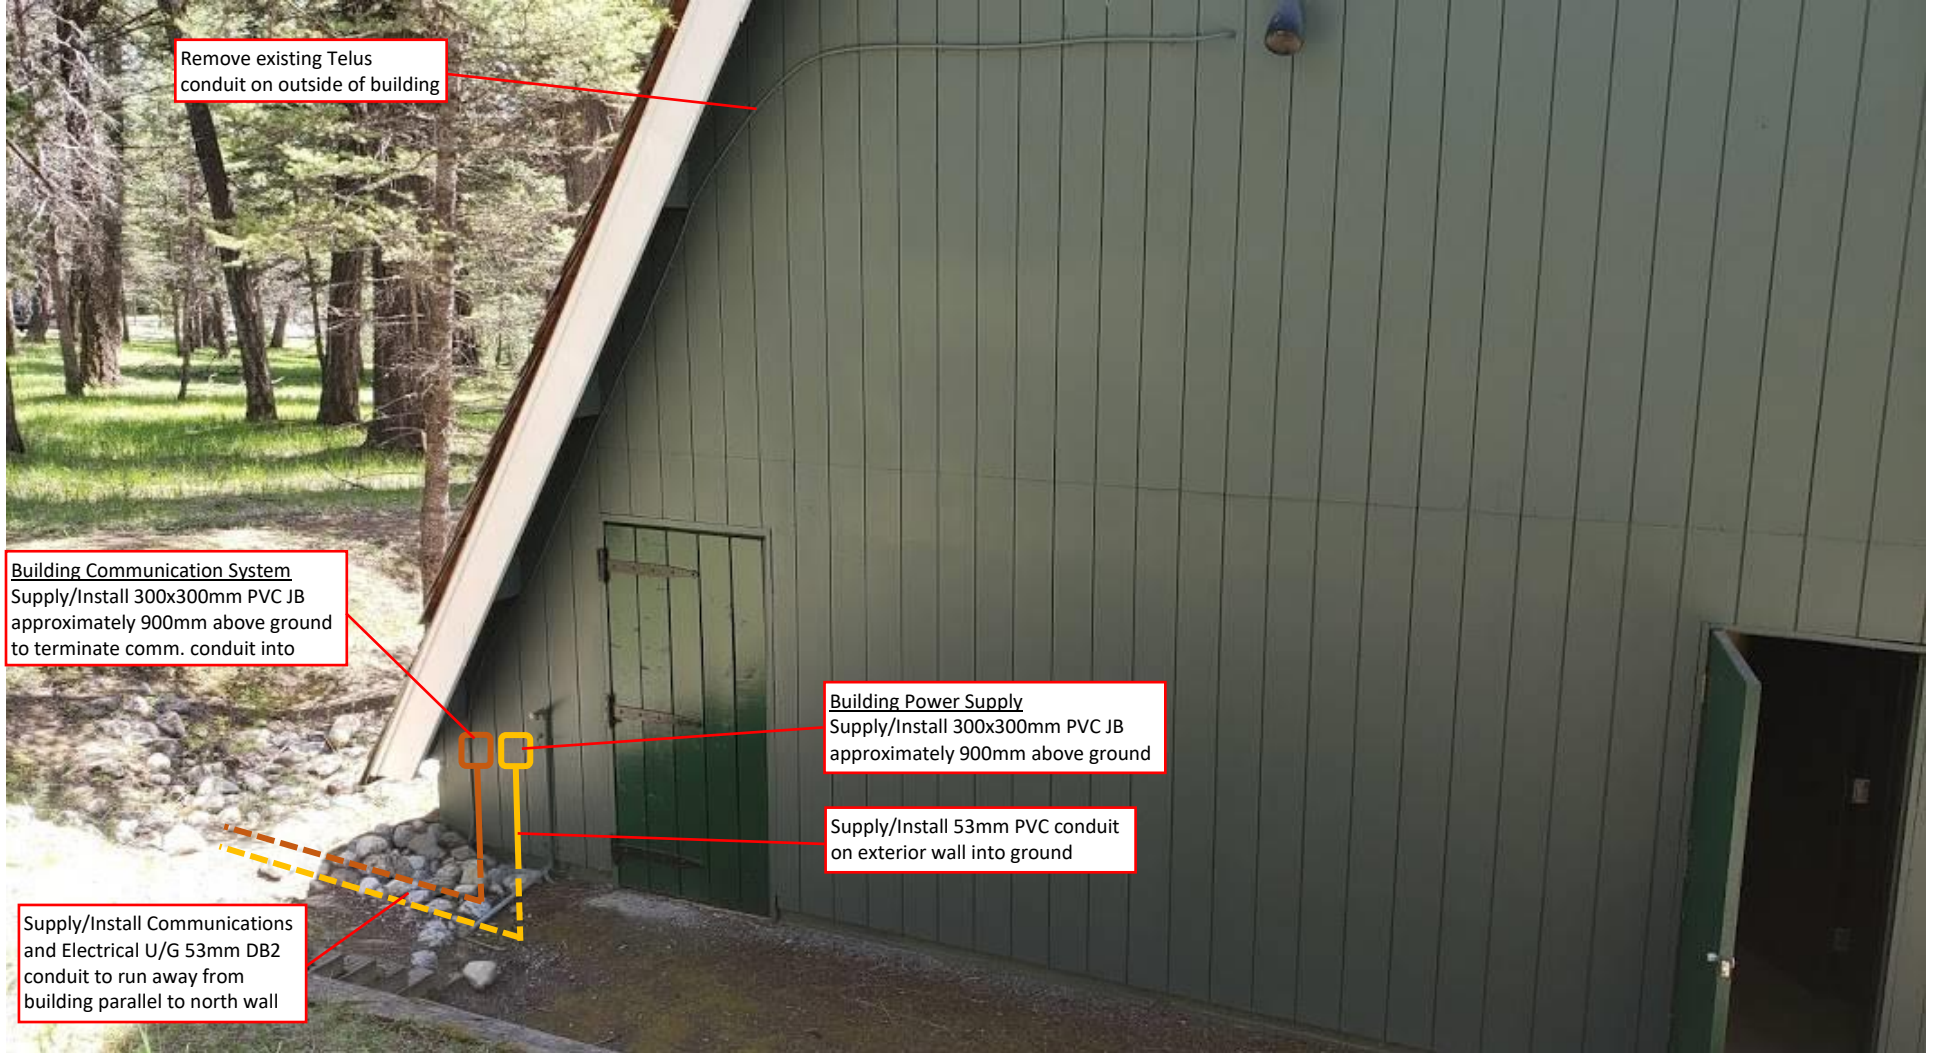
Figure 10 – Theatre Building Utility Tie-in Details (North Side of Building)

1. Contractor is required to repair all holes in siding resulting from removal of existing utilities from side of building.
2. See Drawing E1.3 for DB2 U/G conduit installation details. DB2 conduit to transition to PVC on CDP side of vertical bend.
3. Existing waterline in area to be left in place; waterline is currently not in service.

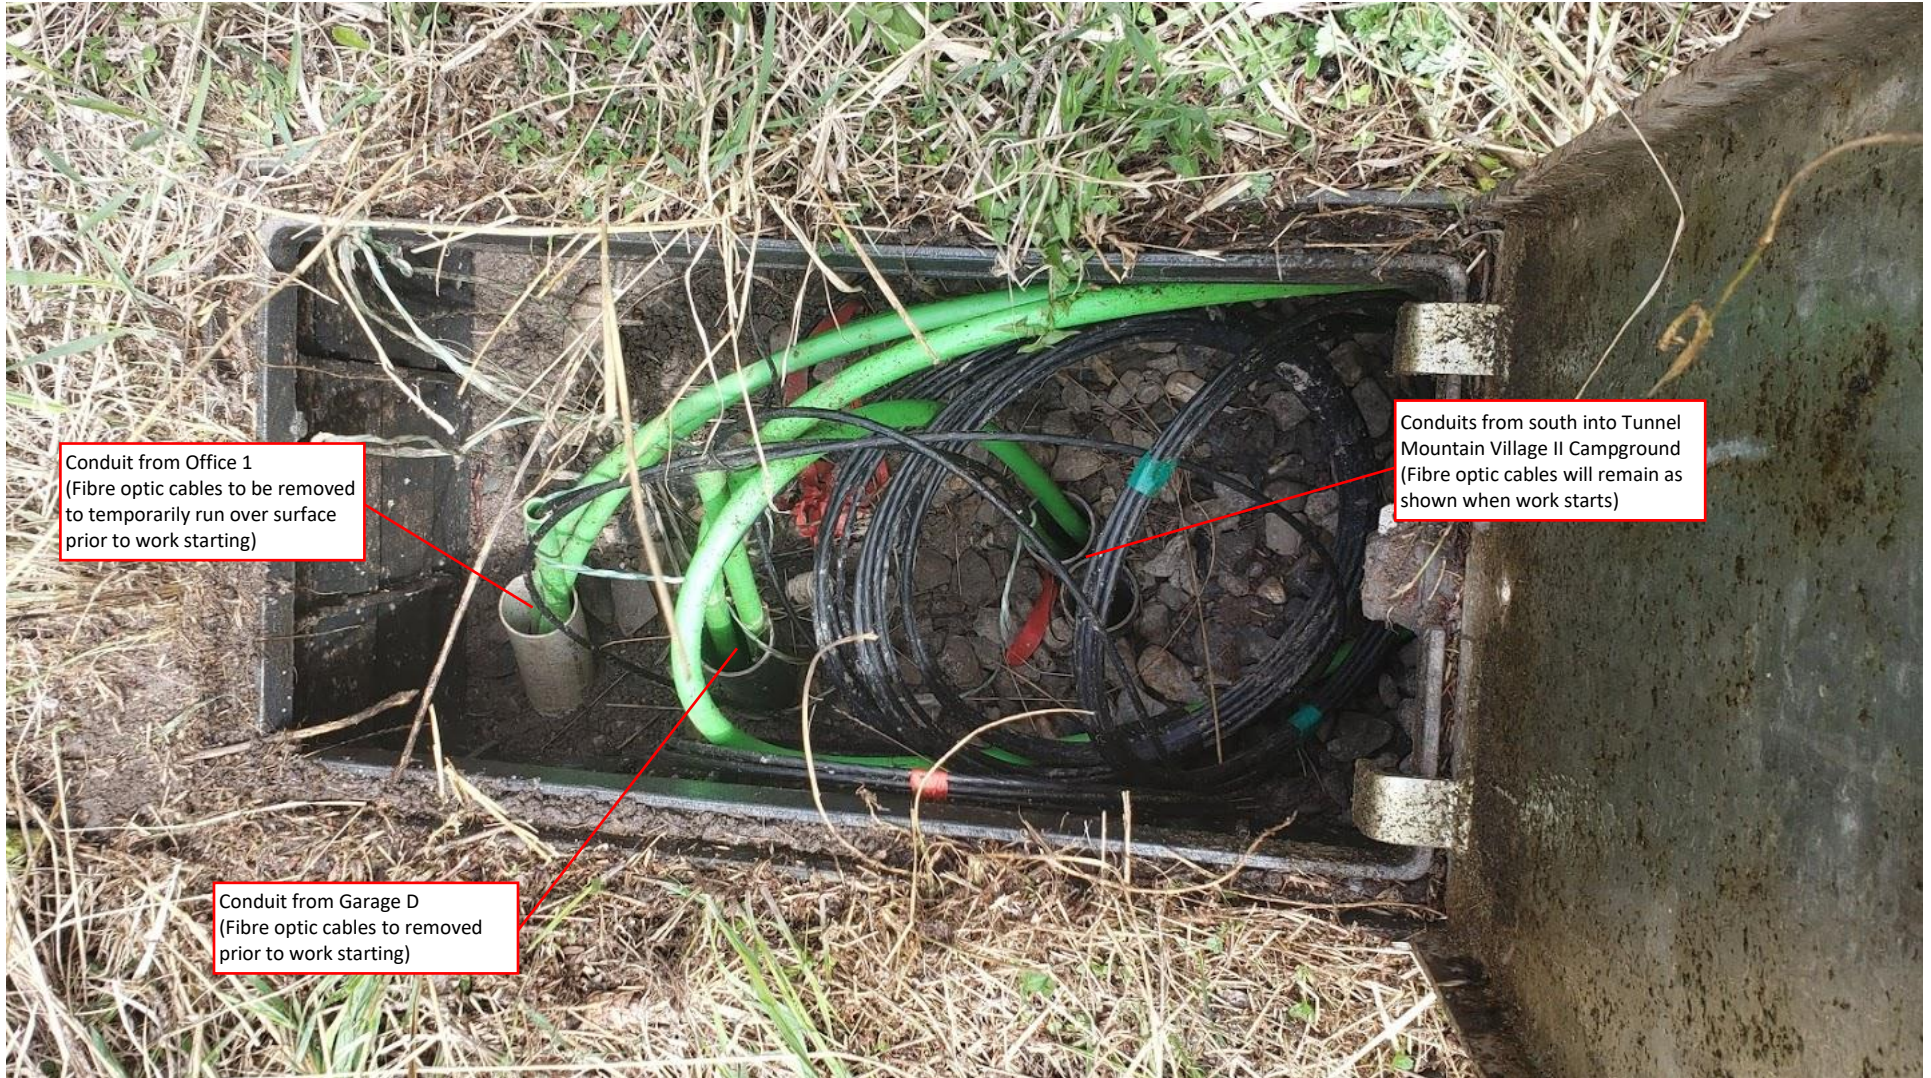
Figure 11 - Inside Existing U/G JB between Offices 1 & 2, South of Offices
