## **UXO Survey and Clearance Navy Island**

**Dartmouth, Nova Scotia**

**UXO Survey and Clearance  
Navy Island**

Document Information	
Document Title	UXO Survey and Clearance
Document Type	Final Report
Current Revision	R3

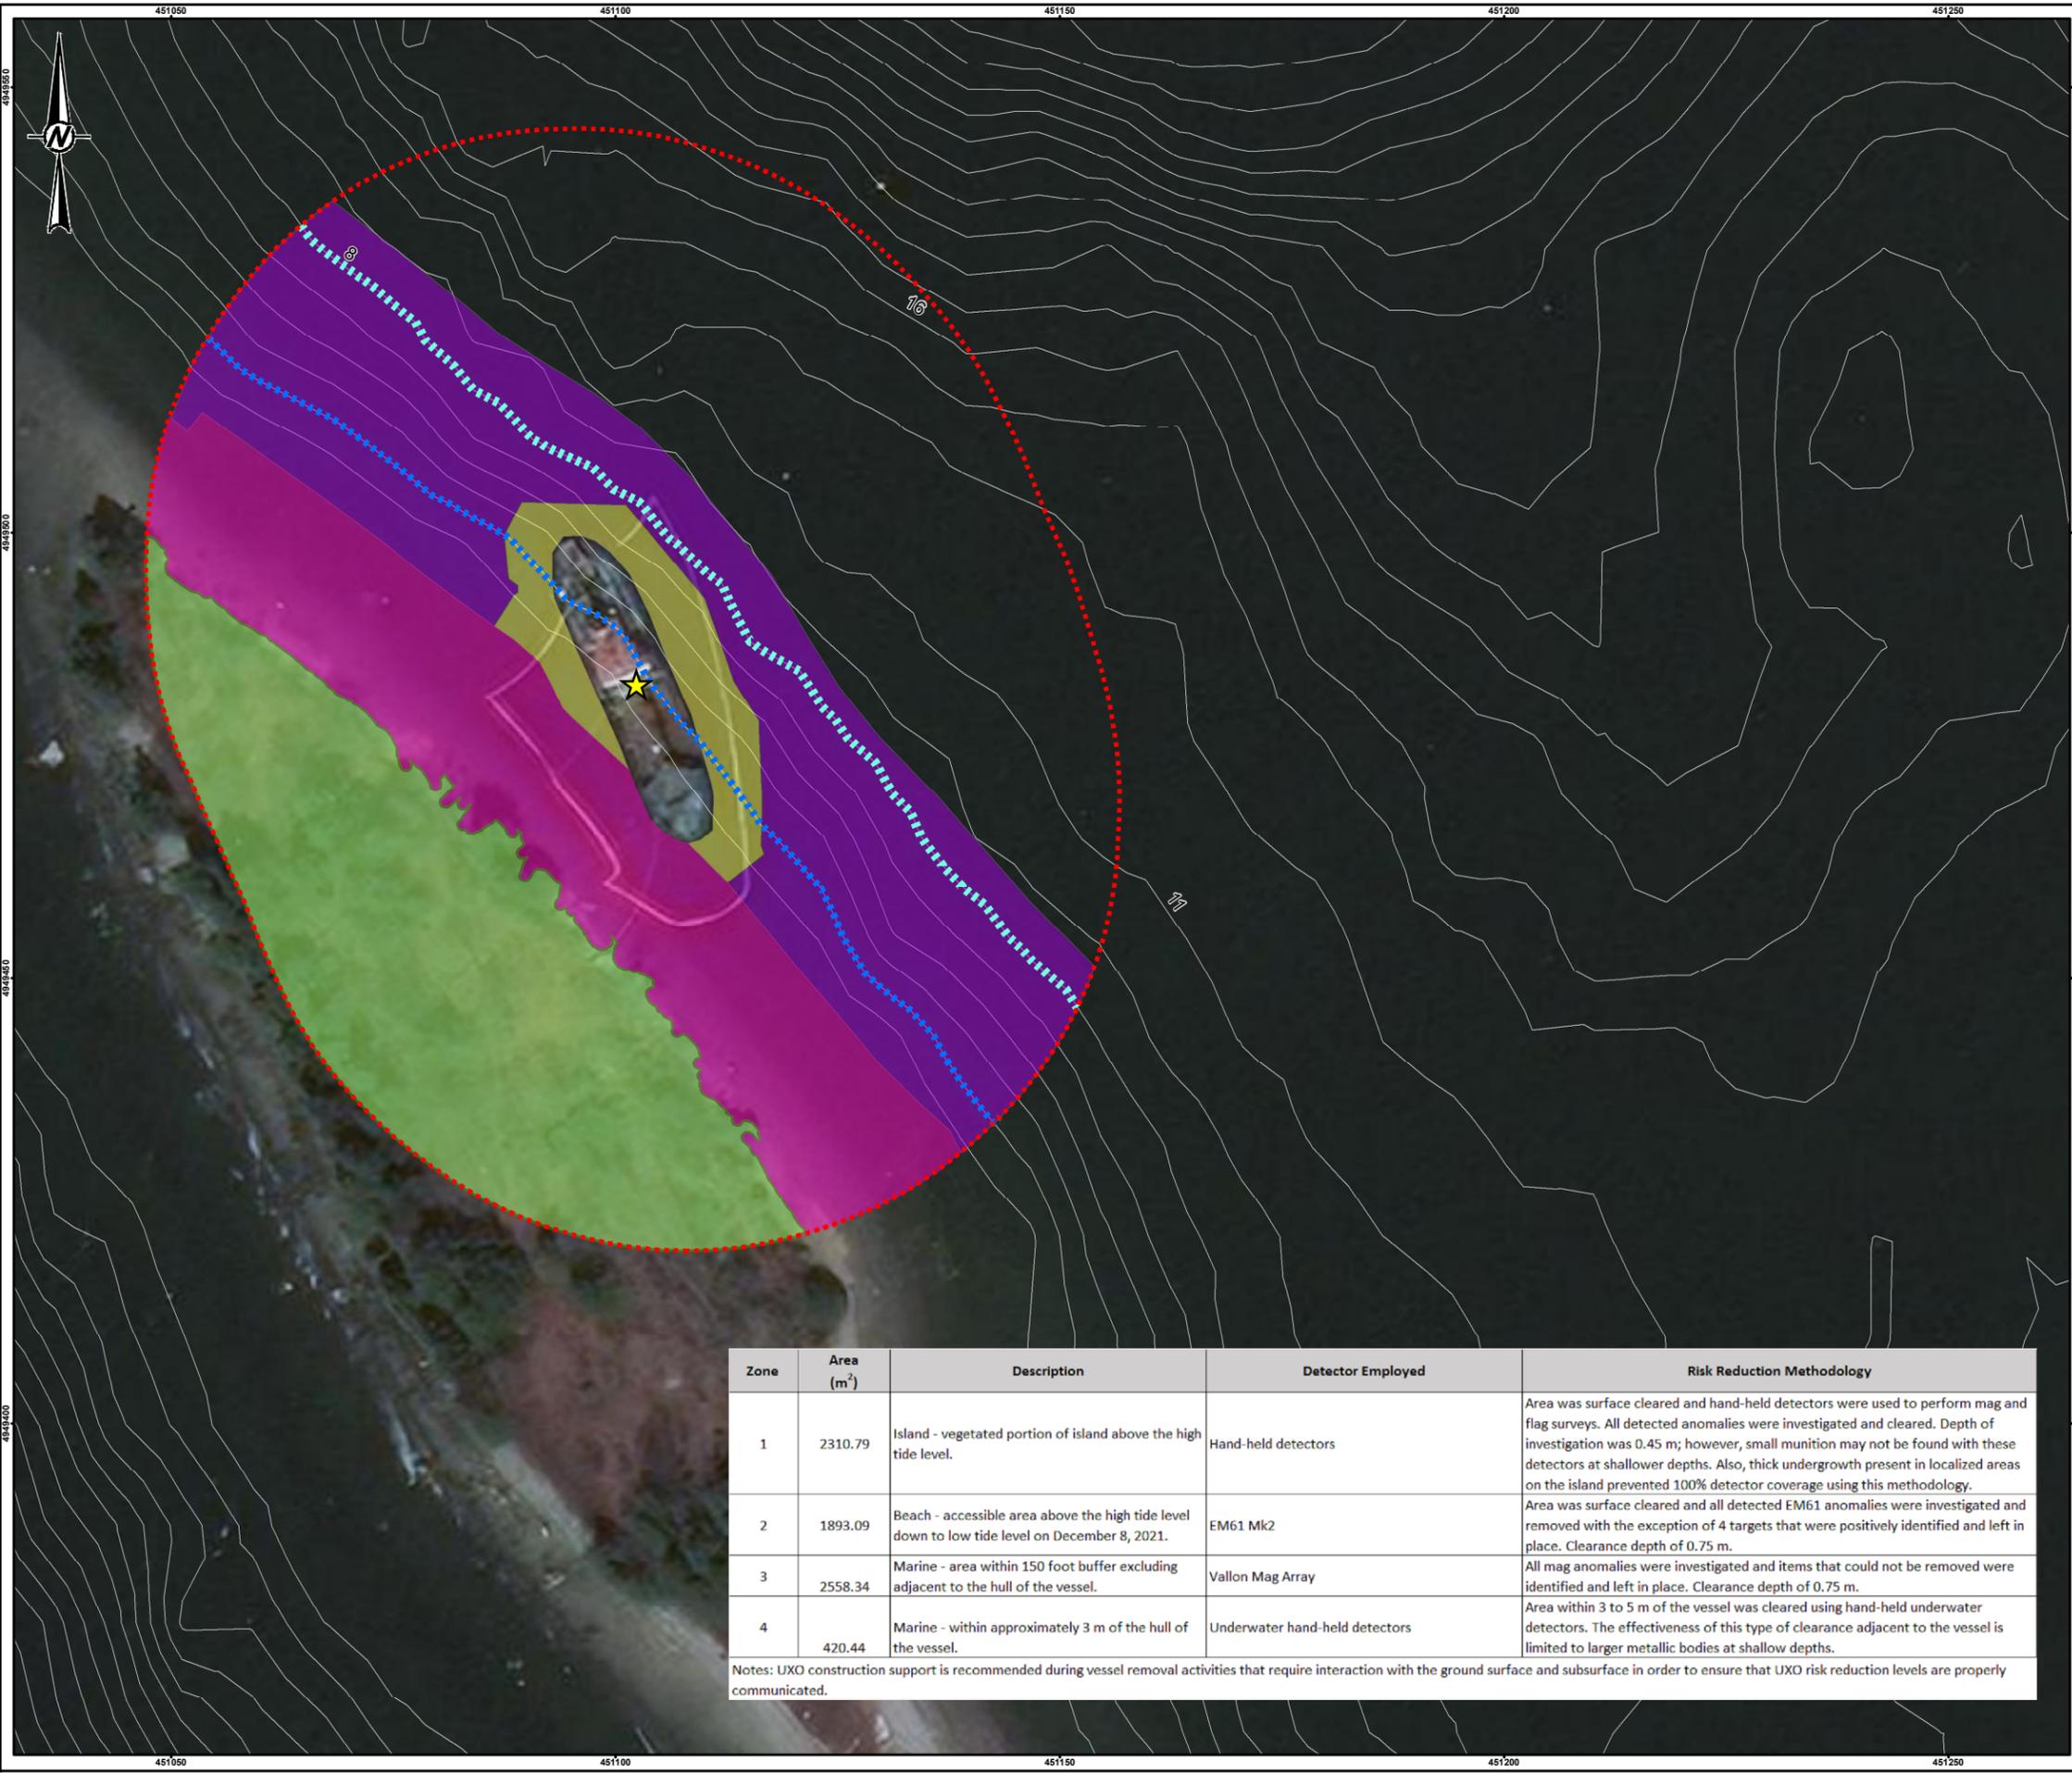
Zone	Area (m <sup>2</sup> )	Description	Detector Employed	Risk Reduction Methodology
1	2310.79	Island - vegetated portion of island above the high tide level.	Hand-held detectors	Area was surface cleared and hand-held detectors were used to perform mag and flag surveys. All detected anomalies were investigated and cleared. Depth of investigation was 0.45 m; however, small munition may not be found with these detectors at shallower depths. Also, thick undergrowth present in localized areas on the island prevented 100% detector coverage using this methodology.
2	1893.09	Beach - accessible area above the high tide level down to low tide level on December 8, 2021.	EM61 Mk2	Area was surface cleared and all detected EM61 anomalies were investigated and removed with the exception of 4 targets that were positively identified and left in place. Clearance depth of 0.75 m.
3	2558.34	Marine - area within 150 foot buffer excluding adjacent to the hull of the vessel.	Vallon Mag Array	All mag anomalies were investigated and items that could not be removed were identified and left in place. Clearance depth of 0.75 m.

Notes: UXO construction support is recommended during vessel removal activities that require interaction with the ground surface and subsurface in order to ensure that UXO risk reduction levels are properly communicated.

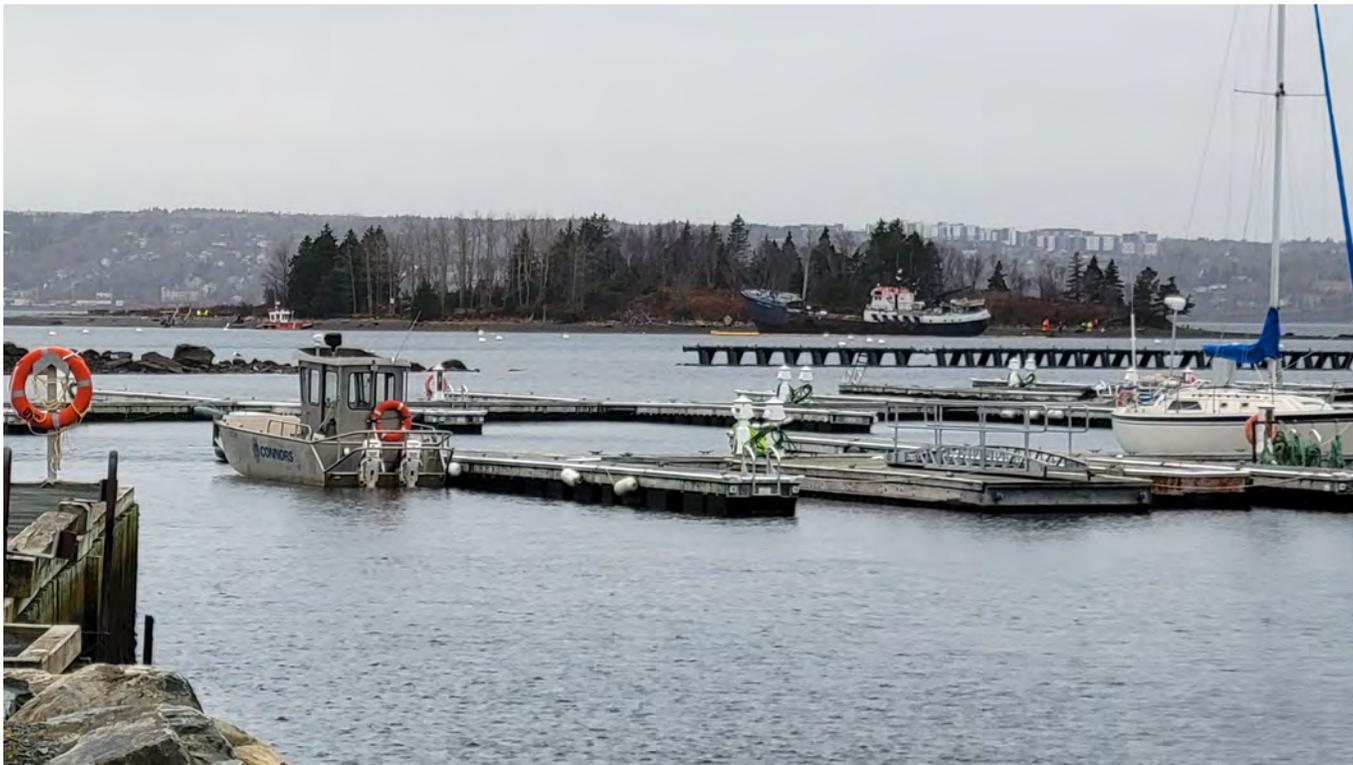
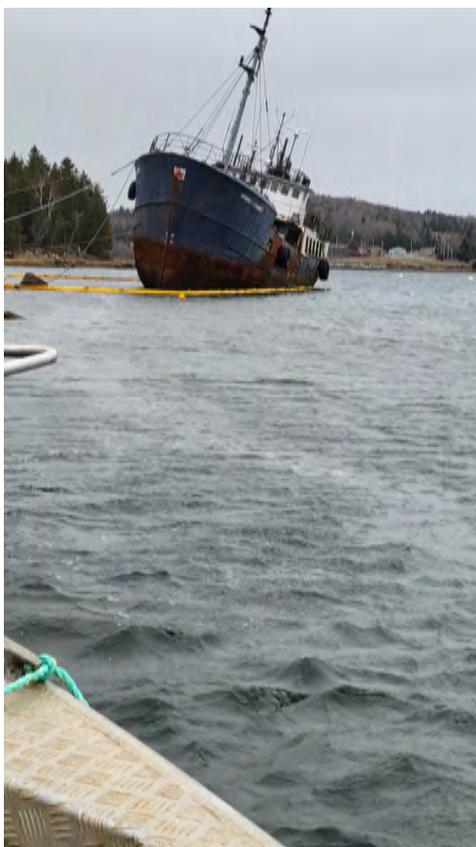
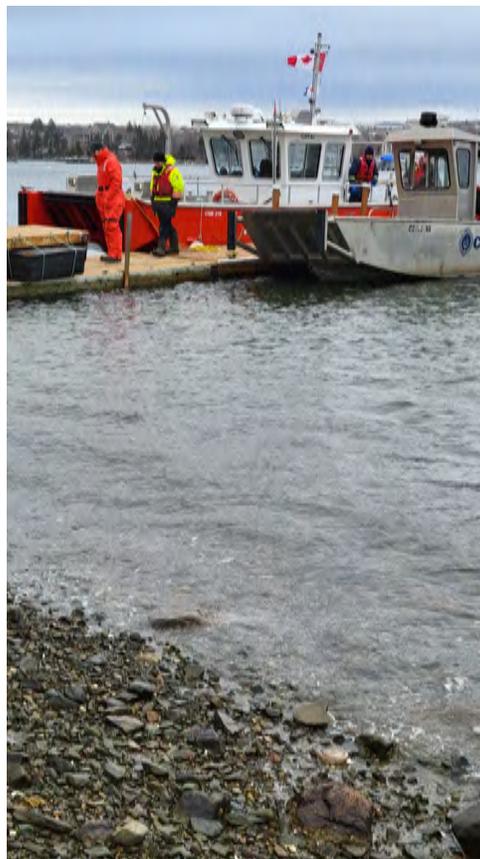
View of Navy Island and grounded vessel from Dartmouth Yacht Club (top). View of vessel from dock on Navy Island, looking north (bottom left). Dock on Navy Island (bottom right).

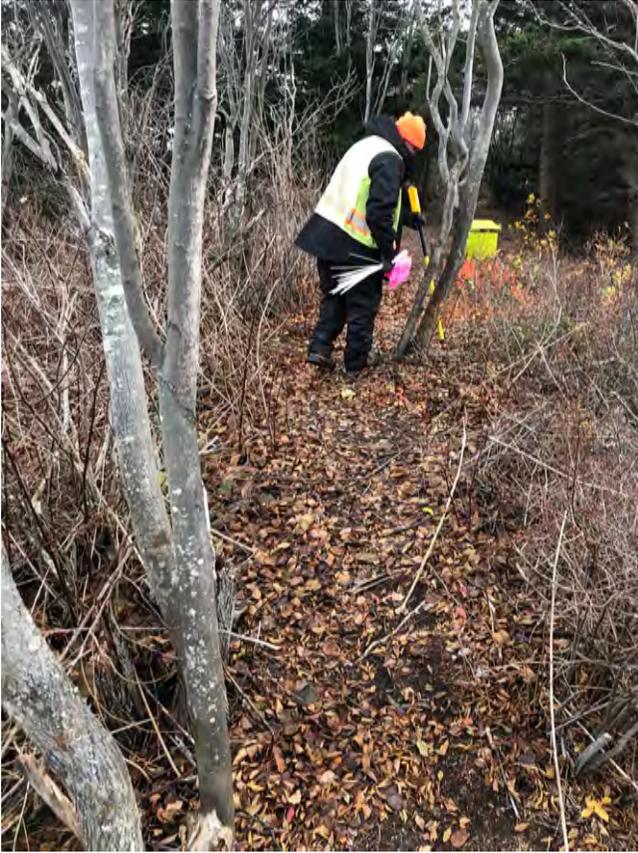
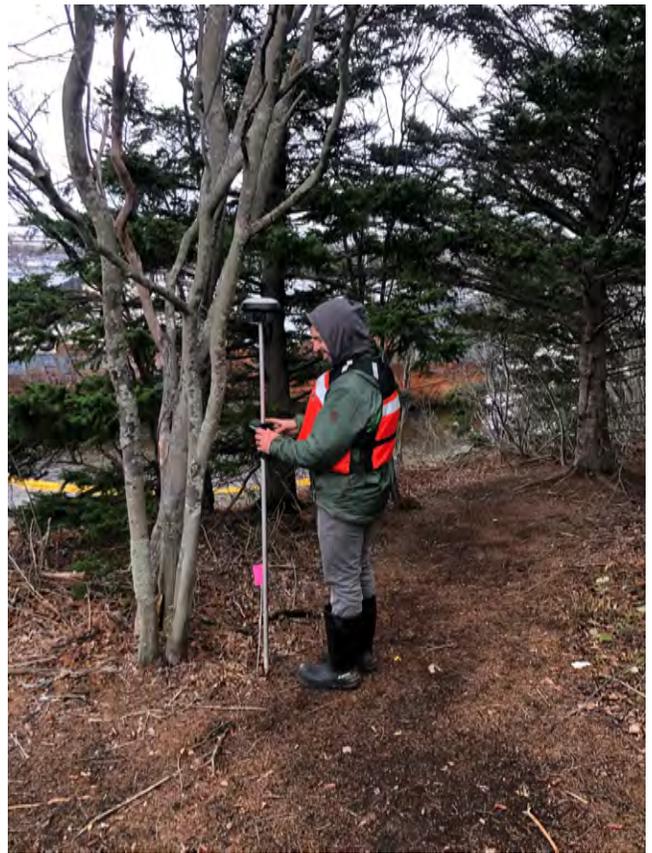
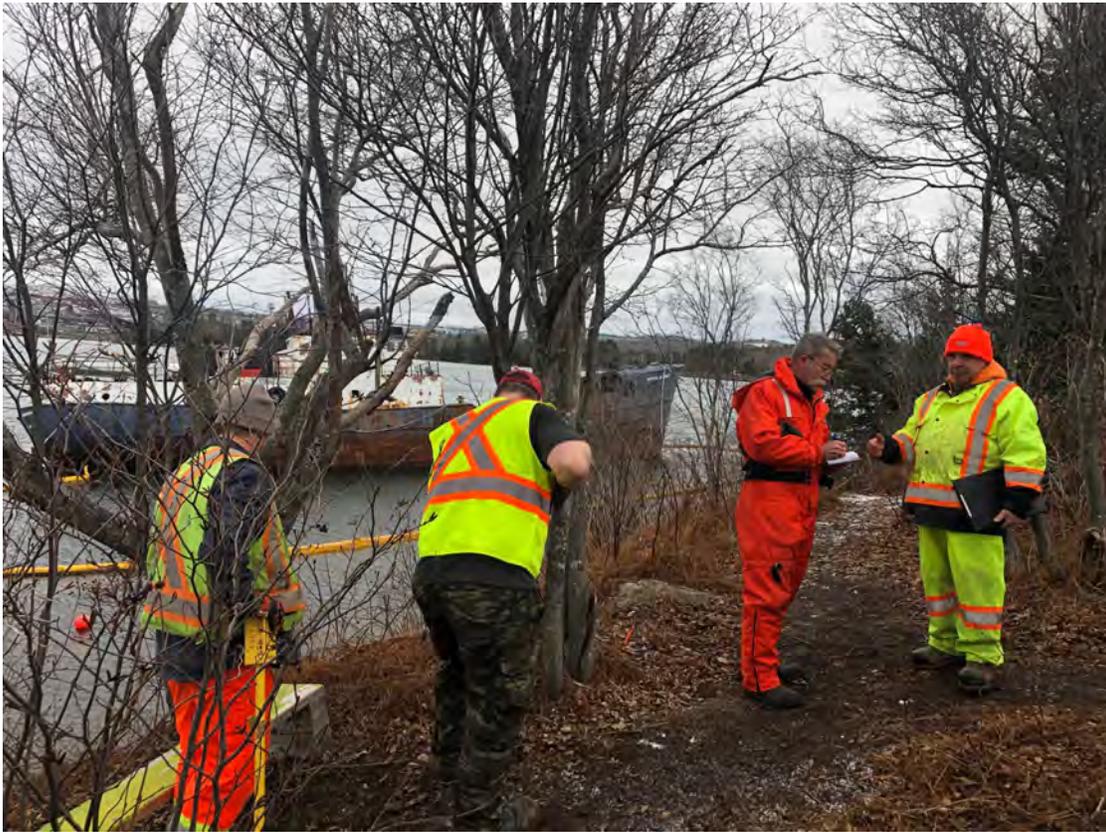
**FIGURE B3**

Detector aided clearance (DAC) activities on Navy Island: using a metal detector to pinpoint and flag anomalies (top left); recording anomaly locations using a RTK GPS (top right); and, re-acquiring and investigating targets (bottom).

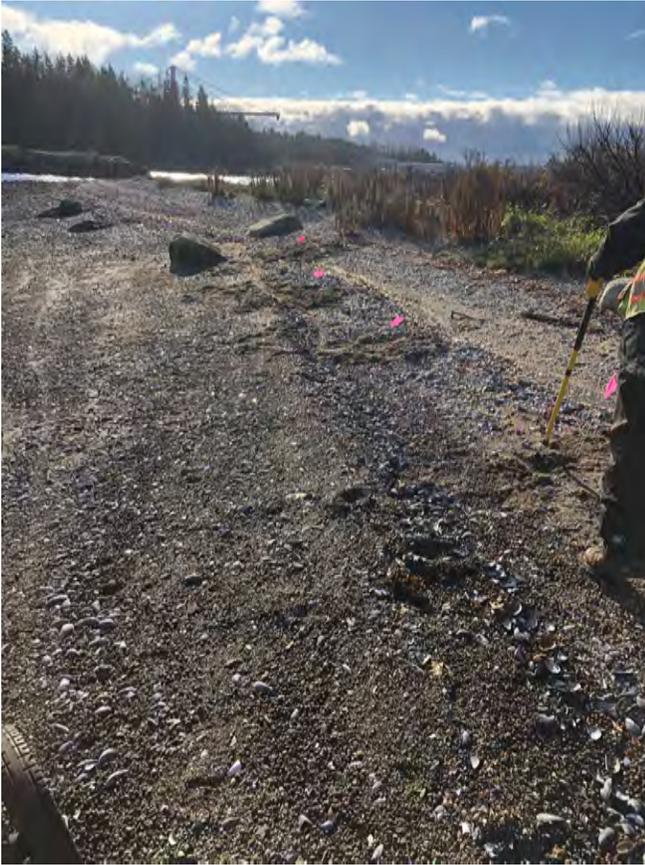
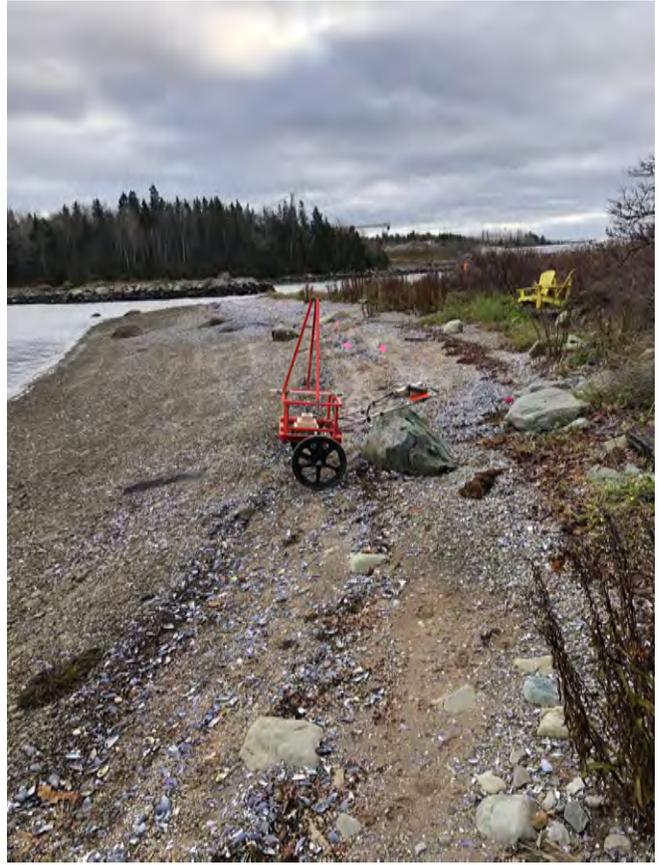
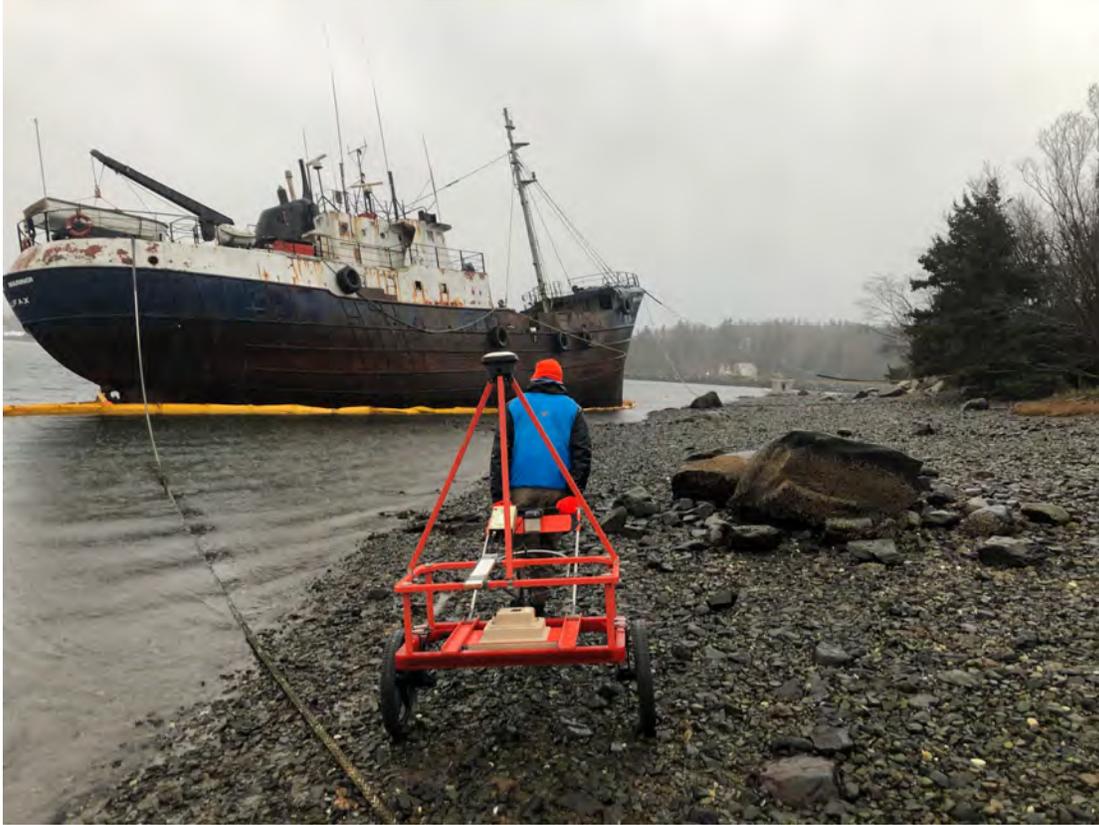
**FIGURE B4**

EM61 Mk2 survey activities: Instrument Verification Strip (IVS) survey (top left); instrument function tests (top right) ; and, beach survey (bottom).

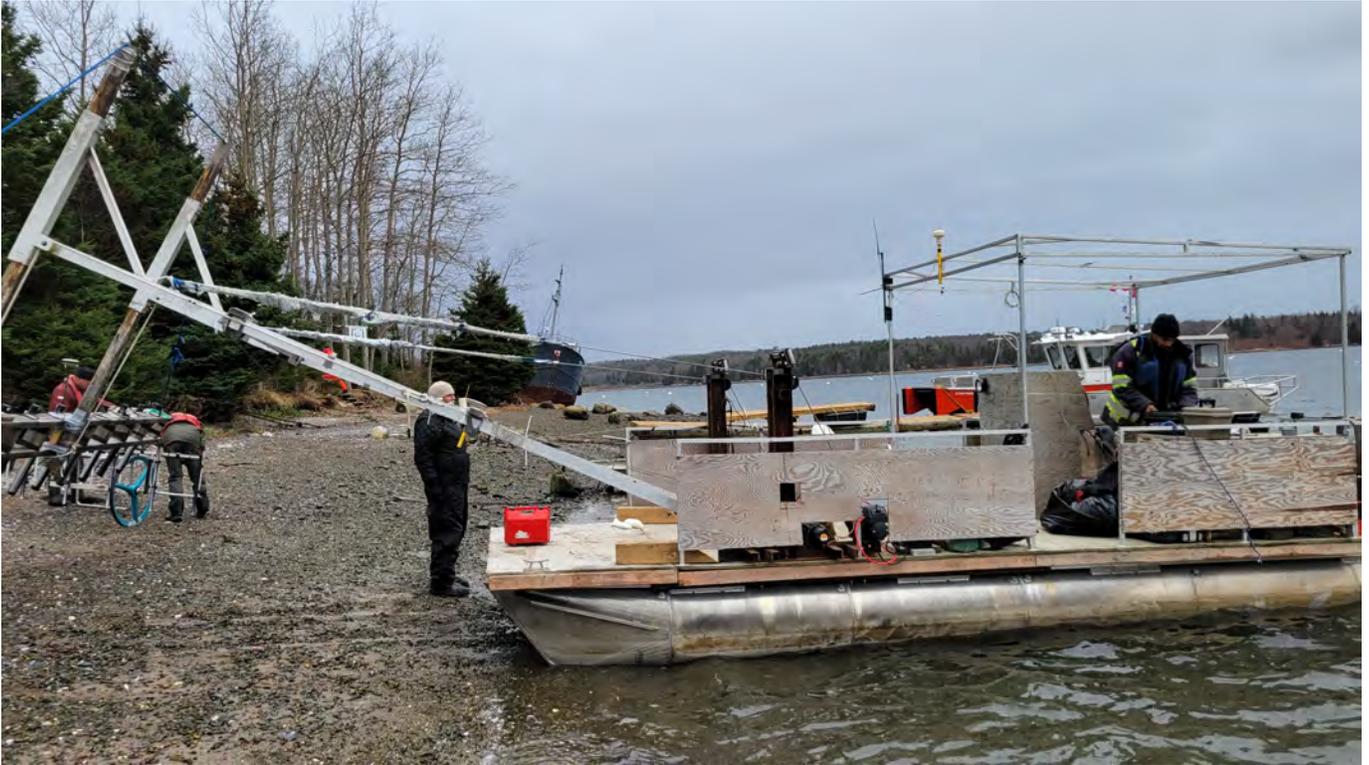
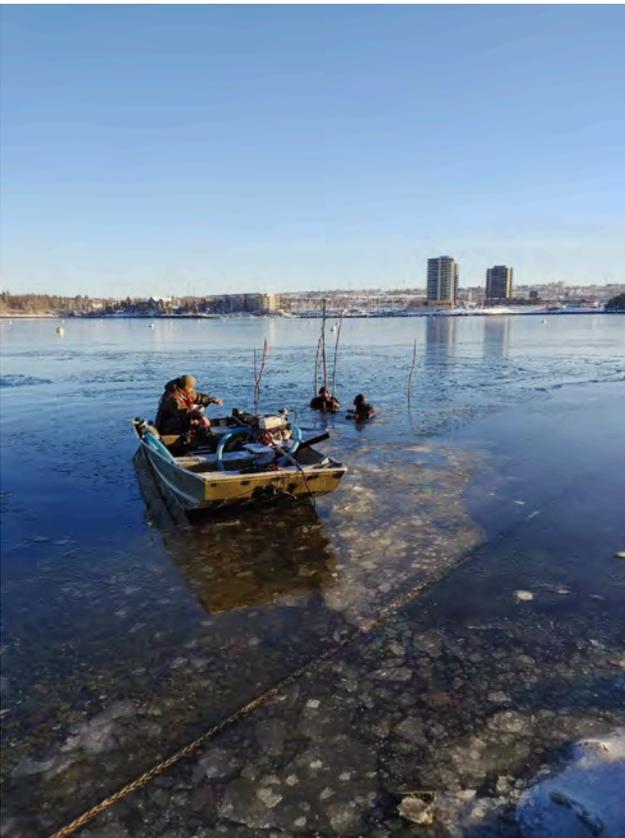
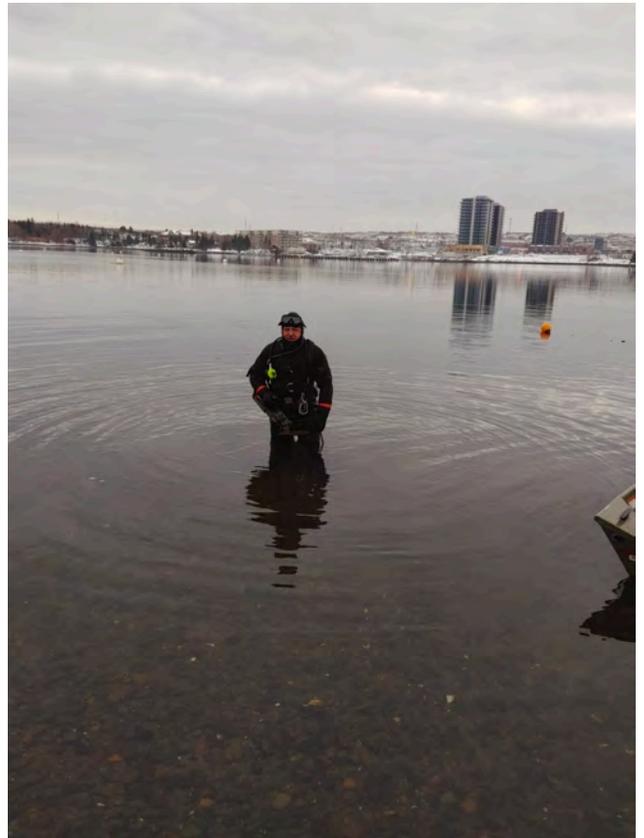
**FIGURE B5**

Marine survey: setup of Vallon mag array (top); flagging and investigating mag anomalies / targets (bottom left); and, preparing for search around vessel hull (bottom right).

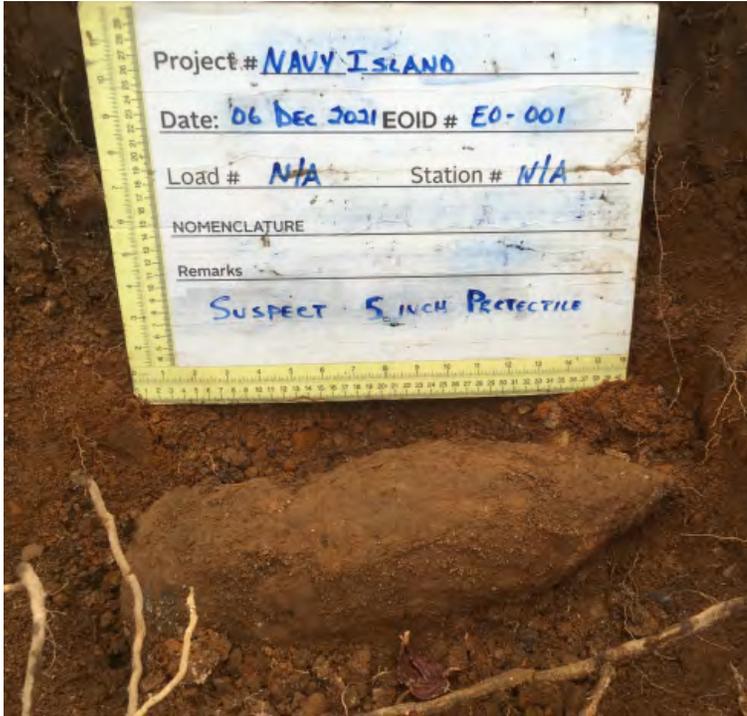
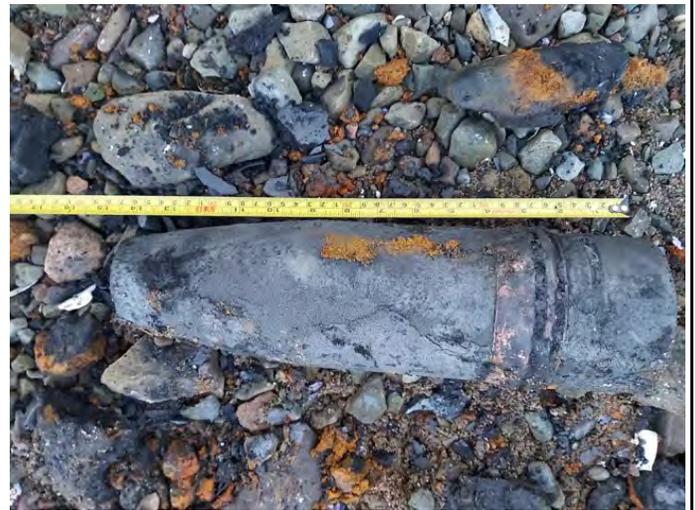
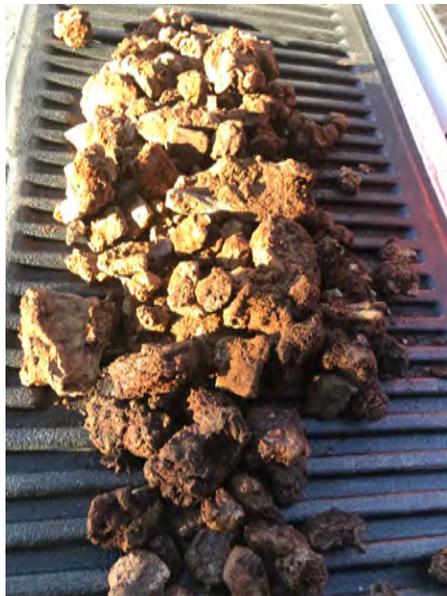
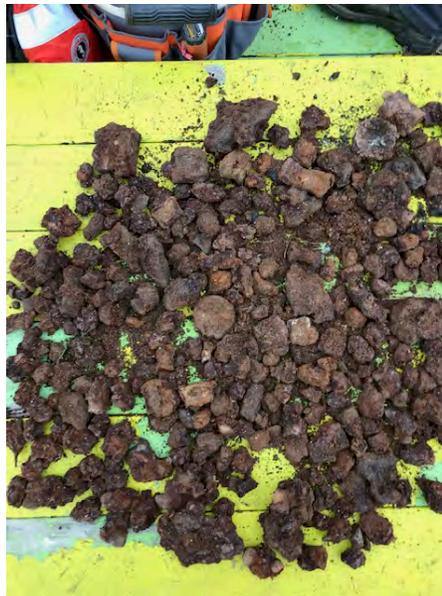
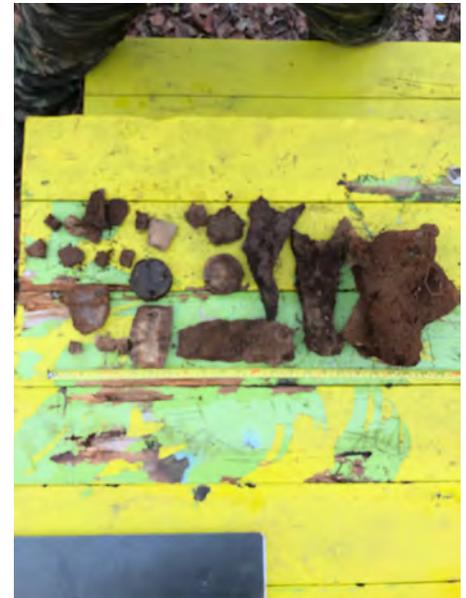
**FIGURE B6**

- Two UXOs were recovered and turned over to the Fleet Diving Unit (FDU) for offsite disposal (one 5-inch HE projectile; one 4-inch HE projectile – no fuze);

UXO found: 5-inch projectile (top left) and 4-inch projectile (top right).  
Munitions scrap (MS) from high-density anomalous areas (HDAA)  
and various other locations (bottom).

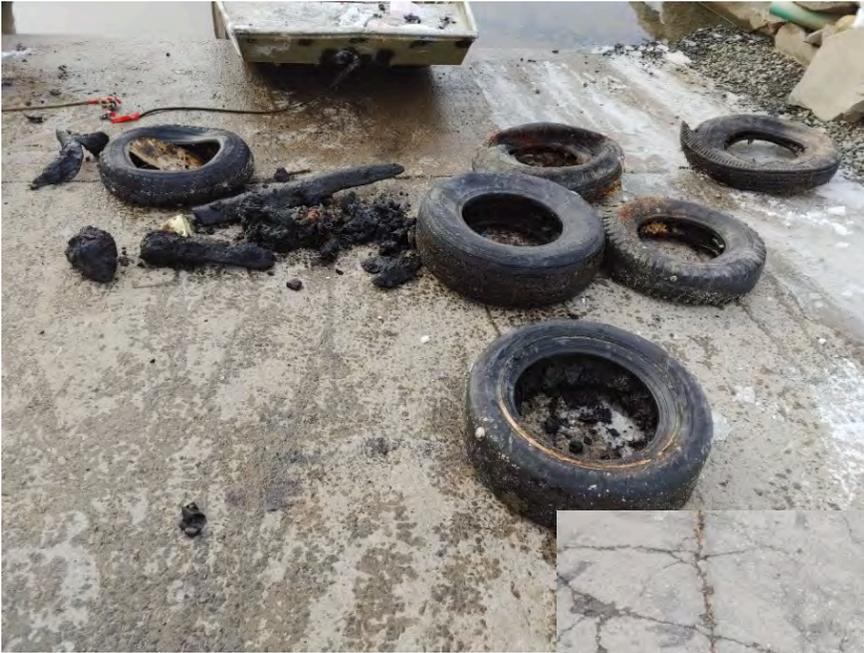
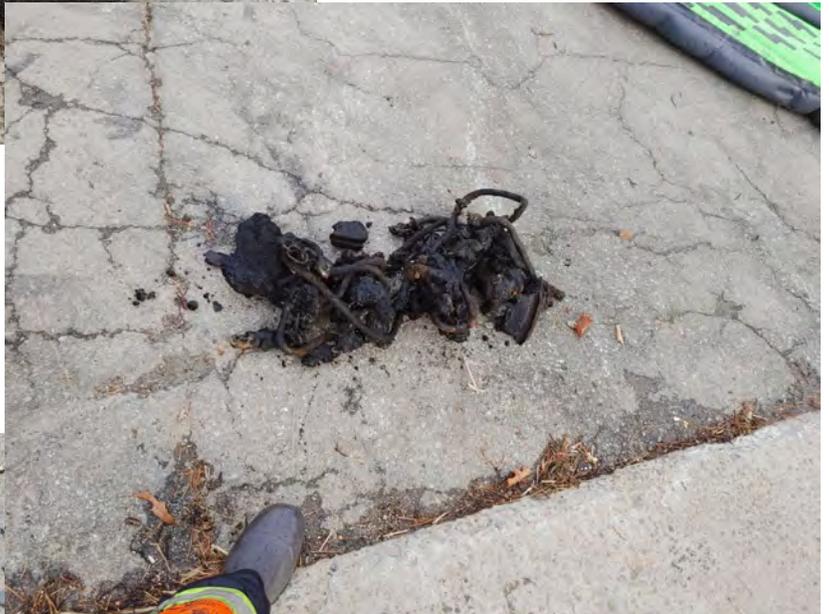
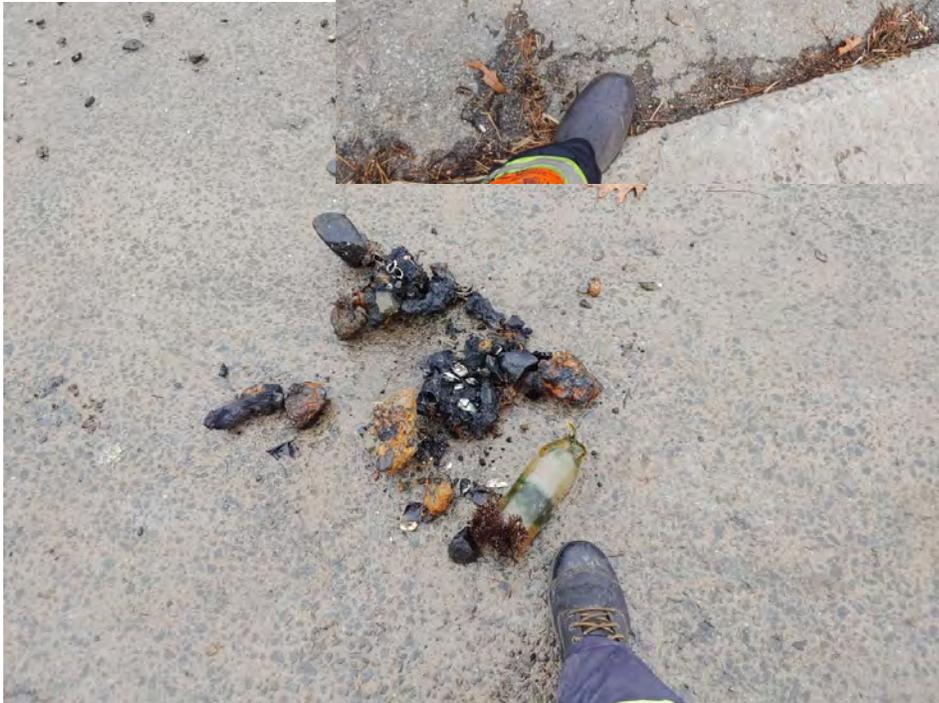
**FIGURE B7**

Examples of Non-Munitions Scrap (NMS) recovered from surveys.
