Basic Impact Assessment

Western Brook Bridge Replacement

Gros Morne National Park, Western Newfoundland and Labrador Field Unit

Archaeological Overview Assessment Western Brook Bridge Replacement (Amended for Construction)

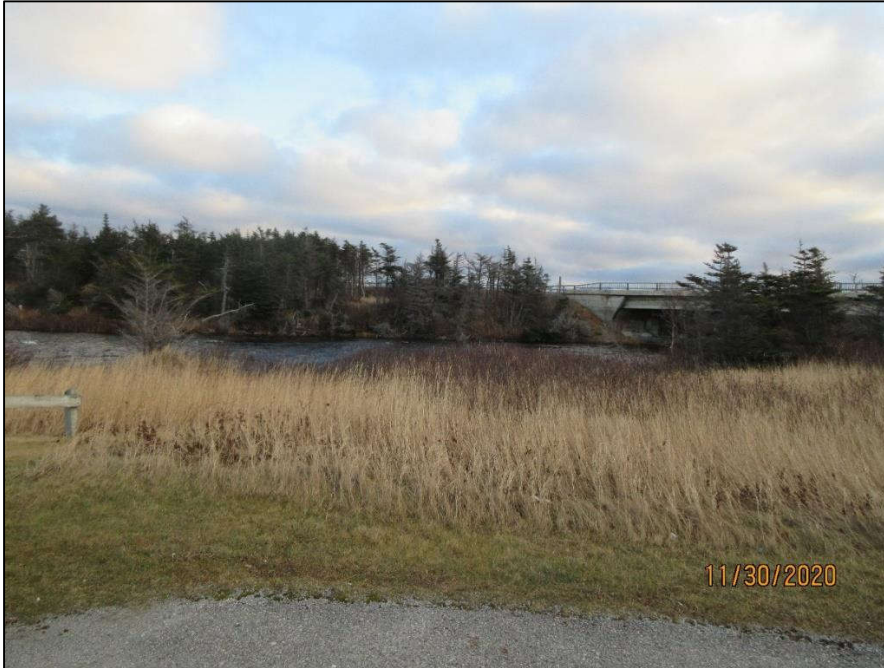
Figure 4. The area adjacent to the Western Brook day-use area and highway Route 430, downstream of Western Brook Bridge. Vegetation is characterized as riparian, consisting of alders and common grass species on the southern shoreline. Mature coniferous and a mix of common grass species occur on the northern shoreline.

vegetation removal, and excavation and placement of fill material to accommodate the temporary structure (Figure 3). The southern abutment of the detour bridge will, for the most part, overlap with the limits of the day-use area, which has a landscape that is managed to facilitate visitor experience and is mowed regularly during the summer months (Figure 4).

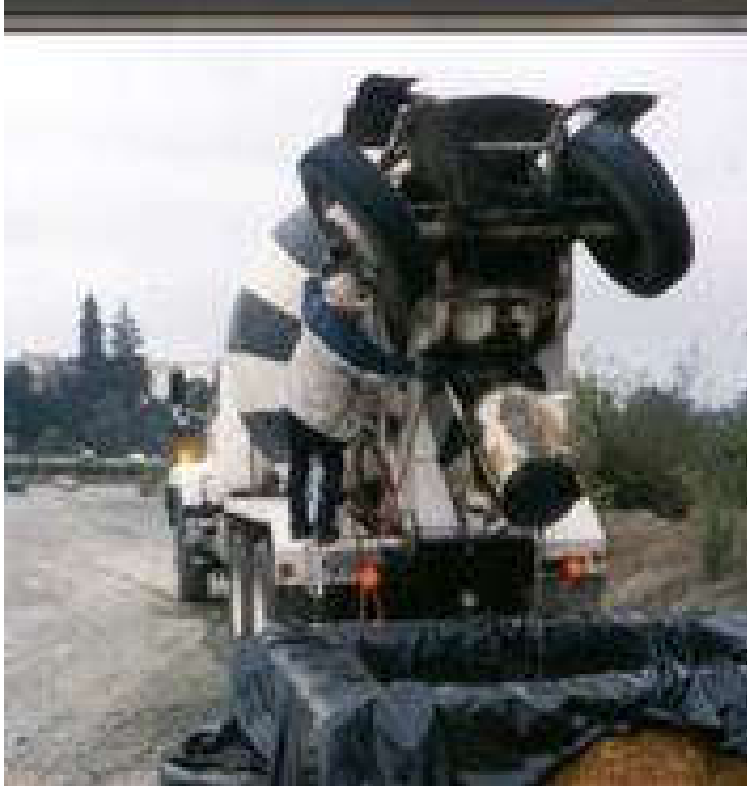
Appendix 3. Specifications for the collection of excess concrete, and wash or waste water.

An encircled area of approximately 4 feet long, by 2 feet wide and 2 feet deep, shall be constructed by creating a berm with sand bags or other materials, surrounded by an impermeable layer, such as a plastic liner. After excess concrete or waste water has been collected it shall be left until materials harden, any remaining waste water/ fluid shall be collected and sent to the appropriate waste facility, and the hardened concrete can also be disposed off, at the appropriate facility.

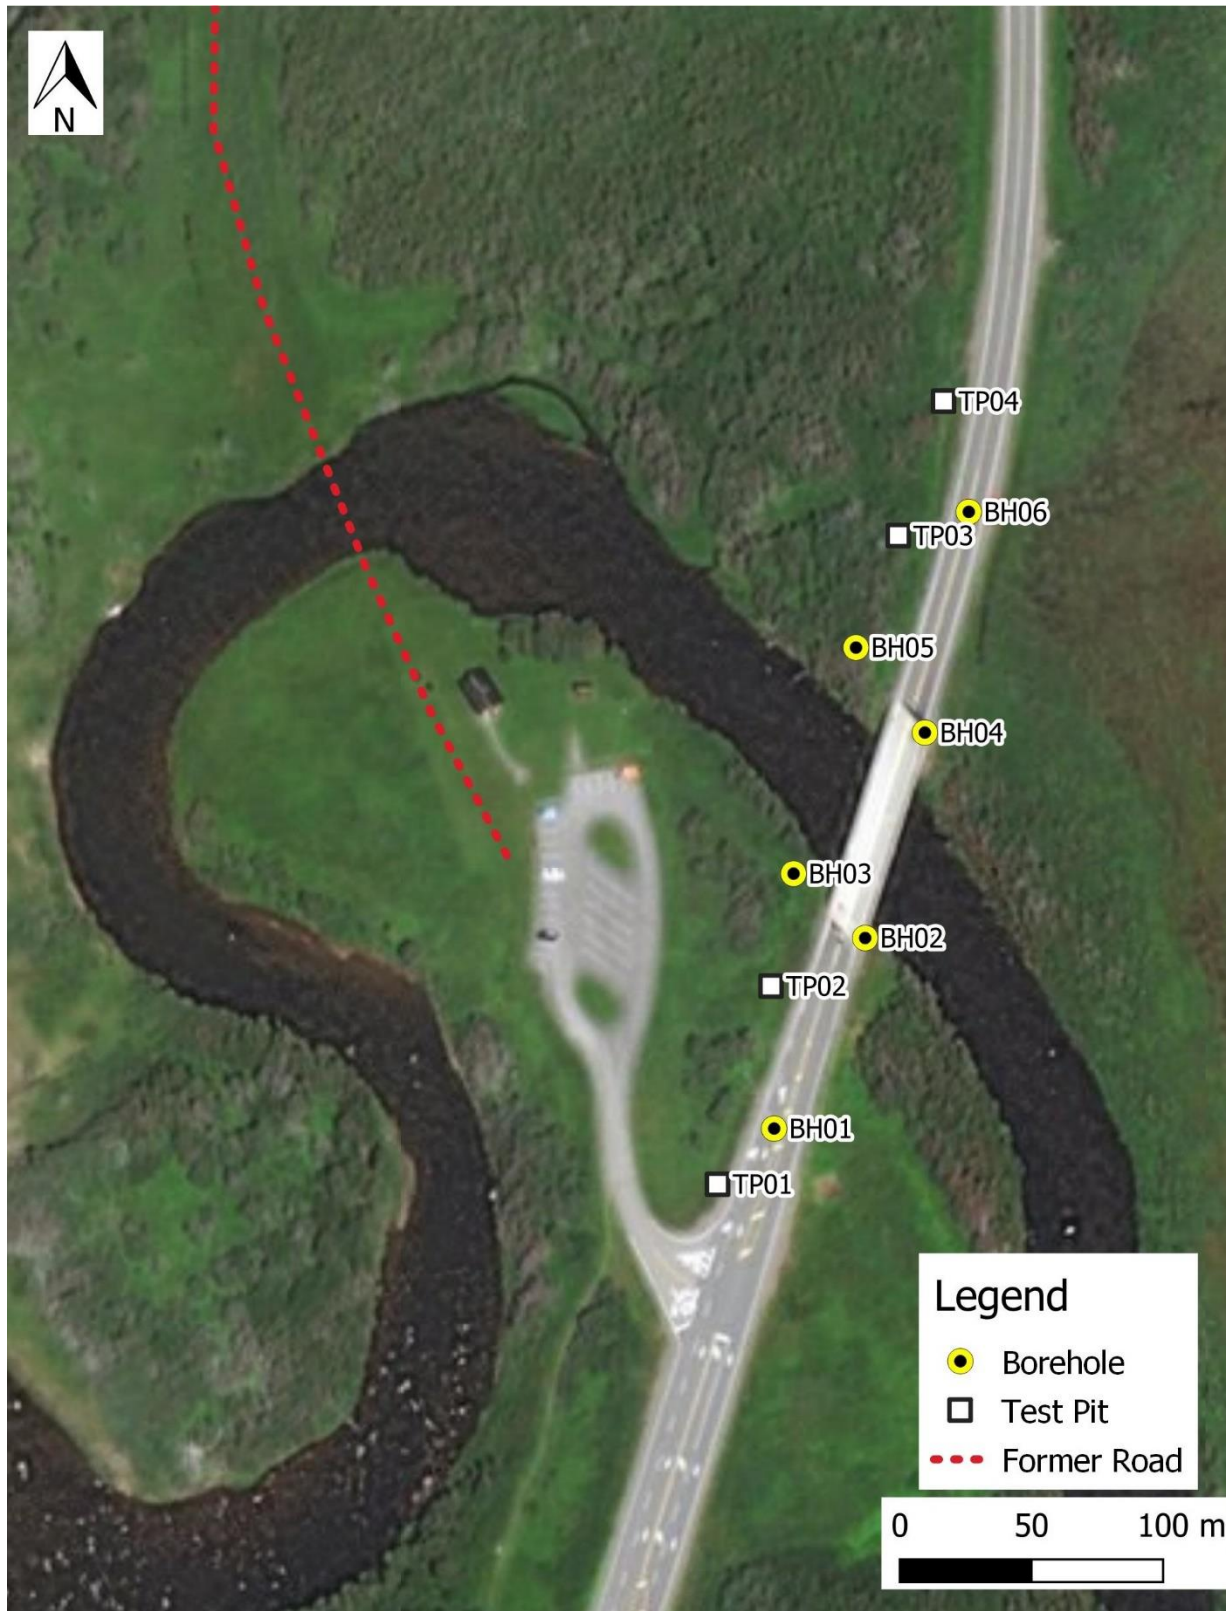
Figure 4: Borehole and test pit locations provided by Harbourside Engineering, as well as location of former road / access road, as indicated in Public Works 1981 Note. Test Pits TP02 and TP03 were not tested following Dec 2019 discussions with Field Unit (Higdon 2019, Harbourside 2020b).

Please note that an initial archaeological overview assessment (AOA) for the geotechnical investigation associated with the design phase of the Western Brook Bridge Replacement Project (RPA 1268.05) was completed in November 2019 (Figures 4, 5, Parks Canada 2019a, Higdon 2019). Given the project's proximity to the salmon river, an archaeological impact assessment was recommended at that time. The project scope was subsequently amended and test pits in specific areas removed to allow for the geotechnical sampling to take place while the weather was still amenable. This resulted in two amendments to the original AOA. The geotechnical investigation took place in December 2019 (Harbourside 2020b).

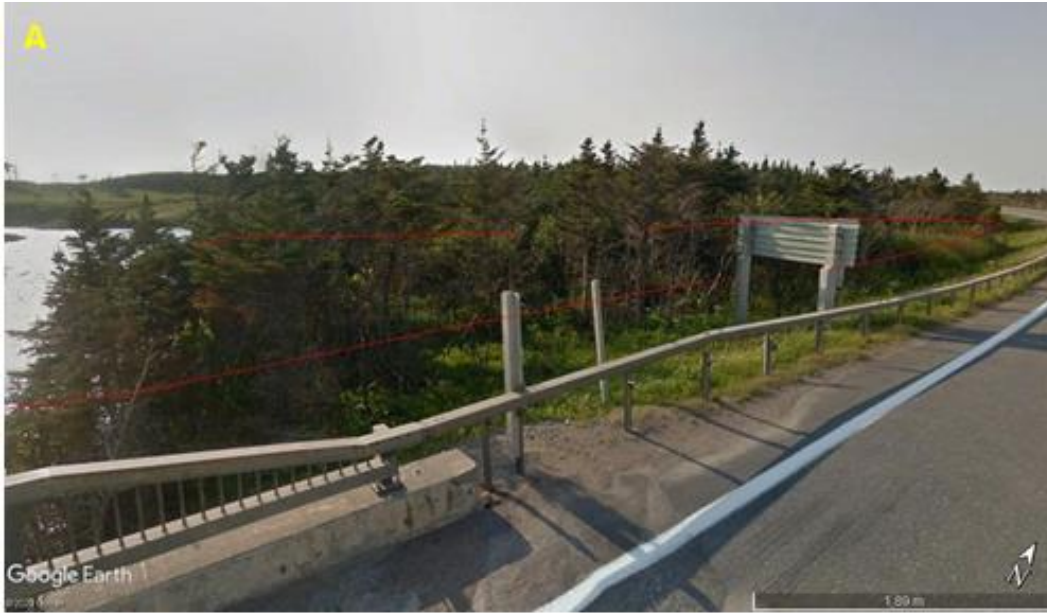
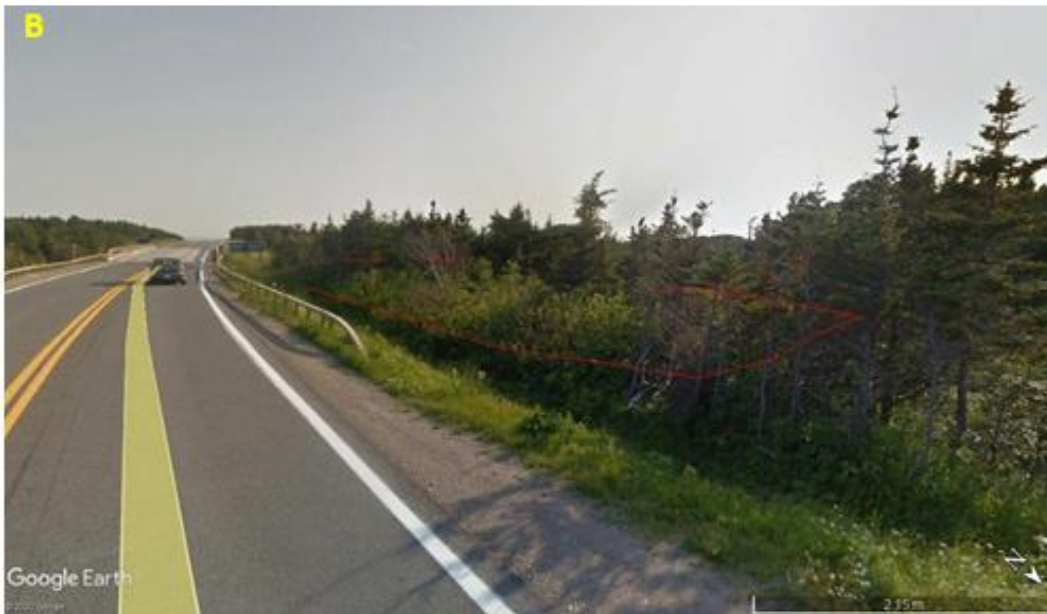
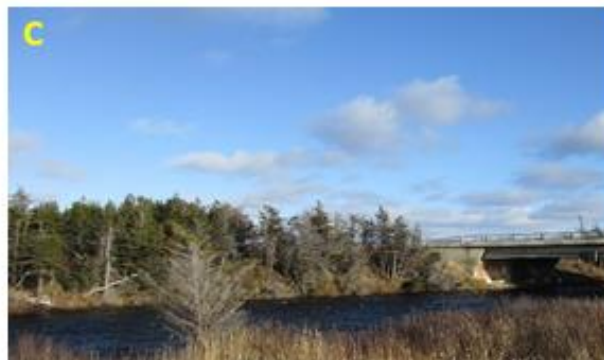
Figure 9: Assessment Area AA-1 Images. A) southern extent of assessment area, facing northwest from bridge; B) northern extent of assessment area, facing southwest; C) southern extent of assessment area, facing northeast from parking lot.

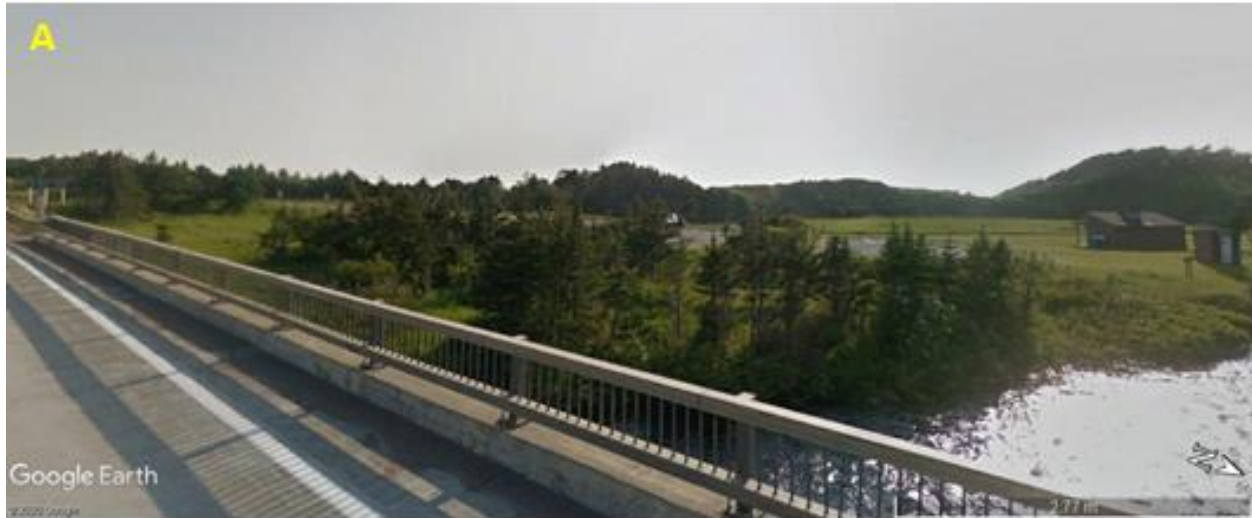
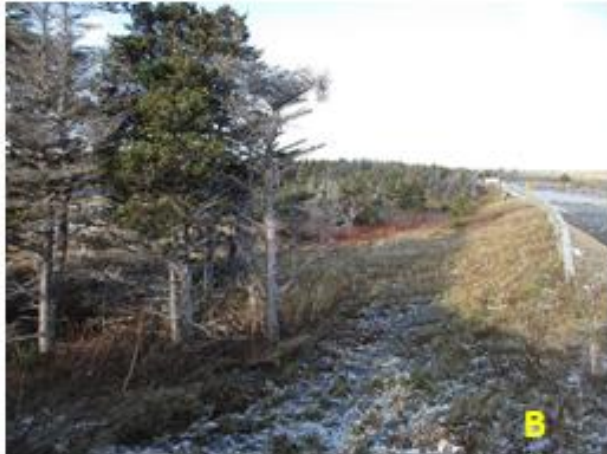
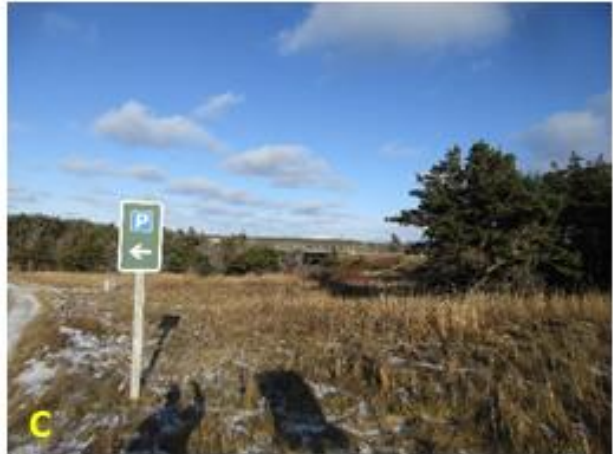
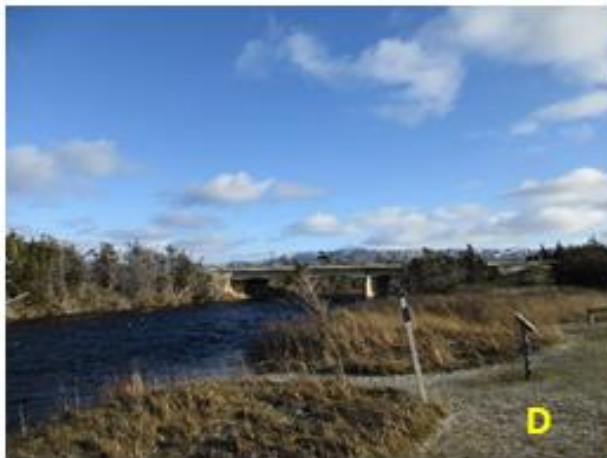
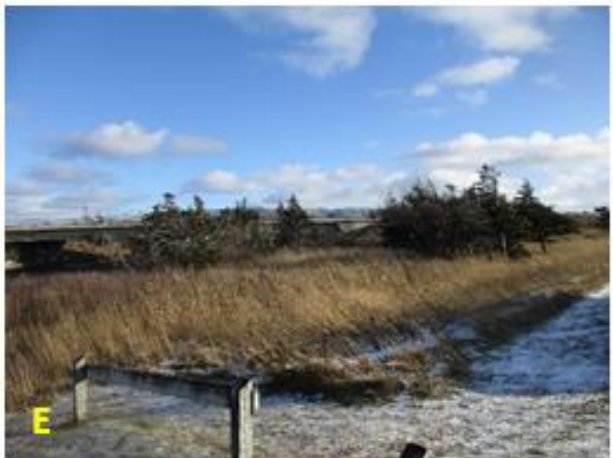
Figure 11: Assessment Area AA-2 Images. A) Assessment area facing southwest from bridge; B) View of shoulder of road and previously disturbed slope, facing north; C) western extent of assessment area, facing north from parking lot; D) western extent of assessment area, facing east from northern extent of parking; E) assessment area, facing east from parking lot.

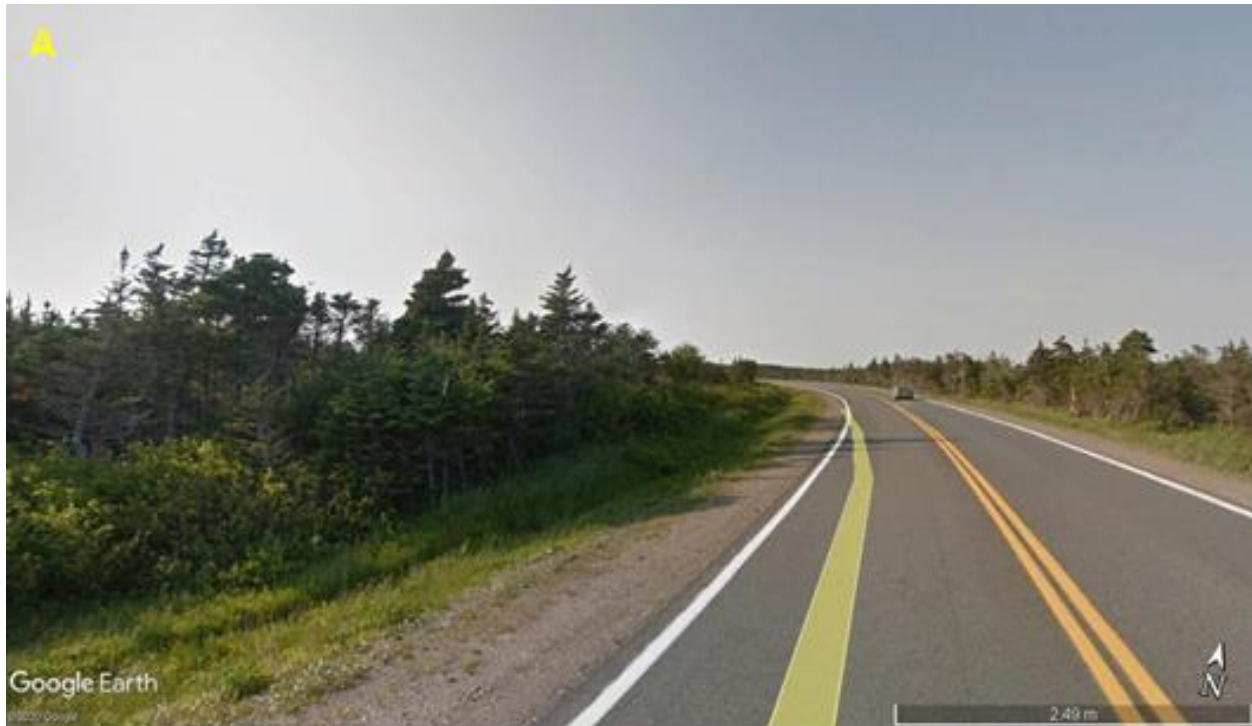
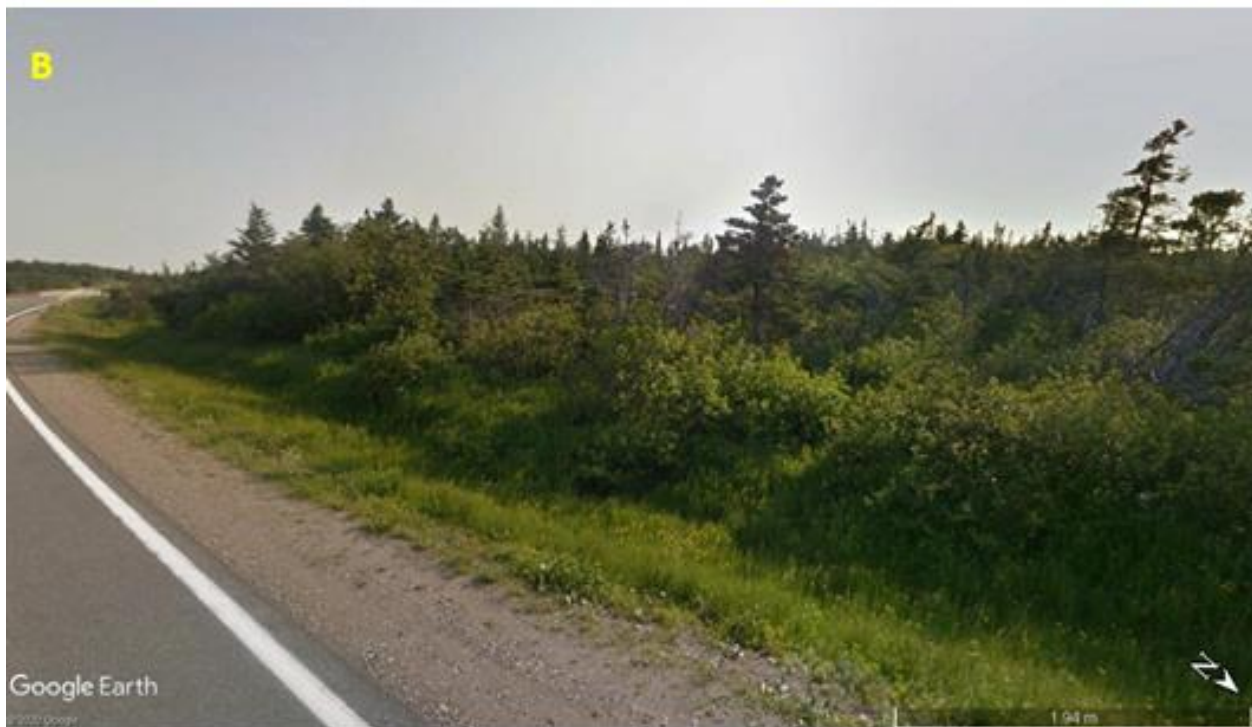
Figure 13: Assessment Area AA-3 Images. A) Northern extent of assessment area, facing southwest; B) Southern extent of assessment area, facing northwest.

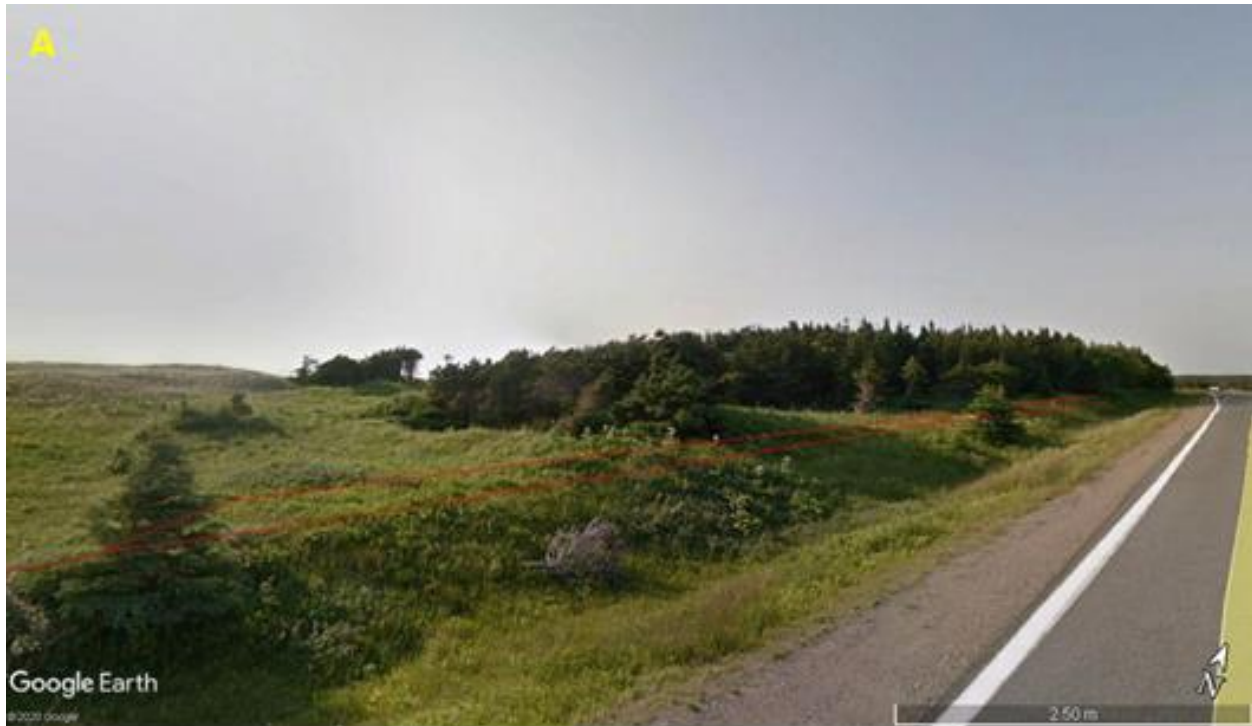
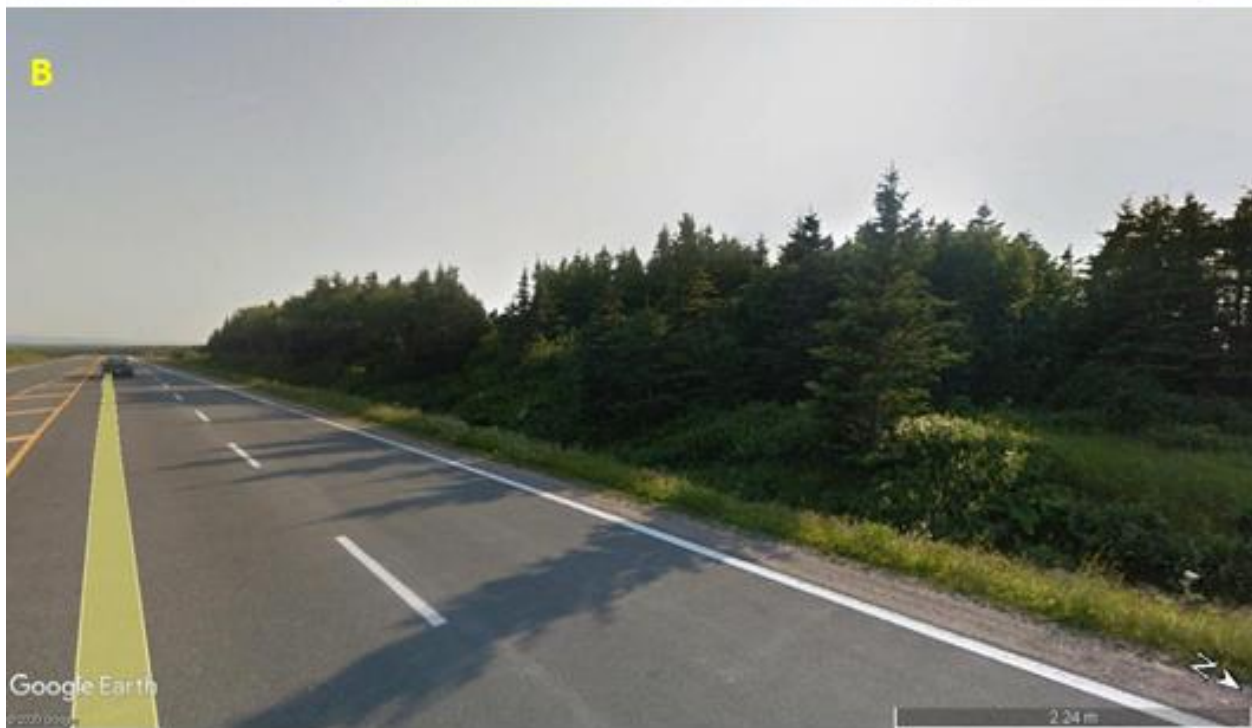
Figure 16: Assessment Area AA-4 Images. A) Northern extent of assessment area, facing southwest; B) Southern extent of assessment area, facing northwest.
