<p>RETURN BIDS TO/RETOURNER LES SOUMISSIONS À:</p> <p>Bid Receiving - Environment Canada / Réception des soumissions – Environnement Canada</p> <p>Electronic Copy: soumissionsbids@ec.gc.ca</p> <p>BID SOLICITATION AMENDMENT MODIFICATION DE LA DEMANDE DE SOUMISSIONS</p> <p>The referenced Bid Solicitation is revised in this document; unless otherwise indicated, all other terms and conditions of the Bid Solicitation remain the same.</p> <p>La demande de soumissions citée en référence est modifiée dans ce document; sauf indication contraire, les modalités de la demande de soumissions demeurent les mêmes.</p>	<p>Title – Titre Cableway Upgrades and Repairs at Telkwa River below Tsai Creek (08EE020)</p>	
	<p>EC Bid Solicitation No. /SAP No. – N° de la demande de soumissions EC / N° SAP 5000064501</p>	<p>Amendment No. - N° de modification 001</p>
	<p>Amendment Date (YYYY-MM-DD) – Date de la modification (AAAA-MM-JJ) 2022-09-02</p>

AMENDMENT No. 001

Amendment 001 of Solicitation # **5000064501** is raised to answer questions from Suppliers.

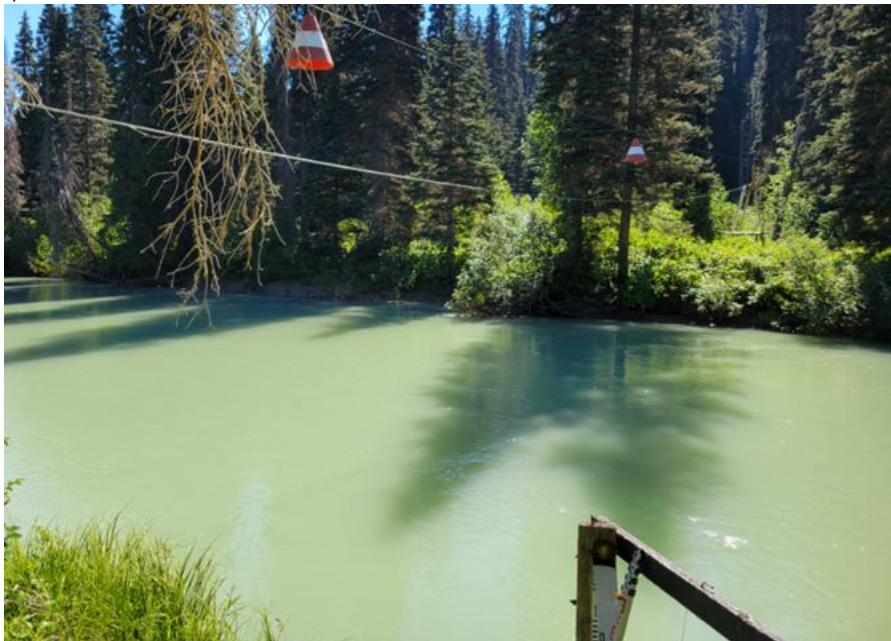
A1. Far side vegetation may need to be cleared to create a laydown area for slinging equipment and materials. The extent of vegetation clearing for these purposes will require approval from the Technical Authority and the Wet'suwet'en. See below image of cableway and far side taken on August 23, 2022.

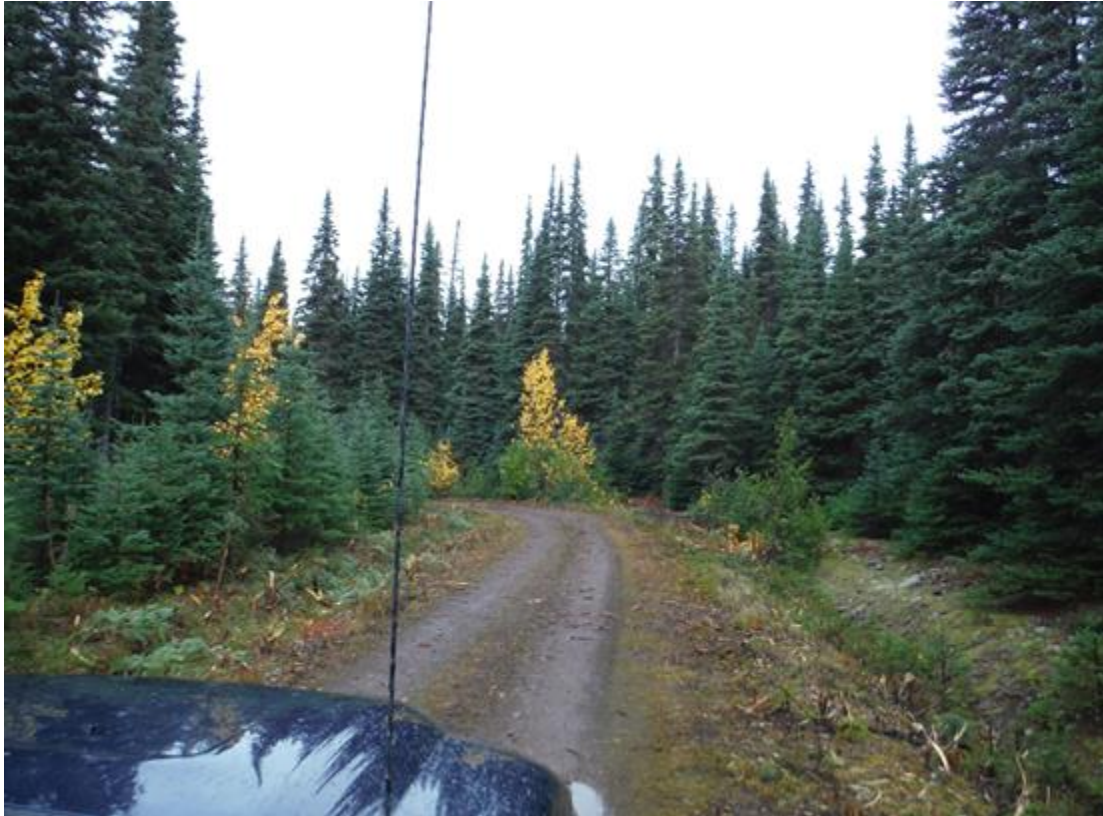
Sep 24, 2015- Access road near powerline and pipeline ROW; road still in good condition in summer, 2022.

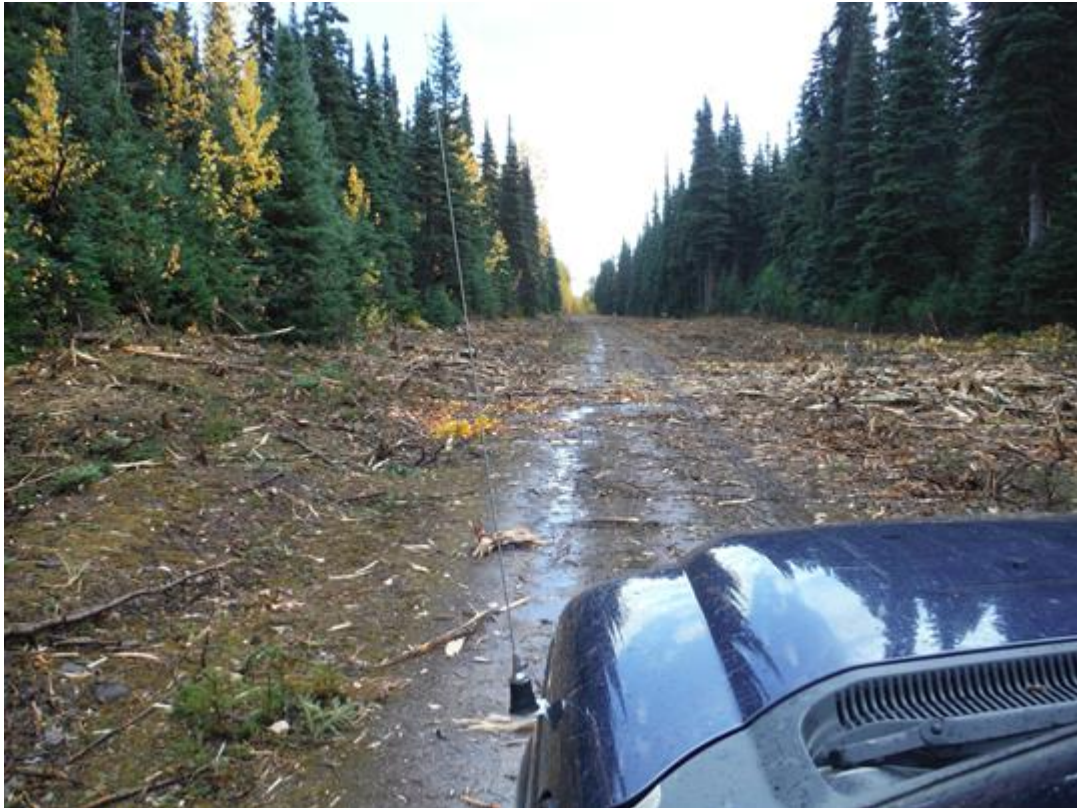
Sep 24, 2015- Access road along pipeline ROW; road still in good condition in summer, 2022.

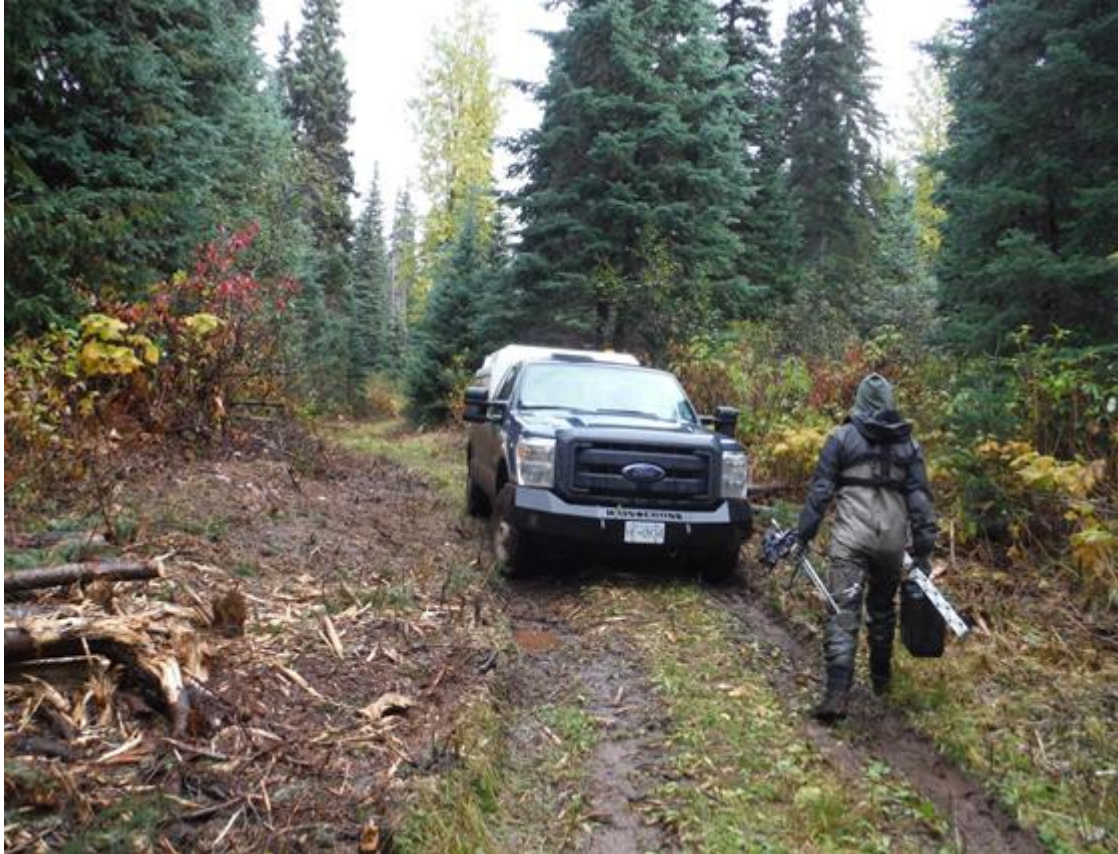
Sep 24, 2015 - 4x4 trail off access road; drivable to about 800m from site. ATV required for last 500-800m.

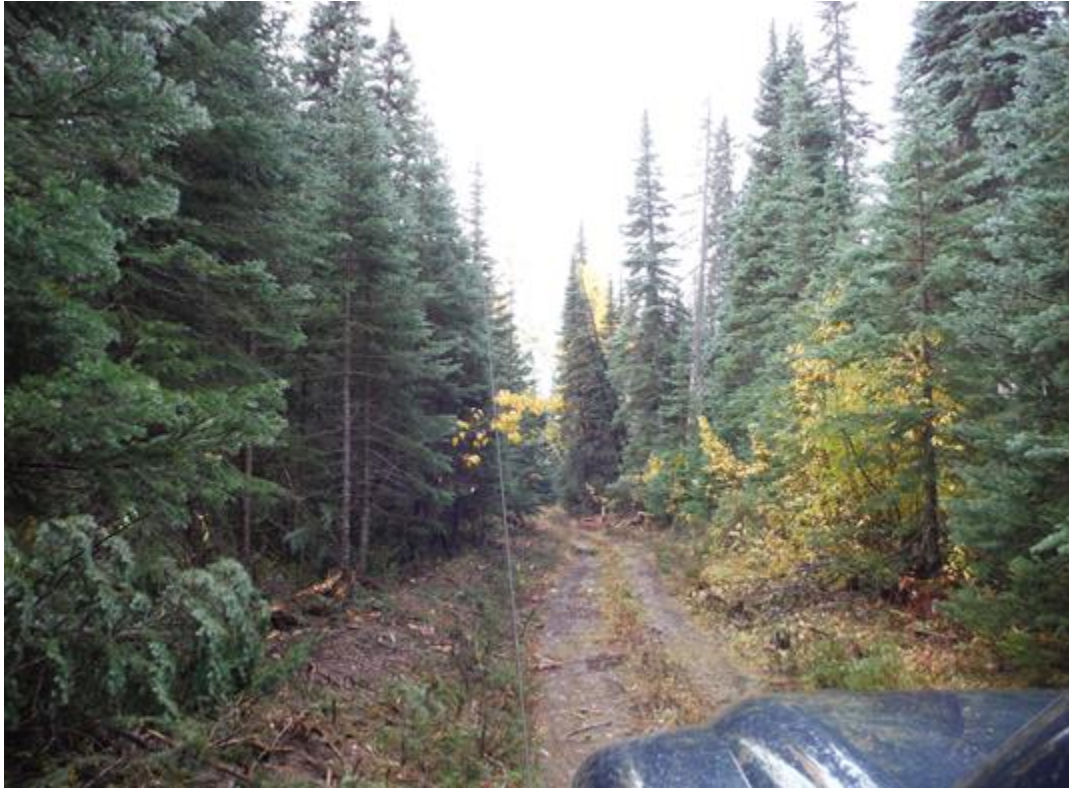
Sep 24, 2015 - 4x4 trail off access road.

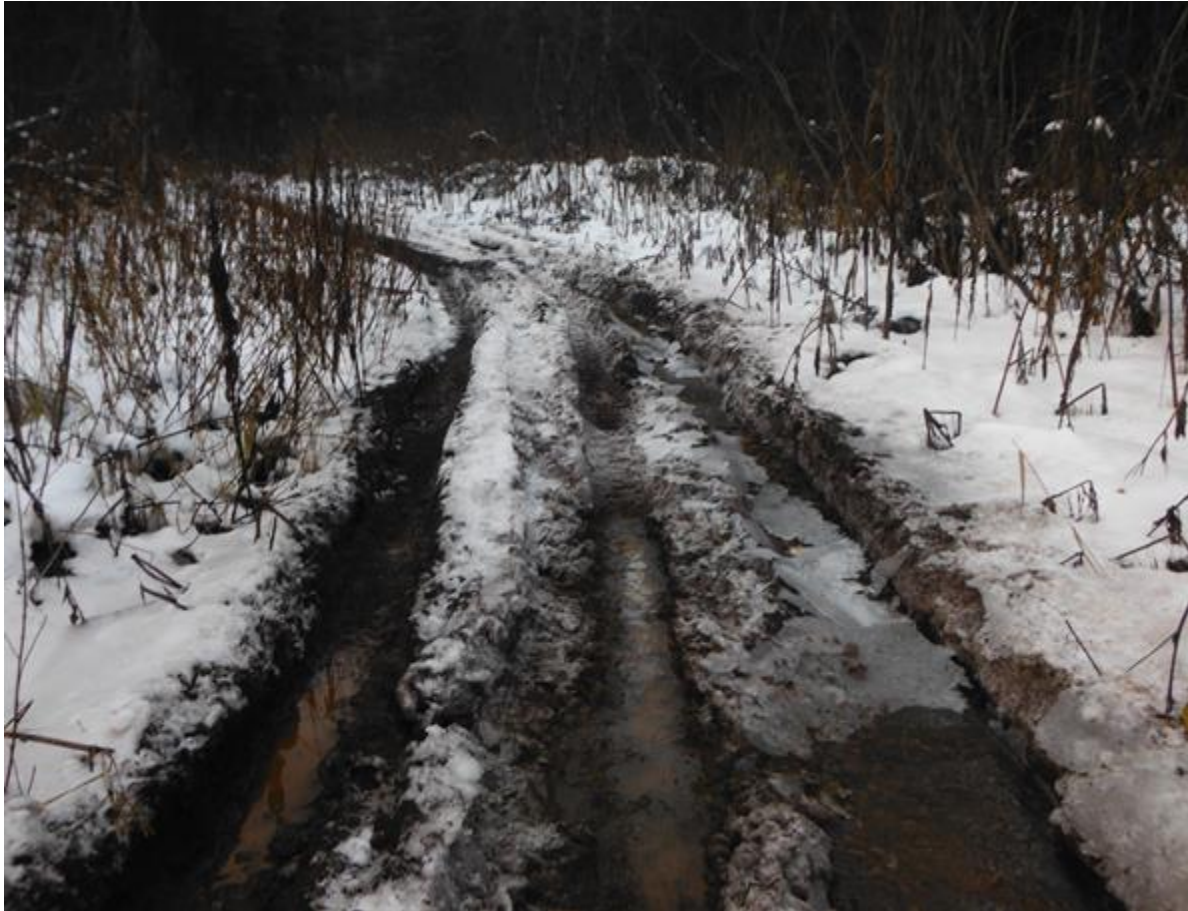
Oct 26, 2017 – soft/rutted spot about 75m from end of trail gauge. This spot is still rutted and ATV only (as of spring 2022)

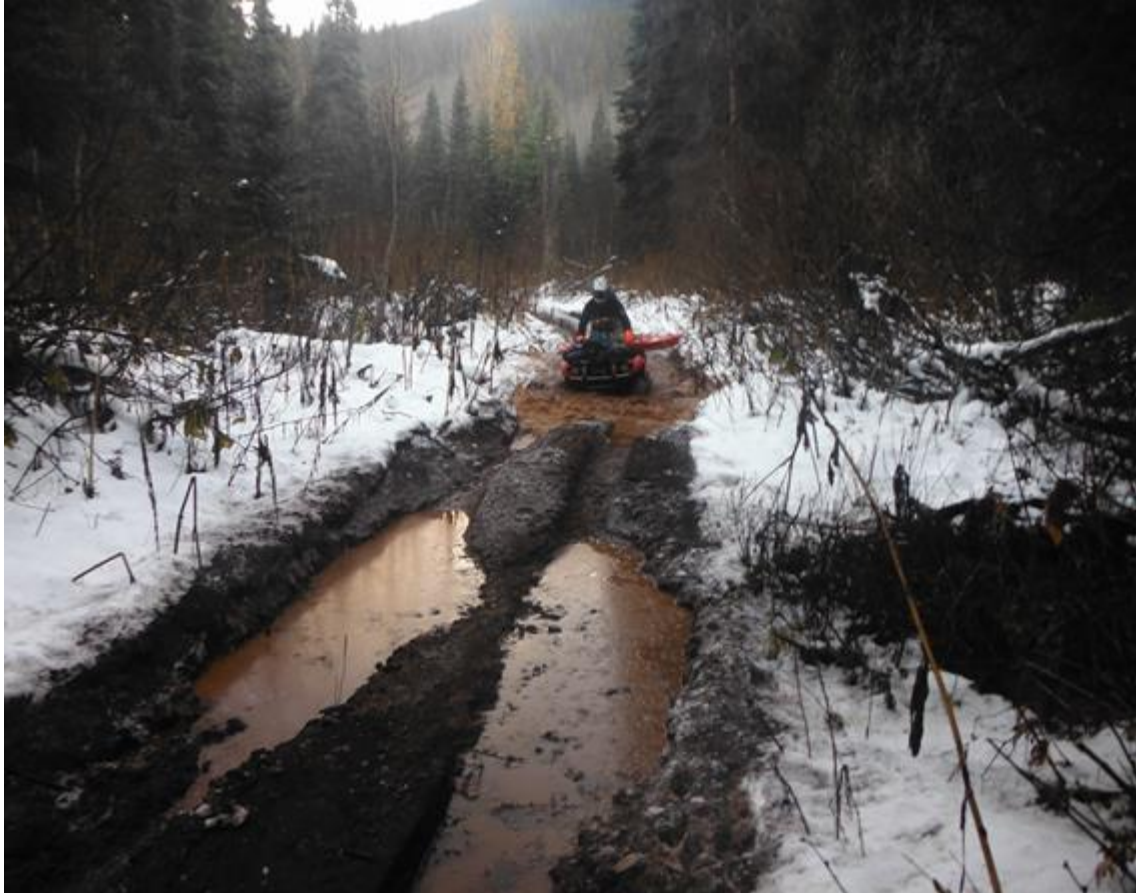
Oct 26, 2017 – rough spot on access trail/ road.

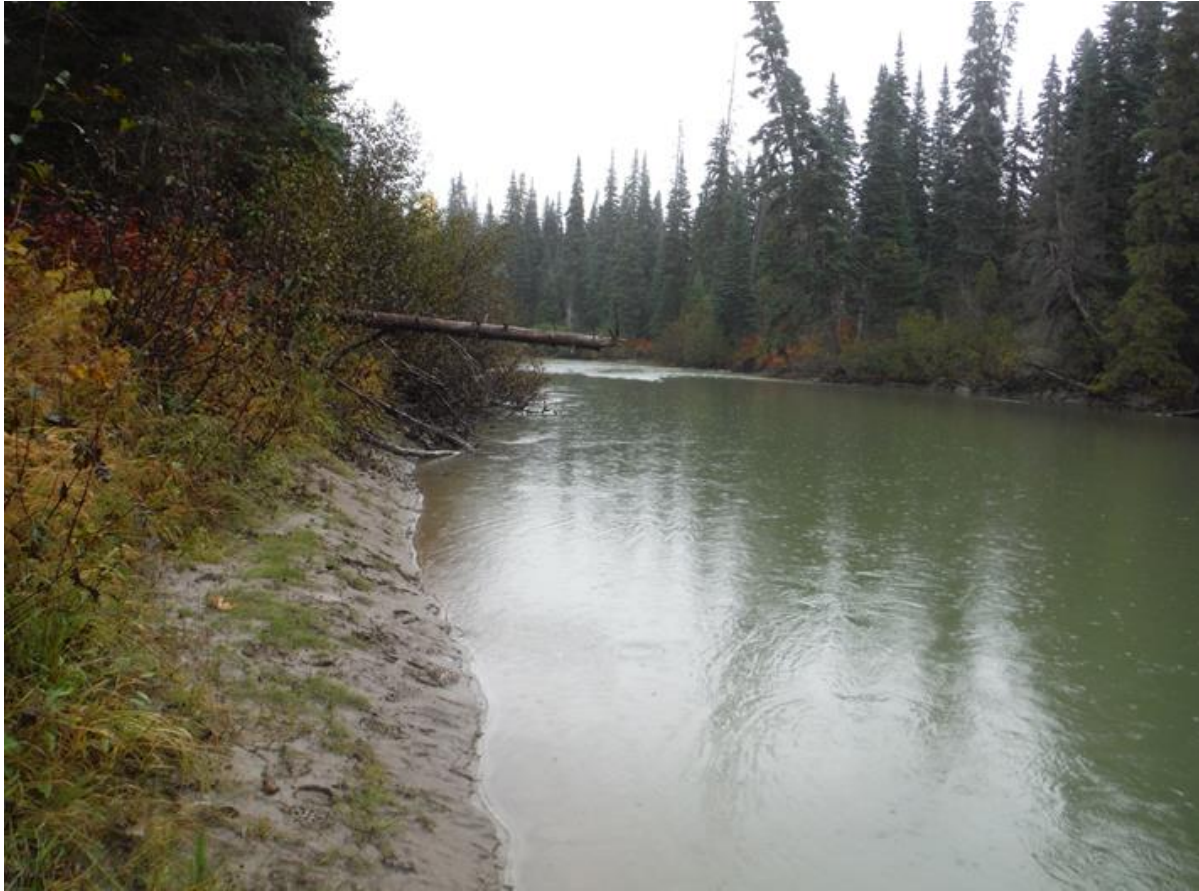
Sep 24, 2015; looking downstream to shallower riffle from left bank vantage point at cableway. Typical conditions for Sep/Oct; steep muddy bank along both shores.

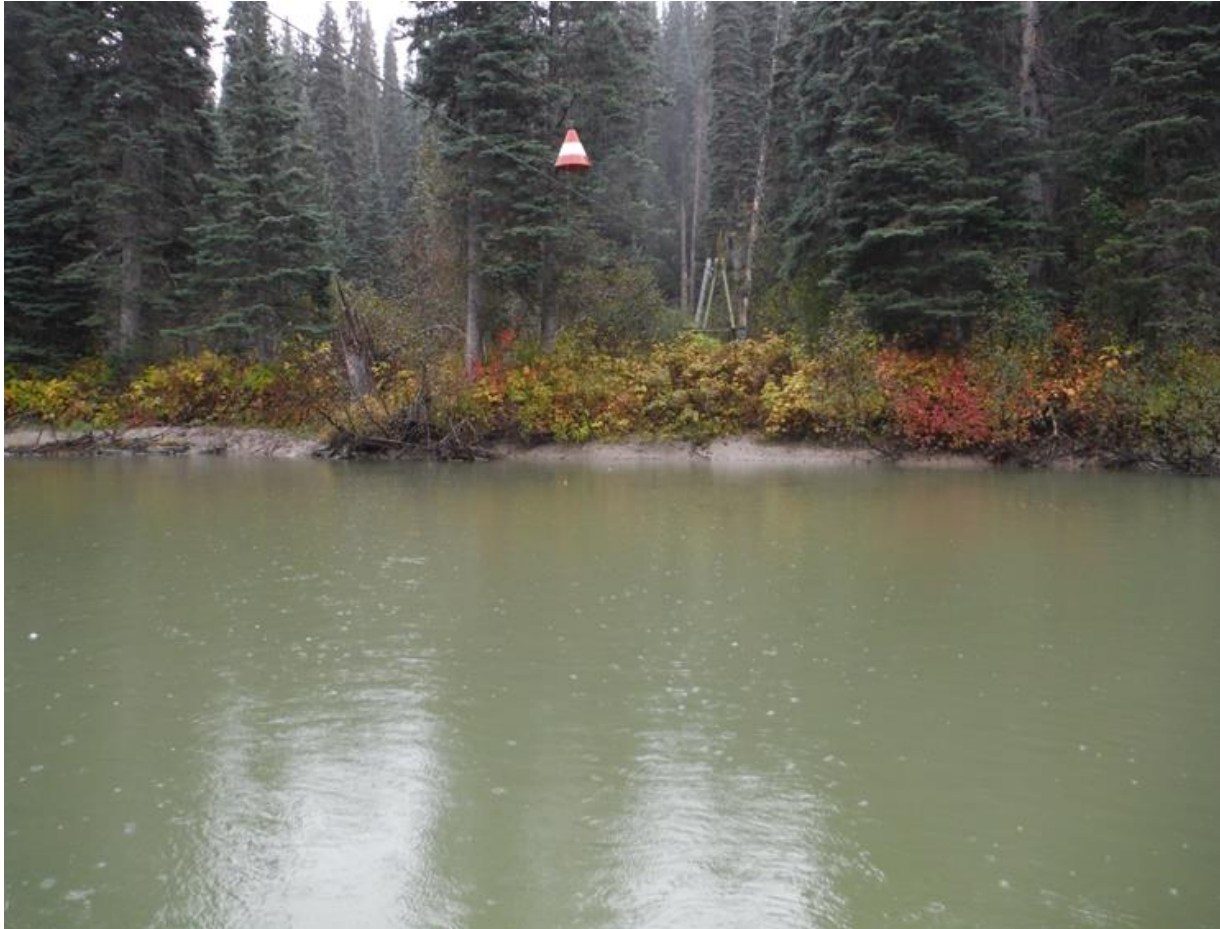
Sep 24, 2015; looking towards right bank (home side) from left bank vantage point. Typical conditions for Sep/Oct; steep muddy bank along both shores.

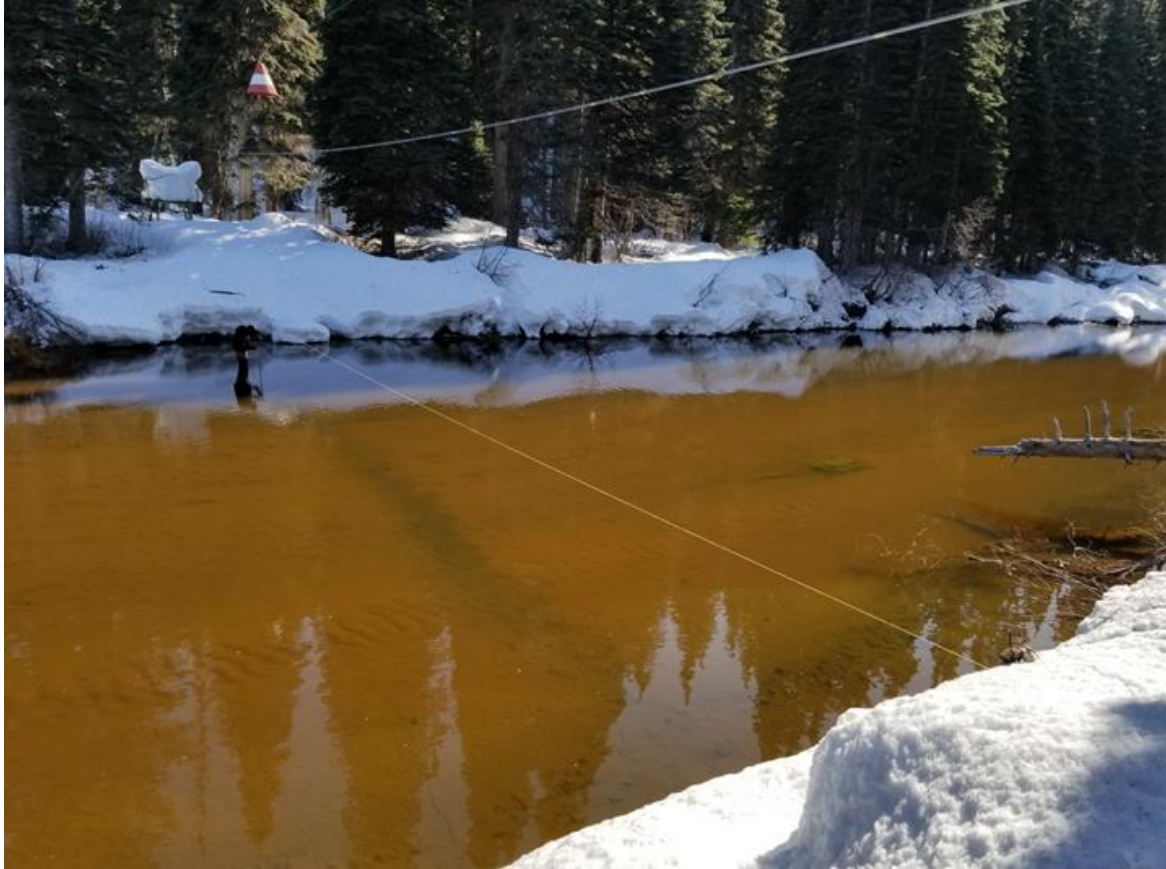
Apr 12, 2021 – typical low flow conditions in early spring. Streambed is gravel with mud along shores.

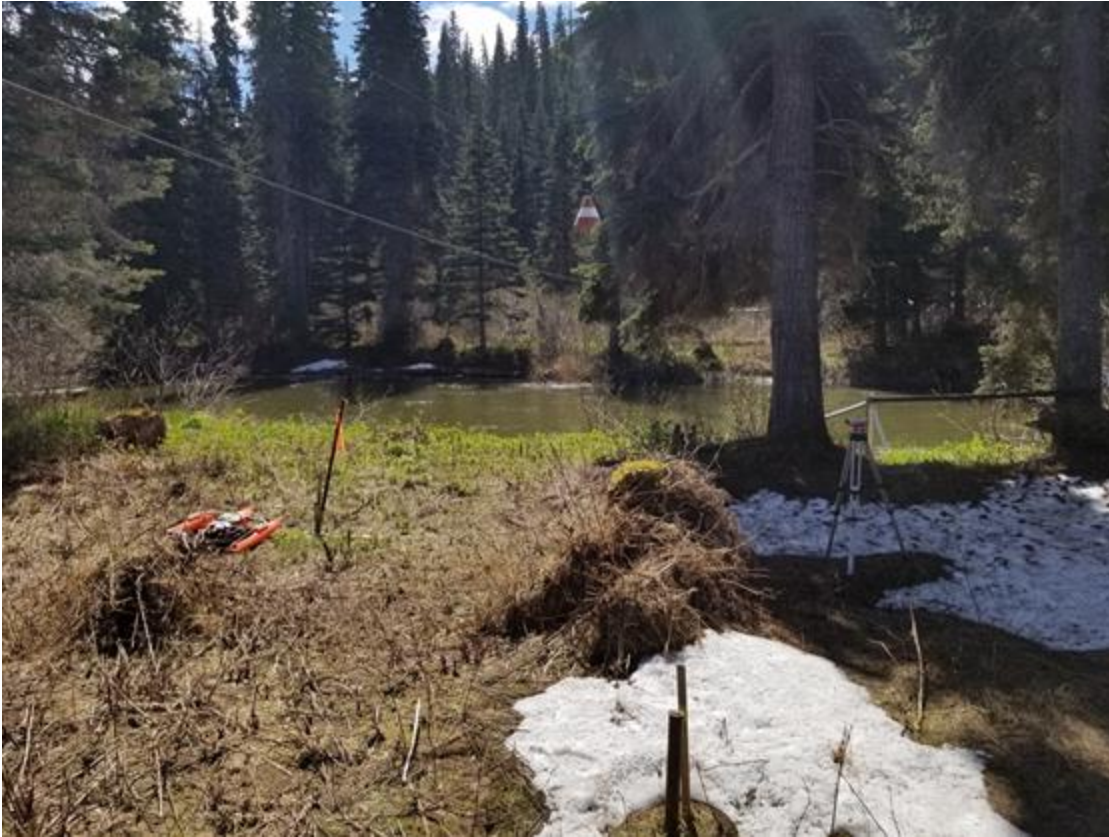
May 25, 2021 – access to river from end of trail at gauge location.
