Geotechnical Investigation The Chancery of the Canadian High Commission Bridgetown, St. Michael Parish, Barbados

Report Number: 10-1121-0089-1

**GEOTECHNICAL INVESTIGATION
THE CHANCERY OF THE CANADIAN HIGH COMMISSION
BRIDGETOWN, ST. MICHAEL PARISH, BARBADOS**

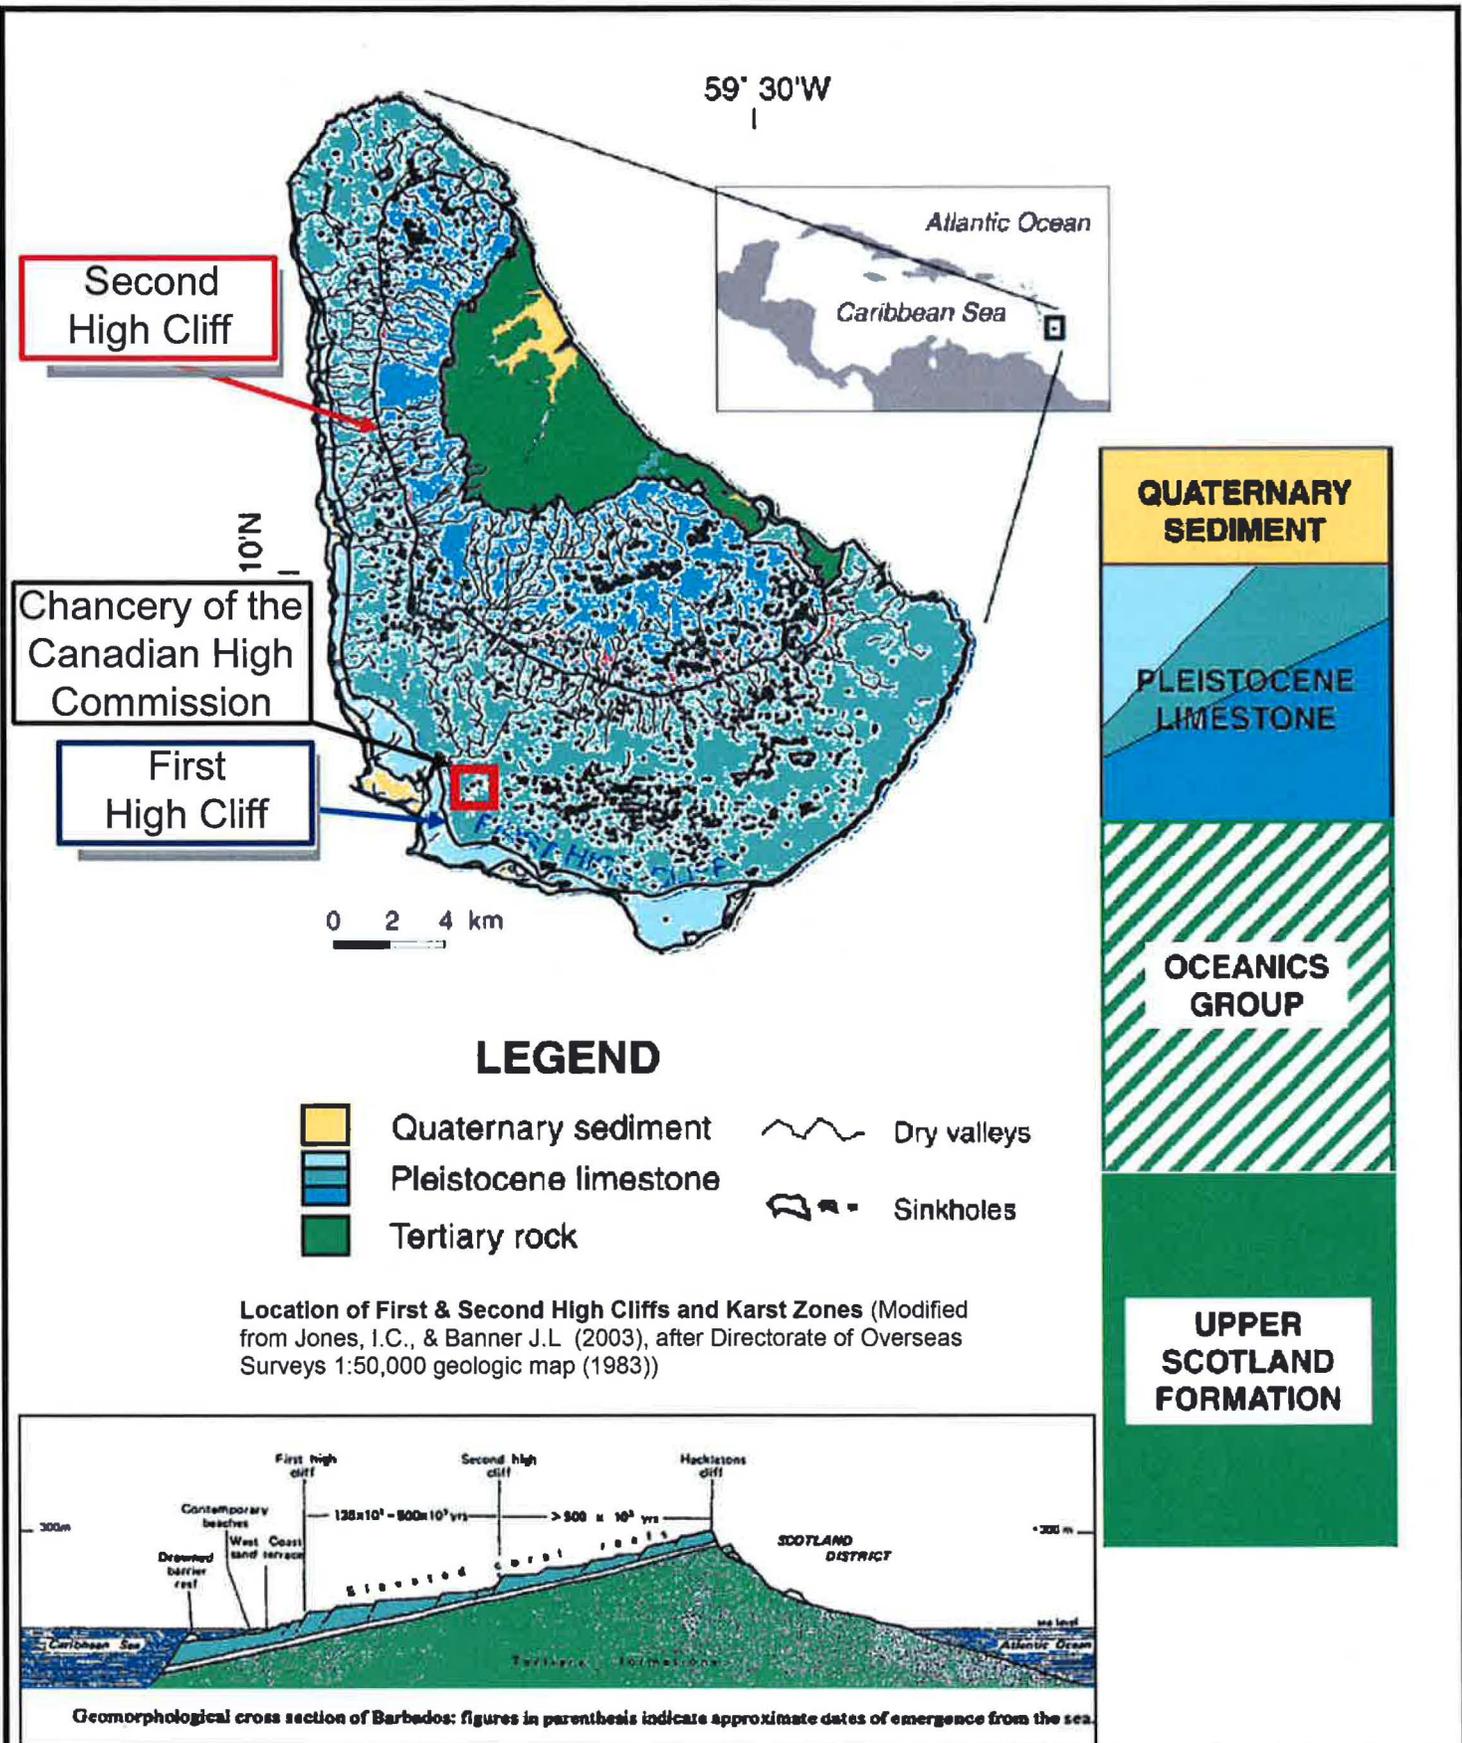
Published geologic maps indicate that the geological conditions in the area of the Chancery consist of coral limestone of the Middle Coral Reef Terraces, as shown in Figure 2. According to available geological and topographic maps, the coral rock formations are approximately 70 metres thick and are underlain by the Tertiary rock of the Upper Scotland Formation.

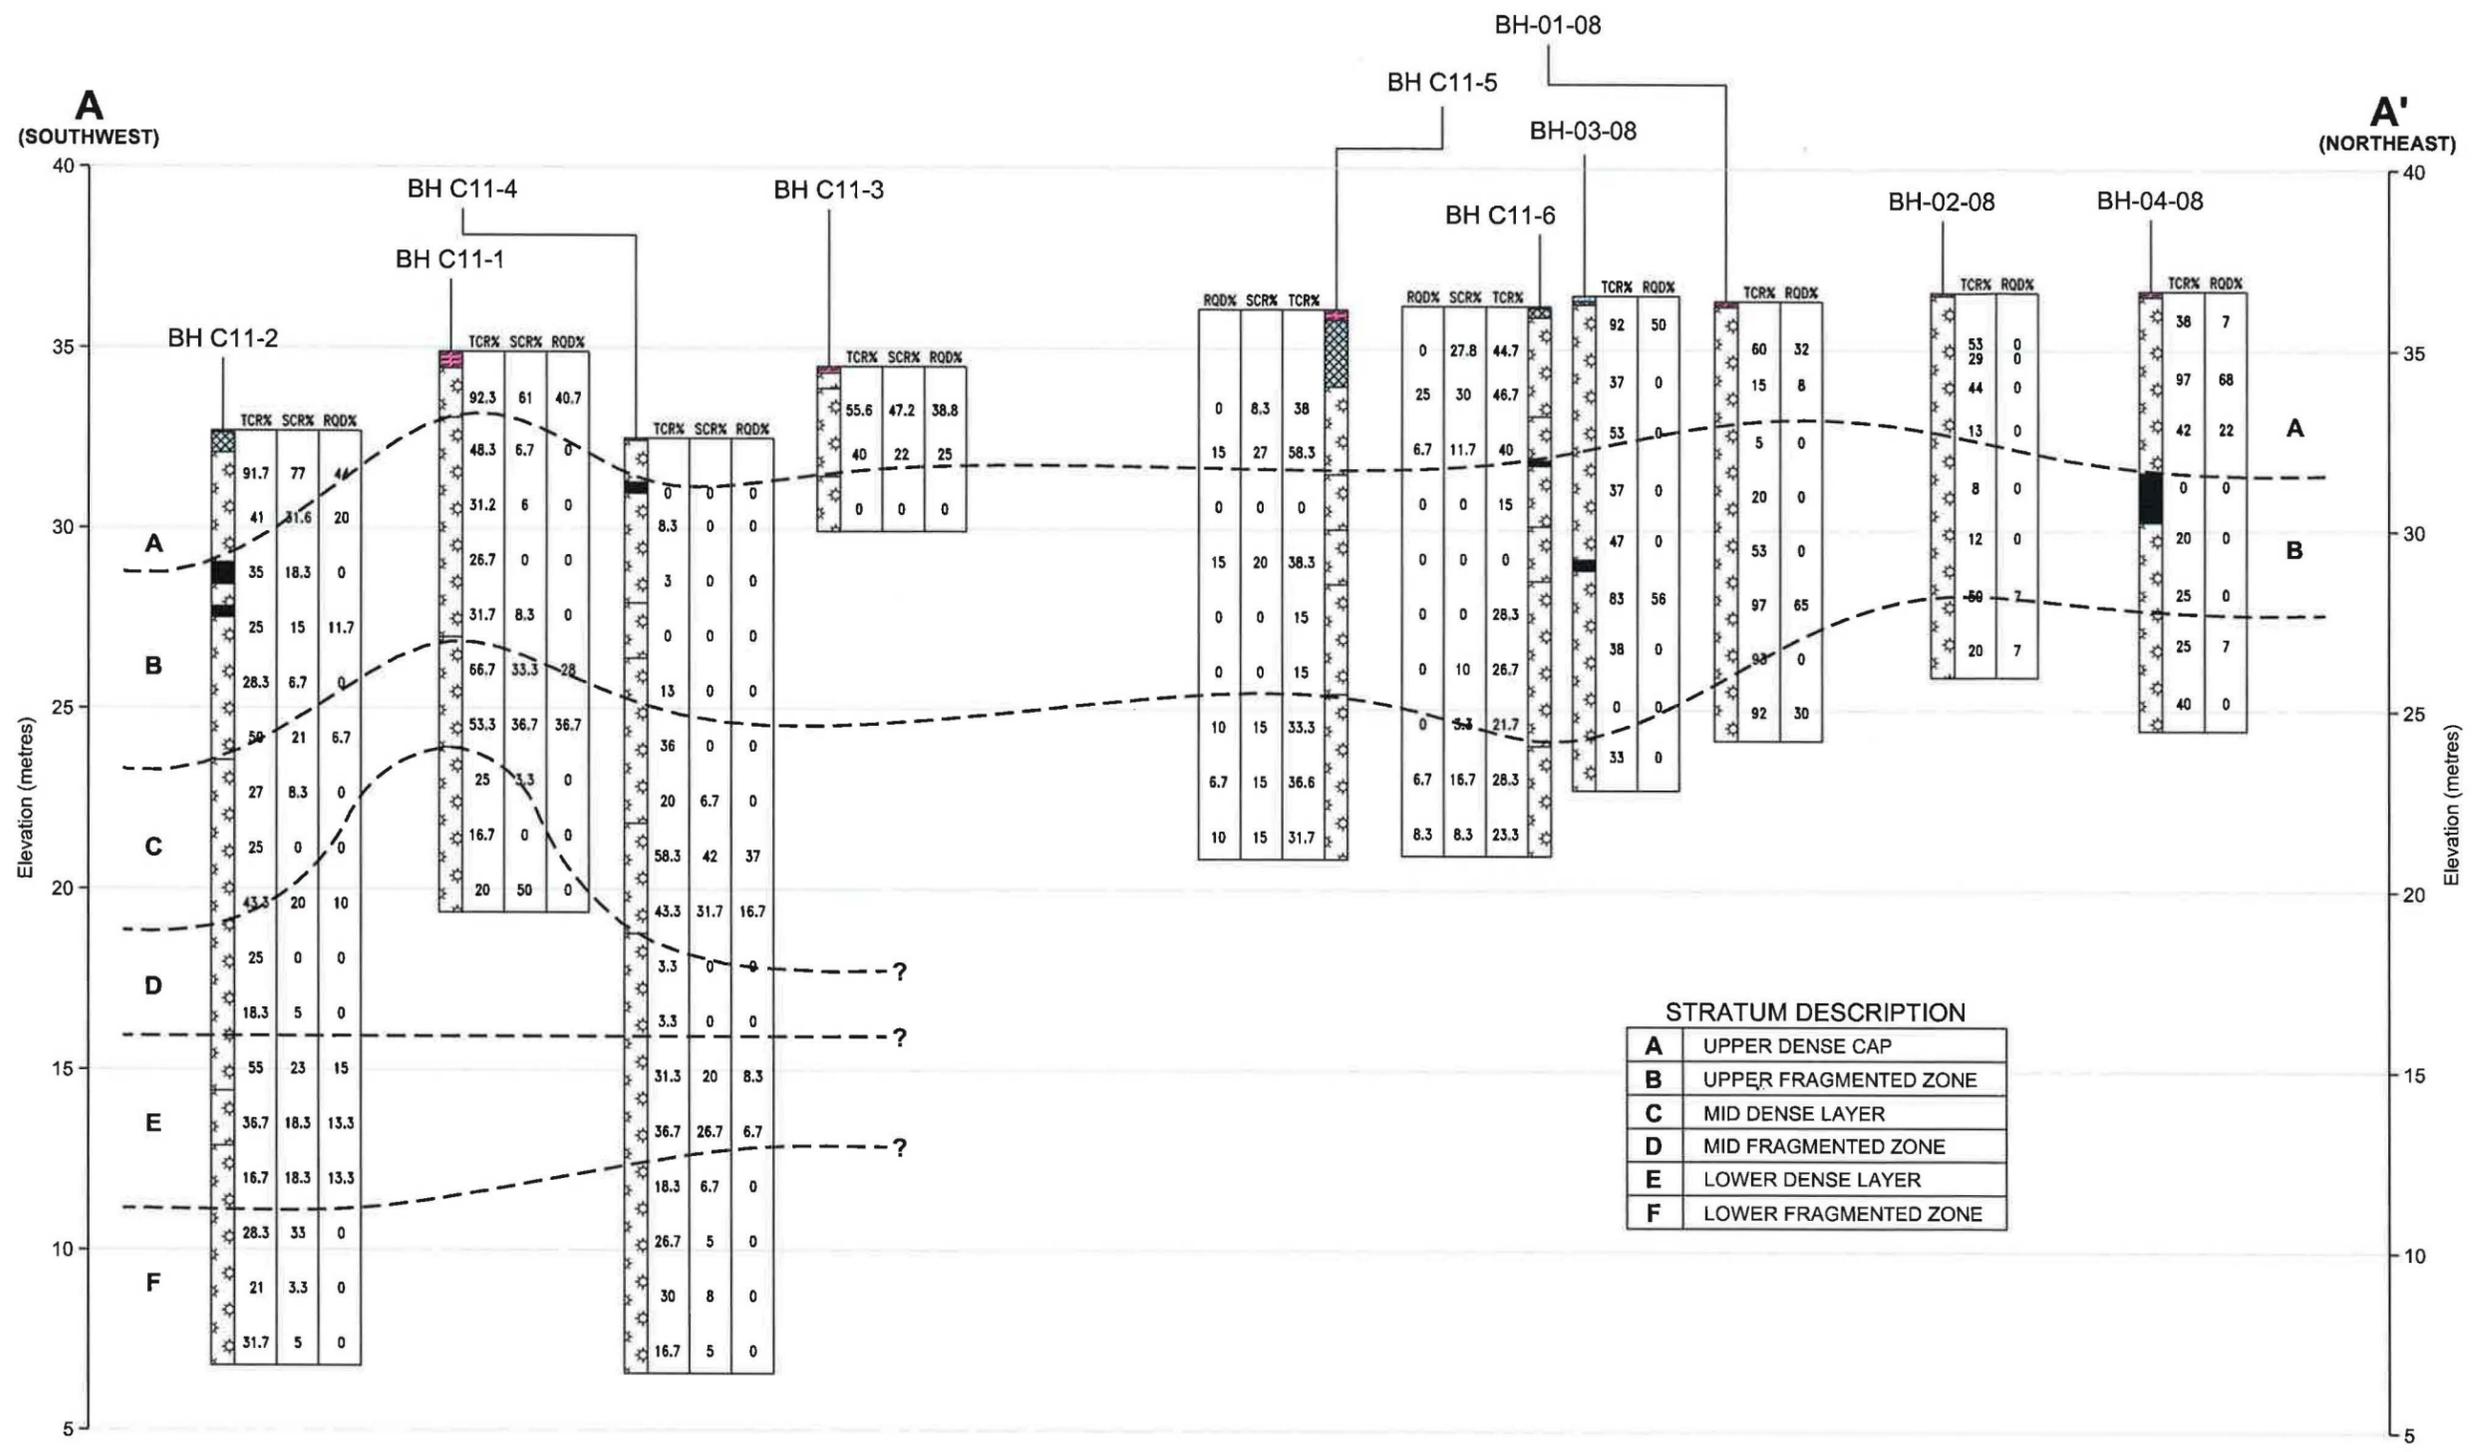
Based on the borehole records, field observations, and the laboratory test results of the recovered core, it appears the coral limestone is banded in layers at the site. There are bands of coral limestone that have higher density with smaller voids and higher compressive strength and then there are also bands of highly fractured coral limestone that have larger voids and lower densities and strengths. Figure 4 illustrates this banding and the varying rock properties throughout the site. The following table provides a summary of this stratigraphy across the site. It should be noted that at certain locations at the site each stratum level may differ from the following given elevation range and there is high variability across the site.

A	UPPER DENSE CAP
B	UPPER FRAGMENTED ZONE
C	MID DENSE LAYER
D	MID FRAGMENTED ZONE
E	LOWER DENSE LAYER
F	LOWER FRAGMENTED ZONE

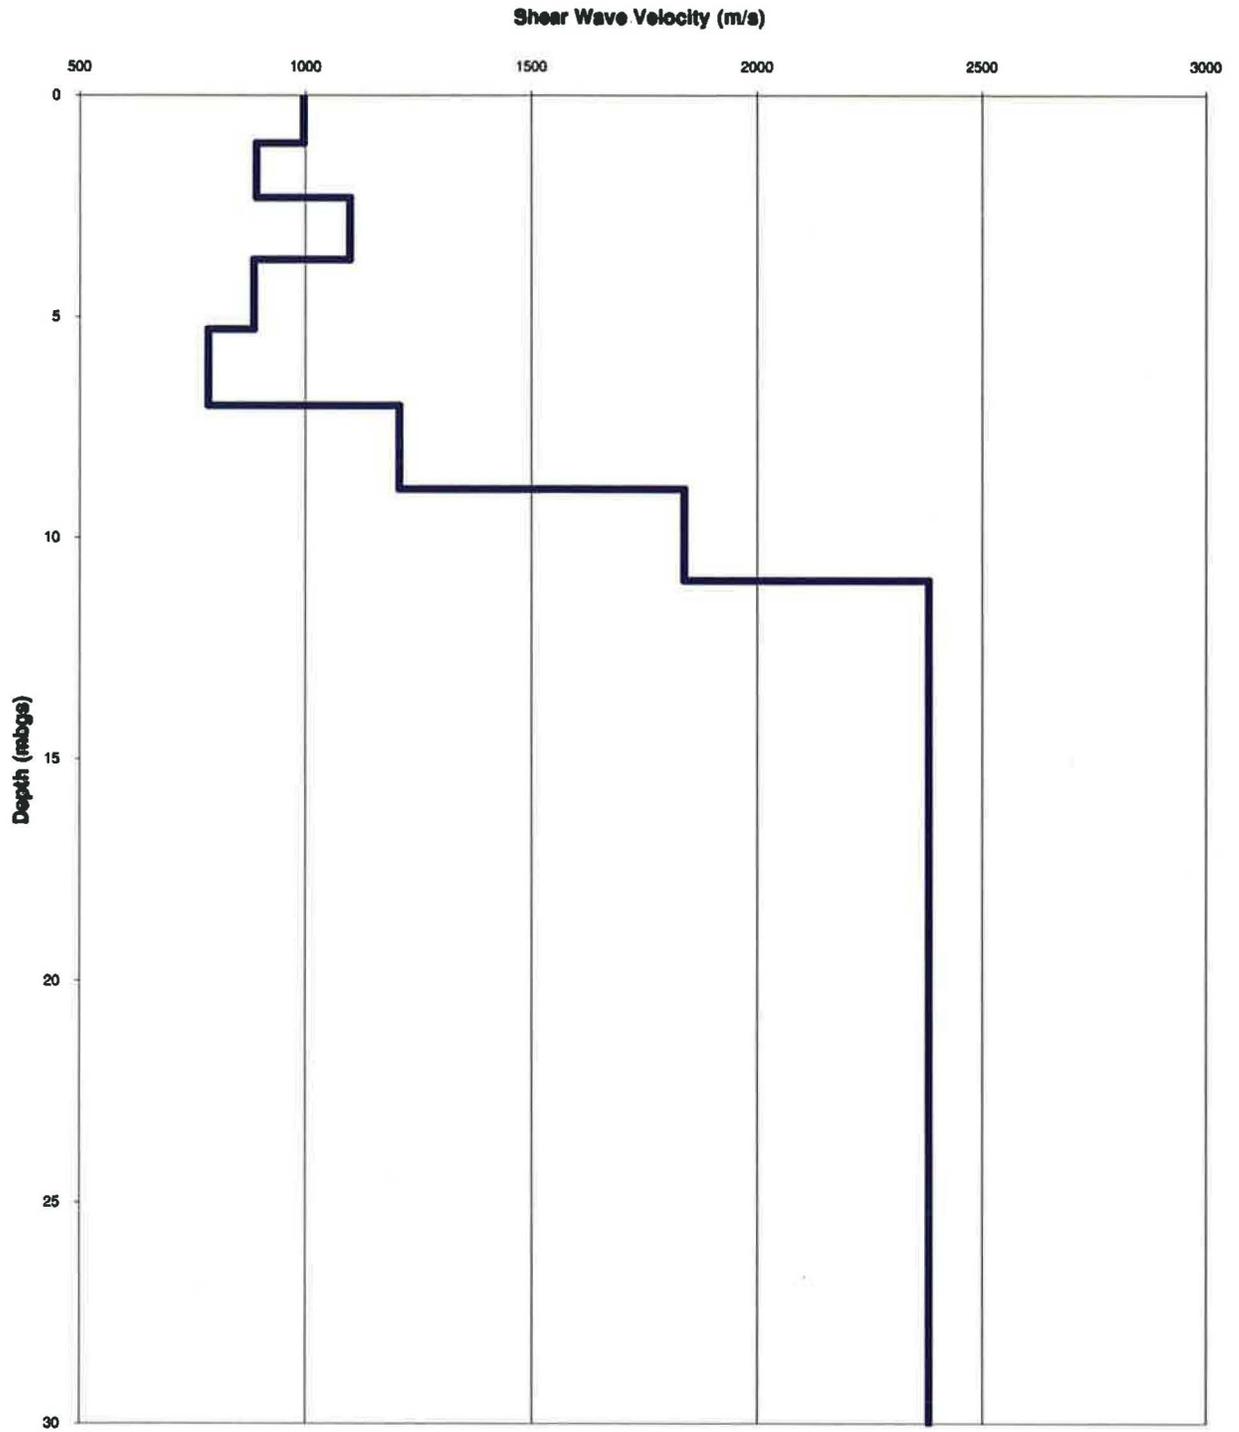
Plate 3: MASW Modelled Shear Wave Velocity Depth profile

The MASW test results are presented in Plate 3 which presents the calculated shear wave velocity profiles measured from the field testing. These results have been inferred using a sledgehammer located at 5 m from the first geophone. The field collected dispersion curves are compared with the model generated dispersion curves on Plate 4. There is a good correlation between the field collected and model calculated dispersion curves, with a root mean squared error of 1%. The shear wave velocity depth profile indicates a gradual increase in velocity at approximately 7 m from 785 m/s to approximately 2,400 m/s at 11 m.

To calculate the average shear wave velocity as required by the National Building Code of Canada, 2005 (NBCC2005), the results were modelled to 30 mbgs. The limited low frequency content of the dispersion curve did not allow us to sufficiently resolve shear-wave velocities at depth below 11 m. The average shear wave velocity was calculated assuming that the velocity from the maximum resolved depth (approximately 11 m) to a

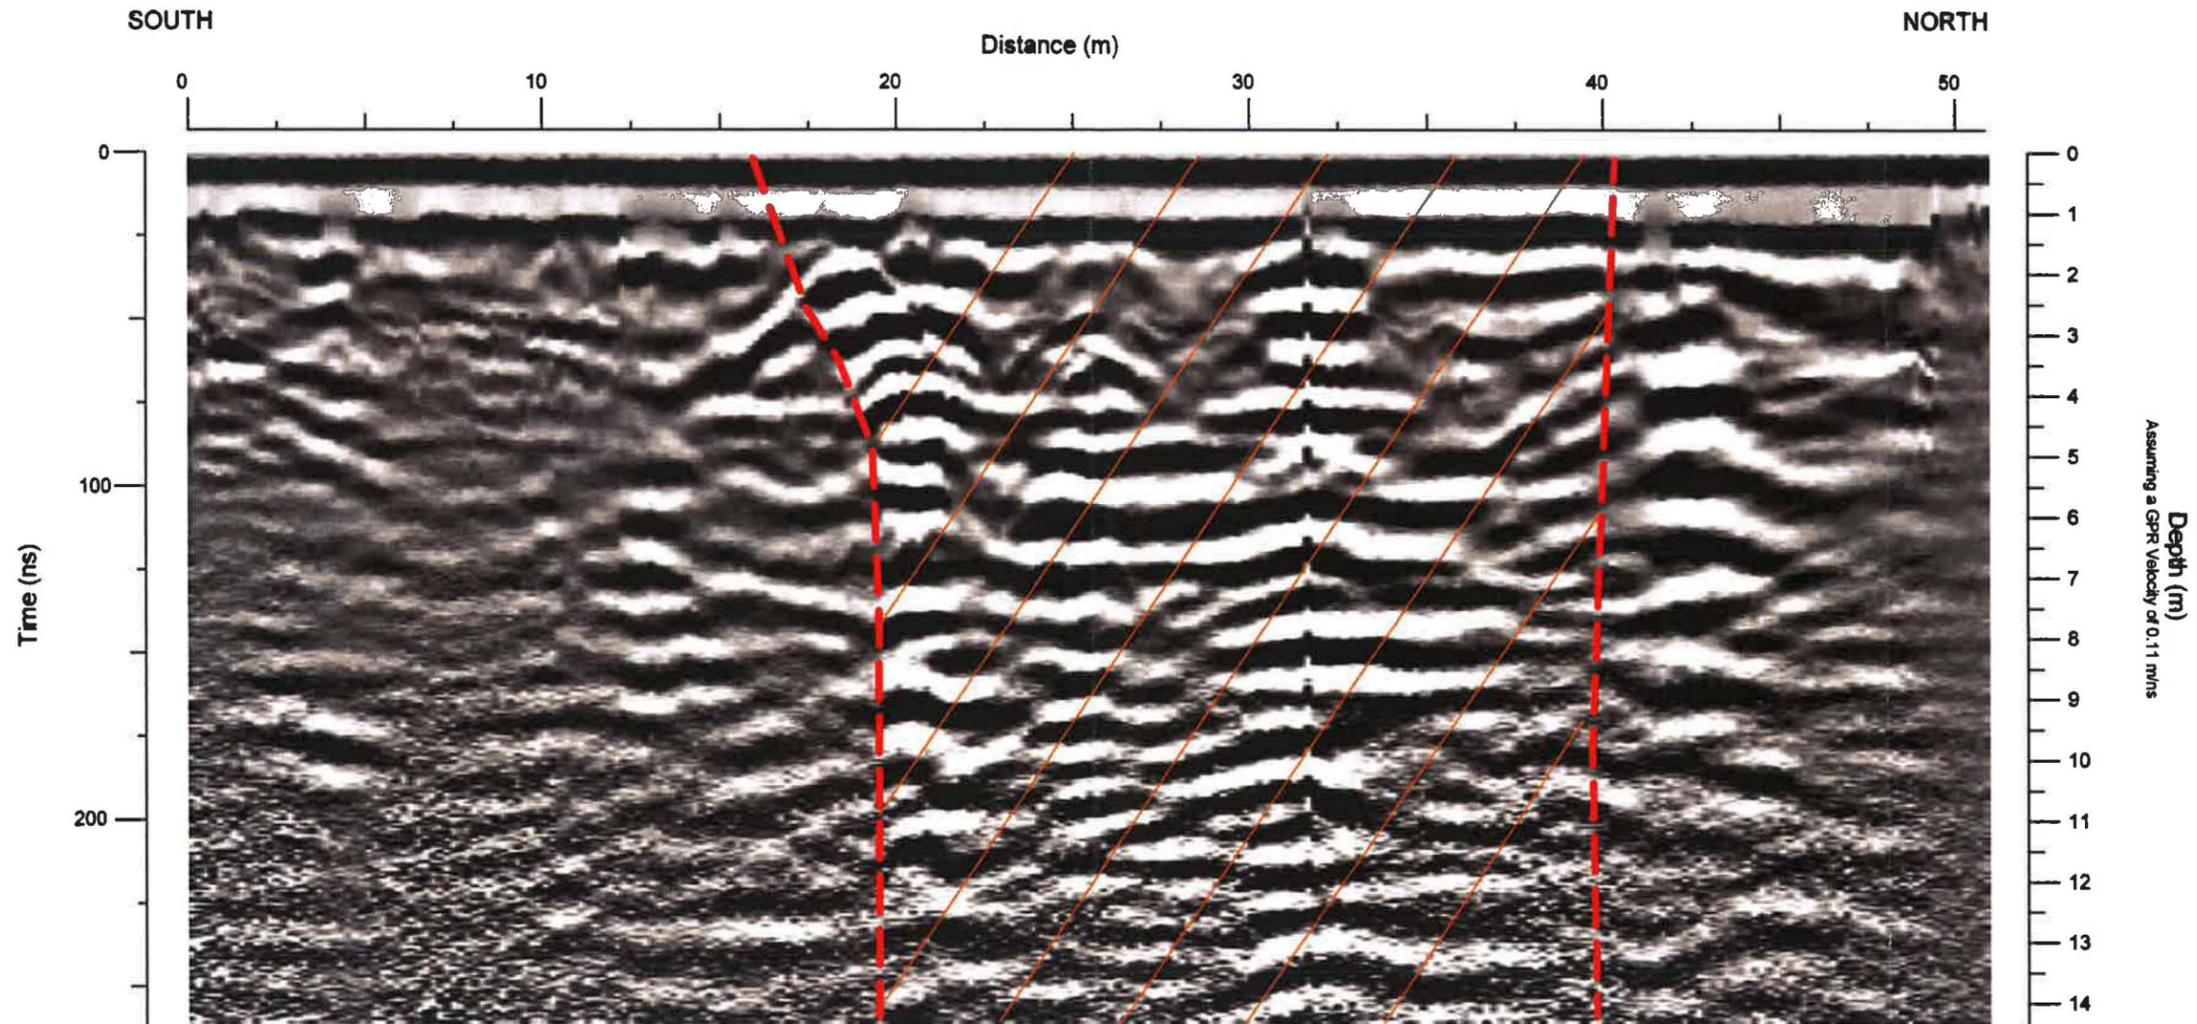
GPR LINE GC28 - 100 MHz

- / Interpreted Karstic Zone
- Interpreted Air Wave

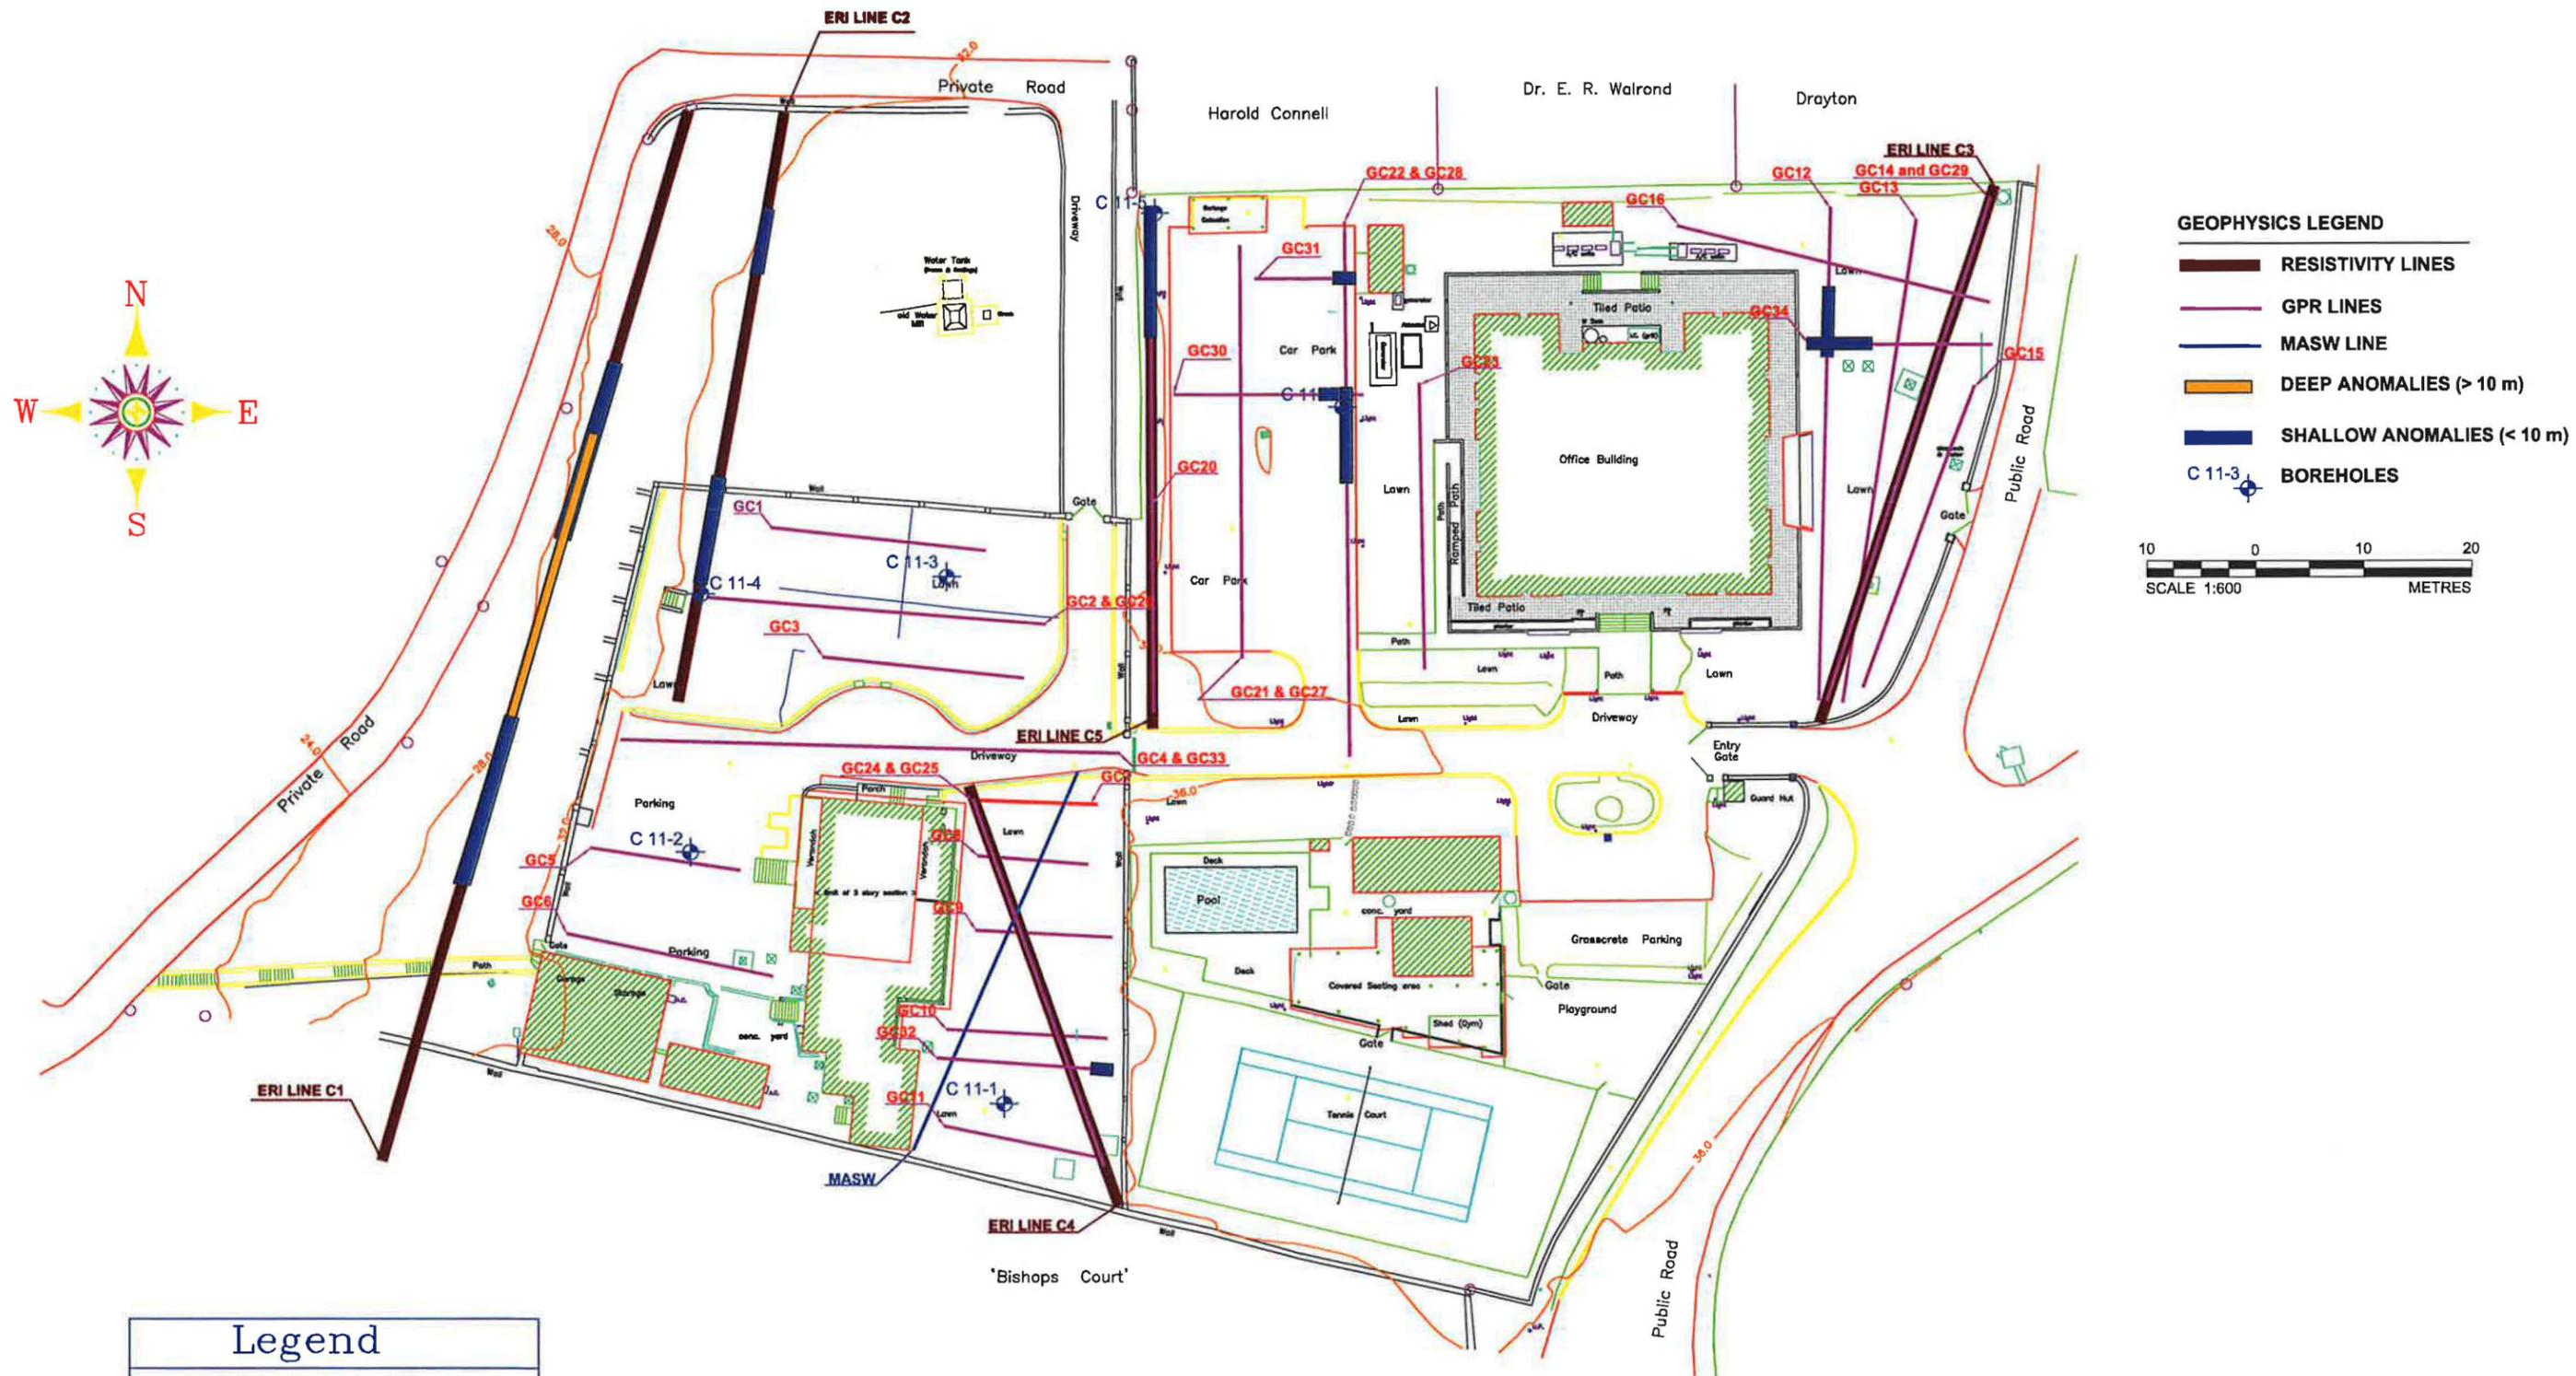
Several anomalies were observed in these surveys. Most of the anomalies were observed within 10 metres of the surface and generally located sporadically in the north half of the property. A deeper and more significant anomaly was observed along ERI Line C1 and possibly along ERI Line 2 in the western portion of the property as indicated in Figures 2, 3 and 10 of our technical memorandum in Appendix A. This deep anomaly was observed at a depth of 9 metres to the survey depth limit (15 metres) from the existing ground surface along ERI Line C1. Another possibly significant anomaly was observed in the staff parking lot. This shallower anomaly was also observed along GPR Lines C28 and C30. These areas were later explored by geotechnical boreholes to better define the composition of the subsurface conditions in these areas. These findings are presented in the Section 4.0, Subsurface Conditions.

- RESISTIVITY LINES
- GPR LINES
- MASW LINE
- DEEP ANOMALIES (> 10 m)
- SHALLOW ANOMALIES (< 10 m)
- BOREHOLES

The recent geophysical investigation carried out by Golder throughout much of the property indicates several anomalies or significant changes within the coral limestone, which could be related to karst activities. These anomalies were observed at a variety of depths and were grouped into shallow anomalies (less than 10 metres depth) and deep anomalies (greater than 10 metres) as shown in Figures 2 through 10 of our technical memorandum in Appendix A. Based on the subsurface conditions encountered within the boreholes put down along or near these survey lines, these anomalies generally consisted of less dense coral limestone with an increased in karst activity/formations. No significant large voids (> 3 metres) or caves were encountered in the boreholes, but several smaller voids (up to 1.5 metres in size) were encountered within the anomalies that were noted during the geophysical survey.

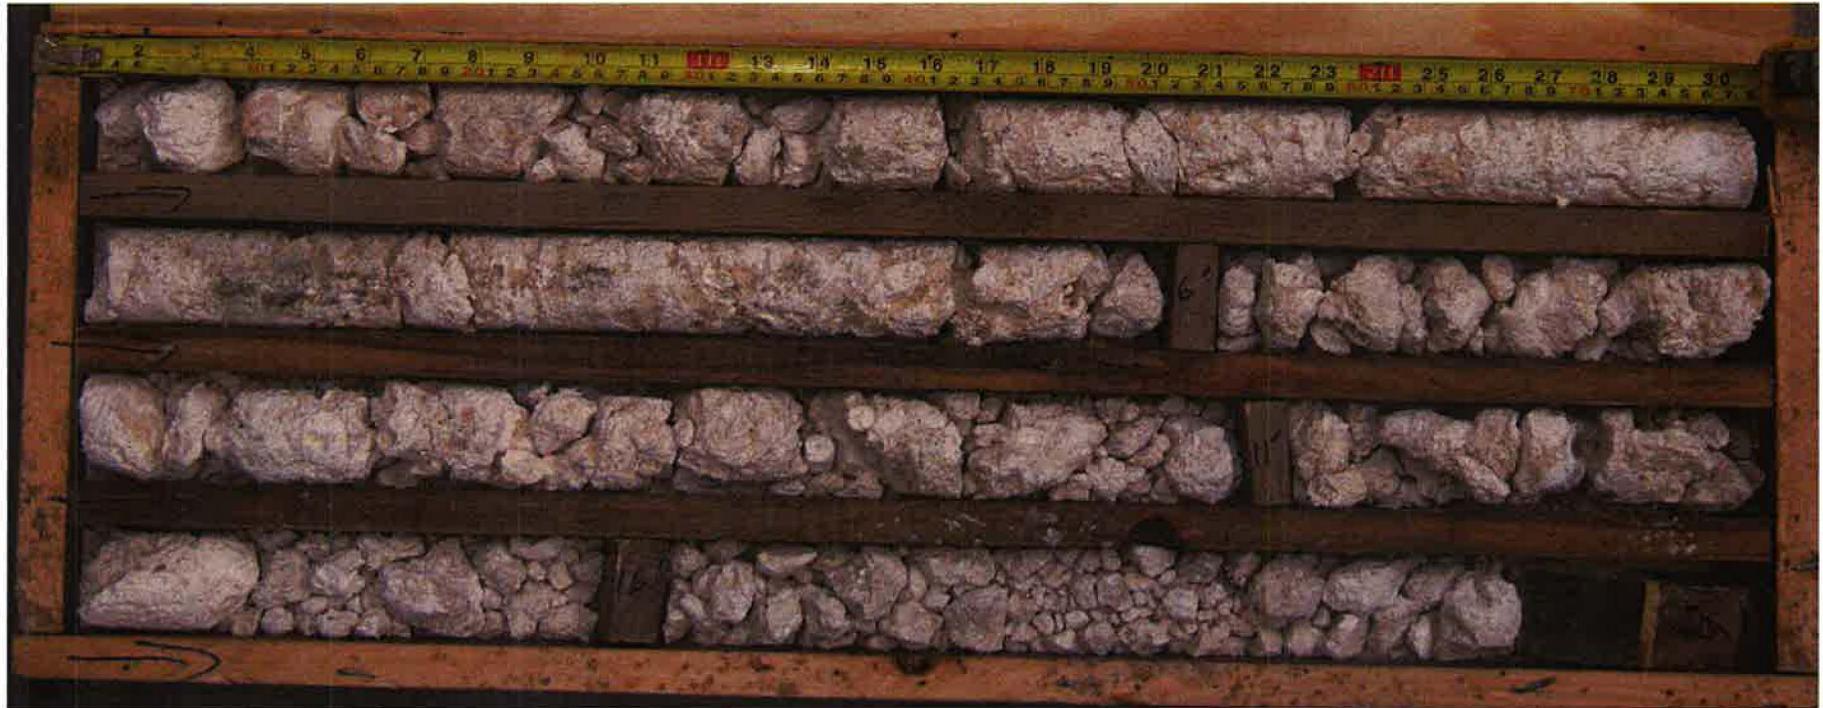
Bedrock Core from Borehole C11-1

Depth 0.46 m to 6.40 m

The coral limestone rock consists of discontinuous layers of highly fractured rock interbedded with layers of massive intact rock with numerous small cavities. In the rock core samples retrieved, the cavities within the coral limestone ranged from 5 to 30 millimetres in diameter. Larger voids were also encountered and are summarized below.

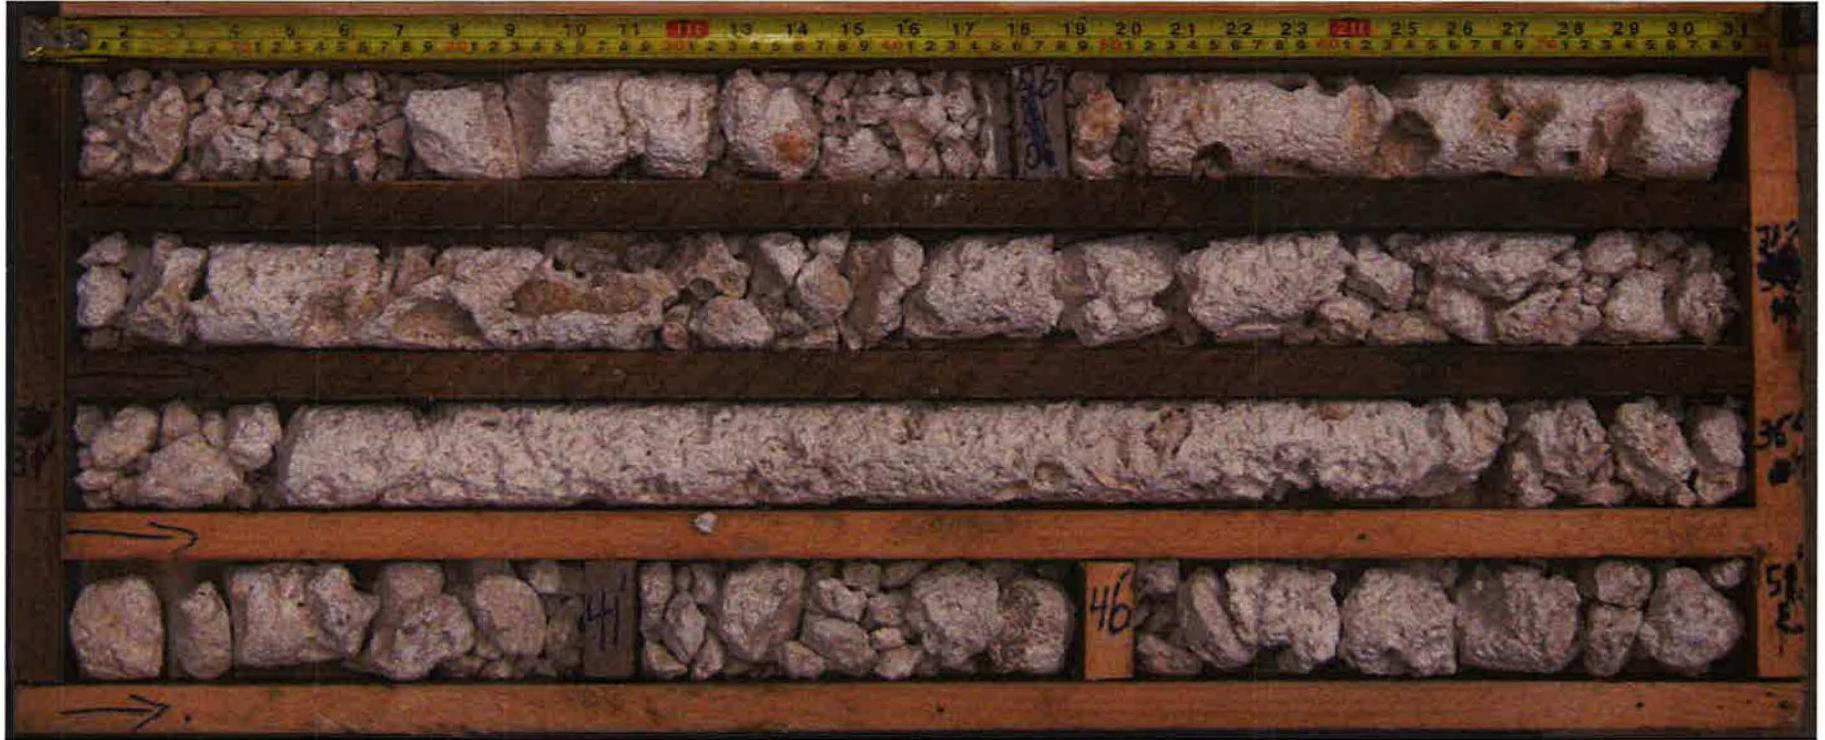
Bedrock Core from Borehole C11-1

Depth 6.40 m to 15.54 m

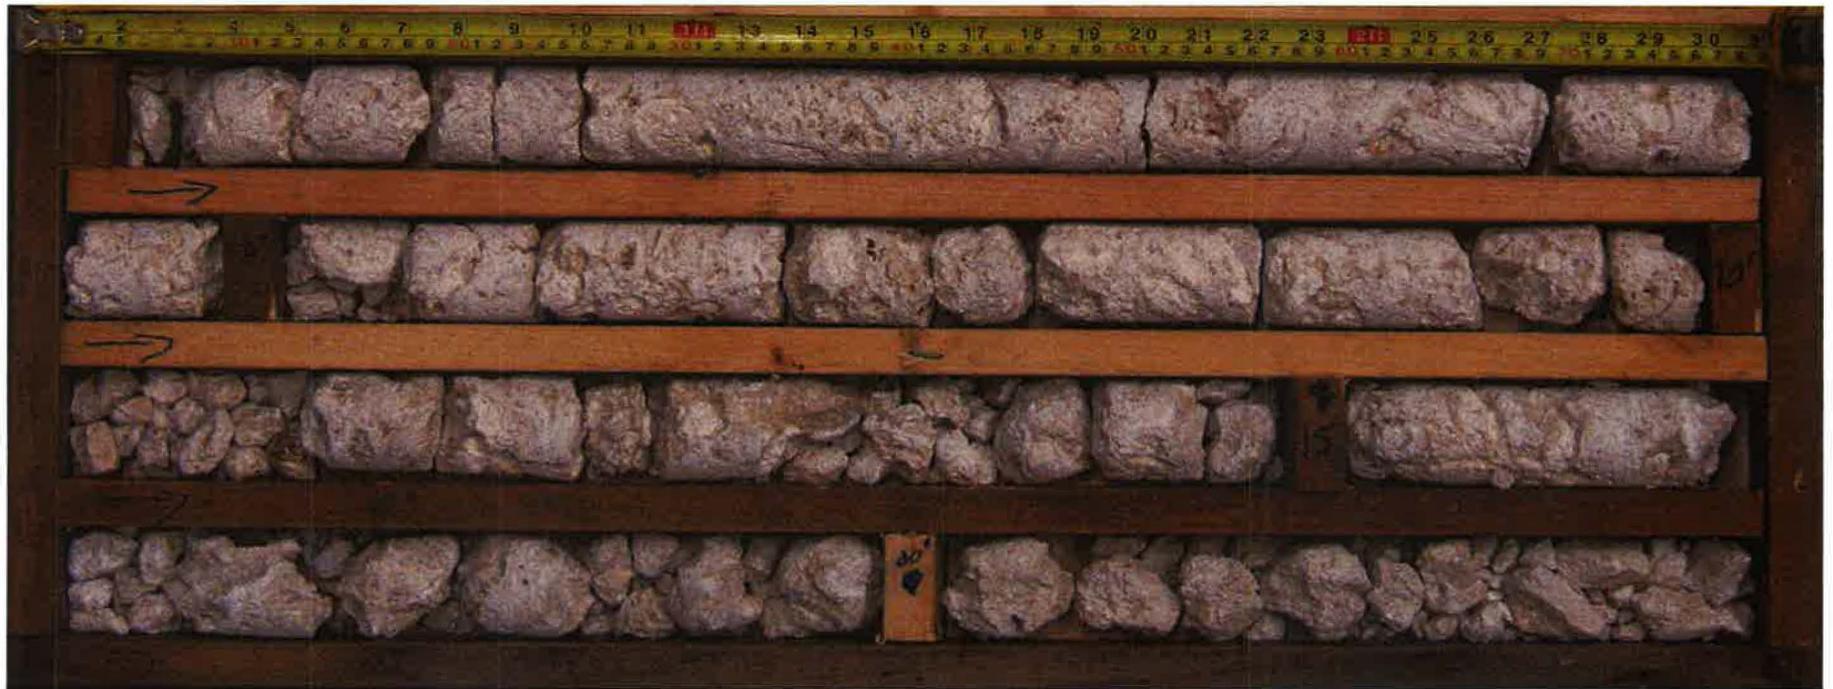
Bedrock Core from Borehole C11-2

Depth 0.61 m to 7.47 m

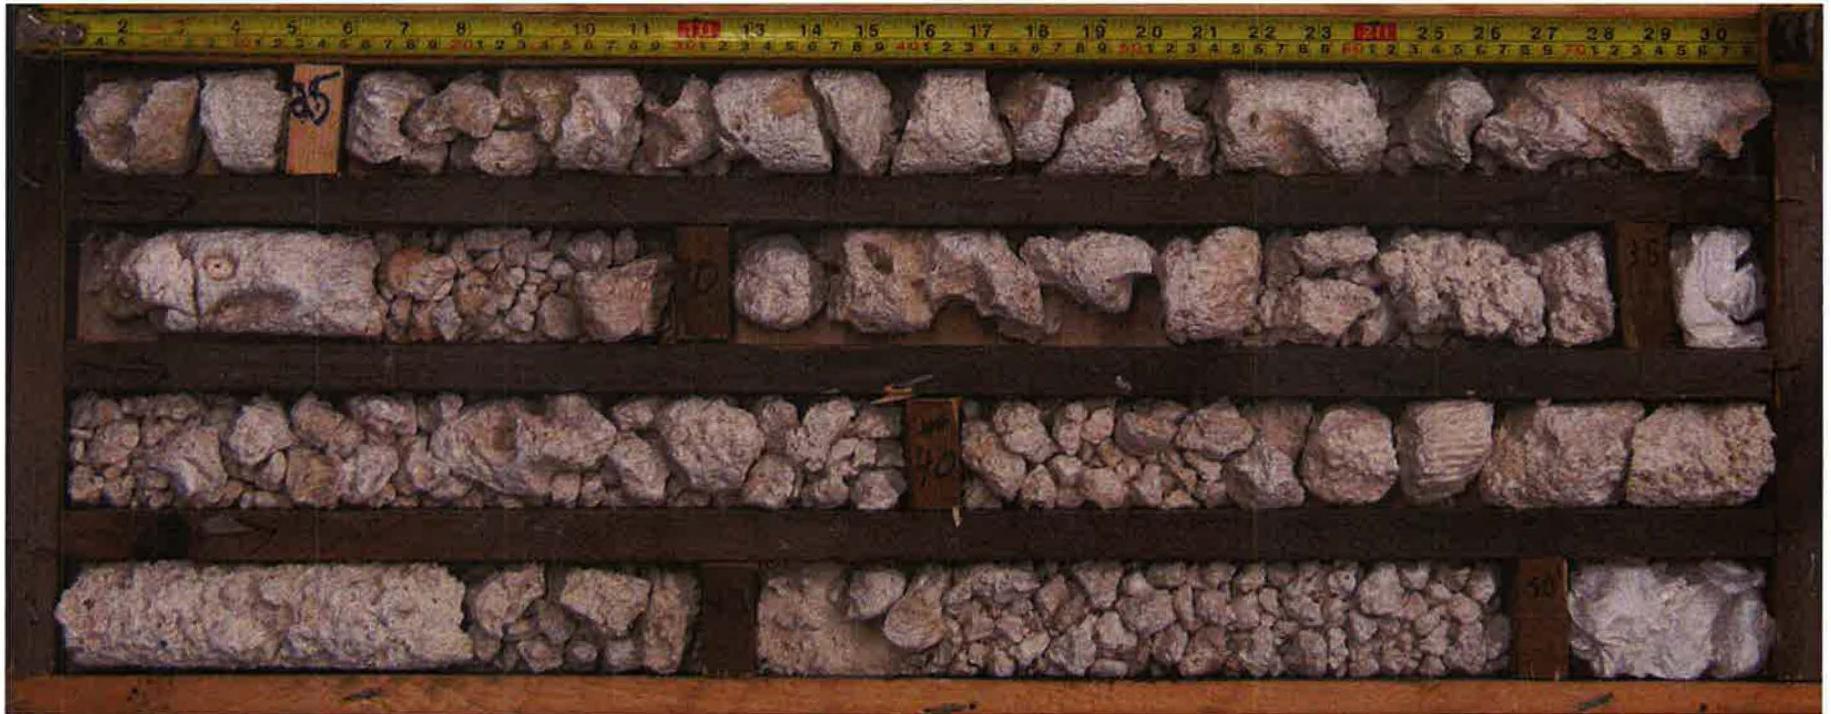
Bedrock Core from Borehole C11-2

Depth 7.47 m to 15.24 m

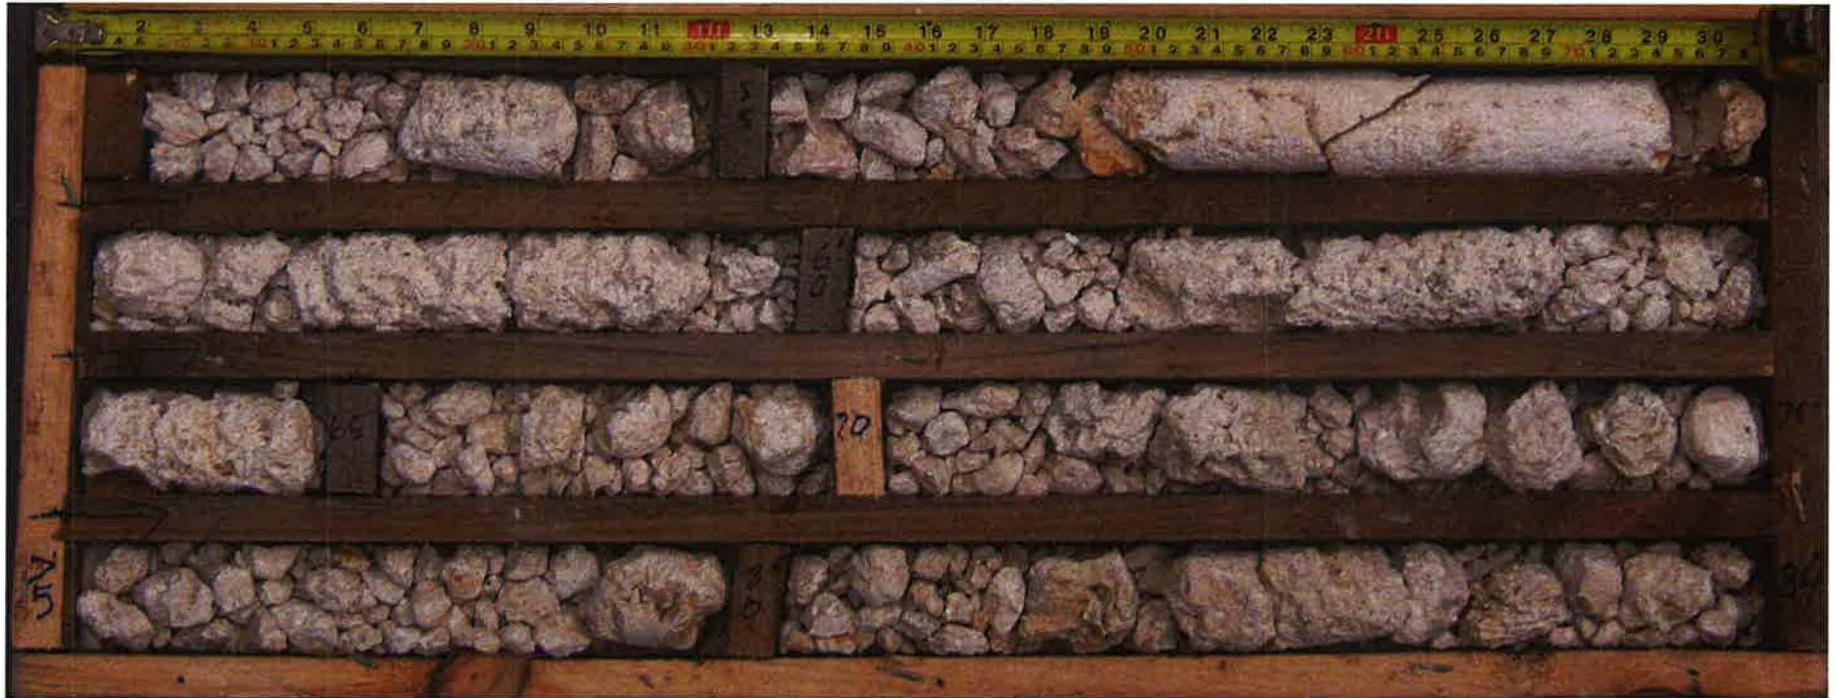
Bedrock Core from Borehole C11-2

Depth 15.24 m to 25.91 m

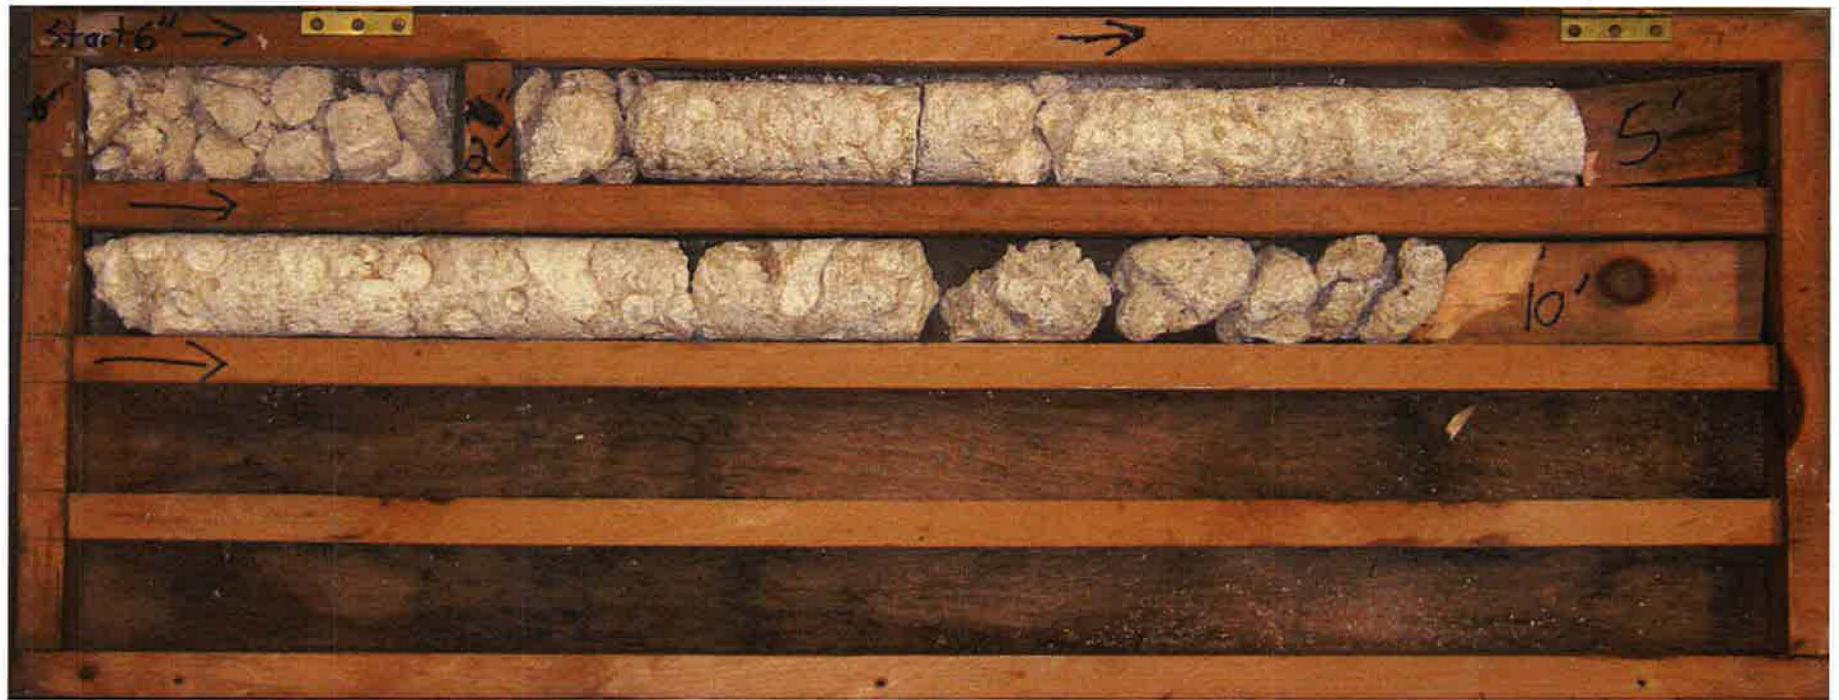
Bedrock Core from Borehole C11-3

Depth 0.18 m to 3.05 m
